National Register of Historic Places
Registration Form

other names/site number Crystal Springs Historic District

city or town Crystal Springs n/a vicinity

Historic and Architectural Resources of Copiah County, Mississippi

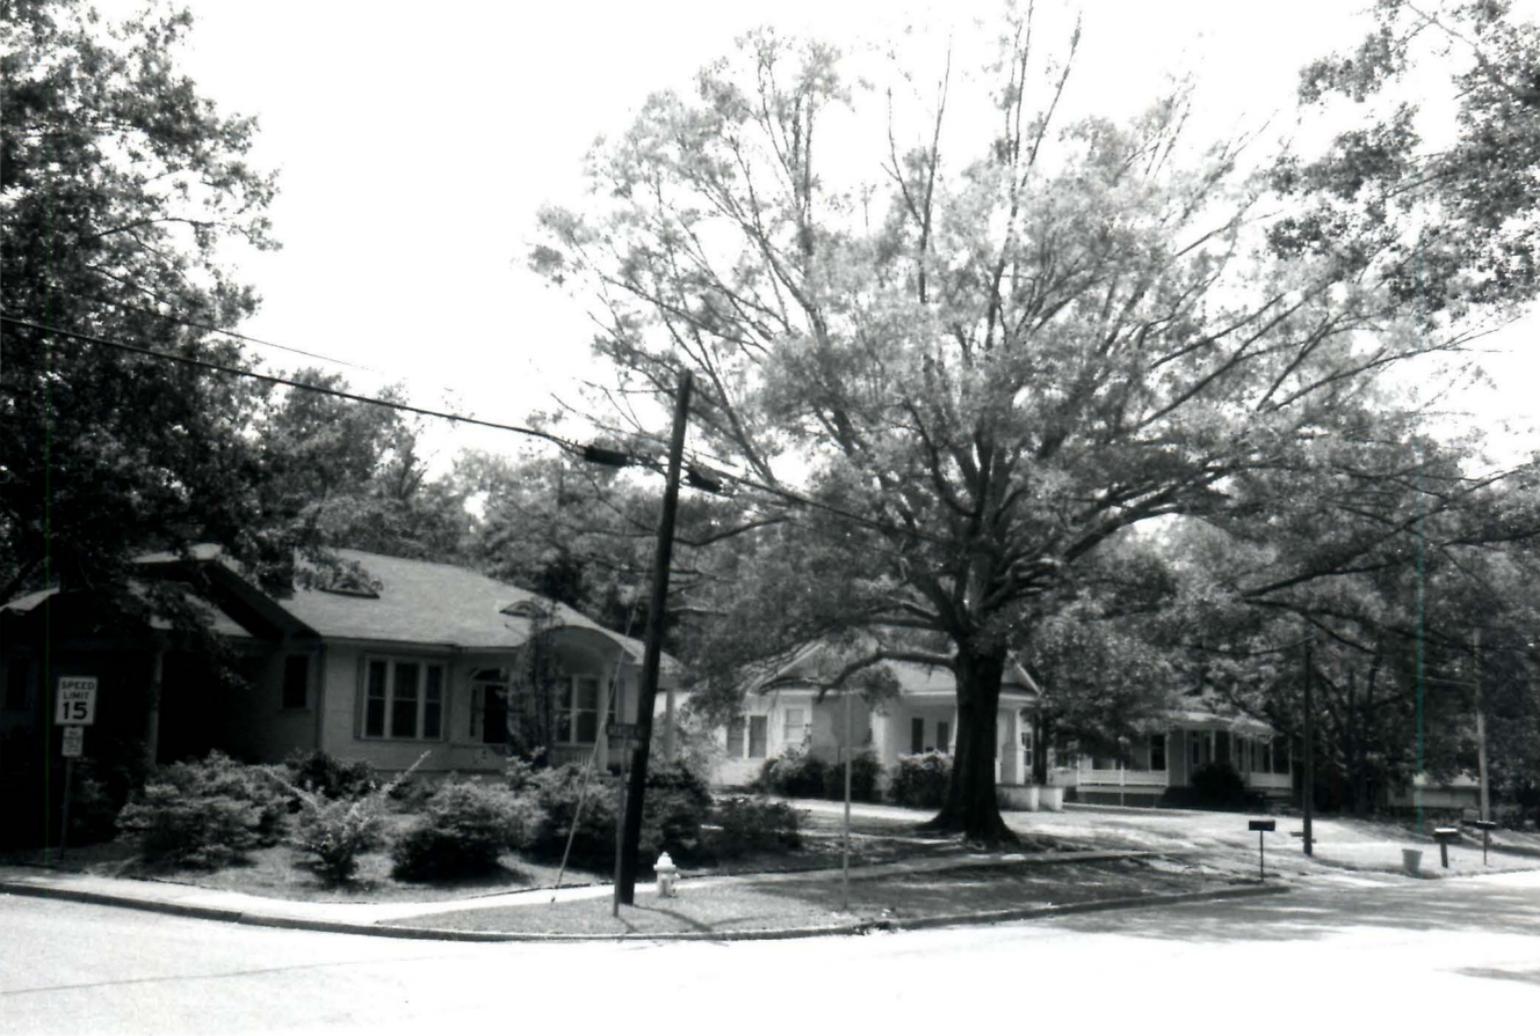
412, 410, 408 E. Georgetown St.
Crystal Springs Historic District
Catahulpa Co., MS
Photo 4 of 42

- 19A. **412 East Georgetown.** Colonial Revival. Between 1925-1930. Architect: Robert Cook Jones.
One-and-one-half story, frame, side-gabled house resting on a brick foundation and finished with narrow clapboard siding. The roof has clipped gables and is pierced by an interior end brick chimney and two eyebrow dormers. The three-bay main facade has a central, single-leaf, panelled door topped by a fanlight and framed by four-light sidelights, and the entrance is protected by a one-bay portico with Tuscan columns. The entrance is flanked by tripartite windows composed of a central 9/1 double-hung sash framed by 6/1 sash. The west elevation has a porte cochere with clipped gable roof supported by Tuscan columns on brick pedestals, while the east elevation has a porch with clipped gable roof supported by Tuscan columns. (Photo #4) (C)

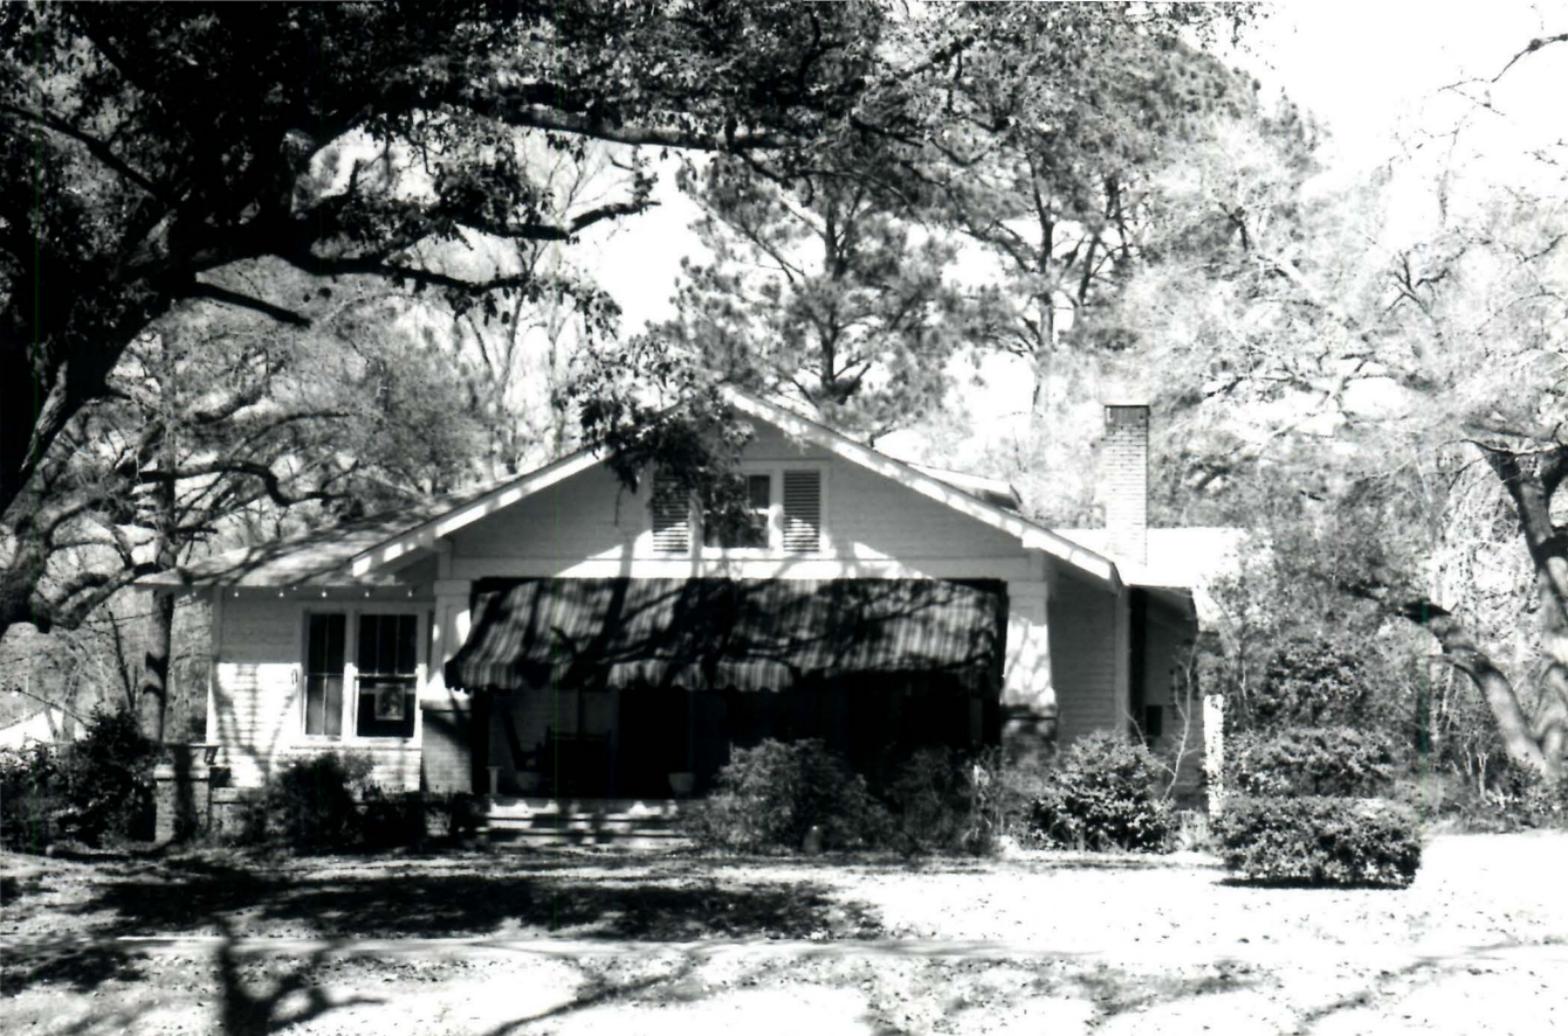
Photo 6 of 42

- B. Outbuilding. Ca. 1980. Concrete block, gable-front building with full-width integral porch having turned posts on brick pedestals. (NC)
22. **503 East Georgetown. Robert Cook Jones House.** California Craftsman. Ca. 1922. Designed by Robert Cook Jones.
One-and-one-half story, frame bungalow resting on brick foundation and crowned by a hip roof with intersecting cross gables. There are exposed rafter tails in the eaves and purlins in the gables. The three-bay facade has a central glazed and panelled door with three-part transom (2/5/2) and sidelights of paired, short, vertical lights set above large panelled aprons. The entrance is flanked by tripartite windows of 3/1 double-hung sash flanked by 4-light casements. The two-bay, gabled porch has battered and panelled columns on brick pedestals, a brick balustrade, and a concrete deck that extends to the west as a terrace, which is fronted by a low brick wall with concrete coping. The front gable has a 3/1 window flanked by louvers. An exterior end brick chimney is on the east elevation, and both side elevations have shed dormers. (Photo #6) (C)

Robert Cook Jones House, 503 E. Georgetown (#22)

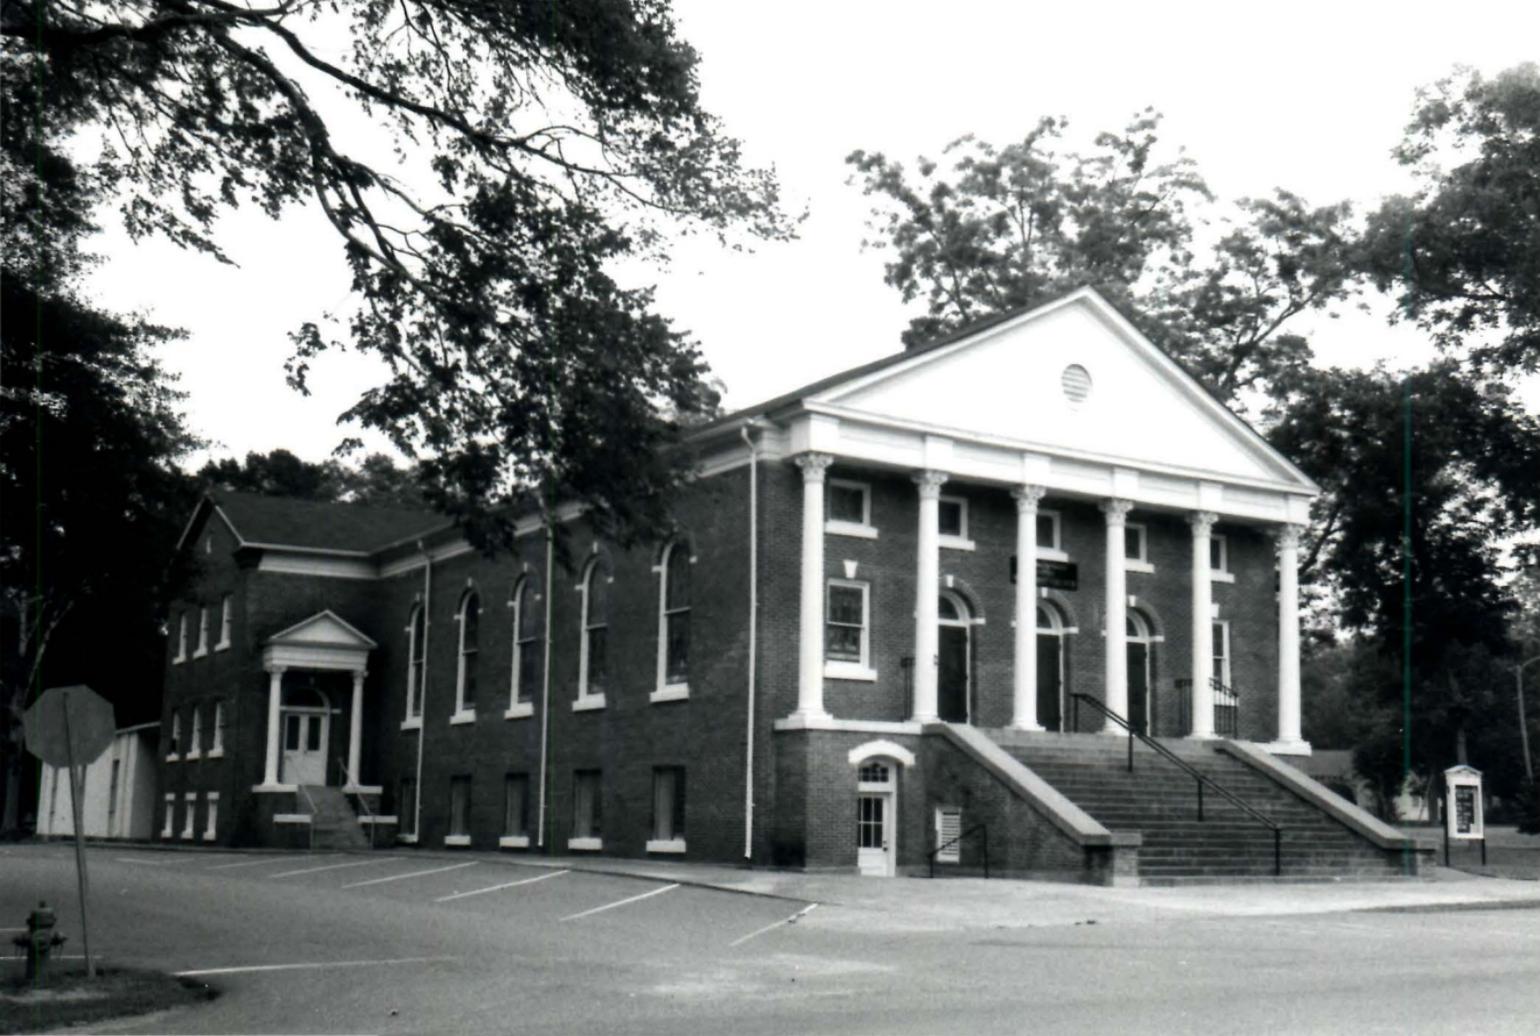
Photo 9 of 42

- 40A. **306 West Georgetown. Crystal Springs United Methodist Church.** Neoclassical Revival. 1919.
Front-gabled, brick, T-shaped, one-story church on high raised basement. In the central three bays of the main facade are double-leaf, three-panel doors with round-arched, stained glass fanlights, and the doors are trimmed with radiating voussoirs with concrete keystones and spring blocks. In the outer bays are stained glass, double-hung windows with brick jack arches and concrete keystones. Above each of the five openings is a small stained glass window with concrete sill. A full-width portico, accessed by a flight of 18 steps framed by a low brick wall with concrete coping, features fluted Corinthian columns supporting a pediment with flush board tympanum and circular louvered vent. The frieze is panelled. The basement windows of the facade are wood 6-light sash topped by 8-light transoms, set within segmentally-arched openings topped by concrete lintels. The side elevations have round-arched, stained glass windows with brick radiating voussoirs and concrete keystones, spring blocks, and sills. The basement windows of the side elevations are jalousie windows. In the cross bar of the T is a double-leaf, panelled and glazed door with round-arched, stained glass fanlight, and the entrance is protected by a one-bay portico with fluted Corinthian columns supporting a pediment trimmed with a full entablature. The cross bar of the T is two-story with a basement; the basement windows are 6-light with concrete lintels and sills, while the openings on the first and second stories are 12/12 sash with concrete sills. (Photo #9) (C)

Crystal Springs United Methodist Church, 306 Nl. Georgetown
(#40)

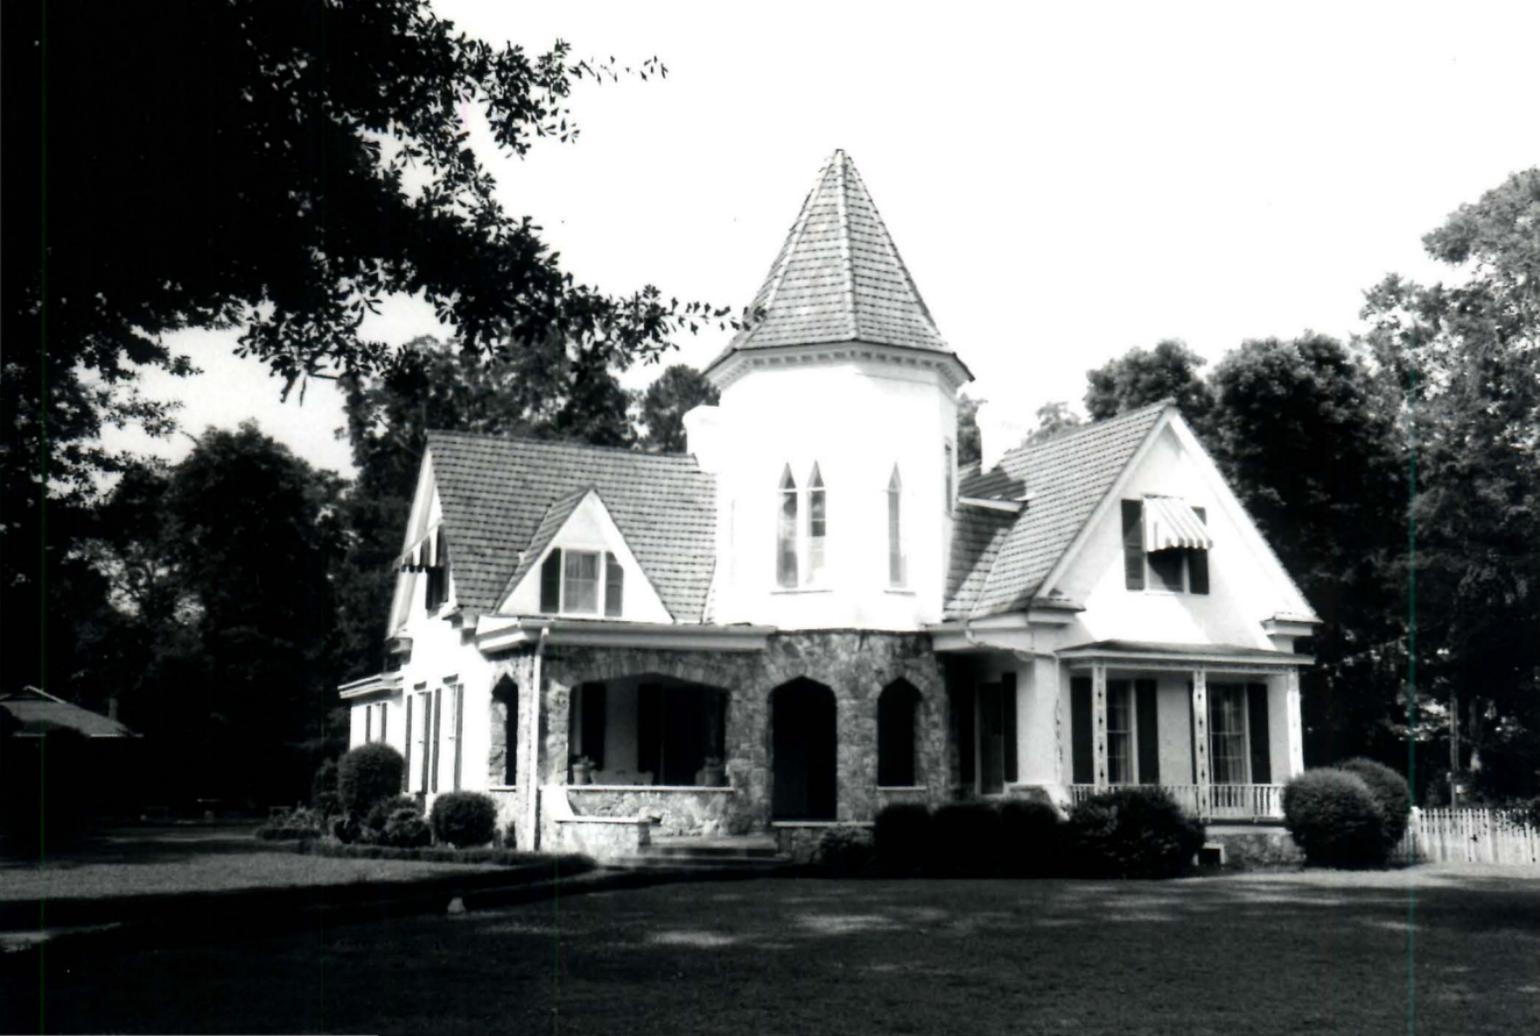
Photo 12 of 42

- 52A. **601 West Georgetown. Garland House.** Tudor Revival. Ca. 1858/Ca. 1938.
Although originally constructed ca. 1858, this one-and-one-half story house was extensively remodeled in 1938, with the weatherboard walls being stuccoed and uncoursed rubble stone foundation and porch added. The complex gable roof is clad in slate, and two stuccoed interior chimneys with corbelled caps and a skylight pierce the roof. The house is dominated by a two-story, polygonal tower with pointed arched openings and polygonal slate roof trimmed with modillions (a circa 1920 photograph shows the house with the tower, which was probably added around the turn of the century). The three-bay porch has Tudor arched openings and is constructed of uncoursed rubble stone walls and balustrade. The projecting gable on the west end of the facade has two floor-length, 6/9, double-hung windows opening onto a porch with pierced wooden columns and frieze and is enclosed by a balustrade with turned balusters. In the upper gable is a 6/6 window. The main entry is a panelled, 2-light door, to the east of which are two floor-length, 6/9 windows. Windows on the side elevation are 6/6. (Photo #12) (C)

Crystal Springs, 601 W. Georgetown (#52)

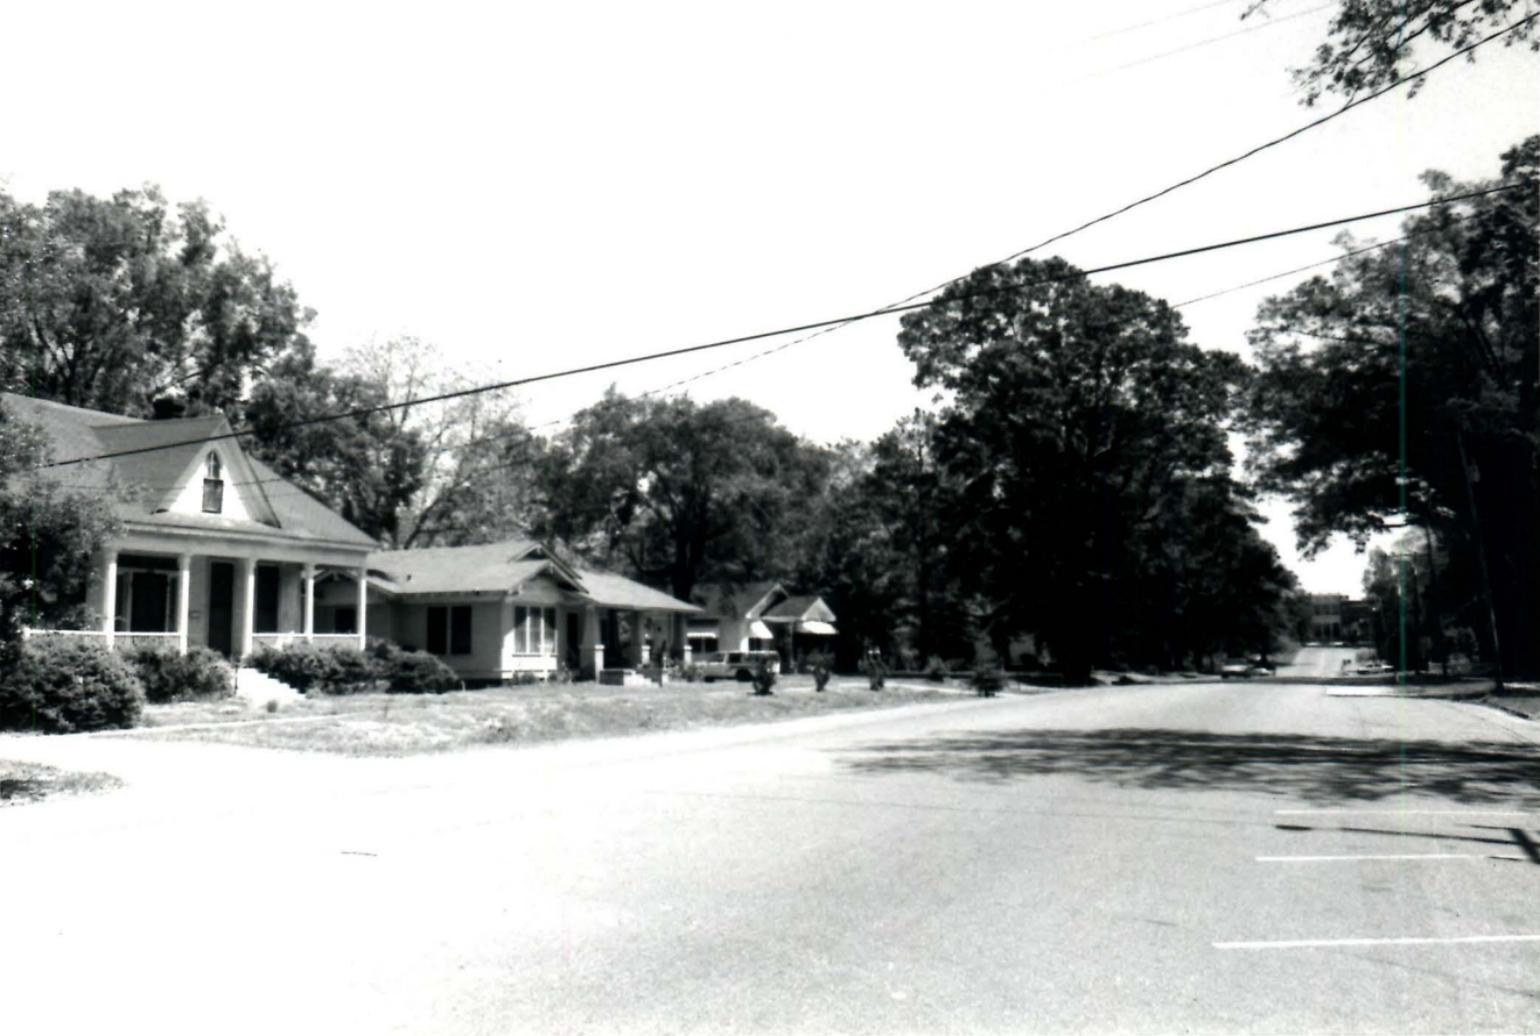
Photo 22 of 42

94. **309 East Marion.** Craftsman. Between 1925-1930.
One-story, frame bungalow on brick foundation and crowned by a multi-gable roof with decorative purlins in the gables and exposed rafter tails in the eaves. The main entrance is a French door, and windows are 9/1 double-hung sash arranged singly, in pairs, and in trios. The porch originally wrapped around a portion of the south and east elevations, but was enclosed on the east elevation to create a sun porch. The porch features a wooden deck and battered and panelled box columns on brick piers. The south elevation of the sun porch has a French door flanked by multi-light sidelights, and on the east elevation are three pairs of 10-light casements. (See Photo #22) (C)

East Marion St., view to NE (307, 309, 311 E, Marion)

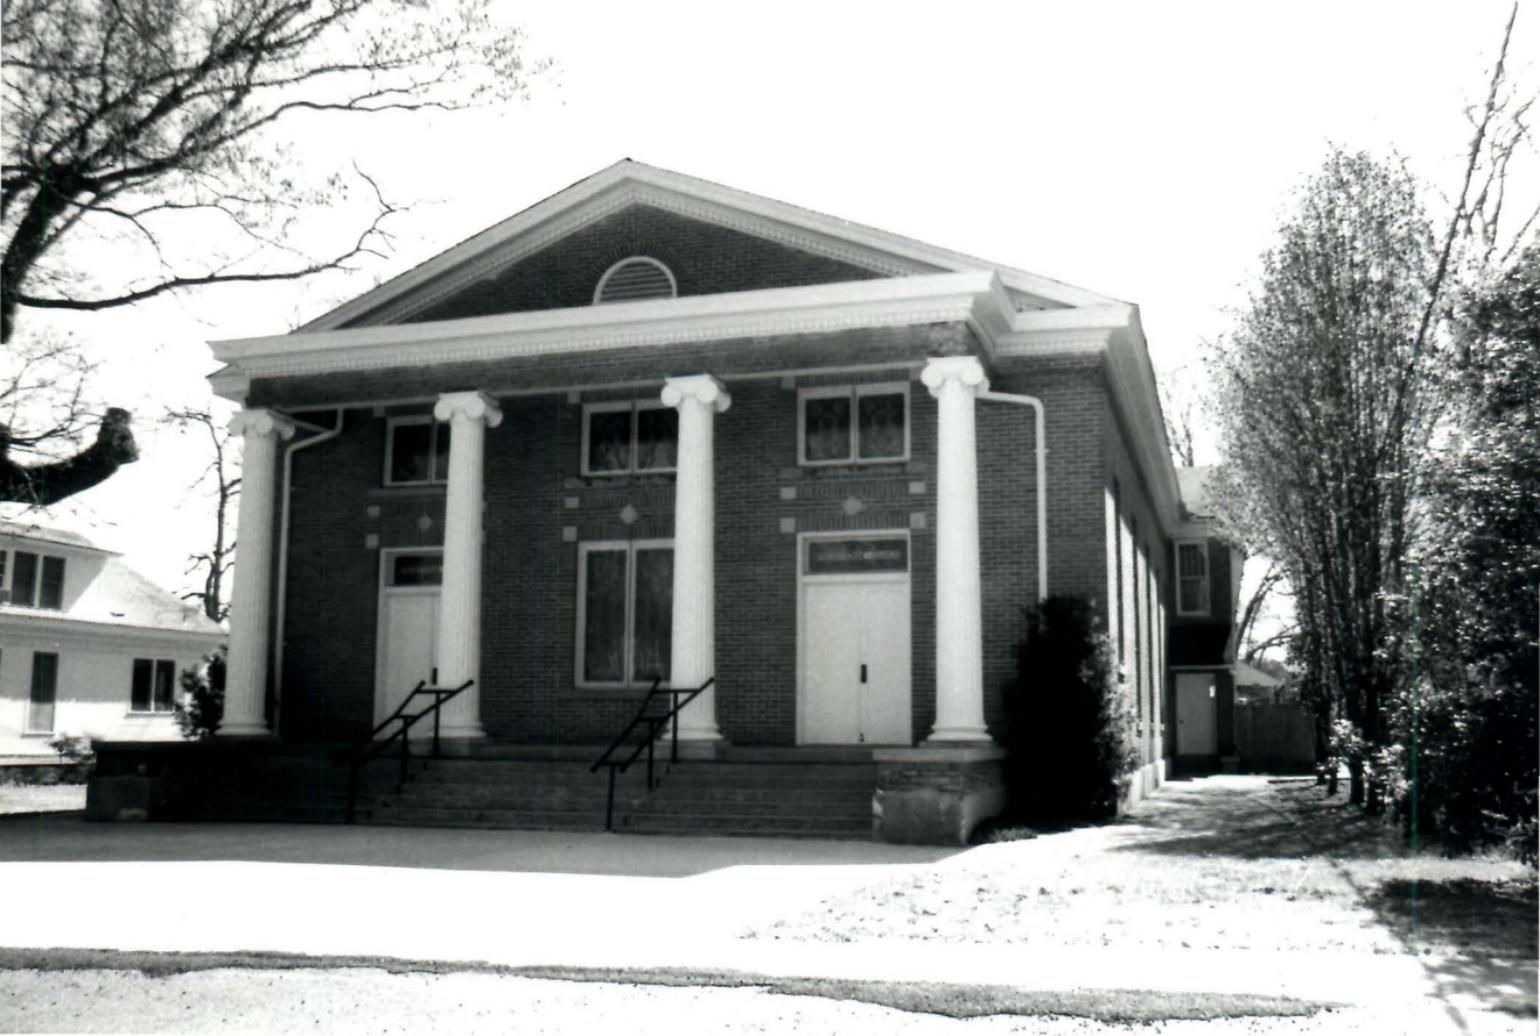
100. **316 East Marion. First Presbyterian Church.** Neoclassical Revival. 1926.
One-story, brick, gable-front, T-shaped, Neoclassical Revival church building resting on concrete foundation and dominated by a full-width portico featuring Ionic columns supporting a flat roof with denticulated frieze. The walls of the church are blond brick with a decorative belt course above the windows composed of three rows of corbelled red brick. The three-bay main facade has double-leaf, one-panel doors with stained glass transoms in the outer bays, and in the center bay is a pair of stained glass casement windows. Above these three openings is decorative brickwork and smaller paired stained glass casements. The gable is pedimented and has a denticulated frieze, and a semicircular ventilator with red brick trim is in the tympanum. The side elevations have five stained glass windows with flat jack arches and concrete keystones and sills. The Sunday school rooms are located in the cross-bar of the "T" and feature 4/1 windows. A sympathetic brick addition to the rear of the church has been made and also features 4/1 windows. (Photo #23) (C)

Crystal Springs Church 316 E. Marion (#100)
Copiah Co., MS Historic District
Photo 23 of 42

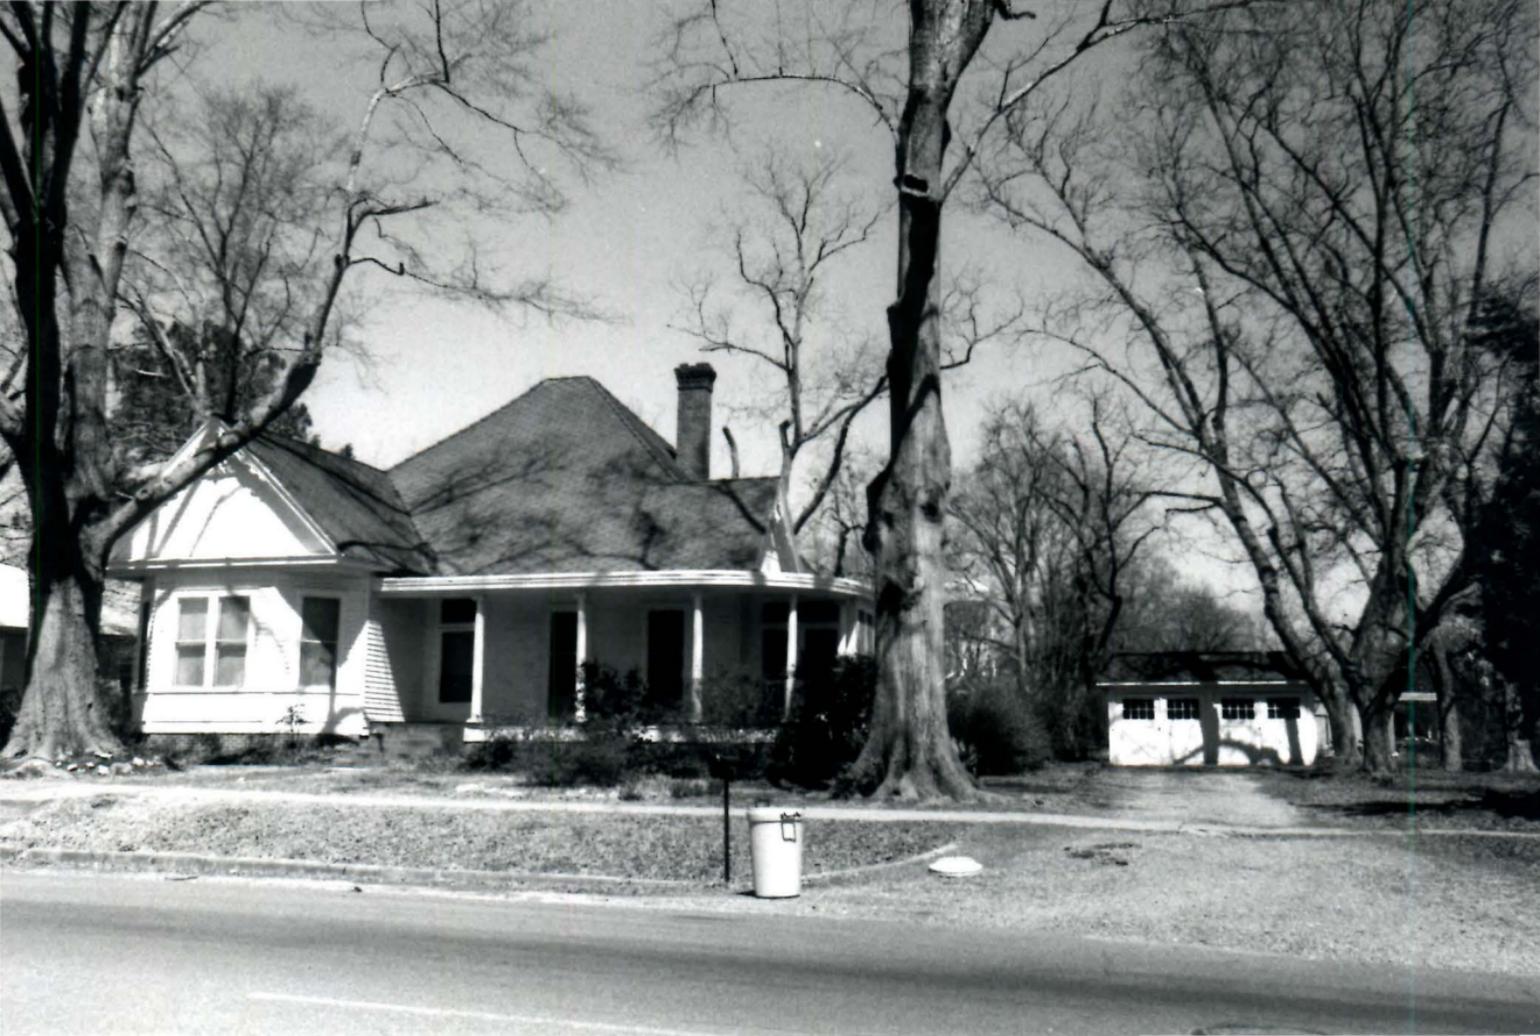
- 101A. **317 East Marion.** Queen Anne Free Classic. Ca. 1905.
This one-story, frame house rests on a brick foundation and is crowned by a steeply pitched hip roof with lower intersecting cross gables. A tall brick chimney with corbelled cap pierces the roof. The main facade has a projecting cutaway gabled bay on the west end that features 1/1 double-hung windows set above a vertical beaded board wainscot. The gable is clad in a variety of imbricated shingles, and an ornate sawn and spindled gable ornament is in the gable peak. The main entrance is a single-leaf glazed door with a single-light transom, and the two windows to the east are 1/1 sash. The wraparound porch with wooden deck and Ionic colonettes is enclosed on the east side elevation by eleven 4/4 windows to create a sun room, which is accessed from the porch by double-leaf, 10-light French doors topped by a 5-light transom. Gables with a variety of imbricated shingles and gable ornaments pierce the roof on each side elevation. Windows on the west elevation are 2/2 sash, and an ell extends from the west end of the rear elevation. (Photo #24) (C)

317 E. Marion (#101)
Crystal Springs Historic District
Copiah Co., MS
Photo 24 of 42

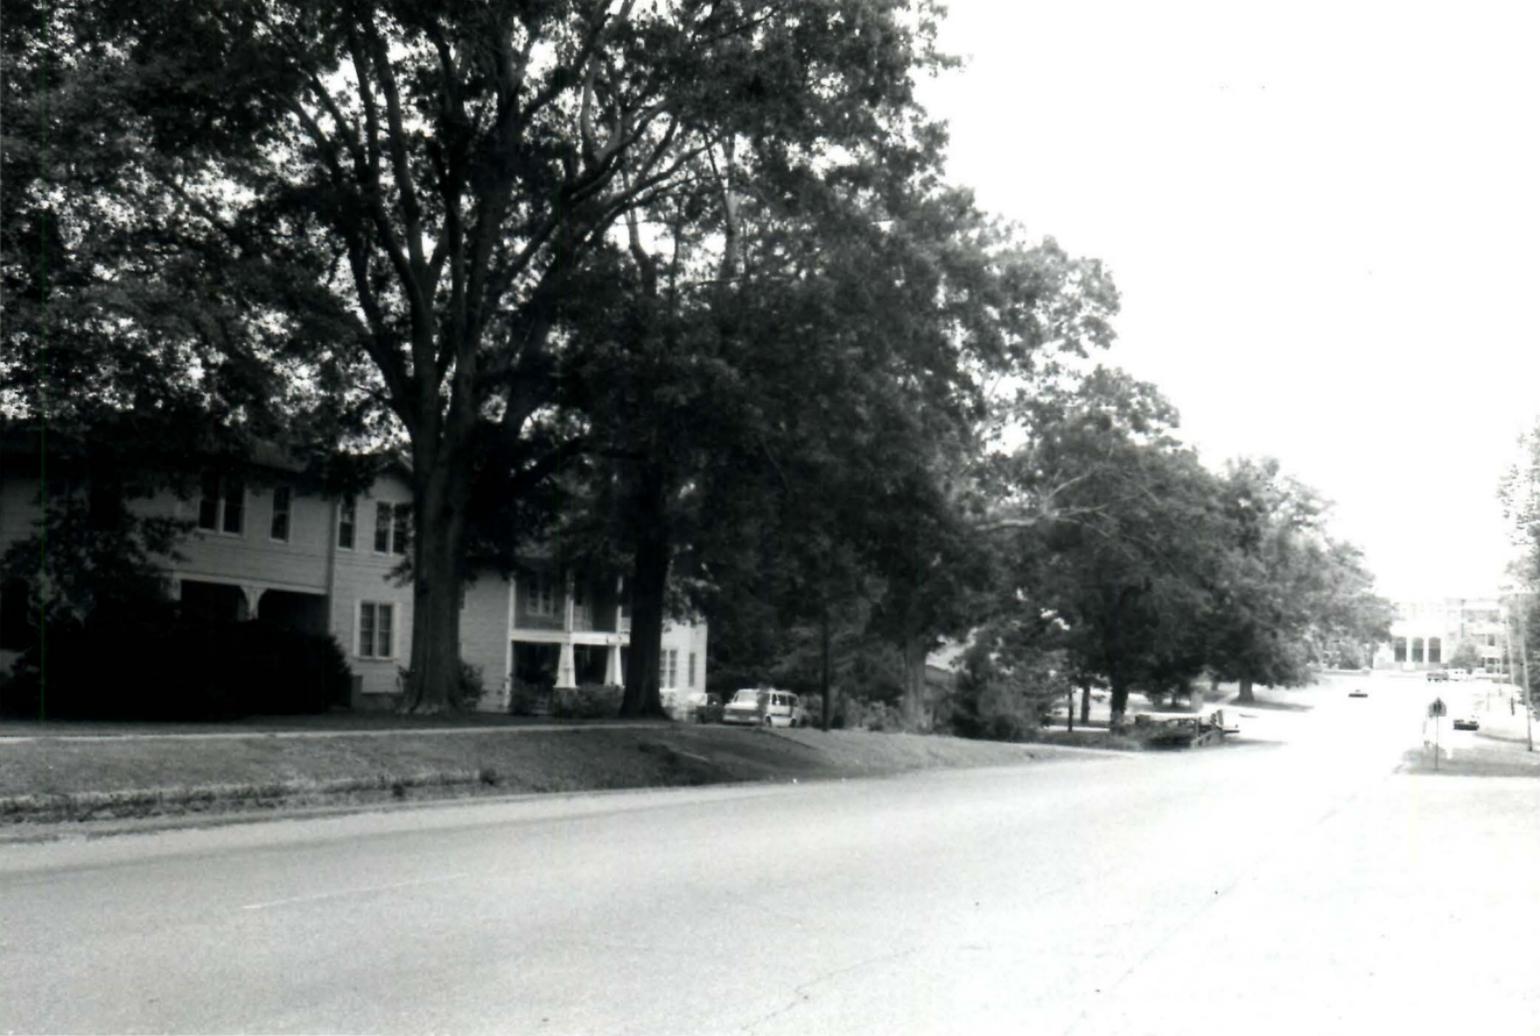
Photo 25 of 42

103. **319 East Marion. Old Henington Hotel.** Craftsman influence. Ca. 1910/Ca. 1920
Two-story building resting on a brick foundation and clad in composition shingles. The roof is hipped with intersecting gables, and there are exposed rafter tails in the eaves and knee braces in the gables. The main facade has a two-bay, one-story recessed porch with battered and panelled box columns resting on brick pedestals. The porch apparently was originally two-tiered, like that of 321 E. Marion, but the upper level has been enclosed. The main entrance is a single-leaf, glazed and panelled door, and windows throughout are 6/6 and 9/6 double-hung sash arranged singly and in pairs. According to the present owner, James Harris, this building originally was a one-story, five-room structure but was added onto 13 times, to become a two-story building connected to 321 East Marion by a one-story covered walkway that has been removed. The 1915 Sanborn map shows this building as one-story, but by 1925 it had achieved its present form. This building housed hotel rooms as well as the dining rooms and kitchen for the hotel. (Photo #25) (C)

Old Henington Hotel, 319 and 321 E. Marion, looking
east toward Crystal Springs Consol. School

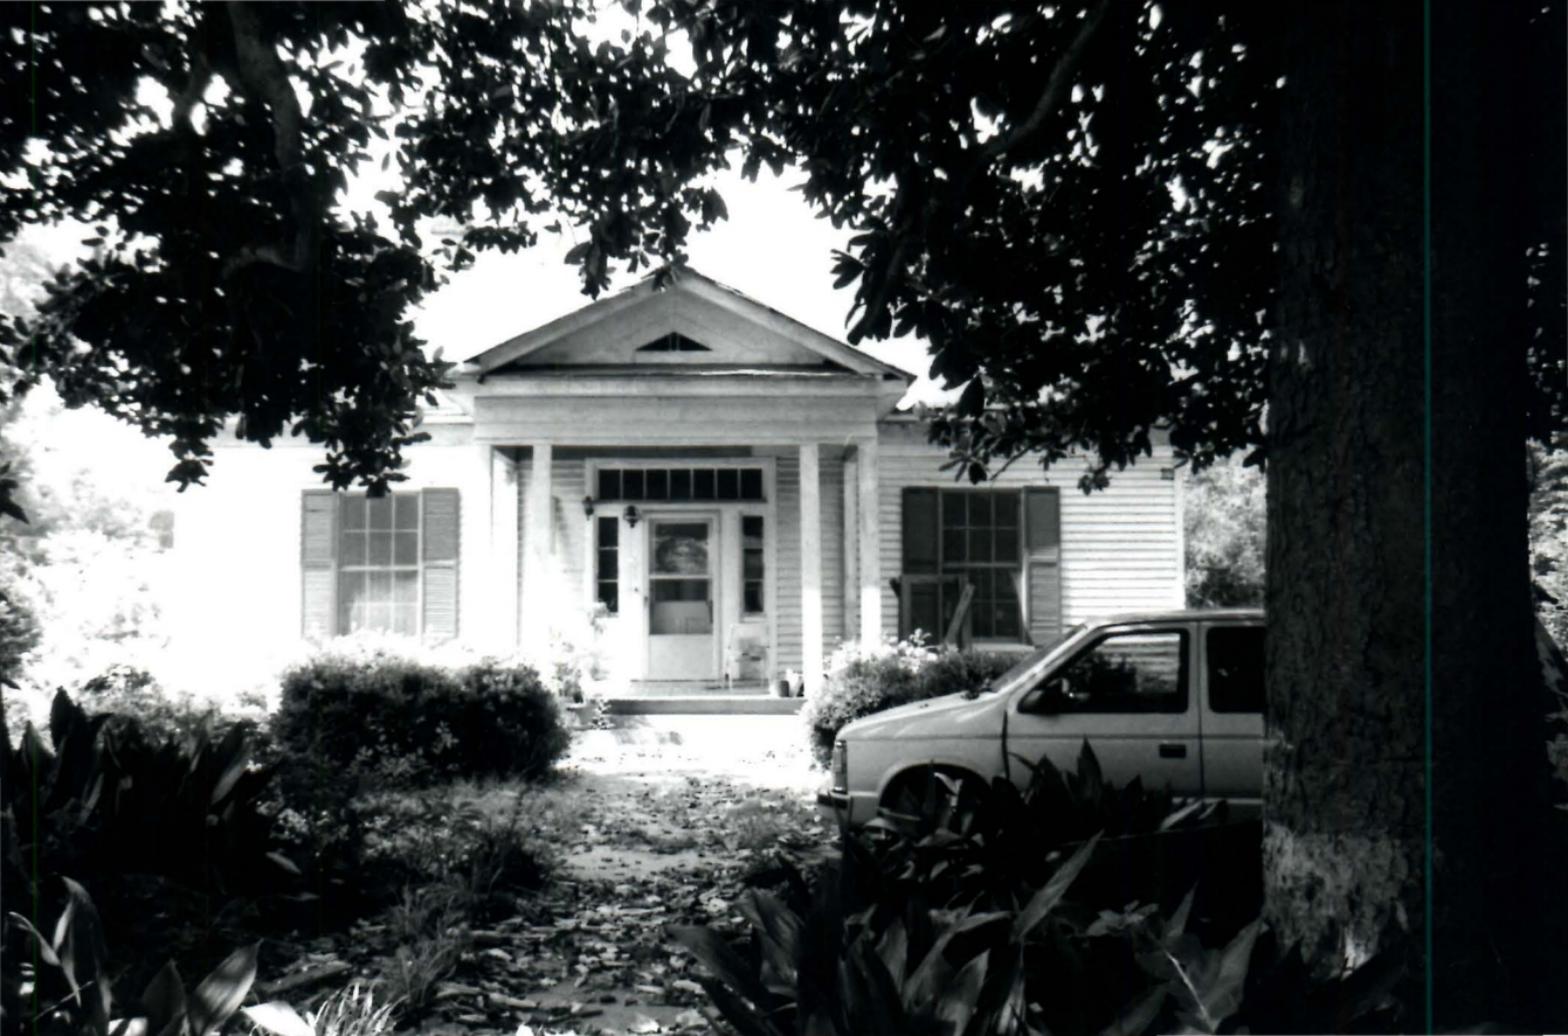
Photo 30 of 42

136. **501 West Marion. Wilson House.** Greek Revival. Ca. 1860.
One-and-one-half story, frame, side-gabled, Greek Revival cottage on brick foundation piers. The roof is pierced by an interior brick chimney with corbelled cap and trimmed with incomplete cornice returns. The main facade has a central single-leaf, panelled and glazed door with 7-light transom and 3-light sidelights. The house originally had a portico that was replaced in the 1920s by a full-width porch, which in turn was replaced about 1993 by the present one-bay portico with paired plain posts. To each side of the entrance is a 6/6 double-hung window. An ell extends from the east end of the rear elevation. Windows throughout are 6/6 sash. (Photo #30) (C)

Wilson House, 501 W. Marion (1922)
Historic District

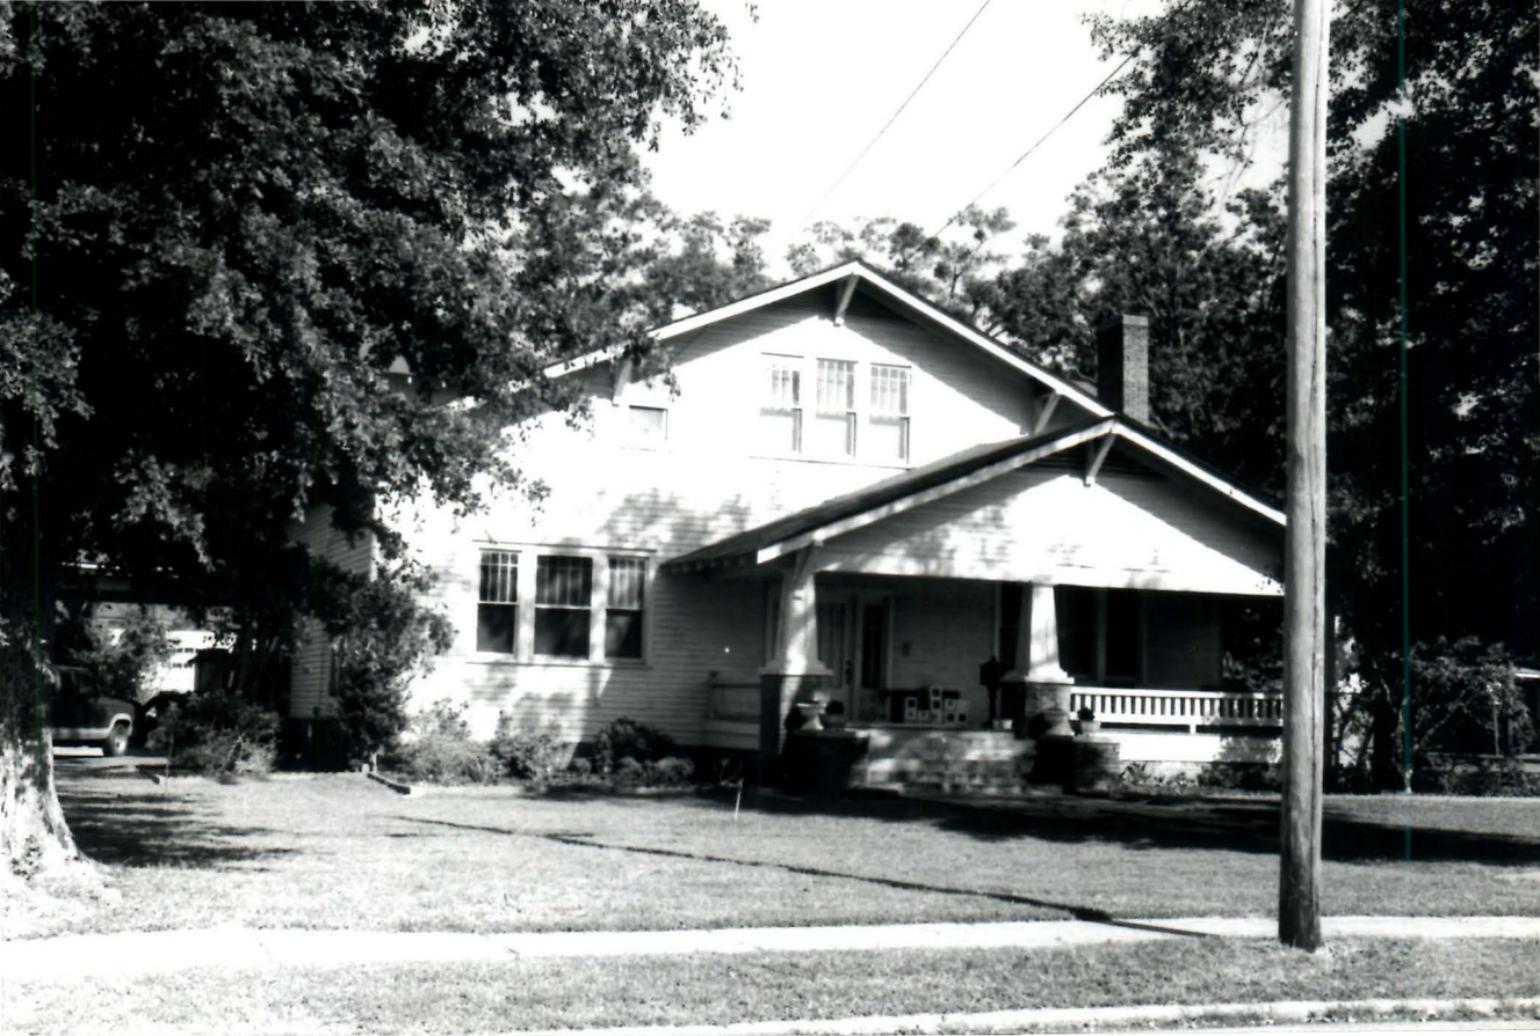
Photo 36 of 42

416-418 E. Railroad Ave (#163) (405 Lee in background)

- B. Garage. Ca. 1940. Front-gabled, frame, one-car garage. (C)
163. **416-418 East Railroad.** Cottage Orne. Ca. 1885.
One-and-one-half story, side-gabled, frame cottage with undercut gallery. The main facade is pierced by a gable having paired 4/4 double-hung windows and imbricated shingles. Exterior end, stuccoed chimneys are on each side elevation, but the one on the south has been partially removed. The main facade features a central entrance that originally was double-leaf with a 10-light transom and 3-light sidelights. At present, the entry contains a single-leaf door with an additional set of 3-light sidelights. To each side of the central entrance is a single-leaf, panelled door with single-light transom, and in the outer bays are 6/6 windows framed by louvered blinds. The gallery has stuccoed piers on which rest box columns on high wood bases, a jigsaw balustrade, and a sawn frieze. Windows are 6/6 except in the upper half story, where they are 1/1 sash. (Photo #36) (C)
