National Register of Historic Places Registration Form

historic name Spain House
other names/site number Pounds House

street & number 553 West Main Street not for publication
city or town Tupelo vicinity
state MS code MS county Lee code 081 zip code 38804

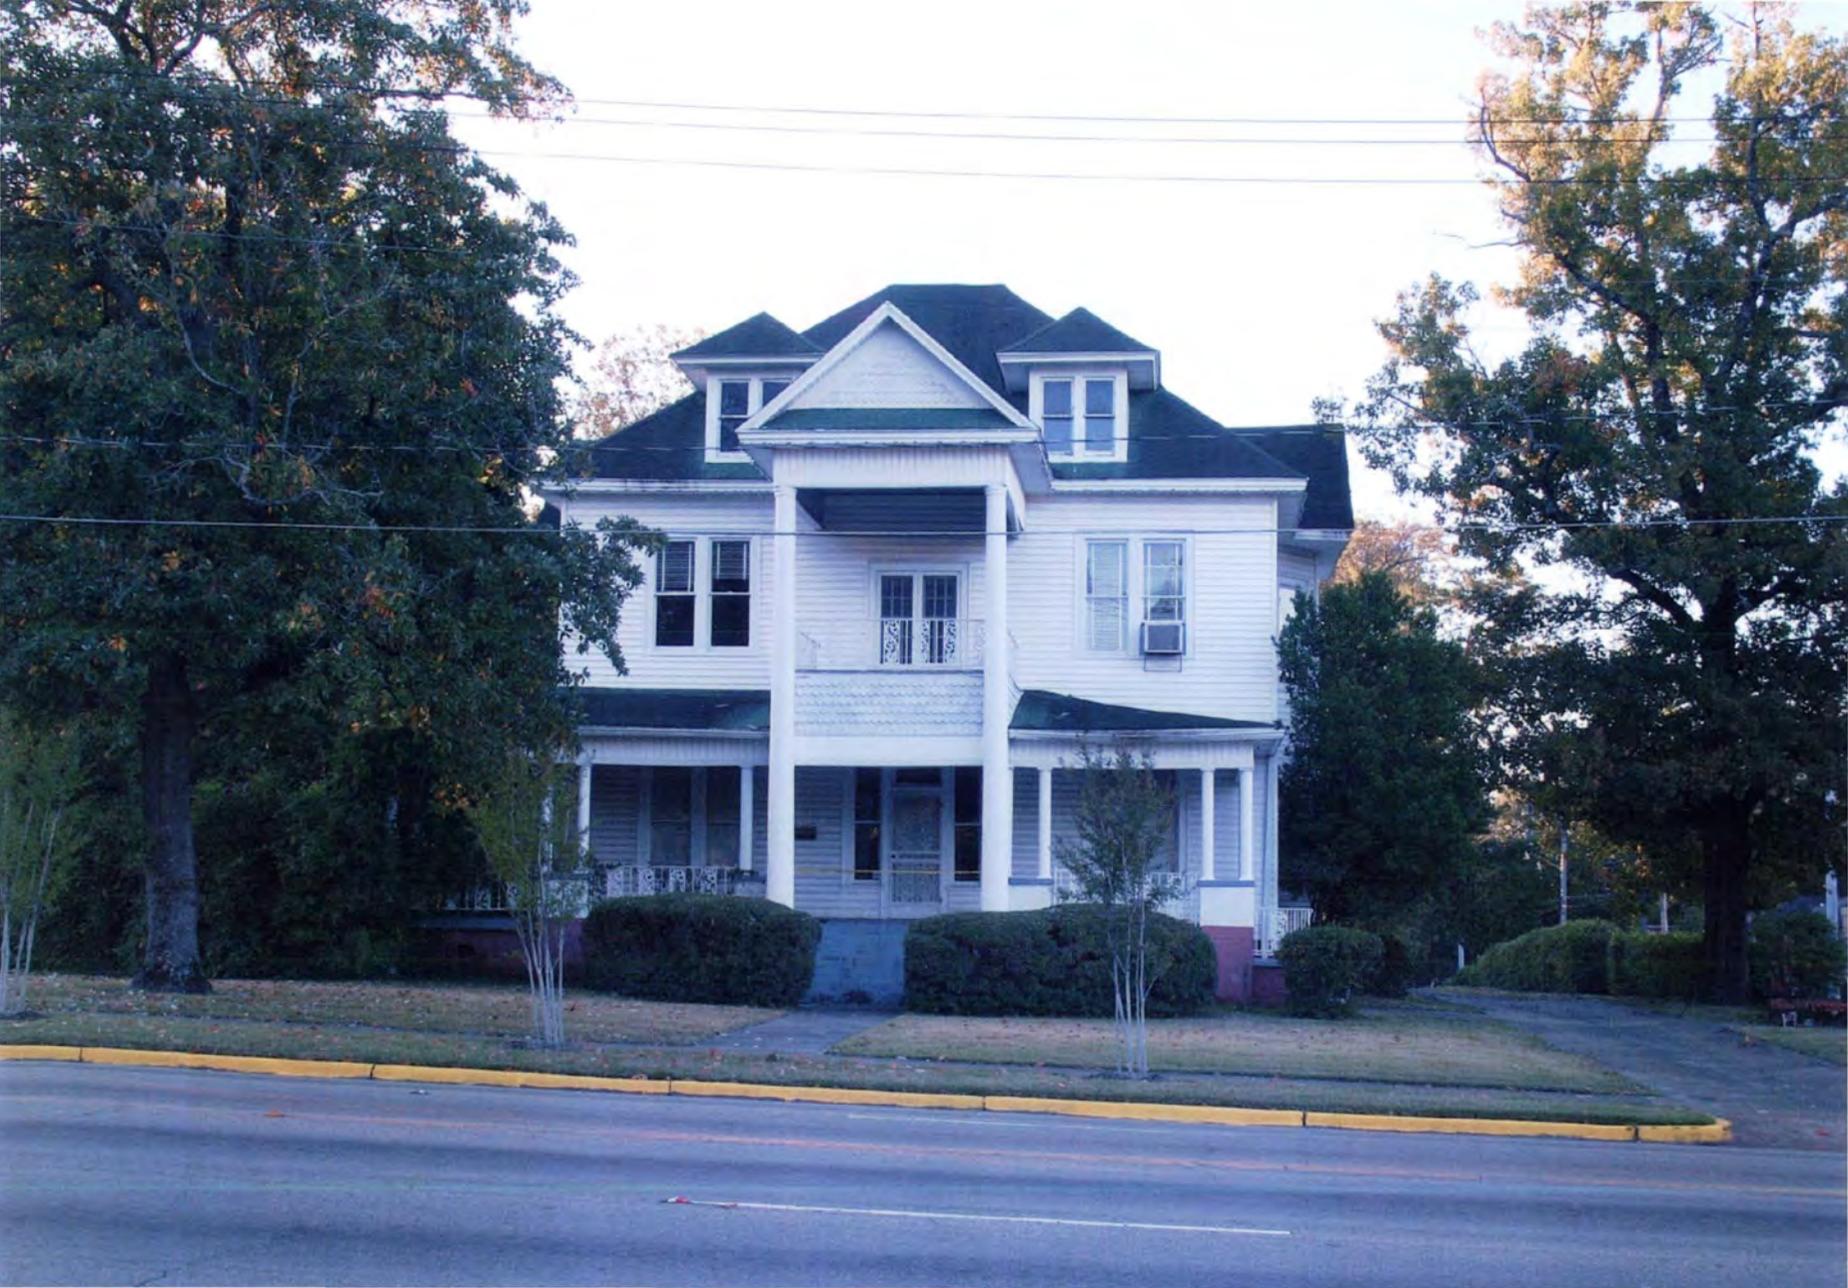
MS - LEE COUNTY - TUPELO - SPAIN HOUSE - 0001

The massing and fenestration of the east facade is very similar to the west façade (See Photo #1, 6), except that the porch wraps around to the front of the two bays and terminates at the projecting gable.

The west façade reveals the Queen Anne massing. A gable end with a louvered vent projects out of the hipped main roof. Below the gable is a two story projecting bay. Original wood 1/1 double-hung windows are centered on each side of the bay. A set of steps from the west side drive gives a secondary entrance to the porch. A few windows on the first floor appear to be spaced according to room layout. The second floor kitchen window dates approximately to 1948, and it is a set of three over four windows. On the southern end of the west façade, a single story ell with a hipped roof projects to the south. This area is generally referred to as the funeral prep area. In fact, this projection began as a drive for the Spain Funeral home hearses when the lower level began to function as a funeral home. It was later enclosed by the Spain family in the late 1960s. (See Photo #3, 4, 5). The walls were clad in vinyl siding in the 2000s .

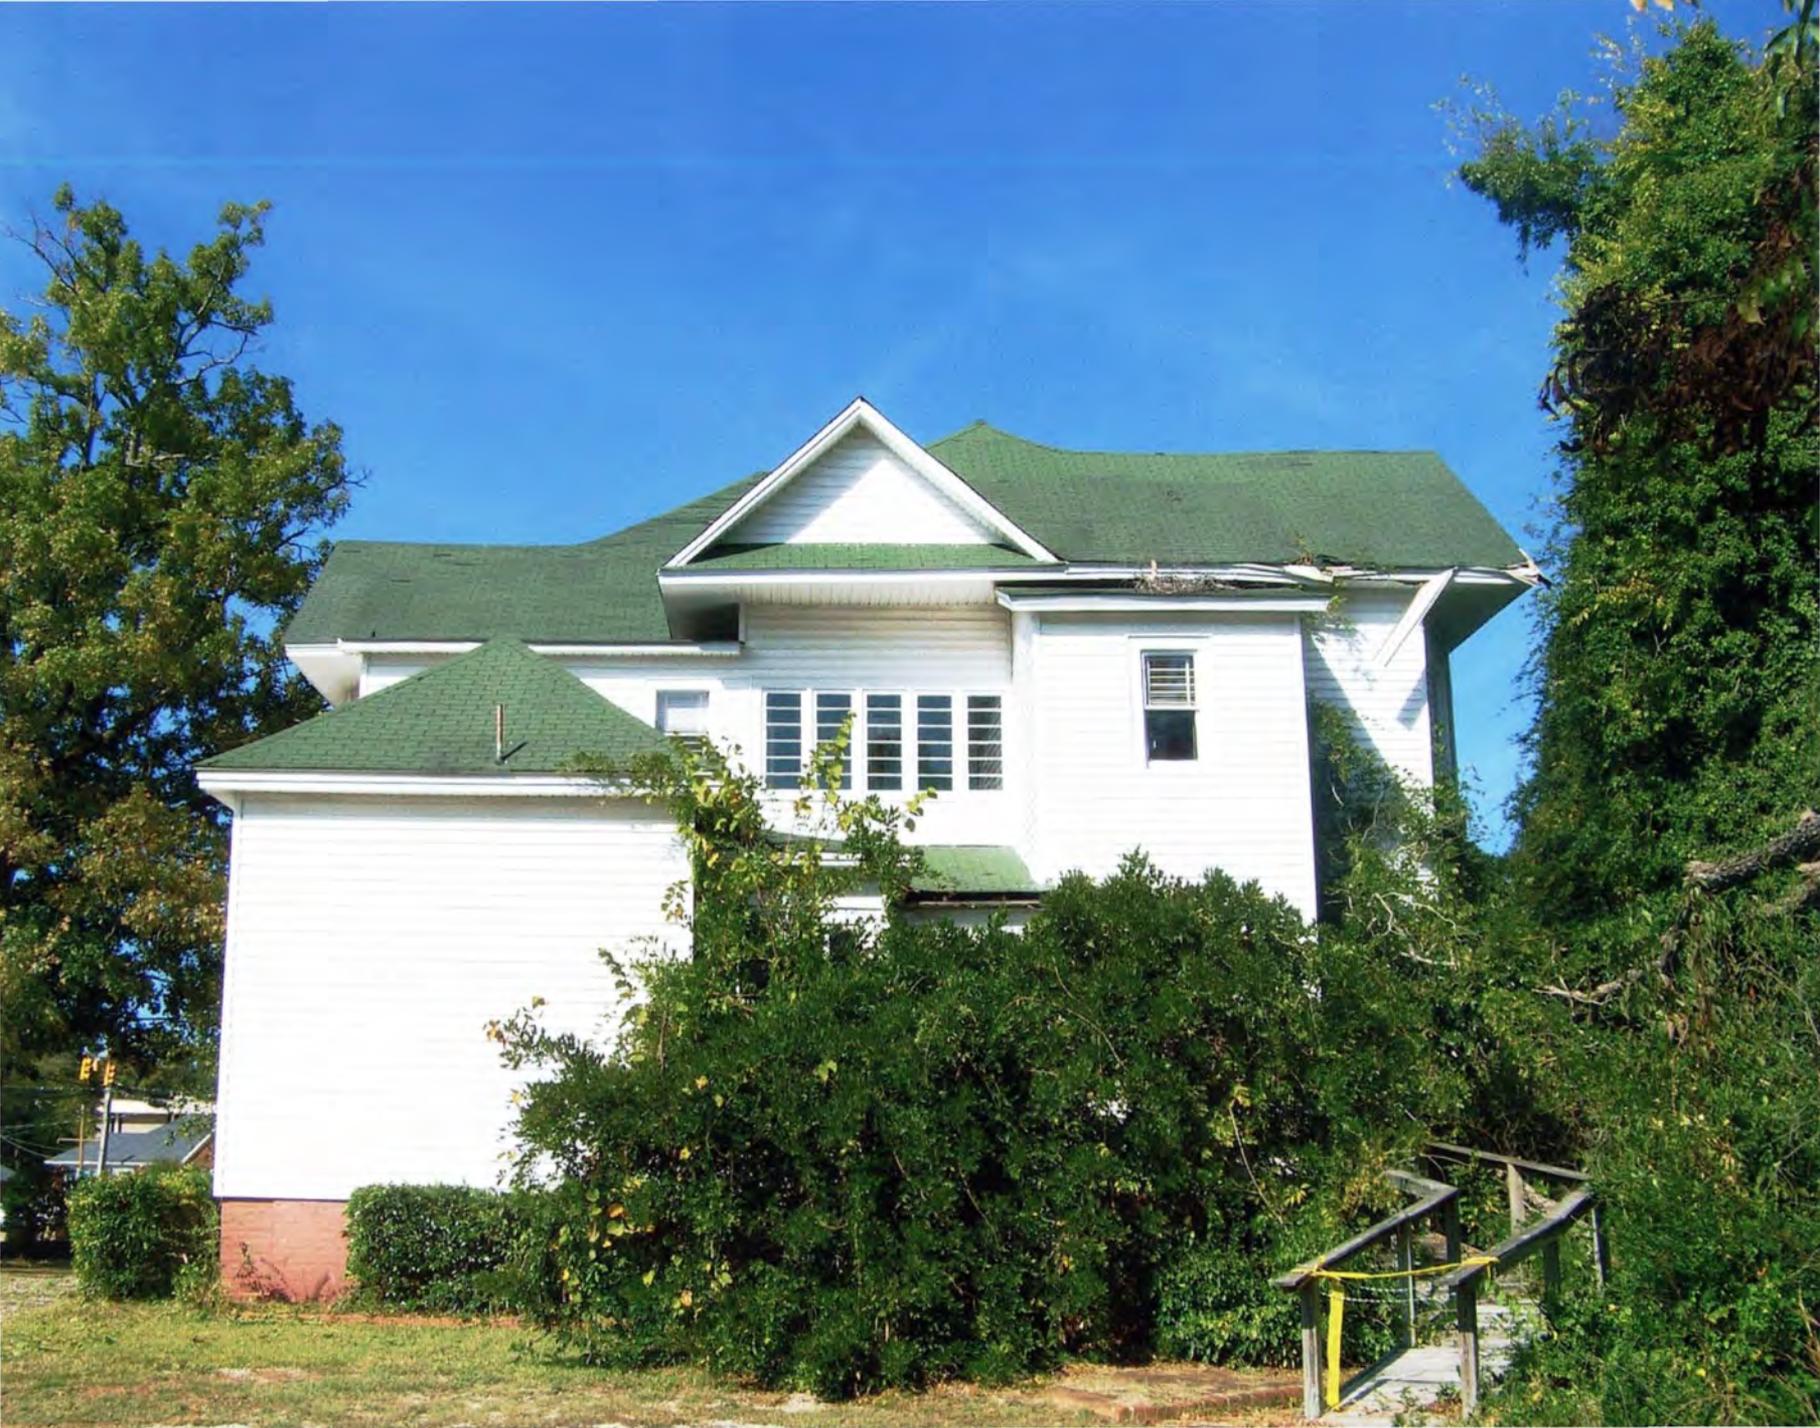
MS - LEE COUNTY - TUPPELO - SPAIN HOUSE - 0006

The south (rear) façade of the house has been altered many places all in the mid-twentieth century. The main roof line is a gable that stretches left to right (west to east) over the bay projections. A central end-facing gable projects from the main roof line. Beneath the gable, a set of five over six windows enclose the original second floor porch. A small two story ell with a shed roof encloses additional storage and dressing areas. The first floor hosts a square wood picture window that was added in the 1990s. A deteriorated wood ramp circles part of the rear to the parking area. (See Photo # 6)

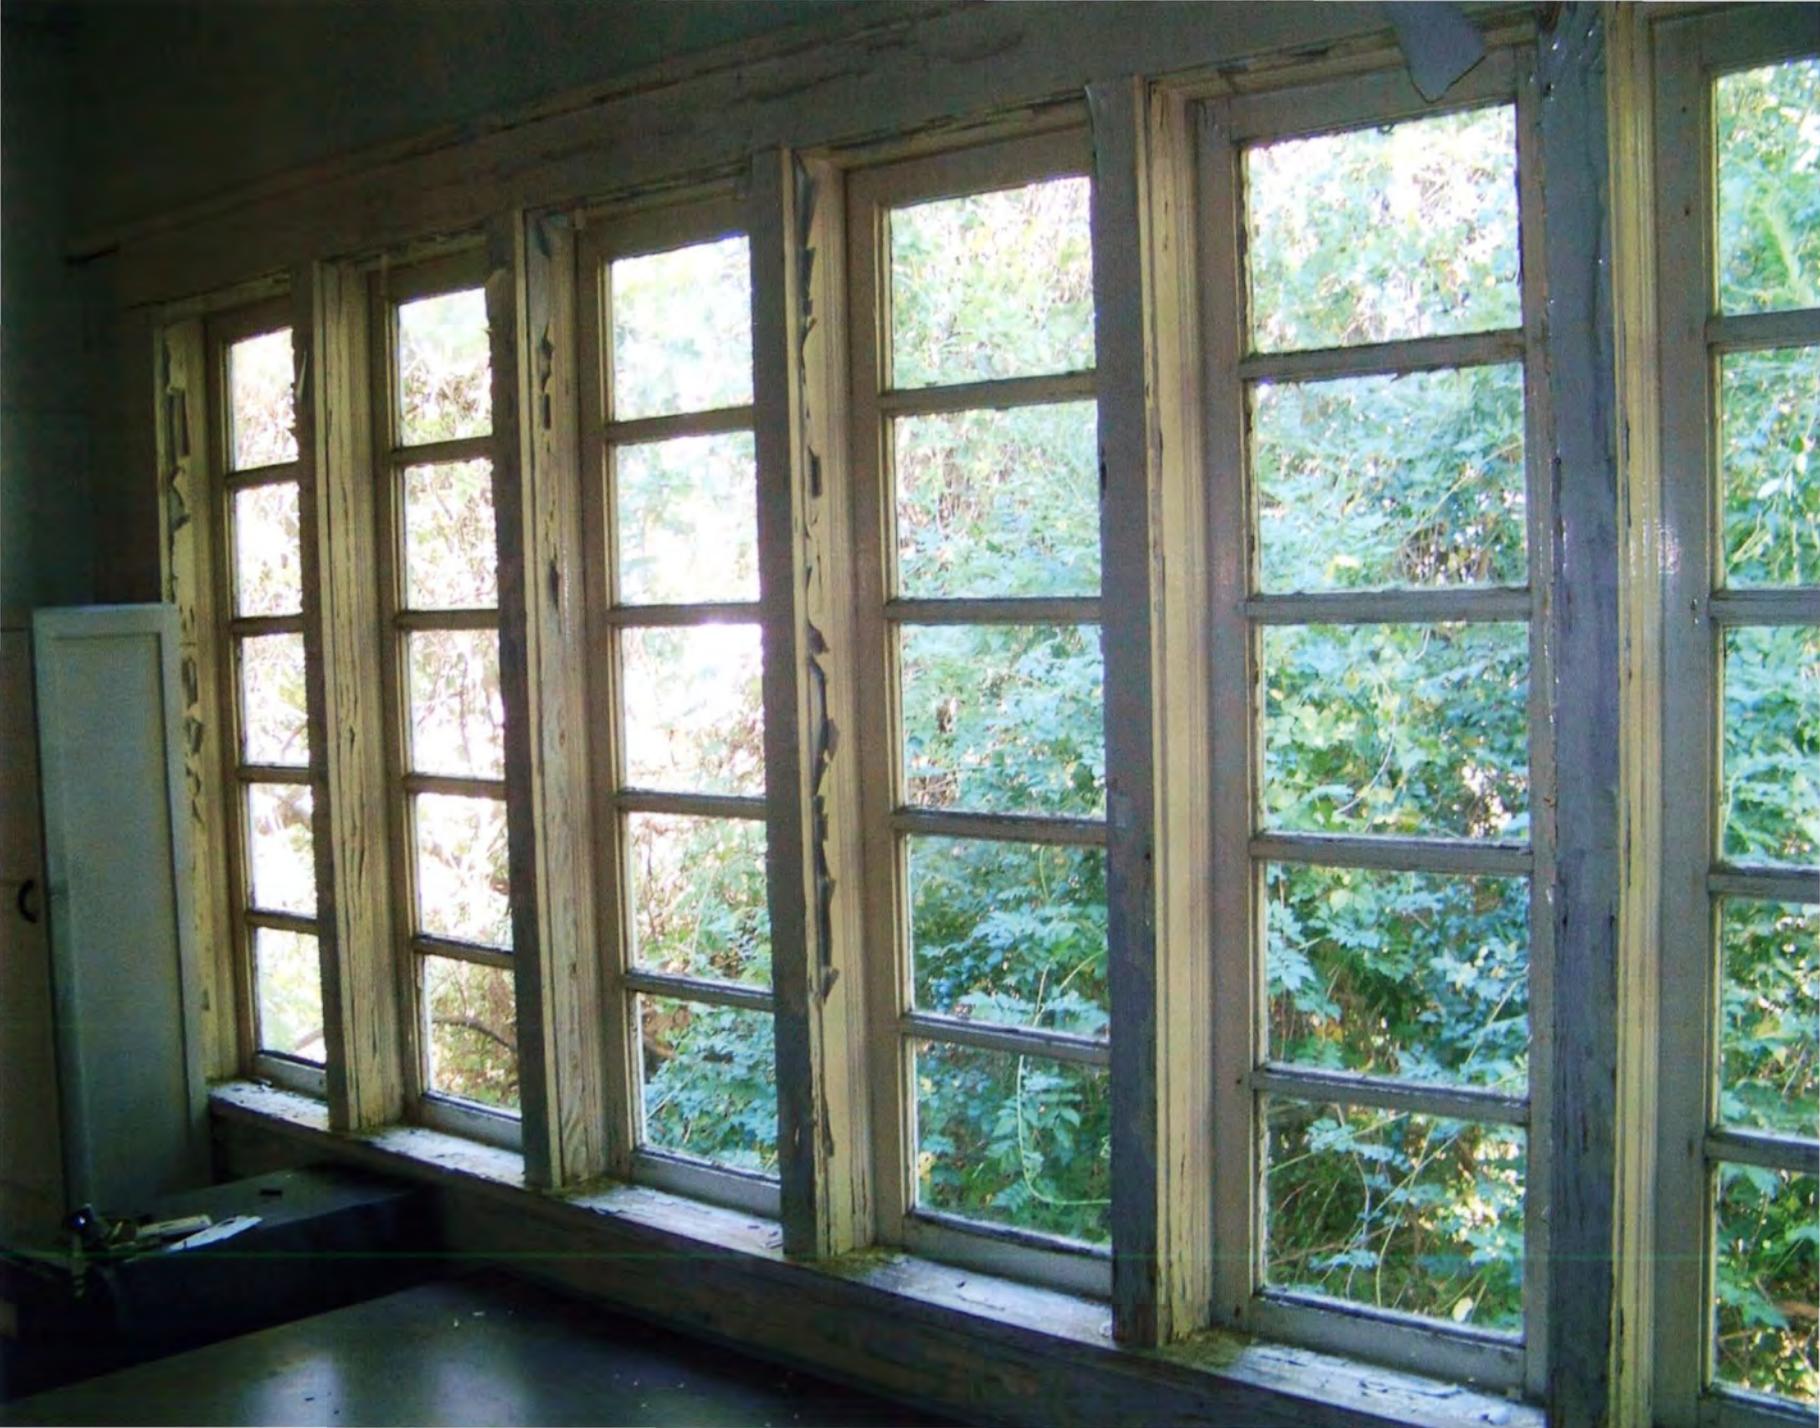
MS - LEE COUNTY - TUPELO - SPAIN HOUSE - 0010

On the east side of the porch, a sunroom was shelled out by enclosing part of the porch during the Spain alterations of circa 1948). (See Photo #10) A set of double French doors on the North side is the only entry into the space. The original intent for this space is unknown and has been acting as storage for many decades.

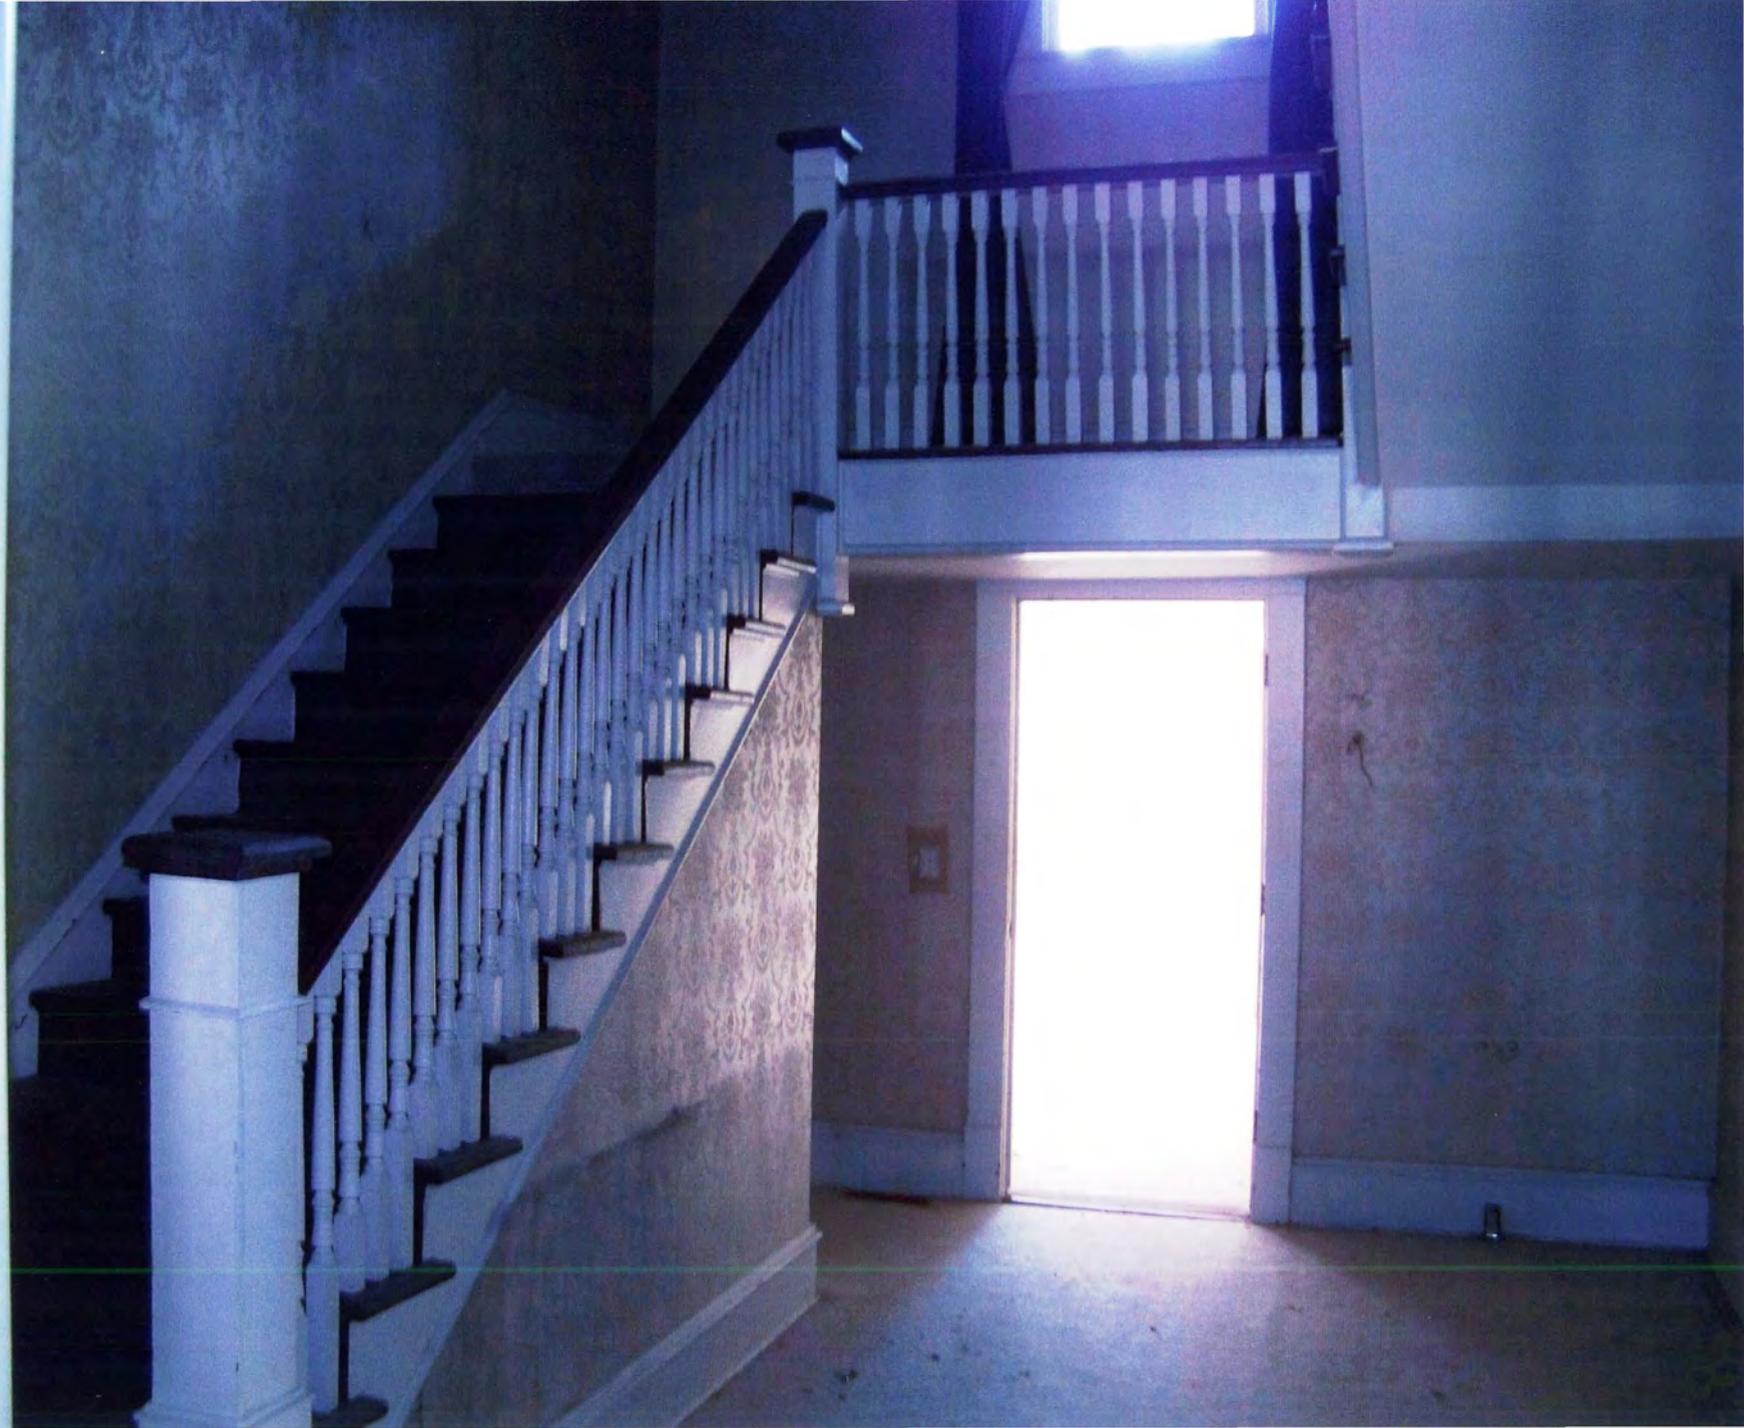
MS - LEE COUNTY - TUPELO - SPAIN HOUSE - 0011

The most striking element on the interior is the two run staircase (See Photo #11, 12, 13). A central 1/1 window graces an intermediate landing. The hand railing, balustrade and newel posts have never been altered. The posts are in the Colonial Revival style with boxed newel posts and a molded wooden cap. The solid hard wood handrail is defined by straight run sections with a plowed profile. The staircase contained no intermediate posts supporting it. It exemplifies the craftsmanship of the early 20th century.

The Hall spills into the Central Stair Hallway. A small closet is nestled beneath the first run of the staircase (See Photo #11, 12, 13). The closet door is the original four stile door and metal door hardware. Directly to the east lies the Showroom. The Showroom hosts the same bay arrangement as the dining room. The view is now covered by overgrown landscaping. However, this room would

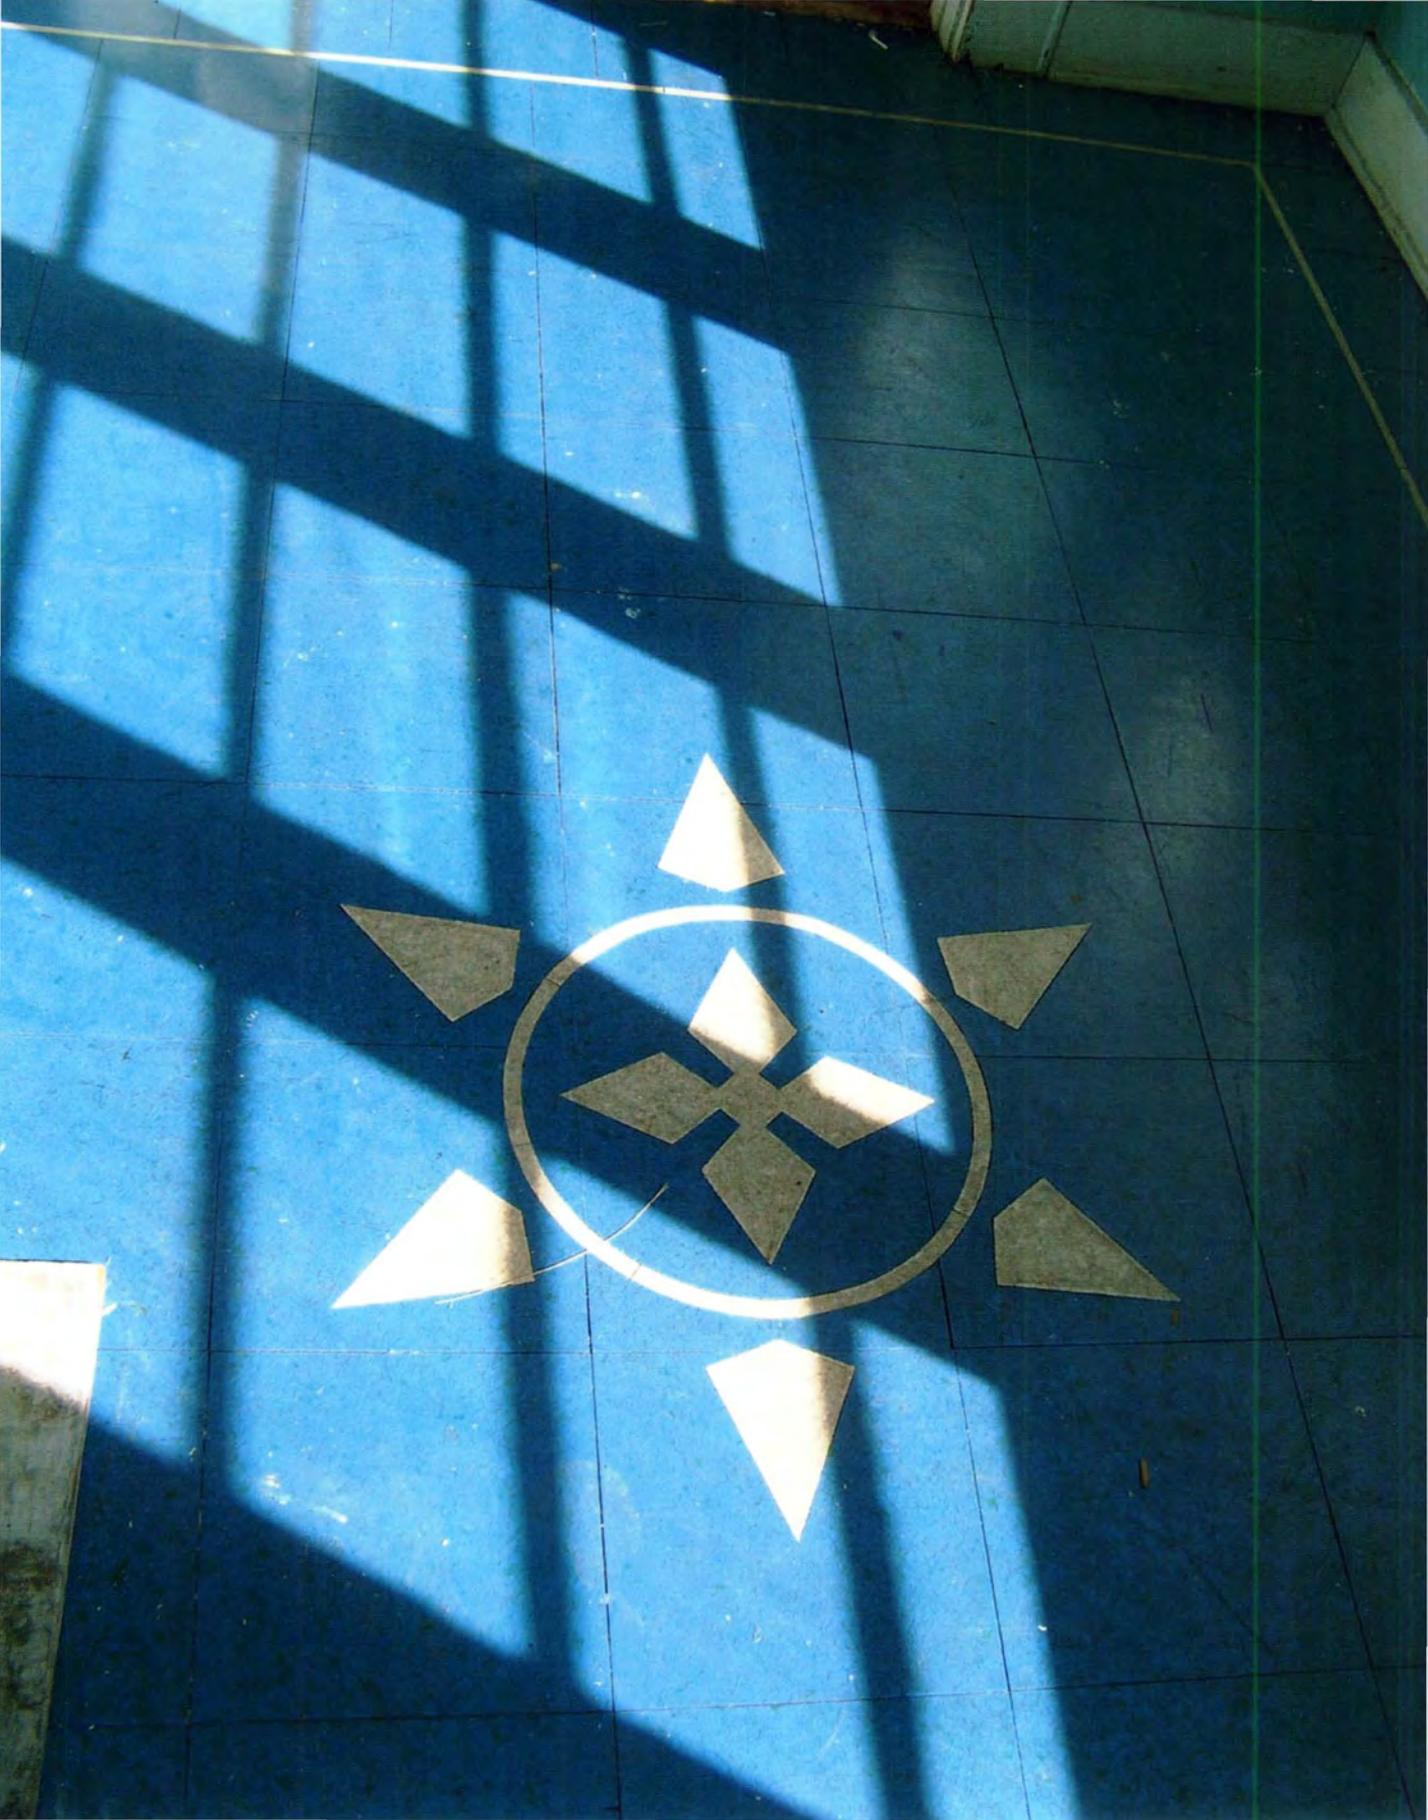
MS - LEE COUNTY - TUPELO - SPAIN HOUSE - 0015

The tile continues from the Kitchen into the Sleeping Porch. The turquoise flooring has an intricately cut pattern with a white asbestos tile inlay (See Photo #15, 26). This area must have been closed in during the major Spain alteration. Another set of French doors lead to this sleeping porch. A group of windows let in the light from the south. The sleeping porch still has the exterior 1/1 window from the staircase landing.

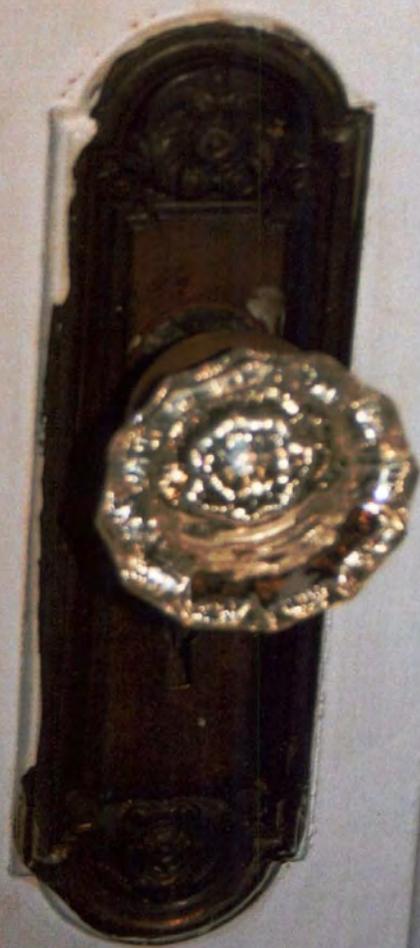
MS - LEE COUNTY - TUPELO - SPAIN HOUSE - 0016

The sleeping porch gives entry to a bedroom. The bedroom is arranged in a bay shape. A dressing room has been added onto the south end of the bedroom. The Dressing Room has a five panel wood door with vintage glass door knobs (See Photo #16). The Bedroom has a small louvered wood door with glass door knob. The floor has been replaced with a wood parquet flooring that has been damaged by a minor roof leak. The parquet flooring is set directly over the hardwood floor, as evidenced at the closet. (See Photo #17)

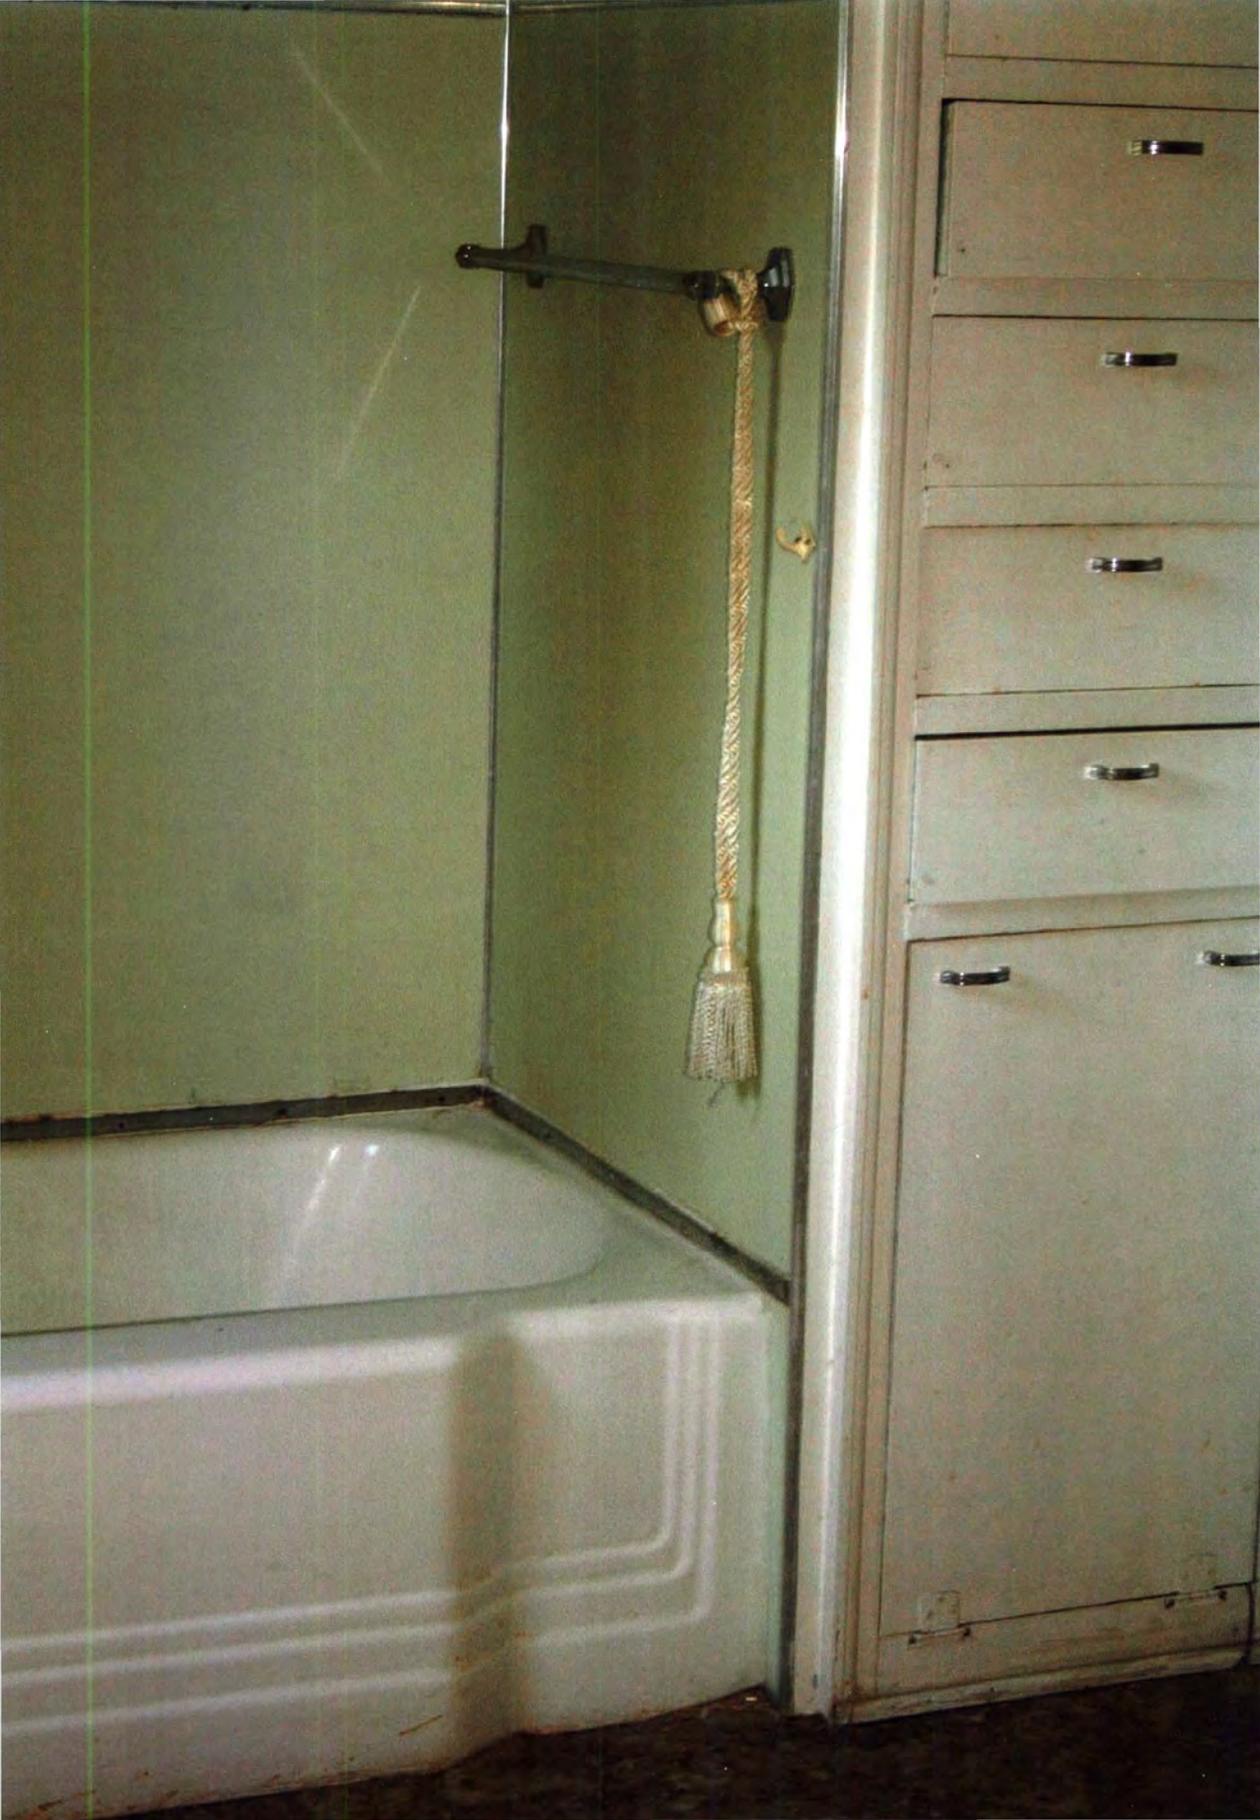
MS - LEE COUNTY - TUPELO - SPAIN HOUSE - 0018

From the Bedroom, a non-descript hall leads into a full bath. The Bathroom is again original to the house with original tub and lavatory (See Photo #18, 19, 31, 32). White subway tile provides the wainscoting for the room, while wallpaper covers the plaster walls above. The Bathroom leads to the front bedroom. This Bedroom has been altered to hold two built-in closes along the North wall with a low built-in seat set between them. (See Photo #21) The south wall hosts a bed nook that has been formed by two colonial-style wood-trimmed pilasters and a domed plaster alcove (See Photo #20).

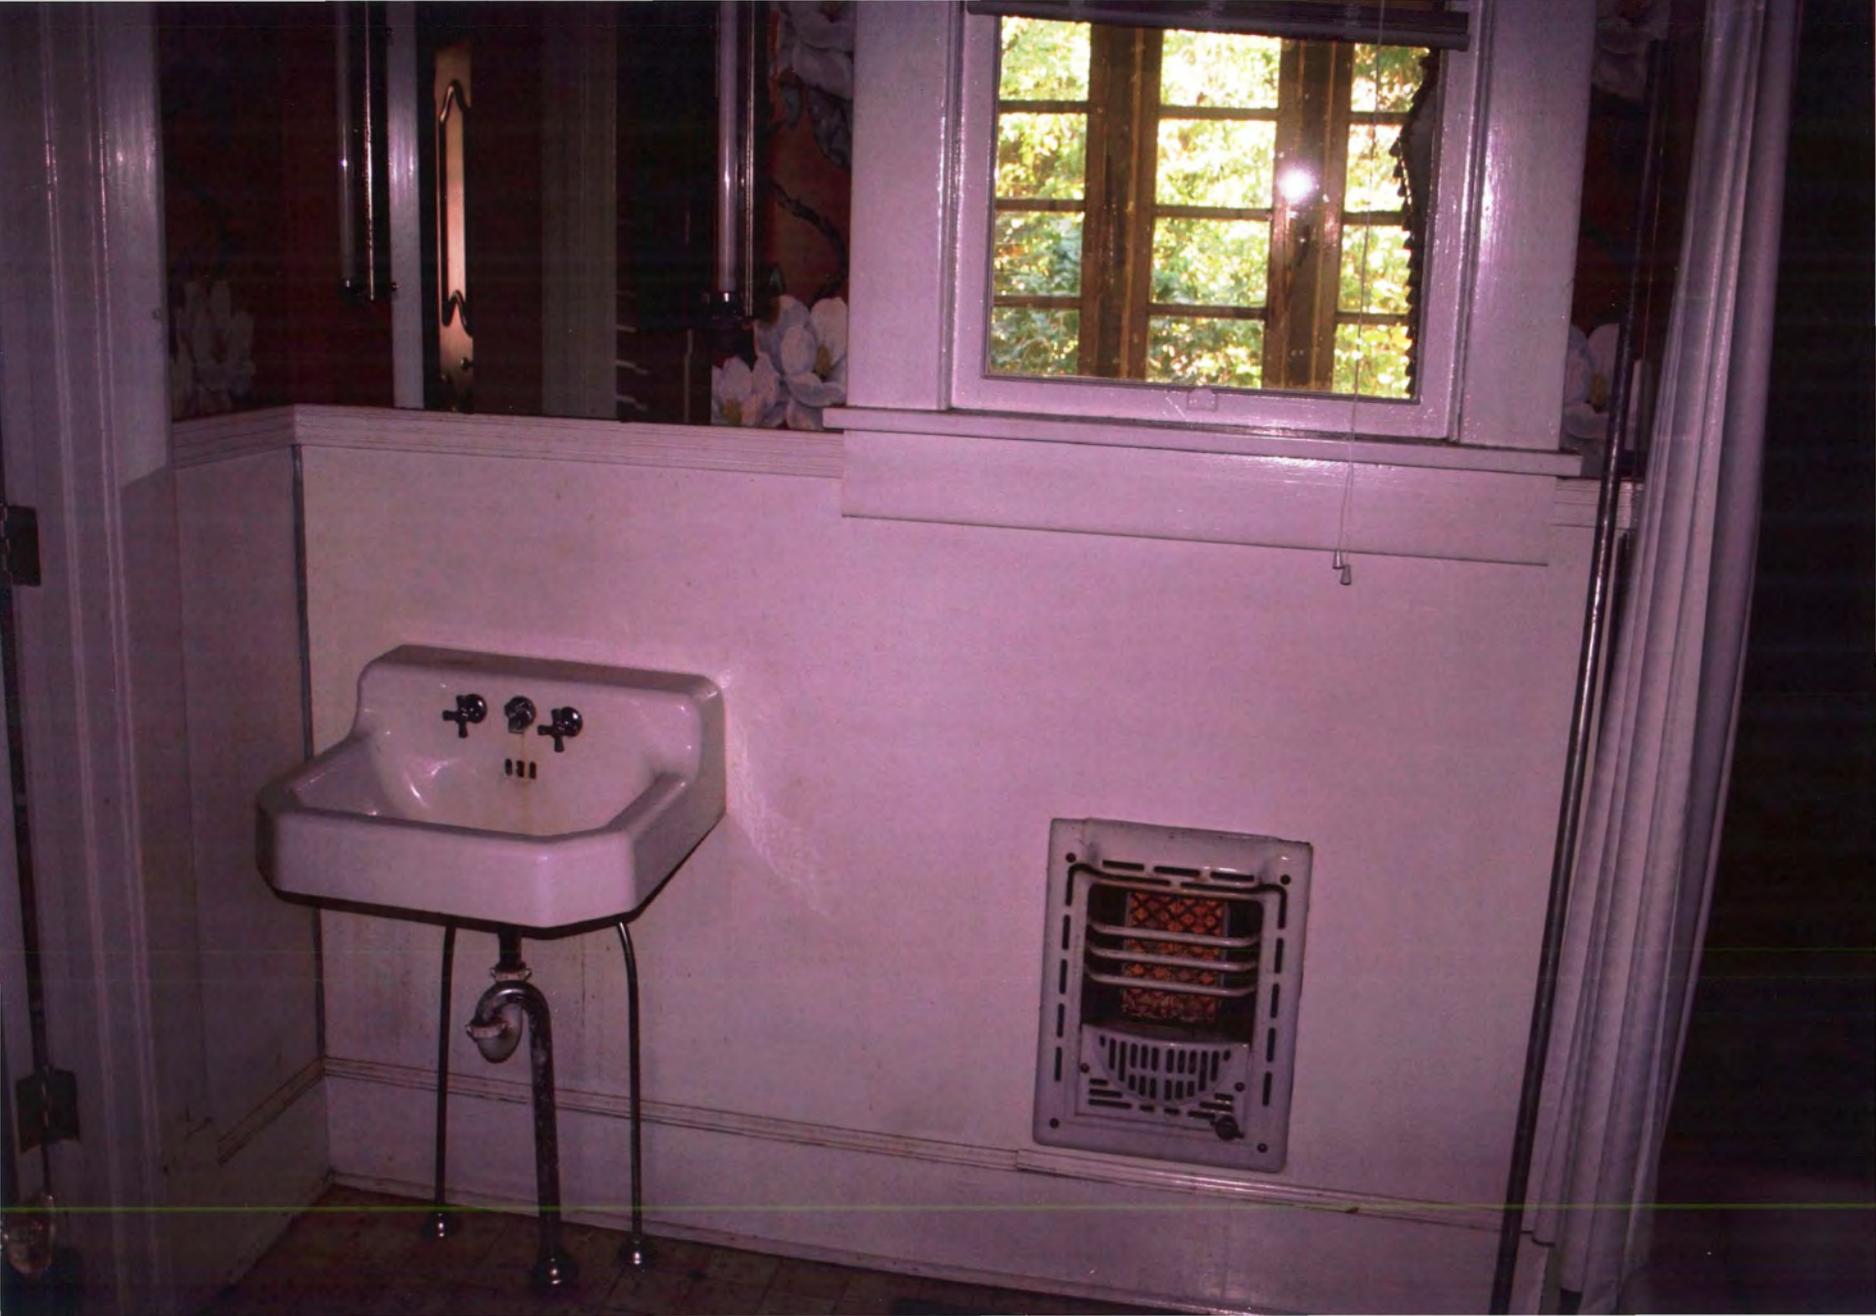
MS - LEE County - Tupelo - Spain House - 0034

A non-descript hall leads from the Showroom to a full Bathroom. The Bathroom is the original configuration. The lavatory and tub are original fixtures (See Photo #34). The shower surround has a laminate and a wainscoting of white subway tile covers the bottom half of the walls. The bathroom directly opens into the east Viewing Room. The doors of the east Viewing Room have more applied round wood molding trim applied in decorative patterns. The doors were replaced & altered in the Spain alteration (circa 1948). The front bedroom has an exterior door that leads out onto the east side of the wraparound porch.
