# **CLEVELAND DESIGN GUIDELINES**

Prepared by: David Preziosi, AICP - Mississippi Heritage Trust  
2008

**CLEVELAND, MISSISSIPPI  
2008**

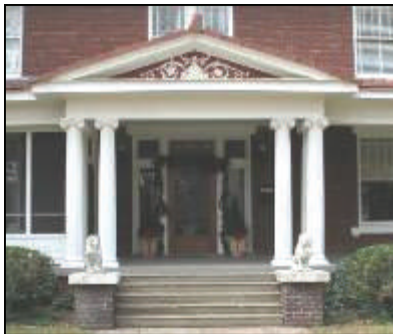
*The Cleveland Design Guidelines will encourage the preservation of architectural detailing like the original entry porch with paired Ionic Columns and decorative relief in the gable at 208 South Pearman Avenue a significant expression of the Colonial Revival style of architecture.*

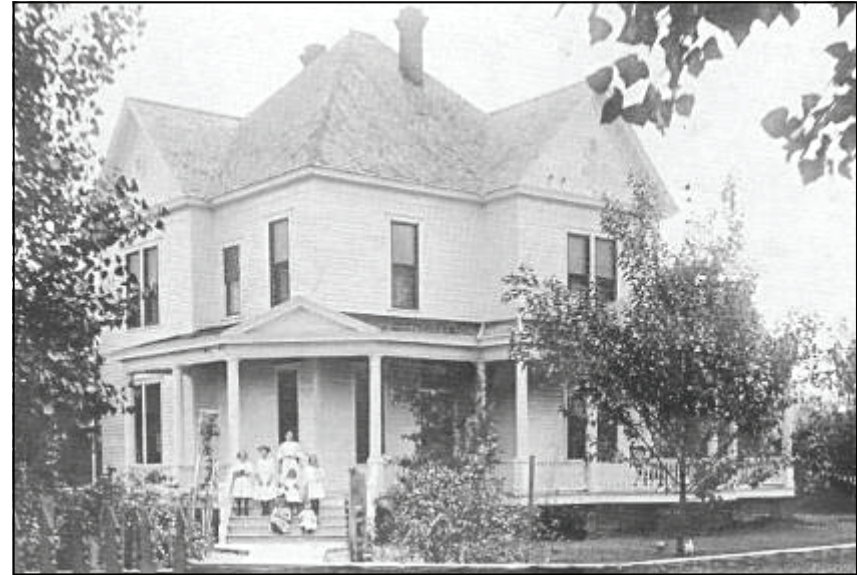
*The E.J. Nott house at 301 South Bolivar pictured circa 1904 still survives to this day although the porch has been altered. Photo from Reflections of Bolivar County.*

Cleveland has several examples of Free Classic Queen Anne. 213 North Bolivar exhibits the form of the Queen Anne style however the detailing is that of the Colonial Revival style with Tuscan style porch columns and Palladian window in the front bay. The E.J. Nott house at 301 South Bolivar Avenue is another example of the hybrid style although it leans more to typical Queen Anne except for the use of Tuscan columns instead of typical turned columns of the Queen Anne style.

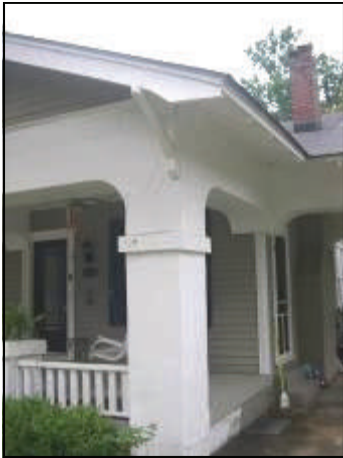
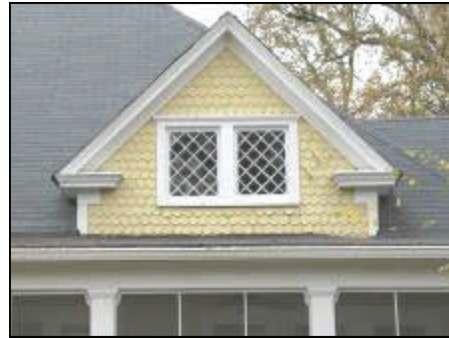
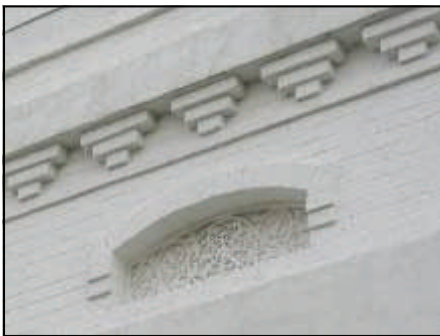
*Above are some of the architectural features found in Cleveland. On the upper left a massive porch column supporting a large porch typical of the Bungalow style, a gable with a multi-pane window and decorative shingles characteristic of the Queen Anne style in the upper right, the decorative brick work and a cast-iron decorative vent of a commercial building on Sharpe Avenue in the lower left, and in the lower right a pedimented surround around the entry door typical of the Minimal Traditional style.*

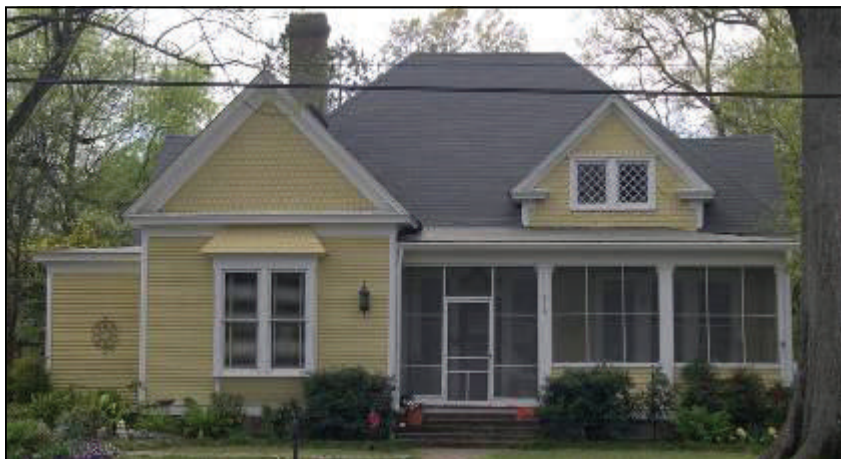
*204 South Bolivar Avenue is an excellent example of the Queen Anne style as it retains many original features including: wood double hung sash windows, wood lap siding, shingle siding in the gables, and a multi-gable and hip roof.*

The Queen Anne style arrived in Cleveland with the introduction of the railroad to the city which most likely allowed for the delivery of mass produced decorative pieces which were popular in the construction of houses in the Queen Anne style. One of Cleveland's most intact Queen Anne style houses is 204 South Bolivar Avenue, which retains a great deal of its original exterior features such as the multi gable and hip roof, original wood double hung sash windows, and decorative shingles in the gable.

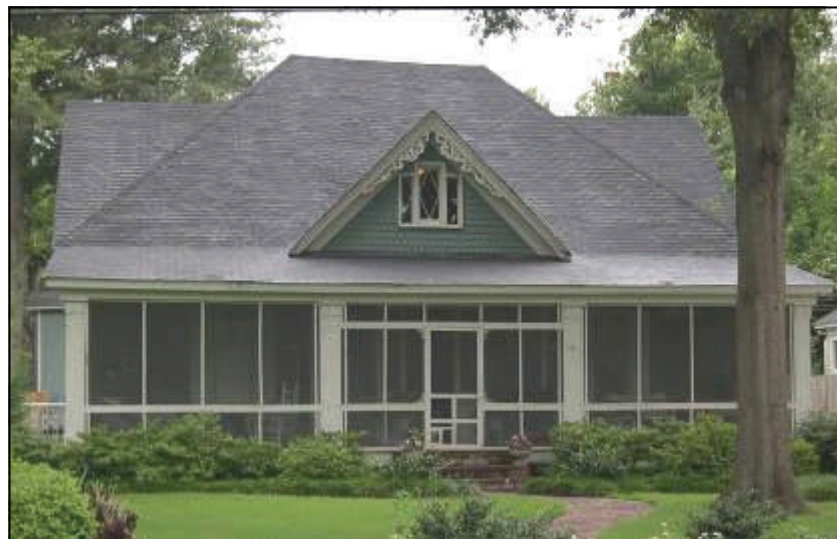
*The original columns at 210 South Bolivar Avenue were most likely turned and later replaced with box columns.*

A number of the houses built in the Queen Anne style in Cleveland have had modifications over the years mostly to their porches as columns were replaced with those in the current popular style or simple inexpensive box columns.

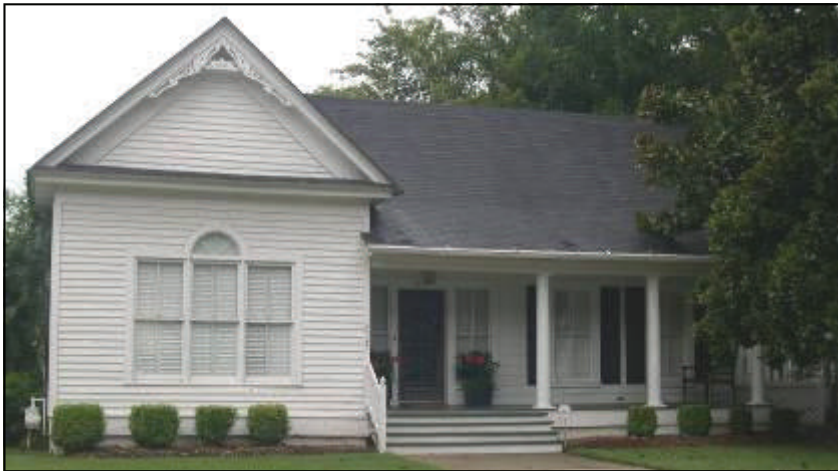
*The house at 213 North Bolivar Avenue exhibits Queen Anne massing with Colonial Revival details such as Tuscan Columns and a Palladian window unit in the front bay.*

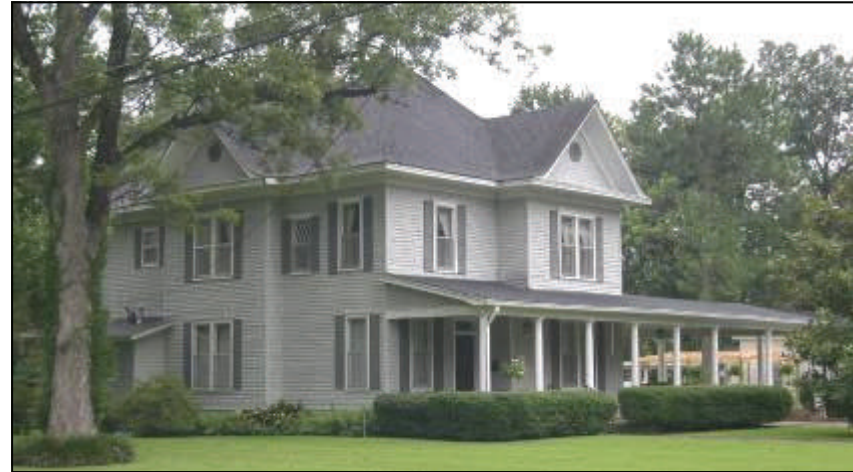
*4301 South Bolivar Avenue has Queen Anne massing and a porch with Tuscan columns characteristic of the Frere Classic Queen Anne style. The original wrap around porch has been altered to the current porch but also had Tuscan columns.*

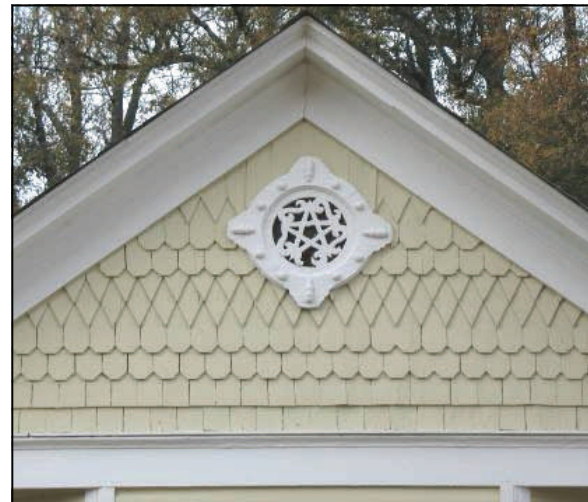
*The gable at 204 South Bolivar Avenue features a combination of wood shingle siding patterns with square, diamond, and Fish Scale typical of the Queen Anne style of architecture.*

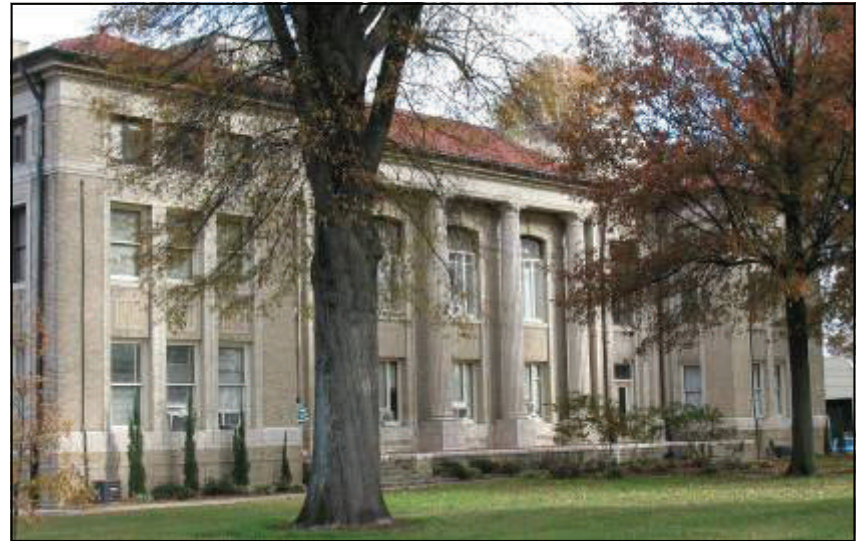
*Bolivar County Courthouse*

Cleveland's has two grand examples of the Neo-Classical Revival style with the Bolivar County Courthouse and the First Methodist Church both located on Court Street. Both exhibit Neo-Classical Revival style characteristics. They are monumental in size, symmetrical in plan and have colossal columns supporting large entablatures. The courthouse uses fluted Tuscan Columns and the Methodist Church uses fluted Corinthian Columns.

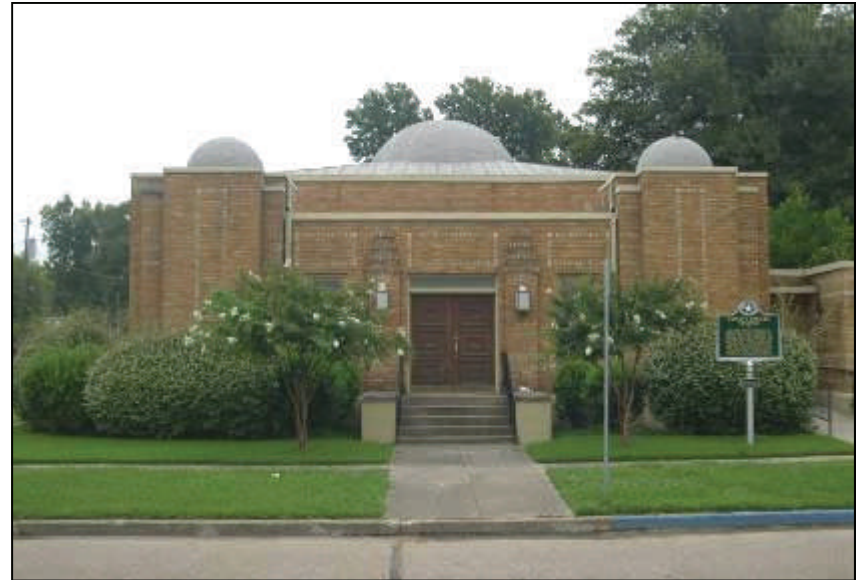
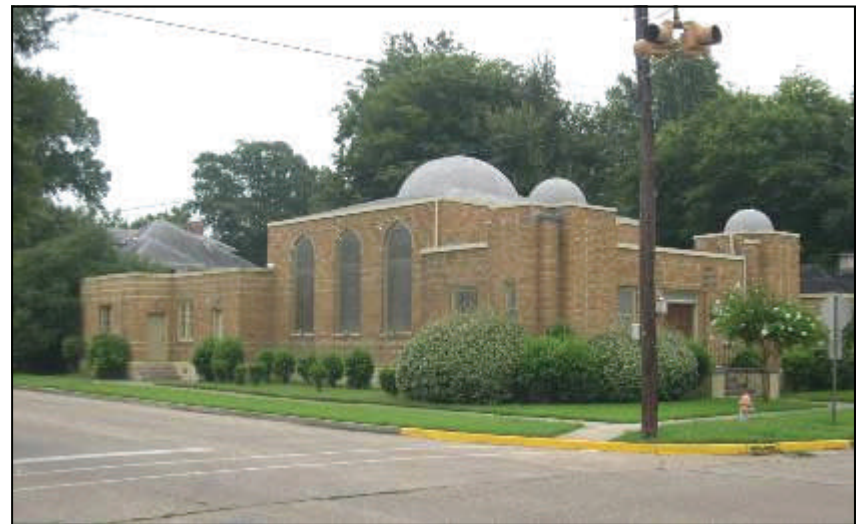
There is only one example of the Byzantine style in Cleveland with the Adath Israel Temple on South Bolivar Avenue. It has the characteristic dome and is symmetrical in plan.

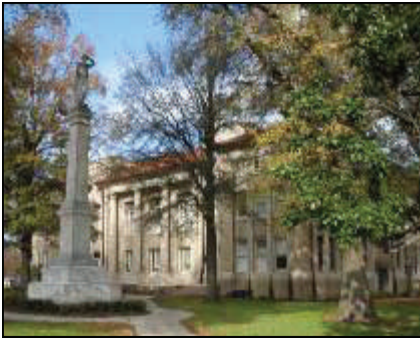
*The Bolivar County Courthouse uses a stone veneer over brick walls and cast stone for the detailing.*

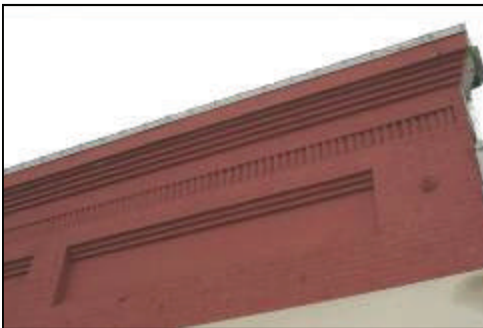
*The brickwork of the parapets on several commercial buildings in downtown Cleveland feature decorative brick patterning and projecting bricks to give interest to the façade.*

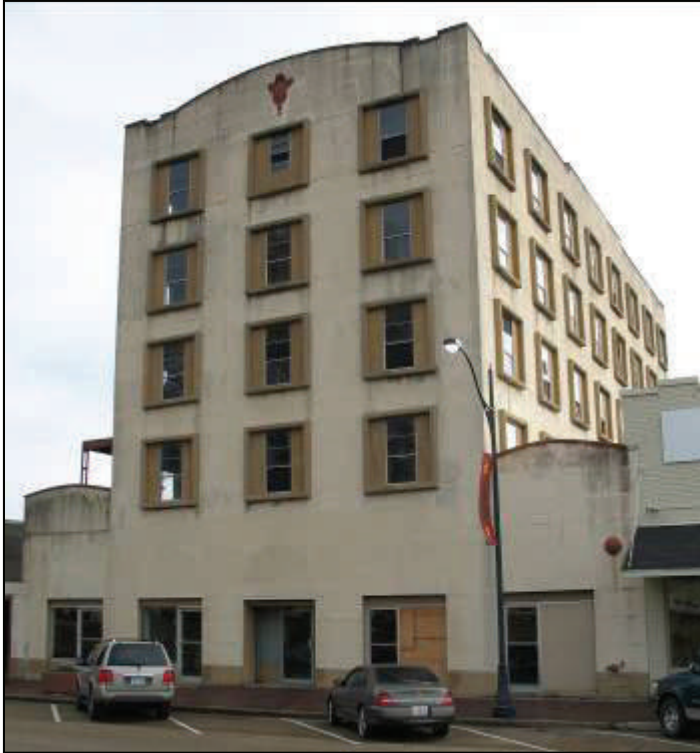
*The original brick exterior of the Grover Hotel in downtown Cleveland was covered with stucco and scored to look like large blocks.*

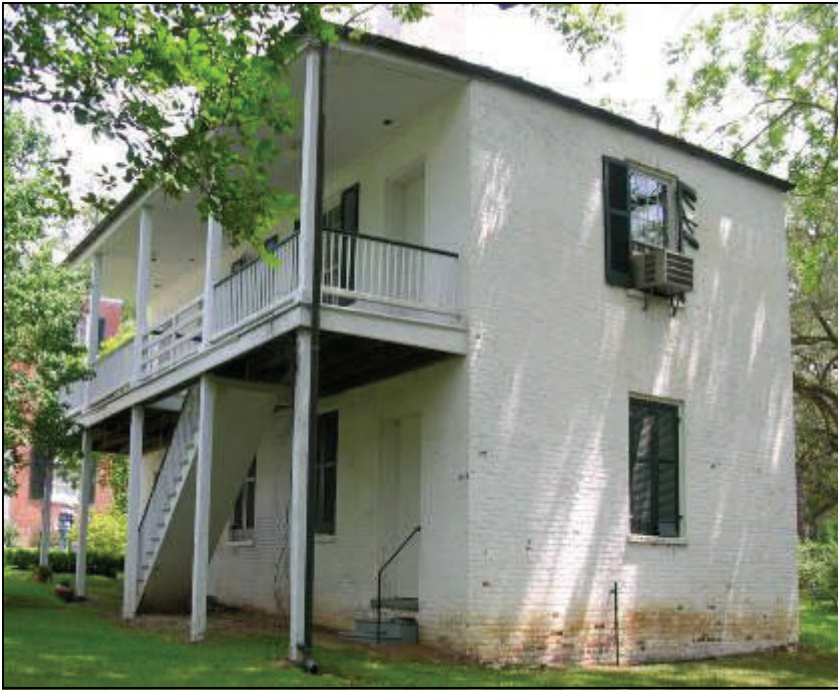
*This kitchen building behind a historic mansion in Natchez shows the effects of rising damp along the base of the building. Water running along the façade and pooling at the base of the side elevation is the source of the problem. Controlling water run-off and preventing the pooling of water will correct the problem.*

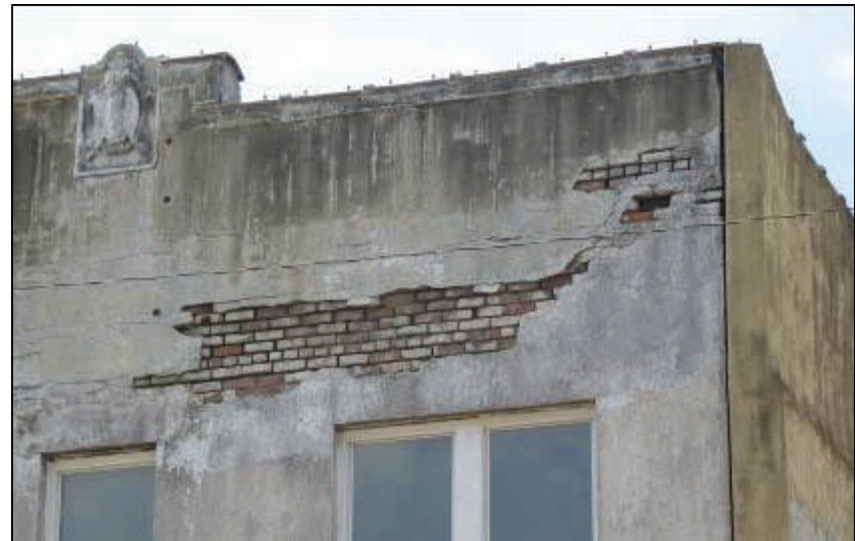
*This building is suffering from falling damp most likely from water that is infiltrating at the top of the parapet and causing the noticeable stucco discoloration at the top of the wall and the problems with the stucco losing its bond with the brick below and falling off of the building.*

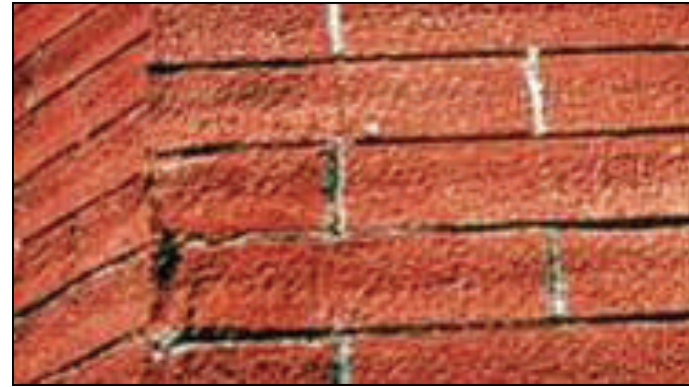
*This National Park Service photograph well illustrates the negative effects of sandblasting, which should never be used to clean brick buildings. Sandblasting will not only erode mortar but will also remove the glazed outer surface of brick and hasten deterioration.*

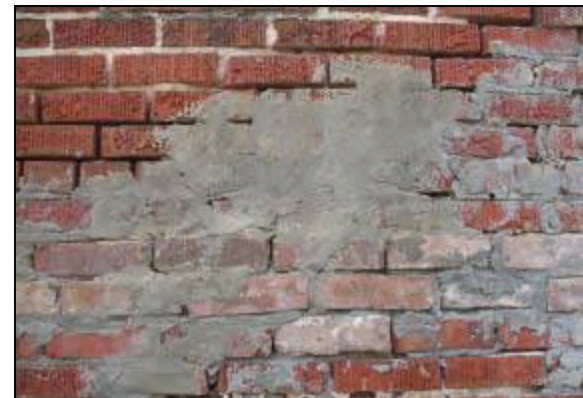
*The owner of this brick building tried to stop the mortar erosion and water infiltration by smearing concrete over the deteriorated areas. This makes it very difficult to properly repair the problems in the future and has caused more damage to the brick surface*

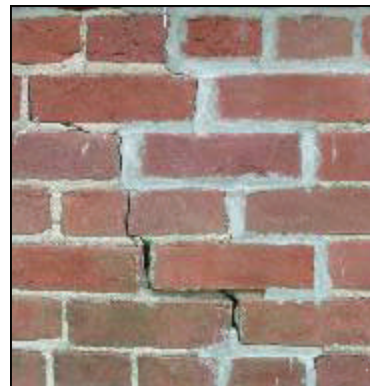
*The spot repointing of this brick wall does not match the original in color, texture, or form. Joints are too large and mortar is smeared on the face of bricks. The tell-tale, dark gray color and texture of the mortar indicates that portland cement mortar was used. The cracked brick and the spalled brick (center top) resulted from the hard portland mortar.*

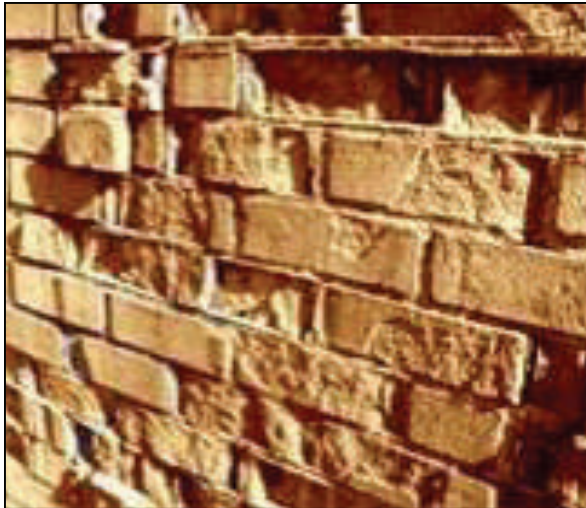
*This photograph supplied by Chagrin Falls Preservation in Ohio illustrates the spalling that can occur only five years after using portland cement mortar in repointing.*

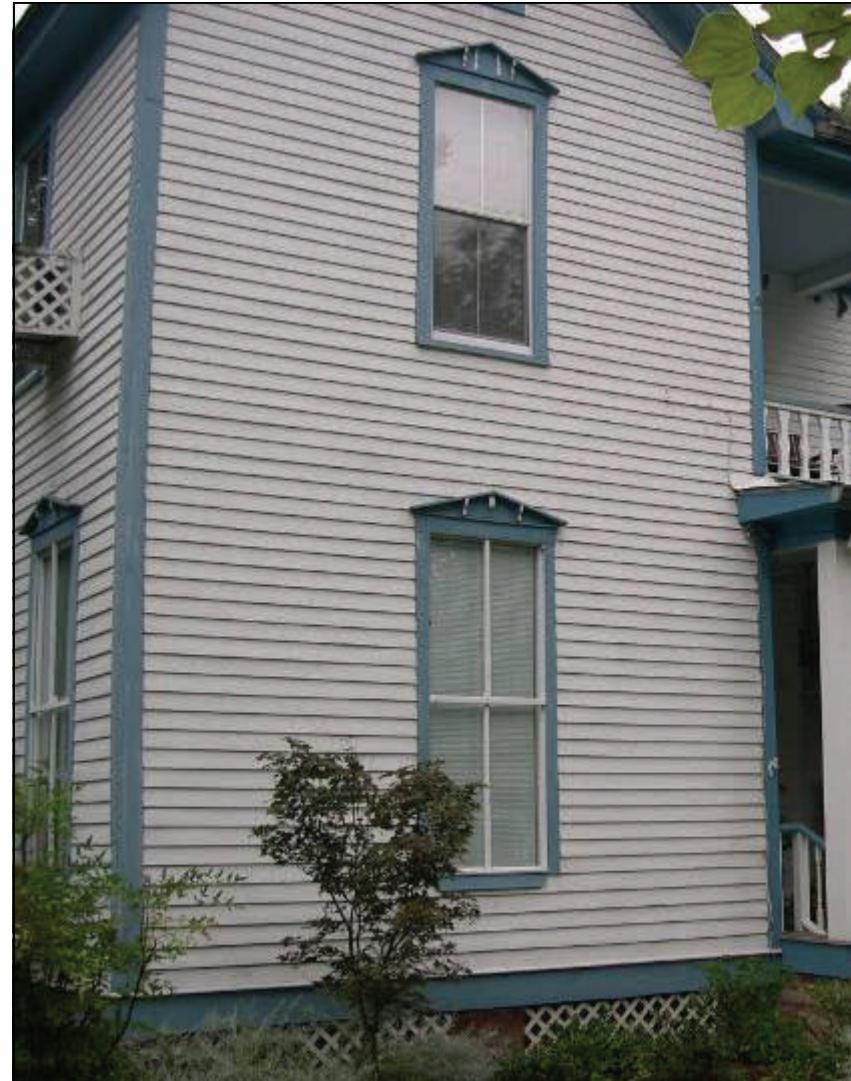
*This Folk Victorian style house at 214 South Bolivar Avenue retains its original horizontal wood lap siding.*

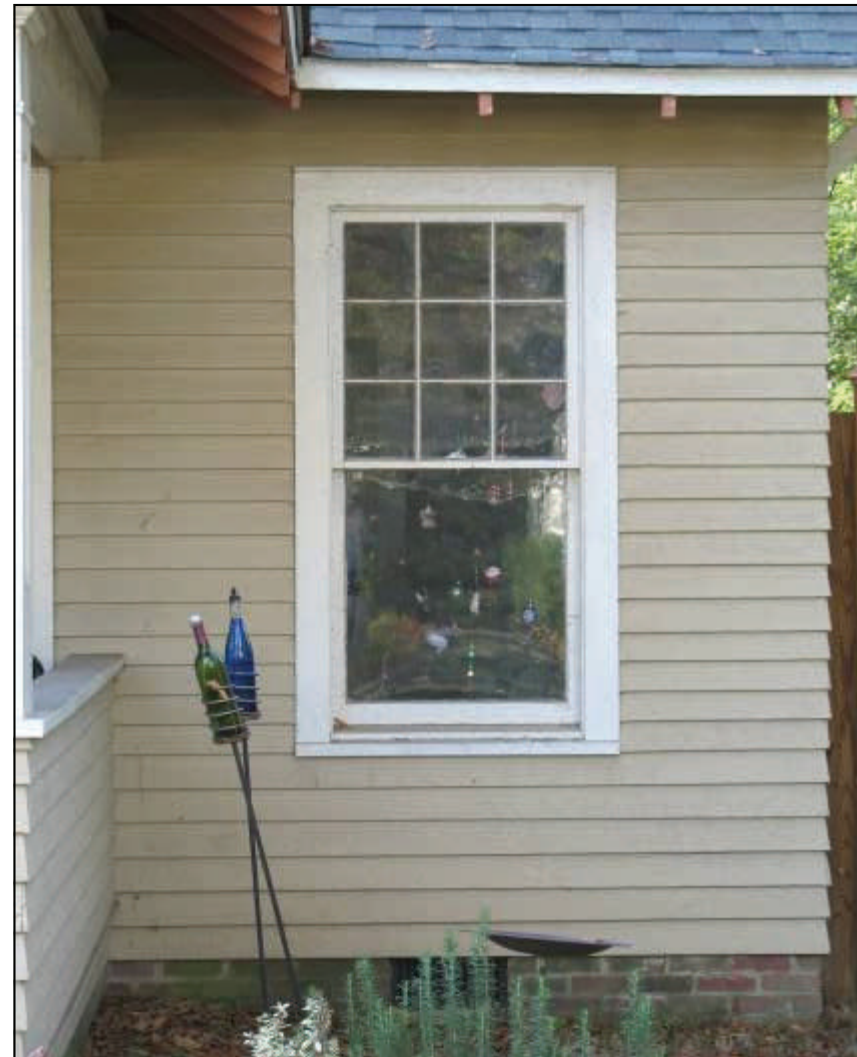
*115 North Leflore Avenue uses beveled wood siding which is typical of the Craftsman style of architecture.*

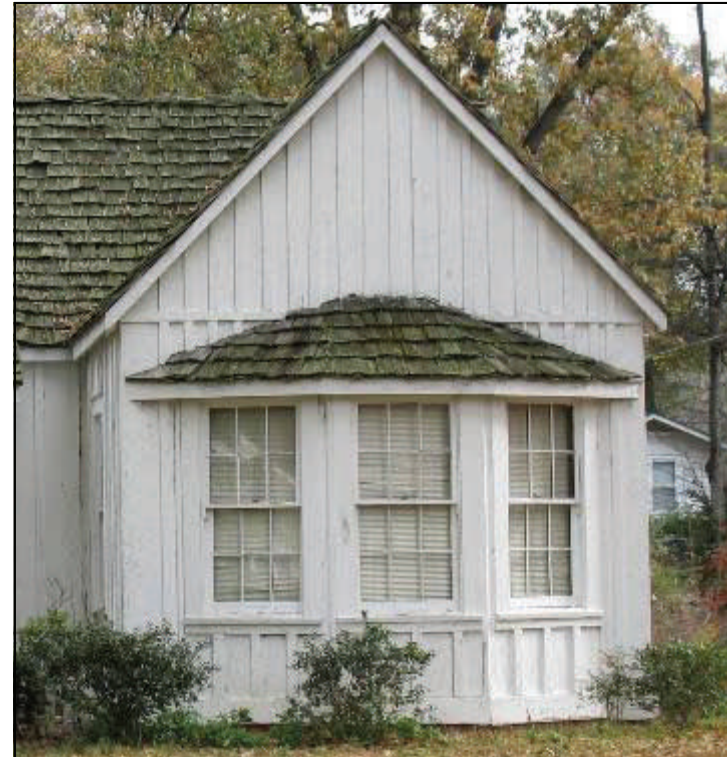
*The house at 209 South Victoria Avenue uses board-and-batten siding.*

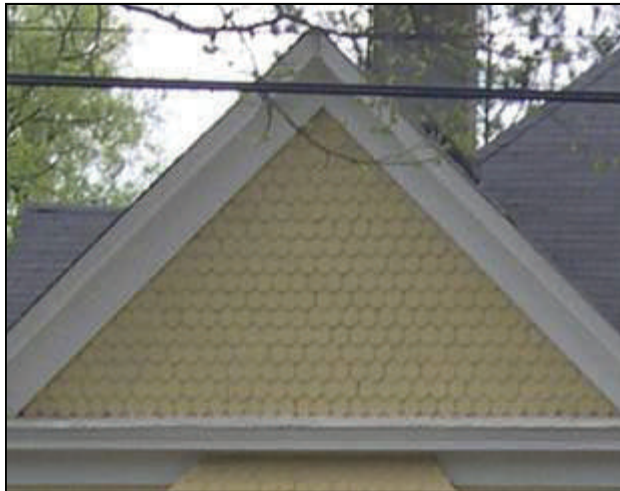
*212 South Bolivar Avenue uses a rounded shingle siding in the gable, commonly known as a Fish Scale pattern.*

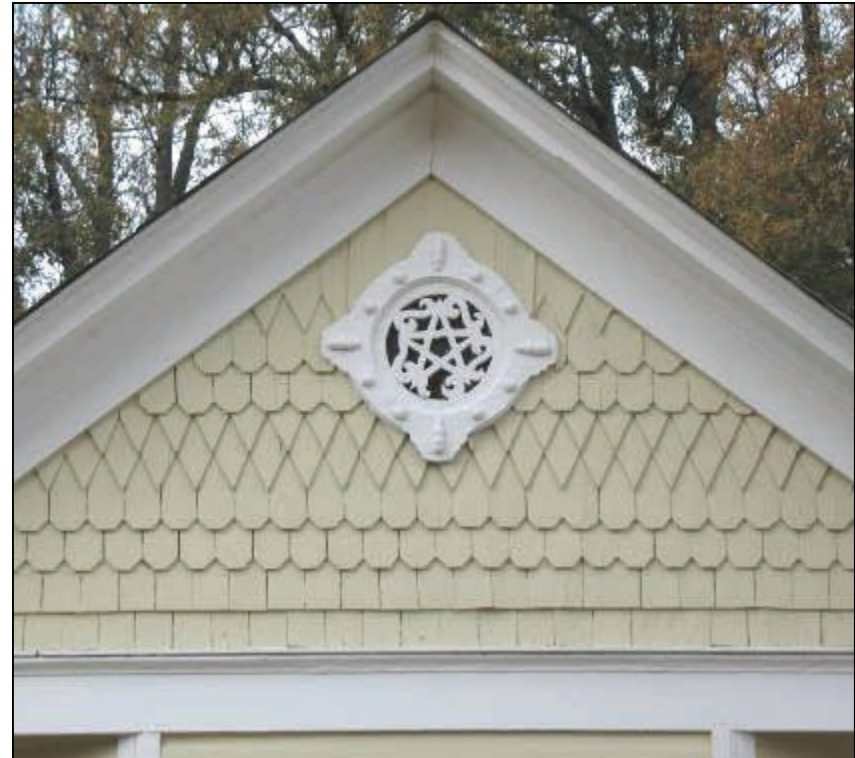
*The gable at 204 South Bolivar Avenue uses a combination of wood shingle siding patterns with square, diamond, and Fish Scale to add visual interest to the gable.*

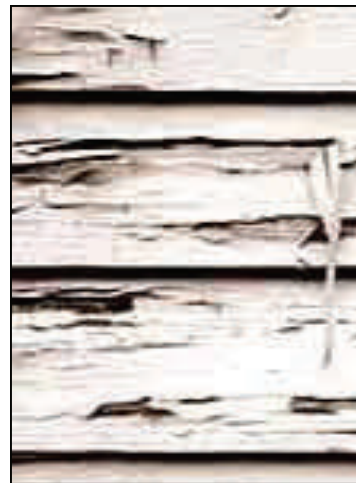
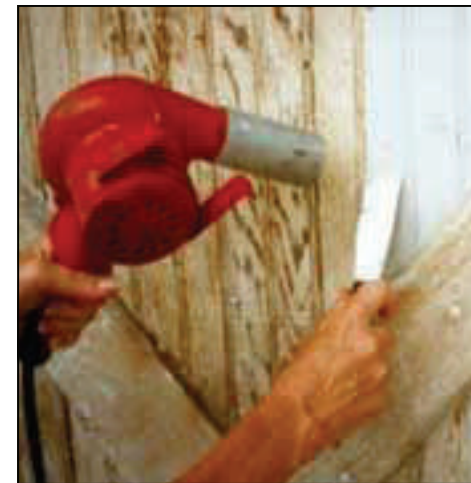
*These National Park Service photographs illustrate a painted finish with severe peeling (left) and the use of a electric heat gun (right) to remove a deteriorated paint finish.*

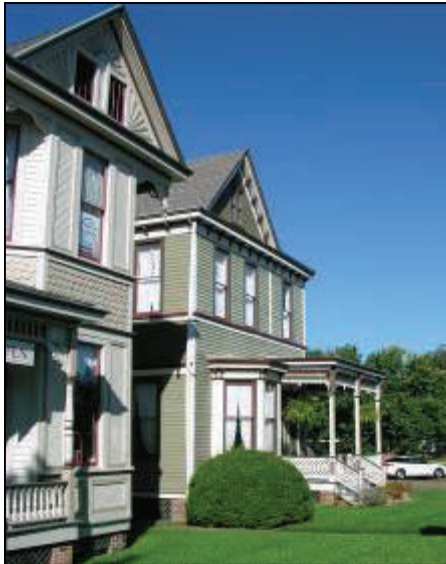
*These two Victorian houses in Natchez were restored in the mid-1980s and feature typical late nineteenth-century paint schemes. Both houses were thoroughly scraped, sanded, washed, primed (oil primer), and painted (two finish coats of latex). Both houses have insulated attics but no wall insulation. Their mid-1980s paint jobs still looked good over a decade later.*

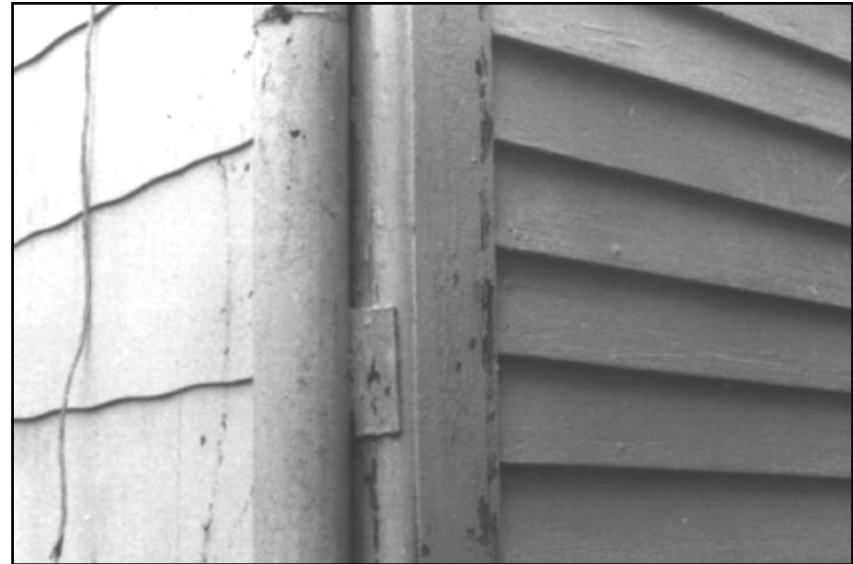
*Inappropriate asbestos-shingle siding has been installed over the historic horizontal wood lap siding. The inappropriate siding does not convey the same visual characteristics of the historic wood siding on the right and can obscure moisture and termite damage.*

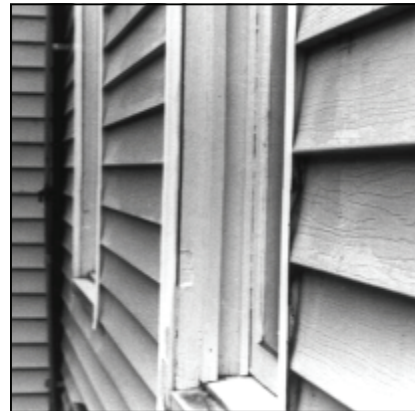
*These photographs illustrate how vinyl siding negatively alters the exterior appearance of a historic building. The vinyl siding is nearly flush with the trim around the windows, and J-channels have been installed around the windows to prevent water infiltration behind the siding.*

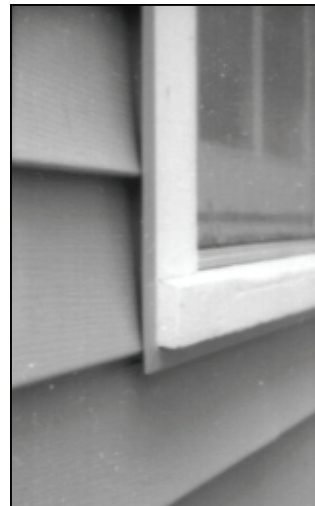
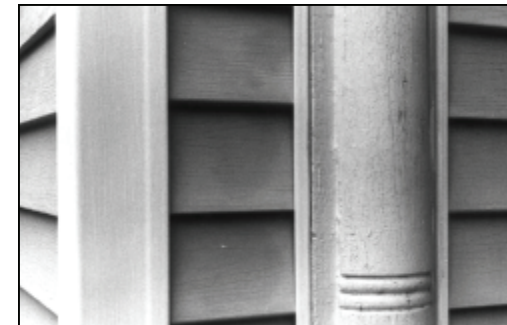
*Examples of vinyl siding showing the installation of J-channels around every opening and the historic trim, if it survived the installation process.*

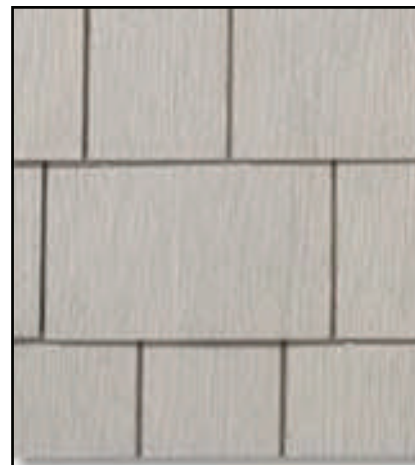
*Cement fiber siding is available in a shingle pattern.*

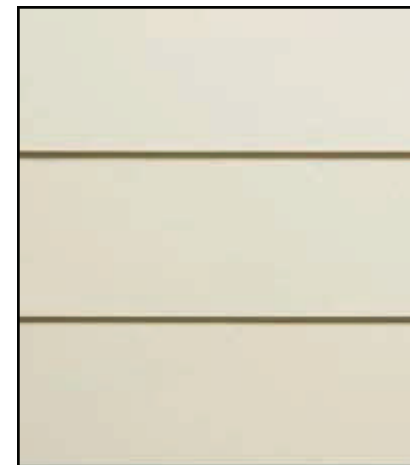
*Cement fiber siding is available in lap siding with a smooth or textured finish.*

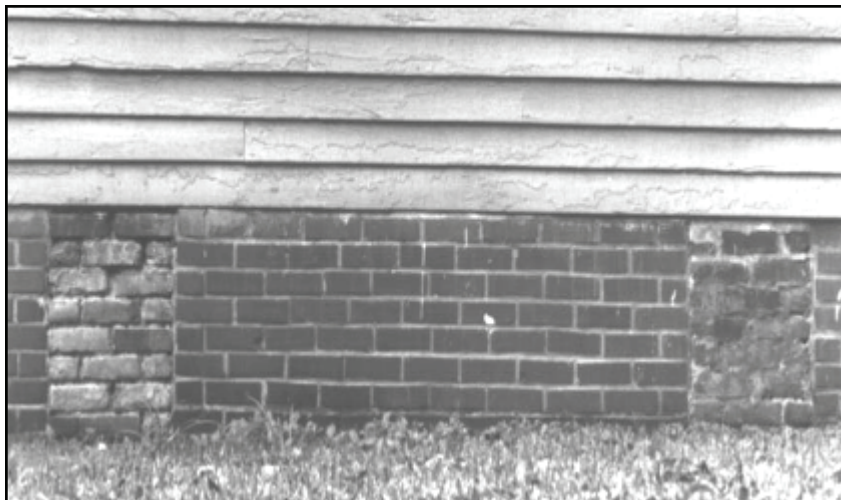
*This crawl space enclosure between the original brick piers has altered the historic character of this house and is visually inappropriate. The enclosure also has no vents to allow air circulation beneath the house to prevent the build up of moisture under the house.*

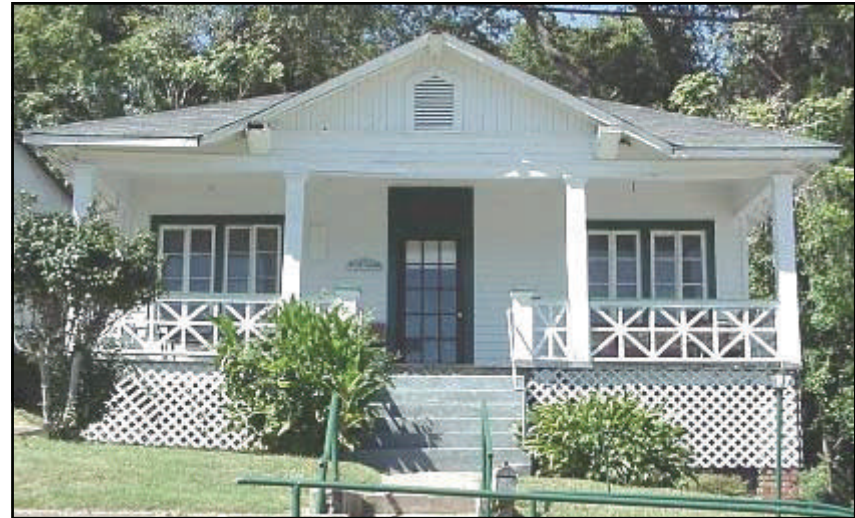
*The lattice used to enclose the crawl space beneath this historic house in Natchez is an example of an inappropriately installed enclosure as it overlaps and obscures the brick supporting piers.*

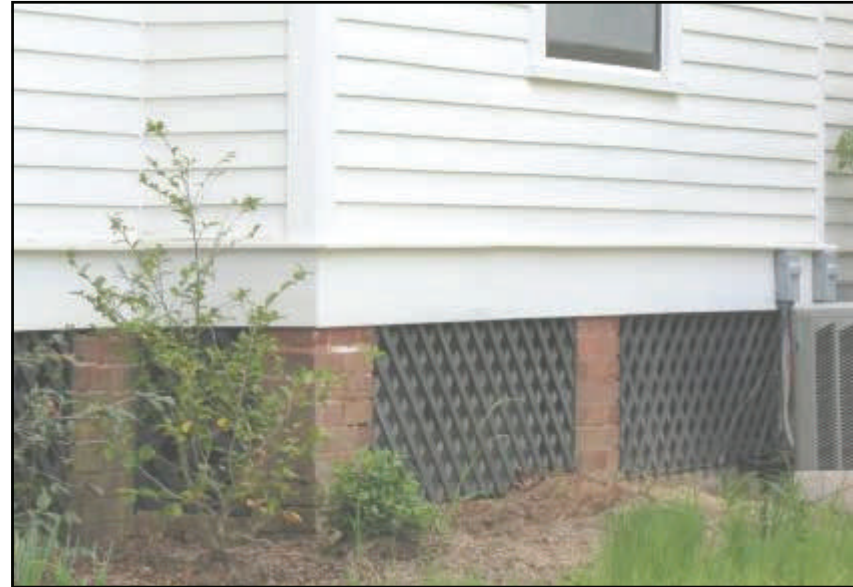
*The lattice panels between the brick piers appropriately enclose this crawl space.*

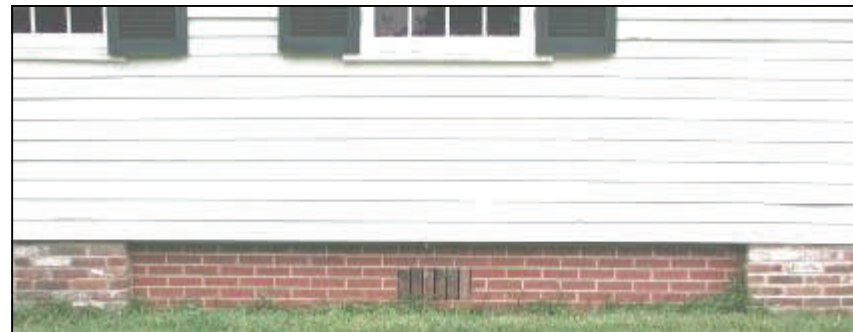
*This homeowner at least recessed the new brick crawl space enclosure and included an air vent pattern in the bricks. This treatment would look more appropriate if the new brick were painted black and faced with lattice.*

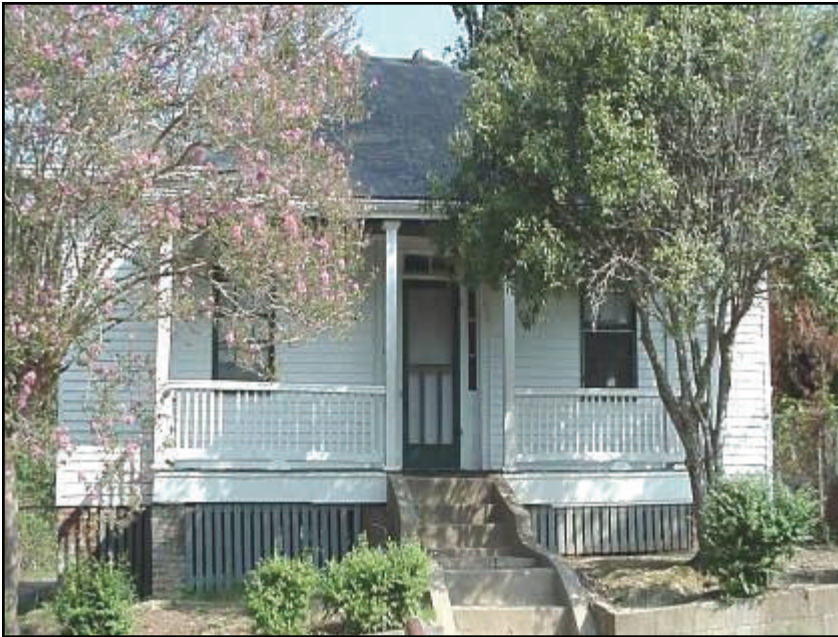
*This vernacular house in Natchez features a crawl space appropriately enclosed with vertical boards nailed to a frame between the brick piers.*

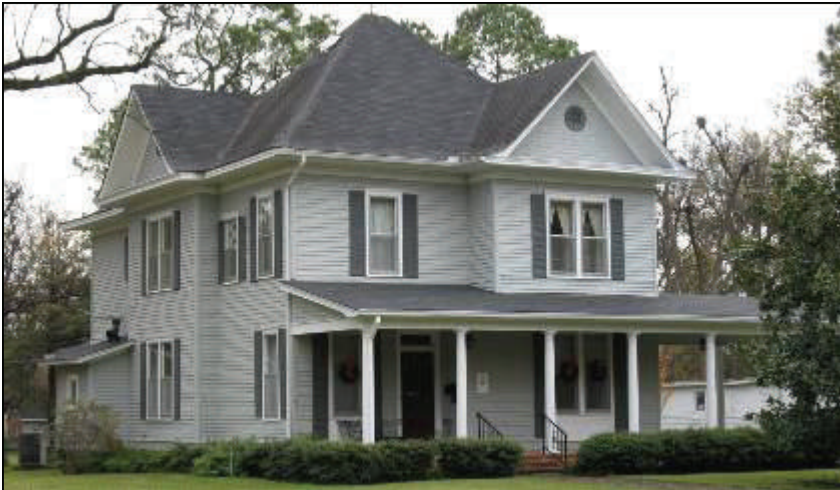
*301 South Bolivar Avenue has both a hipped roof and gable roofs which is very typical of the Queen Anne style.*

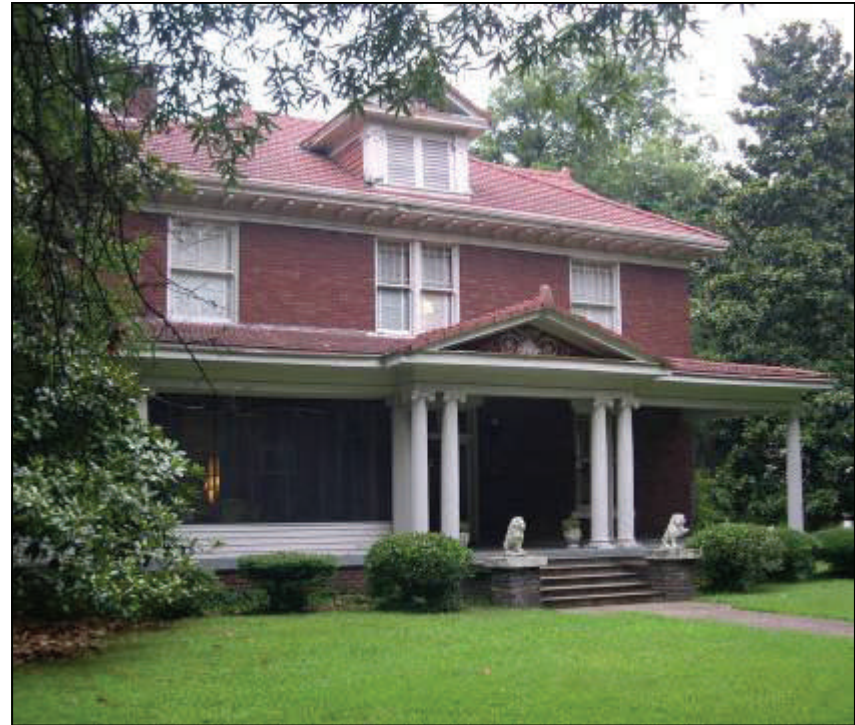
*208 South Pearman Avenue features a hipped roof over the house and porch both which use clay tile. The roof shape and material are typical of the Colonial Revival style.*

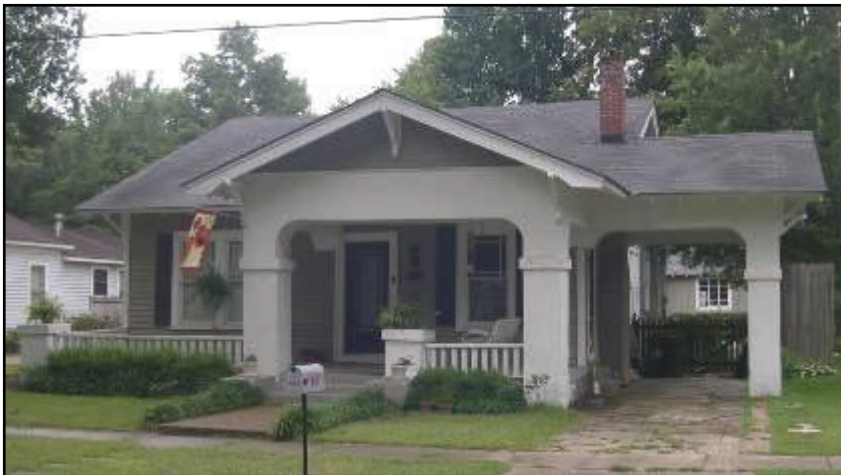
*The Craftsman style house at 109 North Victoria Avenue features multiple low-pitched gable roof with exposed rafter tips.*

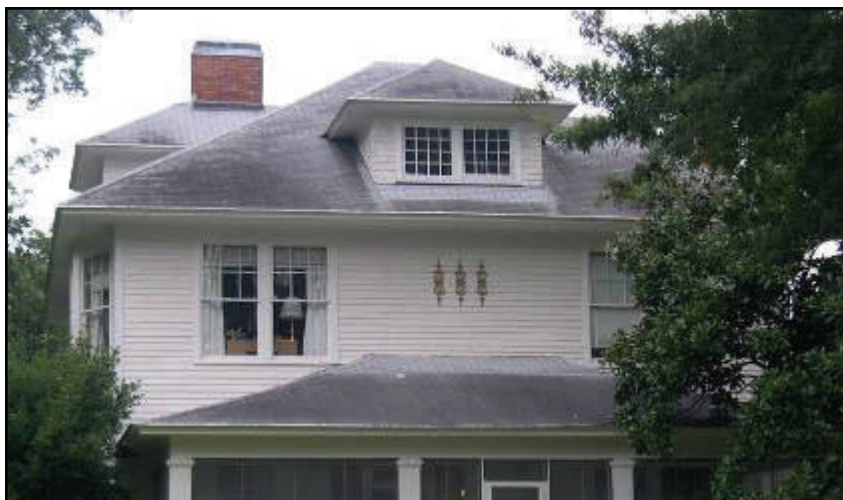
*200 South Pearman Avenue has a dormer with a hipped roof matching the main roof and windows to light the attic space under the roof.*

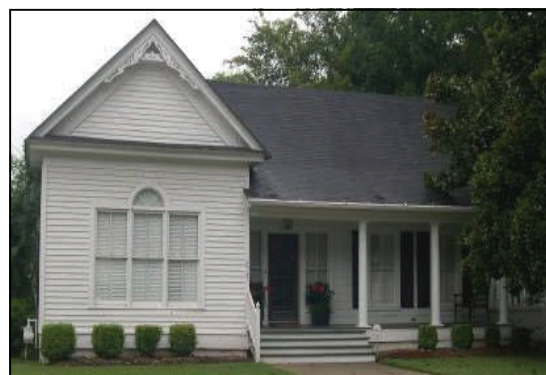
*The gable at 213 North Bolivar Avenue features a decorative vergeboard or bargeboard in the upper portion of the gable made up of cut pieces of wood to form a pattern.*

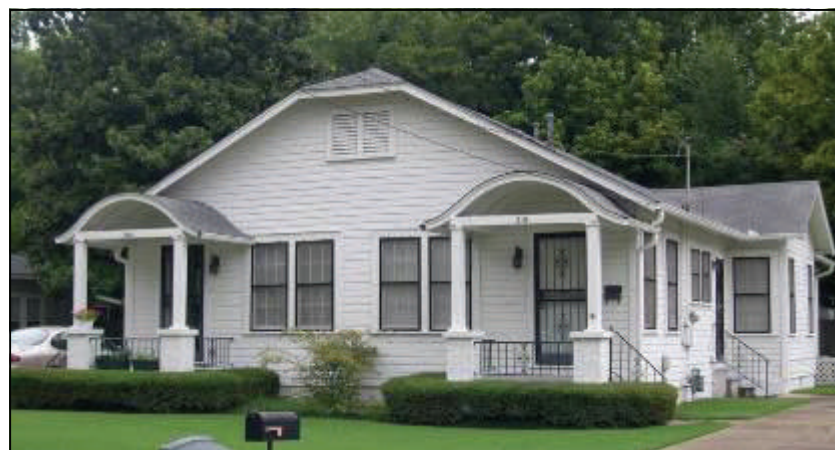
*218-220 North Leflore Avenue has a clipped gable end to the main roof and more unusual arched roofs over the entry porches.*

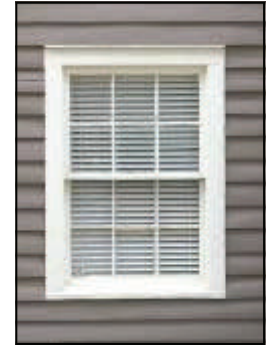
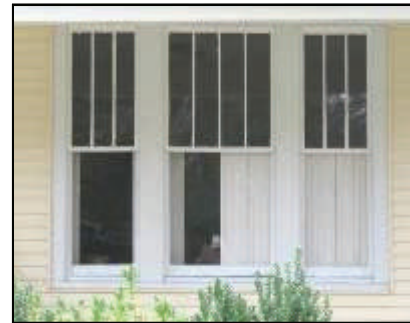
*The three-over-one and four-over-one windows on the left are typical windows found on Craftsman style houses.*

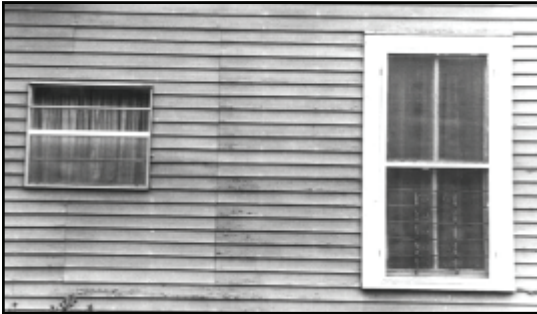
*The metal window on the left is inappropriate for a historic structure and does not convey the same visual appearance as the neighboring original window.*

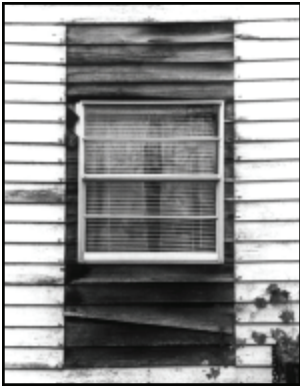
*This metal window is not appropriate for a historic house. It is an obvious replacement for a much larger window that has been removed. The original window hole has been filled by unpainted boards. Modern metal windows with horizontal divisions, like this ones above and below the left, are not suitable for historic buildings.*

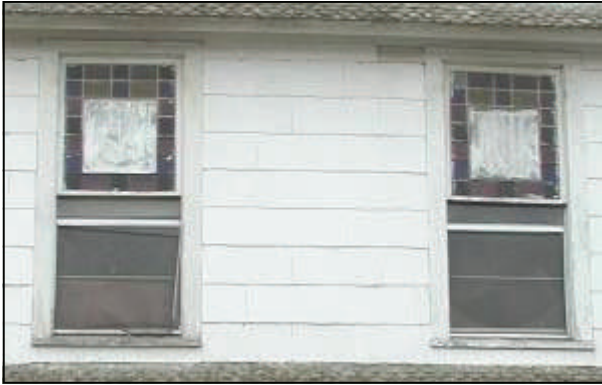
*These poorly sized aluminum window screens alter the appearance of these historic windows.*

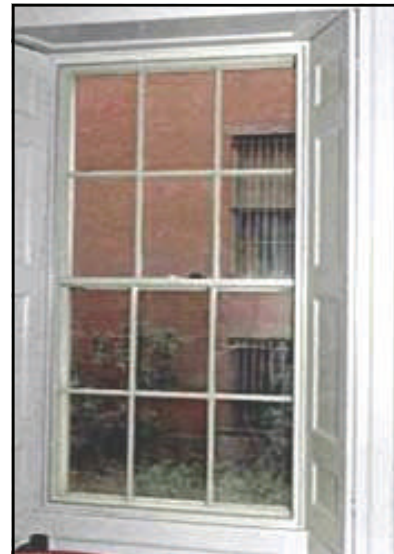
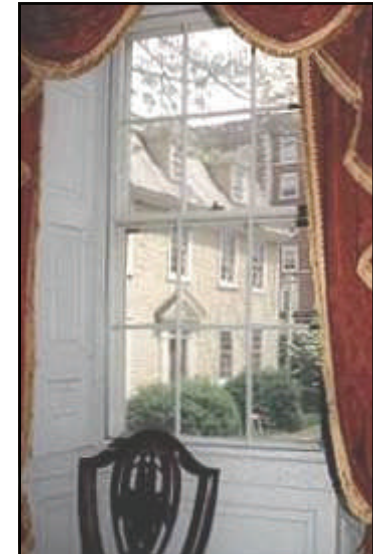
*These photographs of windows in two historic houses illustrate the use of “invisible” interior storm windows. Interior storm windows are easier to remove for cleaning, are not visible on the exterior of the house, and are barely visible on the interior. Manufacturers of “invisible” interior storm windows offer storm windows that are attached either by clip or by magnetic seal, like the examples pictured above.*

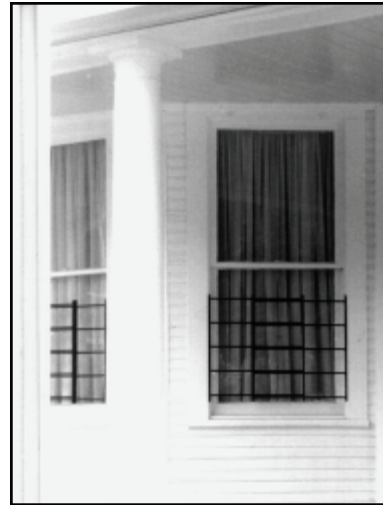
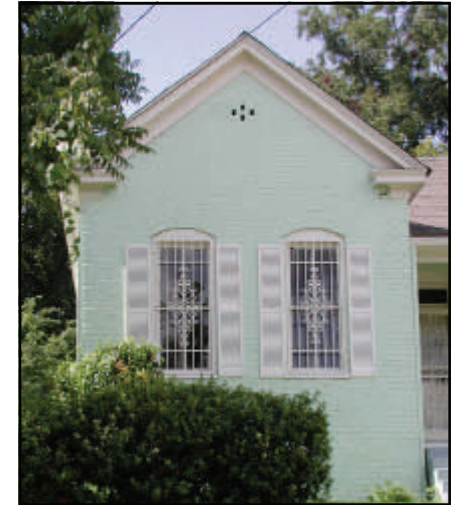
*Burglar bars are not appropriate for historic windows, because they change the historic character of the windows.*

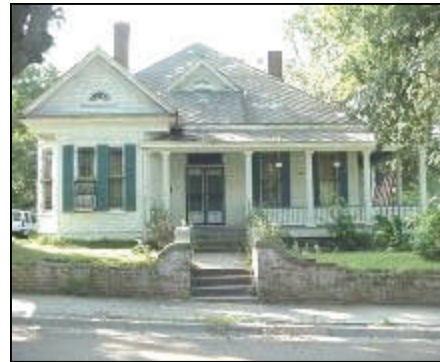
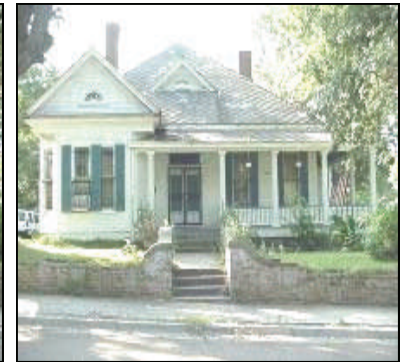
*Burglar bars mask the historic details of this Queen Anne cottage, illustrated in detail on the right.*

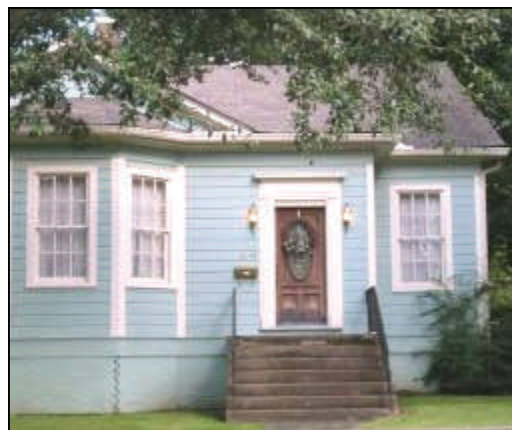
*This mass-produced, leaded-glass door is not appropriate for this mid-twentieth-century Colonial Revival cottage, which would have featured a “colonial” paneled door.*
