# **CLEVELAND DESIGN GUIDELINES**

Prepared by: David Preziosi, AICP - Mississippi Heritage Trust  
2008

**CLEVELAND, MISSISSIPPI  
2008**

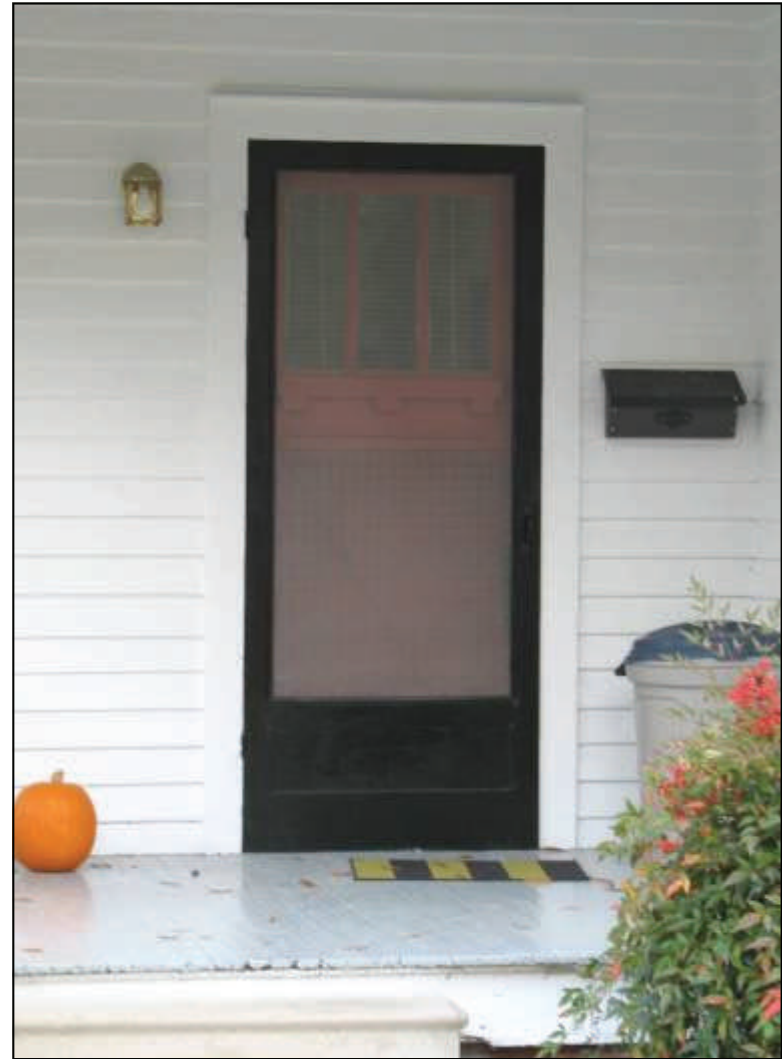
*This screen door on this Craftsman style house at 313 South Bolivar Avenue is a simple design that fits the character of the house.*

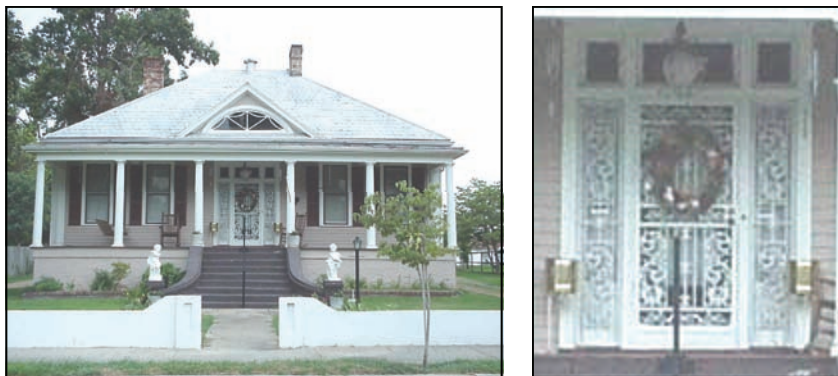
*A burglar door and sidelight grilles (right) obscure the historic doorway of this Colonial Revival house. Burglar doors and barred windows also increase the risk of death from fire, by making it difficult for rescue personnel to enter the build-*

Metal burglar doors are inappropriate for historic doorways, and their use should be restricted to doorways not visible from the public right-of-way. These metal doors are sometimes elaborately decorated and radically alter the character of a historic building. Metal burglar doors also give a negative impression to potential residents, businesses, and tourists, because their existence implies a high crime rate.

**WARNING:** *Section 1005.7 of the Standard Building Code states: “Each sleeping room or room with a required exit door in a residential occupancy that has burglar bars installed shall have at least one emergency egress window or door that is operable from the inside without the use of a key, tool, special knowledge, or effort.”*

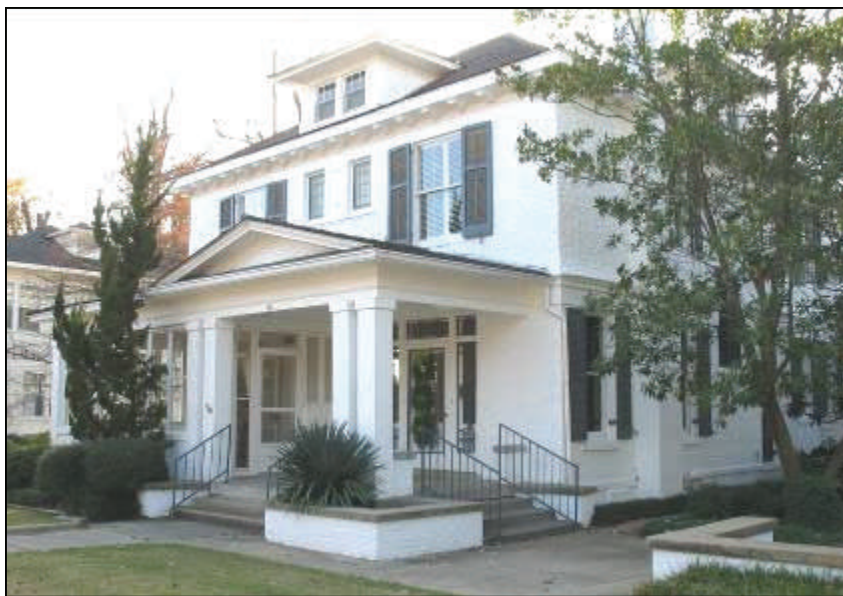
*The house at 111 North Victoria Avenue has original louvered wood shutters that are operable and hang on shutter hooks.*

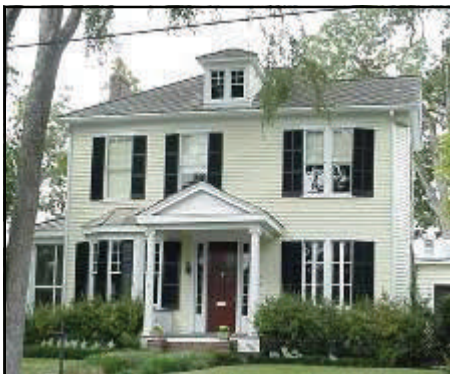
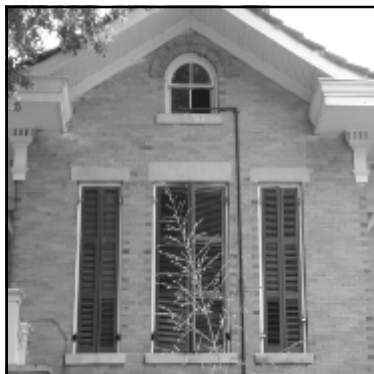
*The window shutters of these two houses are original and properly fit the windows. The house on the left illustrates original shutters that are properly sized and hung for paired windows and a bay window.*

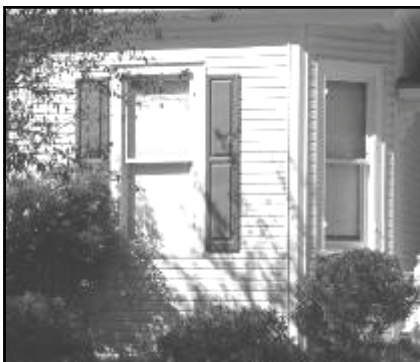
*The vinyl shutters flanking this window are too narrow and incorrectly hung outside the window frame. Paneled shutters are also inappropriate for Queen Anne style houses.*

Vinyl shutters and blinds, as well as many stock replacements in wood, are not appropriate for historic buildings. The proportions and detailing of stock modern blinds are usually incorrect for historic buildings.

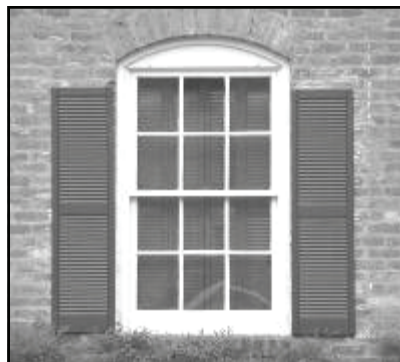
*Shutters on this arched window are too short, too narrow, and wrongly hung outside the window frame. Shutters for this window should also form an arch when closed.*

When installing replacement shutters or blinds, make sure that the replacement shutters or blinds are the same height and width as the window opening. Installing shutters or blinds on picture windows is inappropriate.

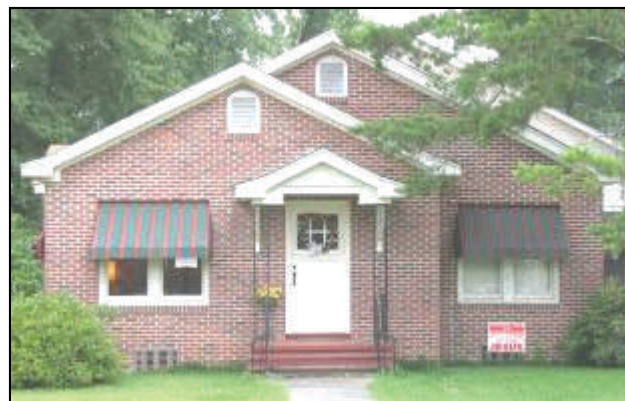
*The canvas awnings on this house are appropriately sized for the residential windows.*

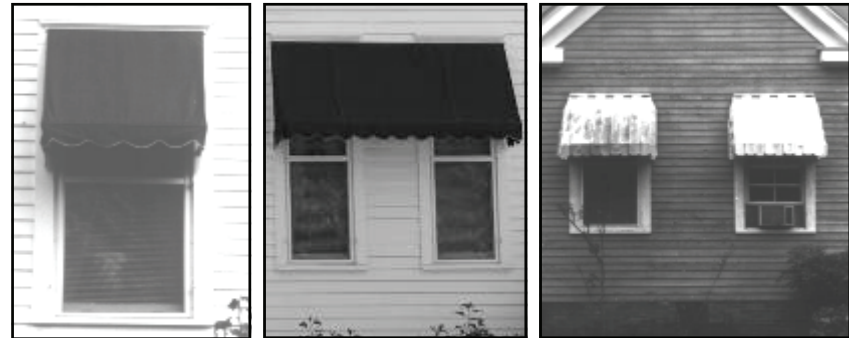
*Canvas awnings are appropriate for residential buildings. The awning above left is correctly hung. The awning in the center is incorrectly hung with one awning for two windows. The metal awnings above right are incorrect for historic buildings.*

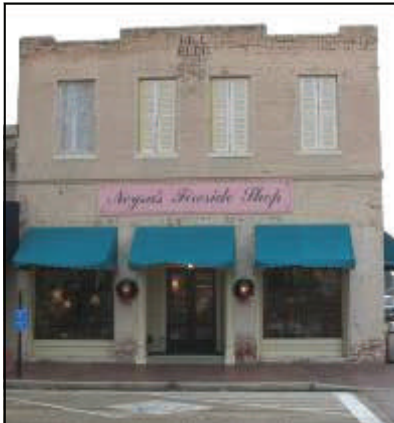
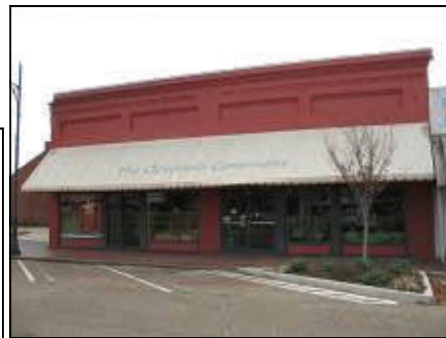
*The canvas awnings on these commercial buildings on Main Street show the correct location for canvas awnings on one and two-story buildings.*

Install canvas awnings to maintain, rather than disrupt, the architectural rhythm of the buildings on a block. On historic buildings with altered storefronts, install the awning to reflect the original first-story height rather than the lowered plate-glass storefront.

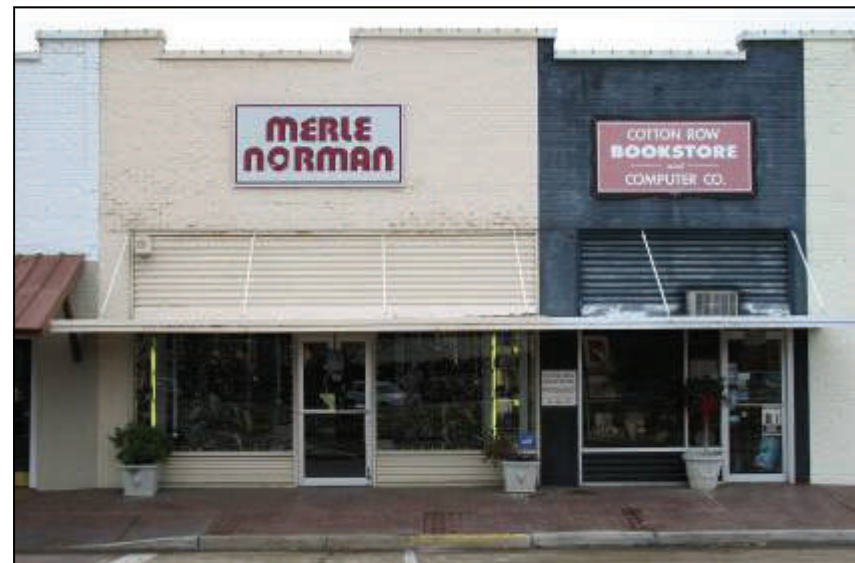
*These buildings on Sharpe Avenue show the correct installation and projection for suspended canopies on a commercial building. The projecting flat canopies are anchored by rods which is typical of commercial buildings built in the 1920s to 1940s.*

Canopies should be at least eight feet above the sidewalk and connect to the building above storefront windows.

Metal rods or chains should be used to suspend the canopy and securely anchored to the building wall. Look for original anchors before installing new ones.

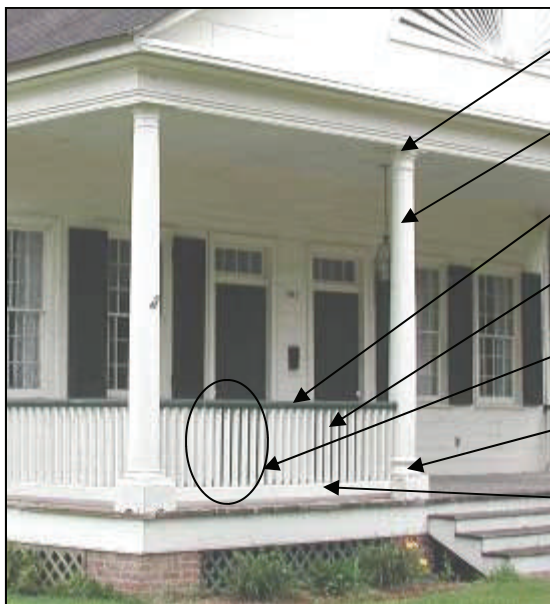
## PORCH COMPONENTS

*Column Capital*

*Column*

*Column Base*

*Bottom Rail*

Porch components include columns or posts which are the vertical members that support the roof structure. They can either be full height columns that go from the porch floor to the porch ceiling or can be shorter height and sit on masonry piers that extend up from the porch floor. Columns can be round and turned with different shapes or can be one of the classical order of columns including Tuscan, Doric, Ionic, Corinthian, and Composite. Within the classical order of columns there are smooth columns or fluted columns that have shallow concave grooves that run vertically up the column. In between the columns usually there will be a set of balusters (short vertical pieces) that support a horizontal rail that goes between columns. The baluster together with the rail is termed a balustrade. Balusters can be of different designs corresponding with the architectural style of the building. Versions of wood balusters include: turned (of various shapes and design), square, or flat sawn cut. Balusters can also be made of iron, or other metal. In some cases historic houses were built with out the use of a balustrade in between columns and if that is the case no balustrade should be installed unless required for safety reasons. If that is the case the balustrade so be appropriate for the style of the building.

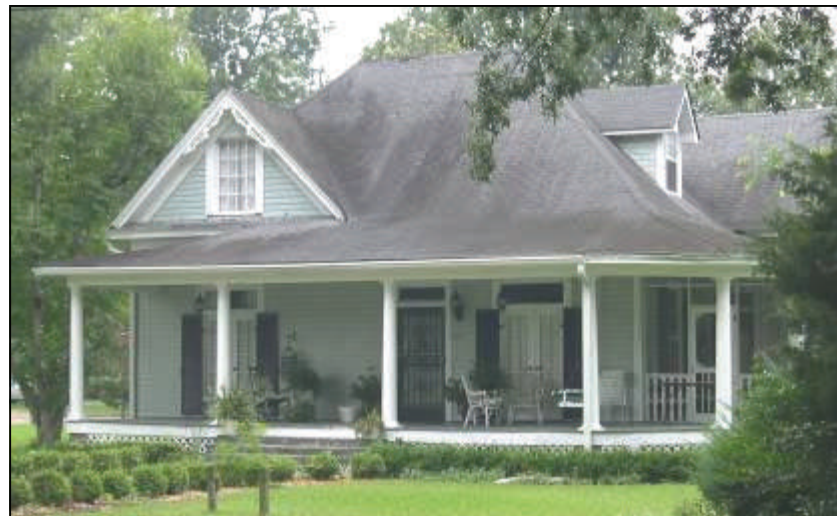
*The house at 314 South Bolivar Avenue features a projecting wrap-around porch typical of the Queen Anne style however, the Tuscan columns are more Colonial Revival in detail.*

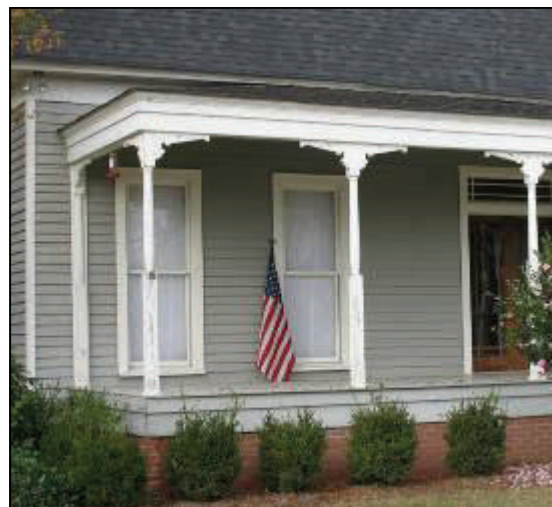
*The porch at 209 North Pearman Avenue features typical Queen Anne style details of turned columns and brackets at the top of the columns.*

Porches of late nineteenth-century buildings in the Queen Anne style are usually generous in size and may wrap around two or more elevations of the house. Typically the Queen Anne style porch is integral with turned columns and balusters and may even have decorative brackets attached to the columns. Some later Queen Anne houses have the form of the Queen Anne style with the detailing of the Colonial Revival style.

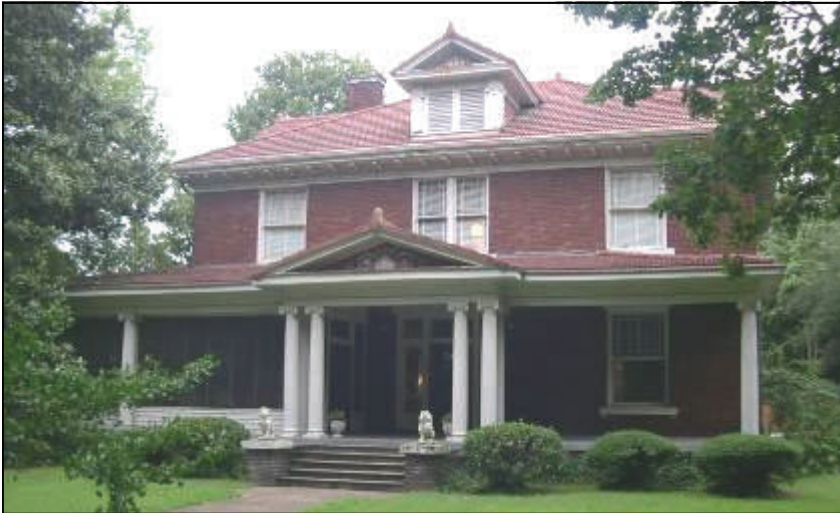
*This Colonial Revival House at 208 South Pearman Avenue features a full width porch with Ionic columns and paired columns at the entrance typical of that style of house.*

Colonial Revival porches dating to the early twentieth century echo the designs of the earlier periods with turned columns or columns of Roman classical orders. Often columns are paired together and sometimes are on bases or pedestals. Balusters of Colonial Revival houses are usually decoratively turned but slender in proportion.

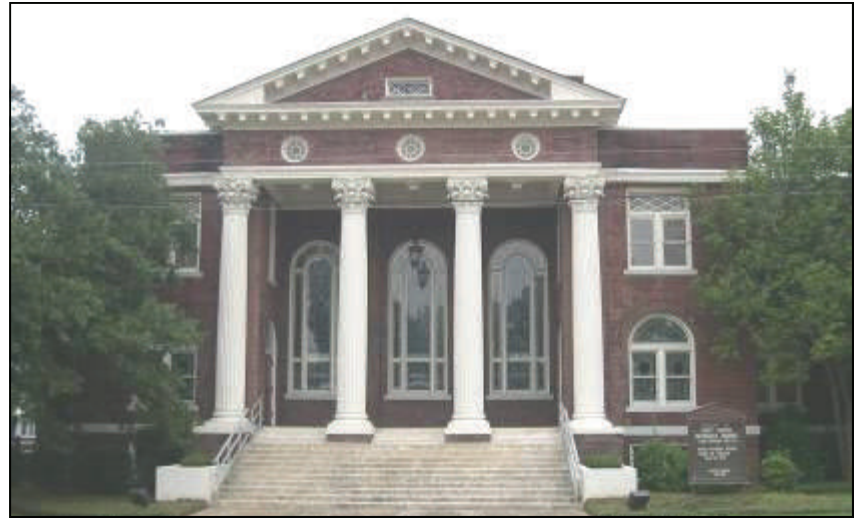
*The First Methodist Church features a full height two-story porch typical of the Neo-Classical style.*

The porch of the Neo-Classical Revival style differs from the Colonial Revival style principally in its reliance on Grecian orders for its columns, its monumentality, and its symmetry. Typically porches on two story Neo-Classical houses are full height and centered on the main façade.

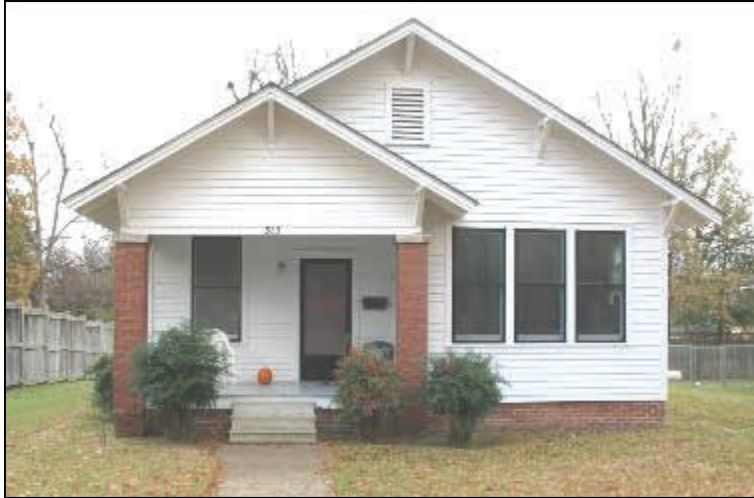
*This Craftsman house at 313 South Bolivar Avenue has a projecting porch supported on brick columns typical of that style.*

A porch that features tapered box columns resting on brick piers is one of the most identifiable and common characteristics of the Craftsman/Bungalow style. The pedestals are sometimes linked by a brick porch wall that substitutes for a balustrade. In Cleveland there are also Craftsman/Bungalow style houses with brick or stucco full height columns supporting the porch. There are also several houses in Cleveland that are of an earlier style than the Craftsman/Bungalow style but received updated porch components during the period when Craftsman/Bungalow style houses were popular. The concrete porch decks of the Craftsman/Bungalow style are practical innovations for lower maintenance. Pergolas are frequently incorporated into the design of Craftsman/Bungalows to create additional outside living space.

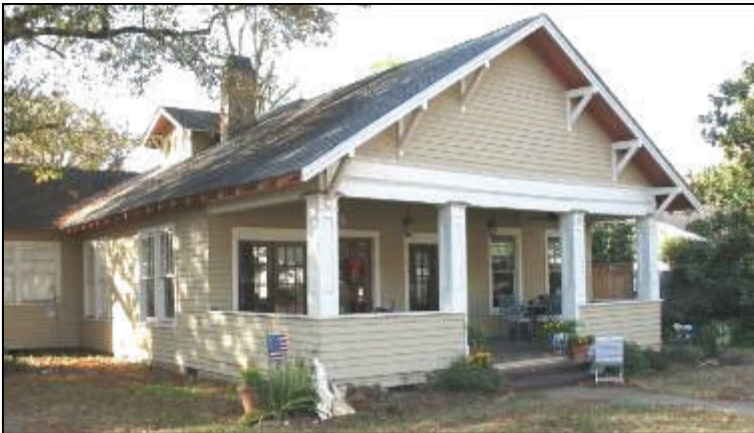
*The Craftsman style house at 115 North Leflore Avenue has full width undercut porch supported n box columns and a half wall balustrade.*

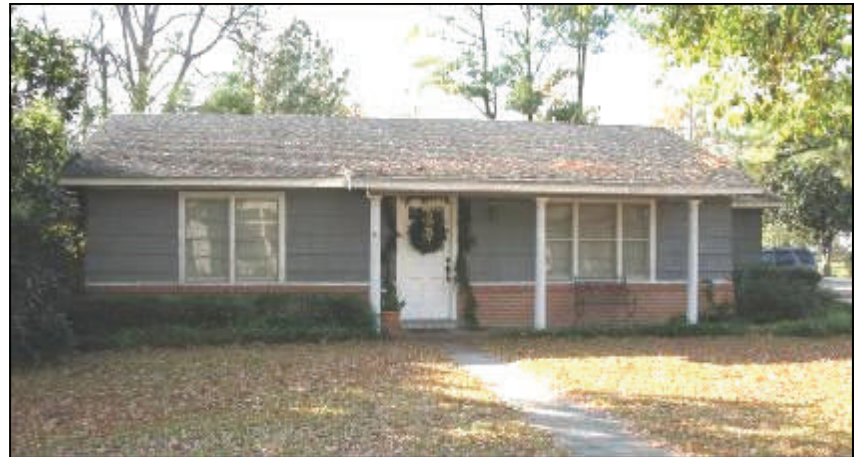
*The Ranch style house 117 North Leflore Avenue has a small overhang that acts as a front porch and is supported by columns on a concrete deck.*

The Ranch style houses of the mid-twentieth century sometimes have porches, but they are usually only concrete decks beneath roof overhangs. Contemporary or Modern style houses feature variations on the porch with wide overhanging sloped roofs or entry porches tucked under roof lines like Ranch house.

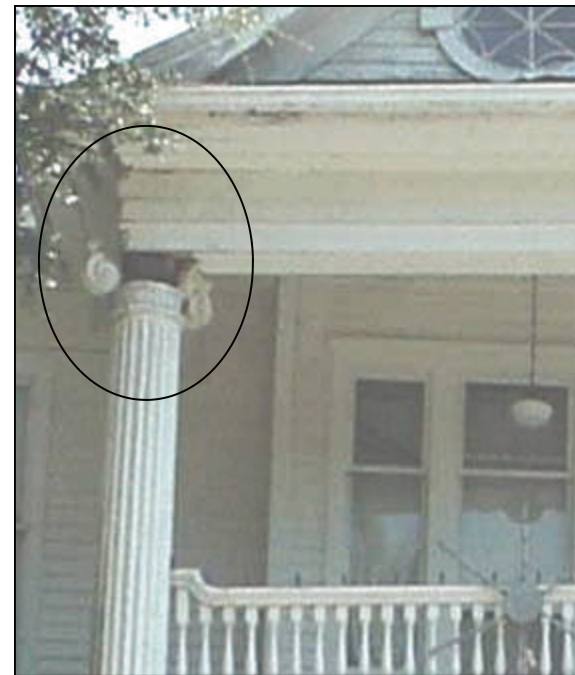
*Failure to clean and maintain gutters is the primary cause of porch deterioration such as the damage caused to the column capital.*

Failure to paint and maintain porch decking accelerates deterioration of perimeter beams and joists. Bases of posts and columns should be periodically checked for signs of settlement that indicate deterioration and compression of supporting perimeter beams. Porches should be routinely painted, and joints, joints, cracks in posts, columns, and balustrades should be carefully caulked to prevent water infiltration.

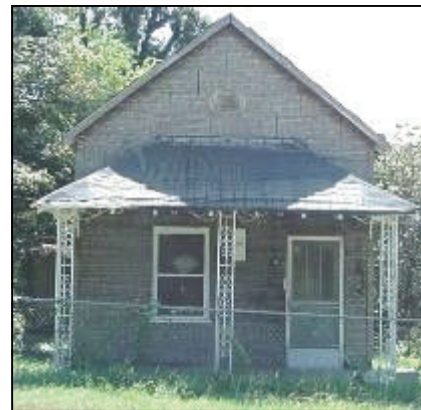
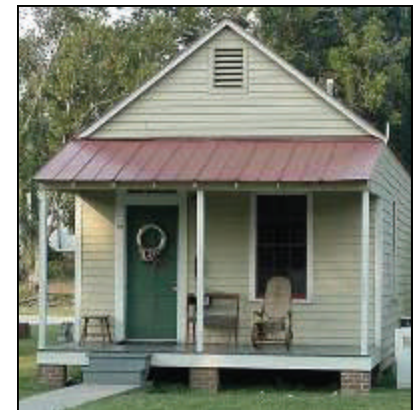
*These two Natchez shotgun houses illustrate how changing the porch components alters the historic appearance and integrity of the house. The original columns on the house on the left were replaced with metal trellis columns while the house on the right has wood columns, which are also replacements but are more in keeping with original style of the building.*

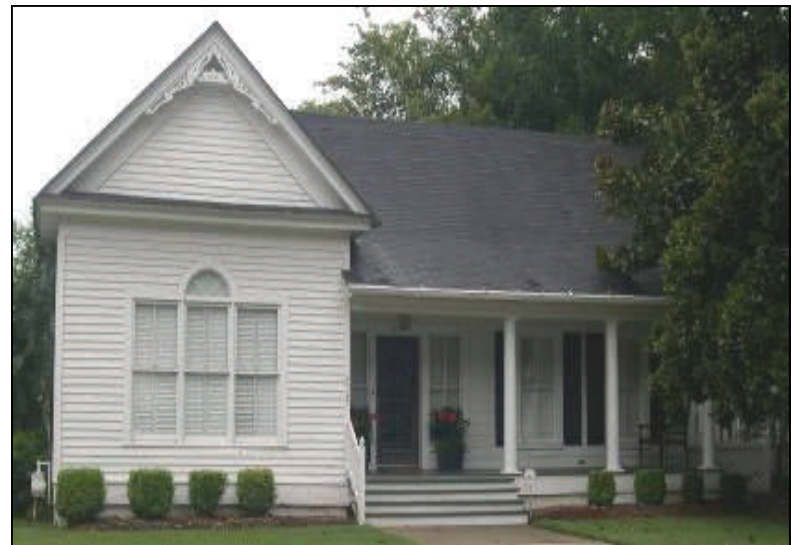
*The steps of this Free Classic Queen Anne style house at 213 North Bolivar Avenue are appropriately constructed of wood.*

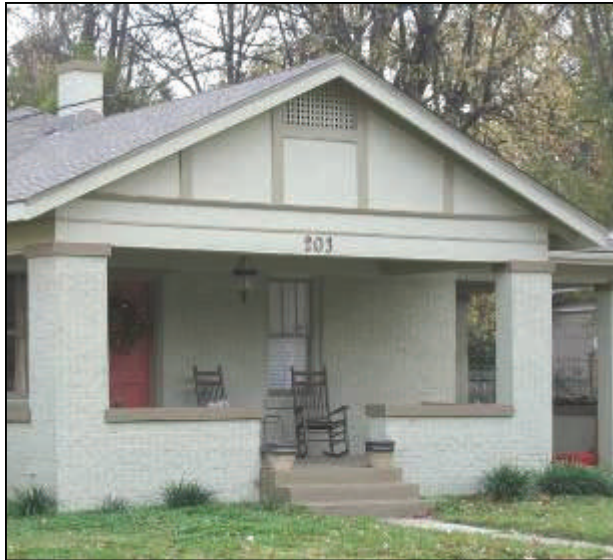
*This Craftsman Bungalow style house at 203 South Bolivar Avenue has appropriately painted concrete entry steps for the style of house.*

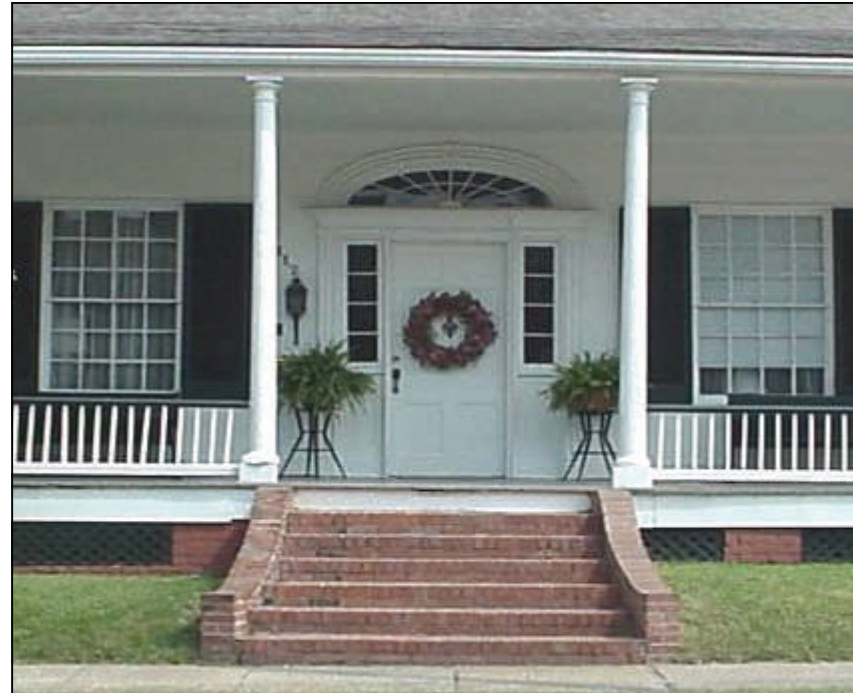
*The brick steps overpower this house and draw attention from the historic character of the building.*

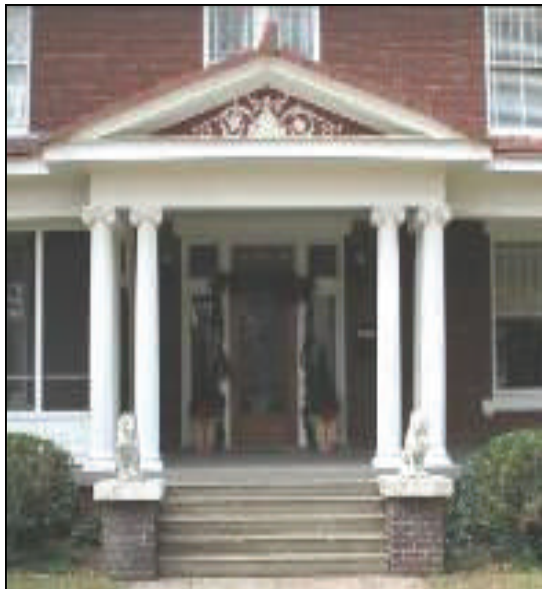
*The concrete steps of this Colonial Revival style house at 208 South Pearman Avenue are appropriate for the style of the house.*

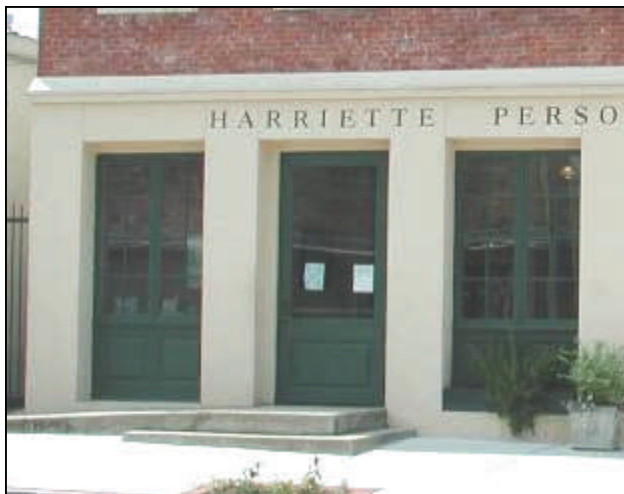
*This commercial building in Port Gibson provides accessibility with the use of a discrete ramp on the front of the building.*

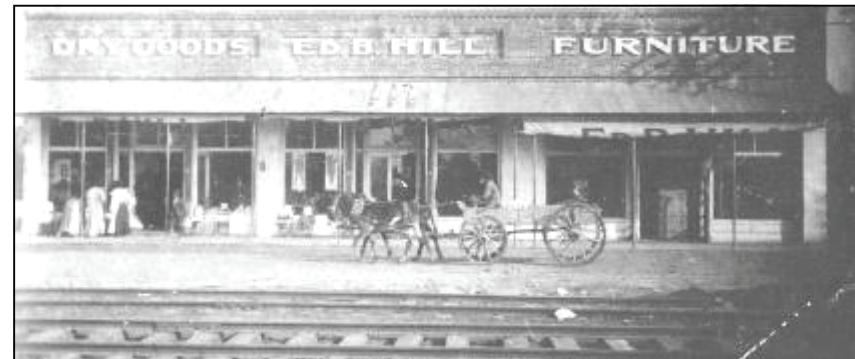
*This photo of the Ed B. Hill store from the early 1900s shows a typical Cleveland storefront of the time with wide openings for glass and doors to showcase the merchandise and light the interior. Photo from Cleveland: A Centennial History.*

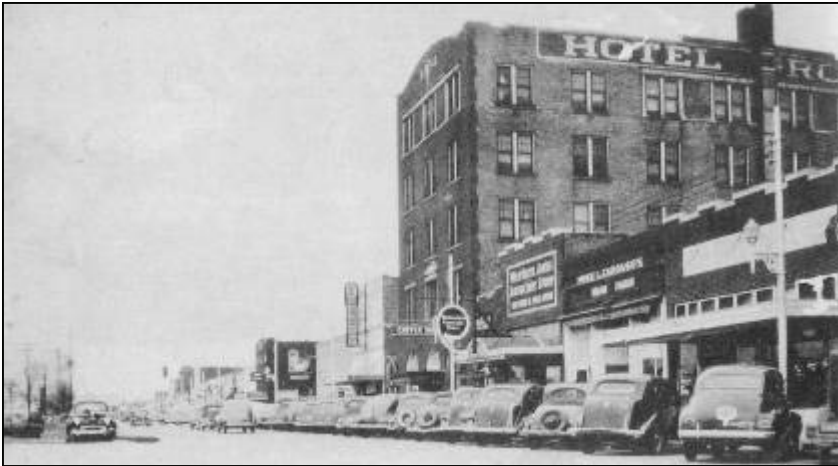
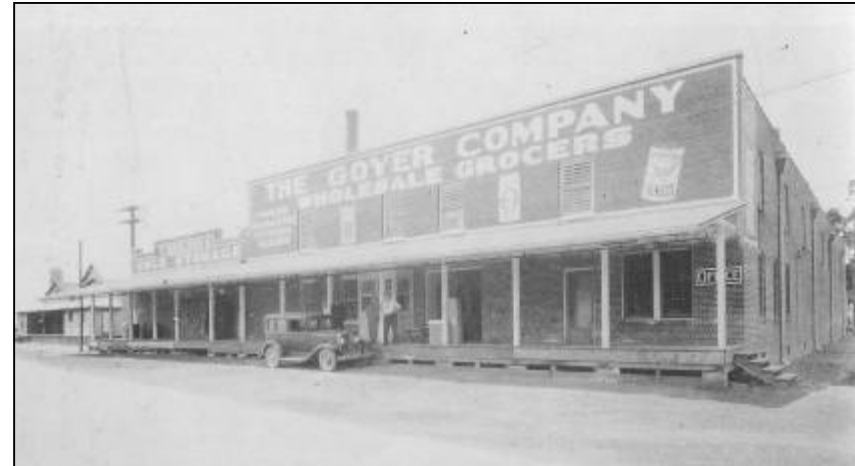
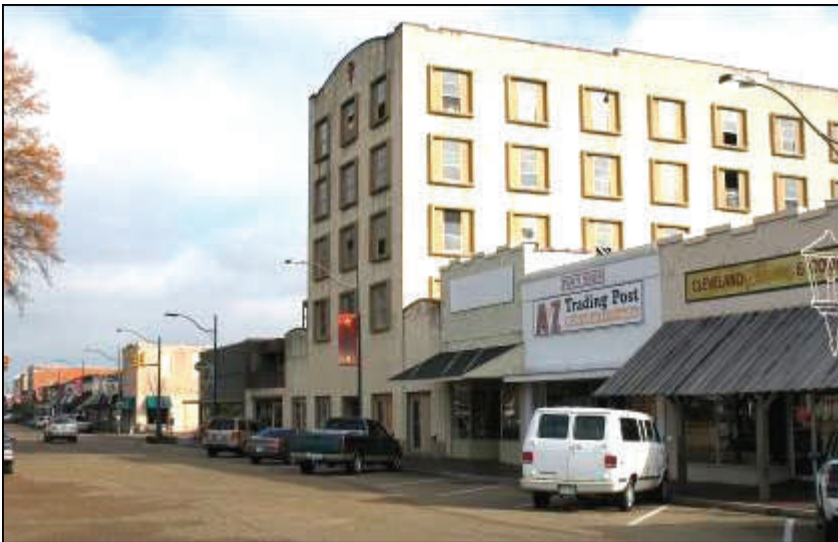
*Sharpe Avenue in the late 1930s and today. Notice the changes in the Grover Hotel windows and the changes to the storefronts which include painting of the buildings, new canopies, and alterations to the display windows.*

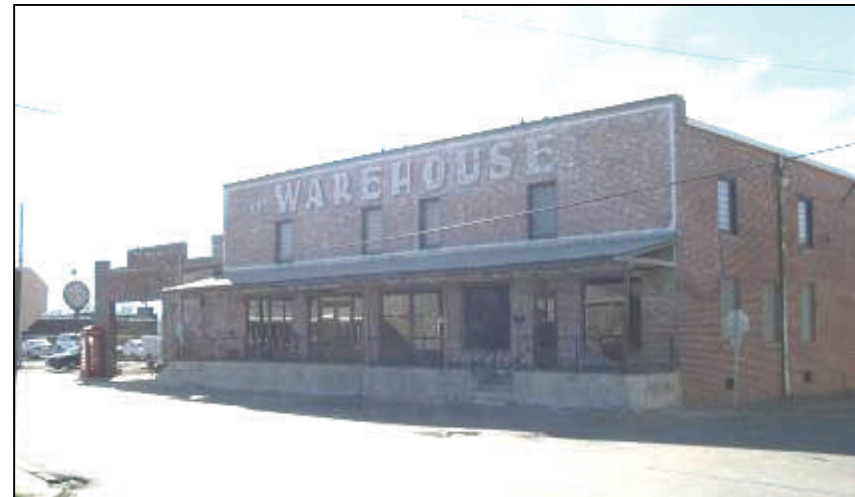
*The top photo shows the Goyer Company building in the 1920s and the photo below shows the building today. Some minor changes have taken place to the windows and openings on the first floor and the wood deck under the canopy has been replaced with concrete.*

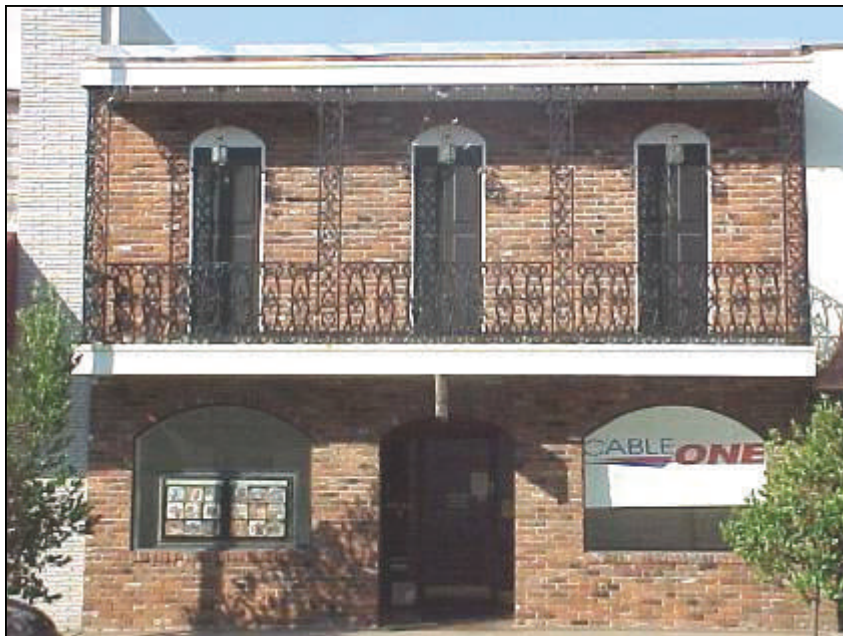
*Avoid creating a false historic appearance like this one-story building in Natchez where a faux New Orleans style balcony and doors were added to make it look like a two-story building.*

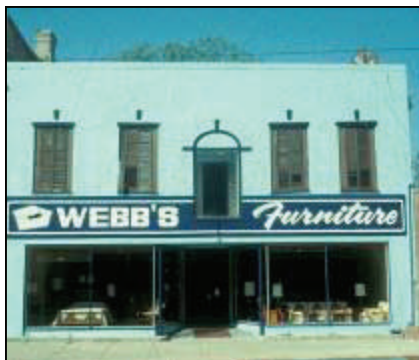
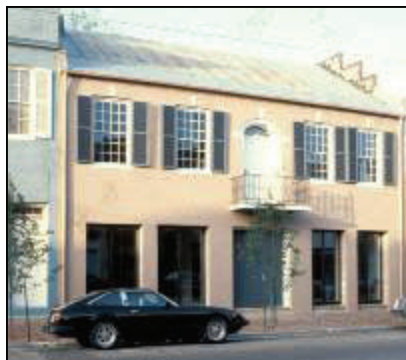
*No photographs existed to guide the restoration of the first-story of the Natchez commercial buildings above and below. Following National Park Service guidelines, the owner installed a contemporary first-story storefront that is compatible with the building and the streetscape in the top photo. Below original storefront doors found in the building and historical precedents and patterning found on other Natchez buildings were used for the design of the new storefront.*

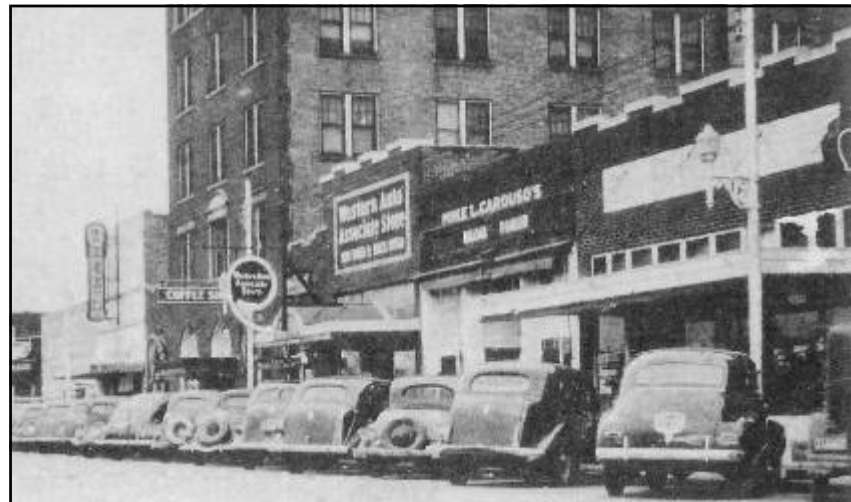
*This photo of Sharpe Avenue in the late 1930s illustrates the historic use of signage on buildings. Photo from Cleveland:*

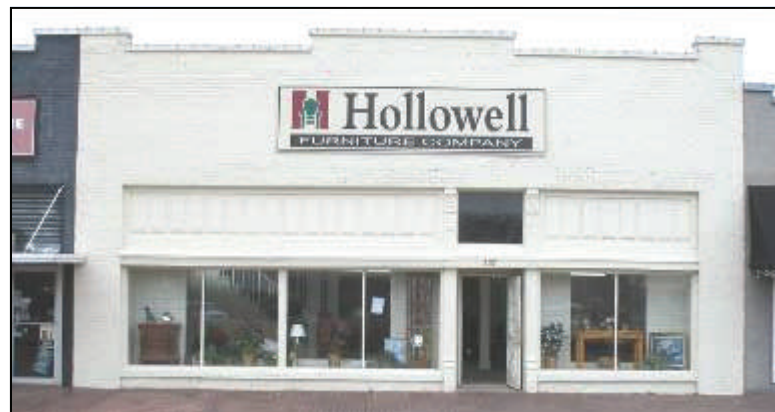
*The signage on this building in downtown Cleveland is an example of how to place signage in a historically correct location in the parapet area above the transom windows. The lettering is of an appropriate size and fits neatly in the sign board.*

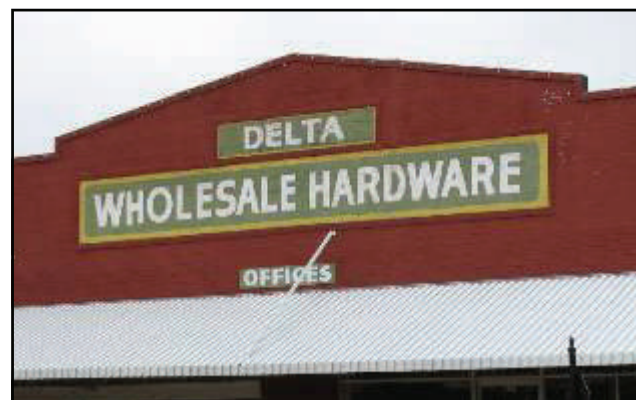
*The sign on this building in Cleveland is painted in the sign board area which is delineated by a projecting brick border.*

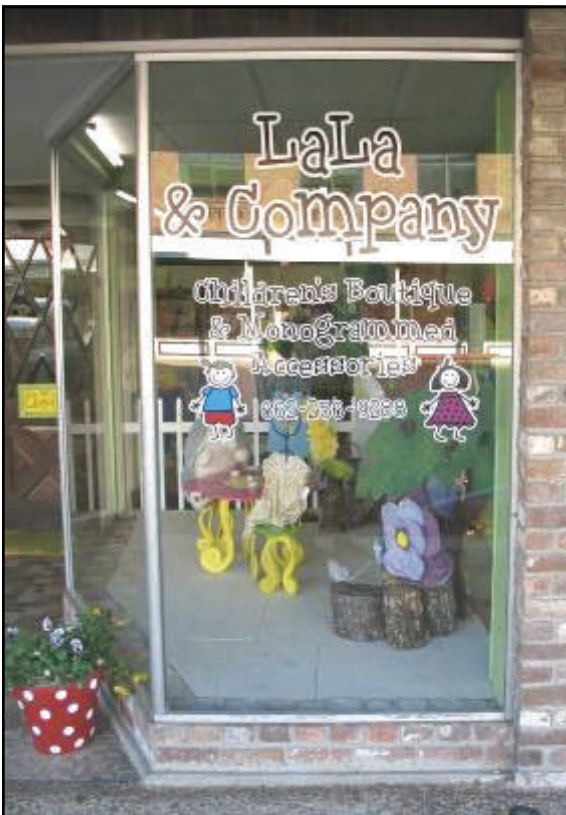
*The window sign is very effective displaying the name of the store and the items that are carried. The signage can easily be altered for the additional of new items or removal of existing items.*

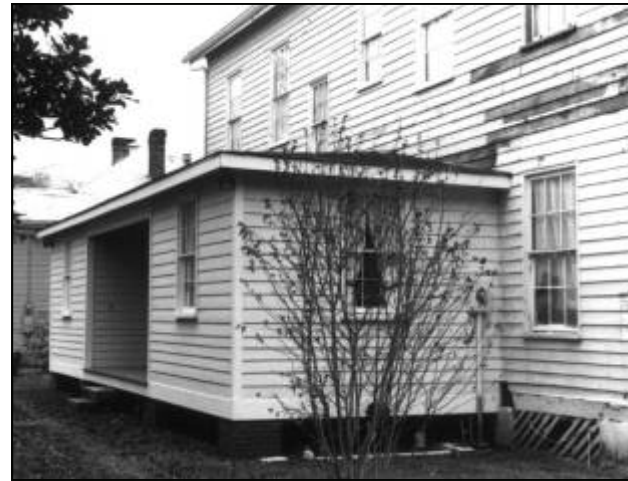
*This rear addition is secondary to the original house and reads as an addition yet uses materials similar to the original house.*

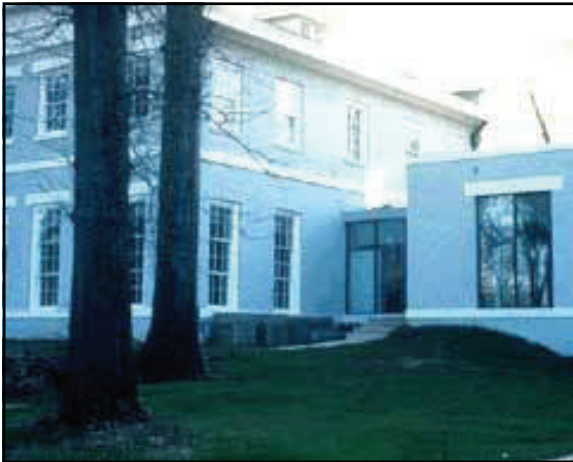
*This National Park Service photograph illustrates an appropriate design for a modern addition and a proper method of connecting it to the historic building.*

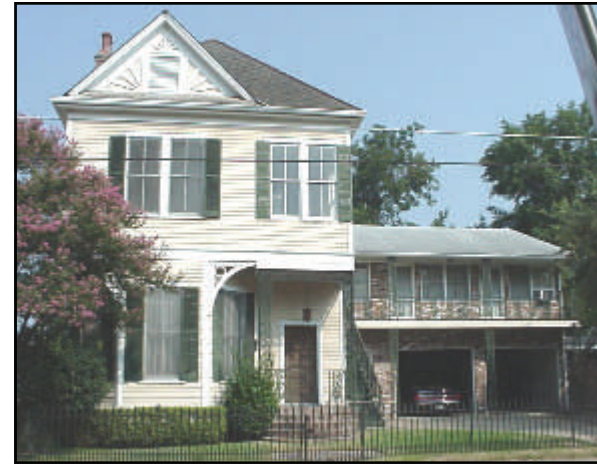
*This side addition is inappropriate in proportion and scale, height, materials, massing, and roof shape. The upper and lower porches, the entrance door, and the second-story windows of this historic house have also been remodeled.*

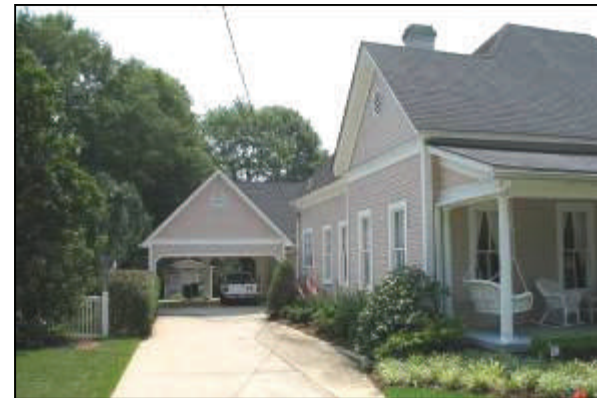
*This example of a carport addition is very successful as it does not compete with the historic house and uses similar materials and roof pitch to maximize the compatibility.*

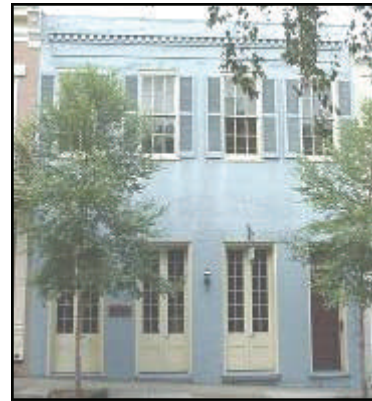
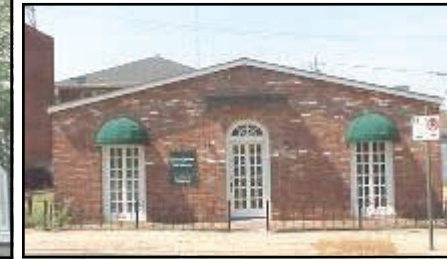
*The circa 1965 building in Natchez on the right stands on the same block as the circa 1870 historic building on the left. This is an example of incompatible new commercial construction with inappropriate height, scale and proportion, massing, for the streetscape.*

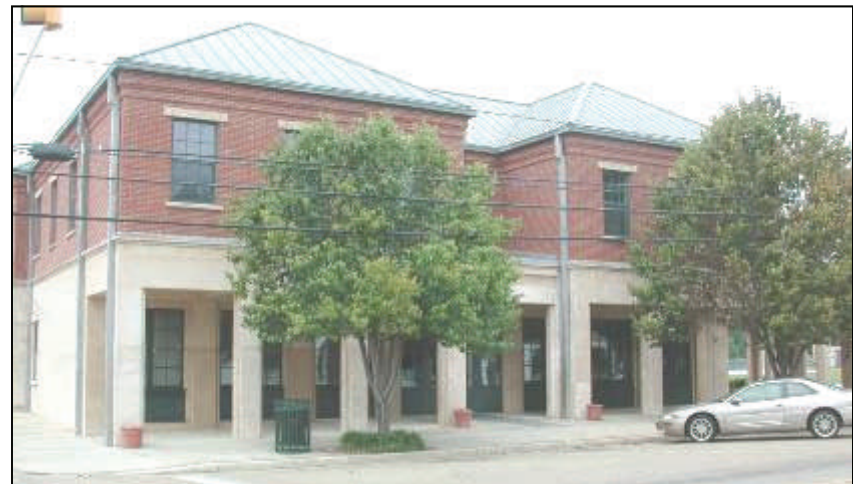
*The Matt Ross Administration Building in Port Gibson is one of Mississippi's most successful examples of designing a new building to fit into a historic context. Although built in the 1990s using modern technology of the time, the building complements its neighbors and echoes the historic character of Market Street in downtown Port Gibson.*

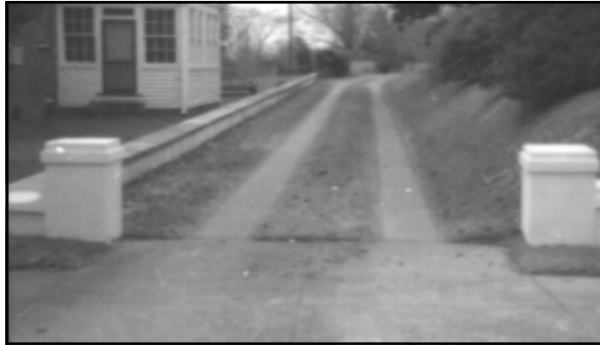
*Concrete strips are appropriate for driveways in historic districts. They minimize the impact of driveways on the character of the historic property and its neighborhood.*

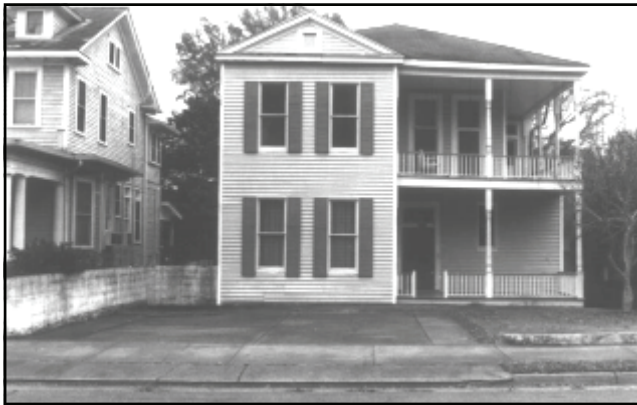
*The front yard of this historic house has been inappropriately paved for parking. Parked cars and the lack of landscaping disrupt the character of the historic neighborhood.*

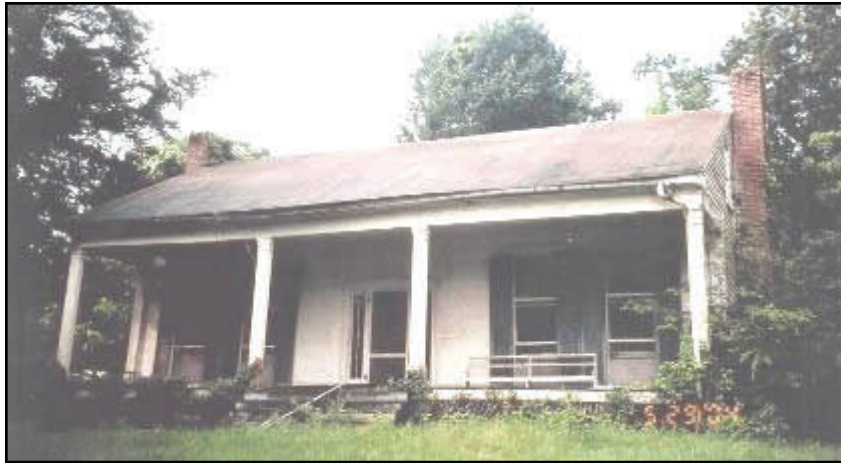
*This historic house above was moved to Raymond from outside the city as the owner wanted it demolished. In order to save the house the only option was to move it. The house was relocated to a vacant lot in the local Raymond Historic District where it was restored for use as a Bed & Breakfast.*
