# Hazlehurst Design Guidelines for Historic District

**June 7, 2012**

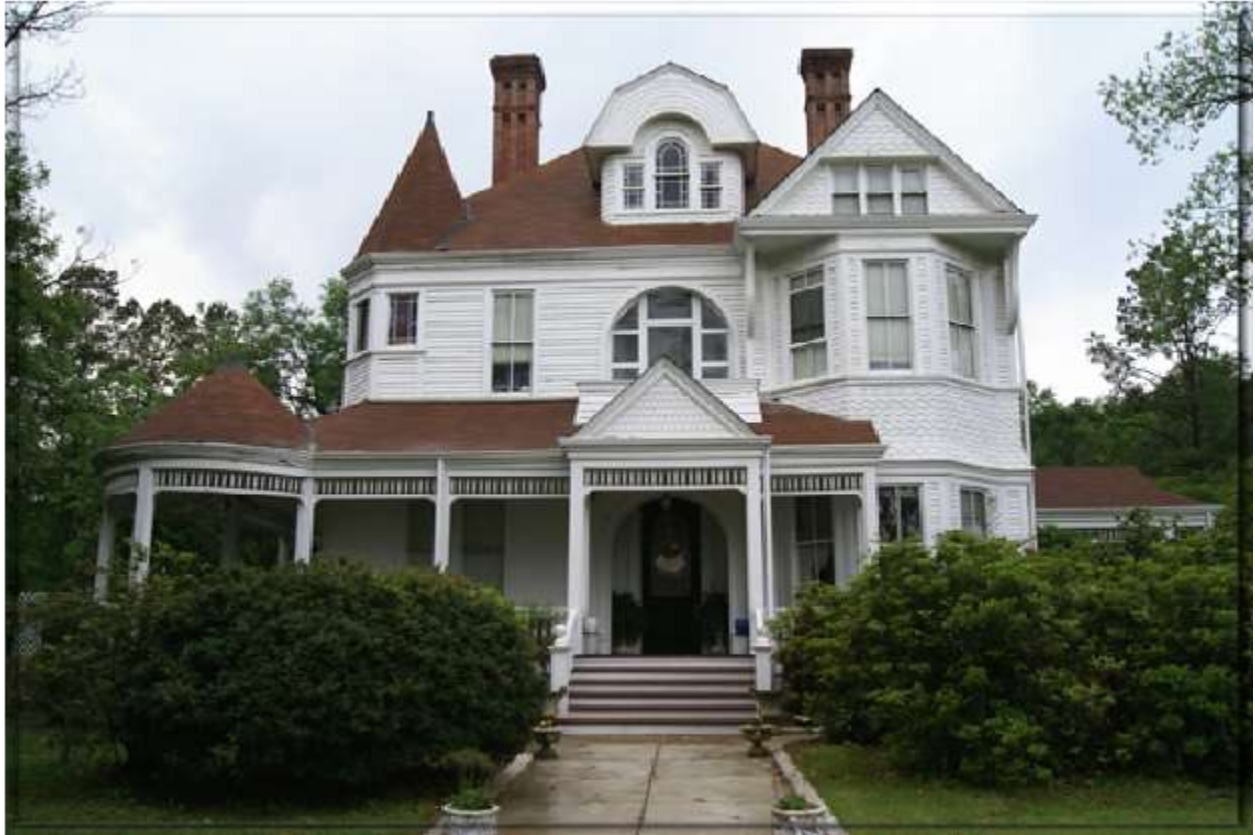
*The Hazlehurst Design Guidelines will encourage the preservation of architectural features such as the original decorative wood siding, unique dormer, circular porch with spindle work frieze, and original multi-pane windows found at 258 South Extension Street, which are significant characteristics of the Queen Anne style of architecture.*

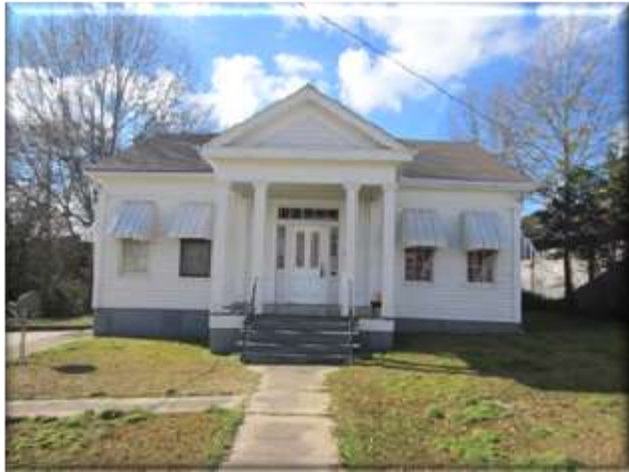
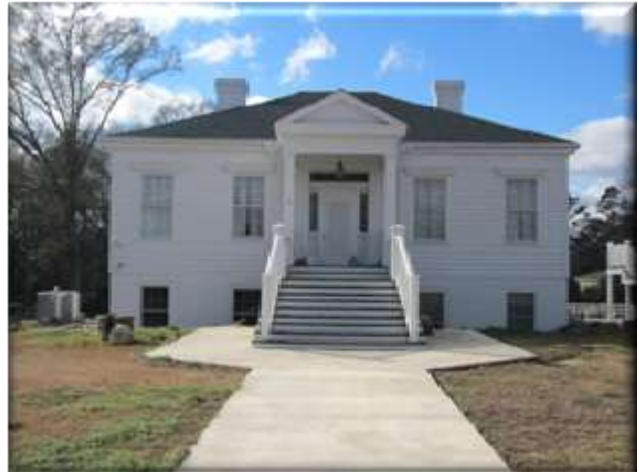
*Both 204 and 222 South Extension Street are examples of the Greek Revival style with symmetrical facades, use of square columns supporting the porch and six-over-six windows.*

located at 204 South Extension Street and the 1866 Cook House located at 222 South Extension Street. Both are symmetrical in design with a central pedimented entrance porch supported by square columns, and feature six-over-six windows. 204 is a one-story example and 222 is a raised one-story version with a basement level.

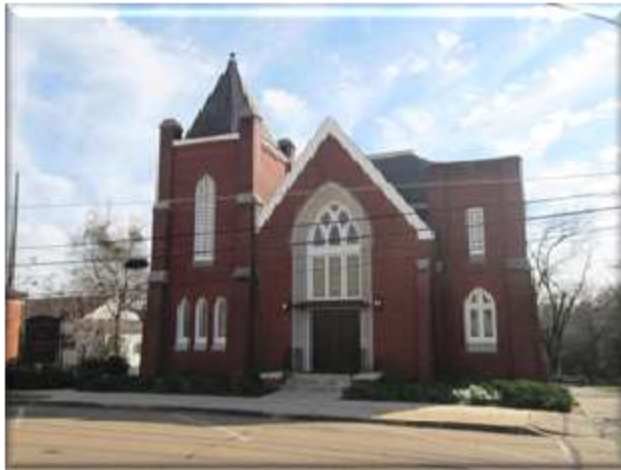
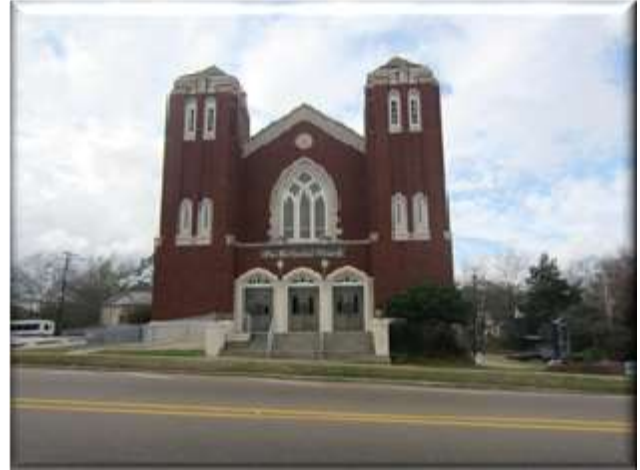
*Both the First Presbyterian Church and the Hazlehurst Methodist Church are examples of the Gothic Style with brick facades, pointed arched windows, and use of corner buttresses.*

There are several examples of the Gothic Revival style in Hazlehurst found in religious buildings. The Hazlehurst Methodist Church at 127 Caldwell Drive constructed in 1928, and the First Presbyterian Church at 133 Downing Street constructed in 1867 and bricked in 1941, are brick examples of the style with pointed arched windows, battlements, and large buttresses at the corners. St. Stephens Episcopal Church at 214 Downing Street was built in the Carpenter Gothic style in 1872. It also features pointed arch windows; however, it is much simpler in design, massing and detailing than the other Gothic Churches.

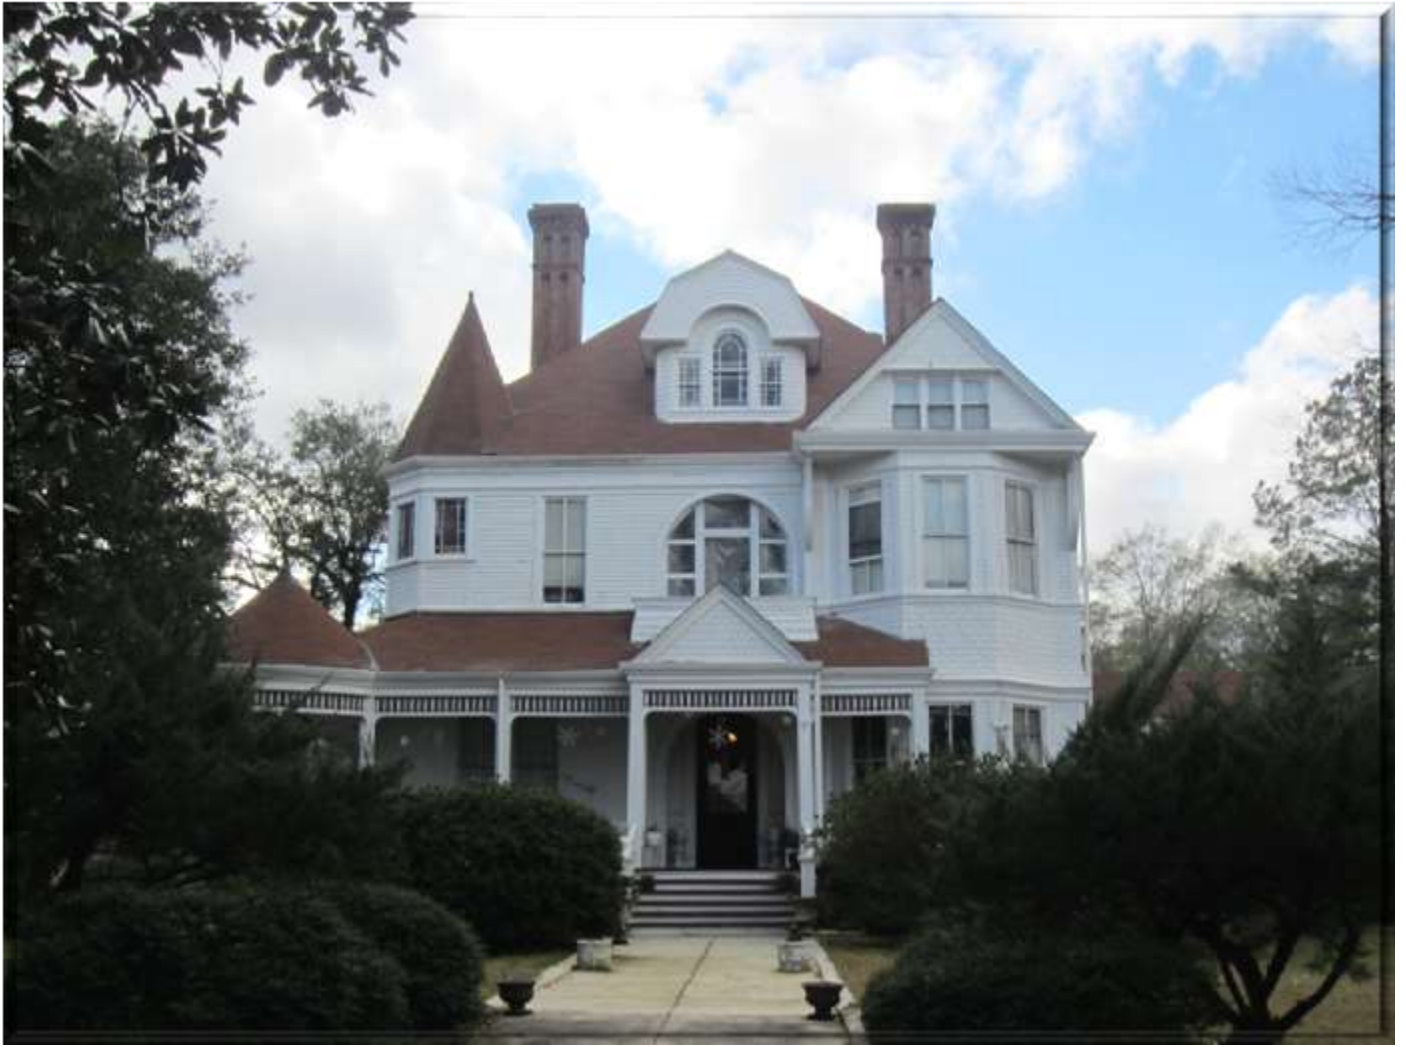
*The house at 258 South Extension Street is the grandest example of the Queen Anne style in Hazlehurst with multi gable roofs, a wraparound porch supported by turned columns with spindlework frieze between the columns, a mix of siding patterns, and multi-paned windows.*

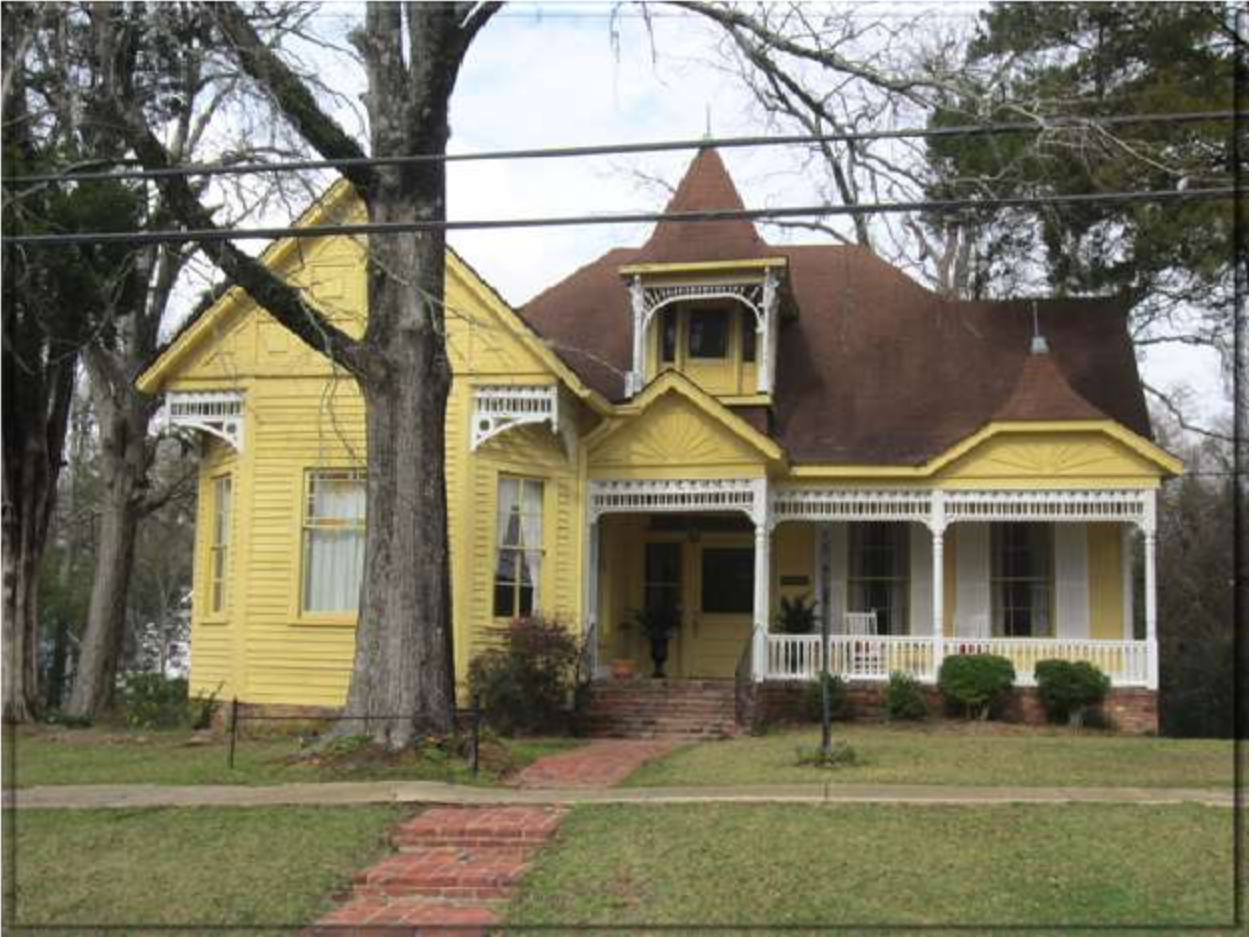
*The house at 336 West Gallatin Street is also Queen Anne in style. It is a simpler one-story version yet still has the hallmarks of the style like multi gables, a mix of siding types, a porch supported by turned columns with spindlework frieze between the columns, eave brackets, and multi-paned windows.*

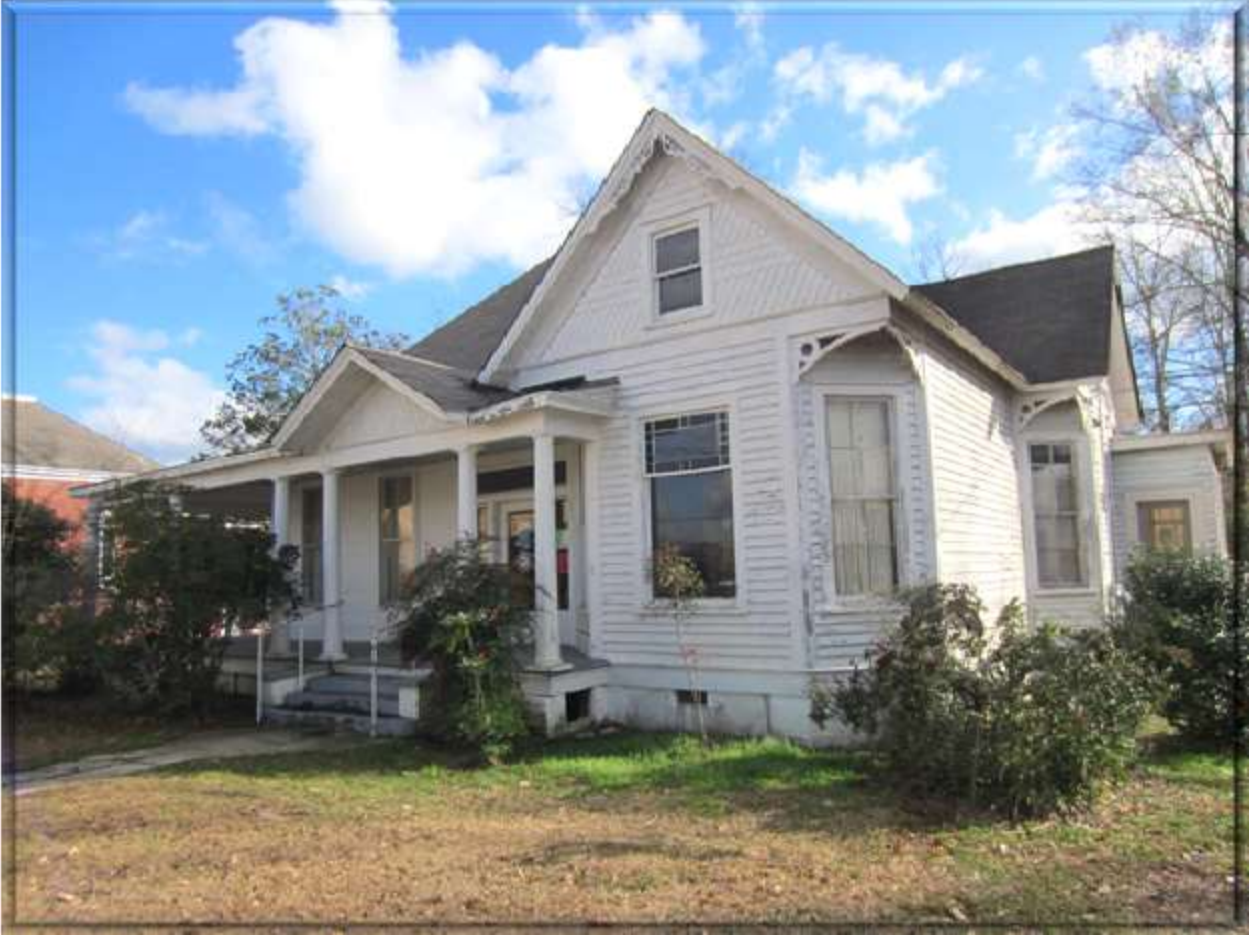
*The house at 153 Downing Street is Free Classic Queen Anne in style as it has the form of a Queen Anne style house yet uses classical detailing like the classical wood Tuscan columns supporting the porch.*

As the Queen Anne style gave way to the newly popular Colonial Revival style, architectural hybrids appeared. Buildings that retained the Queen Anne form often were dressed in the classical detailing of the Colonial Revival style. Some architectural historians have termed these hybrids as the Free Classic Queen Anne style. Hazlehurst has an example of the Free Classic Queen Anne style at 153 Downing Street which exhibits the form of the Queen Anne style however the detailing is that of the Colonial Revival style with Tuscan style porch columns.

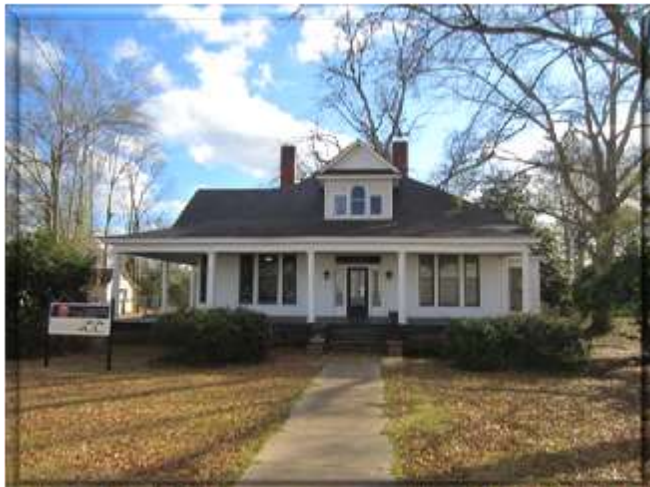
*The house at 201 Downing Street is an early example of the Colonial Revival style and has one-over-one windows, a Palladian window, and classic Tuscan columns supporting the porch.*

Hazlehurst has several expressions of the Colonial Revival style, which began to replace the Queen Anne style in the first decade of the 1900s. Among these are the circa 1900 houses at 201 and 209 Downing Street, and the circa 1905 house at 267 South Extension Street. A later example of the Colonial Revival style is the U.S. Post Office. Both 201 and 209 Downing Street have features of the Colonial Revival style including Palladian windows, Tuscan columns supporting the porch and one-over-one windows. The Post Office is a later version of the style which tended to have a symmetrical facade, multi-pane windows (six-over-six in the case of the Post Office) and used applied detailing like the broken pediment over the Post Office front door.

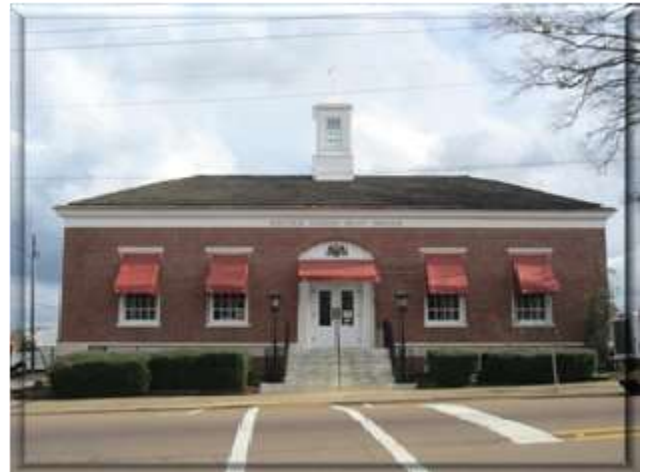
*The Post Office is a later version of the style with a symmetrical facade, six-over-six windows, and a broken pediment over the front door.*

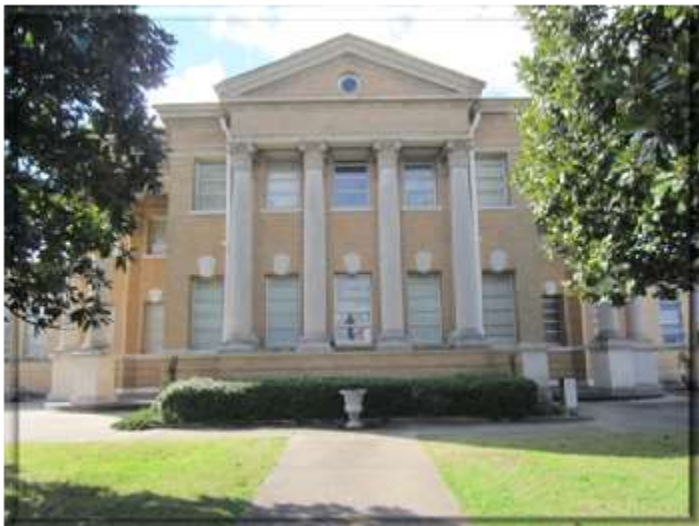
*The Covich County Courthouse is the grandest example of the Neoclassical style in Hazlehurst, with a two-story portico supported by massive Composite style column. Before the additions to the courthouse were added it had a symmetrical façade which is a characteristic of the Neoclassical style. The original windows, which were probably a one-over-one configuration, were replaced with the current metal windows in the 1950s.*

The grandest example of the Neoclassical style in Hazlehurst is the Covich County Courthouse built in 1902 and designed by James Riley Gordon. The Baptist Church is also a grand example of the Neoclassical style designed by R.H. Hunt of Chattanooga, Tennessee and completed in 1926. Premier residential examples of the Neoclassical Revival style can be seen in the 1907 R.L. Covington House at 240 South Extension Street, designed by George F. Barber and built for Robert Covington the first president of the Bank of Hazlehurst, and the circa 1910 Hardy J. Wilson House at 314 South Extension Street built for the president of the Hazlehurst Box Company. Two houses in Hazlehurst were remodeled in the Neoclassical style. They are the circa 1867 house at 224 West Green Street which received its Neoclassical style remodeling around 1900, and the circa 1910 house at 224 South Extension Street which received a late Neoclassical remodeling around 1940. All of the examples of the Neoclassical style in Hazlehurst feature grand two-story porticos or porches supported by massive two-story classical columns, symmetrical facades, and use transoms over the doors.

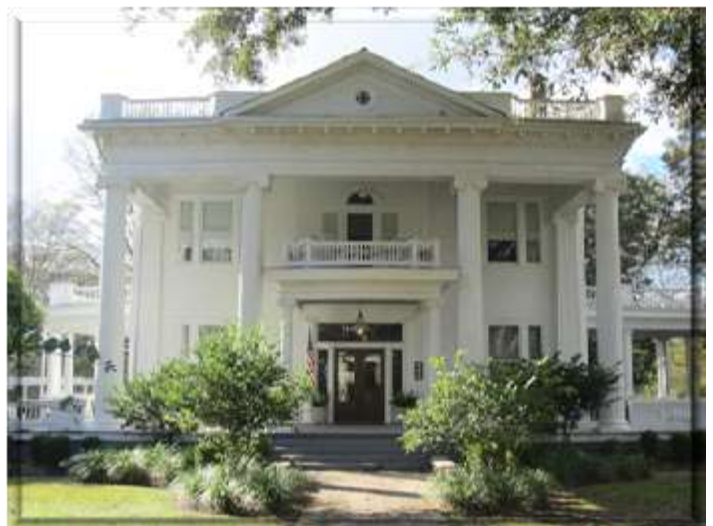
*The Hardy J. Wilson House at 314 South Extension Street was built around 1910 in the Neoclassical style with a grand two-story full-width façade porch supported by two-story Ionic style columns, a symmetrical façade and one-over-one windows.*

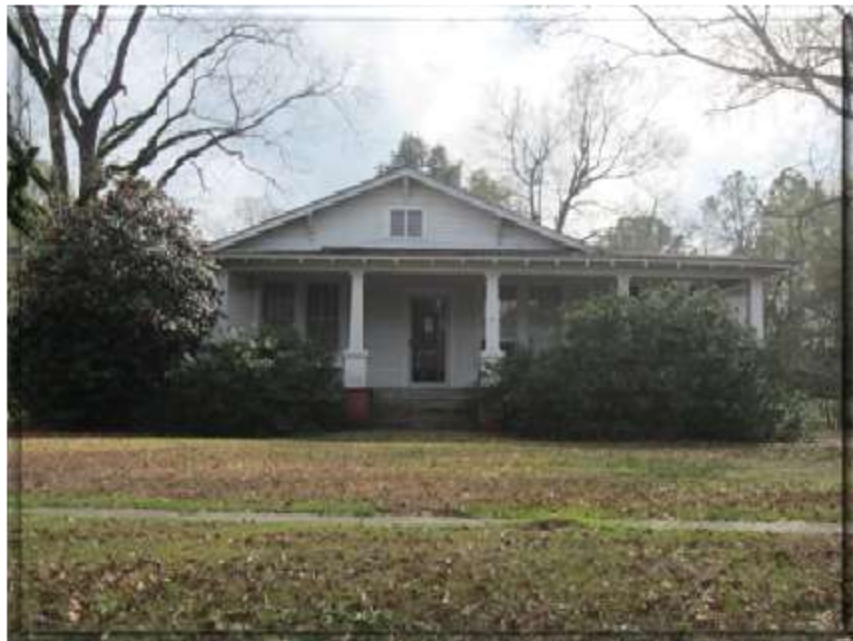
*The house at 110 Whitworth Street features a low pitched front facing gable roof with a wide overhang supported by knee braces, a large porch supported by tapered wood box columns on brick pedestals, and four-over-one windows, all characteristics of the Craftsman/Bungalow style*

The Craftsman style was used extensively for houses built in Hazlehurst from the 1910s to the 1930s. Several houses in the district are good examples of this style including 231 Ainsworth Street, 219 West Green Street, 100 South King Street, and both 110 and 114 East Whitworth Street. All exhibit characteristics of the Craftsman style with low pitched gable roofs, overhanging eaves, and large porches with box columns, some combined with masonry piers.

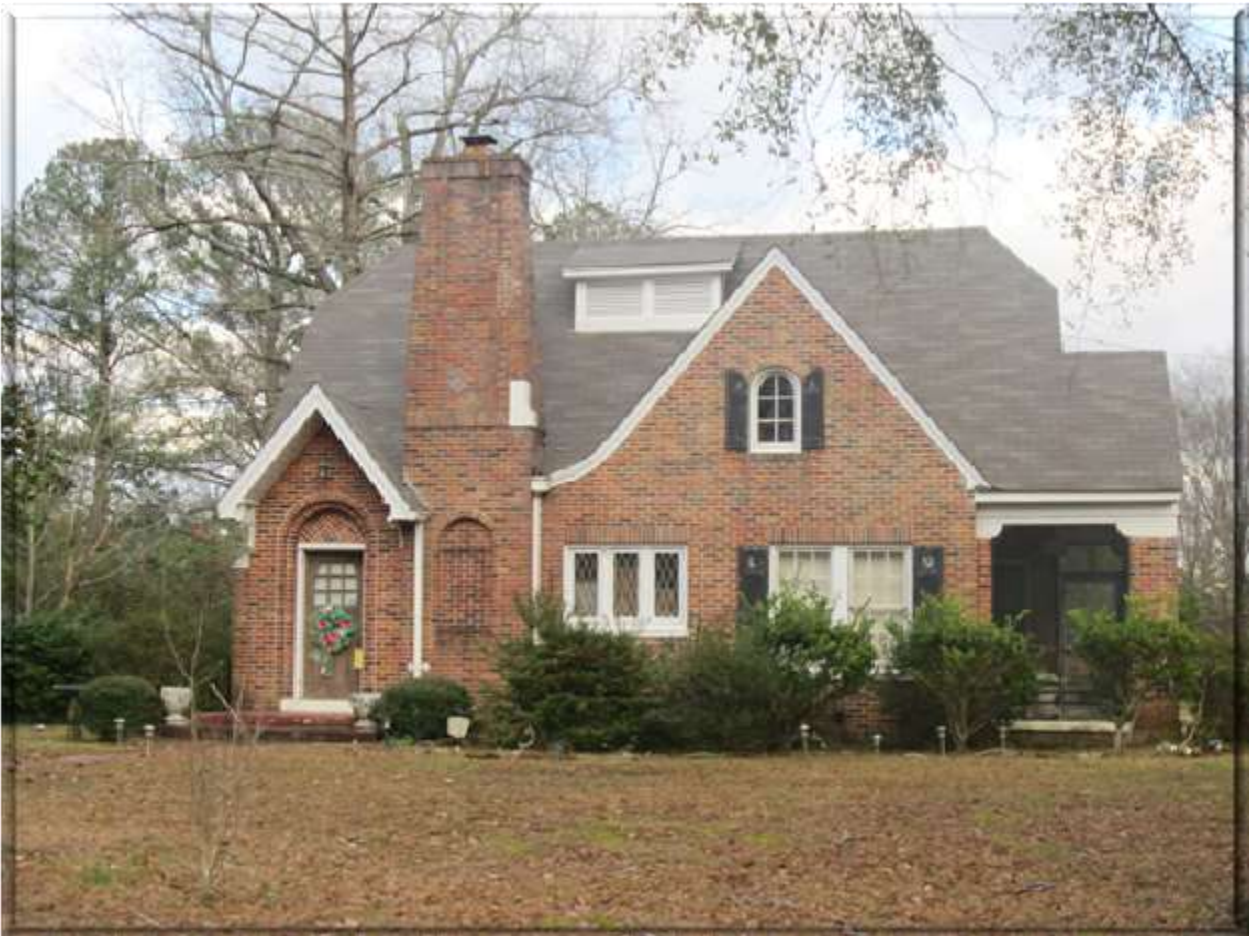
*The house at 124 Jackson Street has typical Tudor Revival Style features such as an asymmetrical façade, multiple gables, a massive front chimney, and multi-pane windows.*

Hazlehurst only has a few examples of houses in the Tudor Revival style. They are located at 415 West Gallatin Street, 522 Georgetown Street, 124 Jackson Street, and 117 North King Street. All of them are brick with typical Tudor features of asymmetric massing, multiple gables, and massive brick chimneys.

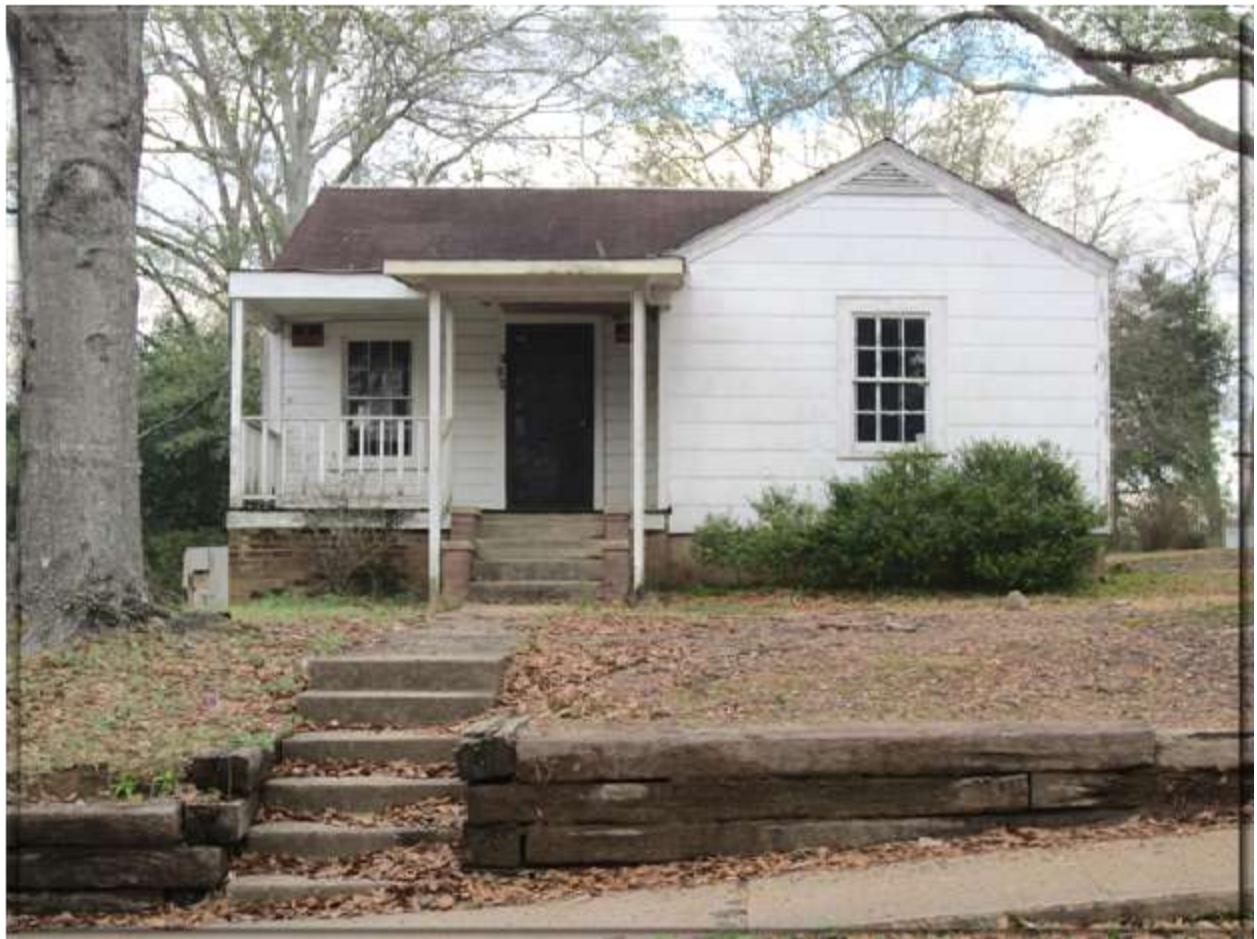
*The house at 106 Haley Street is Minimal Traditional in style with simple massing, a front facing gable and multi-pane windows.*

Examples of the Minimal Traditional style in Hazlehurst include 514 Georgetown, and both 102 and 106 North Haley Street. All have characteristics of the style with asymmetrical massing, multi-paned windows, and front facing gables.

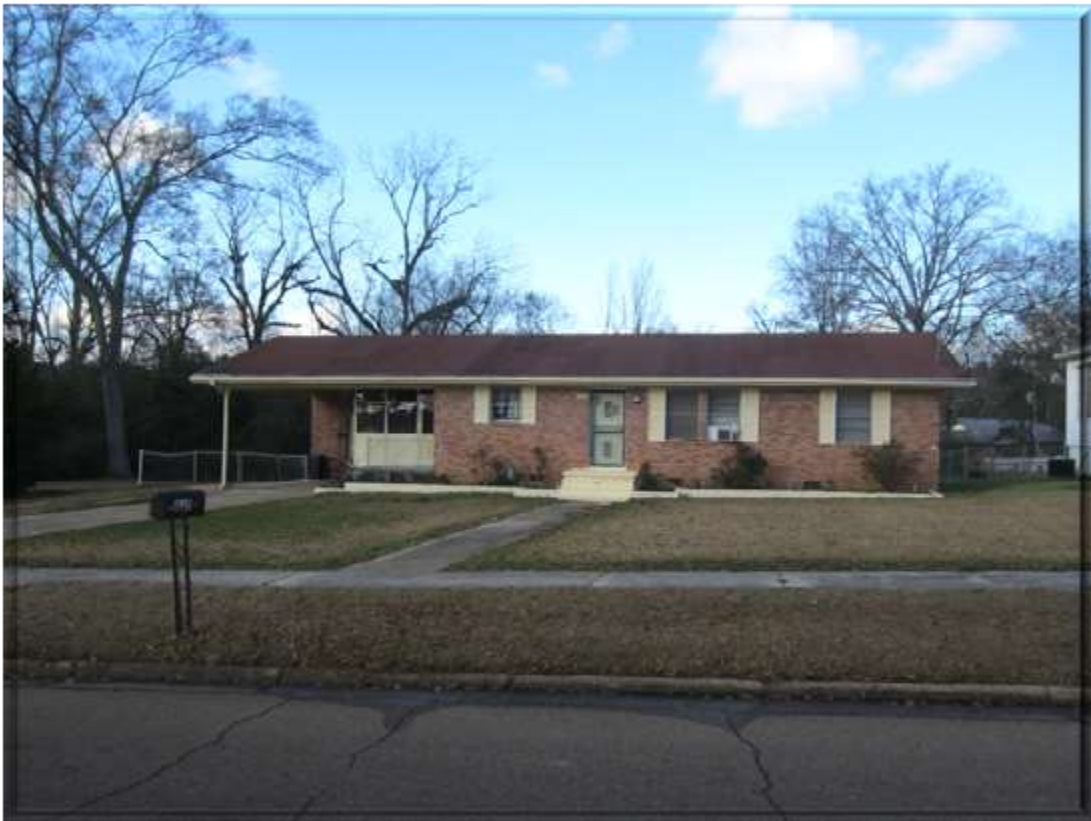
*The Ranch Style house at 310 West Green Street features a low pitched roof, horizontal emphasis to the design, a brick façade and an integral carport.*

There are many examples in Hazlehurst of the Ranch style including 114 Jackson Street, 259 and 345 South Extension Street, 408 West Gallatin, 450 Georgetown Street, and both 301 and 310 West Green Street. All are brick examples with low slung hip or gabled roofs, and some have integral carports.

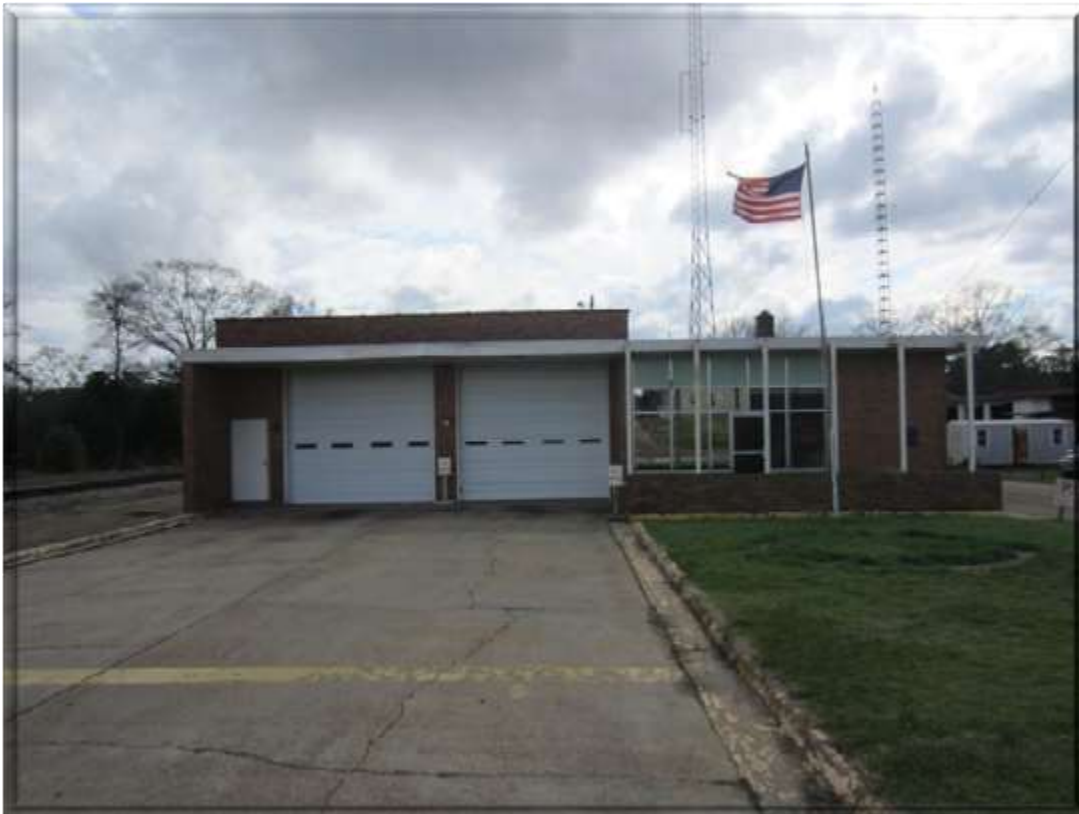
*The fire station located at 115 West Frost Street is a Modern style building with a flat roof, clean lines, and glass wall for the entrance area.*

An excellent example of the Modern style is the fire station located at 115 West Frost Street completed in 1964 with a flat roof, clean lines, and glass wall surrounding the entrance. The old City Hall at 135 West Frost Street built in 1959 is also modern in style with a flat roof, horizontal design and window walls. The Copiah County Chancery Complex located at 122 South Lowe Street is an excellent example of the Contemporary style completed around 1980 with an asymmetrical façade, use of ribbon windows, a mix of siding materials, and flat roofs.

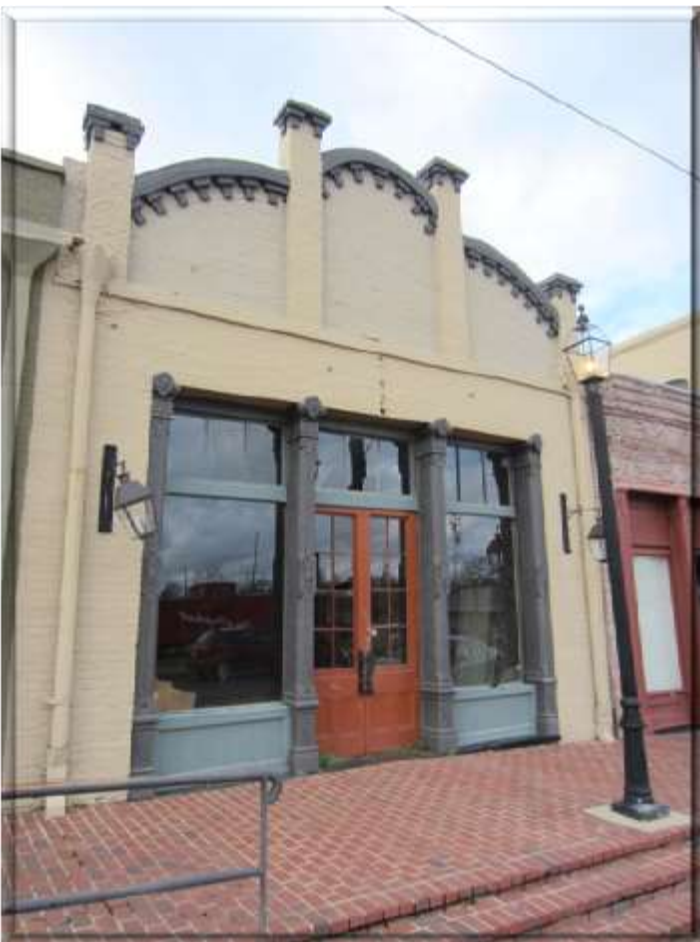
*The commercial building at 145 North Ragsdale Street features a parapet with brick panels between pilasters that extend above the cornice which uses protruding brick in a decorative design.*

The masonry buildings in Hazlehurst mostly use **brick**. The brick of Hazlehurst's early twentieth-century commercial buildings is structural, but most later residential buildings, including Tudor, Craftsman, and Ranch style houses are brick veneer. Brick can be decorative as well as functional with some buildings featuring cornices of protruding brick, recessed brick panels, brick arches defining window and door openings, and patterned brickwork giving visual interest to the façade.

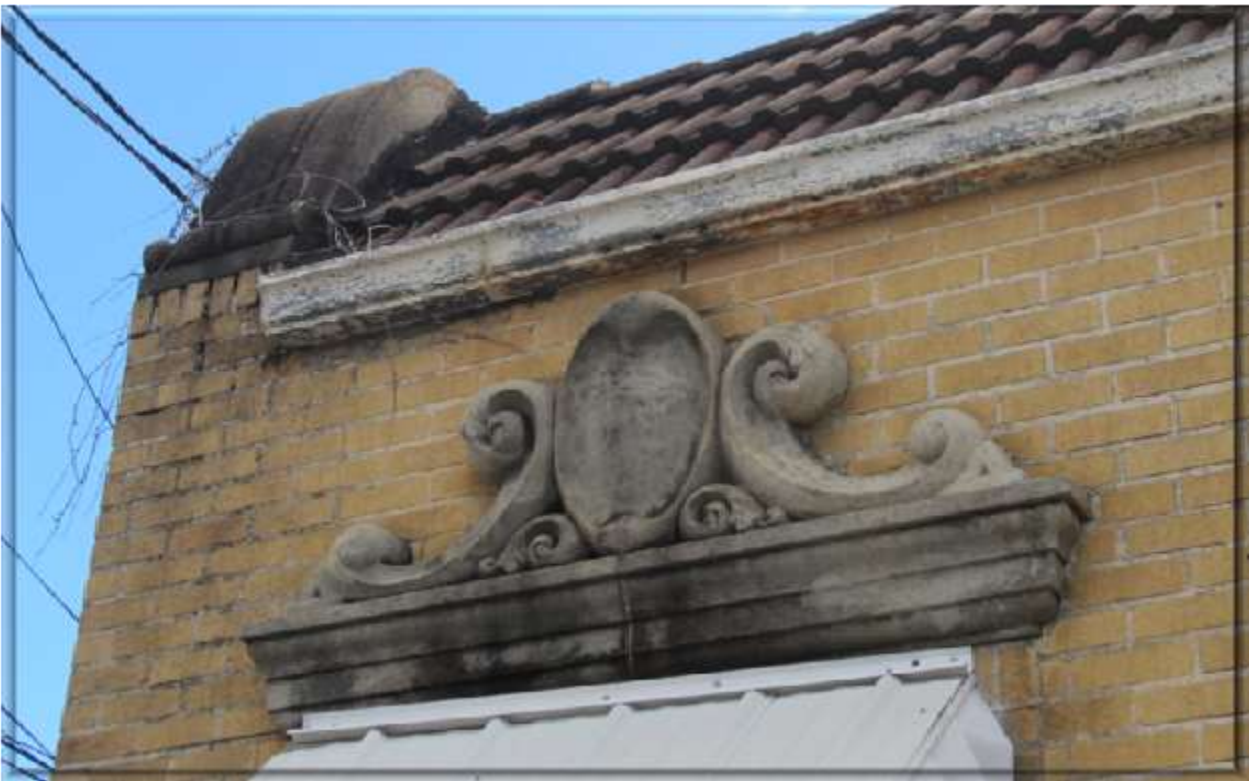
*The building at 101 Downing Street has a brick wall surface and a decorative cast stone window hood with a cartouche.*

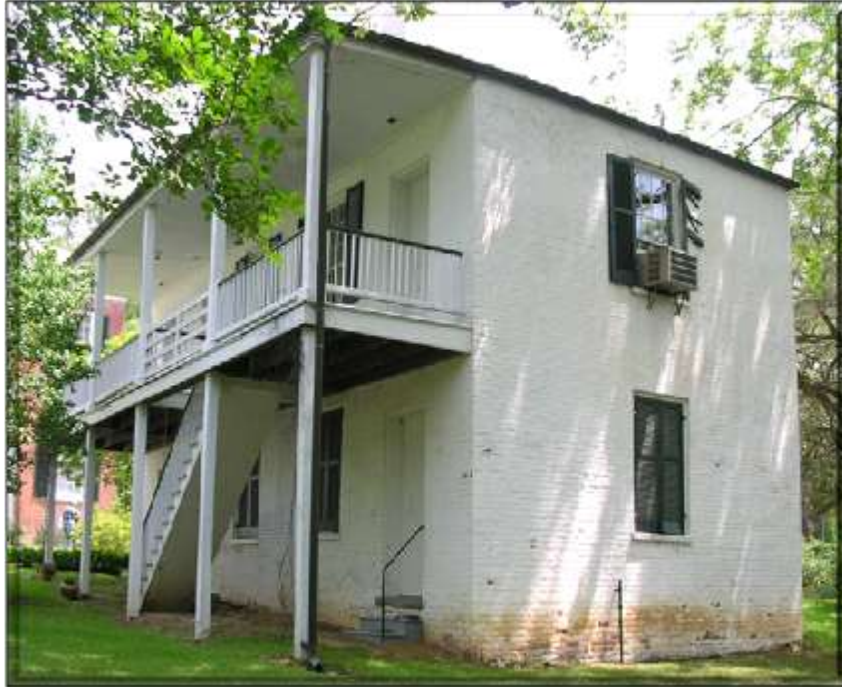
*This kitchen building behind a historic mansion in Natchez shows the effects of rising damp along the base of the building. The discolored surface is where water is being sucked into the bricks and up the wall. Water running along the façade and pooling at the base of the side elevation is the source of the problem. Controlling water run-off and preventing the pooling of water will correct the problem.*

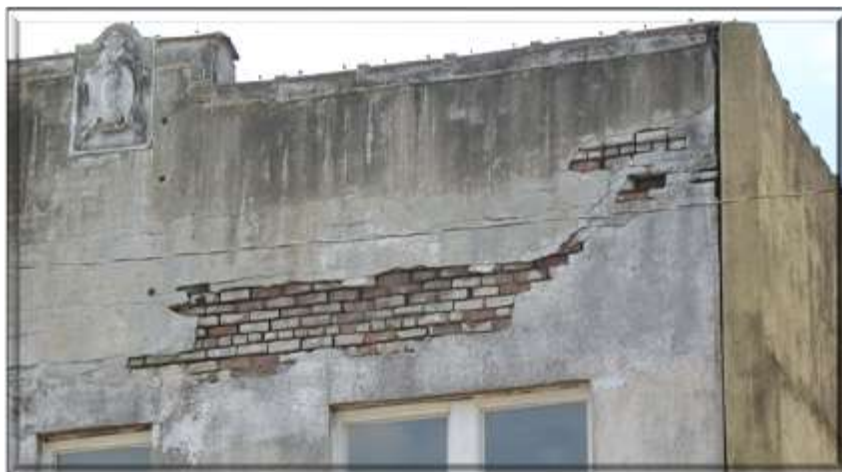
*This building is suffering from falling damp, most likely from water that is infiltrating at the top of the parapet and causing the noticeable stucco discoloration at the top of the wall and the problems with the stucco losing its bond with the brick below and falling off of the building.*

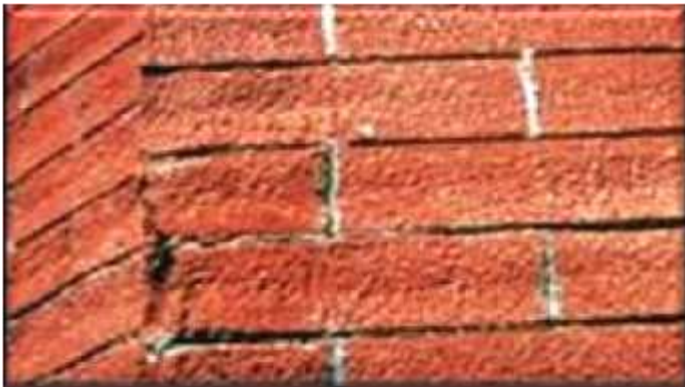
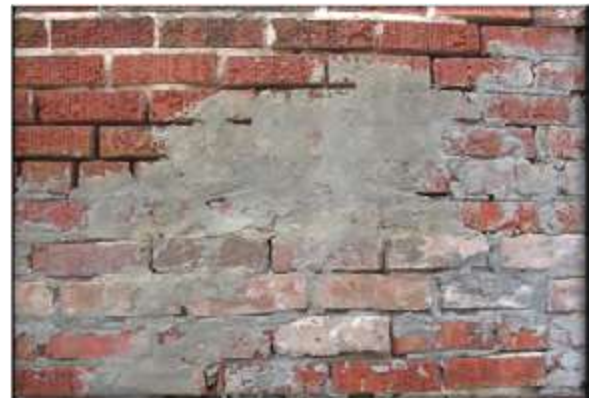
*This National Park Service photograph illustrates the damaging effects of sandblasting, which should never be used to clean brick buildings. Sandblasting will not only erode mortar but will also remove the glazed outer surface of brick leaving a dimpled surface and hasten deterioration.*

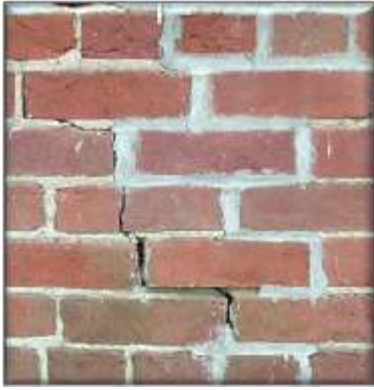
*The spot repointing of this brick wall does not match the original in color, texture, or form. Joints are too large and mortar is smeared on the face of bricks. The tell-tale, dark gray color and texture of the mortar indicates that portland cement mortar was used. The cracked and spalled brick (center top) resulted from the hard portland mortar.*

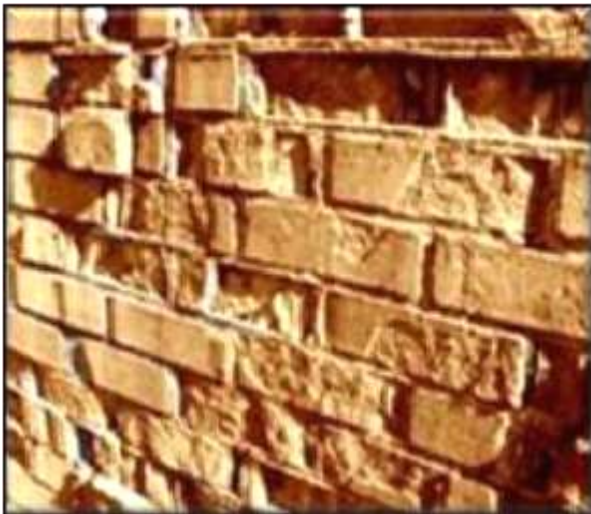
*This photograph supplied by Chagrin Falls Preservation in Ohio illustrates the spalling that can occur only five years after using portland cement mortar in repointing.*

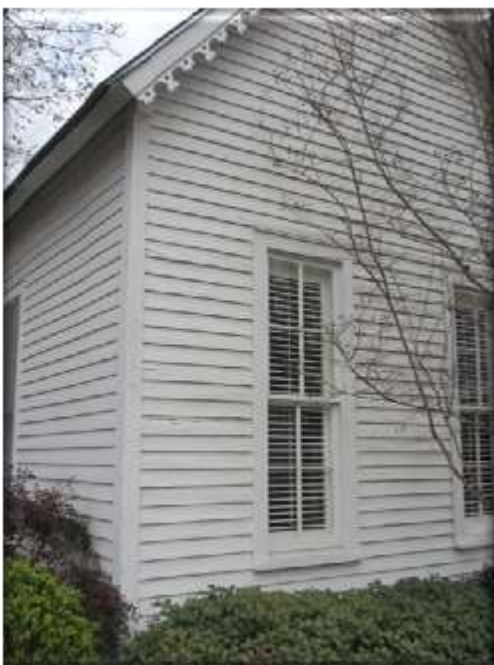
*This house at 216 West Green Street still retains its original wood lap siding.*

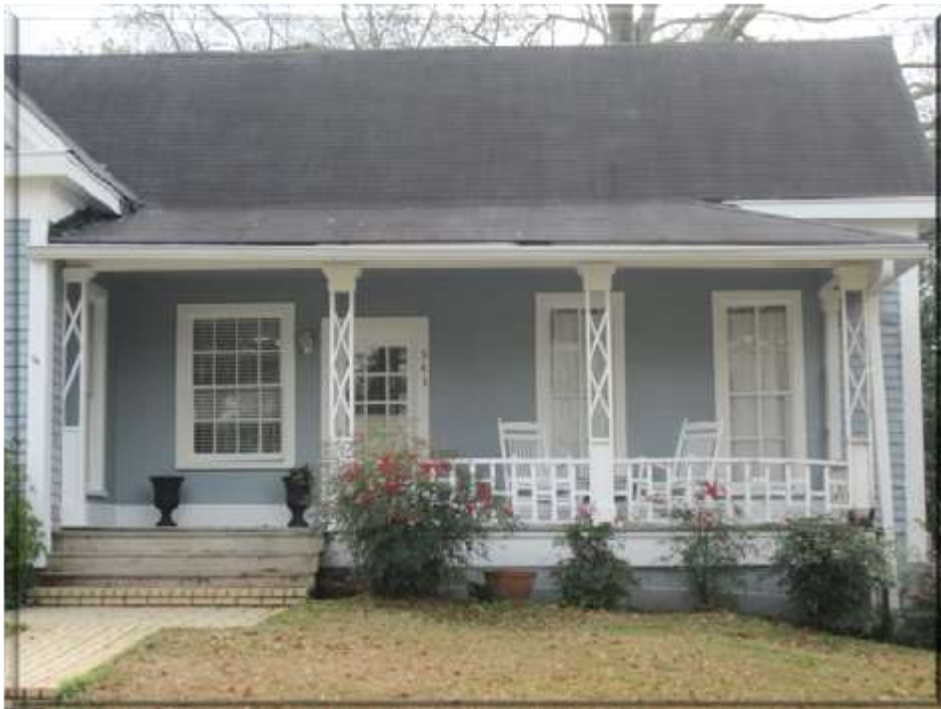
*The house at 343 West Gallatin Street uses tongue-and-groove siding under the porch giving the wall a flat surface as opposed to lap siding which has a protruding wall surface.*

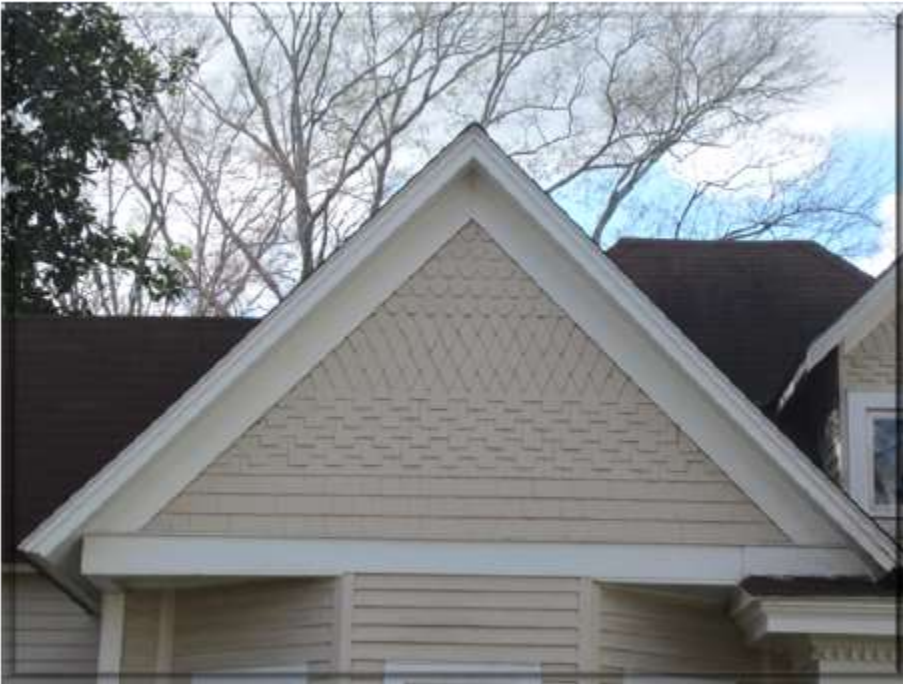
*The gable of 308 South Extension Street uses four different types of shingles to form different decorative patterns.*

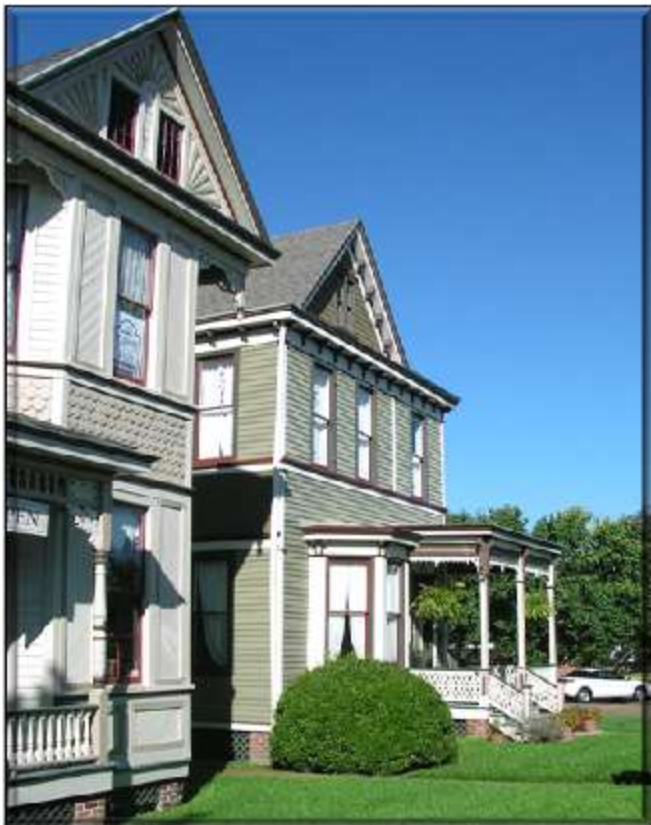
*These two Queen Anne style houses in Natchez were restored in the mid-1980s and feature typical late nineteenth-century paint schemes. Both houses were thoroughly scraped, sanded, washed, primed (oil primer), and painted (two finish coats of latex). Both houses have insulated attics but no wall insulation. Their mid-1980s paint jobs still looked good over a decade later.*

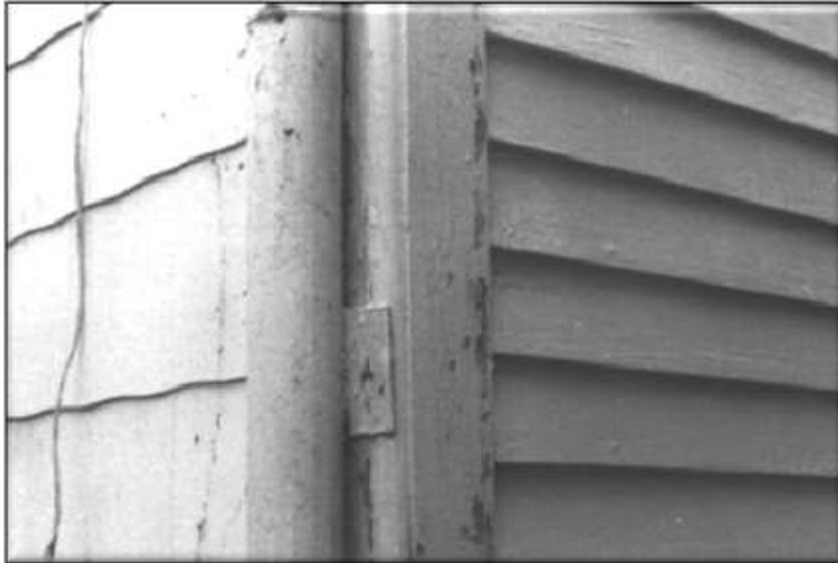
*The photo of this house illustrates how inappropriate asbestos-shingle siding installed over the historic horizontal wood lap siding changes the character of a historic house which was originally sided in wood lap siding. The inappropriate style of the asbestos siding does not convey the same visual characteristics of the historic wood lap siding and can obscure moisture and termite damage.*

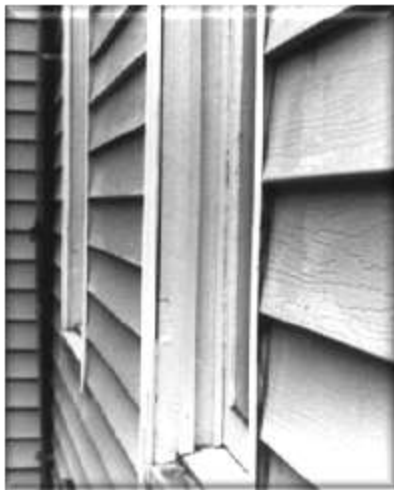
*This photograph illustrates how vinyl siding negatively alters the exterior appearance of a historic building. The vinyl siding after installation is nearly flush with the trim around the windows and the use of the J-channels changes the appearance of the historic trim.*

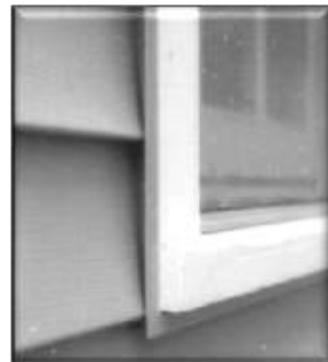
*Examples of vinyl siding showing the installation of J-channels around every opening and the historic trim, if it survived the installation process.*

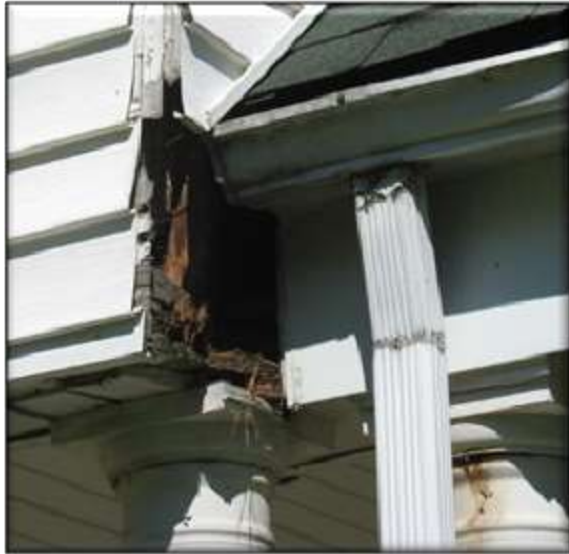
*Rotten wood was found under the vinyl siding on this house in Ripley. Water was trapped behind the vinyl siding causing the wood siding underneath to deteriorate without being noticed until the vinyl siding fell off as it had nothing to adhere to anymore.*

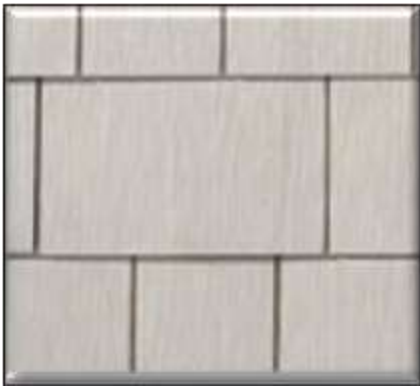
*Cement fiber siding is available in a pattern replicating shingles.*

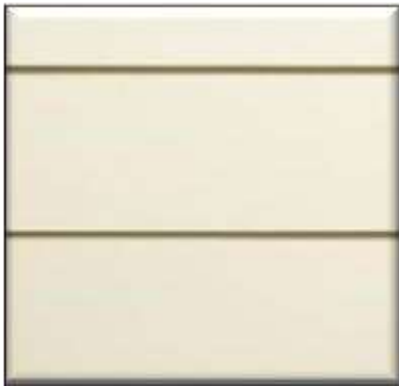
*Cement fiber siding is available in a pattern which replicates lap siding.*
