# Hazlehurst Design Guidelines for Historic District

**June 7, 2012**

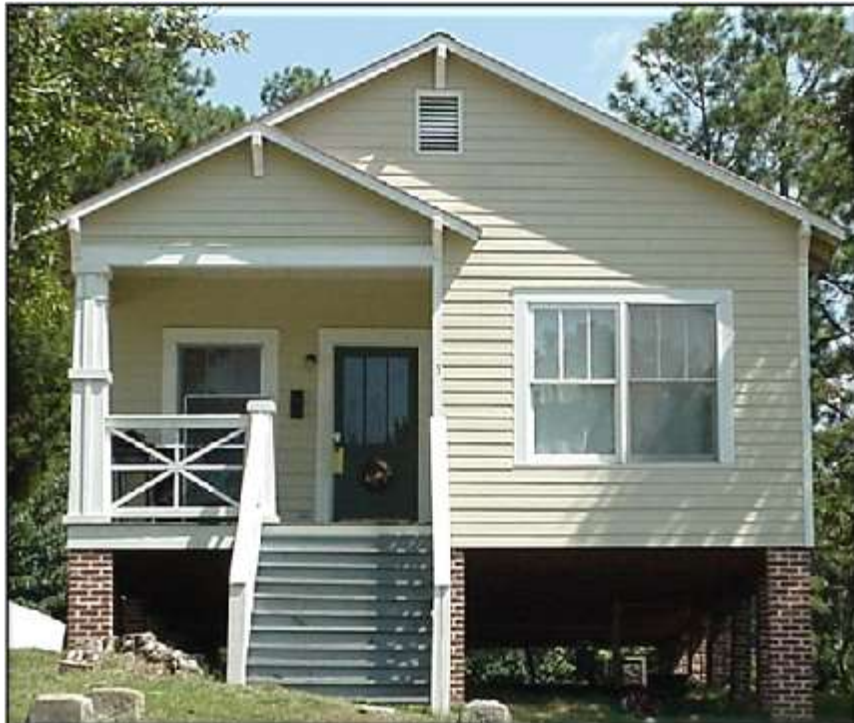
*This new house built in Natchez uses Hardie Plank or cement fiber siding to better match the historic wood lap siding used on neighboring historic houses.*

Cement fiber siding (sometimes referred to as Hardie Plank) may be used on existing historic buildings in the local historic district by approval of the Hazlehurst Historic Preservation Commission. It will be allowed for additions or new construction as long as it is similar in dimension to historic wood siding used on neighboring historic buildings. For use on existing buildings it should match the siding it is replacing or covering as closely as possible in style, shape, and dimensions. Cement fiber siding shall not cover any decorative trim or existing patterned siding.

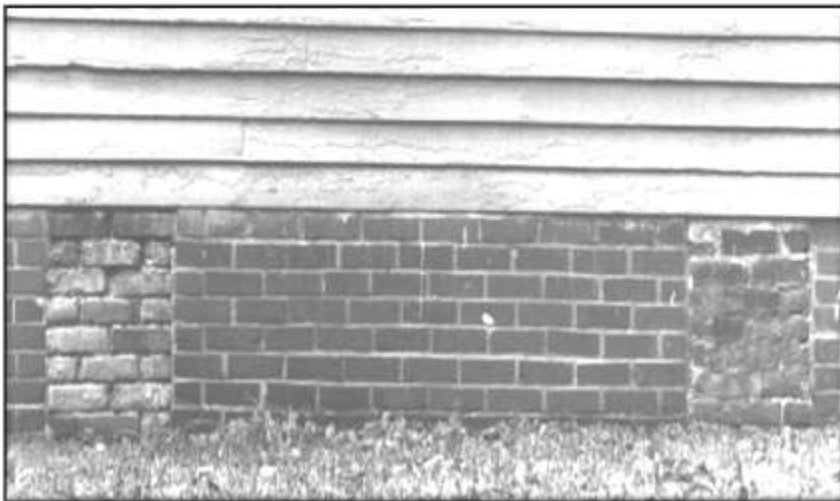
*This crawl space enclosure between the original brick piers on this house has altered the historic character and is visually inappropriate. The enclosure also has no vents to provide air circulation beneath the house to prevent the buildup of moisture under the house.*

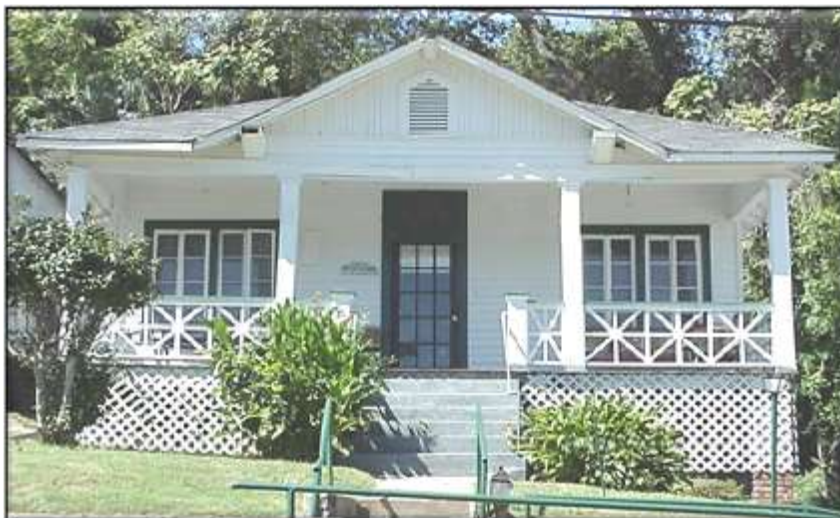
*The lattice used to enclose the crawl space beneath this historic house in Natchez is inappropriately installed, because it overlaps and obscures the brick supporting piers.*

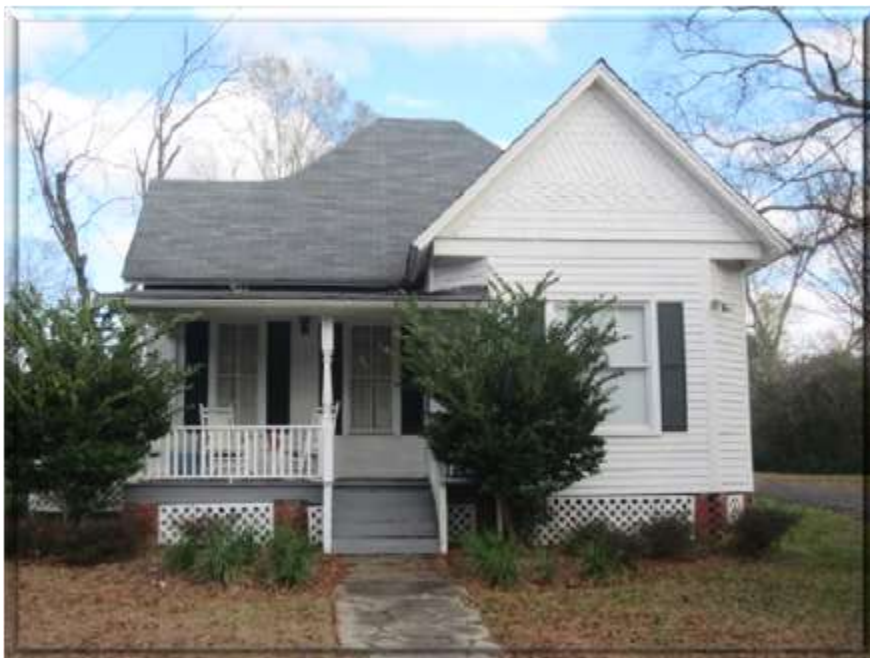
*The house at 271 South Extension Street properly encloses the crawl space area between the brick piers with lattice.*

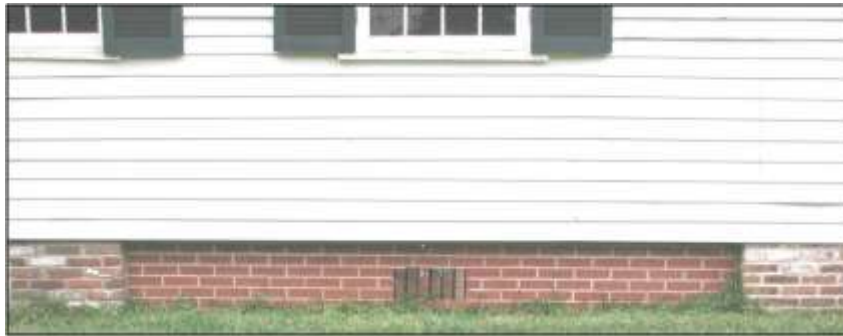
*While not historically appropriate at least this homeowner recessed the new brick crawl space enclosure. This treatment would look more appropriate if the new brick were painted black and faced with lattice.*

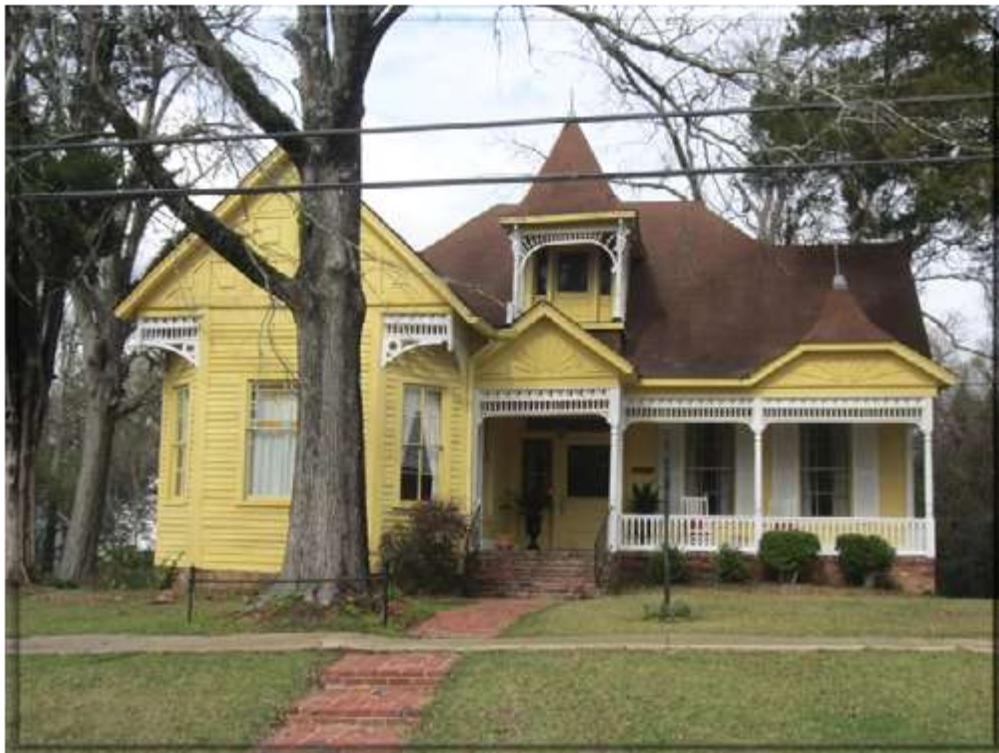
*The Queen Anne style house at 336 West Gallatin Street features a complex roof of multiple gables, which is indicative of the style.*

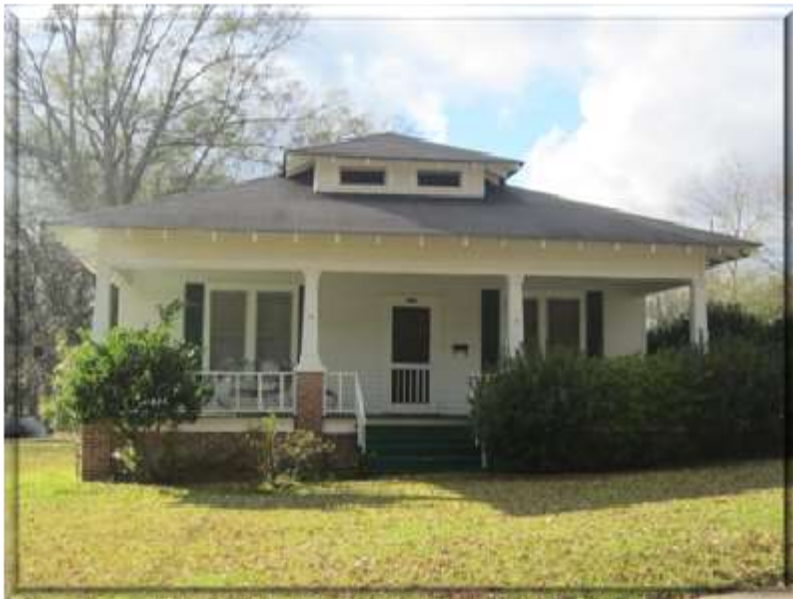
*The Craftsman style house at 120 South King Street has a low pitched hip roof with wide overhanging eaves that have exposed rafter tips, all characteristics of the style.*

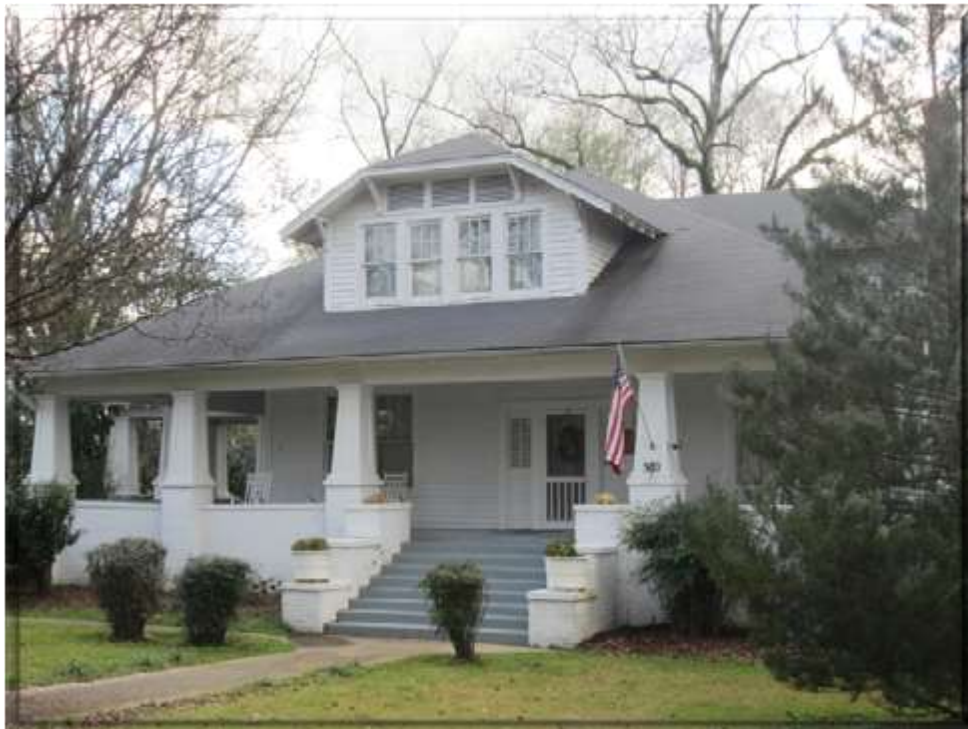
*The dormer at 302 South Extension Street both allows light to the upper story and ventilation into the attic space through the louvered vents above the windows. The dormer also uses a clipped gable roof, where the end of the roof slopes down from the ridge of the gable, and has exposed rafter tips which are a characteristic of the Craftsman style.*

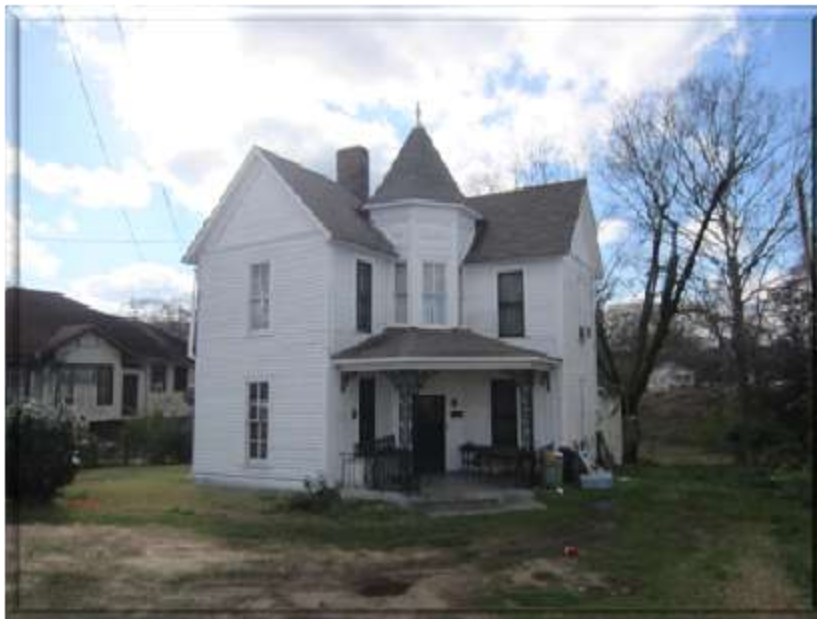
*The house at 210 South Extension Street has an unusual hexagonal shaped tower at the intersection of the two gable roofs.*

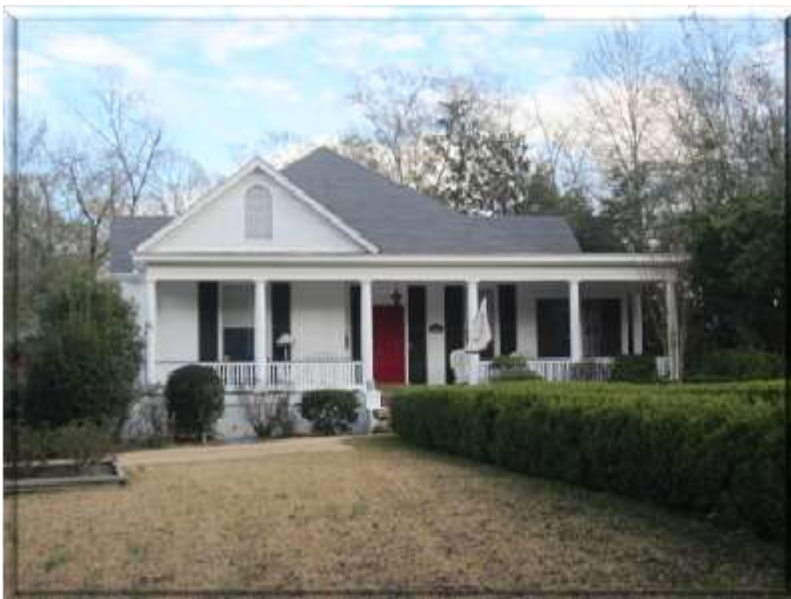
*The house at 251 South Extension Street has a main pyramidal roof with a lower front facing gable roof. The use of a pyramidal roof is typical of early versions of the Colonial Revival style.*

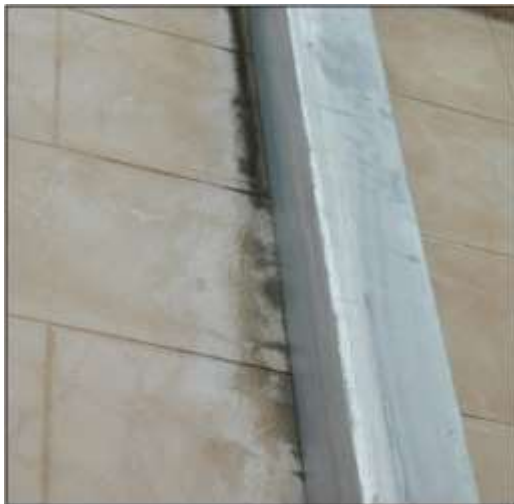
*Moisture problems on the stucco of this commercial building were caused by a rectangular downspout which trapped moisture behind the flat surface of the downspout. Round downspouts have less wall surface contact that could trap moisture.*

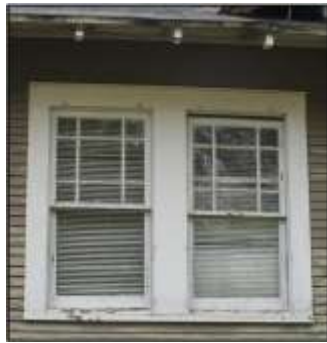
*Craftsman style houses usually have windows with a multi-pane upper sash over a single pane lower sash like the ones to the left and right.*

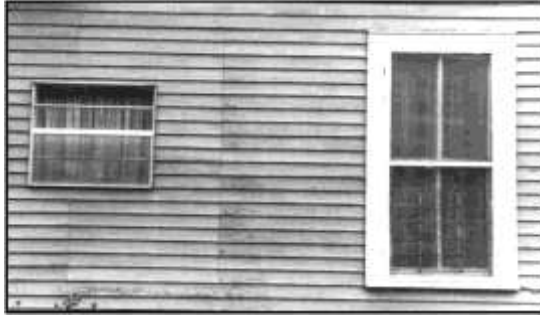
*The metal window on the left is inappropriate for a historic structure and does not convey the same visual appearance as the neighboring original window.*

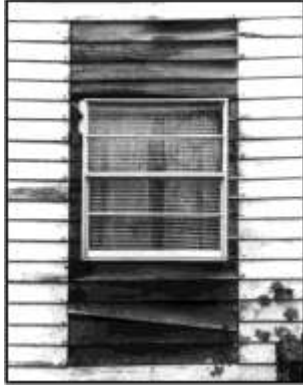
*This metal window is not appropriate for a historic house. It is an obvious replacement for a much larger window that has been removed as evidenced by the unpainted boards used to fill in the larger space. Modern metal windows with horizontal divisions, like this one and the one above, are not suitable for historic buildings.*

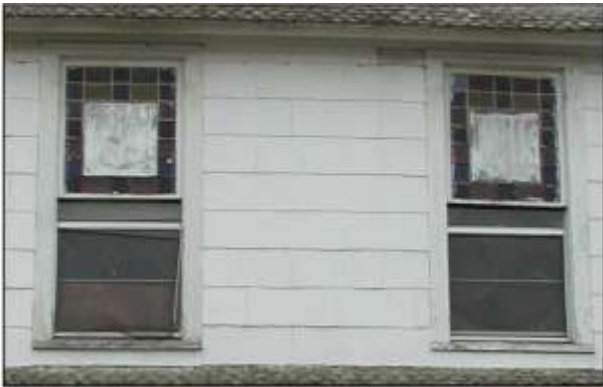
*These poorly sized aluminum window screens alter the appearance of these historic windows.*

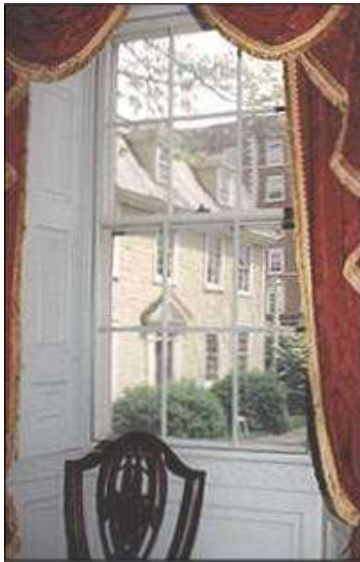
*These photographs of windows in two historic houses illustrate the use of “invisible” interior storm windows. Interior storm windows are easier to remove for cleaning, are not visible on the exterior of the house, and are barely visible on the interior. Manufacturers of “invisible” interior storm windows offer storm windows that are attached either by clip, velcro or by magnetic seal, like the examples pictured above.*

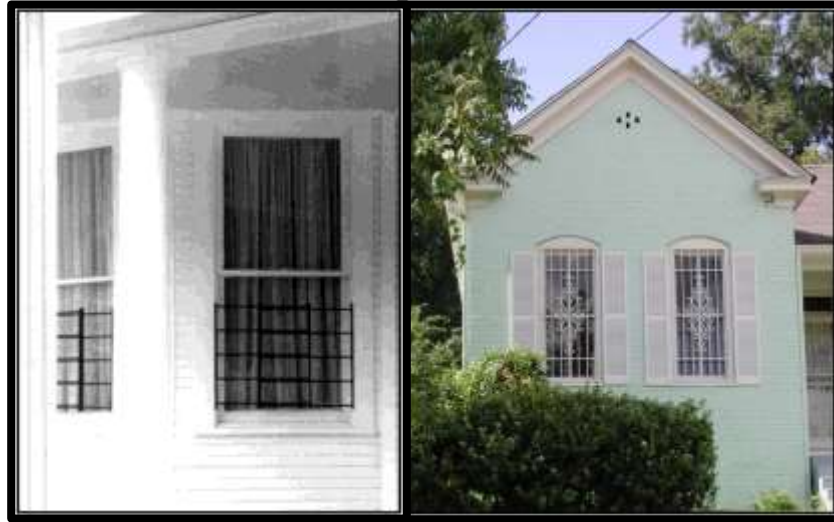
*Security or burglar bars are not appropriate for historic windows, because they change the historic character of the windows and present a safety hazard.*

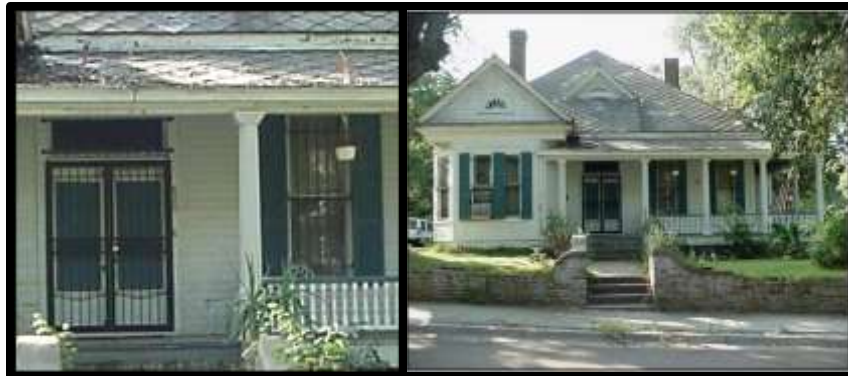
*Security or burglar bars mask the historic details of this Queen Anne cottage, illustrated in detail on the right.*

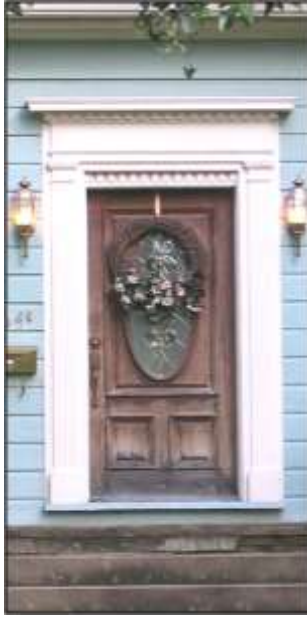
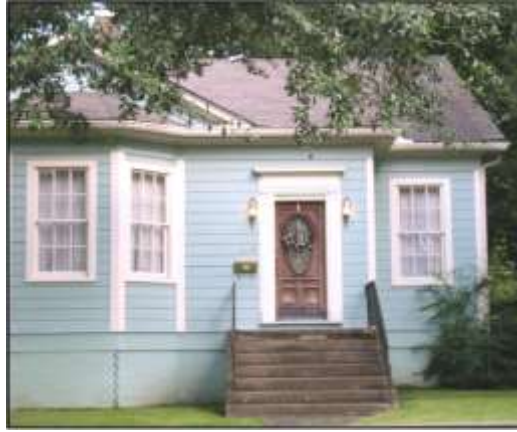
*This mass-produced, leaded-glass door is not appropriate for this mid-twentieth-century Colonial Revival cottage, which would have featured a “Colonial” door normally of six panels.*

Avoid replacement doors that are incompatible with the style of the house. Sliding glass doors and French (glazed) doors have replaced many original paneled doors in historic houses. Glazed Queen Anne doors have been replaced by paneled doors to create an earlier appearance. Today, hundreds of original historic doors are being replaced with mass-produced, leaded-glass doors that are inappropriate for historic buildings.

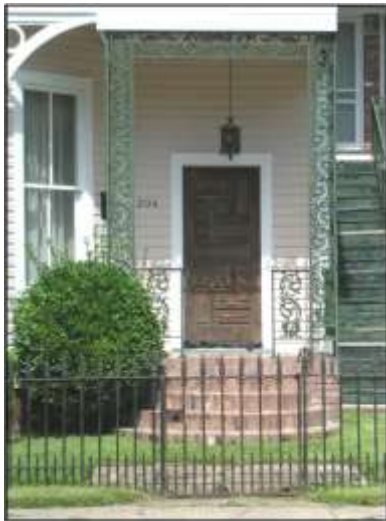
*This Queen Anne style house has lost its original corner porch and entrance doorway. The original doorway would have featured a transom and single-leaf door with glazed upper panel. The original porch was enclosed and a new, inappropriate 1970s door with raised panels was installed. Unfortunately, the house also lost its original porch detailing and entrance steps.*

If the existing door is not original and is inappropriate for the style of the building, a replacement door may be installed based both on historical evidence and the architectural style of the building. The new door can be custom-made to match the missing original based on a historic photograph, if one exists. Without a historic photograph, an original door from a building similar in age and style can also serve as a source for a new custom-made door. Salvage companies may also provide a source for a recycled door appropriate to the style of the building.

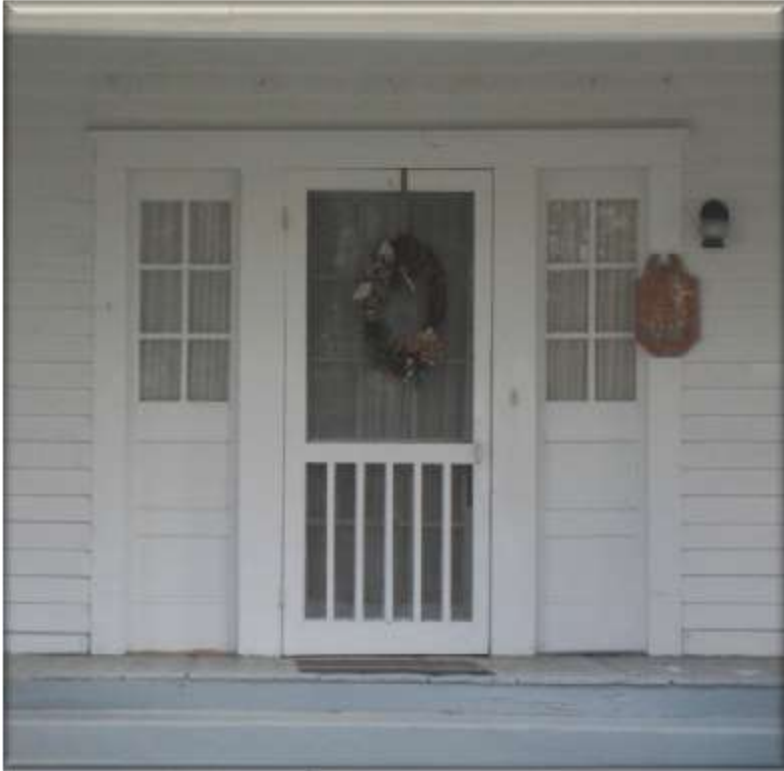
*The wood screen door of this Craftsman style house at 302 South Extension Street properly fits the door opening and is simple in design.*

Screen doors were often original features in late nineteenth and early twentieth century houses and were practical additions to earlier houses. They were constructed with a wood frame, with metal mesh screening between, to match the size of the door opening. Some Queen Anne and Spanish Colonial Revival houses have elaborate screen doors that echo the detailing of the house.

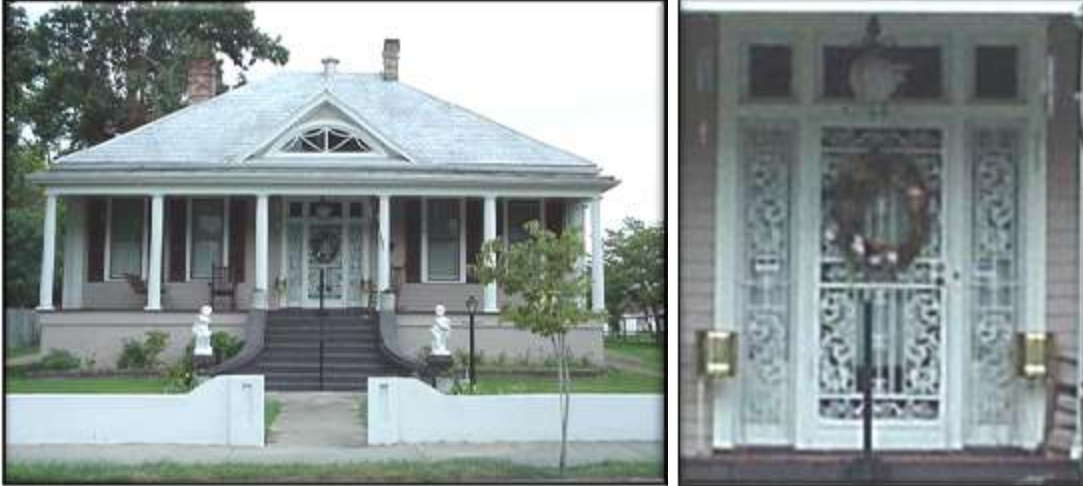
*A metal security door and sidelight grilles (right) obscure the historic doorway of this Colonial Revival house. Security doors and barred windows also increase the risk of death from fire, by making it difficult to exit the building in case of a fire or for rescue personnel to enter the building.*

Metal security doors are inappropriate for historic entrance doorways, and their use should be restricted to doorways not visible from the public right-of-way; however they will be allowed on a primary façade on a case by case basis with approval from the Hazlehurst Historic Preservation Commission. If a security door is approved it should be simple in design with no elaborately decorated pieces which can radically alter the character of a historic building. Metal security doors also give a negative impression to potential residents, businesses, and tourists; because their existence implies that a neighborhood has a high crime rate.

**Warning:** Section 1005.7 of the Standard Building Code states: “Each sleeping room or room with a required exit door in a residential occupancy that has burglar bars installed shall have at least one emergency egress window or door that is operable from the inside without the use of a key, tool, special knowledge, or effort.”

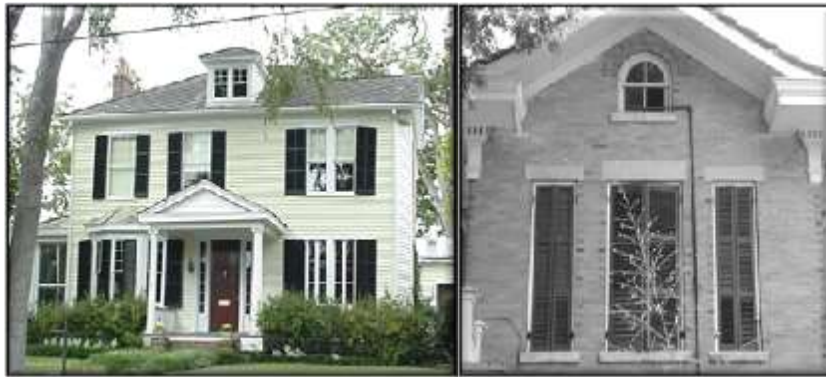
*The window shutters of these two houses are original and properly fit the windows. The house on the left illustrates original shutters that are properly sized and hung for paired windows and a bay window.*

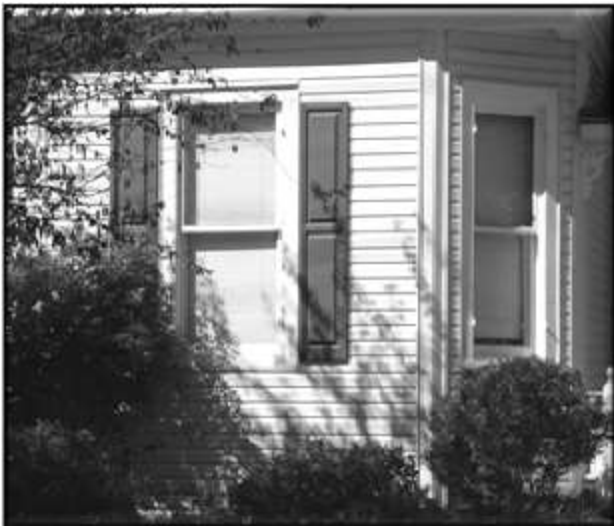
*The vinyl shutters flanking this window are too narrow and incorrectly hung outside the window frame. The paneled shutters are also inappropriate for Queen Anne style houses.*

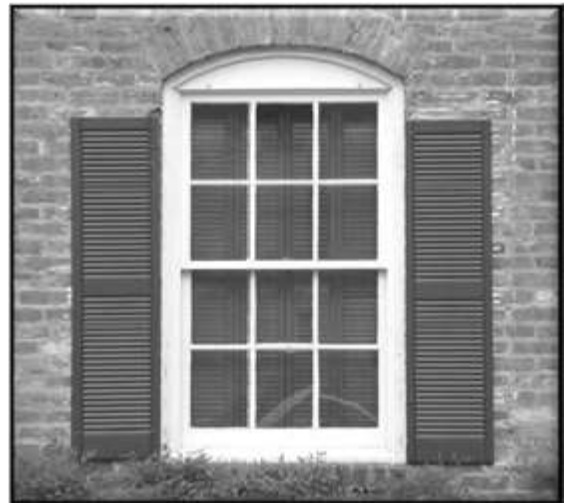
*Shutters on this arched window are too short, too narrow, and wrongly hung outside the window frame. Shutters for this window should also form an arch when closed.*

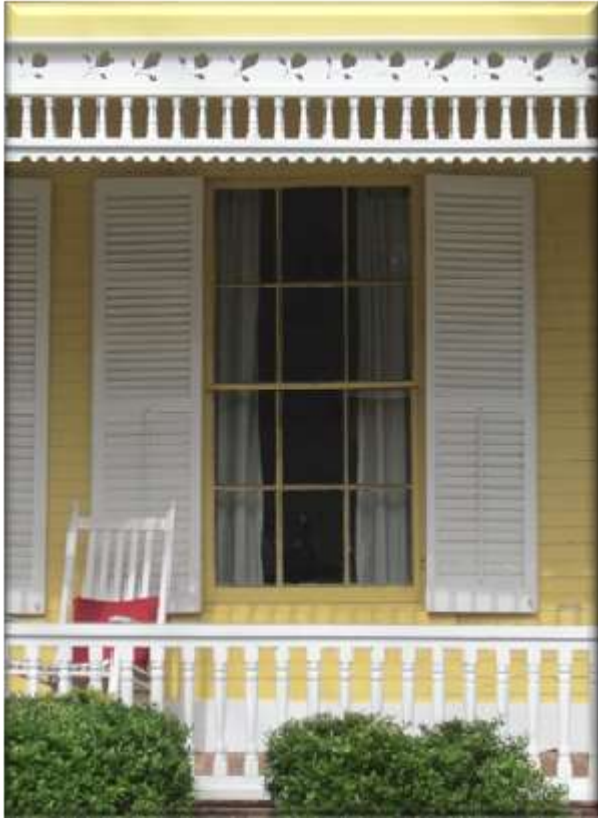
*The house at 336 West Gallatin Street has properly sized and hung shutters.*

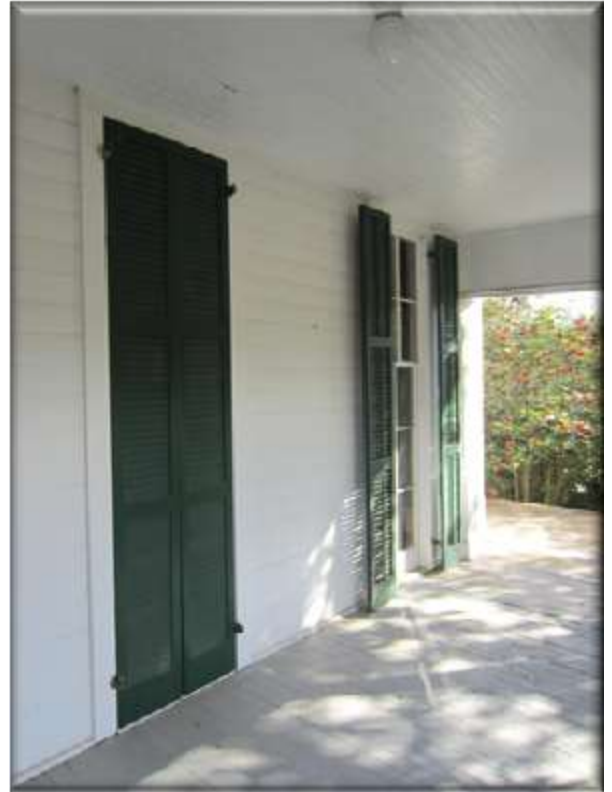
*The house at 231 South Extension Street shows how properly sized shutters should be able to be closed completely.*

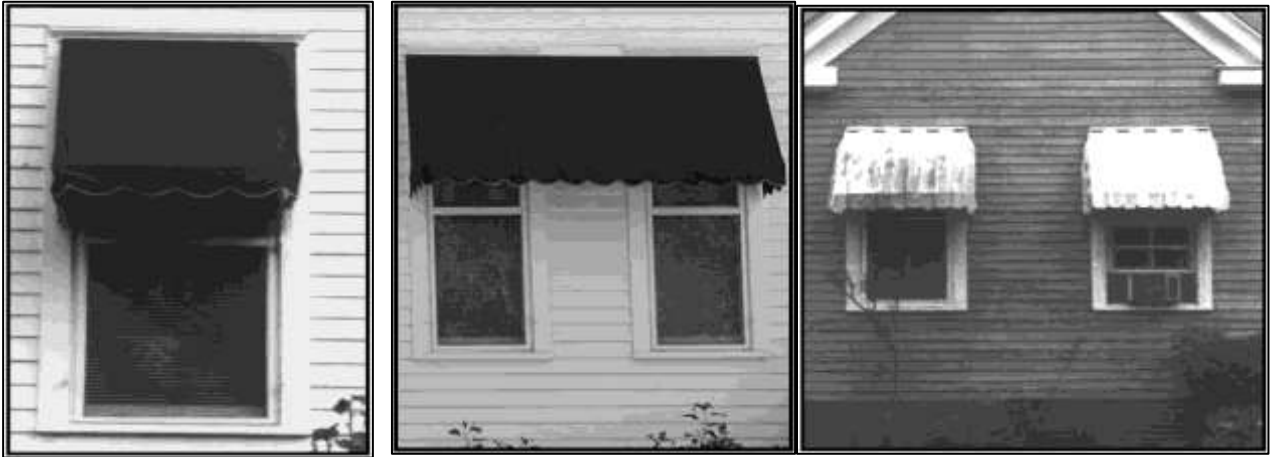
*Canvas awnings are appropriate for residential buildings. The awning above left is correctly hung. The awning in the center is incorrectly hung with one awning for two windows. The metal awnings above right are not appropriate for historic buildings.*

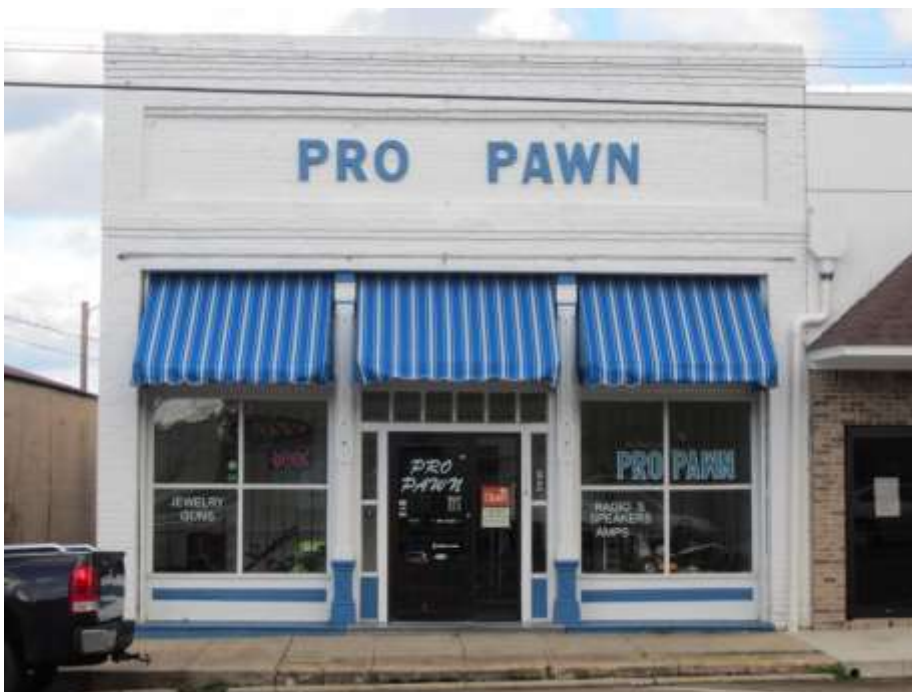
*The commercial building at 114 Caldwell Street has properly installed canvas awnings between the cast iron columns.*

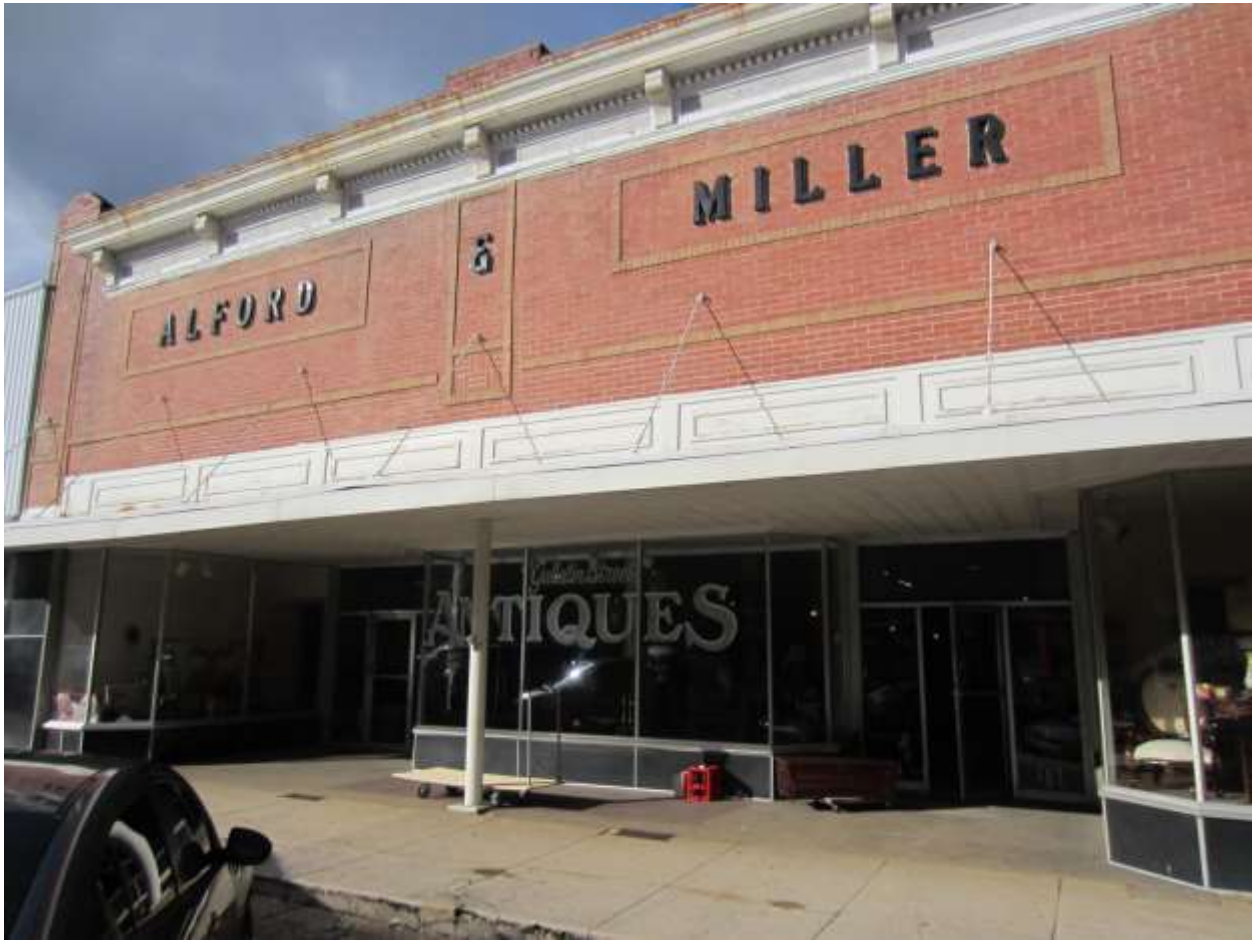
*The building at 156 West Gallatin Street shows the correct installation and projection for suspended canopies on a commercial building. The projecting flat canopy is anchored by rods which is typical of commercial buildings built in the 1920s to 1940s.*

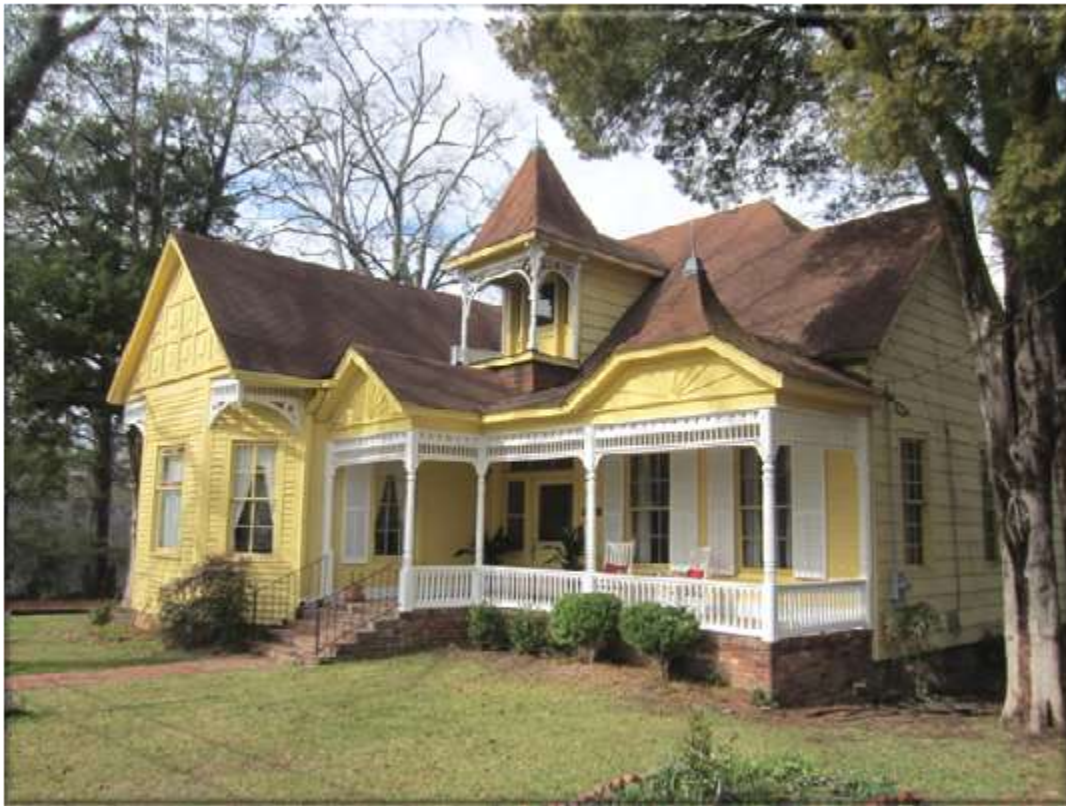
*The house at 336 West Gallatin Street features a projecting porch typical of the Queen Anne style along with turned columns and a turned balustrade.*

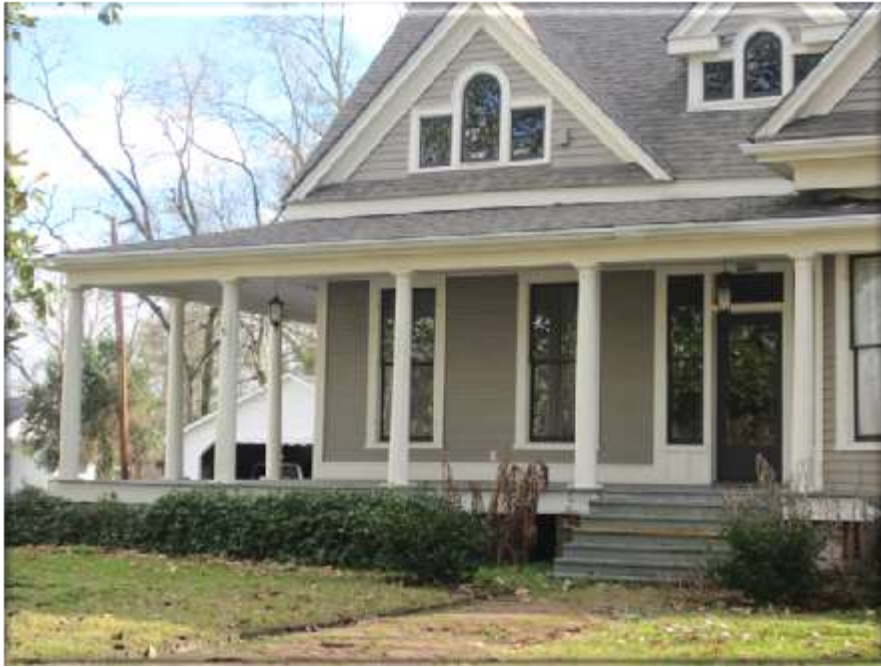
*The porch at 209 Downing Street is projecting, wraparound, and is supported by wood Tuscan columns which are typical of the Colonial Revival style.*

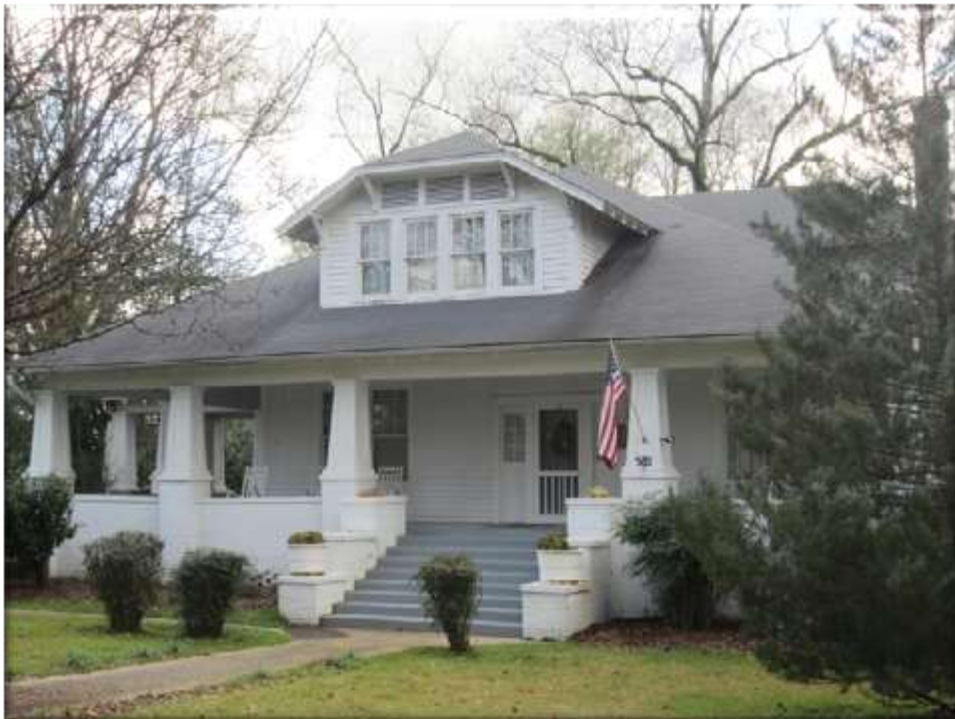
*This Craftsman style house at 302 South Extension Street has an undercut full-width and wraparound porch supported by wood tapered columns on masonry piers which is typical of the Craftsman style.*

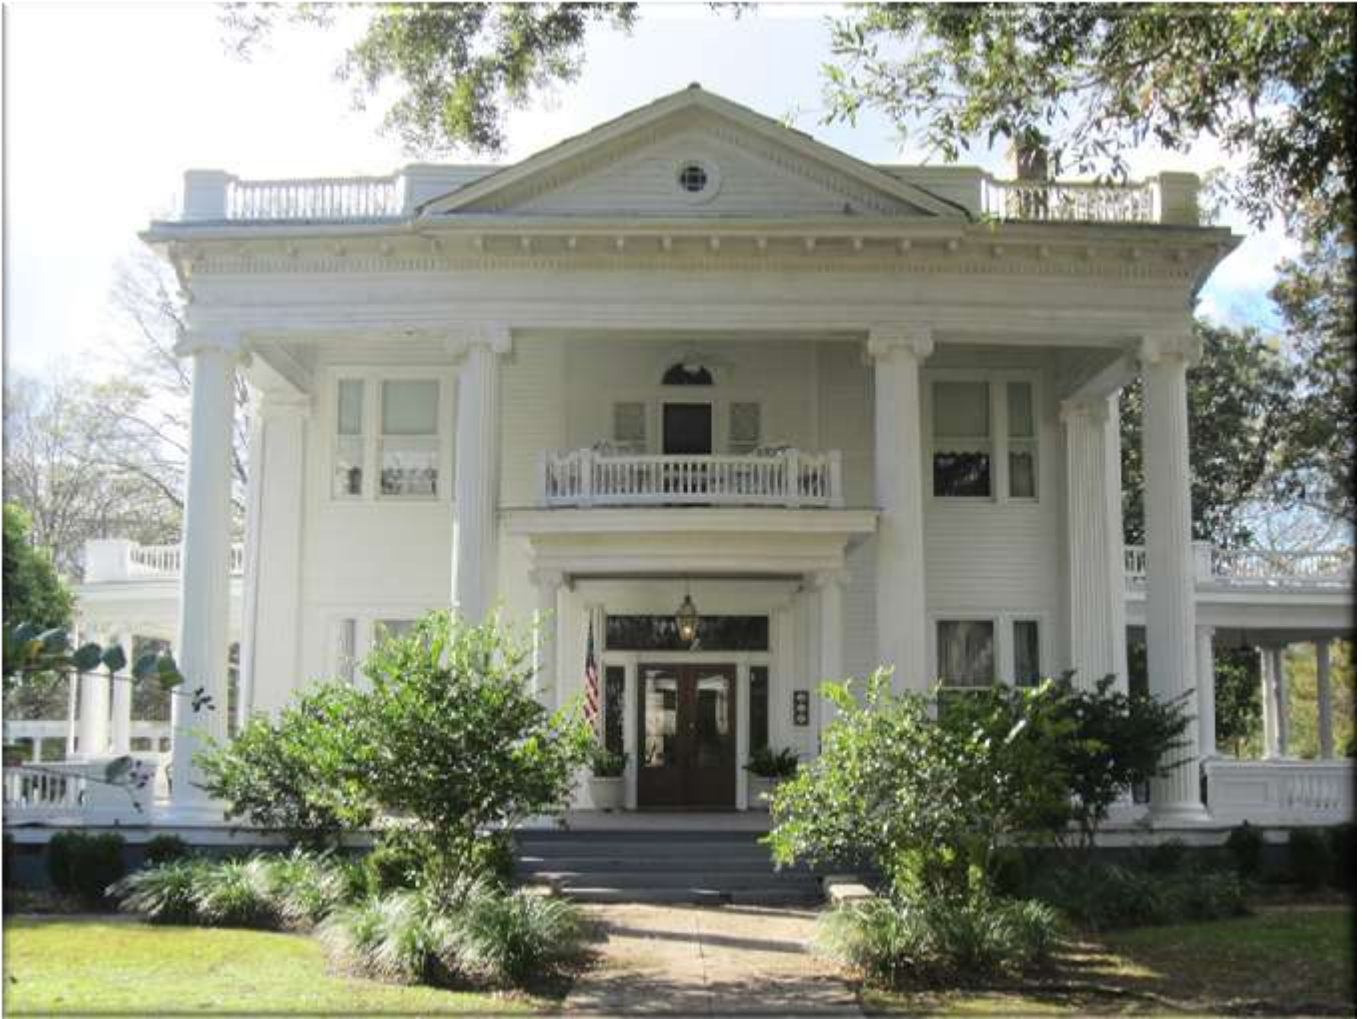
*The house at 314 South Extension Street features a grand two-story full height porch typical of the Neoclassical style.*

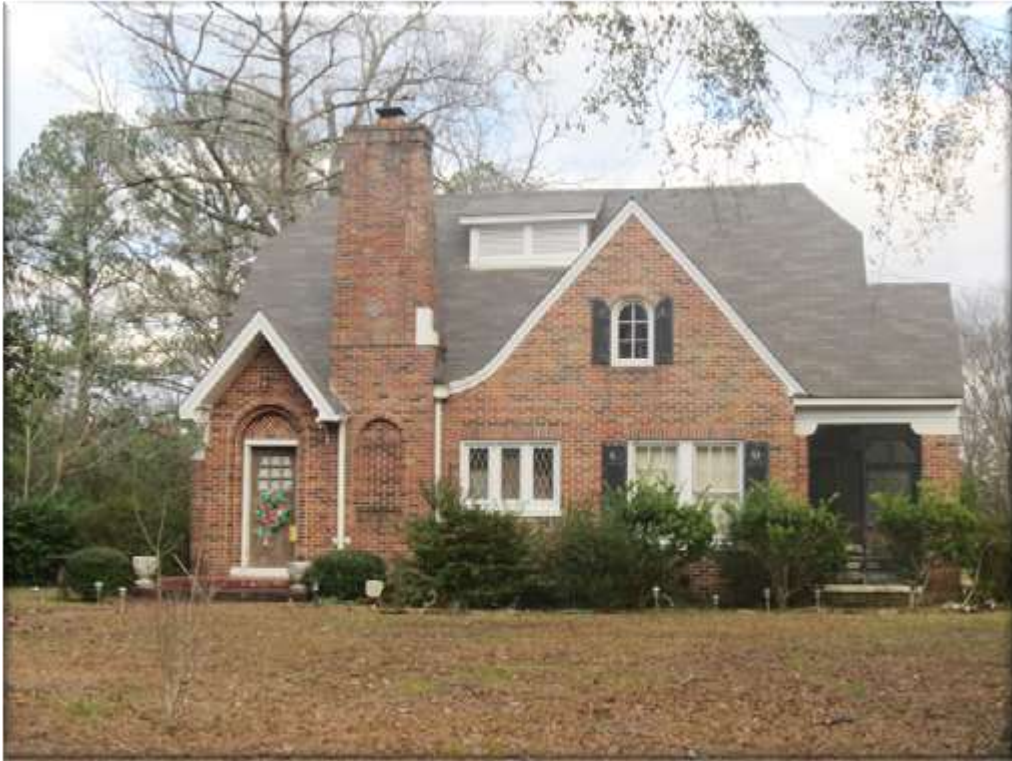
*The Tudor style house at 124 Jackson Street has no main entry porch, just a concrete stoop in front of the entrance door, which is slightly recessed. The house does have a small side porch serving as an outdoor living space.*

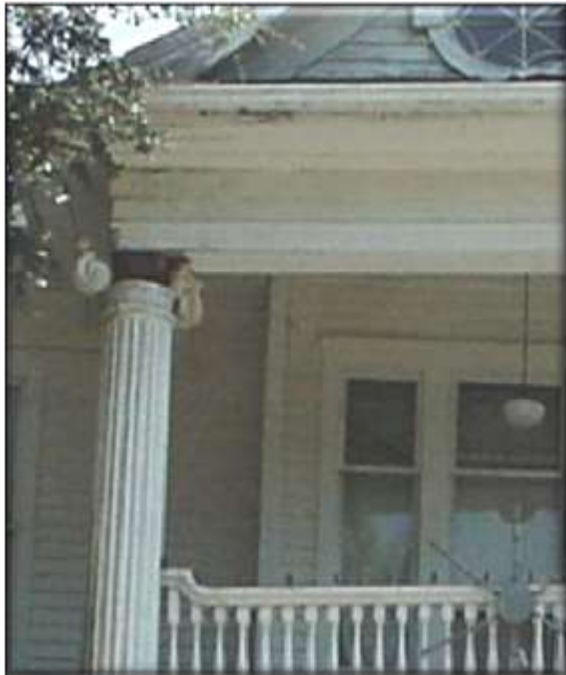
*Failure to clean and maintain gutters is the primary cause of deterioration of porches such as the damage caused to the column capital.*

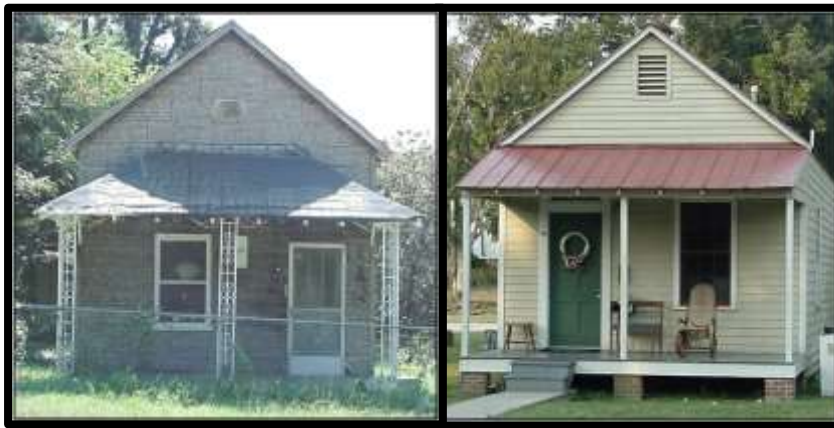
*These two Natchez shotgun houses illustrate how changing the porch components alters the historic appearance and integrity of the house. The original columns on the house on the left were replaced with metal trellis columns while the house on the right has wood columns, which are also replacements but are more in keeping with the original style of the building.*

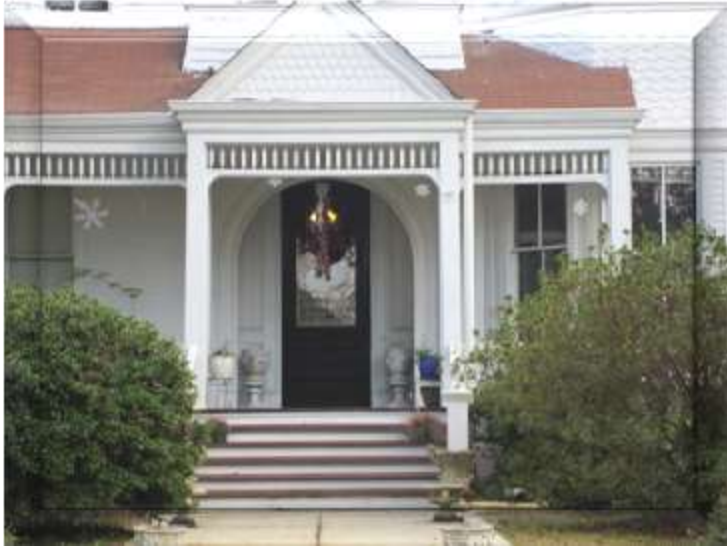
*The steps of this Queen Anne style house at 258 South Extension Street are appropriately constructed of wood.*

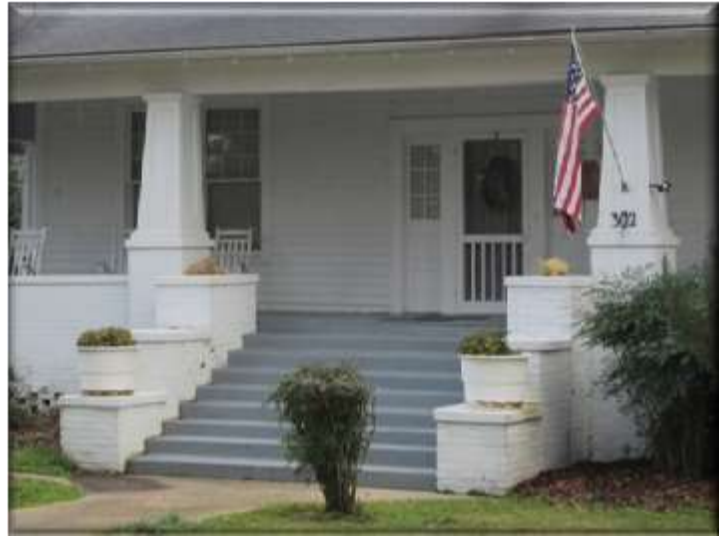
*This Craftsman style house at 302 South Extension Street has appropriately painted concrete entry steps for the style of house. The steps are flanked by stepped wing walls with cast stone caps.*

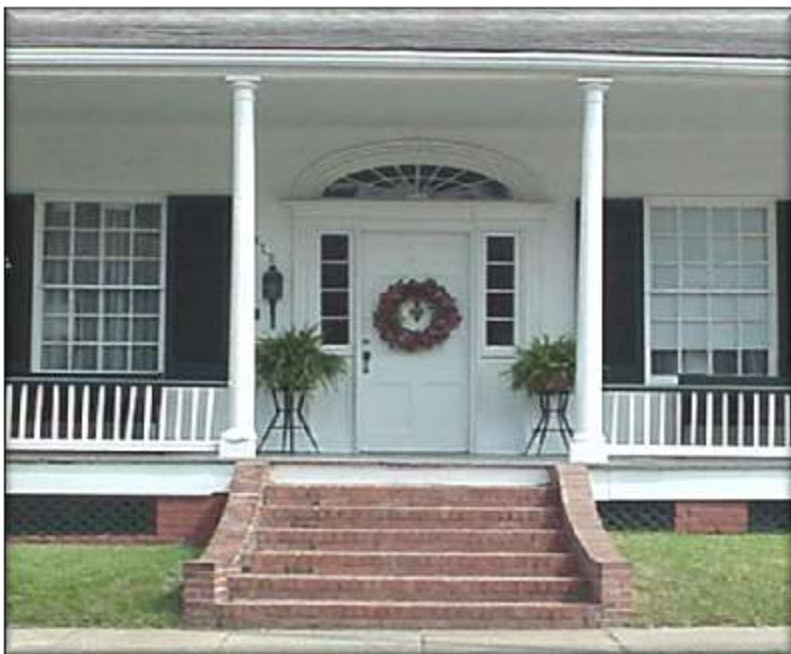
*The brick steps overpower this house and draw attention from the historic character of the building.*

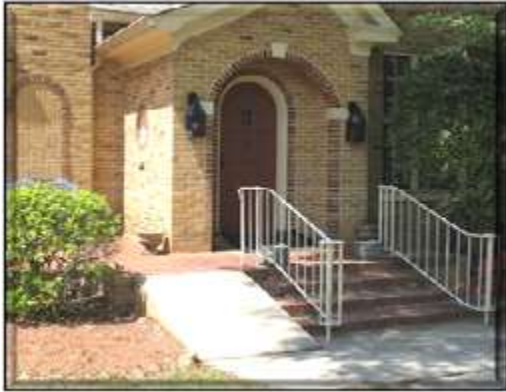
*This former house in Amory, now an office, uses an inconspicuous ramp to the side of the stairs to provide accessibility to the building.*
