# Hazlehurst Design Guidelines for Historic District

**June 7, 2012**

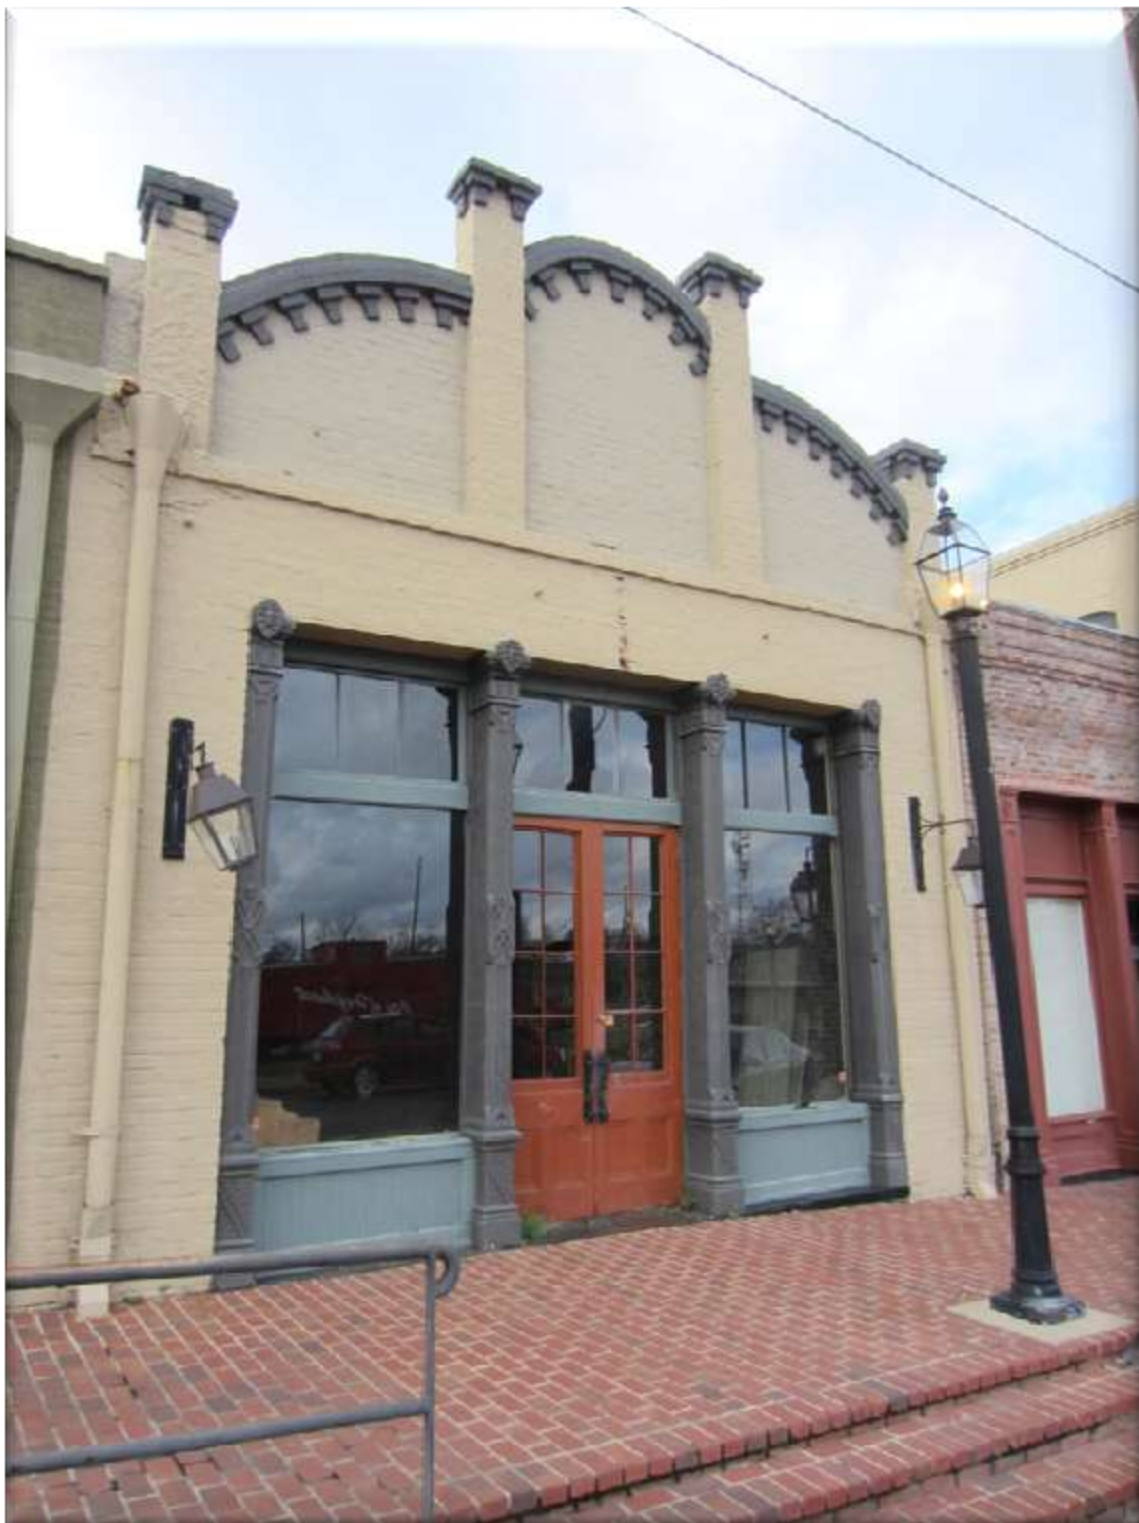
*The original storefront at 145 North Ragsdale Street features a typical storefront design of the late 1800s with cast iron columns supporting the storefront opening, large glass windows with a panel below and transoms above.*

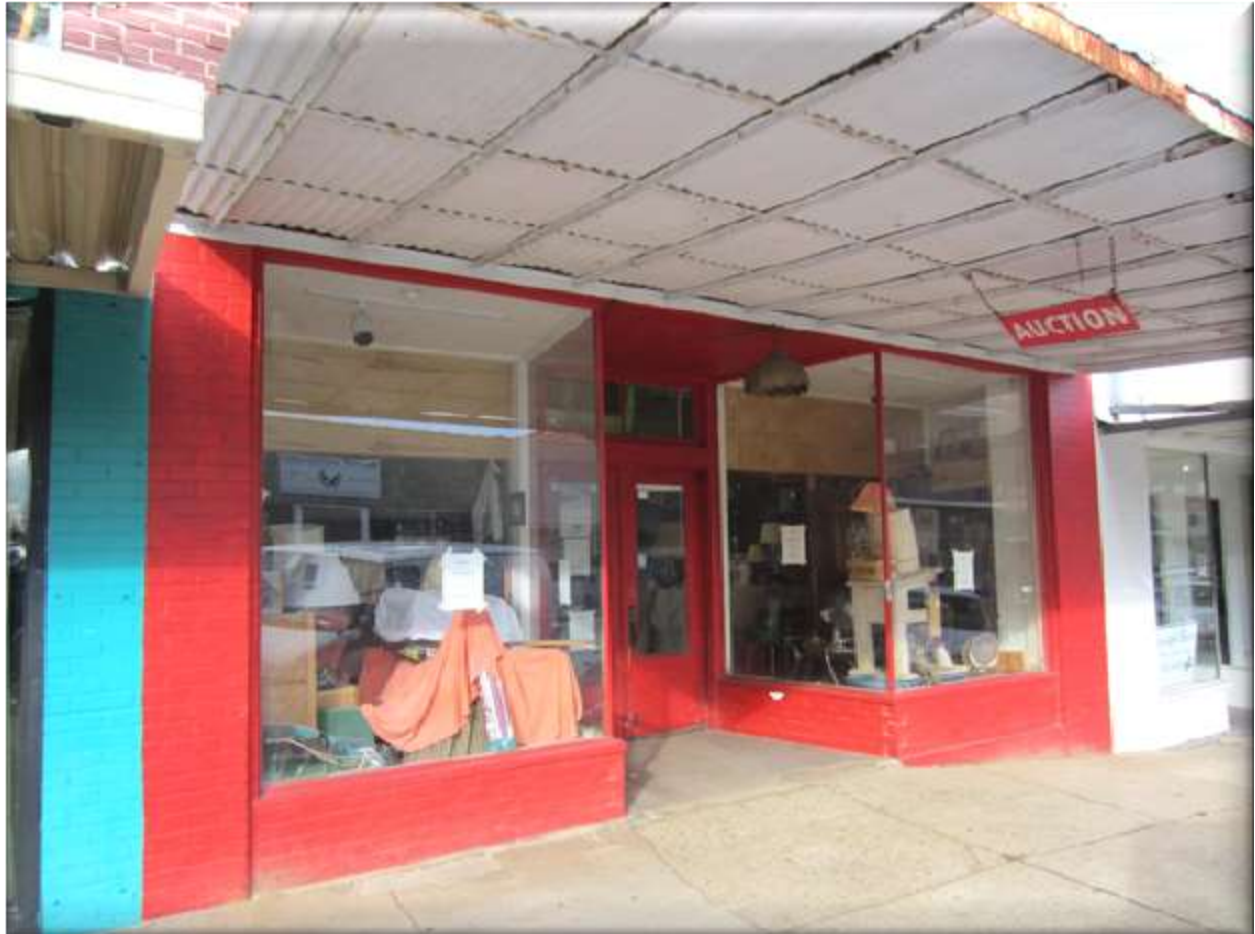
*The building at 138 West Gallatin Street has a typical storefront from the 1920s with large plate glass windows, recessed entry, transoms above the storefront, and wood glazed doors with transoms. These elements should be preserved to maintain the historic character of the building.*

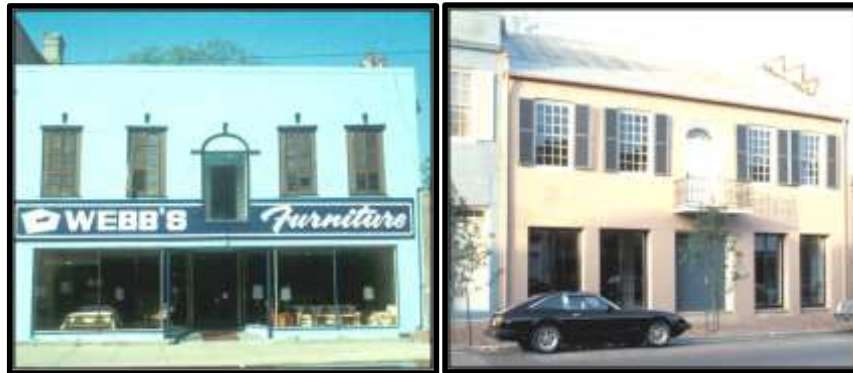
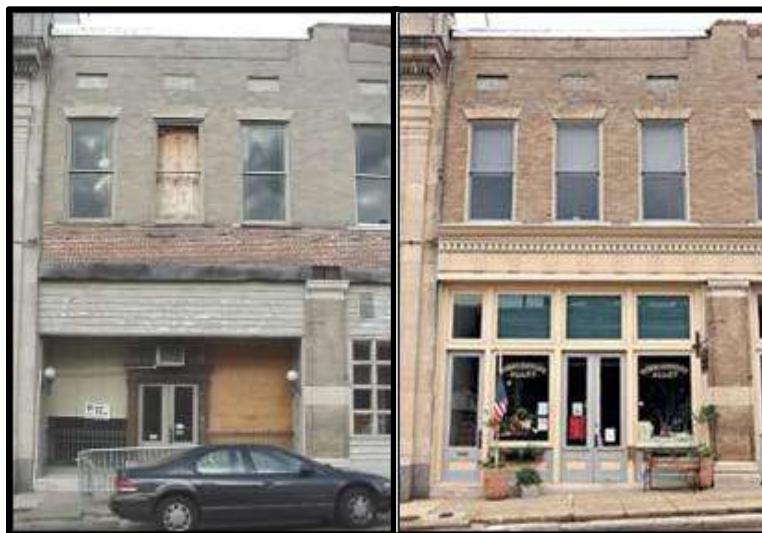
*No photographs existed to guide the restoration of the first-story of the Natchez commercial buildings above and below. Following the Secretary of Interior's Standards for Rehabilitation, the owner installed a contemporary first-story storefront that is compatible with the building and the streetscape in the top photo. Below, the original storefront doors found in the building and historical precedents and patterning found on other Natchez buildings were used for the design of the new storefront also meeting the Secretary's Standards.*

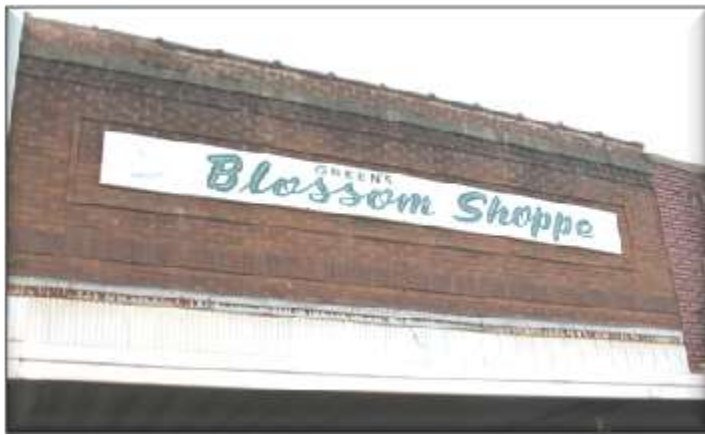
*The sign on this building in downtown Amory is an example of how to place signage in a historically correct location within the sign board area of this early twentieth-century building. On this façade the sign area is delineated by a brick border. The lettering is of an appropriate size and fits neatly in the sign board.*

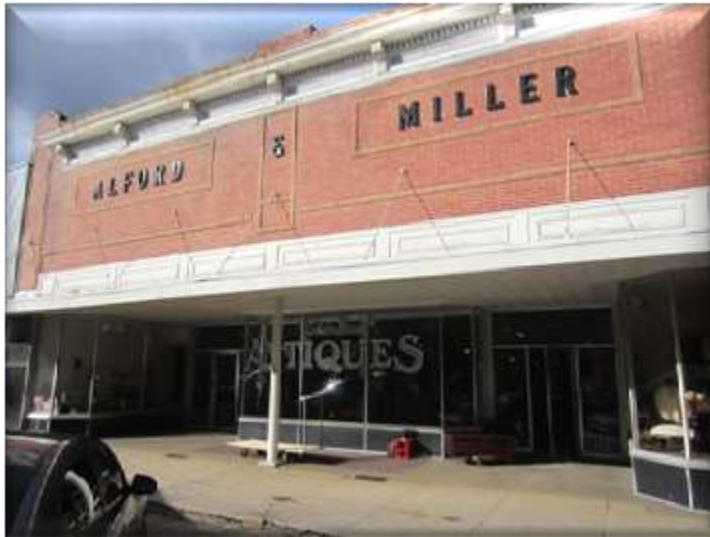
*The sign for the business at 156 West Gallatin Street is in the appropriate location in the historic sign board area of the parapet. Instead of a board for the signage attached to the building, the letters are individually attached.*

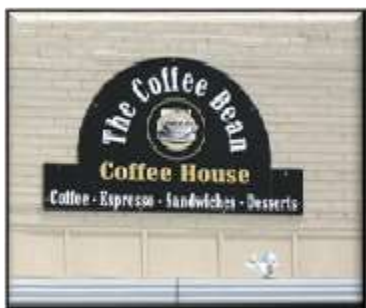
*This professionally designed wall sign from Philadelphia is an example of an appropriately designed sign with an interesting design shape for a historic commercial building without a delineated signboard in the parapet.*

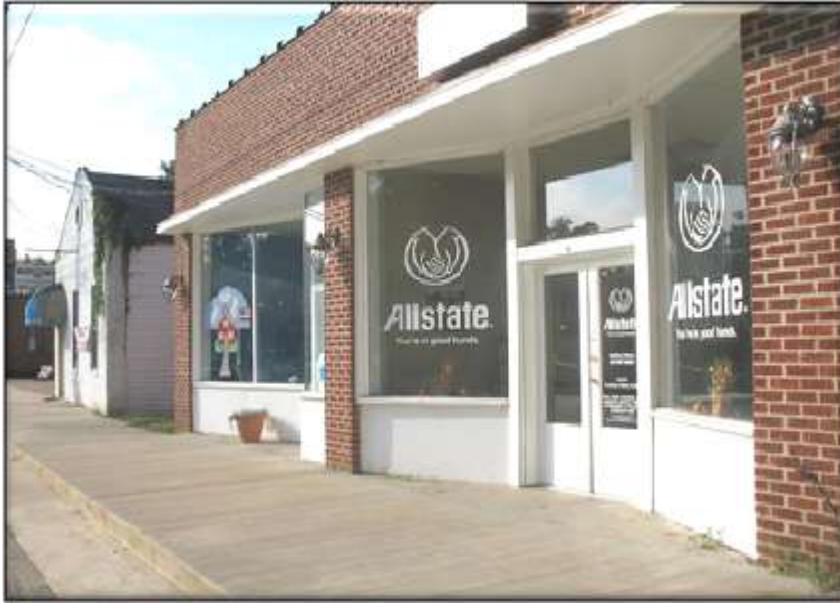
*The window sign on this historic commercial building in Raymond is very effective in displaying the name of the business and hours. The signage can easily be altered with the change of business or in the case of a retail store for the addition of new items or removal of discontinued items.*

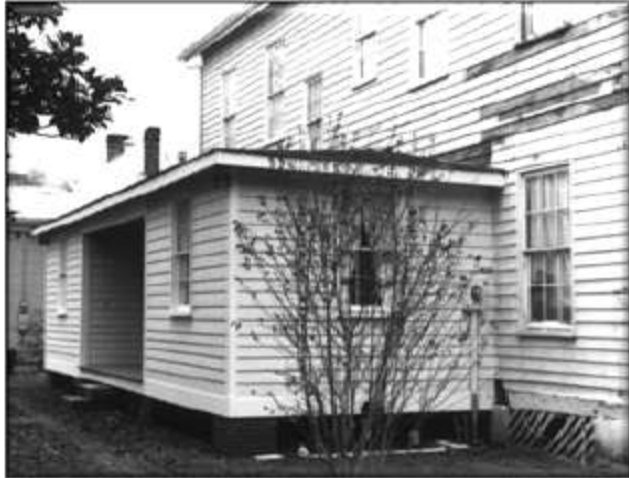
*This rear addition is secondary to the original house and reads as an addition yet uses materials compatible to the original house.*

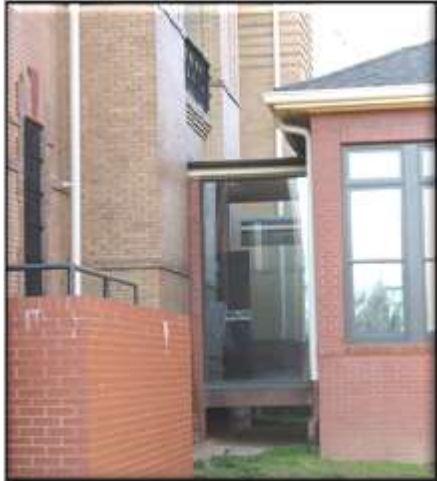
*The new addition to the historic Yalobusha County Courthouse in Water Valley illustrates successful way to connect a modern addition on the right to the historic building on the left. The glass enclosed hyphen visually separates the old and new buildings while reducing the alteration to the historic building where the connection meets.*

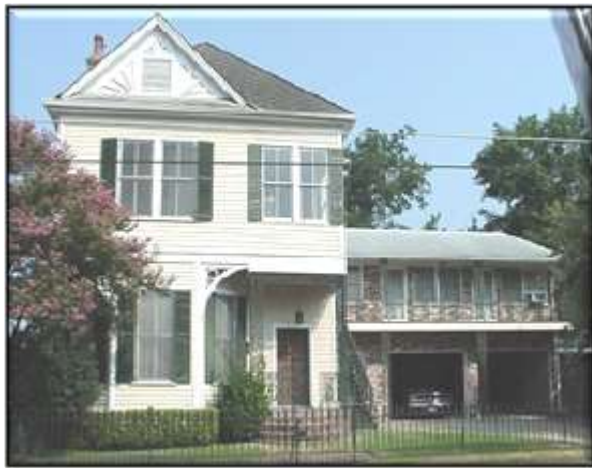
*This side addition is inappropriate in proportion and scale, height, materials, massing, and roof shape. The upper and lower porches, the entrance door, and the second-story windows of this historic house have also been remodeled.*

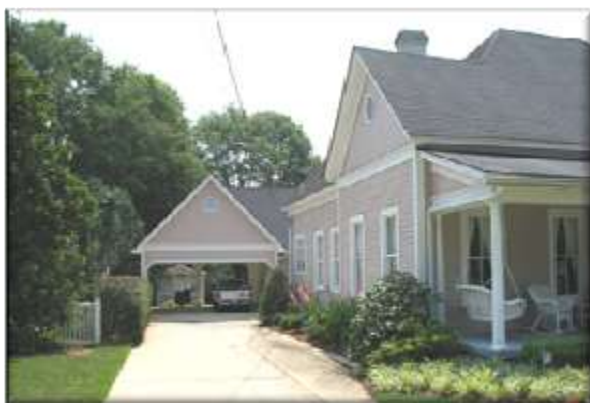
*This example of a carport addition is very successful as it does not compete with the historic house and uses similar materials and roof pitch to maximize the compatibility.*

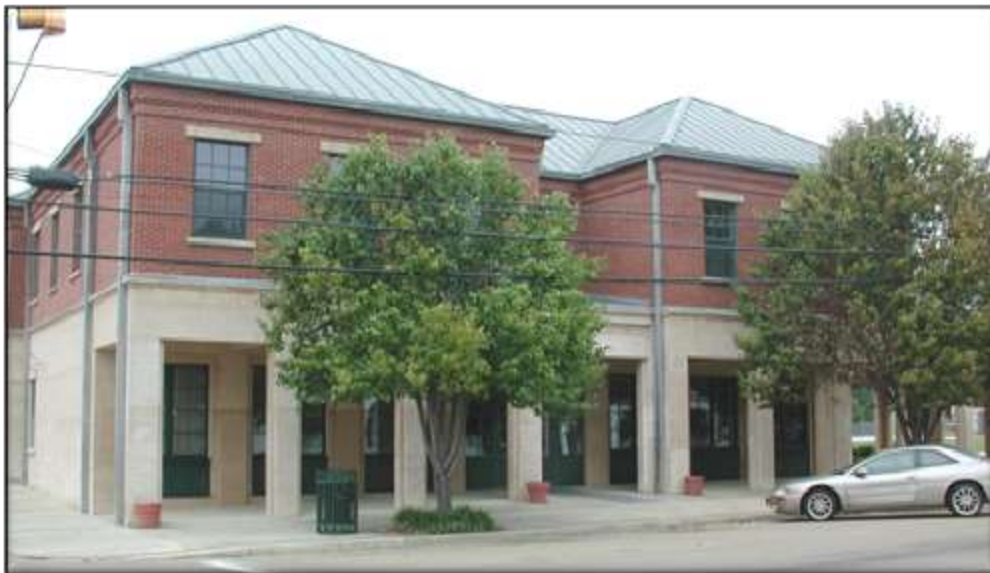
*The Matt Ross Administration Building in Port Gibson is one of Mississippi's most successful examples of designing a new building to fit into a historic context. Although built in the 1990s using modern technology of the time, the building complements its neighbors and echoes the historic character of Market Street in downtown Port Gibson.*

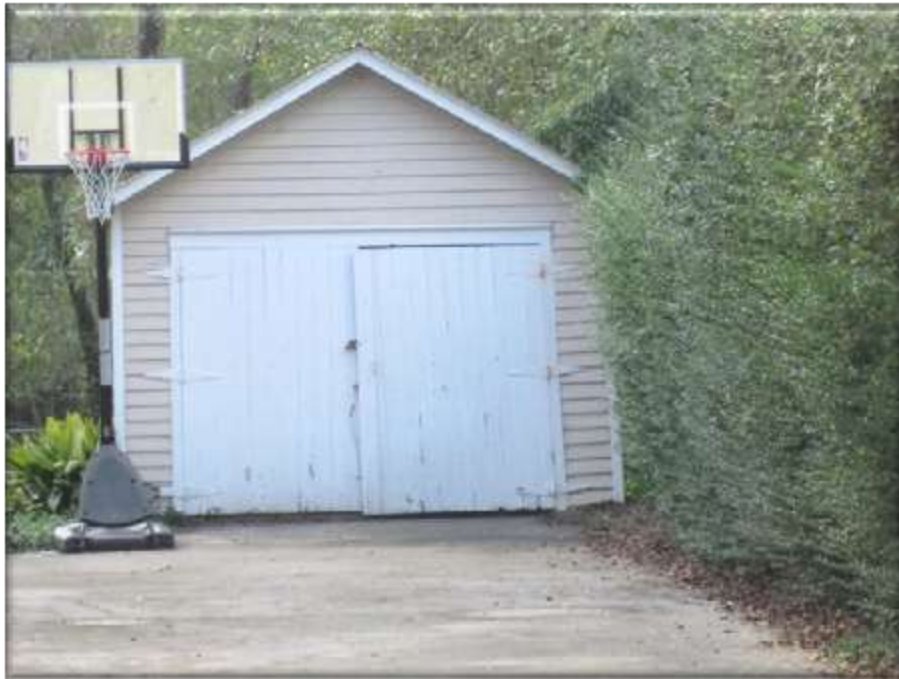
*The garage at 308 South Extension Street is an excellent example of an early detached garage before it became popular to attach the garage to the main house. The garage is fully enclosed with wood lap siding matching the main house and retains the original wood panel barn type doors. This type of garage should be preserved as an example of early garage construction and is especially important since few survive today.*

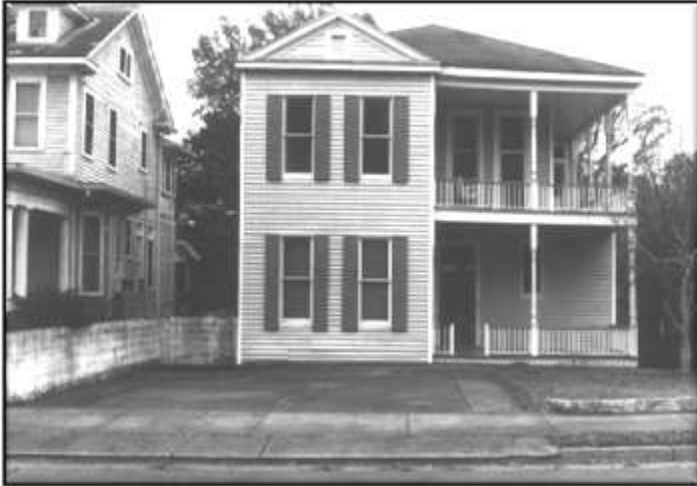
*The front yard of this historic house has been inappropriately paved for parking. Parked cars and the lack of landscaping disrupt the character of the historic neighborhood.*

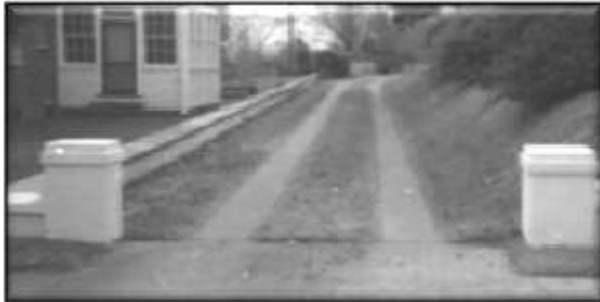
*Concrete strips are appropriate for driveways in historic districts. They minimize the impact of driveways on the character of the historic property and its neighborhood.*

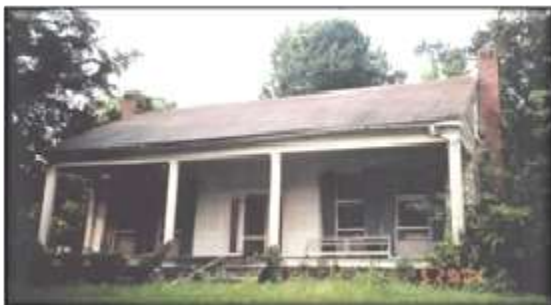
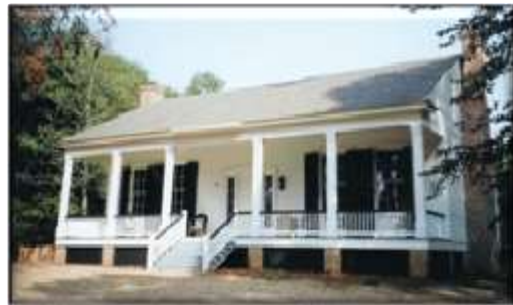
*This historic house above was moved to Raymond from outside the city to save it from demolition. The new owner relocated the house to a vacant lot in the local Raymond Historic District (below) and rehabilitated it for use as a Bed & Breakfast.*
