**National Register of Historic Places  
Inventory—Nomination Form**

historic Clifton Heights *Historic District*

*Roughly bounded by Ridge and Mulberry Aves, Natchez  
Bluff, Park Ave and Maple St.*

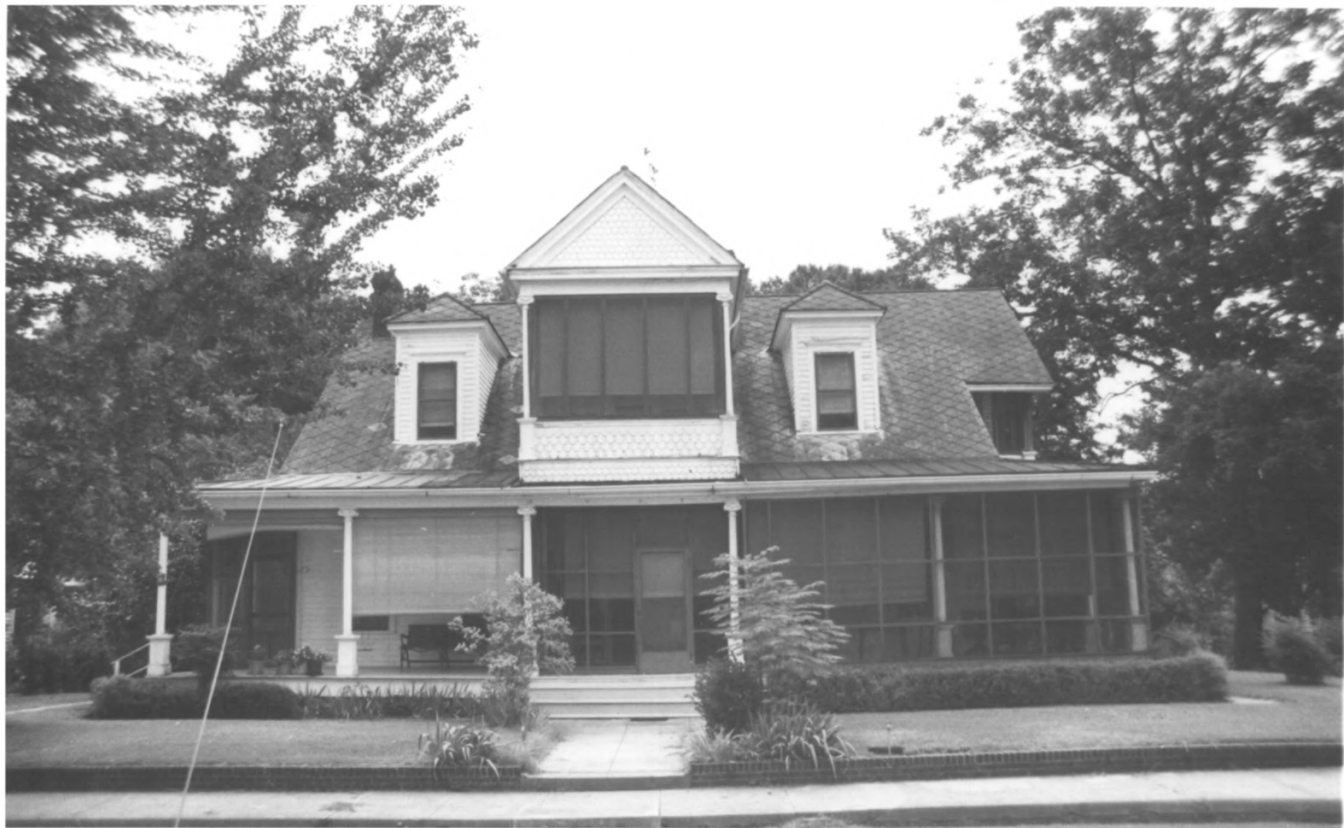
Photo 1 of 18

Looking easterly, the facade of element #2  
(203 Clifton Avenue).

- 2 C 203 Clifton Ave. One-and-a-half story frame residence with gabled roof, two hipped dormers, projecting second-story gable with recessed porch, one-story porch that wraps around the northern and southern side elevations and is supported by modified Ionic columns on pedestals. Colonial Revival. Ca. 1900.

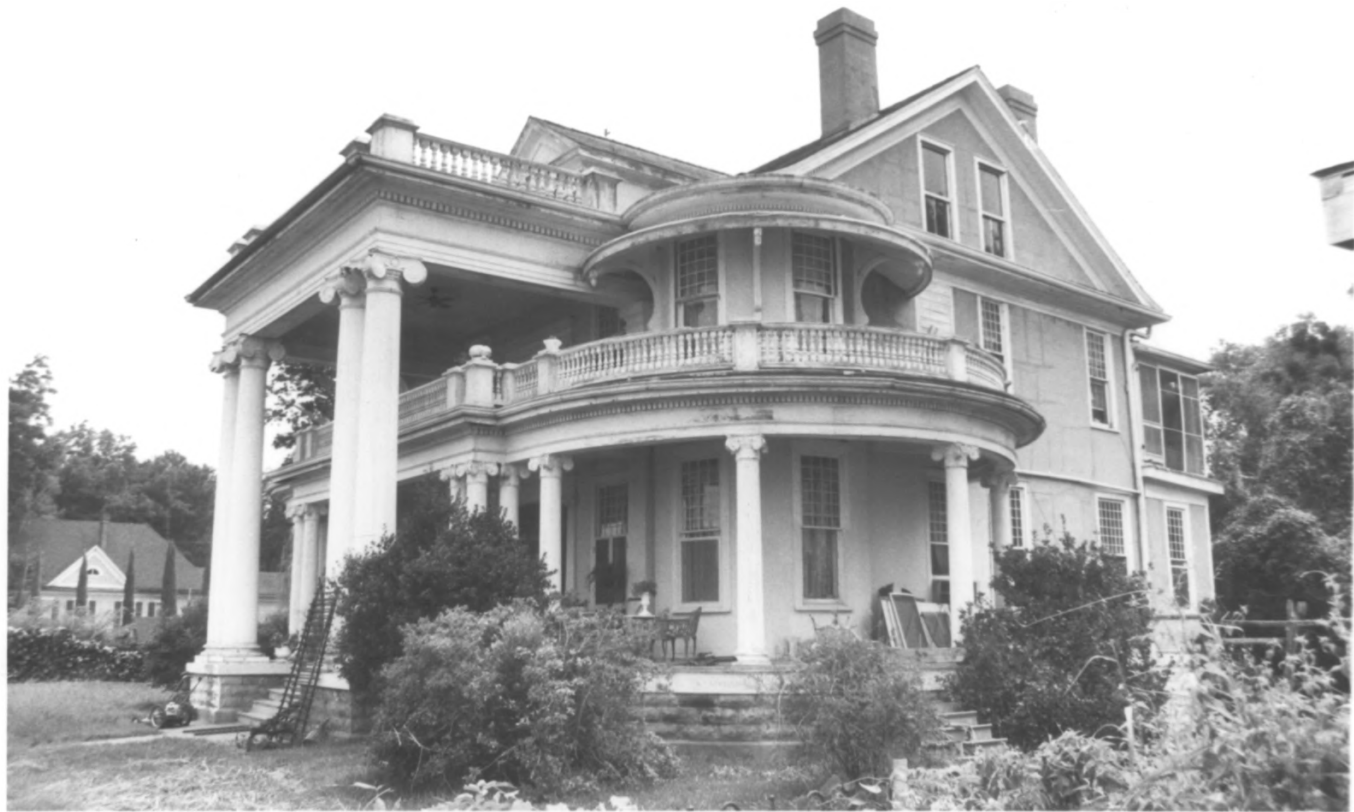
Photo 2 of 18

Looking northeasterly, the westerly facade  
and the southerly side elevation of  
element #7 (213 Clifton Avenue).

- 7 P 213 Clifton Ave. Learned House Important two-story, stuccoed frame residence with gabled roof, circular bays at each corner of the facade, giant-order Ionic portico, one-story porch with Ionic columns, turned baluster railings, full molded entablature with dentiled cornice, multiple-light upper sash and lower single-light sash, frontispiece entrance with full molded entablature supported by Ionic pilasters, and leaded glass transom and sidelights. Colonial Revival. Ca. 1915.

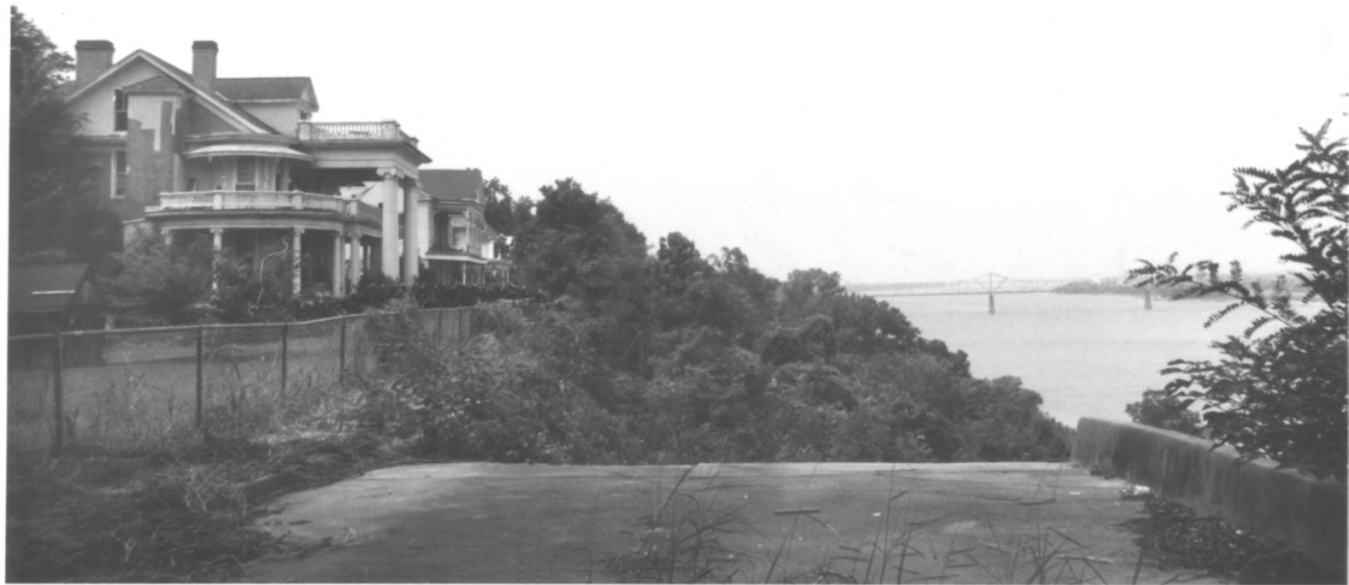
Photo 3 of 18

Looking southerly, the edge of Clifton Avenue showing portion of the street that collapsed, the Mississippi River, and element #7 in the foreground.

**TOPOGRAPHICAL FEATURES:** The district occupies an undulating terrain with selected areas of high elevation. The fine, loose loess soil of the district area has caused erosion problems so severe that portions of Clifton Avenue, which was originally the westernmost street of Clifton Heights, have collapsed (see photo 3). The jagged edges of the steep bluffs, the park-like grassy strips along the bluff edges, the gently rolling terrain, the large trees, and the spectacular view of the Mississippi River combine to create a district of great natural beauty.

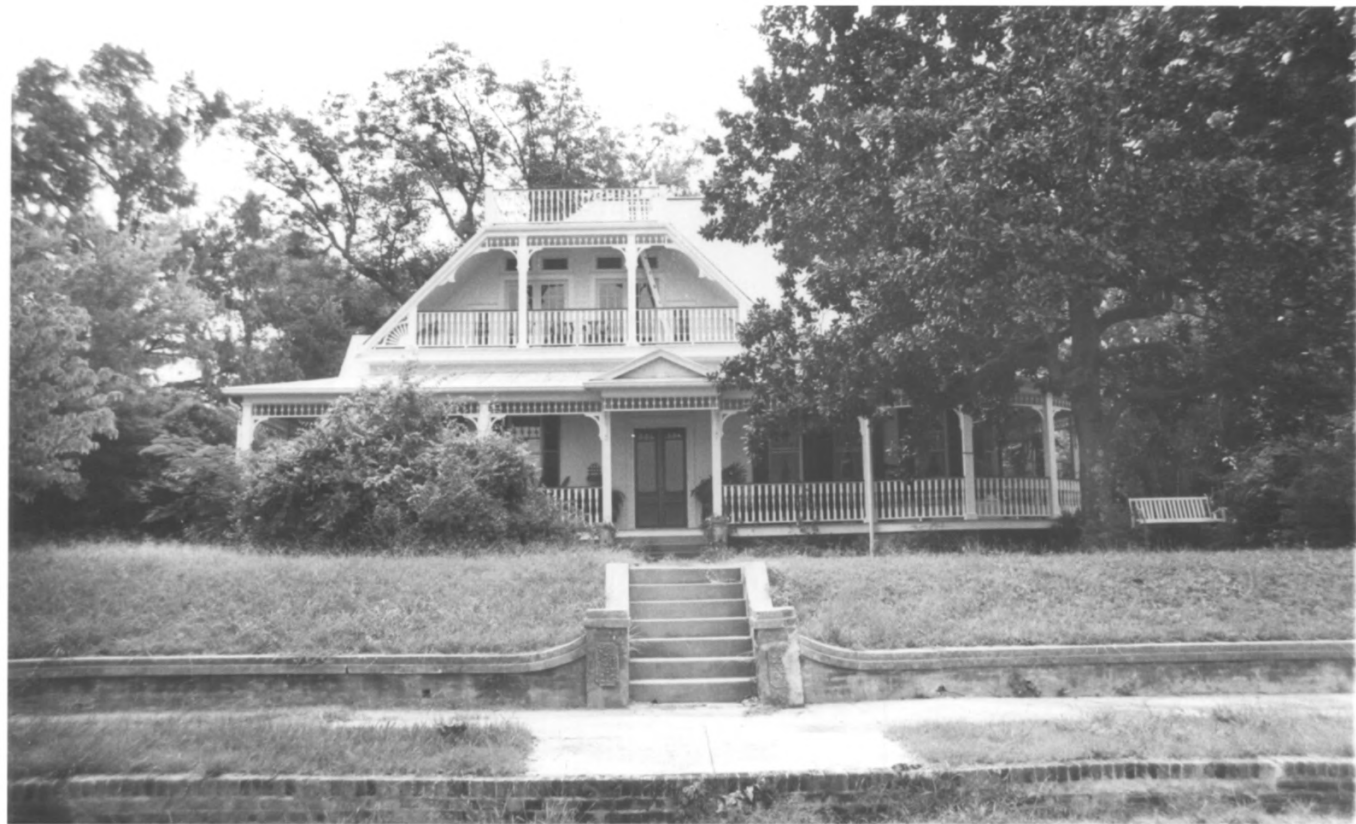
Photo 4 of 18

Looking easterly, the facade of element #12  
(313 Clifton Avenue).

| 12 | C | 313 Clifton Ave.<br>Proby House | Important one-and-a-half story frame residence with hipped roof, projecting second-story hipped-roof porch, one-story porch that wraps around both the northern and southern side elevations, verge-boards, bracketed box columns, turned baluster railings, and stained glass. Queen Anne. Ca. 1895. |

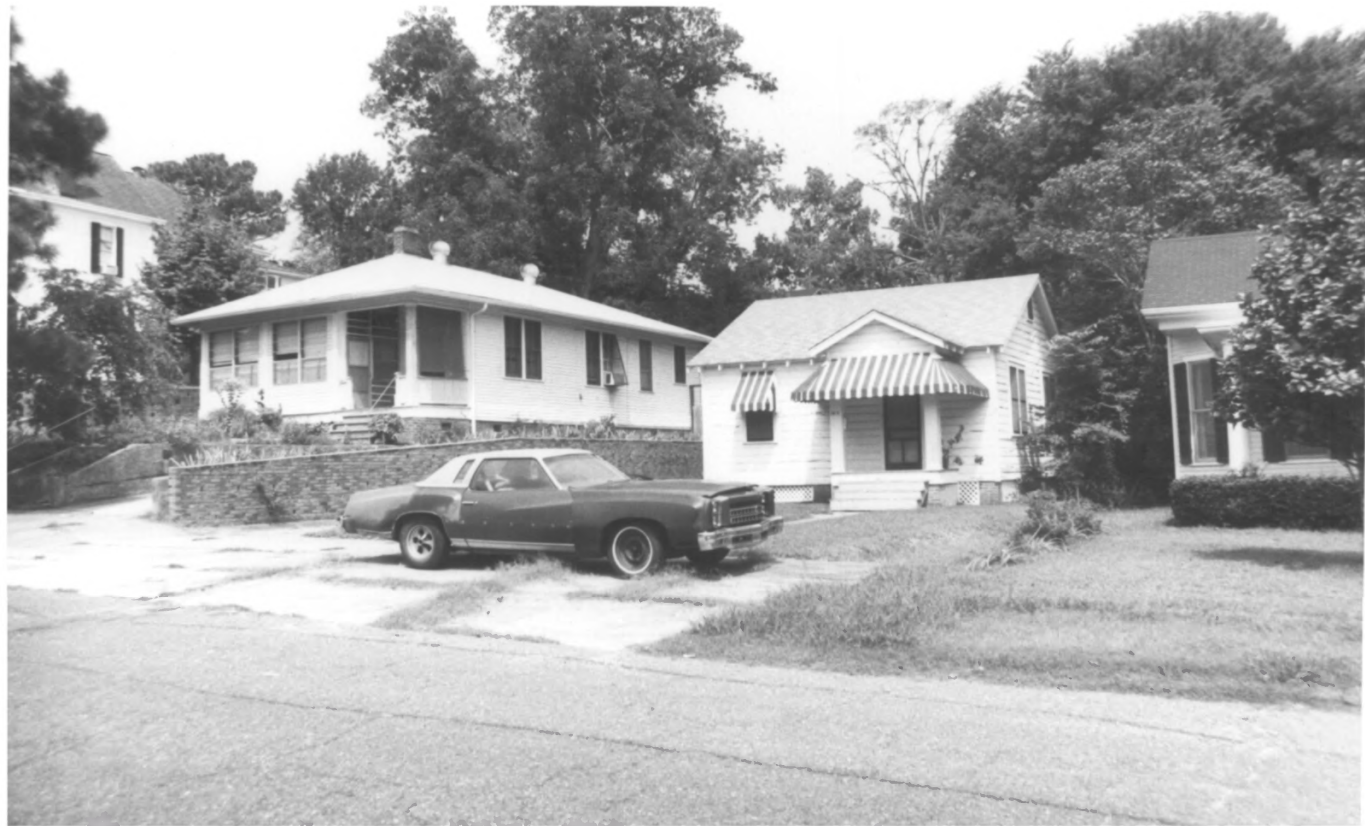
Photo 5 of 18

Looking southwesterly, the facade of element #24 (318 Linton Avenue) and the facade and southern elevation of #26 (316 Linton Avenue) both of which are intrusions within the district.

| Element #, Value (C=contributing; P=pivotal; I=intrusion; NC=noncontributing), Street # & Description | | |
|---|---|---|
| 24 | I | 318 Linton Ave. One-story two-bay frame residence with gabled roof. The scale and poor quality of architectural finish render the house an intrusion on the street scape. 1925-46. |
| 26 | I | 316 Linton Ave. One-story frame residence with hipped roof and altered front porch. The scale, poor quality of architectural finish, and the altered porch combine to render this house an intrusion in the district. 1925-46. |

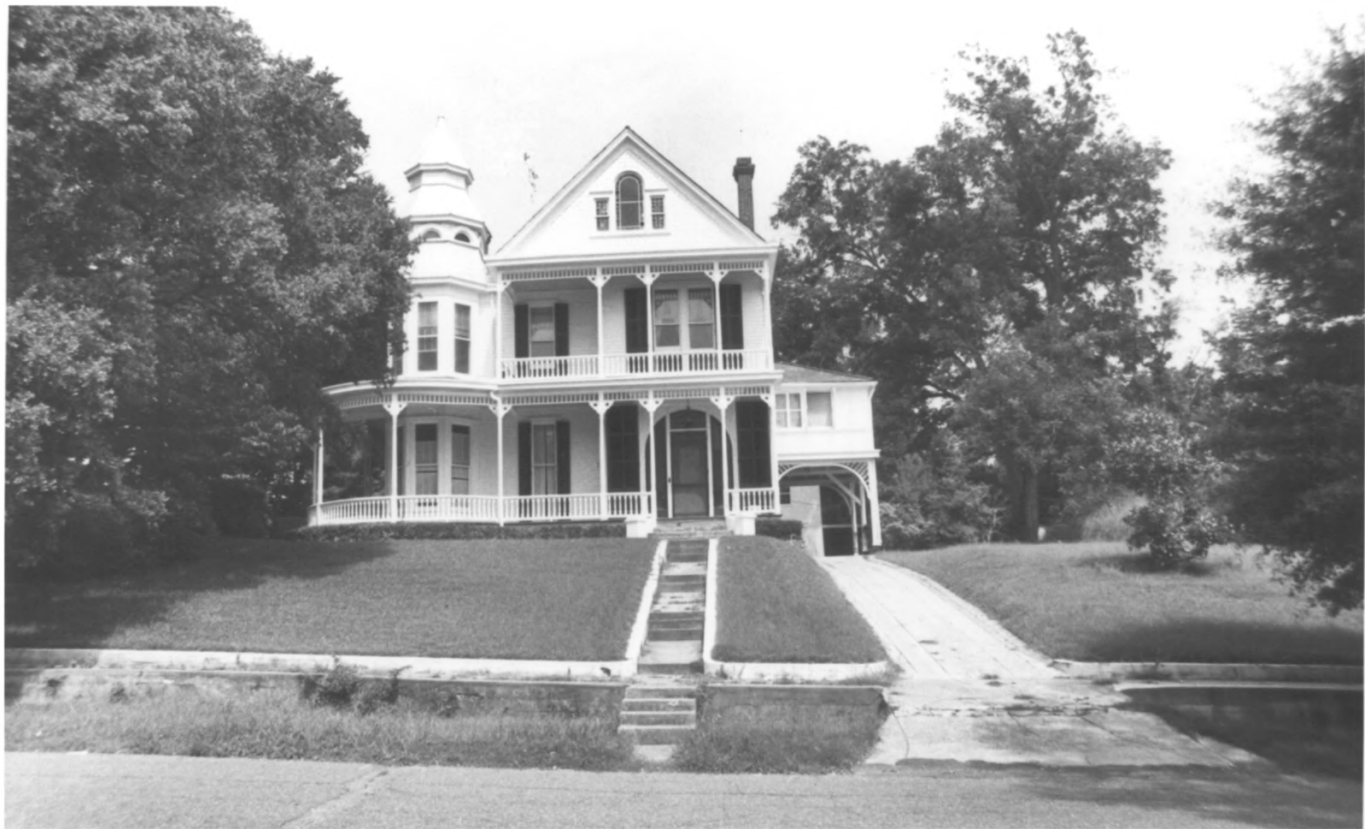
Photo 6 of 18

Looking westerly, the facade of element #27  
(314 Linton Avenue).

| Element #, Value (C=contributing; P=pivotal; I=intrusion; NC=noncontributing), Street # & Description | | |
|---|---|---|
| 27 | P | 314 Linton Ave. Important two-story frame residence with gable-end facade, octagonal turret with three-stage roof, bracketed turned posts, turned baluster railings, spindle friezes, etched and stained glass, and porte-cochere on northern elevation. Original two-story frame carriage house survives. Queen Anne. Ca. 1895. |

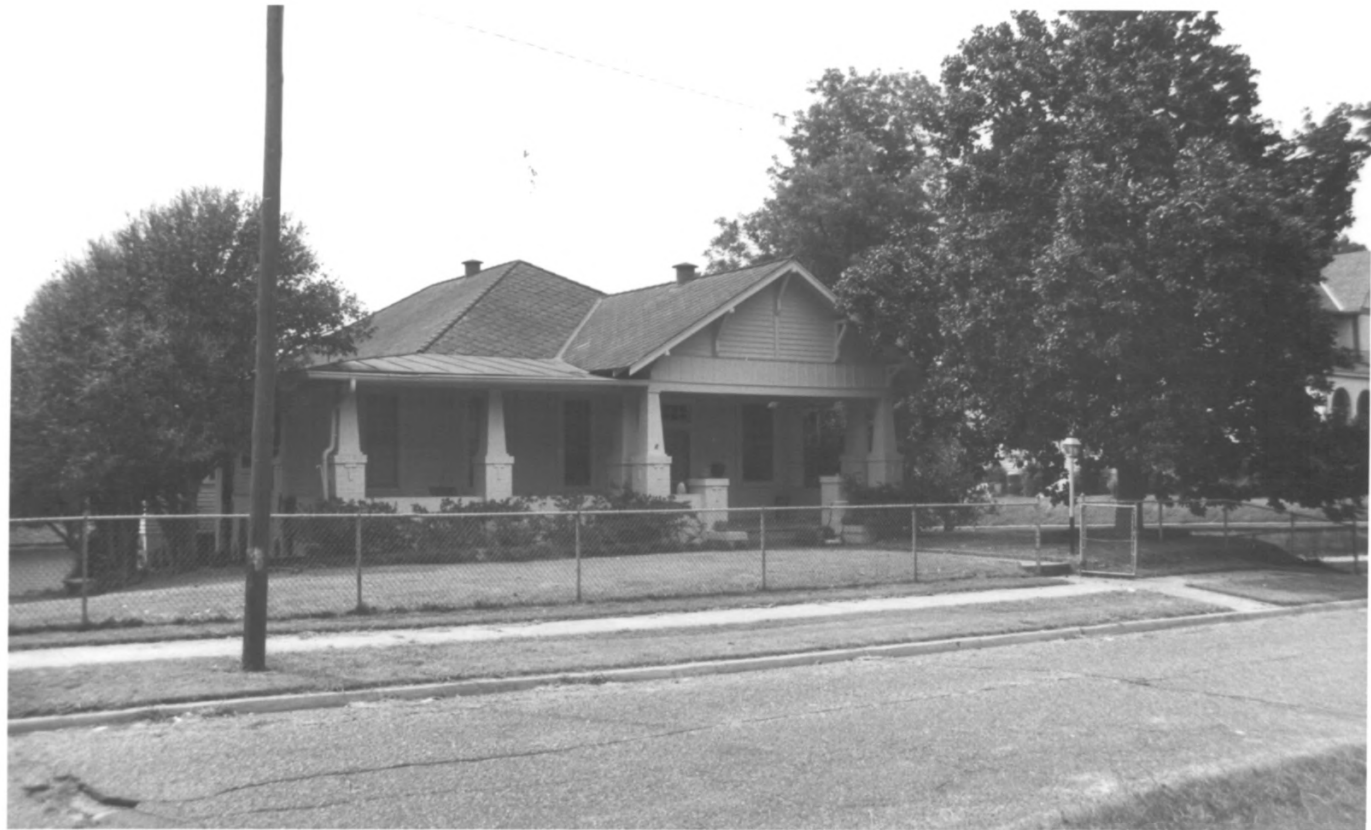
Photo 7 of 18

Looking southeasterly, the facade of element  
#33 (301 Linton Avenue).

| Element #, Value (C=contributing; P=pivotal; I=intrusion; NC=noncontributing), Street # & Descriptive | | |
|---|---|---|
| 33 | C | 301 Linton Ave. One-story frame residence with hipped roof, gabled porch that wraps around the northern elevation, and wooden posts on brick piers. Bungalow. 1910-25. |

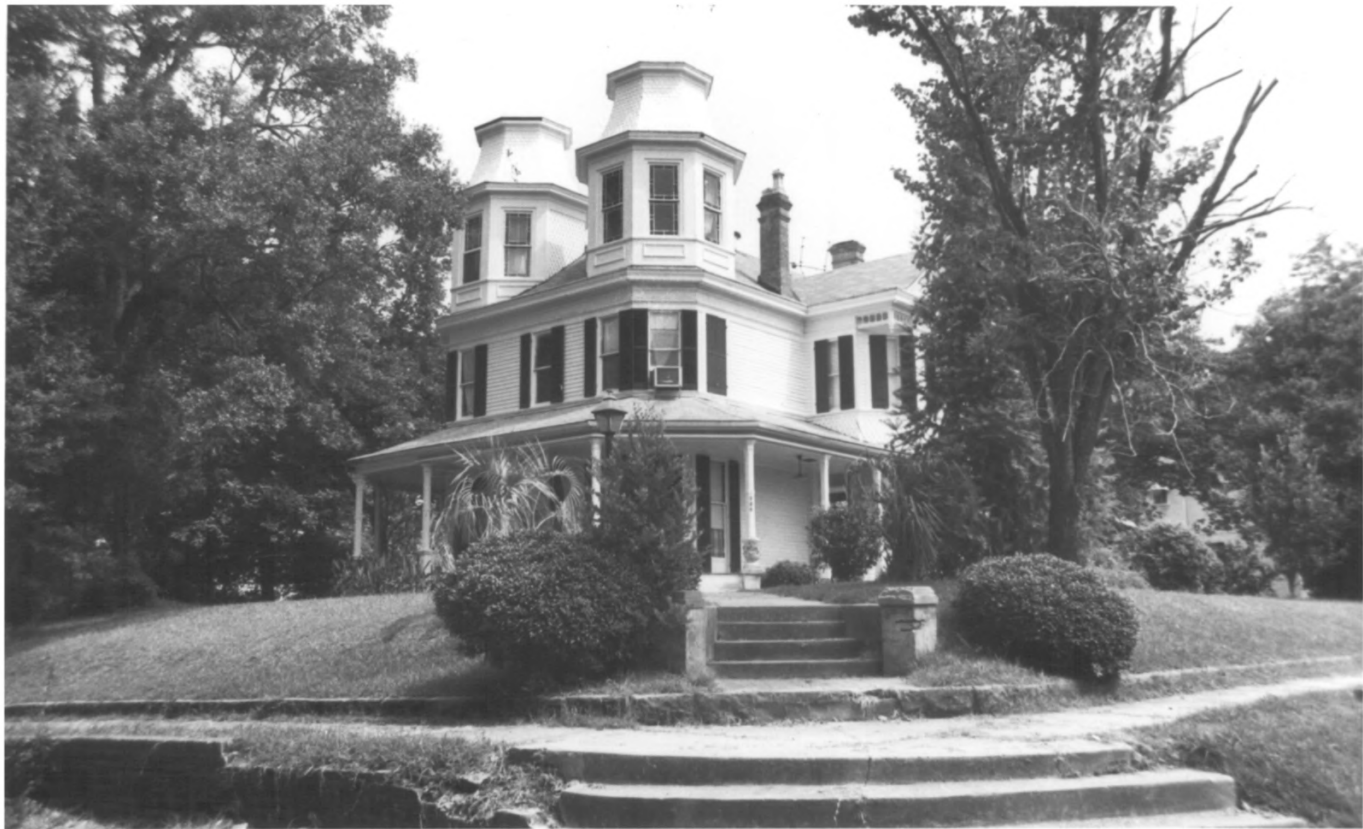
Photo 8 of 18

Looking northwesterly, the facade and western elevation of element 34 (300 Linton Avenue).

| Element #, Value (C=contributing; P=pivotal; I=intrusion; NC=noncontributing), Street # & Descriptive | | |
|---|---|---|
| 34 | P | 300 Linton Ave. Important two-story frame residence with twin octagonal turrets with mansard roofs, one-story porch that wraps around the eastern and western side elevations, chamfered posts on pedestals, stained glass, and small amount of gingerbread trim. Queen Anne. Ca. 1890. |

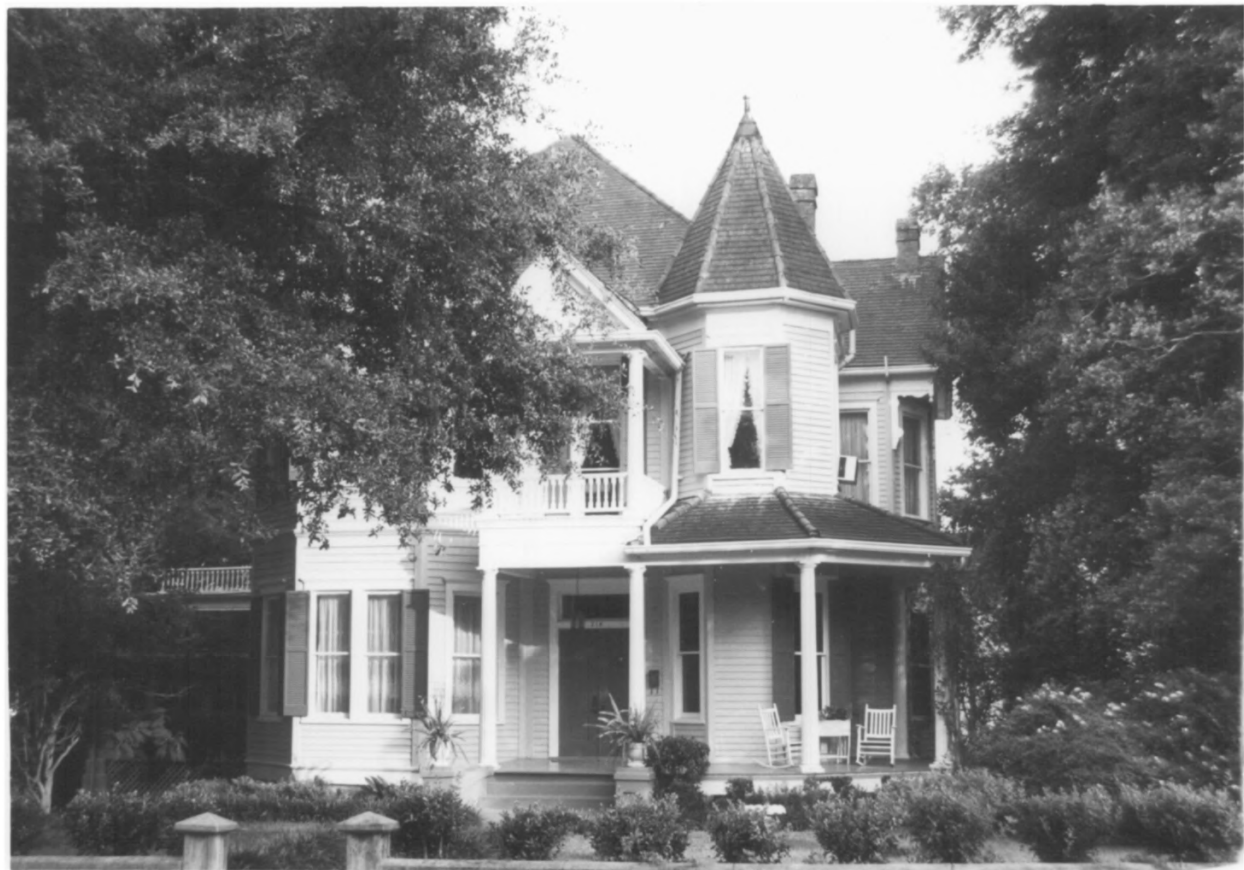
Photo 9 of 18

Looking westerly, the facade of element #43  
(214 Linton Avenue).

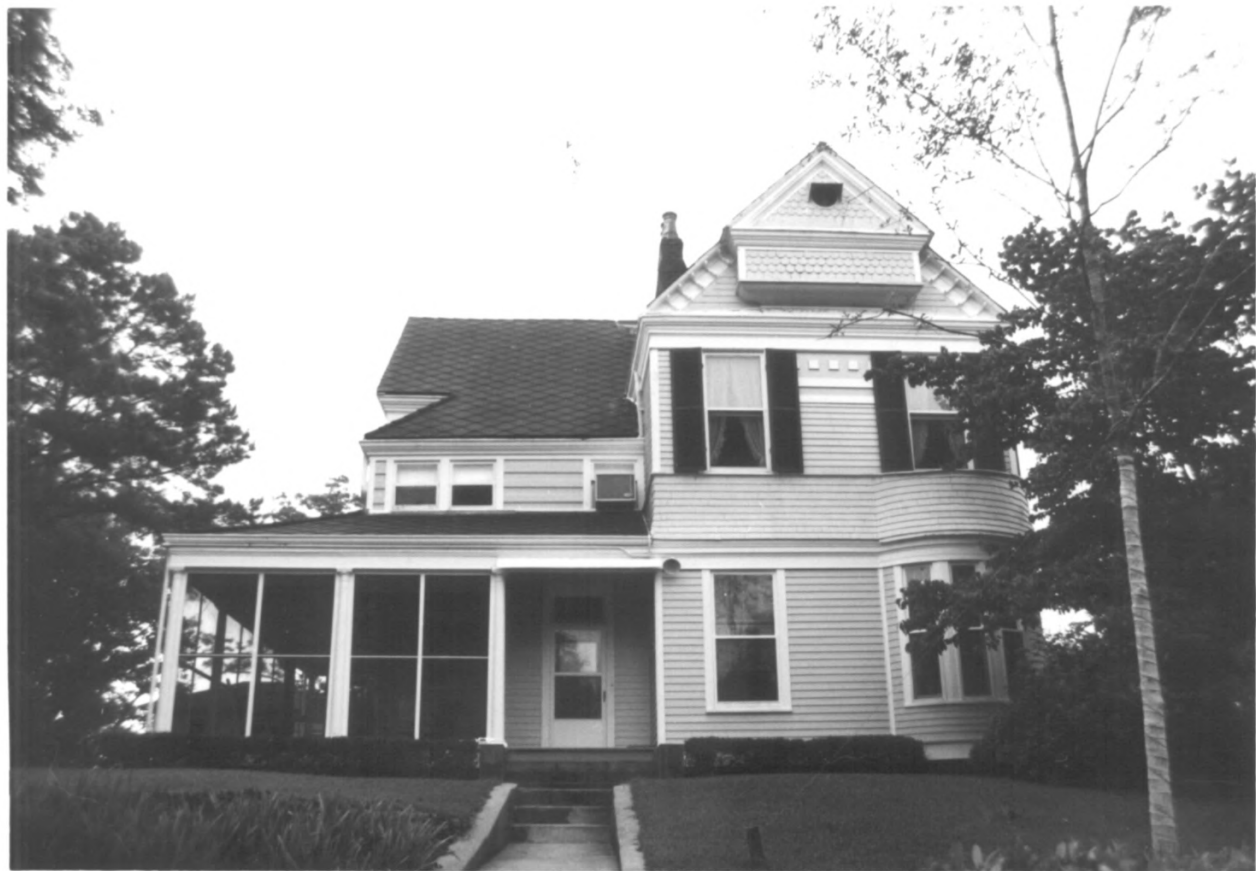
Photo 10 of 18

Looking easterly, the facade of element #38  
(219 Linton Avenue).

| Element #, Value (C=contributing; P=pivotal; I=intrusion; NC=noncontributing), Street # & Descriptive | | |
|---|---|---|
| 38 | C | 219 Linton Ave. Important two-story frame residence with gabled roof, pedimented gable end with bracketed cornice, circular one-story bay, one-story porch that wraps around the northern elevation, and turned columns. Original two-story carriage house survives. Shingle Style. Ca. 1890. |

Elements #29, #38 (see photo #10), and #40 have been described as Shingle Style in the physical description. These three buildings are not classic, high style examples of the Shingle Style as exemplified at the Brown-Donahue House, Cape Elizabeth, Maine, which features total shingle covering and a stone foundation. However, they are good representative examples of the suburban counterpart to the classic resort prototype. In A Field Guide to American Architecture by Carole Rifkind (New York: The New American Library, Inc., 1980), the author makes the following statements in regard to Shingle Style architecture:

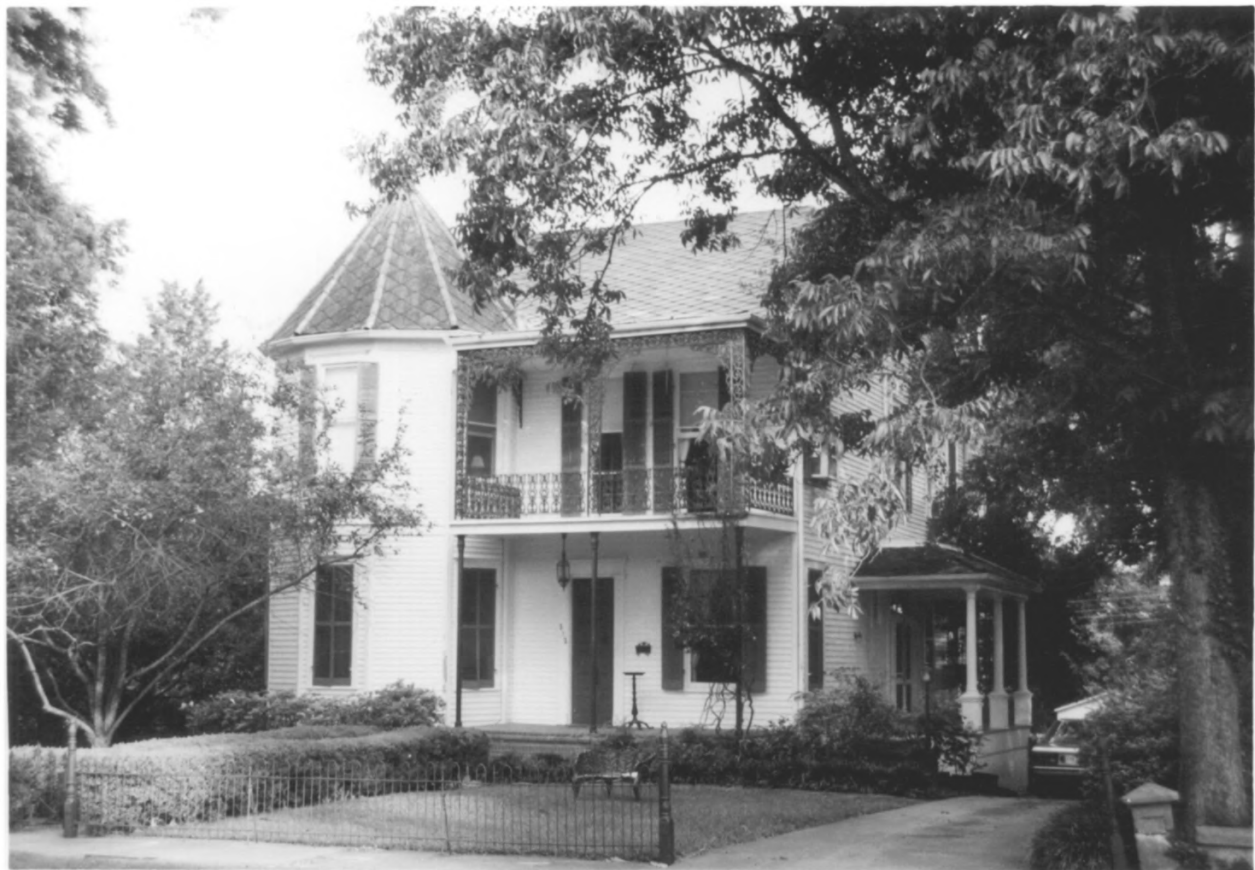
Photo 11 of 18

Looking southwesterly, the facade and  
northern elevation of element # 45 (212  
Linton Avenue).

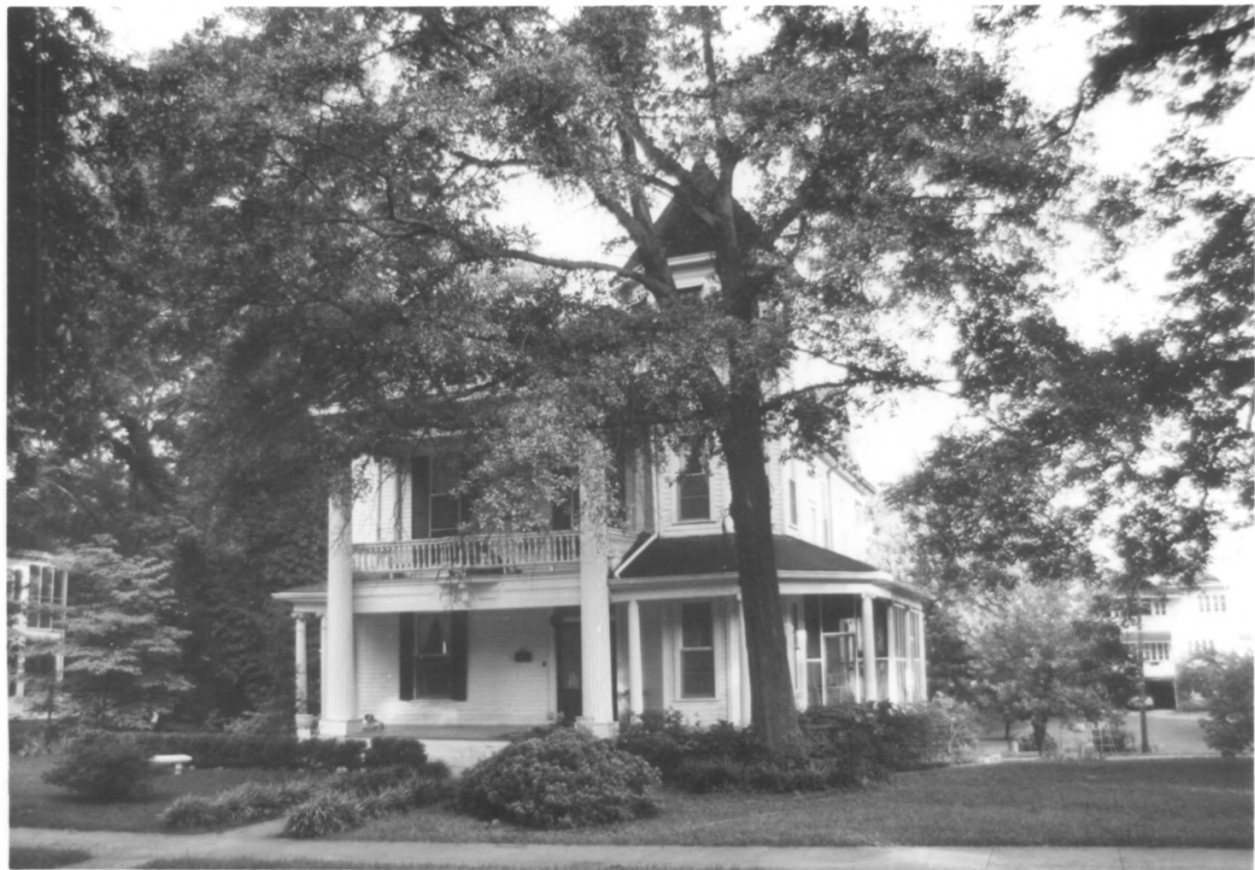
Photo 12 of 18

Looking westerly, the facade and northern elevation of element #47 (210 Linton Avenue).

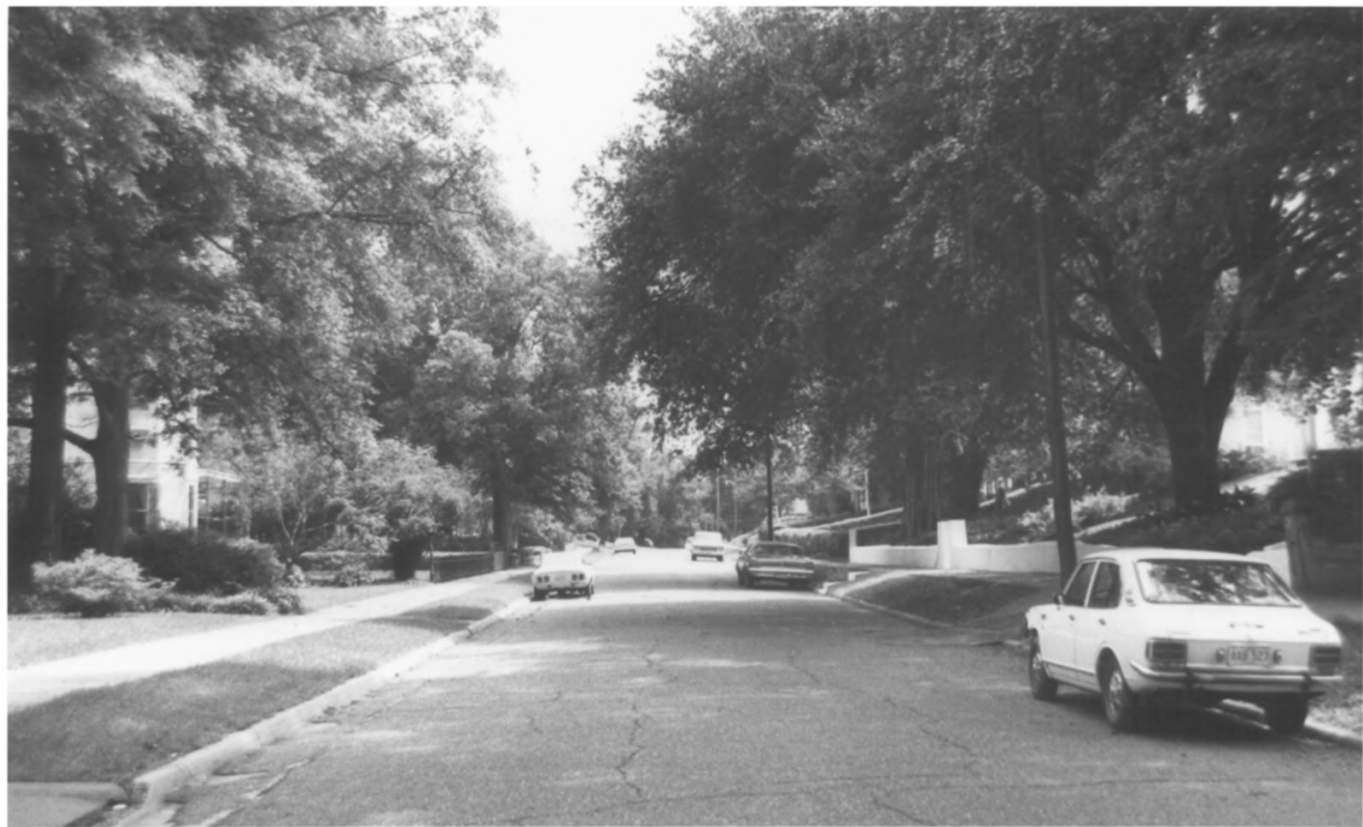
Photo 13 of 18

Looking northerly up the center of Linton  
Avenue between Mulberry Alley and Oak Street.

**STREET PLAN AND STREET PLANTING:** All the streets in the Clifton Heights Historic District are features of the subdivision of the property except for the small portion of Maple Street (formerly Cemetery Road) at the northern extremity of the district. Linton Avenue is the only major thoroughfare within the district boundaries, since Clifton Avenue, which runs parallel to the west, is no longer a through street as a result of the sluffing of the bluff. No formal street planting of trees exists along Linton or Clifton Avenue, and the streets draw most of their abundant shade from the trees located in the yards of the houses (see photo 13).

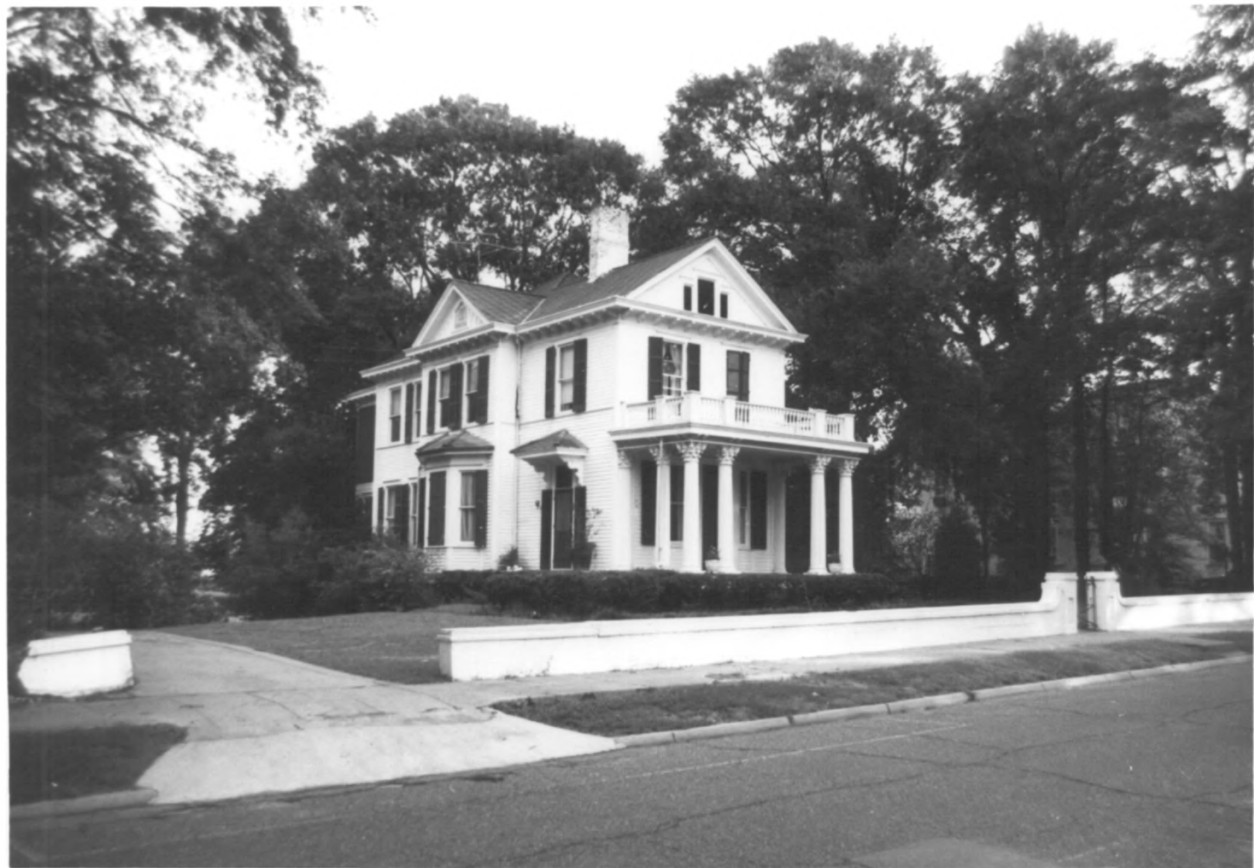
Photo 14 of 18

Looking northwesterly, the facade and  
southern elevation of element #48 (208  
Linton Avenue).

- 48 P 208 Linton Ave. Roos House Important two-story frame residence with pedimented gable-end facade, bracketed cornice, one-story porch with Corinthian columns echoed on porch roof by pedestals linked by turned balusters, entrance doorway and window hoods, leaded and stained glass, and polygonal bay on southern elevation. National Register. Colonial Revival. 1904-10.

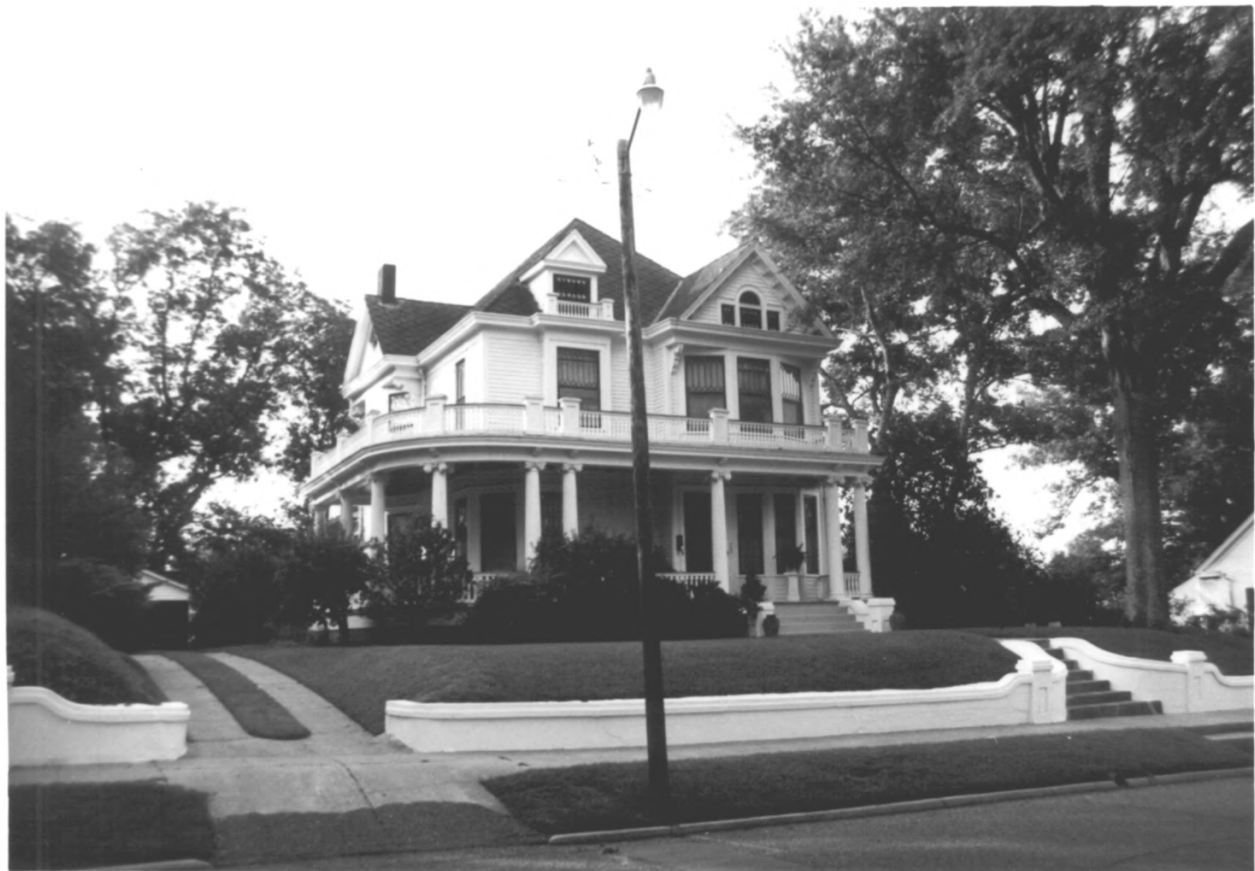
Photo 15 of 18

Looking easterly, the facade and northern elevation of element #49 (207 Linton Avenue).

- 49 C 207 Linton Ave. Important two-story frame residence with hipped roof, gabled dormer, gabled bay projection, fluted Ionic columns echoed on porch roof by pedestals, one-story porch that wraps around the northern side elevation, turned balusters, Palladian window, gabled polygonal bay on northern side elevation, gabled polygonal bay on southern side elevation, and leaded and stained glass. Colonial Revival. 1904-10.

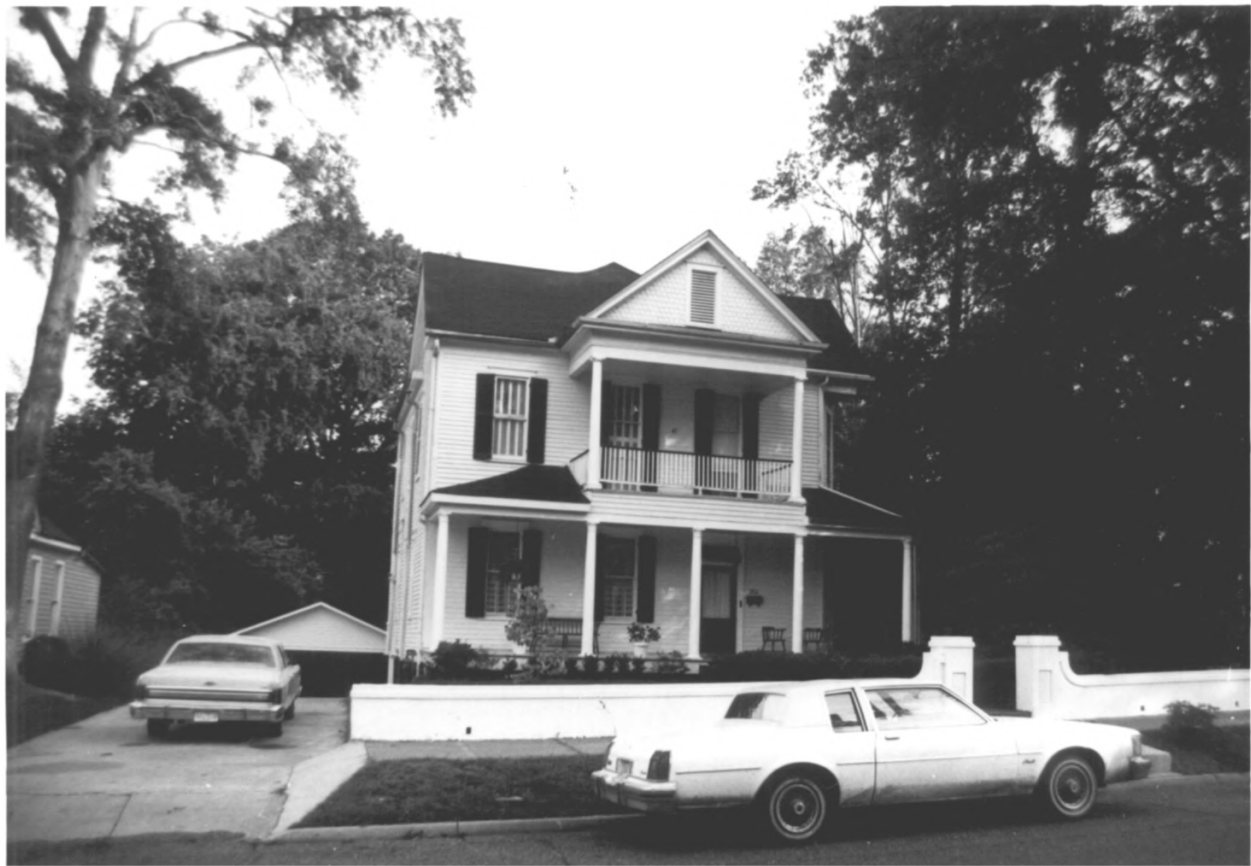
Photo 16 of 18

Looking westerly, the facade of element #50  
(206 Linton Avenue).

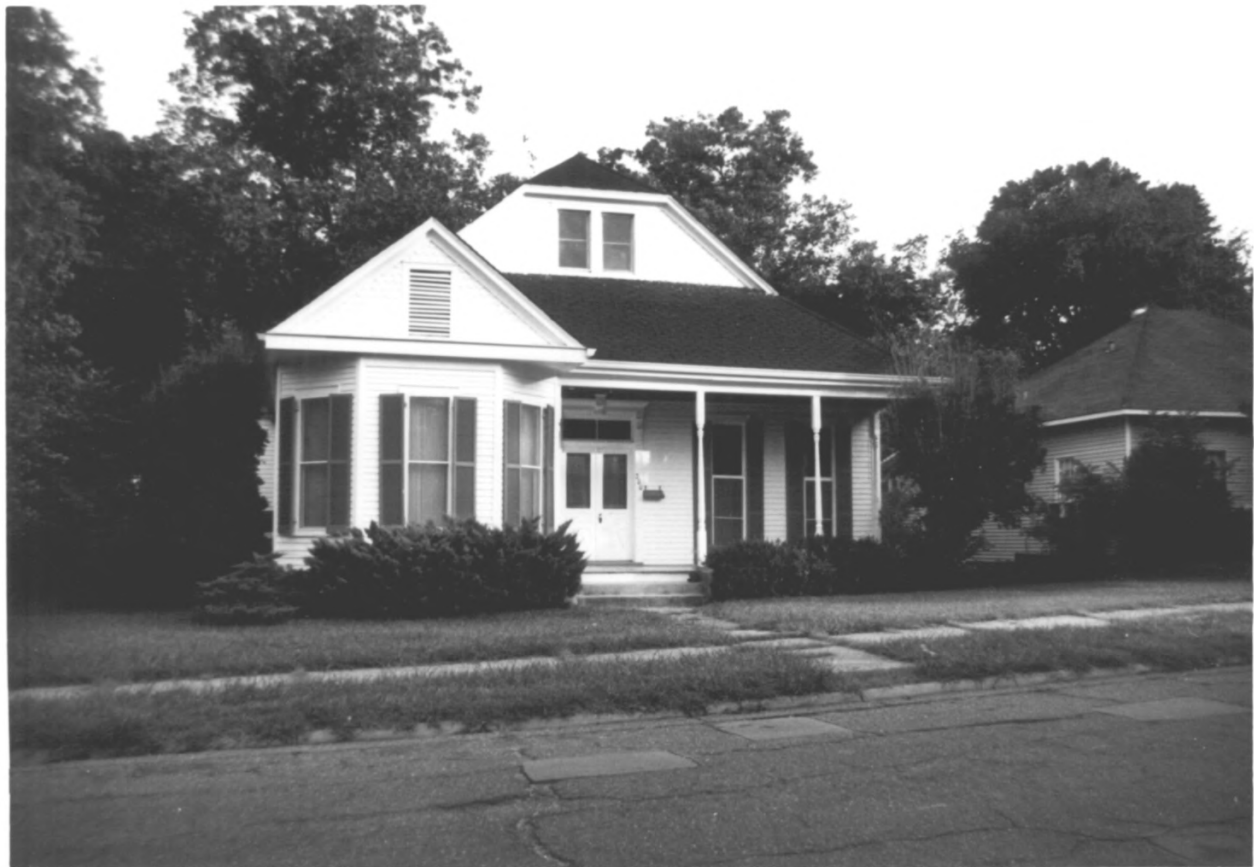
Photo 17 of 18

Looking westerly, the facade of element #56  
(200 Linton Avenue).

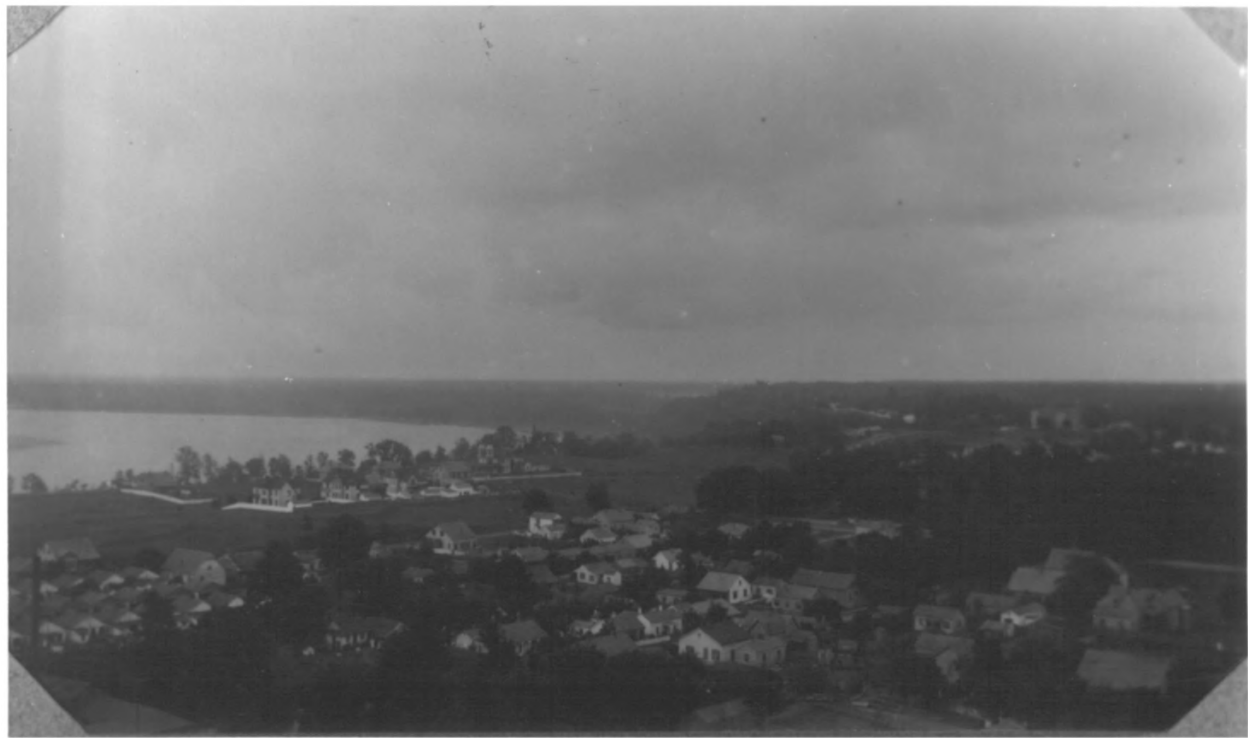
1893-1897 view of the Clifton Heights District running adjacent to the river as seen from the top of a water tower at the corner of N. Union and Monroe Streets. Pivotal element #34 (300 Linton Ave.) is clearly visible at the right edge of the district.
