NATIONAL REGISTER OF HISTORIC PLACES  
REGISTRATION FORM

historic name:  
other names/site number: Greenville Downtown Historic District

**Section**        7            **Page**            2            **Greenville Downtown Historic District**  
**Greenville, Washington County, MS**

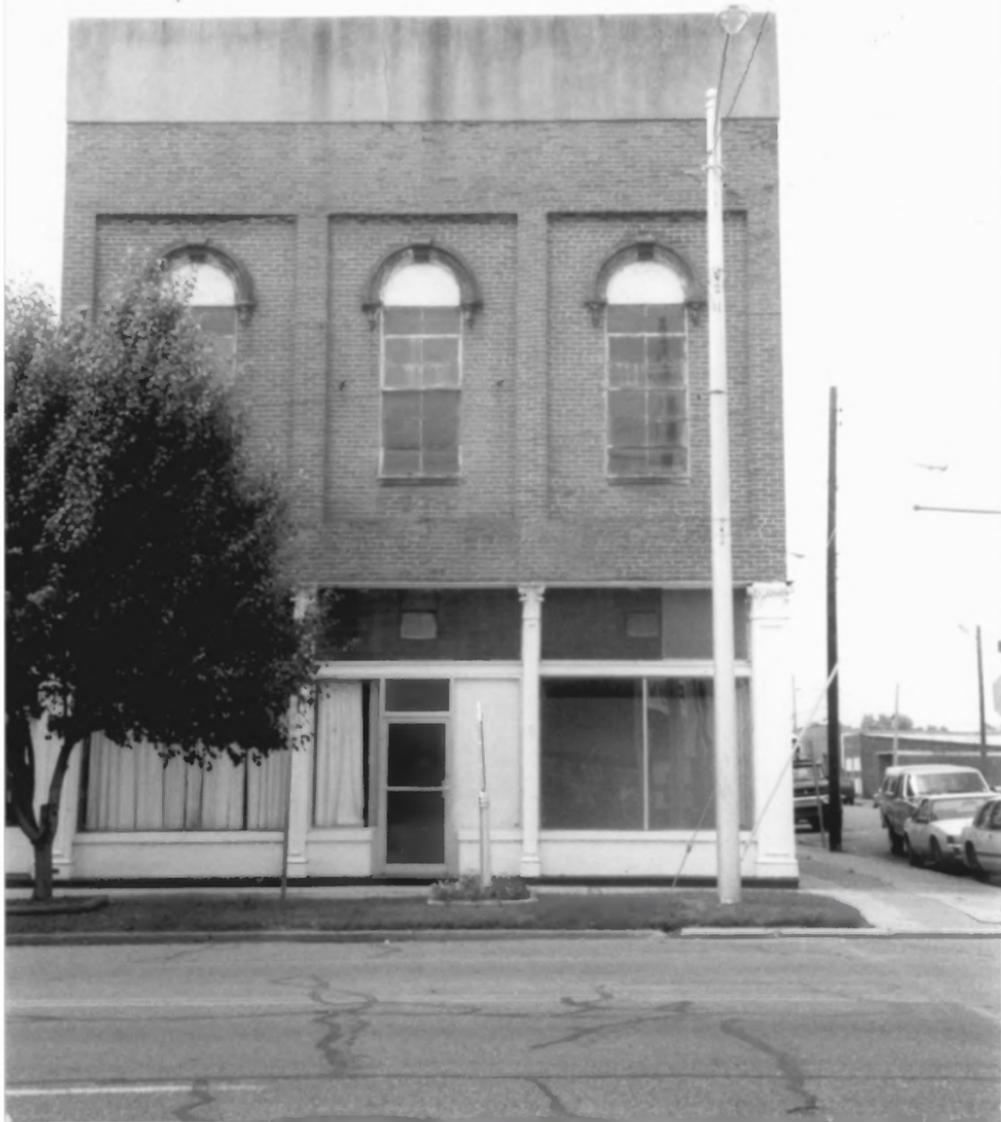
Photo #1 of 24

The Delta Democrat Times Building is a brick, three-bay, two-story Italianate commercial building topped with a flat roof. The upper facade features three arched six-over-six double-hung windows with cast-iron decorative corbelling and set into recessed brick panels. The windows are replacements; however, they fit nicely into the historic frames. The transoms have been covered with plywood. The storefront is divided into three bays by four, paneled, cast-iron columns. A slightly recessed doorway is flanked by large all-glass showcase windows. The doorway is divided by an all-glass door flanked by all-glass windows. The transoms have been altered and currently feature glass blocks. The top of the building might have originally featured a pressed tin cornice that was removed and replaced with stucco. (PHOTO # 1)

Northern Facade, view to the south

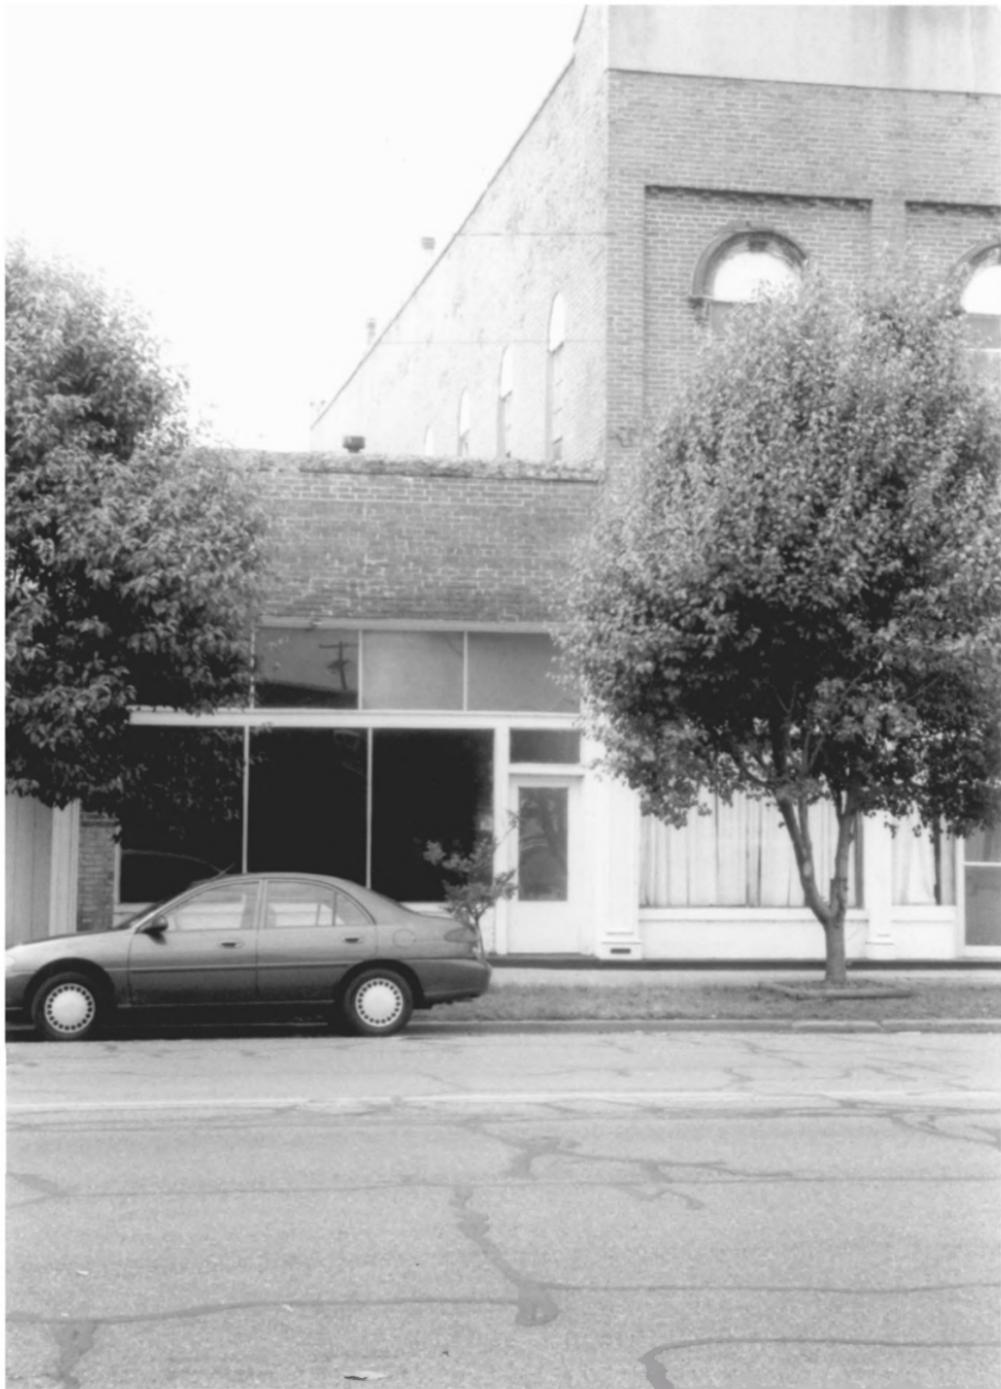
North Facade, view to south  
Photo #2 of 24

This is a one-story, three-bay commercial building topped with a flat roof. The facade is marked by its asymmetrical storefront that features two large all-glass showcase windows and a one-light-and-panel door. A transom runs across all three bays and the building is topped with a name plate. (PHOTO #2)

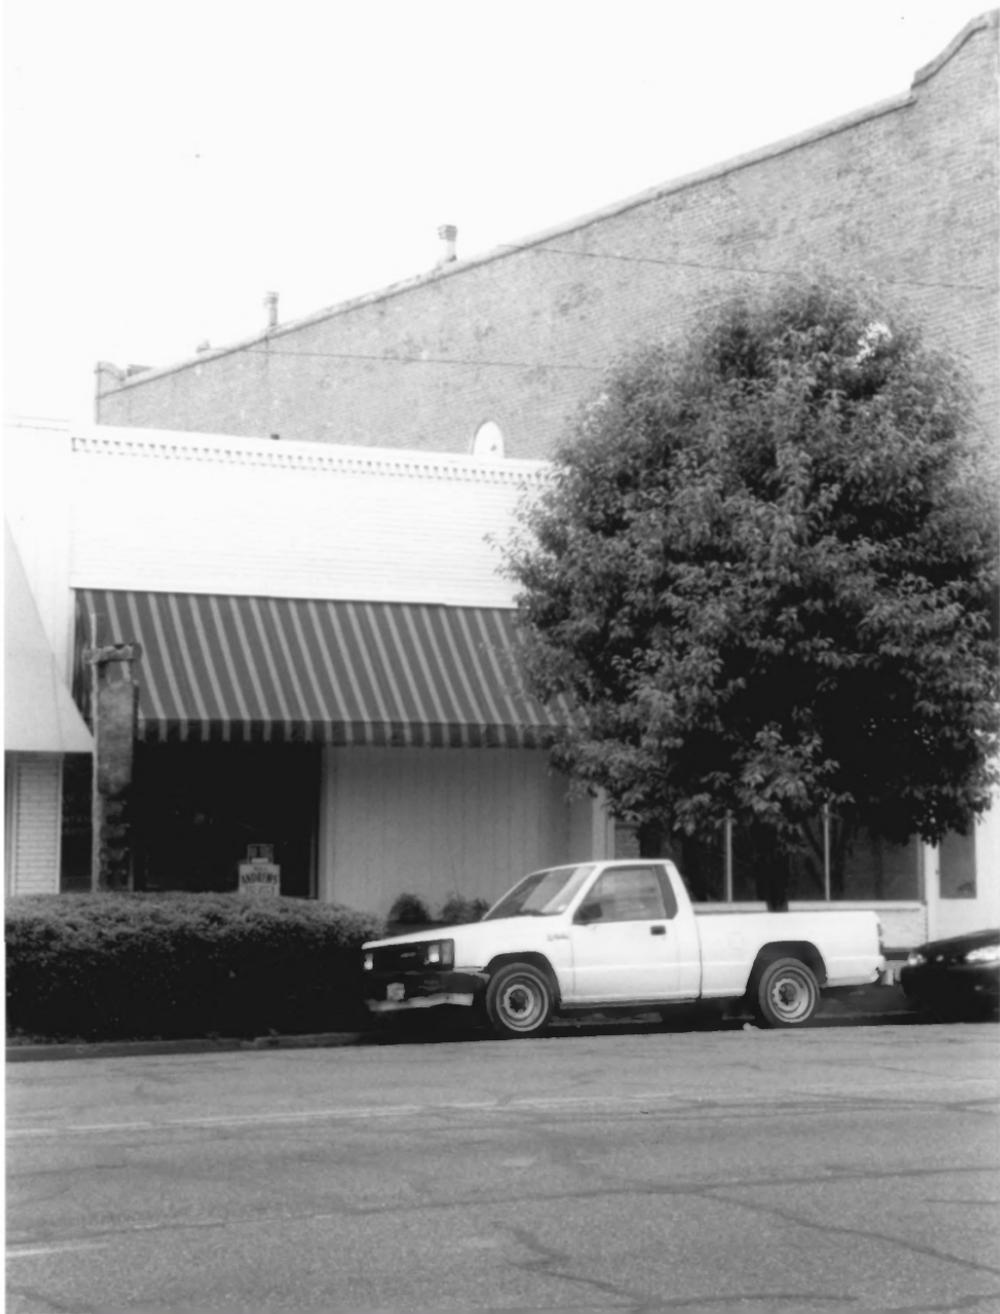
Photo #3 of 24

This is a brick, one-story, flat-roof commercial building. The lower level of the building has been covered with plywood siding. The building lacks ornamentation except for a row of brick dentils that top the building. The entrance is marked by an asymmetrical all-glass door flanked by all-glass tinted windows. (PHOTO #3)

North Facade, view to south

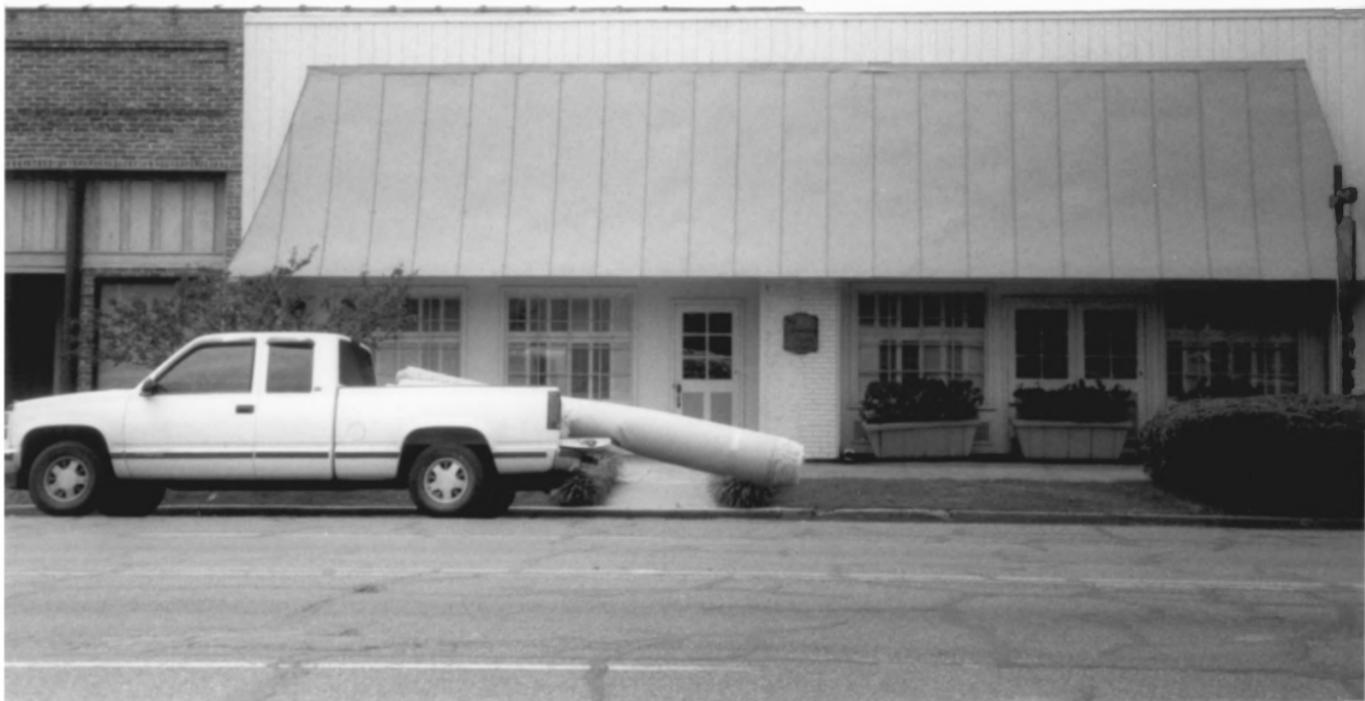
Photo # 4 of 24

This is a one-story, flat-roof, brick commercial building. This was historically two buildings that were unified with the 1980s alteration. The building currently reads as one structure with two storefronts. The building reads from east to west window, window, door, window, double door, and window. All windows are twelve-light in wooden frames with decorative panels. The doors are six-light-and-two-panel configurations. An aluminum mansard roof tops all six bays. (PHOTO #4)

North Facade, view to South

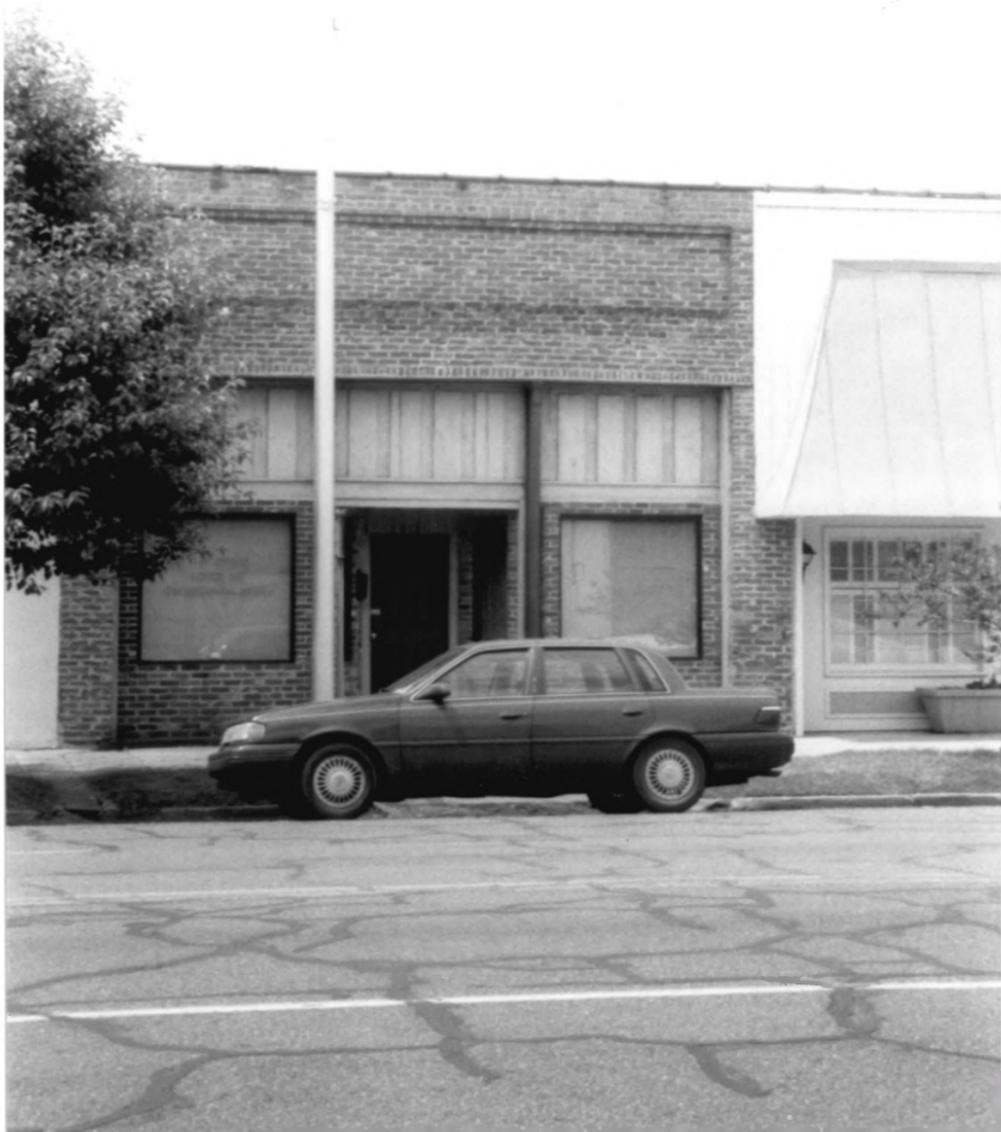
Photo #5 of 24

This is a one-story, flat-roof, brick commercial building. The entrance is slightly recessed with all-glass windows on either end. The transoms have been enclosed with paneled plywood. A brick name plate tops the building. The only historic elements that remains are two cast-iron columns that flank the entrance. (PHOTO #5)

North Facade, view to south

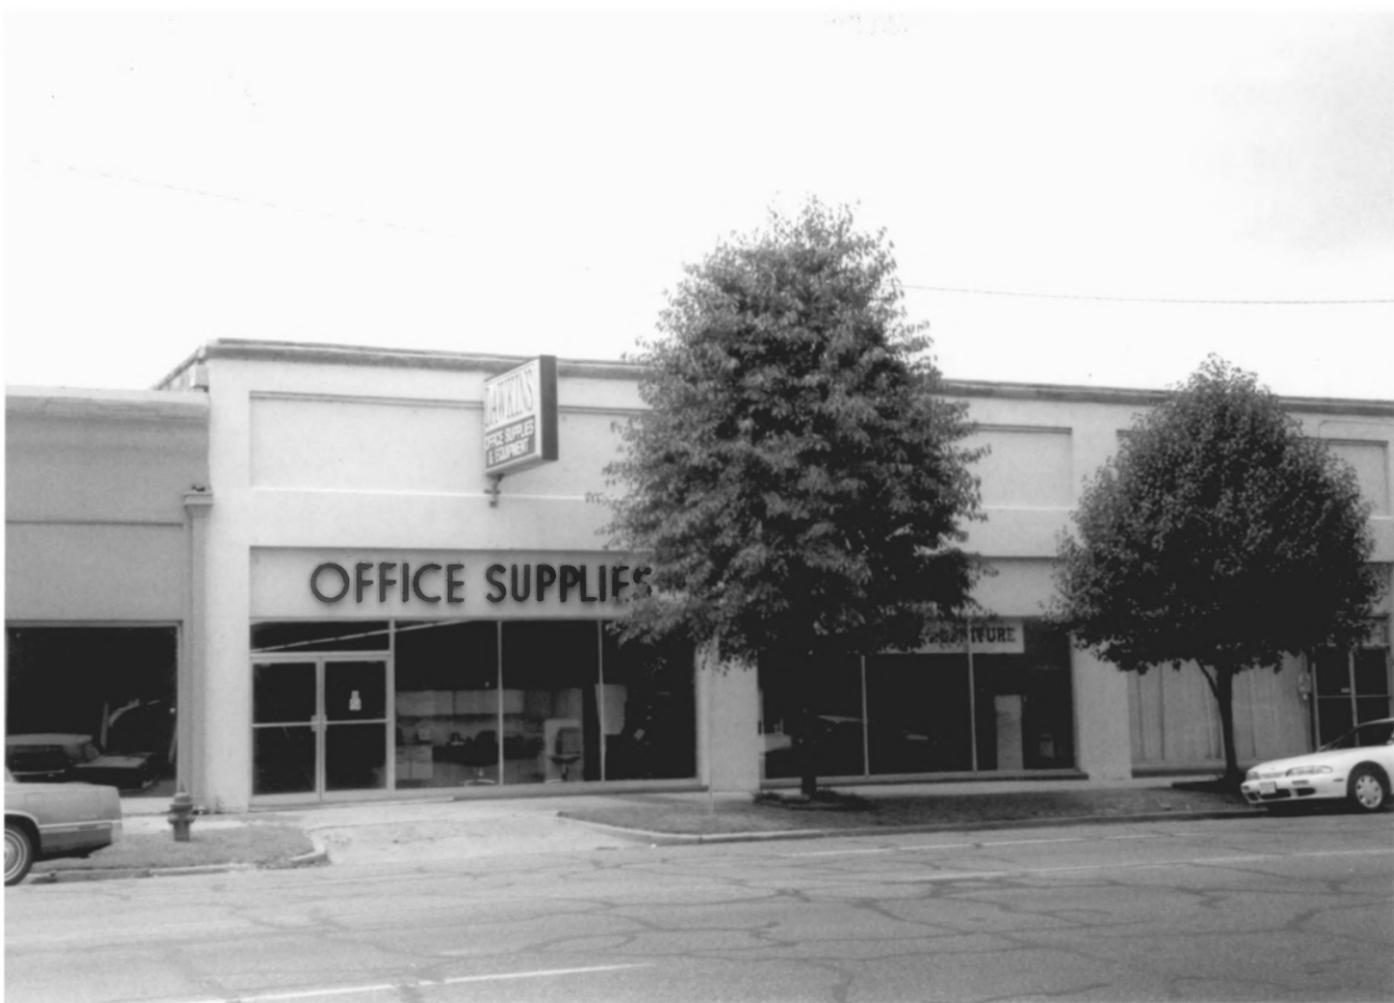
Photo #6 of 24

This is a triple-lot, one-story, flat-roof, brick and stucco commercial building. The building is divided into three storefronts. The storefronts are marked with a centrally located plate-glass showcase window and two outer entrances with all-glass doors. All transoms have been stucco over and the building currently features prominent name plates. (PHOTO #6)

North Facade, view to south

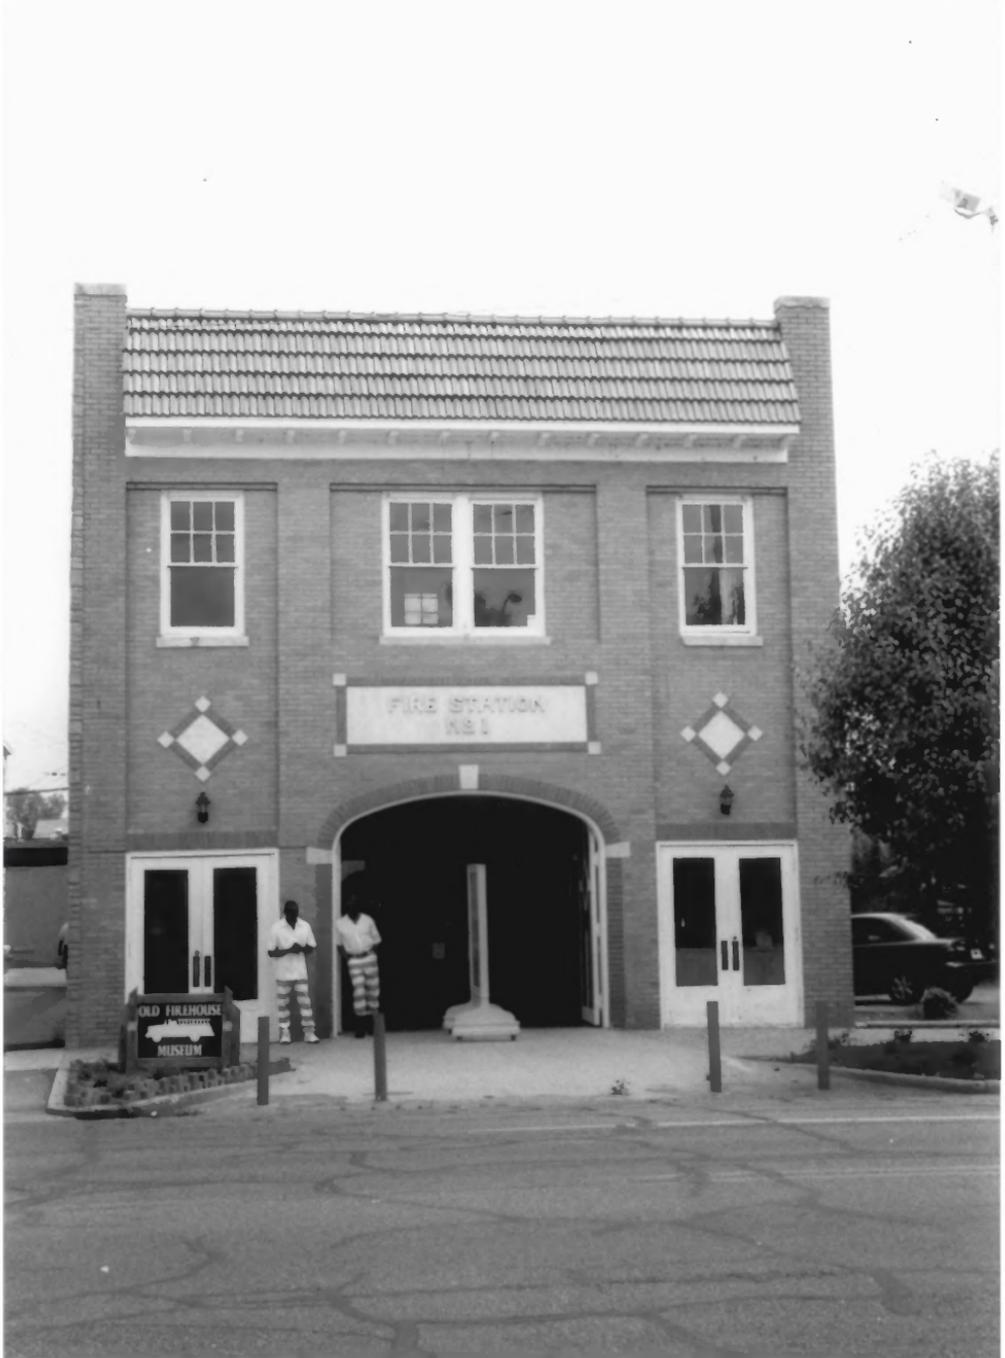
South facade, view to north  
Photo #7 of 24

Fire Station #2 is a two-story, three-bay, stepped-roof, brick commercial building with a falsefront. The facade is marked by its three bays and projecting tile pent roof and parapets. The building is sub-divided with geometrical forms as brick panels are created through slightly recessed portions of the facade. The first story has a basket-arched door with decorative wooden doors highlighted by diamond-shaped windows that include pressed-concrete keystones and imposts. This door is flanked by paired single-light-and-panel doors. Above the first story are decorative diamond-shaped, pressed-concrete medallions that flank the nameplate. The second story is marked by paired six-over-one double-hung windows with flanking single six-over-one double-hung sash windows. (PHOTO #7)

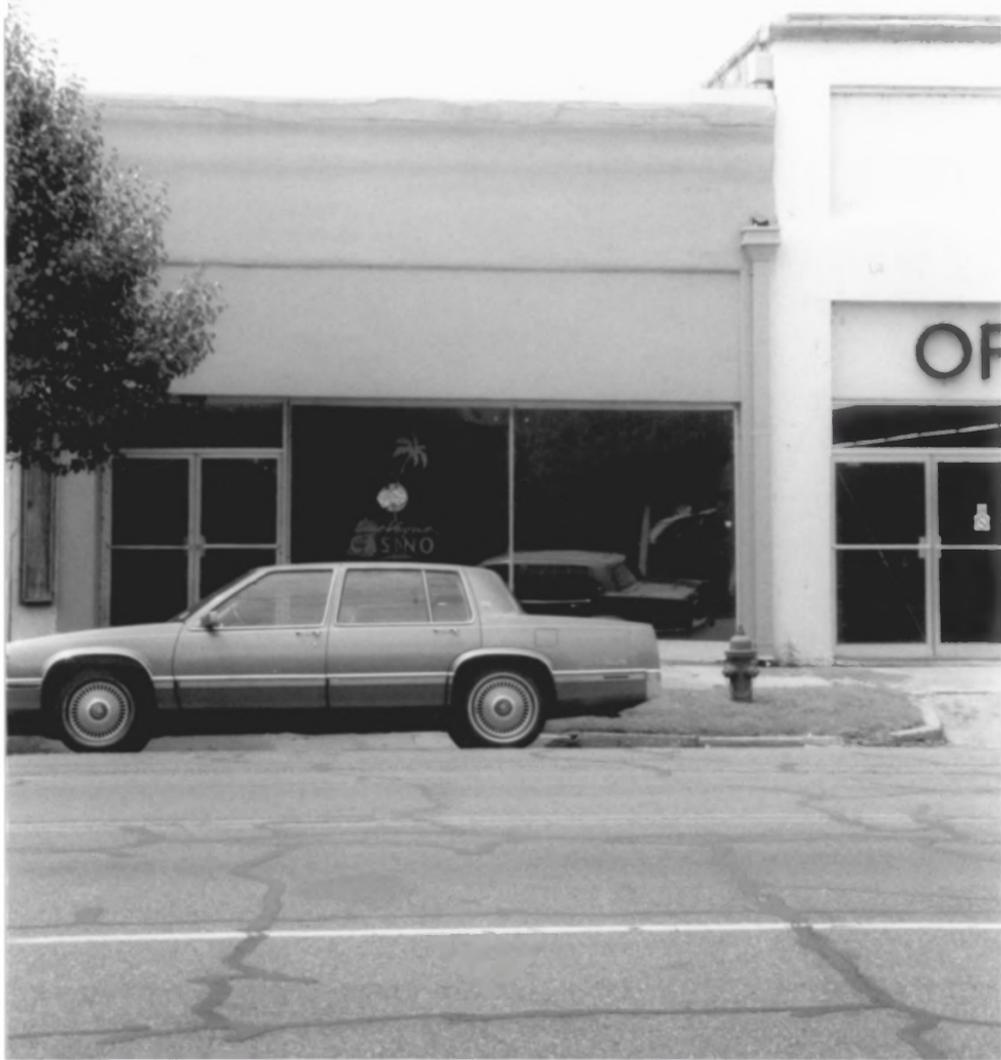
North Facade, view to south  
Photo #8 of 24

This is a one-story, flat-roof, brick commercial building that has been sheathed in stucco. The stucco has obscured any historic ornamentation and covered the transoms. Currently the storefront is marked by paired all-glass doors with plate-glass transom and two double-width plate-glass showcase windows all set into aluminum frames. (PHOTO #8)

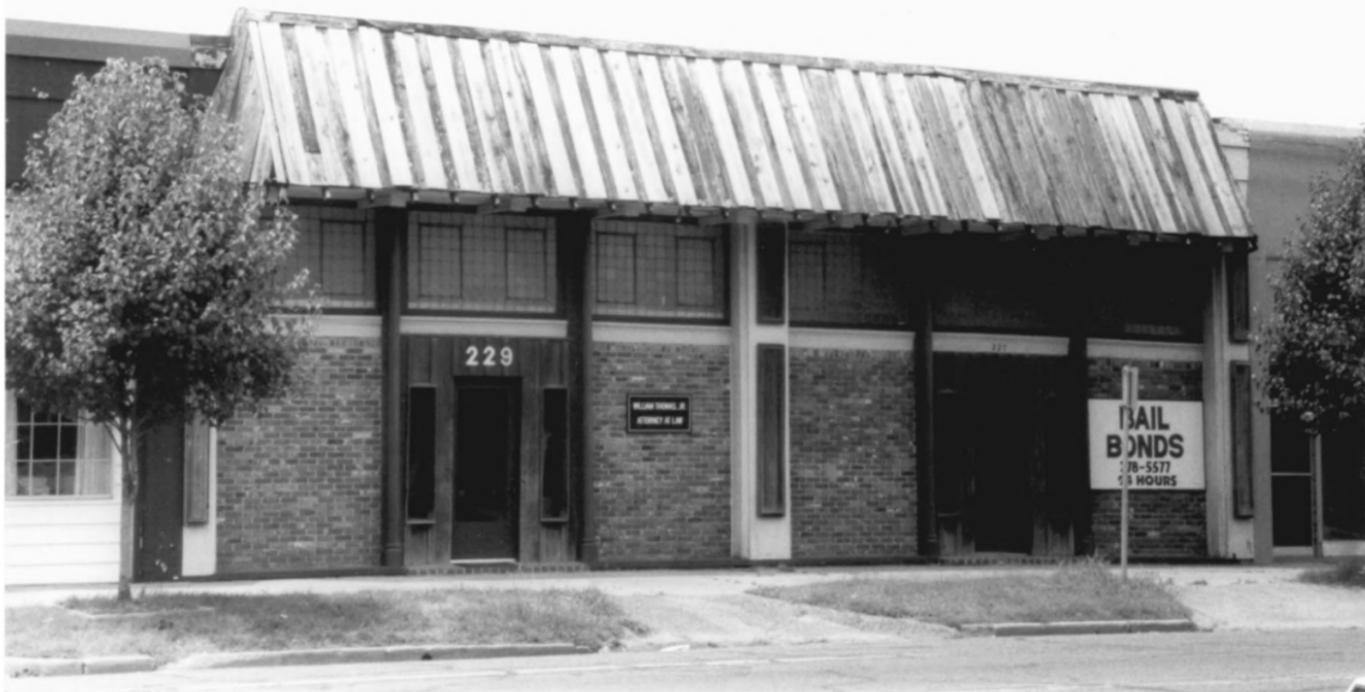
Photo #9 of 24

This is an one-story, flat-roof, brick building. Although the building is shown as two single-lot commercial buildings on the 1911 Sanborn Map by 1931 the interior wall had been cut through therefore historically adjoining the two storefronts. The 1970 modification greatly altered the original building. The massing of the storefront is a historic composition; however, modern materials have obscured any original features. The storefront currently consists of two all-glass doors with one-light sidelights set into wooden frames. The showcase windows have been covered with a modern brick veneer and the transoms have replaced glass-block windows. A wooden falsefront mansard roof currently tops the building. However, the building still retains its historic cast-iron columns and panels. (PHOTO #9)

North Facade, view to south

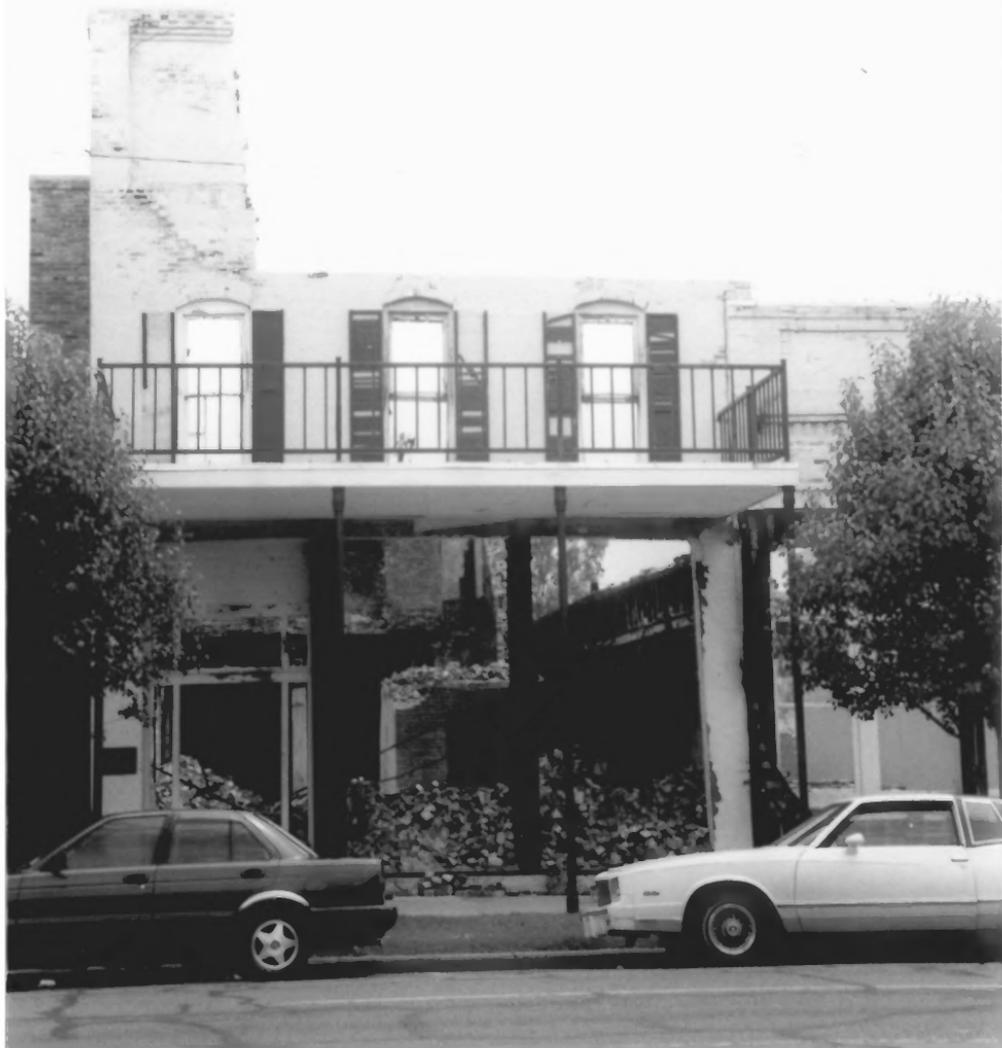
South facade, view to north  
Photo #10 of 24

This is a two-story, three-bay commercial building topped with a flat roof. The building was gutted by fire in July 1996 and currently the facade is falling-in. The first story still remains intact; however, the historic configuration has been altered with modern materials that compromises the storefront but does not destroy is visual elements. The facade has a wooden all-panel door with single-light sidelights and transom flanked by cast-iron columns followed by plate-glass showcase windows. The second story has three bays of round-arched replacement six-over-six double-hung sash windows that have wooden shutters. A cast-iron balcony also runs across the building. (PHOTO #10)

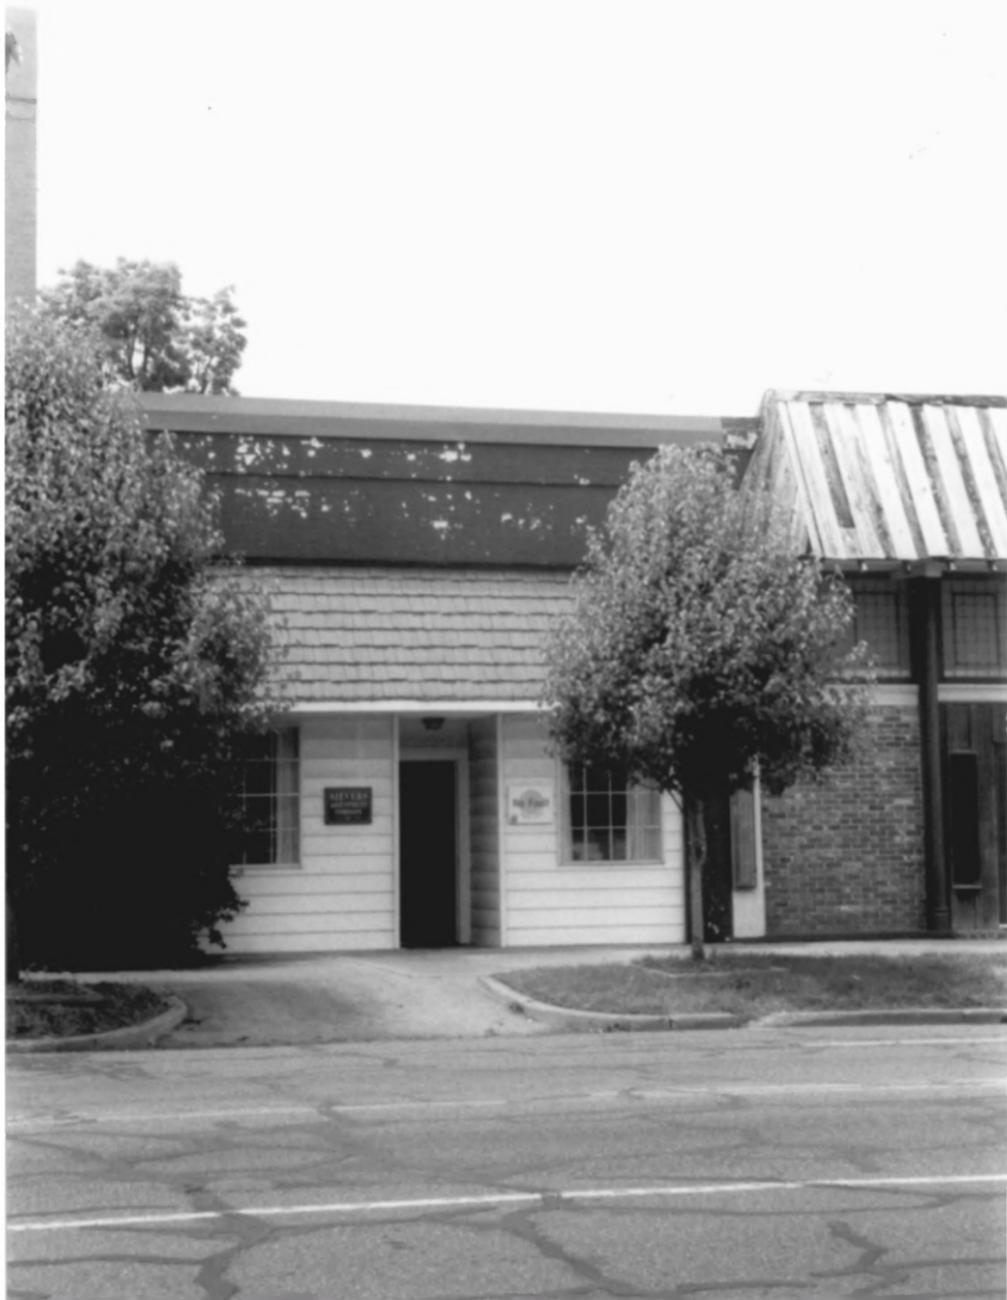
Photo #11 of 24

This one-story, three-bay, brick commercial building that is topped with a flat roof. The storefront has been remodeled and retains none of its historic composition. Currently a recessed six-panel wooden door is flanked by two twenty-light fixed-sash windows all set into a slightly projecting weatherboard falsefront. This falsefront is topped with a projecting mansard roof with aluminum shingles. The upper level of the building is topped with brick. (PHOTO #11)

North Facade, view to South

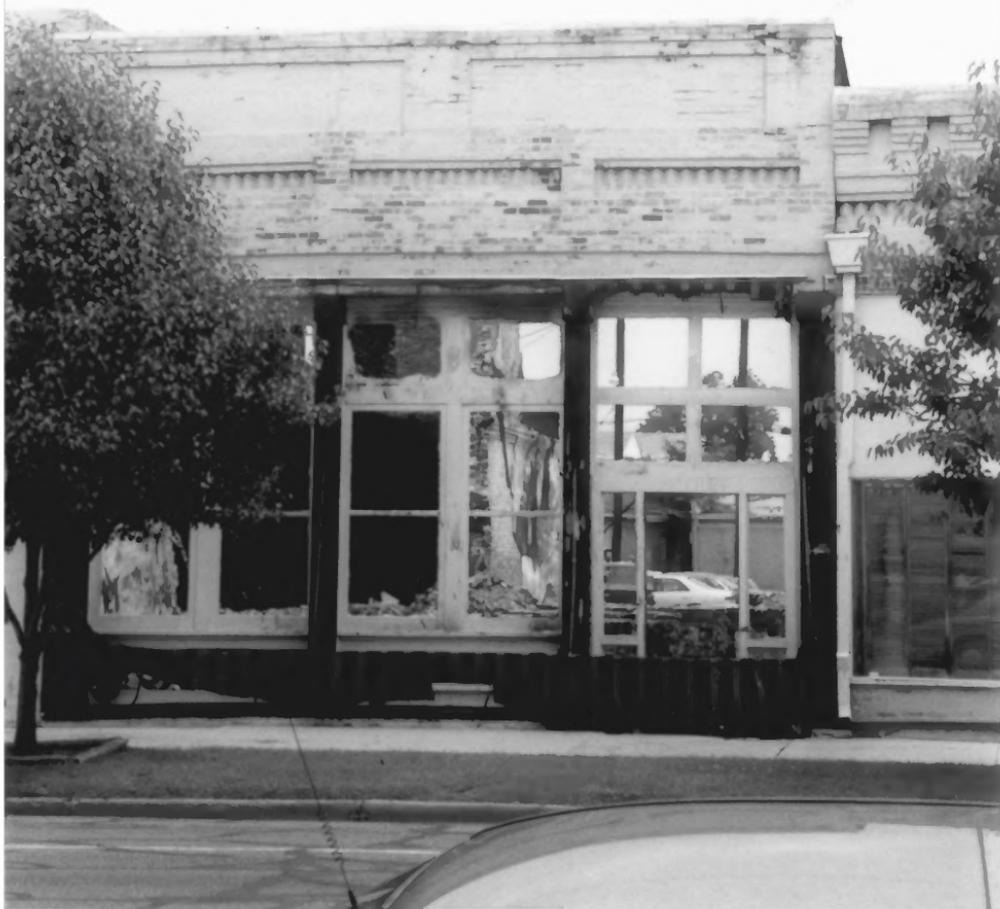
Photo #12 of 24

This is a one-story, three-bay commercial building that rests on a brick foundation and is topped with a flat roof. The building was gutted by fire in July 1996. The storefront has been remodeled with the placement of an asymmetrical all-panel door flanked by two single-light sidelights and transom. Two paired windows set into wooden frames comprise the other two bays. Paneled cast-iron columns divide the storefront into three sections. The building is topped with brick dentils, and two slightly recessed name plates that stand next to one another. (PHOTO #12)

South facade, view to north

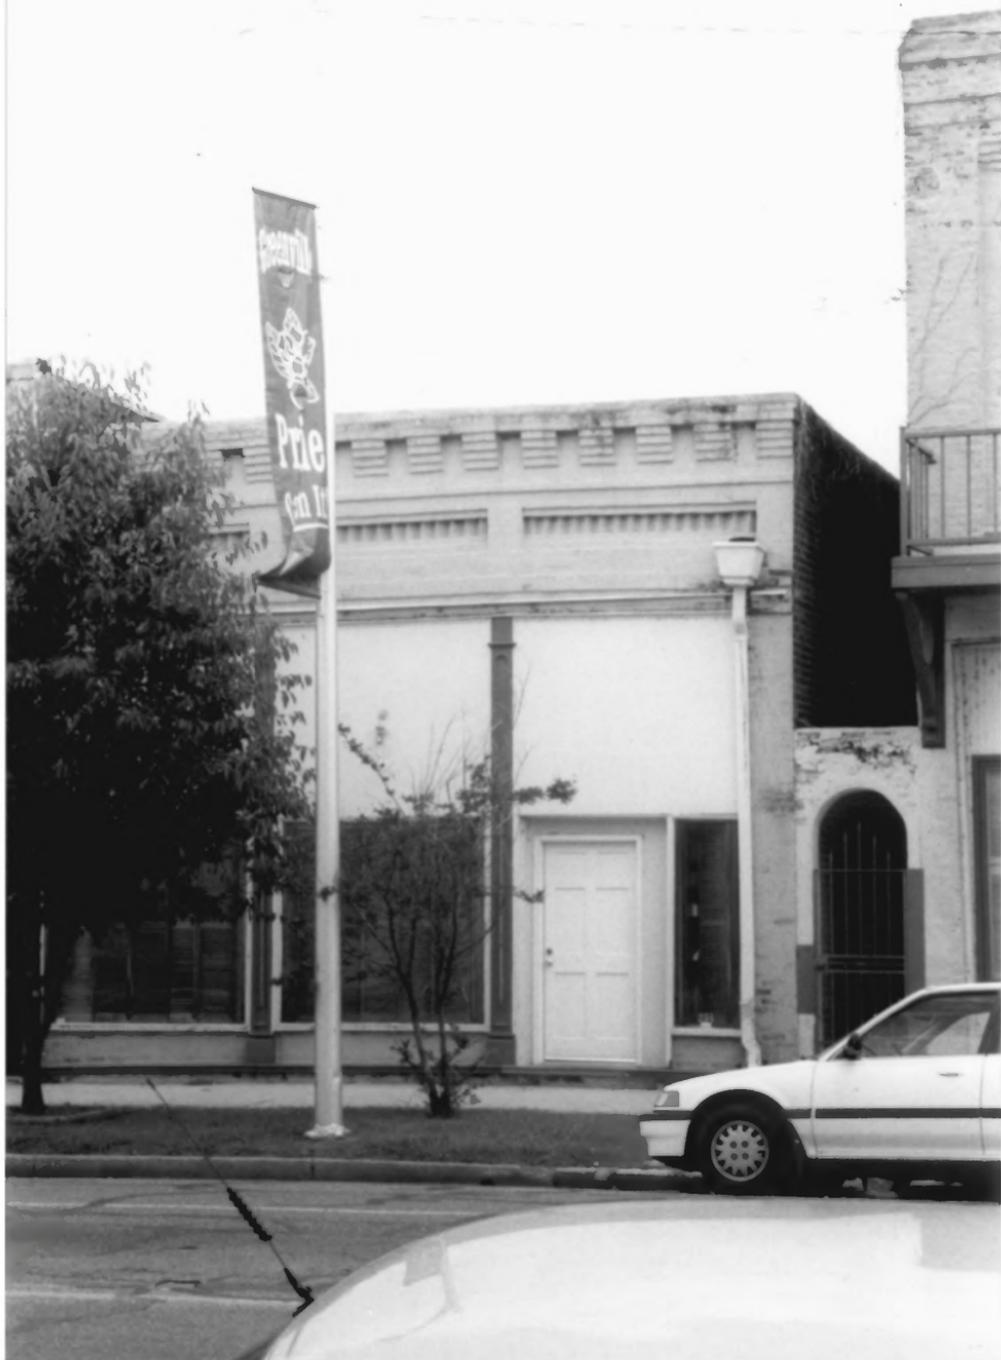
Photo #13 of 24

This is one-story, three-bay commercial building that rests on a brick foundation and is topped with a flat roof. The storefront has been altered but is still clearly divided by its original cast-iron columns. All the transoms have been enclosed and the windows have been changed. There are currently two plate-glass showcase windows followed by a six-panel door and a small plate-glass window. The building is topped with a decorative brick band of dentils and corbelling set into slightly recessed brick divisions. Attached to this building is a round-arched, cast-iron alley door. (PHOTO #13)

South facade, view to ~~the~~ south

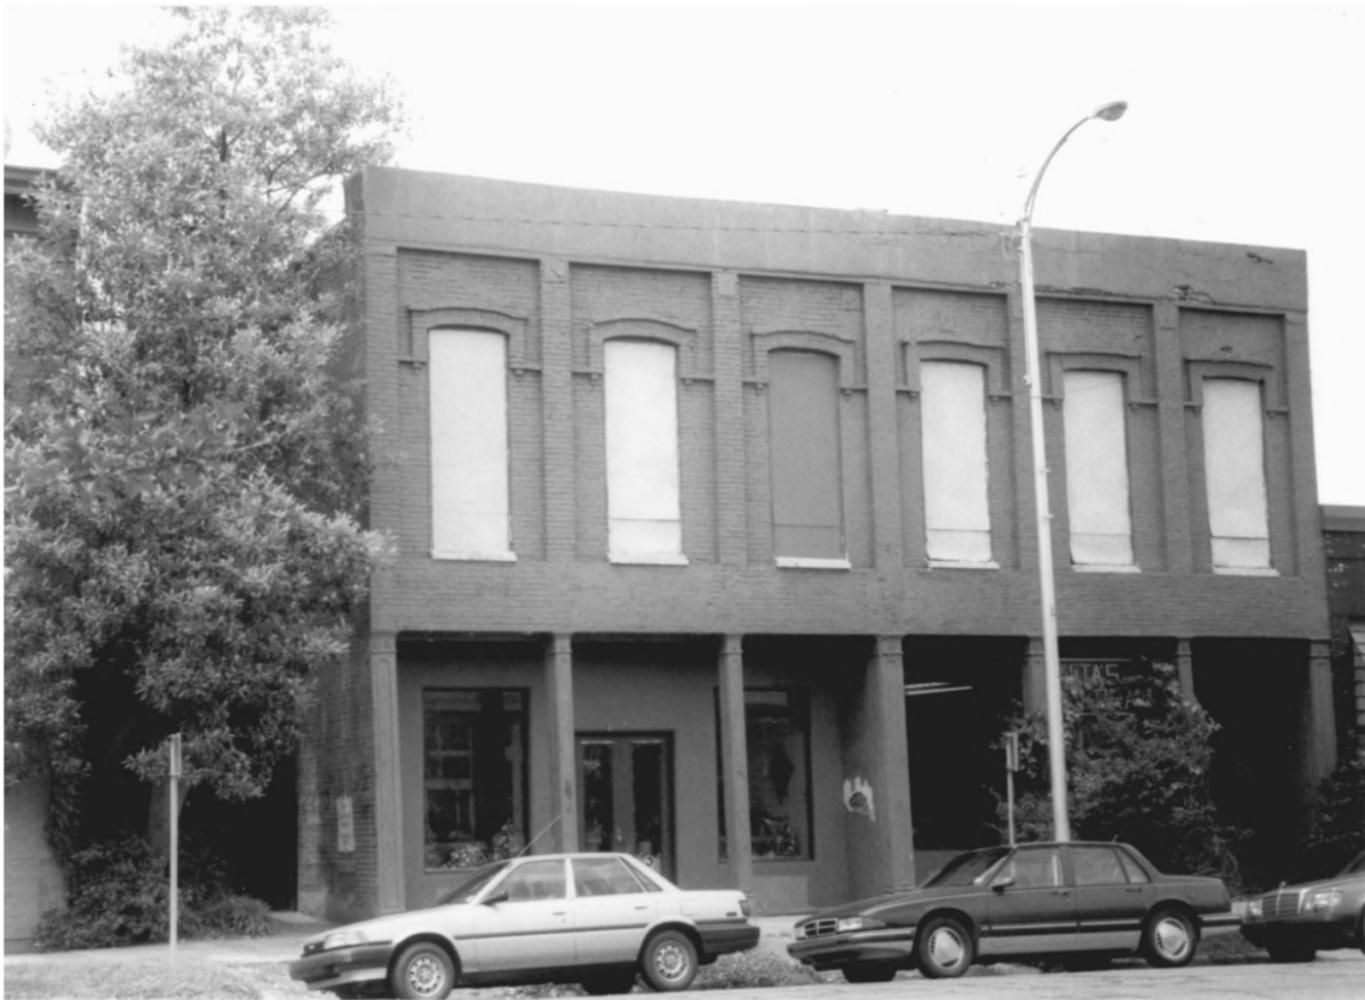
Photo # 14 of 24

236 Main Street

South facade, view to ~~south~~

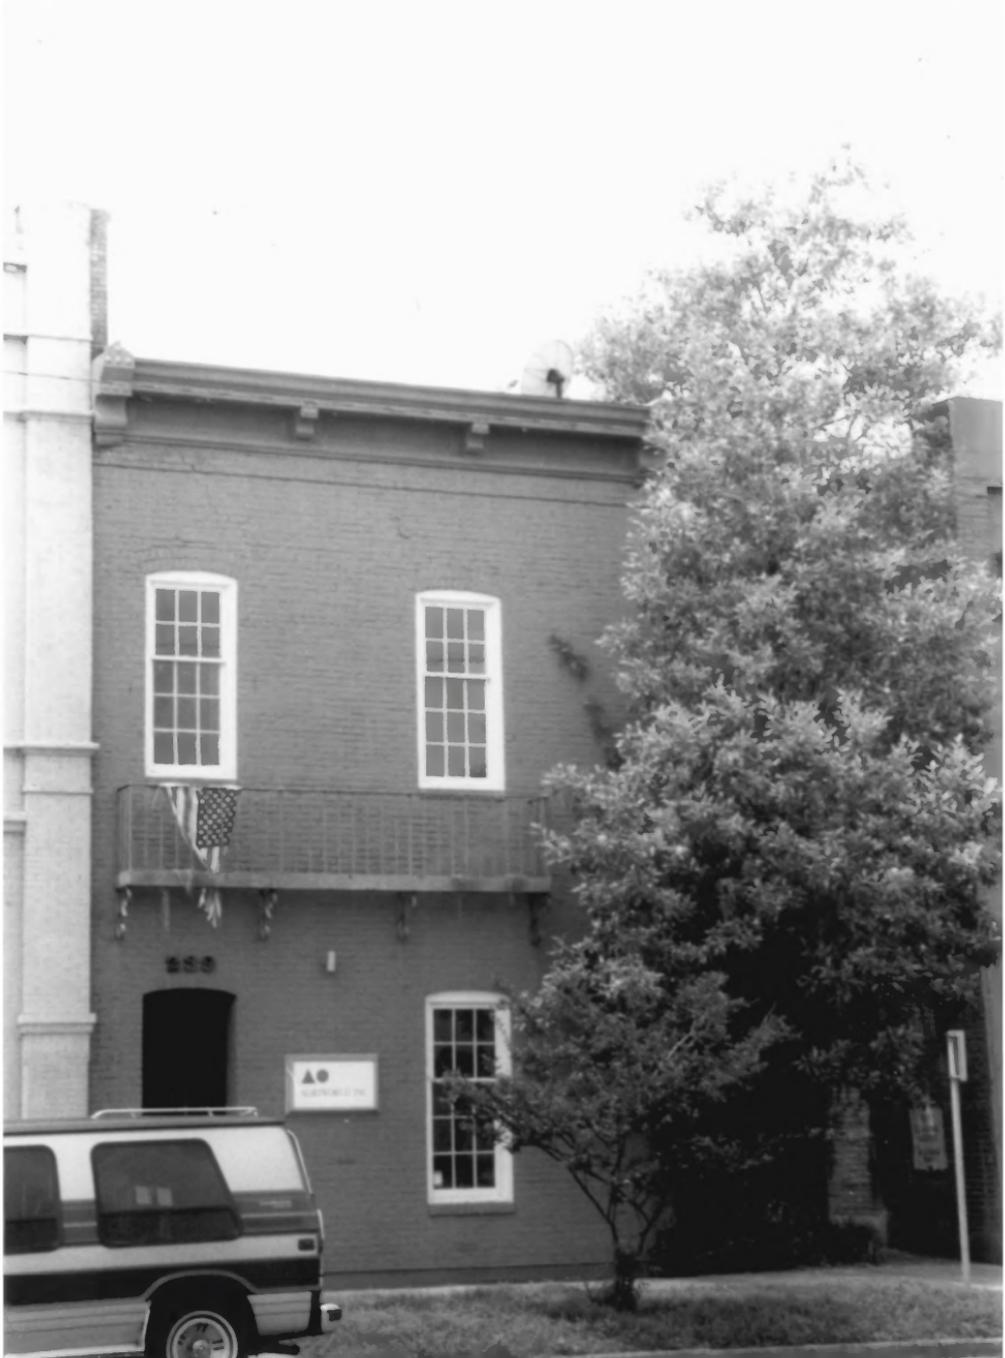
North Facade, view to South  
Photo #15 of 24

Greenville Downtown Historic District  
Greenville, Washington Co., MS  
237 Main Street

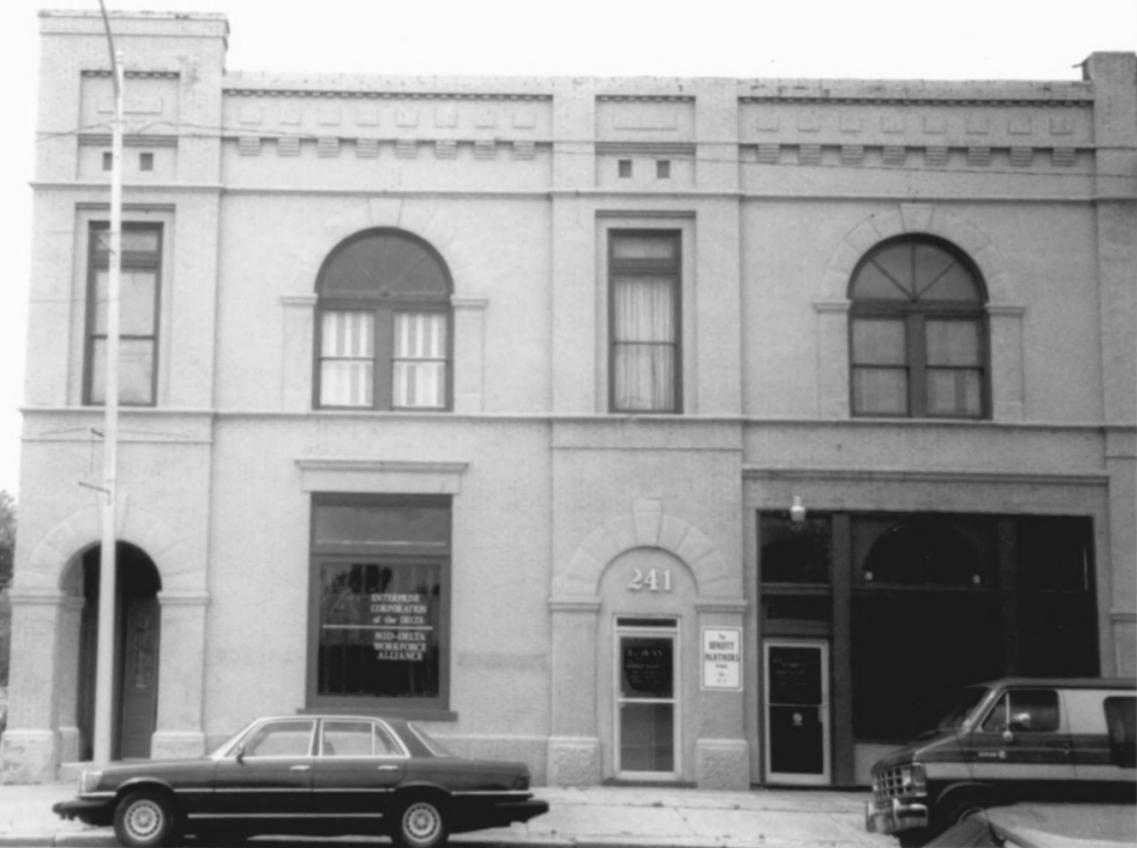
Photo #17 of 24

This is a double-lot, two-story, four-bay brick building that rests on a brick foundation and its topped by a flat roof. The building has many features that are associated with the Richardson Romanesque style. Including its massive elliptical-arched windows and doors that have rusticated stone surrounds with accented keystones and impostes. The facade has been historically divided into two storefronts and reads door, window, door, door. The facade features a corner tower topped with a parapet. The entrance is located in the corner tower and is located on a cant wall that is made flush with the building by two arches similar to an arcade. The second bay in the facade reading from east to west features a recessed elliptical-arched doorway, followed by a double-pane all-glass window with hood mold, and a replacement all-glass door set into the historic arched opening. The westernmost bay has been modernized with a plate-glass window with round-arched transom flanked by all-glass doors with single-light transoms. A beltcourse runs across the building. The second story has four bays that alternate window motifs; beginning with a squared one-over-one double-hung sash window with single-light transom followed by a set of paired one-over-one double-hung sash windows with four-light fanlight transom. Recessed brick panels, corbelling, and dentils top this very ornate building. (PHOTO #17)

North Facade, view to south
