NATIONAL REGISTER OF HISTORIC PLACES  
REGISTRATION FORM

historic name:  
other names/site number: Greenville Downtown Historic District

**Section**        7            **Page**            2            **Greenville Downtown Historic District**  
**Greenville, Washington County, MS**

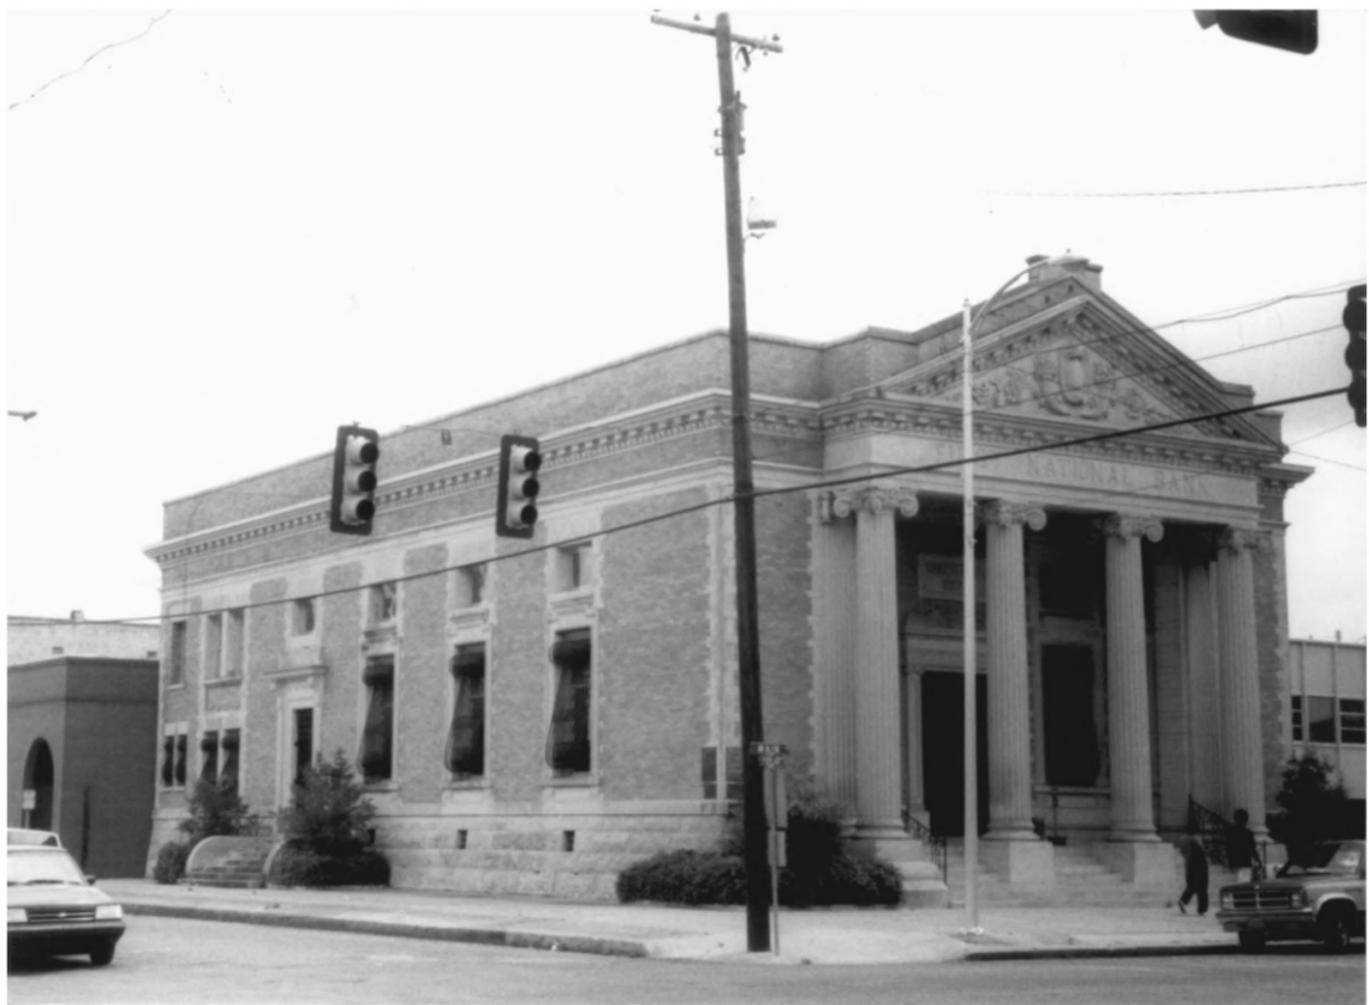
Photo #18 of 24

The First National Bank of Greenville is a two-story, Neo-Classical Revival style building with a flat roof and gabled parapet. The facade is dominated by a monumental pediment supported by four Ionic columns. In 1957, a reinforced concrete wing was added to the east wall of the main building and then in 1971 a metal addition was made to the rear of the building. The facade is brick with a rock-faced stone waterable. The tympanum features elaborate carving including medallions and festoons. A centrally located door is flanked by two windows with transoms that are covered by elaborate iron bars. The building also has stone quoins, entablature, and surrounds. (PHOTO #18)

South facade, view to north

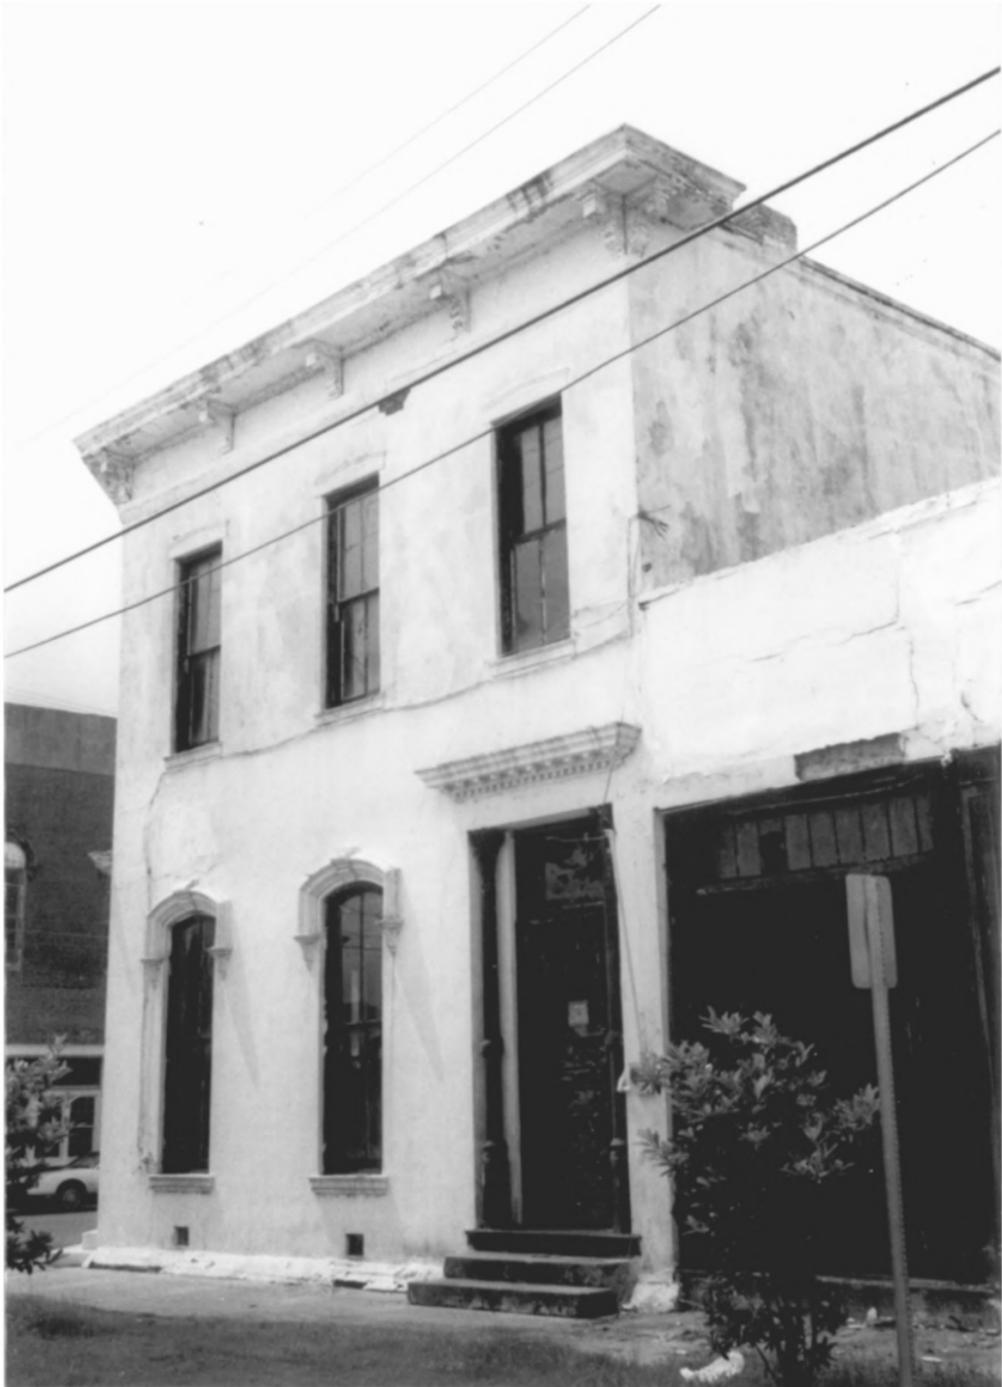
Photo #19 of 24

East Walnut & North Main Facades, view to southwest

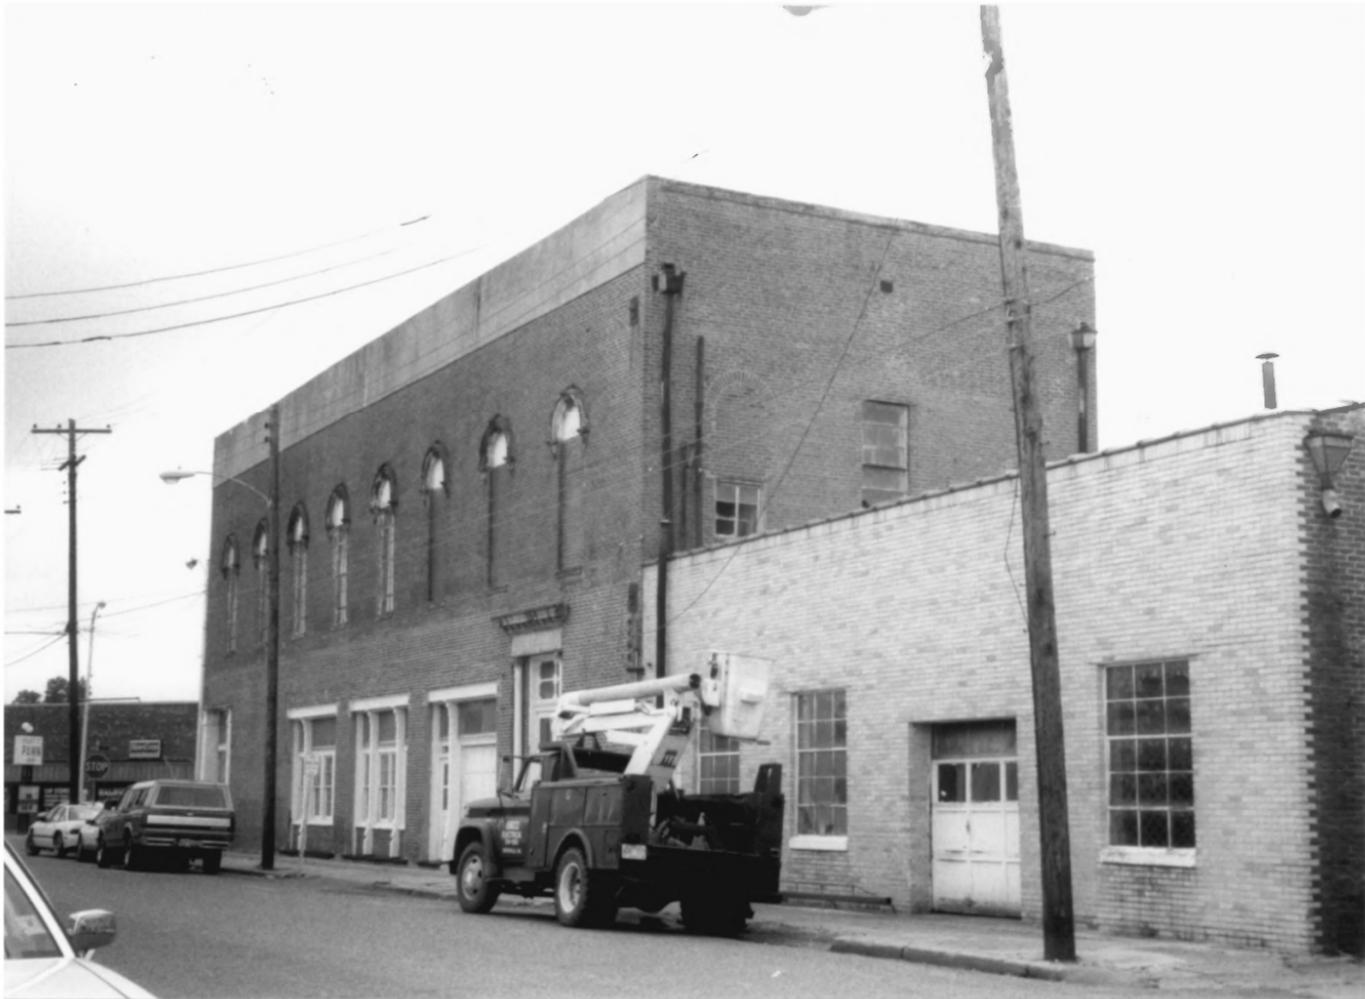
Photo # 20 of 24

North Main Street Facade, view to the south

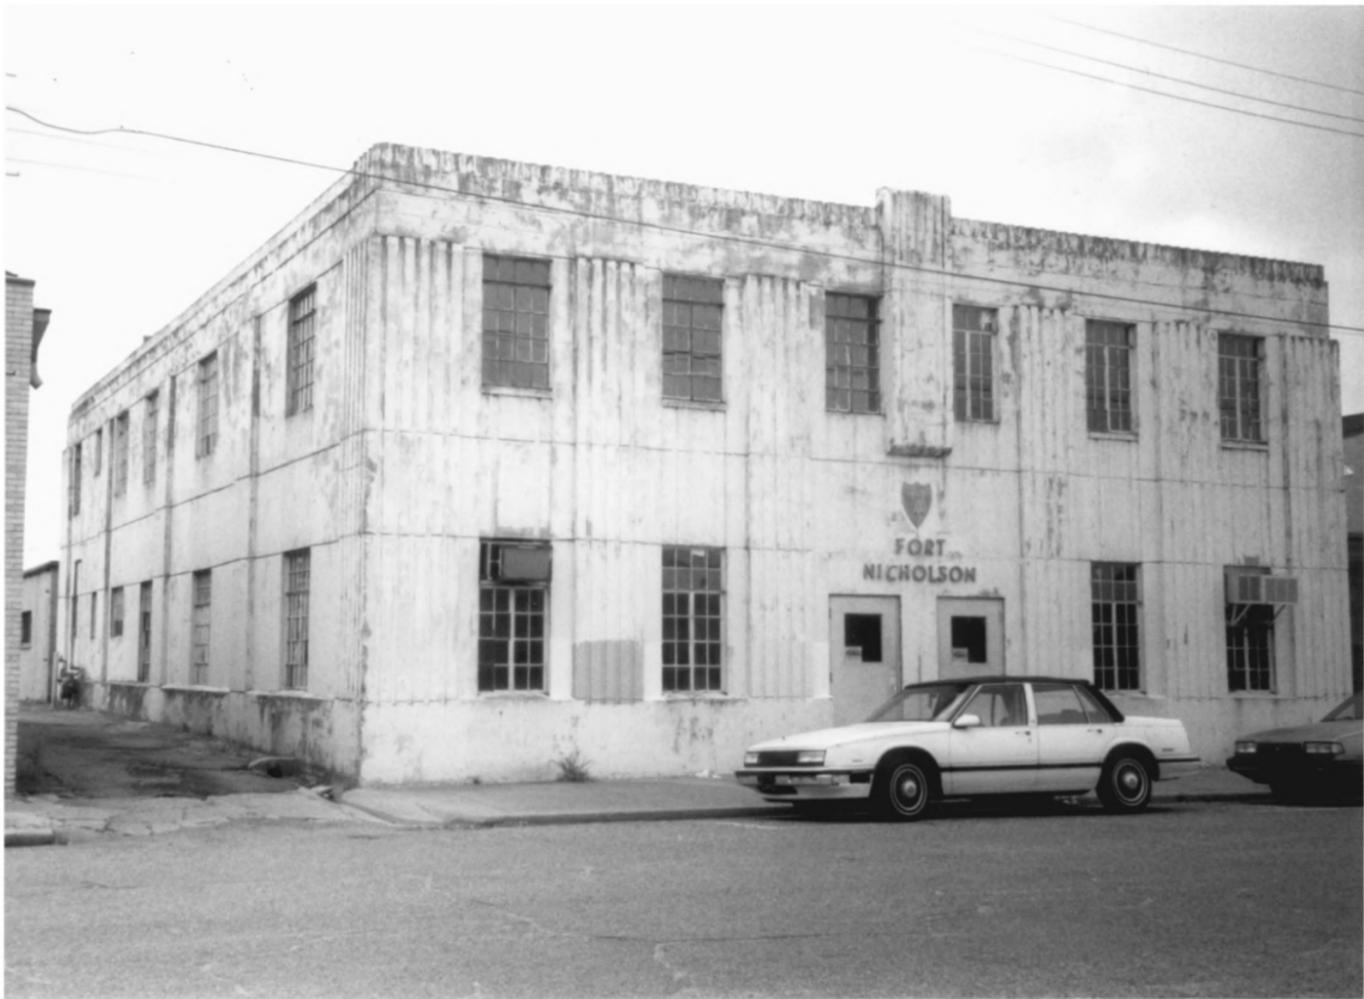
Western Facade, view to the East  
Photo #21 of 24

Greenville Downtown Historic District  
Greenville, Washington Co., MS  
214 Walnut Street

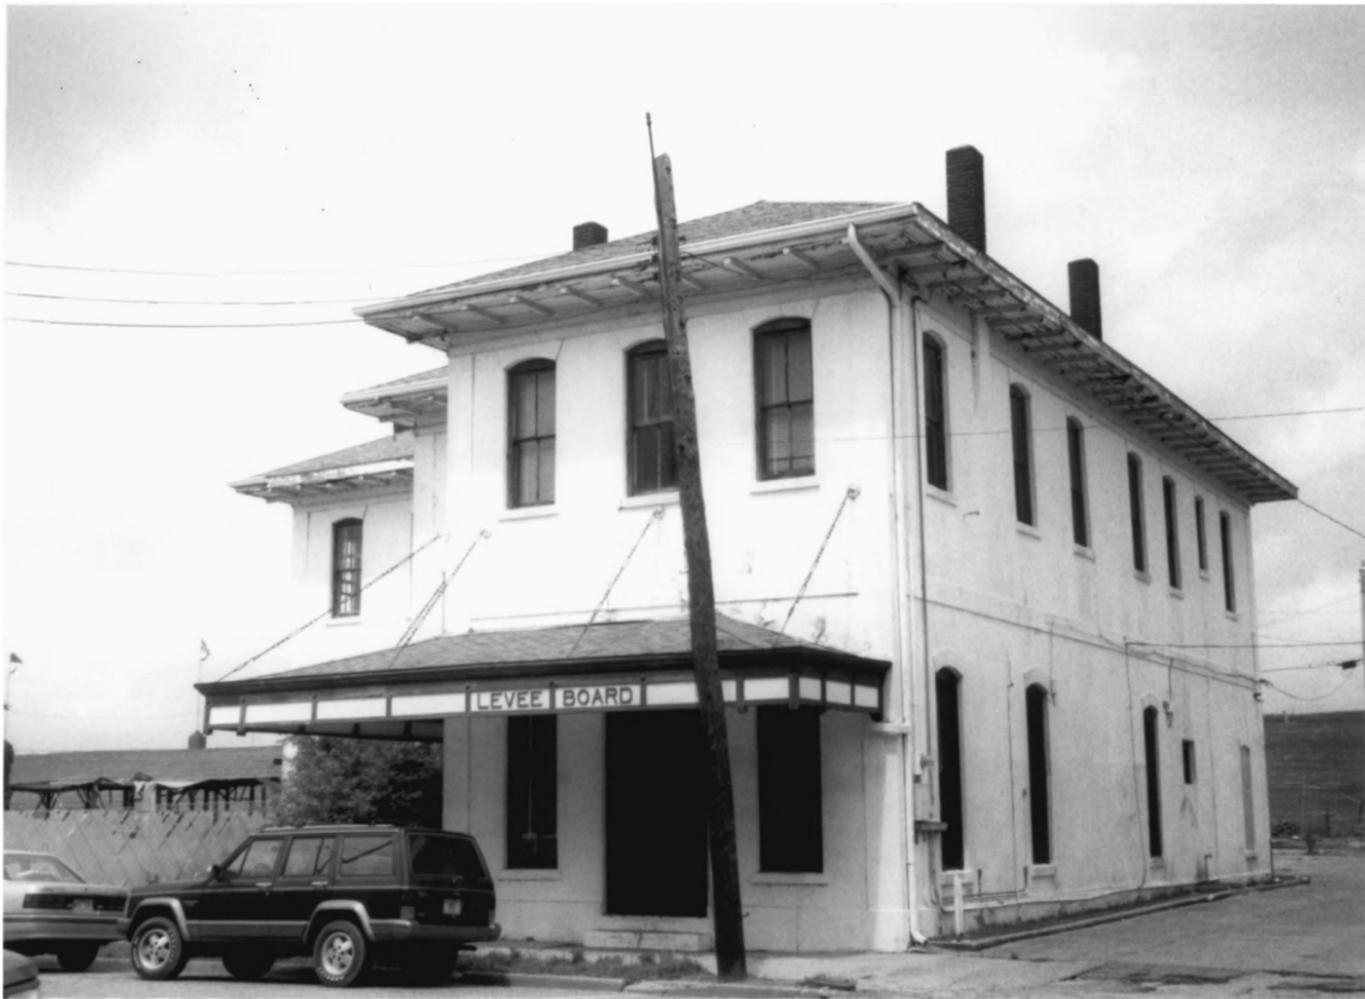
Photo #22 of 24

Western Facade, view to the East

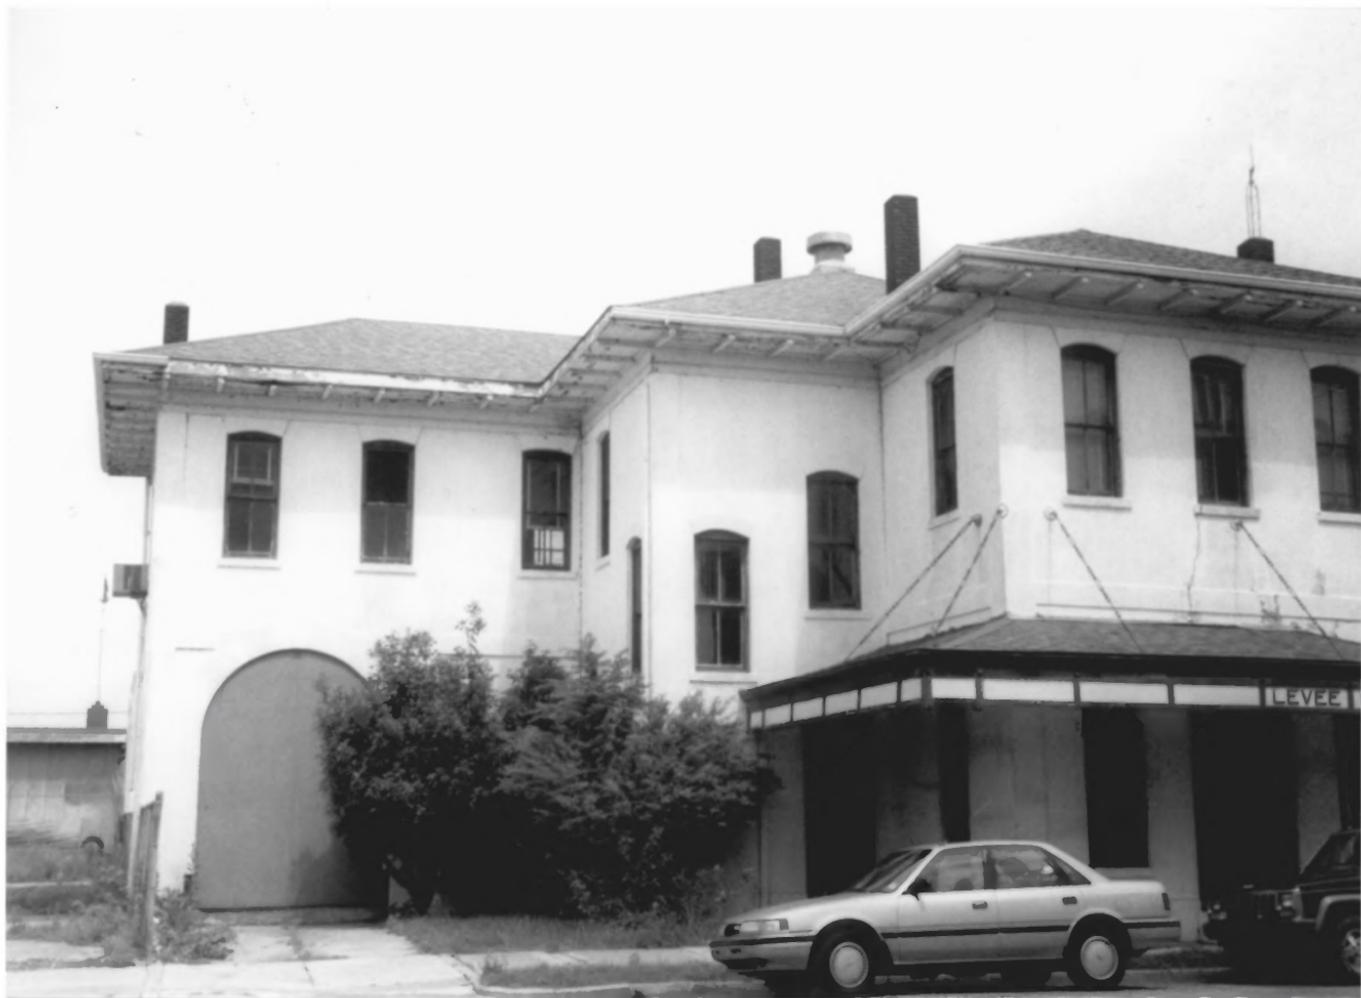
Photo # 23 of 24

Greenville Downtown Historic District  
Greenville, Washington Co., MS  
229 Walnut Street

0000112 N-1  
Eastern Facade, view to southwest
