National Register of Historic Places Registration Form

historic name Baldwyn Historic District

state Mississippi code MS county Lee, Prentiss code 081, 117 zip code 38824

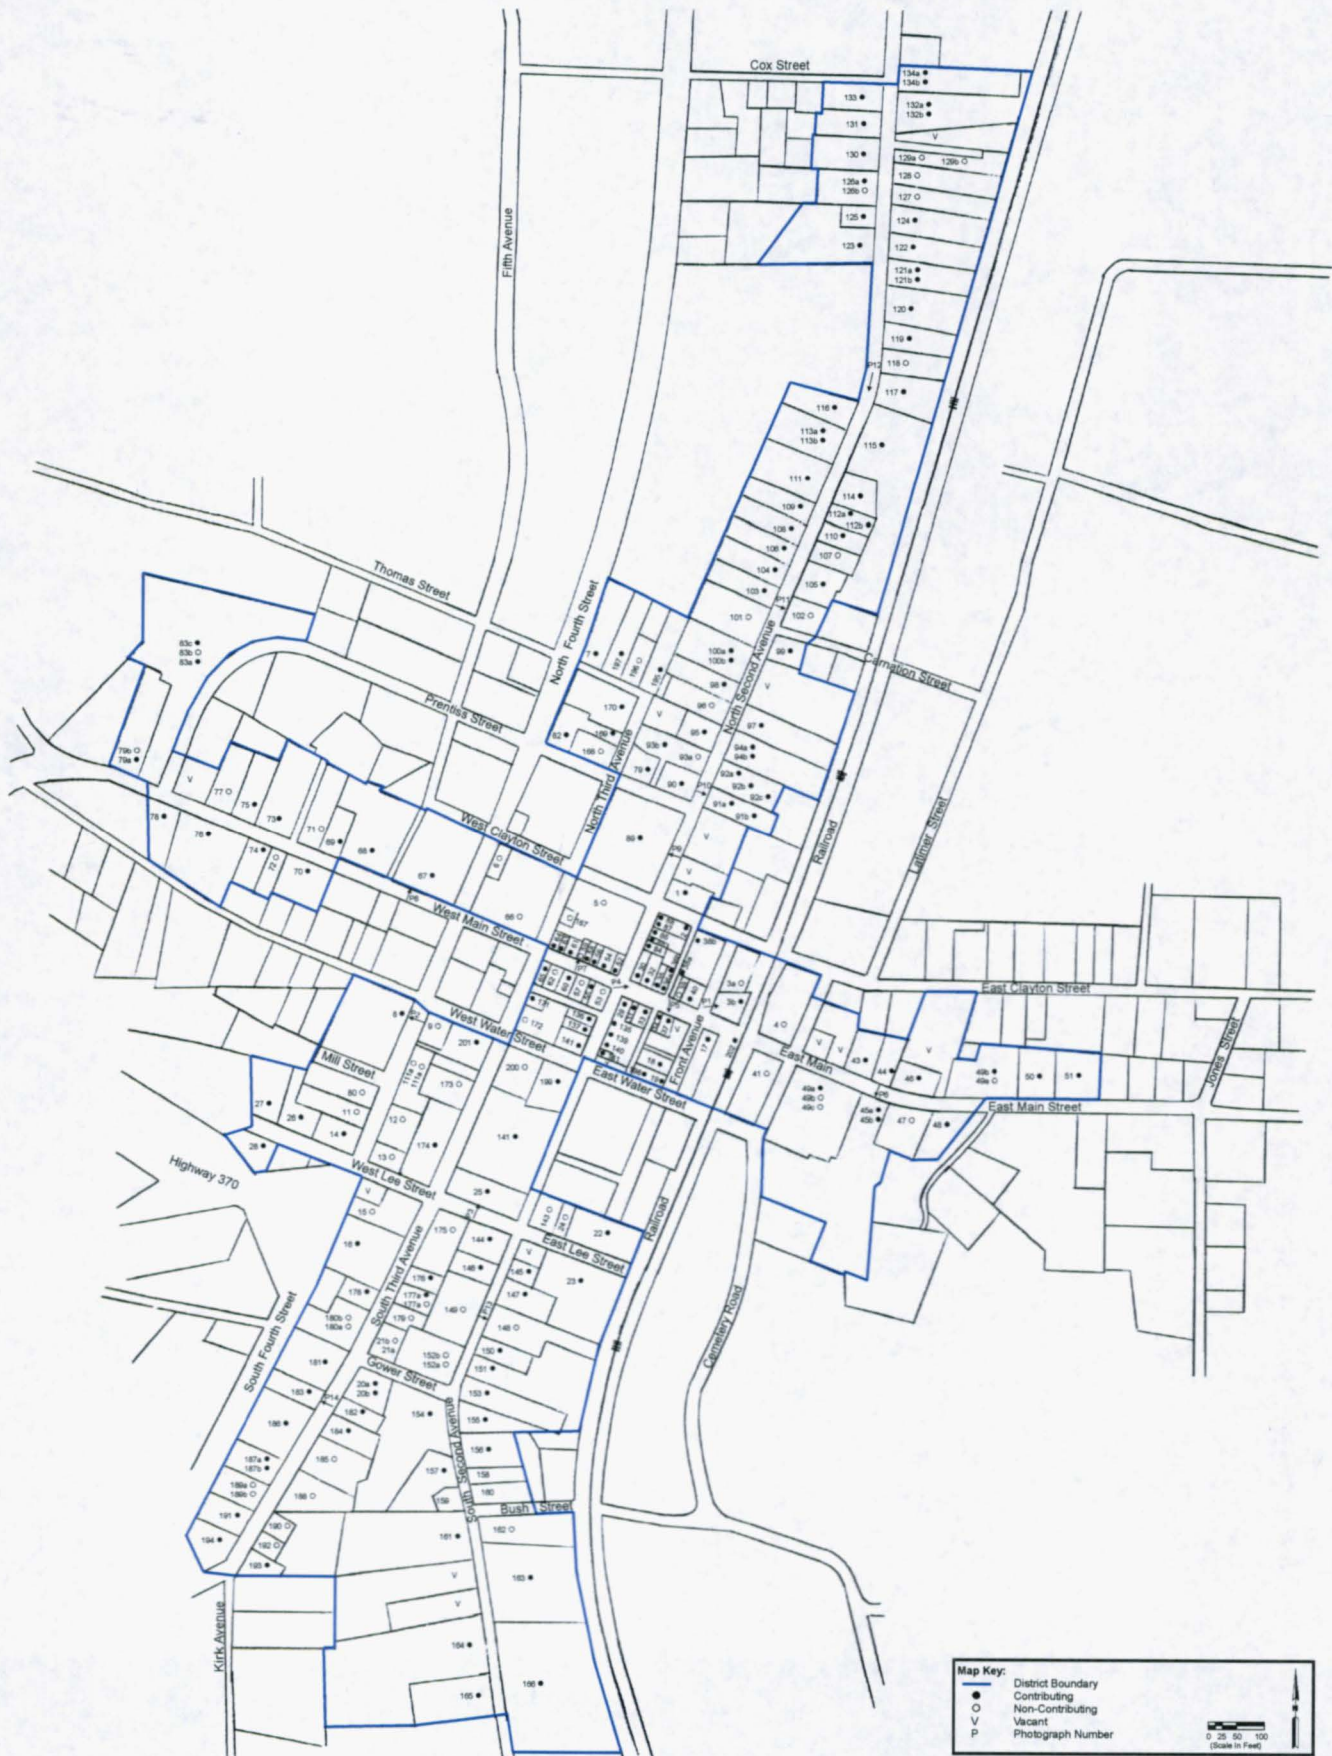
Baldwyn Historic District

Map Key:

- District Boundary
- Contributing
- Non-Contributing
- V Vacant
- P Photograph Number

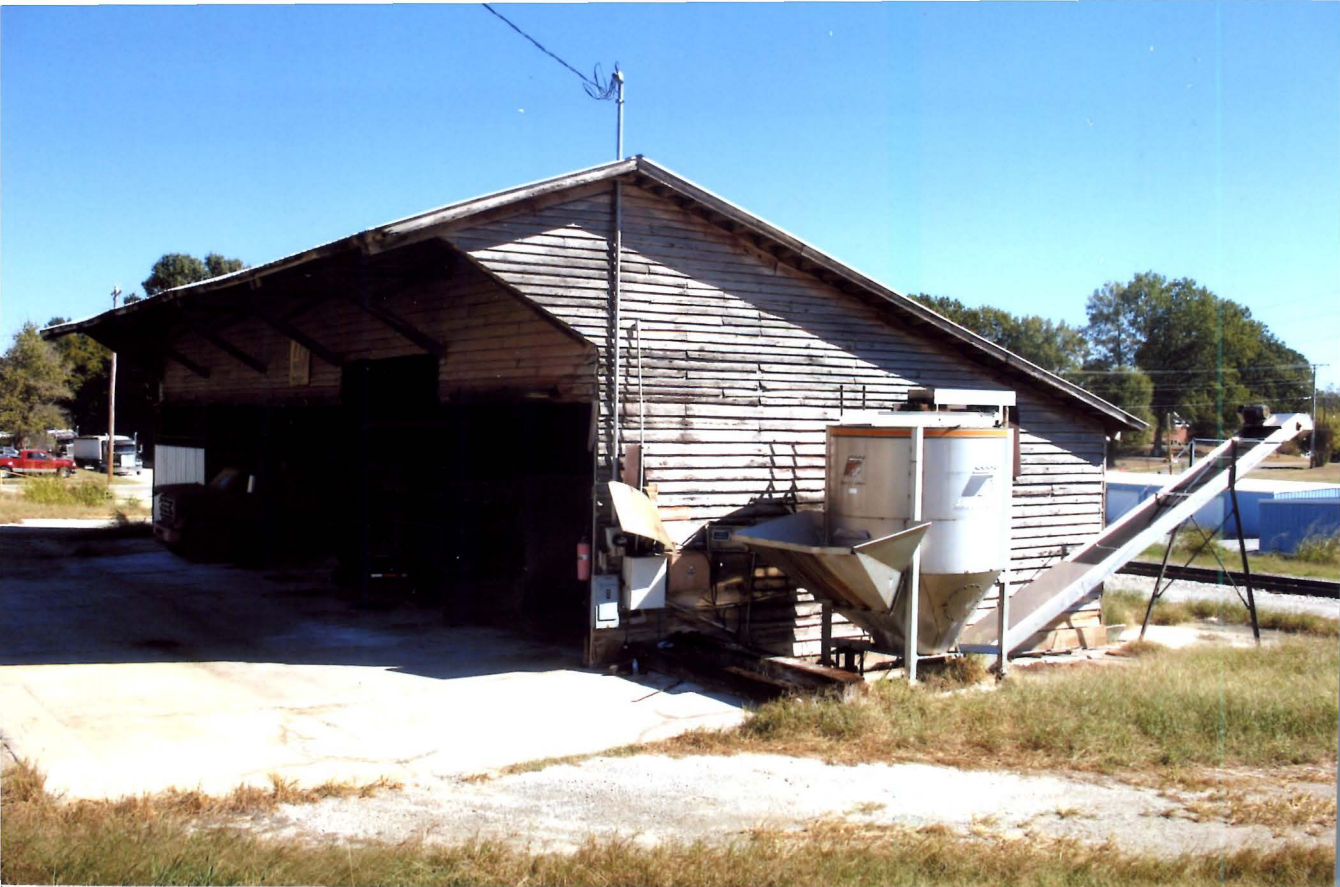
Photo 1 of 14

201 Clayton Street, East

#3b

Rectangular one-story frame warehouse with an uneven pitch gable industrial metal roof; faces west; five interior cargo bays are open to the west; wood weatherboard siding; continuous concrete foundation. [Photo #1]

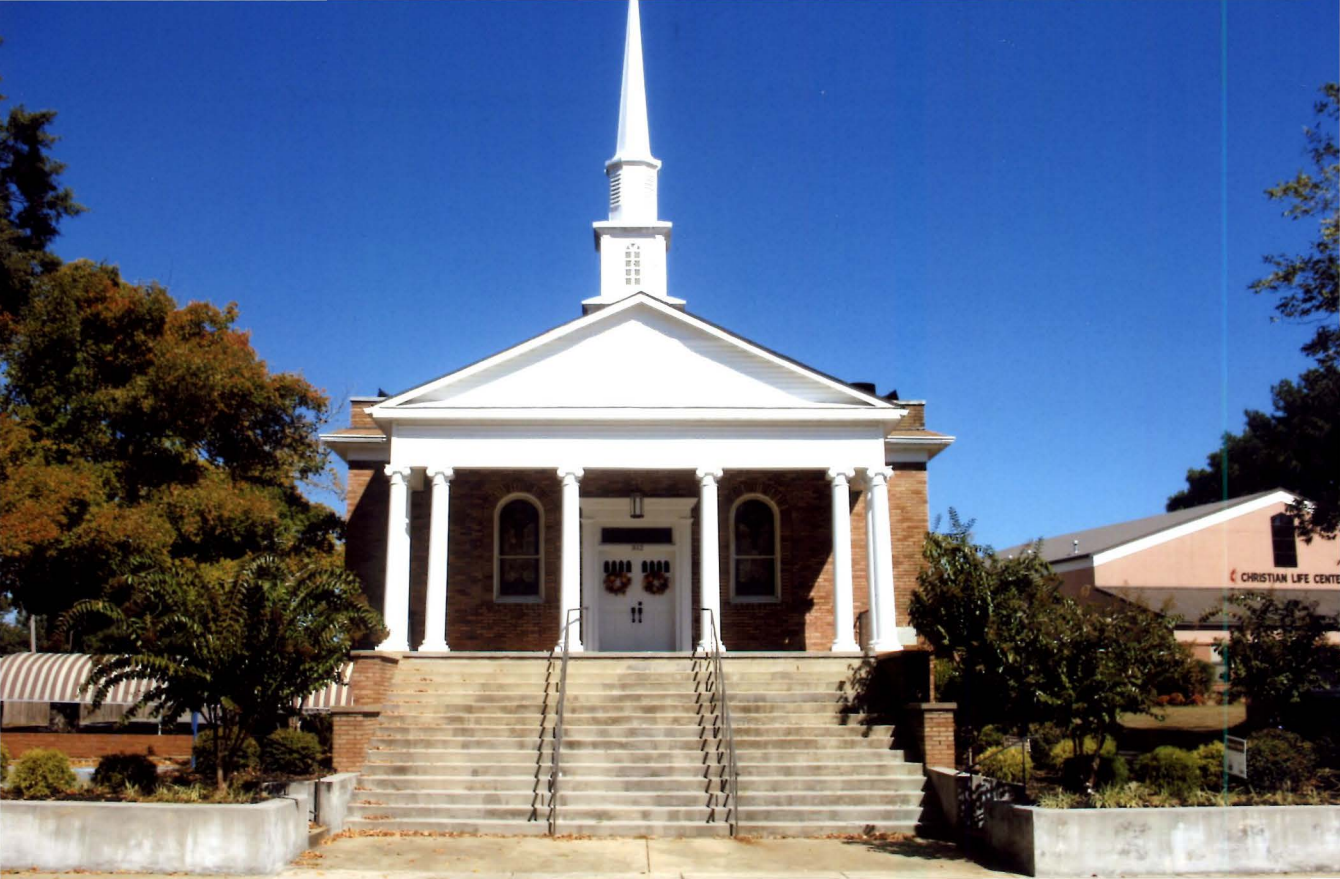
First United Methodist Church
312 Main Street, West

#67
Baldwyn, Lee & Prentiss Counties, Mississippi
Baldwyn Historic District

One-story brick church building with a front-facing gable composition shingle roof with a spire; three-bay rectangular core with slightly projecting side pavilions at the front bays of the side elevations; less than full facade pedimented portico with Corinthian columns; central entrance at facade with a trabeated surround with double leaf doors and transom flanked by single arched window openings with stained glass windows, similar windows at side elevations with rectangular 6/6 windows corresponding at the basement level; exposed brick veneer exterior walls; detached one-story brick veneer ancillary building to rear with a hipped industrial metal roof joined by a covered walkway to a second ancillary stucco and brick Christian Life Center building with a front facing gable industrial metal roof; alterations include the application of vinyl siding at the portico and the steeple appears to be modern. Datestone reads: First Methodist/Church/1925." [Photo # 8]

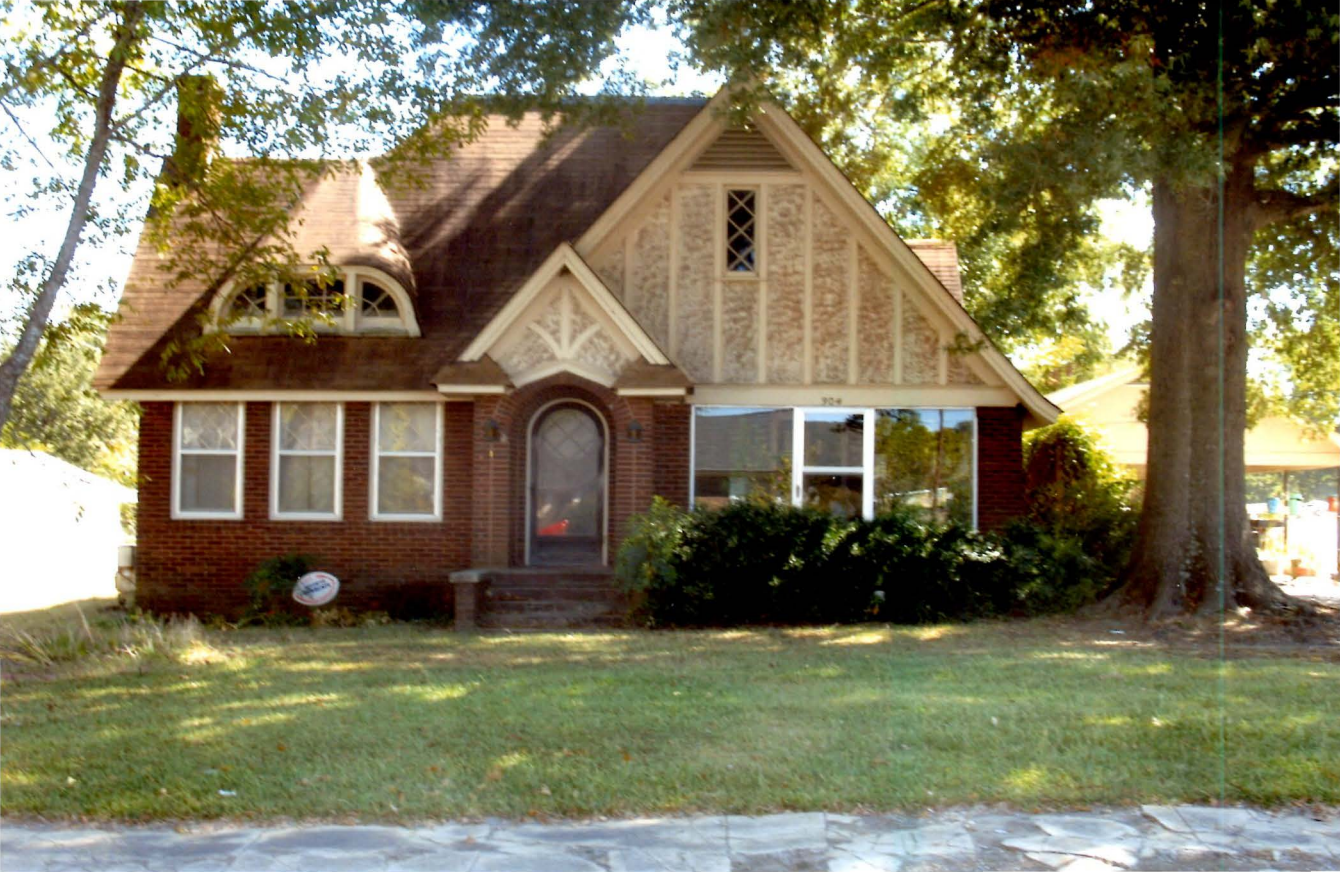
Photo 10 of 14

304 Second Avenue, North
91a

One-story brick veneer Tudor Revival style dwelling with a hipped composition shingle roof with cross gables, arched decorative dormer, one end brick chimney and one interior brick chimney; three-bay rectangular core recessed corner porch at south bay of facade now glassed in, off-center entrance bay with recessed entrance flanked to the west by a triple window with patterned upper sash, similar single and double windows at side elevations, half timbered gable ends; exposed brick veneer exterior walls set in stretcher bond; brick veneer at foundation. [Photo # 10]
