National Register of Historic Places Registration Form

1. Name of Property historic name Steele, L. C., House other names/site number

2. Location street & number 515 Fourth Street city, town Corinth state Mississippi code MS county Alcorn code 3 zip code 38834

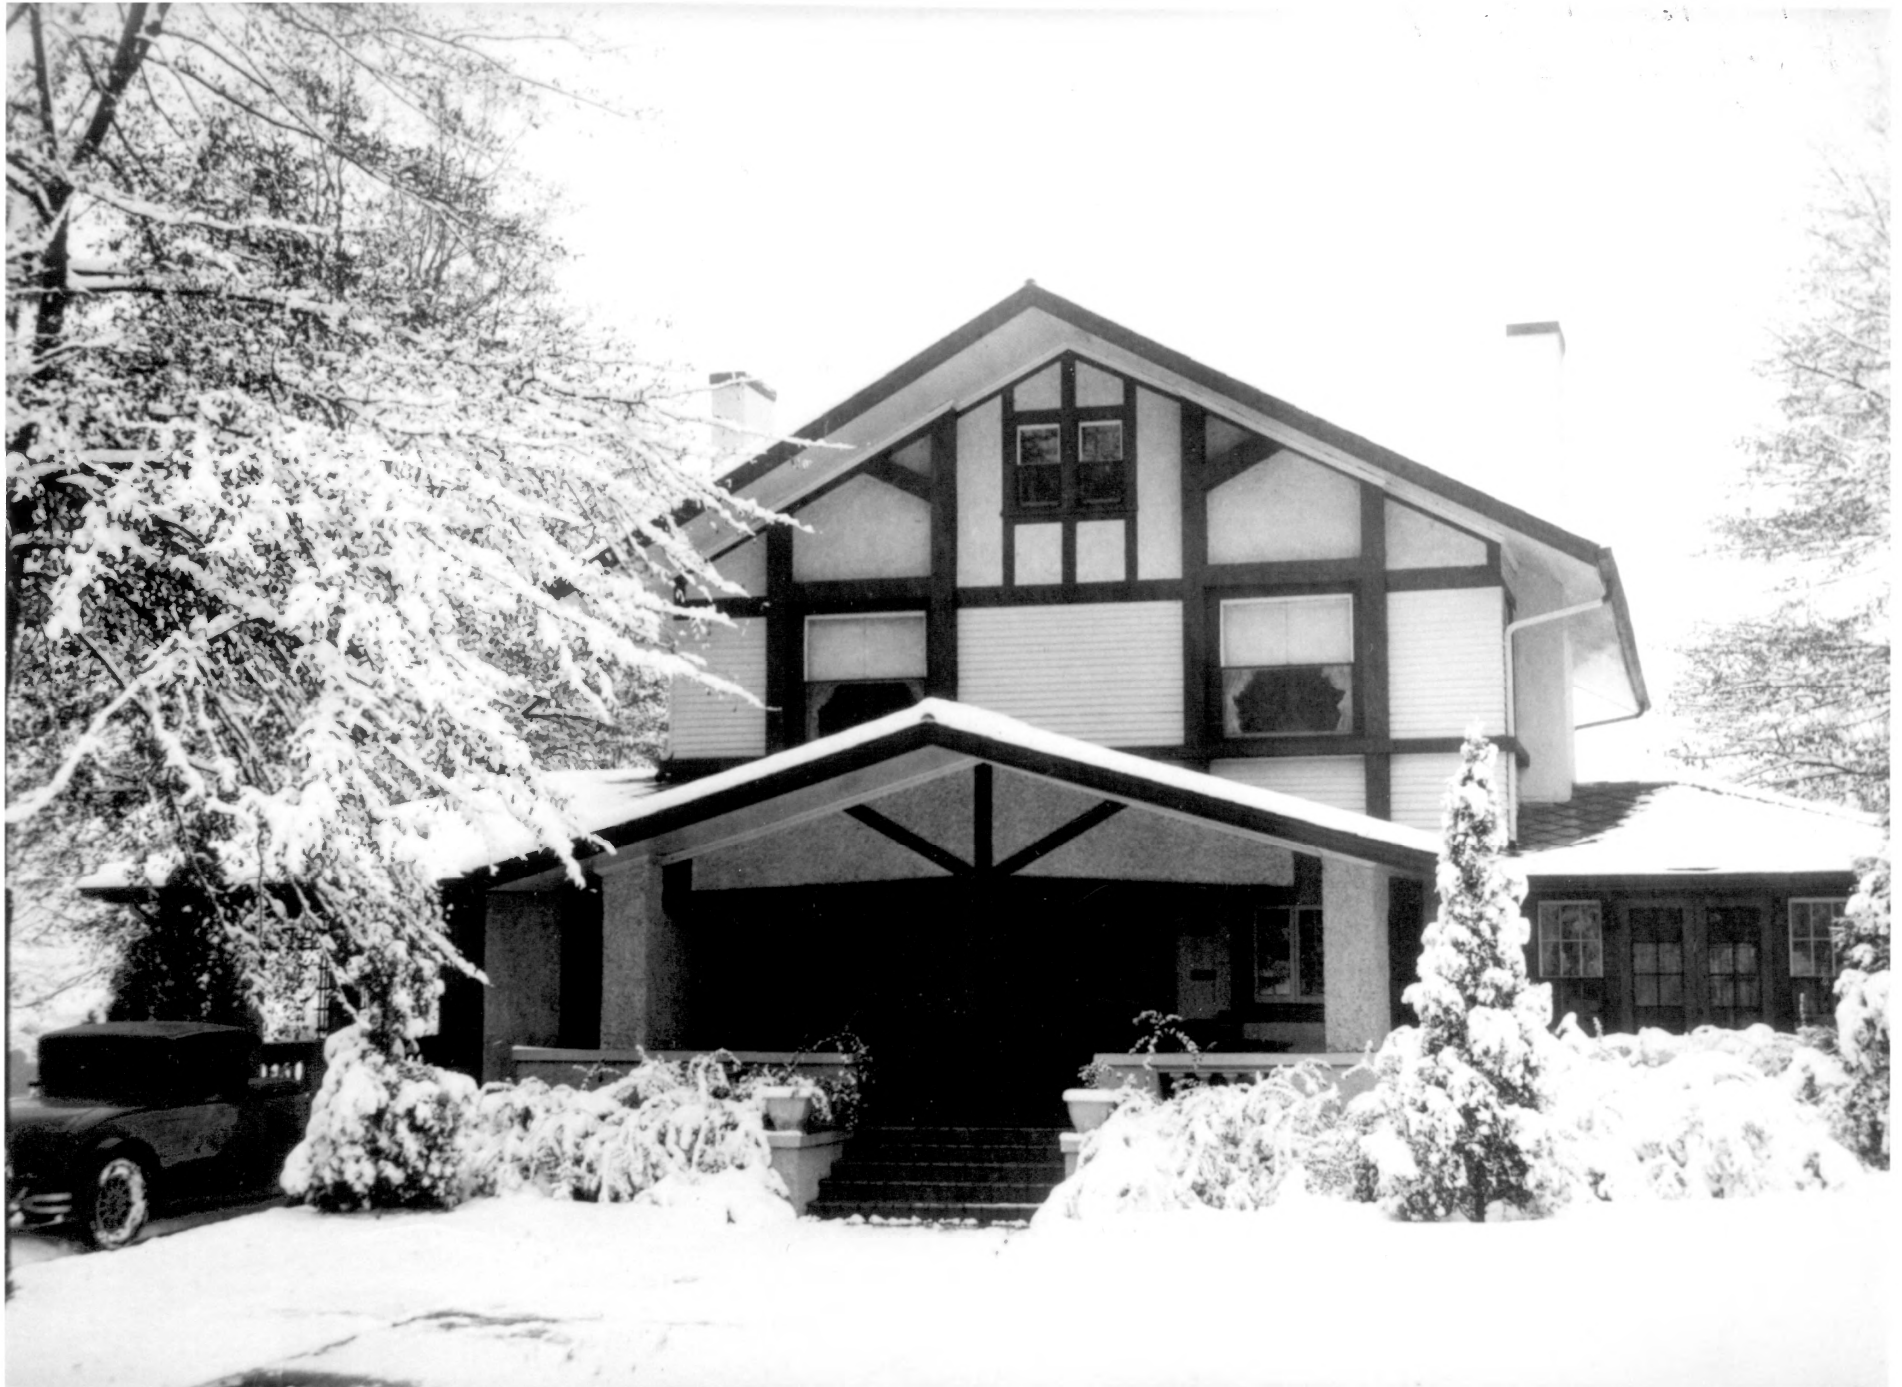
Photo 1 of 7

Photo 1 -- (6) L.C. Steele House Facade (south elevation), view to north. ca. 1925

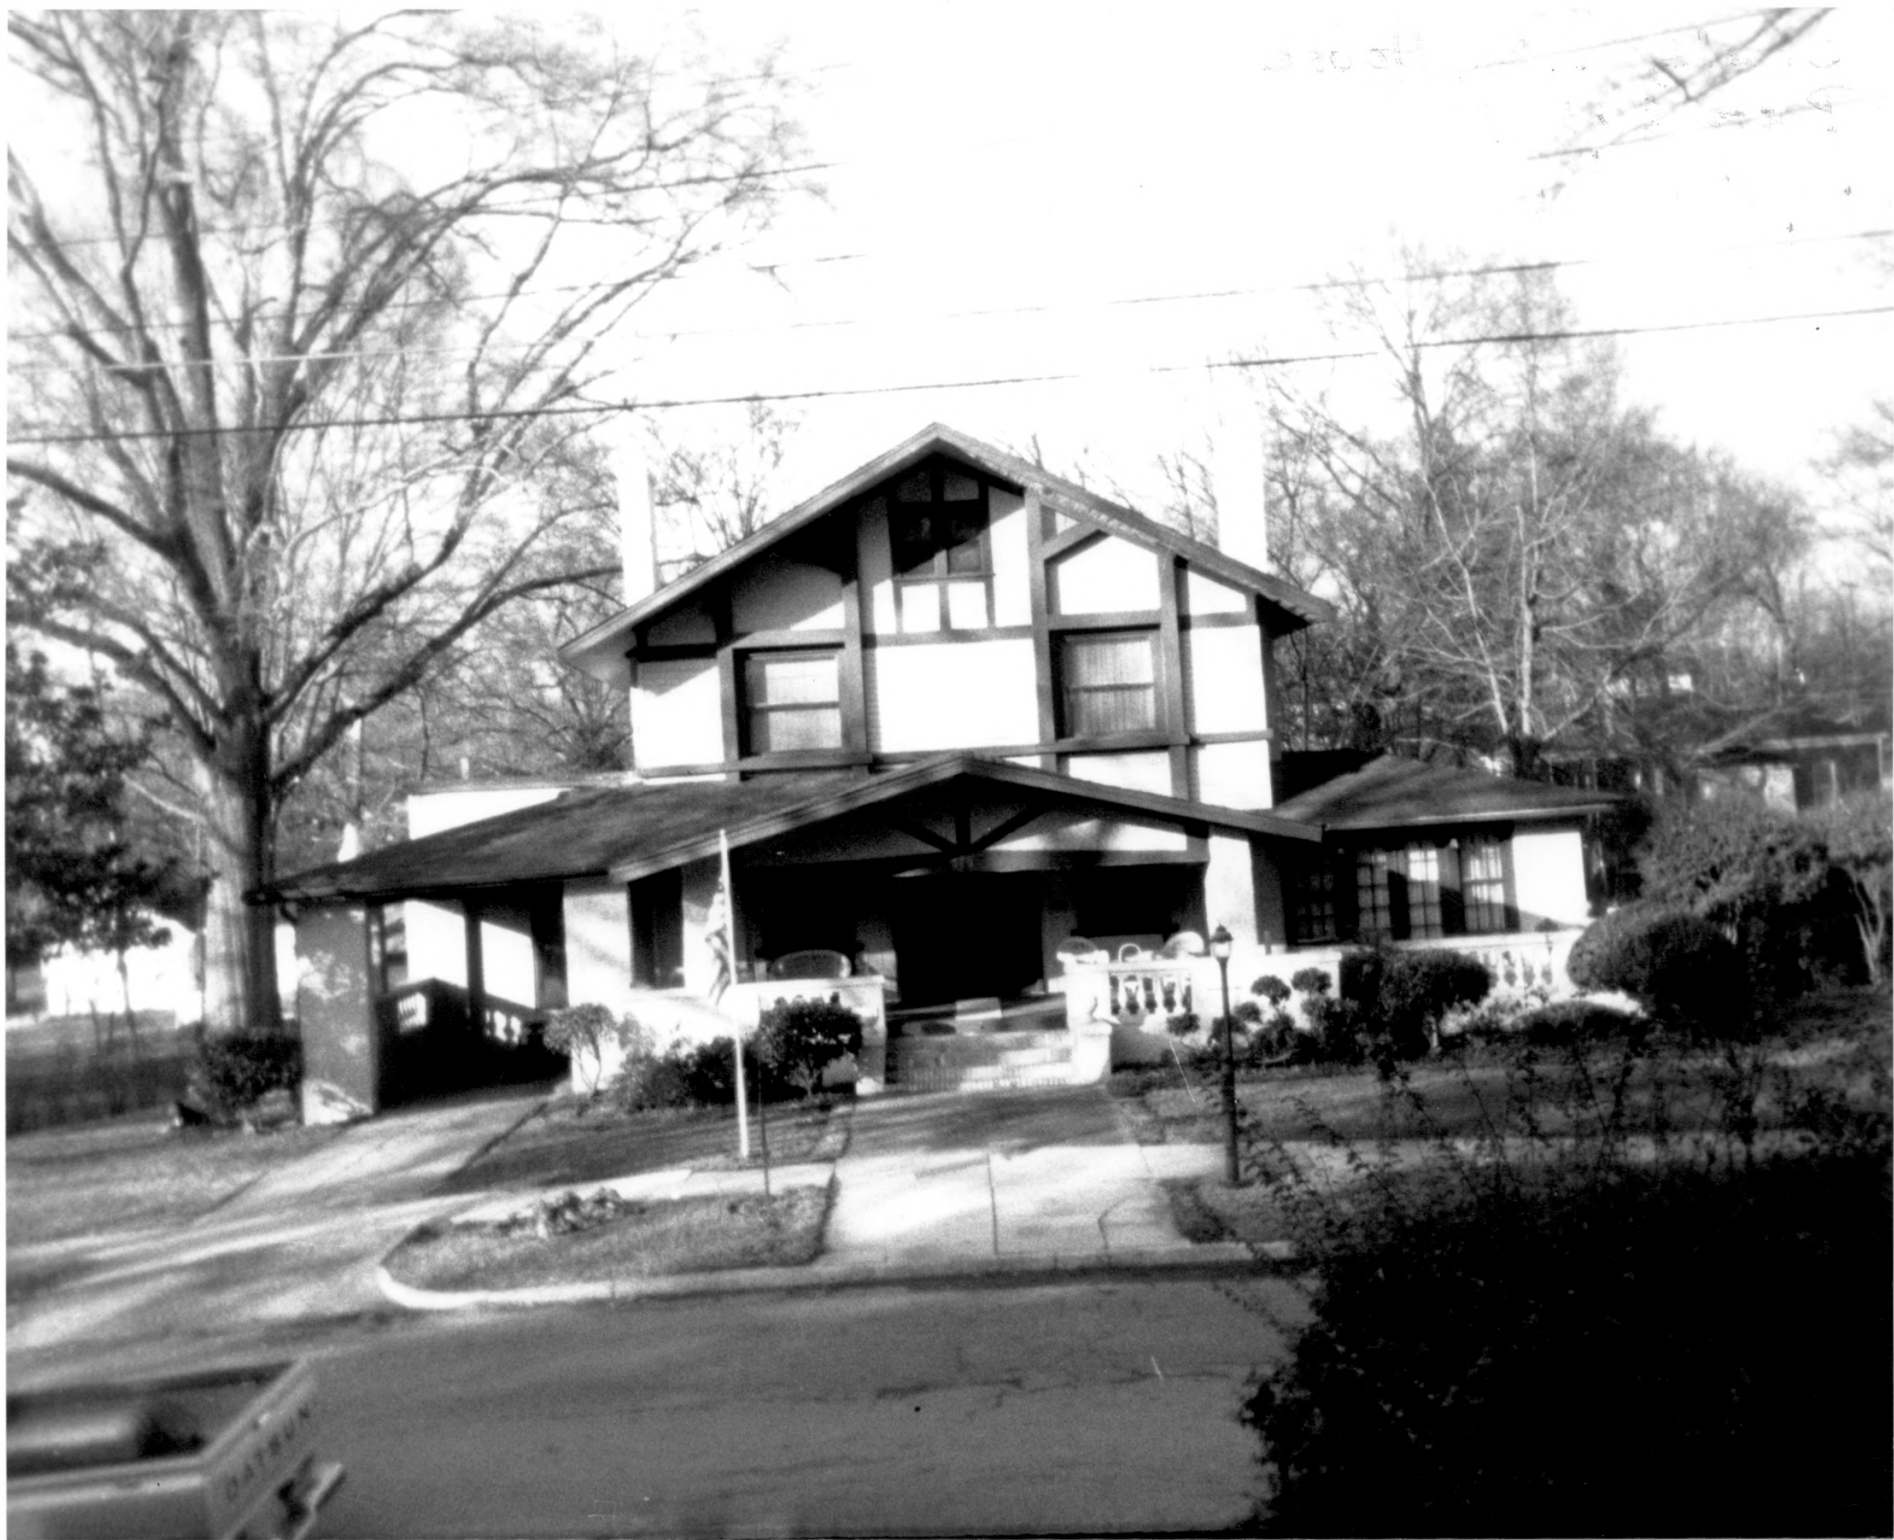
Photo 2 of 7

Facing south, the main facade consists of a two-and-one-half story front-gabled symmetrical central core with a one-story transverse gable wing on the east side and a one-story wing with roof balcony above on the west side. The upper gable roof is pierced by 1 interior and 2 exterior stucco chimneys. The facade is fronted by a one-story front-gabled projecting porch with two heavy rectangular stucco columns, stucco and concrete balustrade and wall. An open carport is located to the west of the porch with large box stucco columns and matching balustrade. The main or formal entrance to the interior, located at the center of the front porch, consists of four-panel with four light wooden double doors with original screen doors, surrounded by small pilasters with raised strips creating geometric patterns and supporting a continuous frieze. Multilight casement windows on either side of the front entrance are surrounded by matching pilasters with horizontal and vertical banding. An additional side entrance is located in the carport. The front porch floor, originally covered with quarry tile pavers, has been partially replaced with wood decking. The side veranda retains its original pavers with a tile border of contrasting size and color. Original metal square lantern light fixtures are wall-mounted on either side of the double doors and suspended from the center of the porch ceiling.

Photo 2 -- (6) L.C. Steele House Facade (south elevation), view to north. January, 1992.

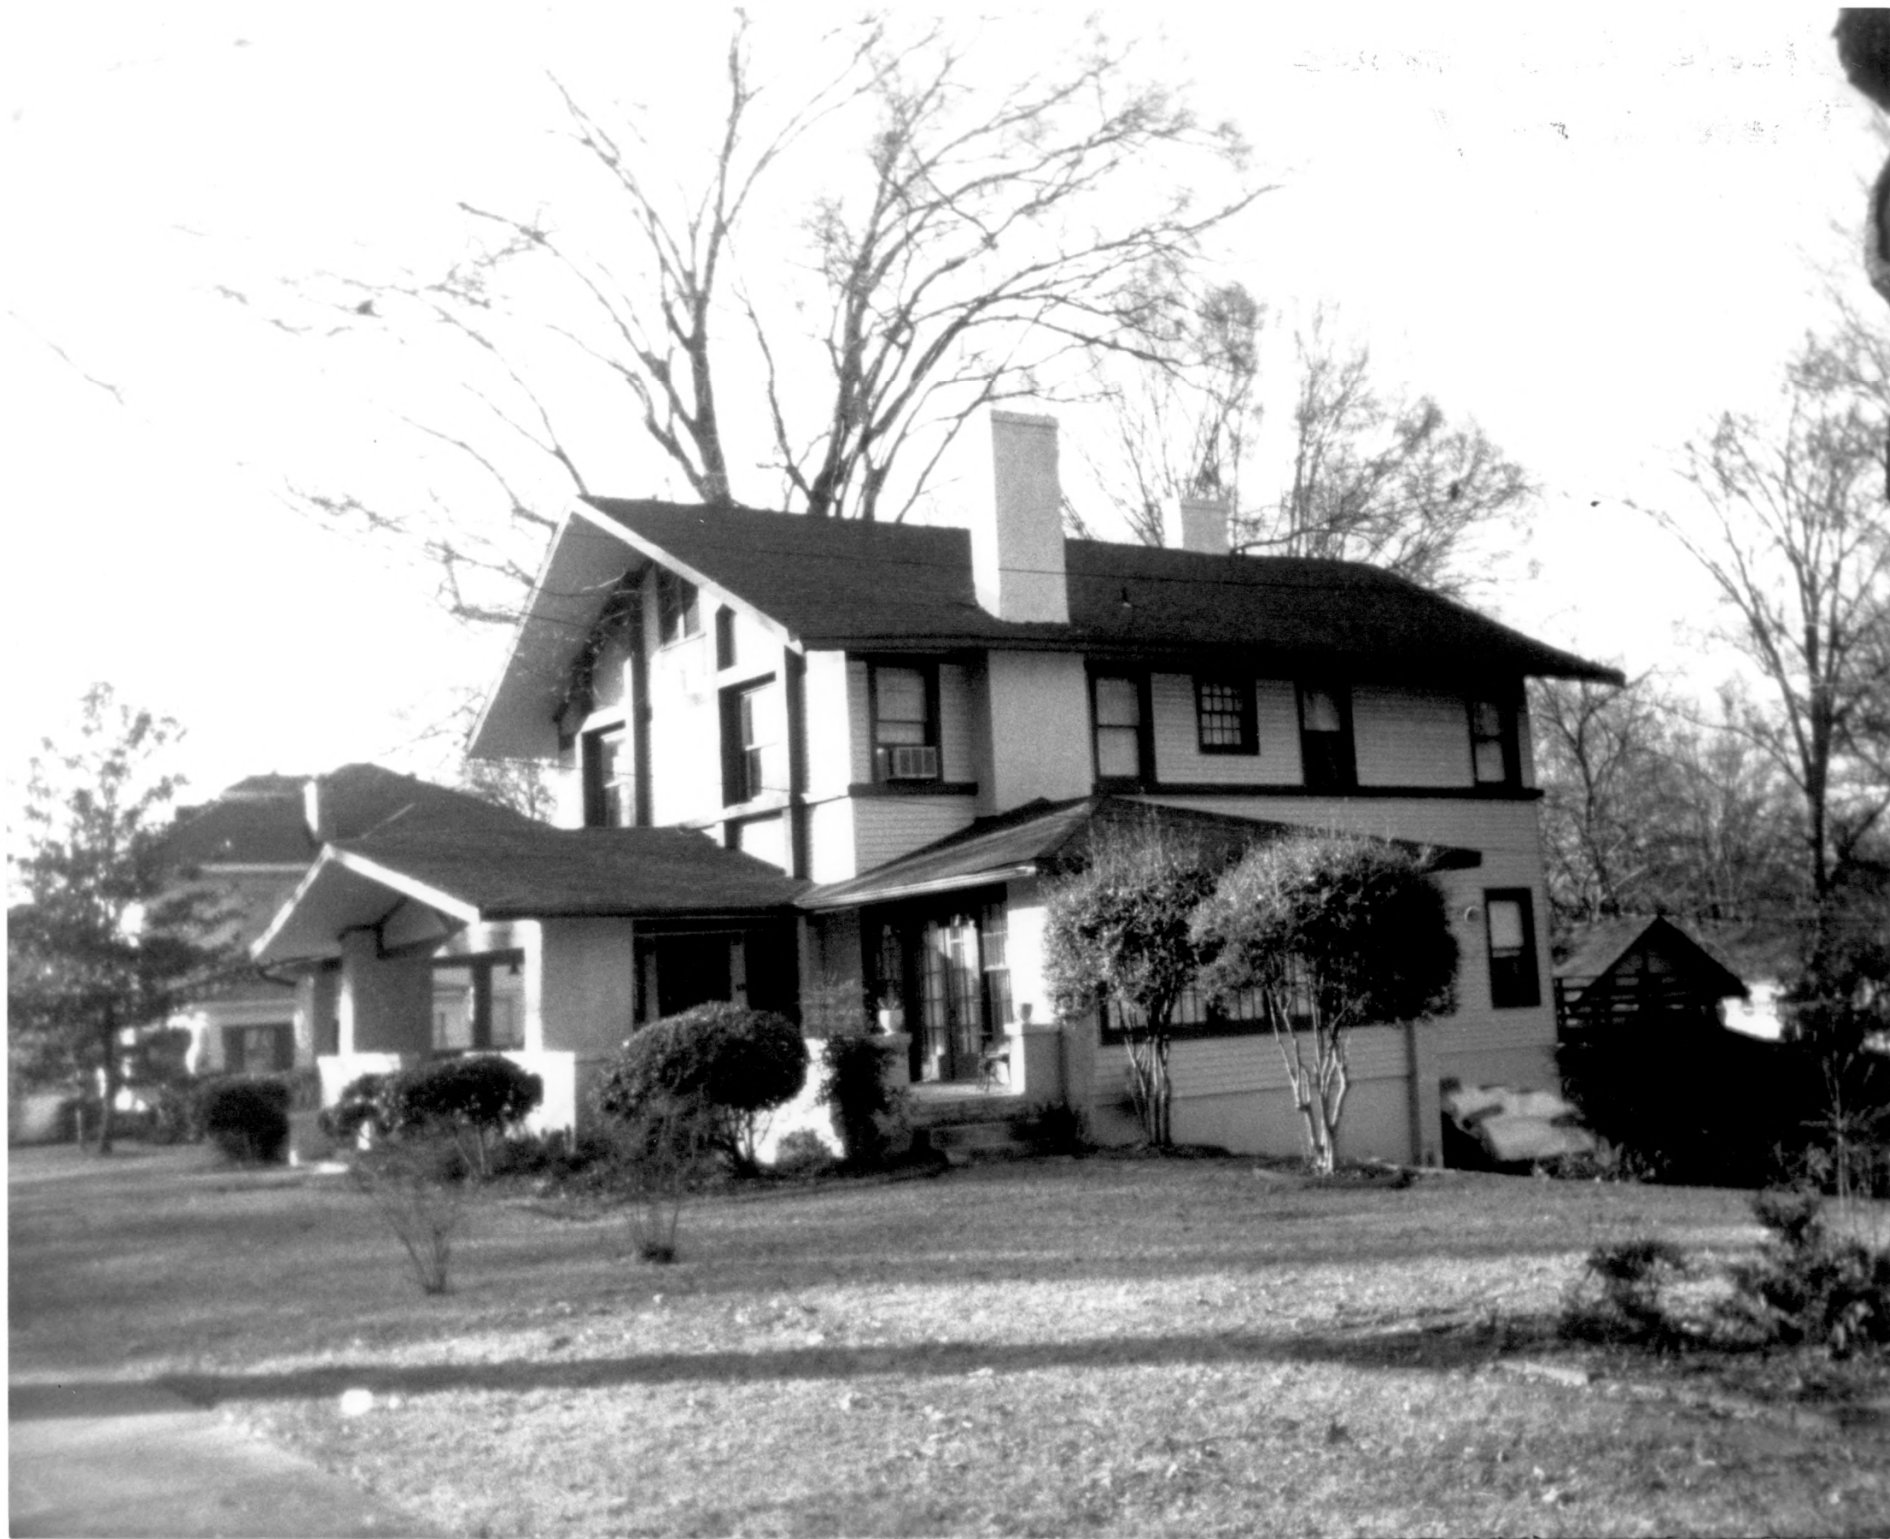
Photo 3 of 7

Photo 3 -- (6) L.C. Steele House, North and East elevations, view to northwest. January, 1992.

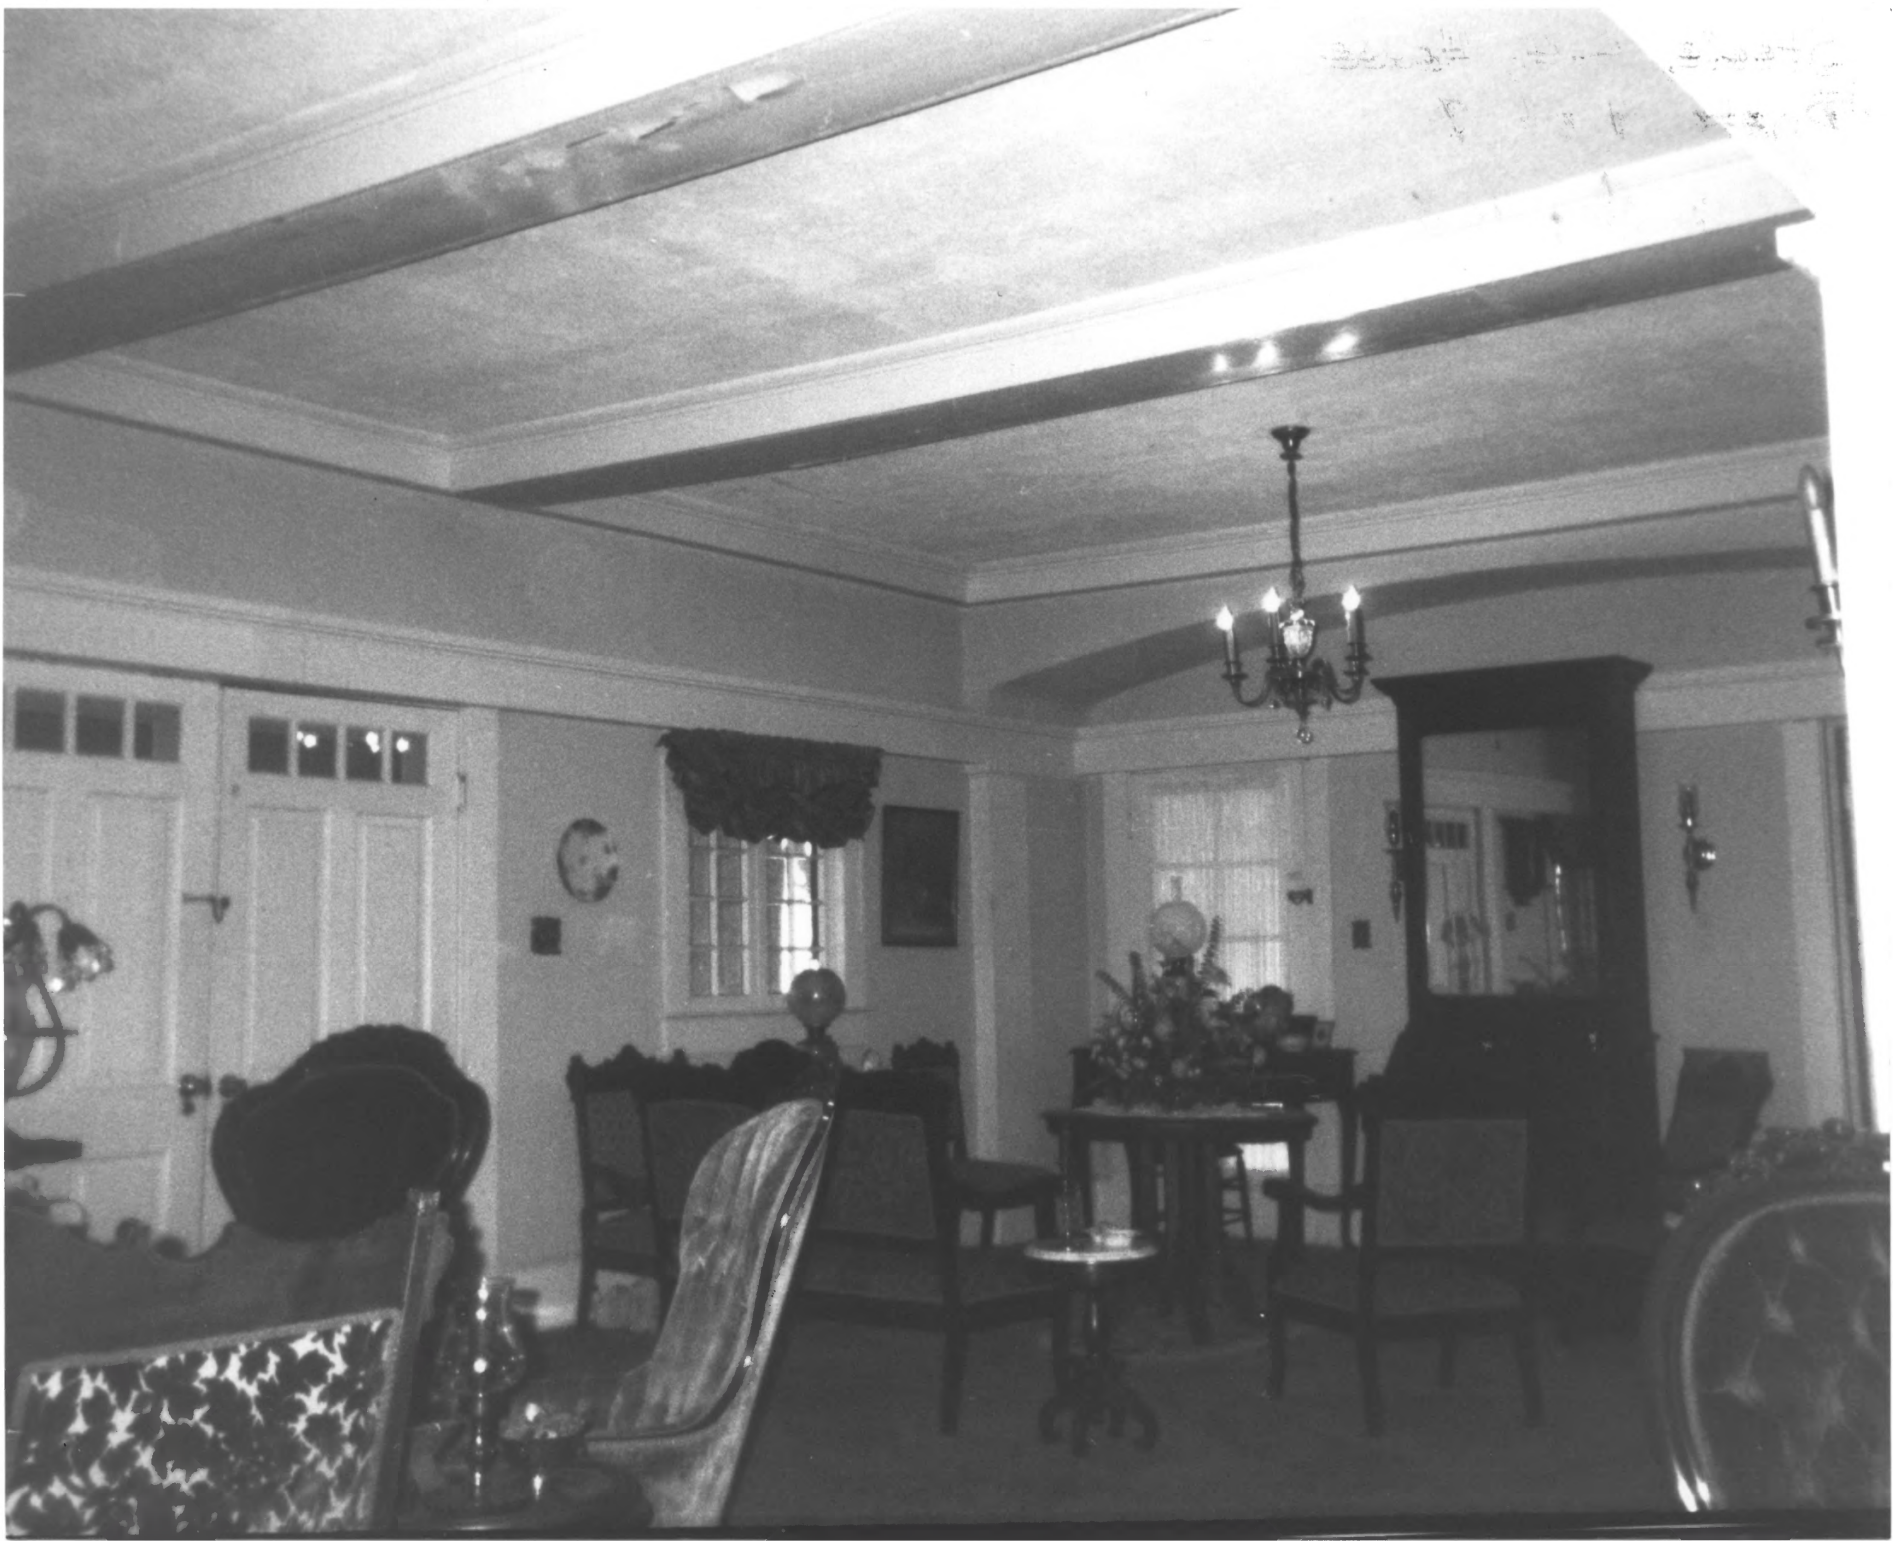
Photo 4 of 7

The interior walls, constructed of plaster, have a continuous horizontal wooden band at the level of the tops of doors and windows throughout the ground floor, creating a continuous frieze below the ceiling plane. In the living and dining room, rectangular ceiling beams occur parallel to the sides of the house. Pilasters occur on the walls beneath the frieze, aligning with the ceiling beams. The ends of the living room, dining room and sunroom contain a shallow, wide arched plaster ceiling. The plaster walls of the upper floor are divided into panels by small strips of wood molding. The sleeping porch is lined with beaded wood walls and double-hung windows opening out onto a parapeted roof deck over the west wing and the carport. The deck is covered with sheet metal sloped to drain to two roof scuppers.

Photo 4 -- (6) L.C. Steele House, Living Room, view to southwest. January, 1992.

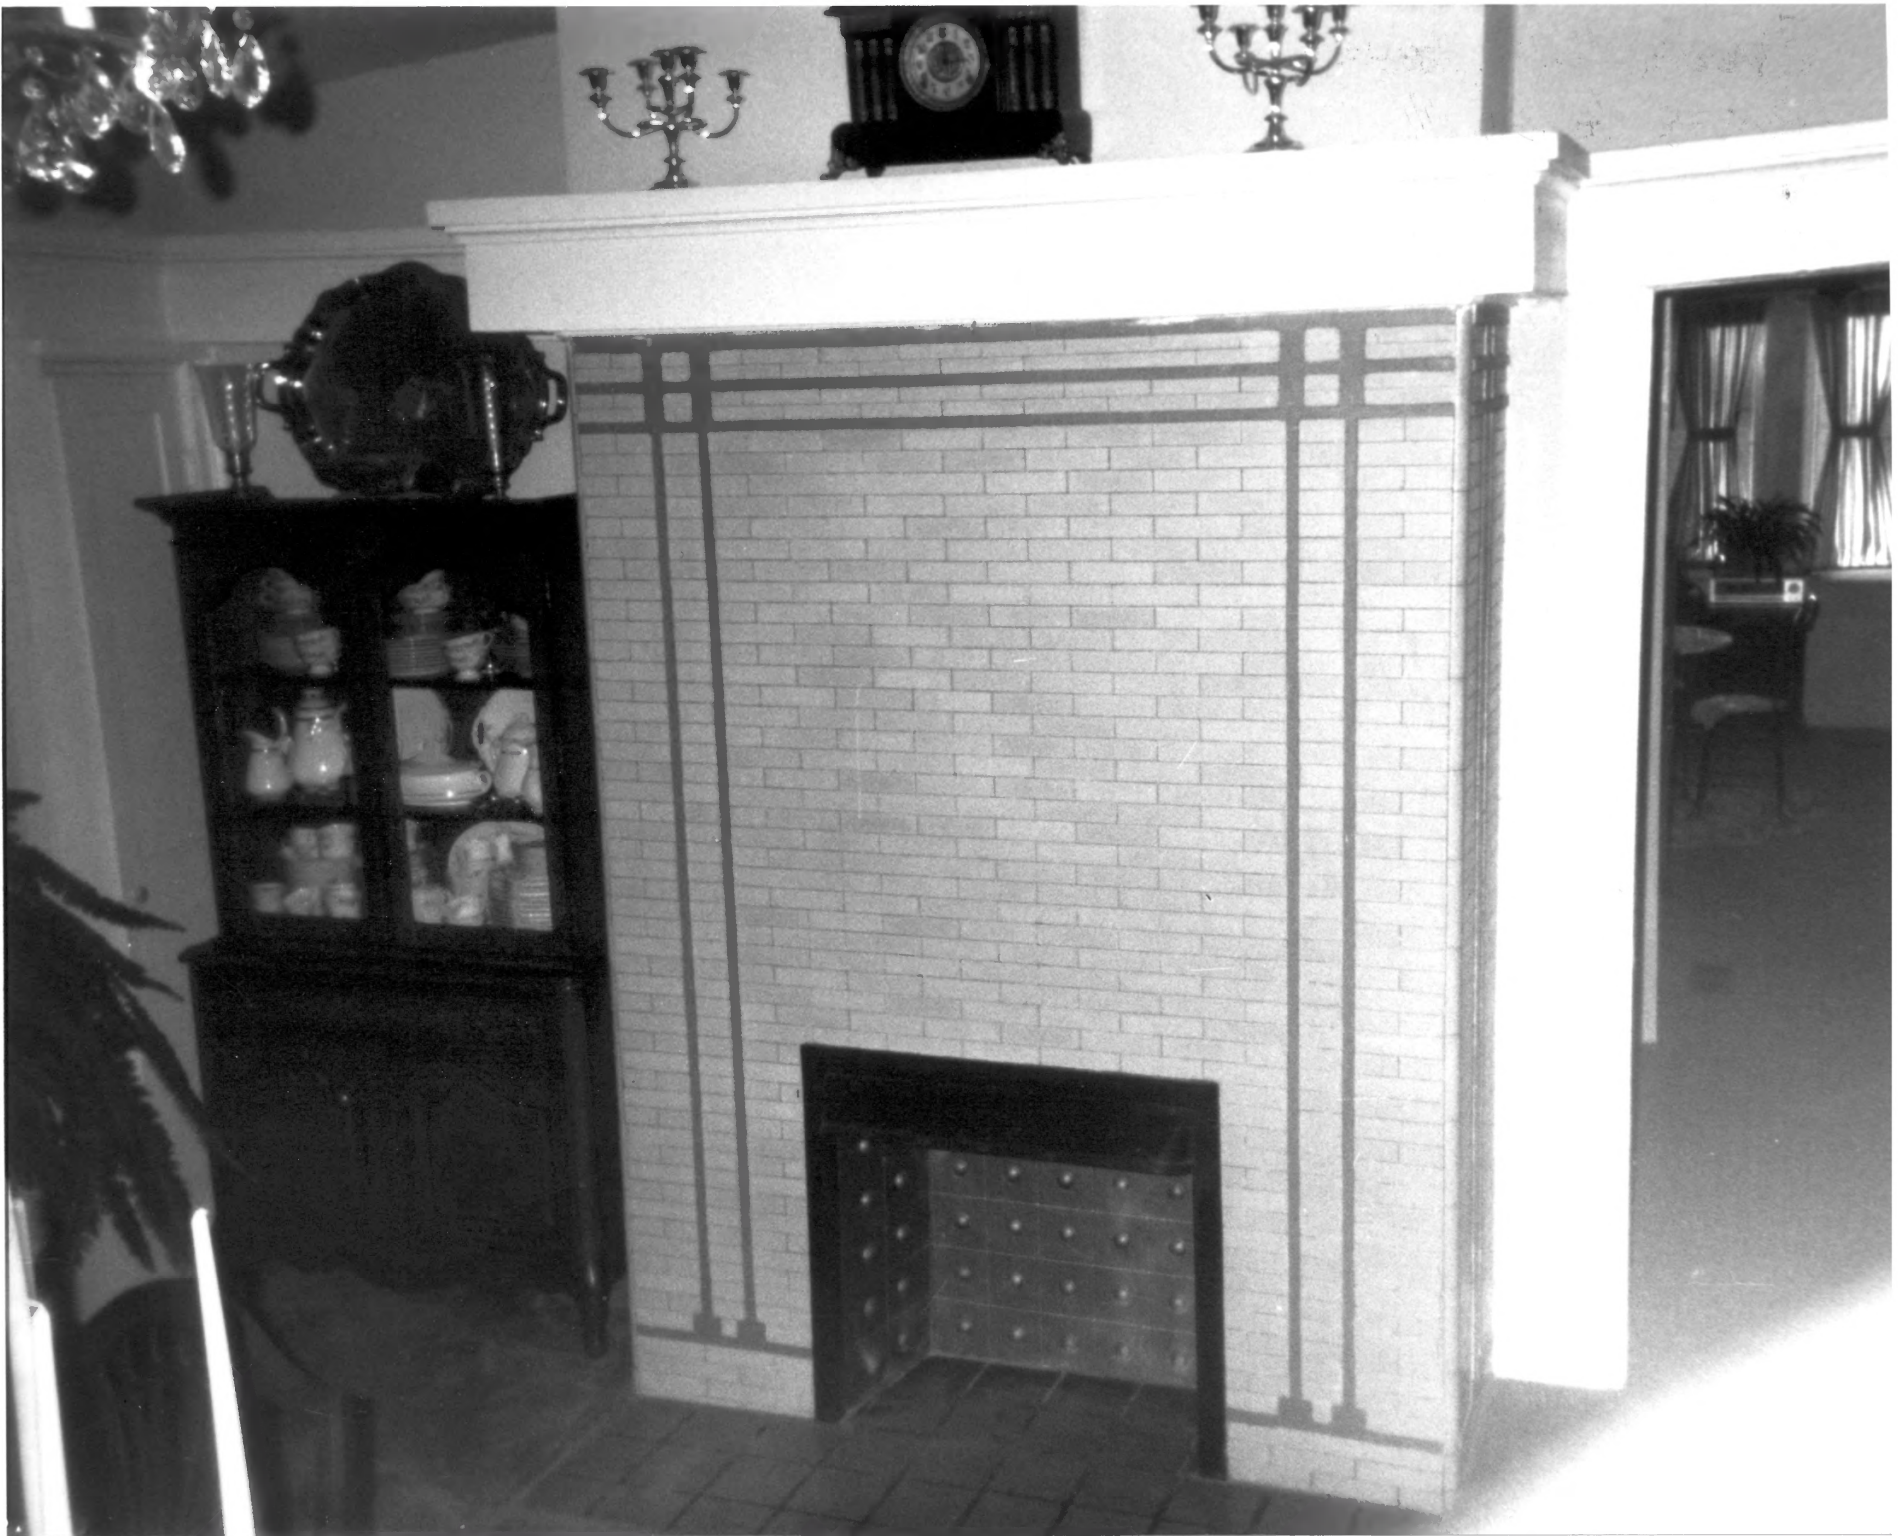
Photo 6 of 7

The house contains six unique fireplaces. The living room and sunroom fireplaces have elaborate glazed tile surrounds and integral bracketed tile mantels. The dining room fireplace is faced with glazed rectangular tile with horizontal and vertical banding of 1x1 tile. The ceramic tile faced fireplace in the master bedroom is recessed in a shallow arched opening with a shelf above the firebox. The fireplaces in the other two bedrooms have wood mantels with ceramic tile surrounds.

Photo 6 -- (6) L.C. Steele House, Detail of Dining Room Fireplace, view to west. January, 1992.

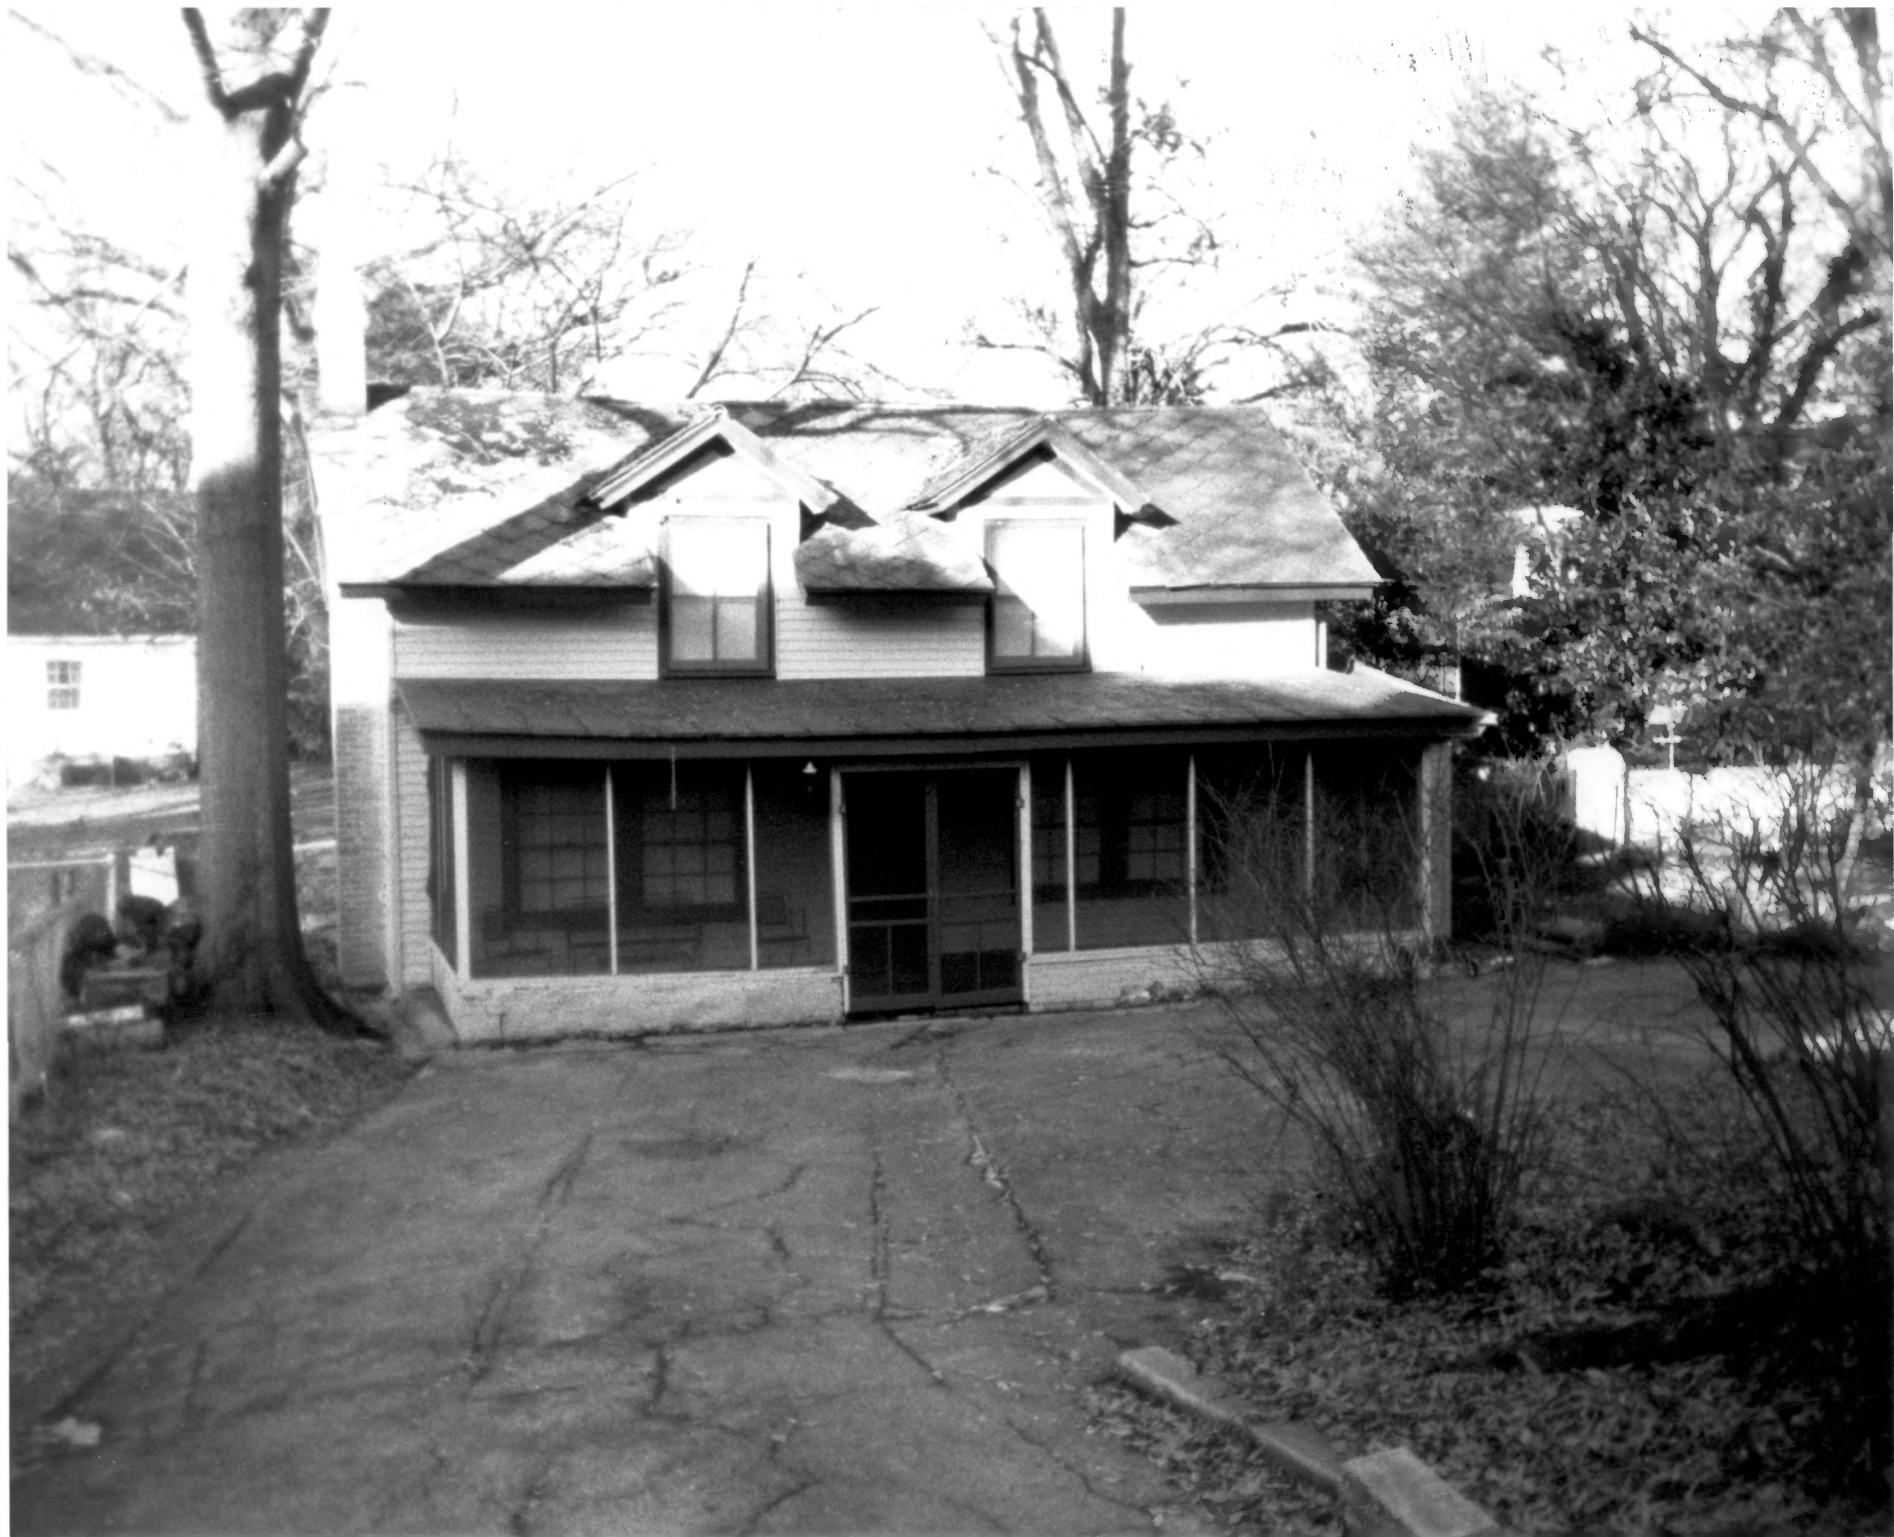
Steele, L. C., House
Photo 7 of 7

The original carriage house, located on the northwest corner of the site, is similar to the house. It is constructed of matching wood siding with half-timbering and stucco in the gable-ends. The half-dormer windows on the upper floor are two-over-two double hung sash. The double-hung windows on the lower floor contain six-over-six sash. The roof is covered with asbestos shingles.

Photo 7 -- (6) Carriage House Facade, view to north. January, 1992.
