**National Register of Historic Places
Inventory—Nomination Form**

historic 1300 Grove Street House

street & number 1300 Grove Street

city, town Vicksburg

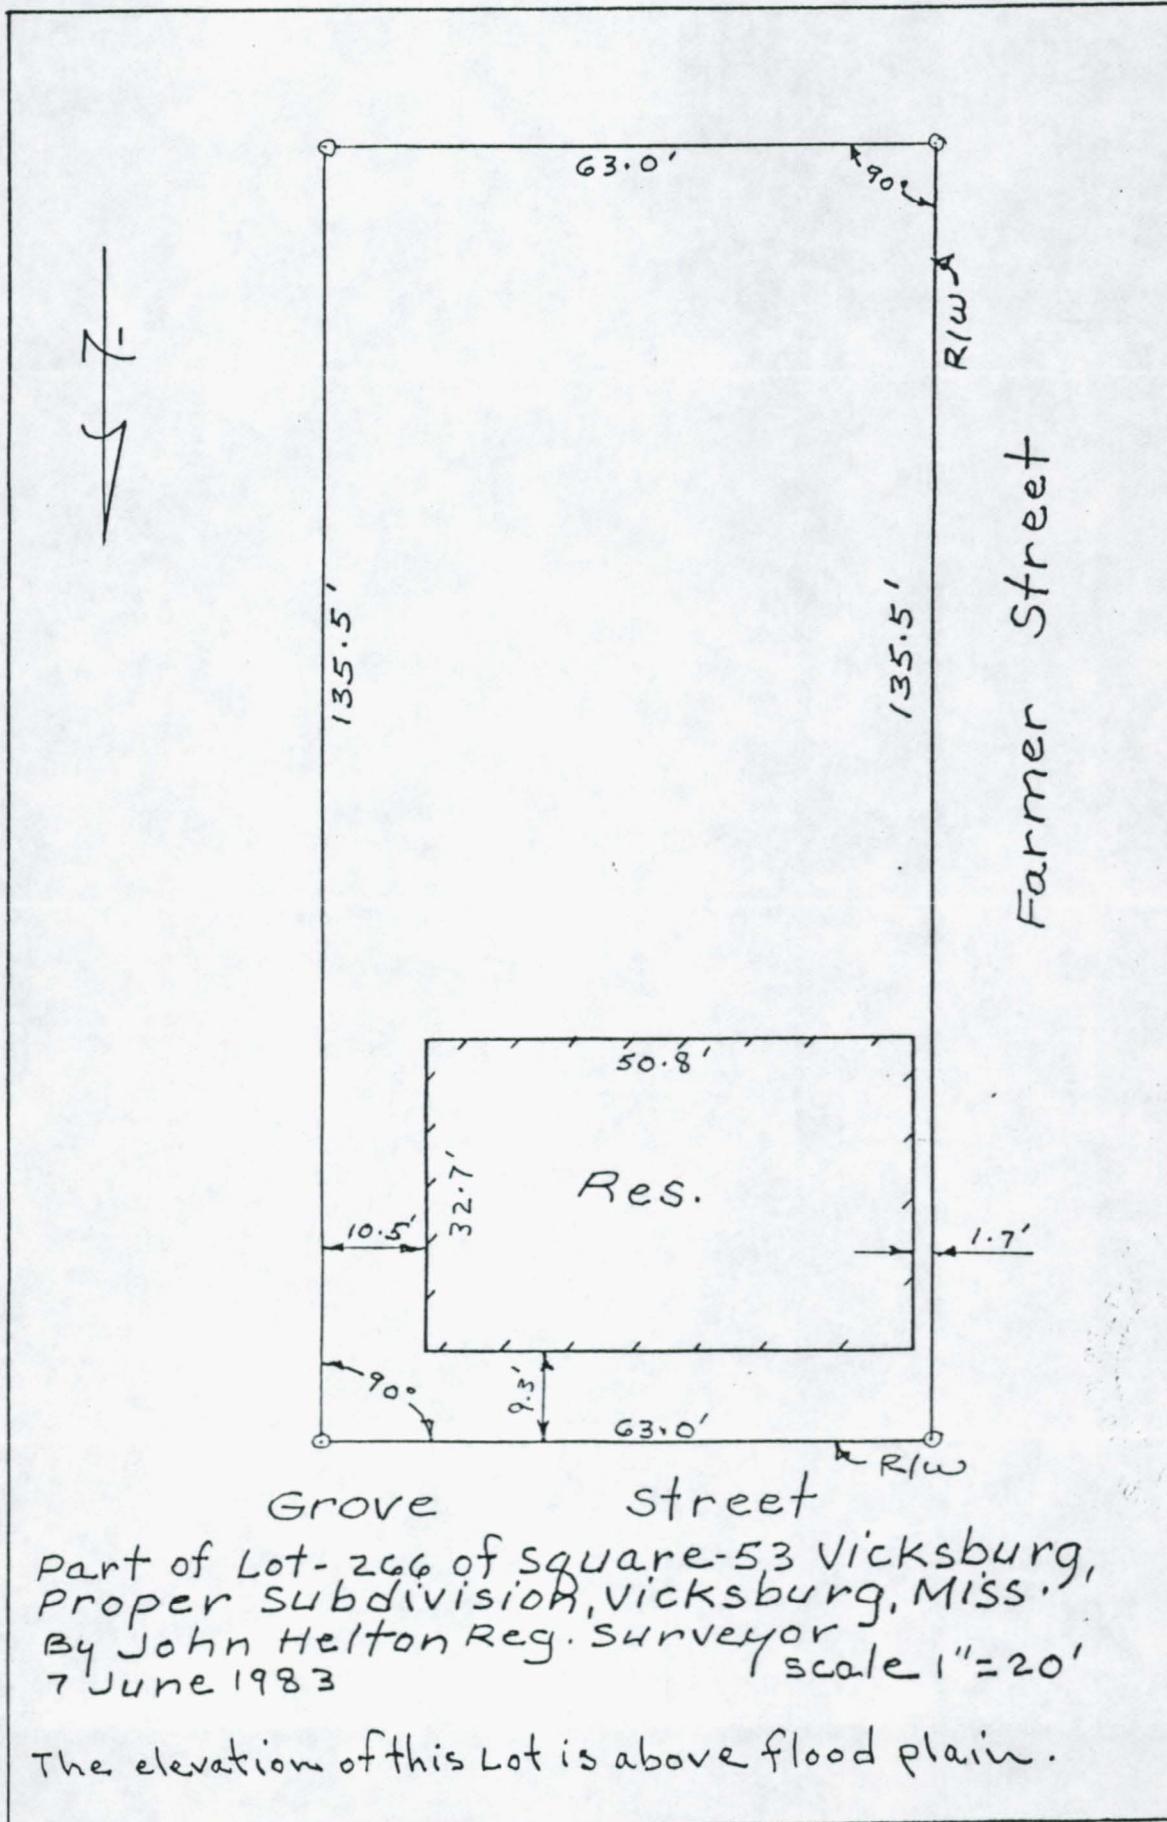
Part of Lot- 266 of square-53 Vicksburg,
Proper subdivision, Vicksburg, Miss.
By John Helton Reg. Surveyor
7 June 1983 scale 1"=20'

The elevation of this Lot is above flood plain.

Verbal boundary description and justification See enclosed copy of survey of nominated property. The nominated property is part of lot 266, square 53, of the city of Vicksburg. The property forms a four-sided figure with right angle corners. The northern and southern boundary lines are 63.0 ft. and parallel; the eastern and western boundary lines are 135.5 ft.

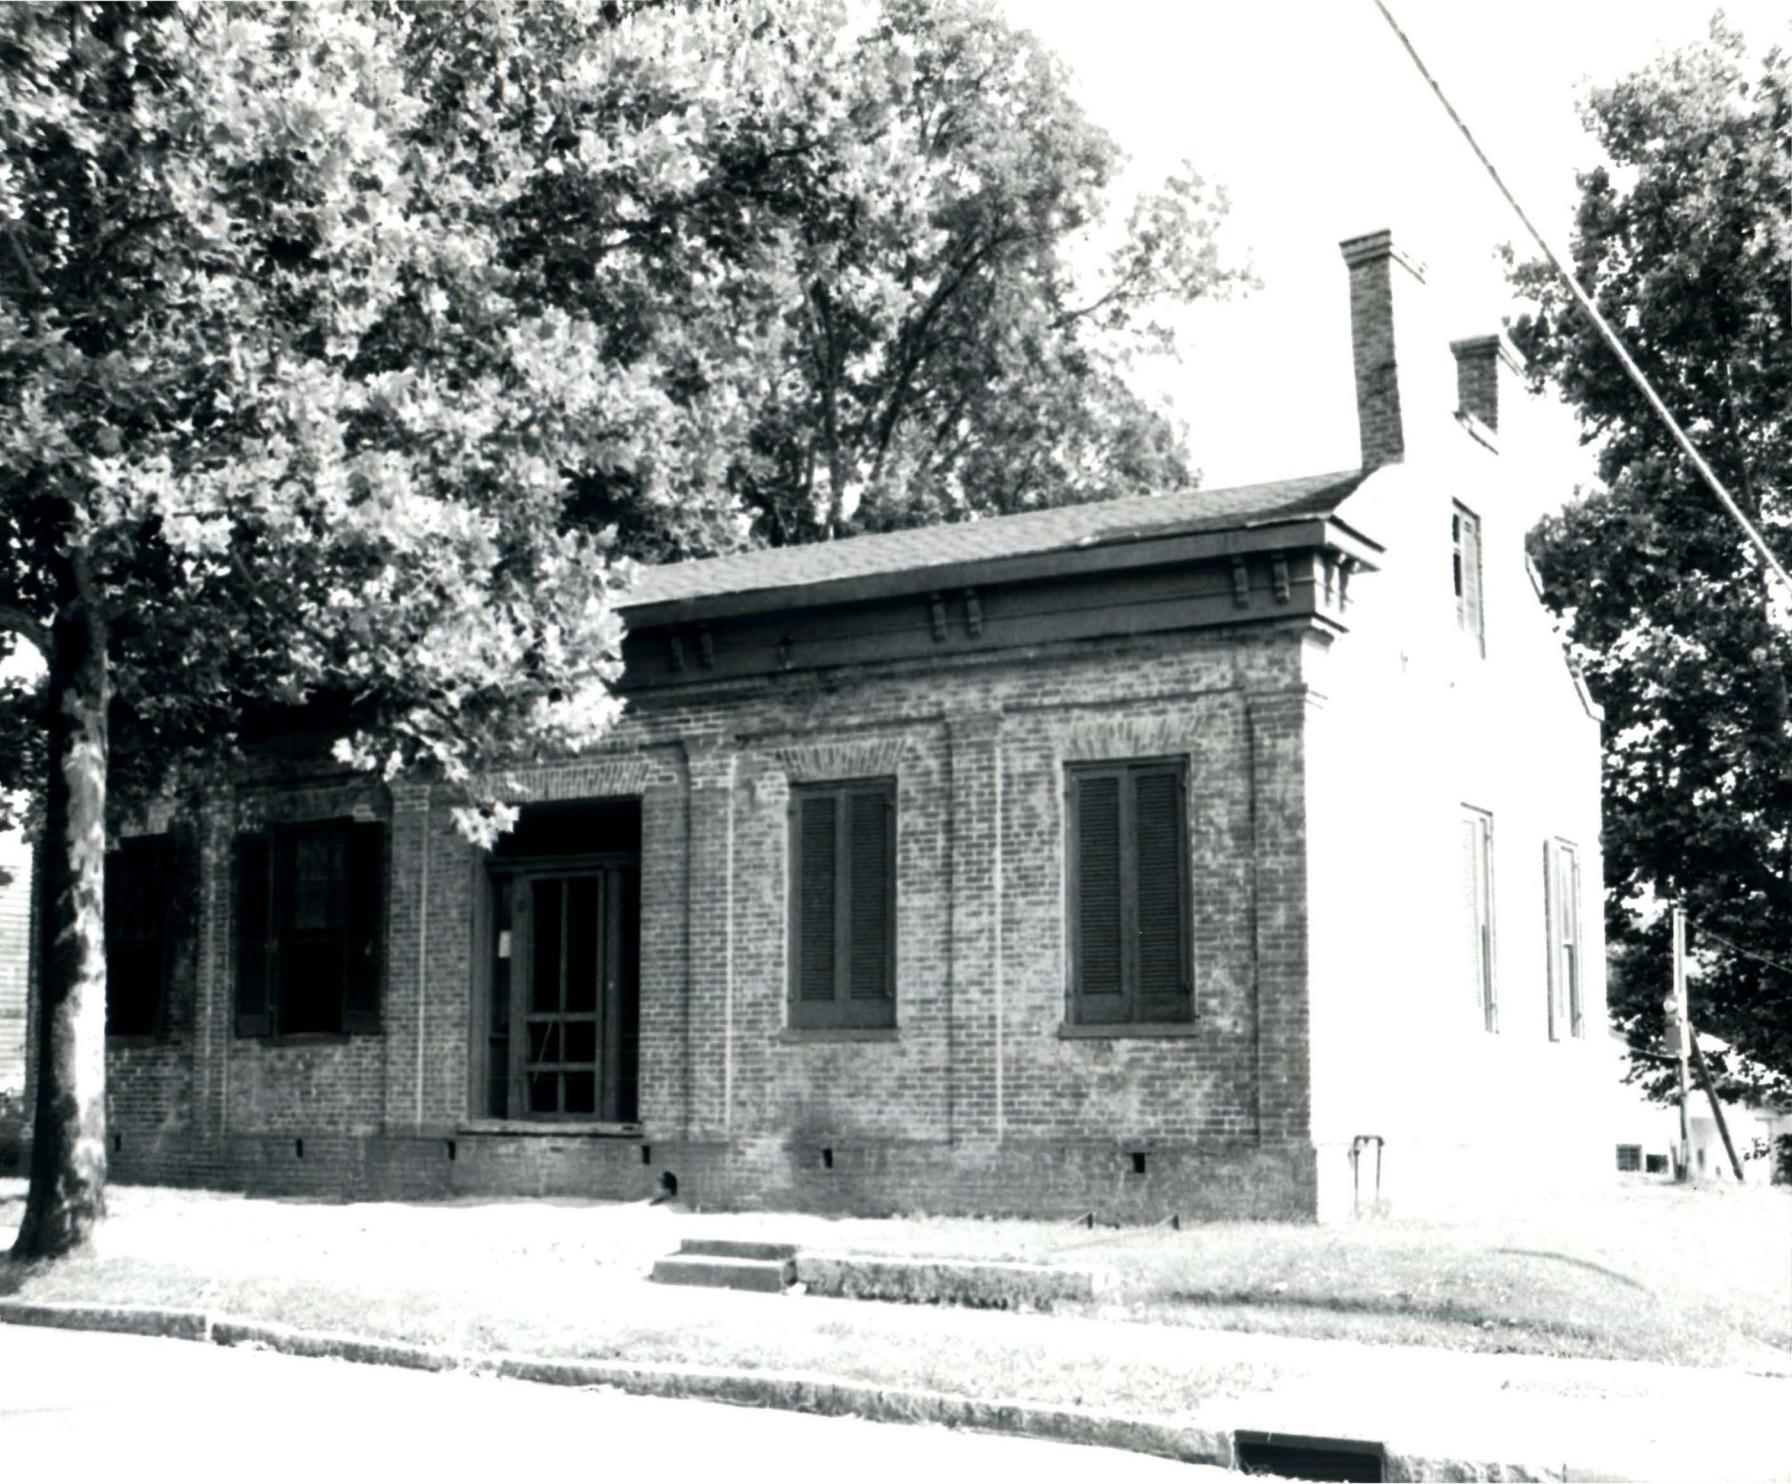
Photo 1 of 4

Looking southeasterly, the northerly facade
and western side elevation.

Located on the southeastern corner of the intersection of Grove and Farmer Streets in downtown Vicksburg, 1300 Grove Street is a one-story, brick Greek Revival residence with gabled roof and parapet gable ends. At each gable end are two brick chimneys with molded caps that are linked by a parapet curtain wall. The original brick cornice of the house is obscured by a bracketed Italianate wooden cornice that dates from the late nineteenth century. The northerly facade is a five-bay composition with the bays defined by a regionally unique treatment of brick pilasters with molded brick capitals. The pilasters rest upon a plinth, or water table, that completely encircles all elevations of the house and is pierced at intervals by narrow, upright, open vents.

The window and door openings are topped by flat arches, and all windows of the house are filled with six-over-six, double-hung sash and are closed by original shutter blinds. The center-bay entrance doorway, which features a single-leaf, molded, four-panel door, enframed by transom and sidelights over unmolded panels, was originally accessed by a small flight of steps, either of brick or wood, that were replaced by a larger concrete porch. A site investigation has revealed the remnants of a herringbone brick walk that provides physical evidence for the width and depth of the original entry steps.

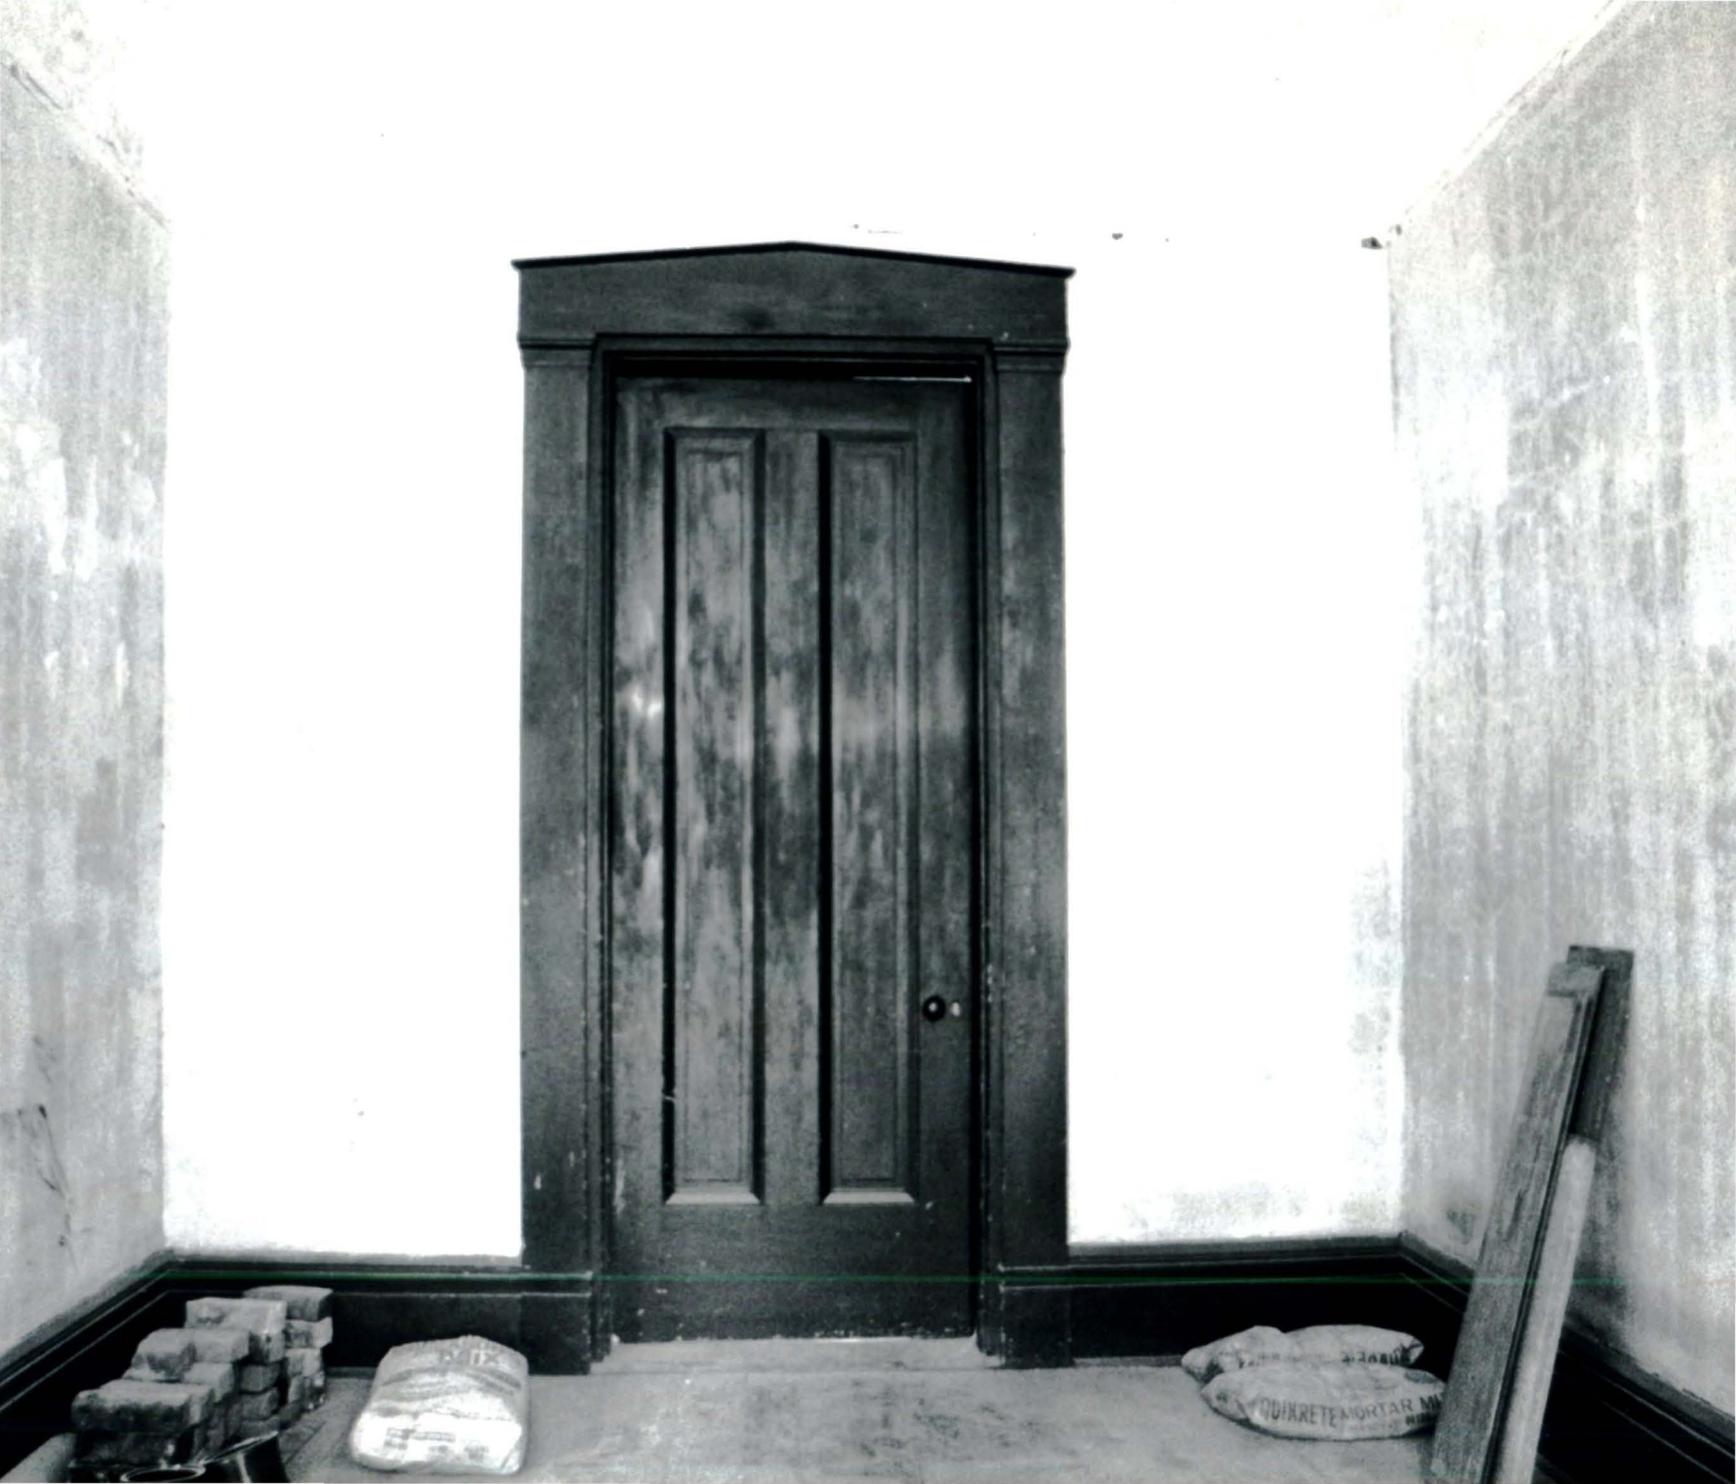
Photo 2 of 4

Looking southerly, the entrance hallway.

The interior plan of the house is a regionally typical double-pile plan. An entrance hallway extends one room deep and then widens at the rear of the house to become a principal room flanked by smaller rooms, or what are regionally referred to as "cabinet" rooms. The entrance hallway and flanking large rooms are identically trimmed and feature door and window surrounds that are pilastered with peaked and molded cornices and windows that are set over unmolded panels. The hallway and eastern front room have foliated plaster ceiling centerpieces and molded plaster cornices, but the upper portion of the walls and ceiling in the western front room, which probably also had decorative plaster, have been sheetrocked. The rear rooms are more plainly trimmed in that the door and window surrounds are unmolded and the windows are not set over panels. All interior doors have two molded and fielded panels, all mantel pieces are wooden and pilastered, and the bases throughout the house are molded with two fascia.

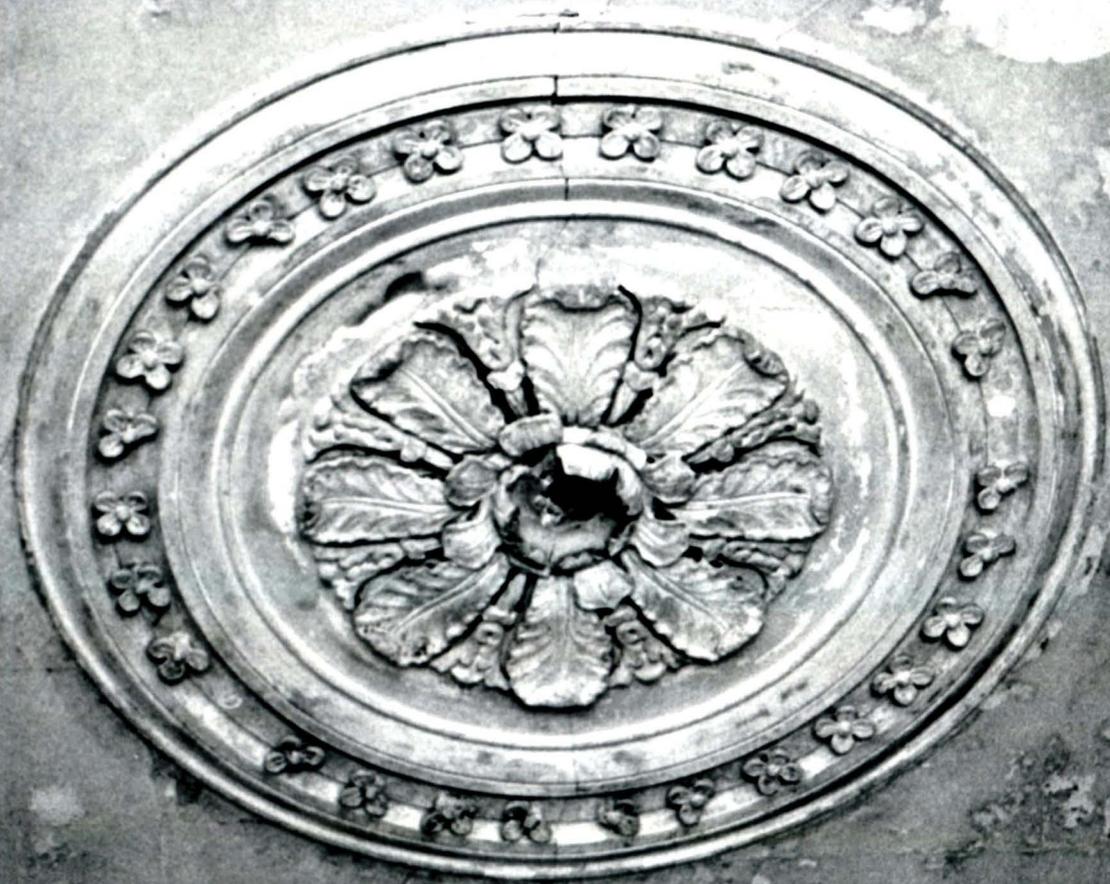
Photo 3 of 4

Looking skyward, the plaster ceiling centerpiece of the entrance hallway.

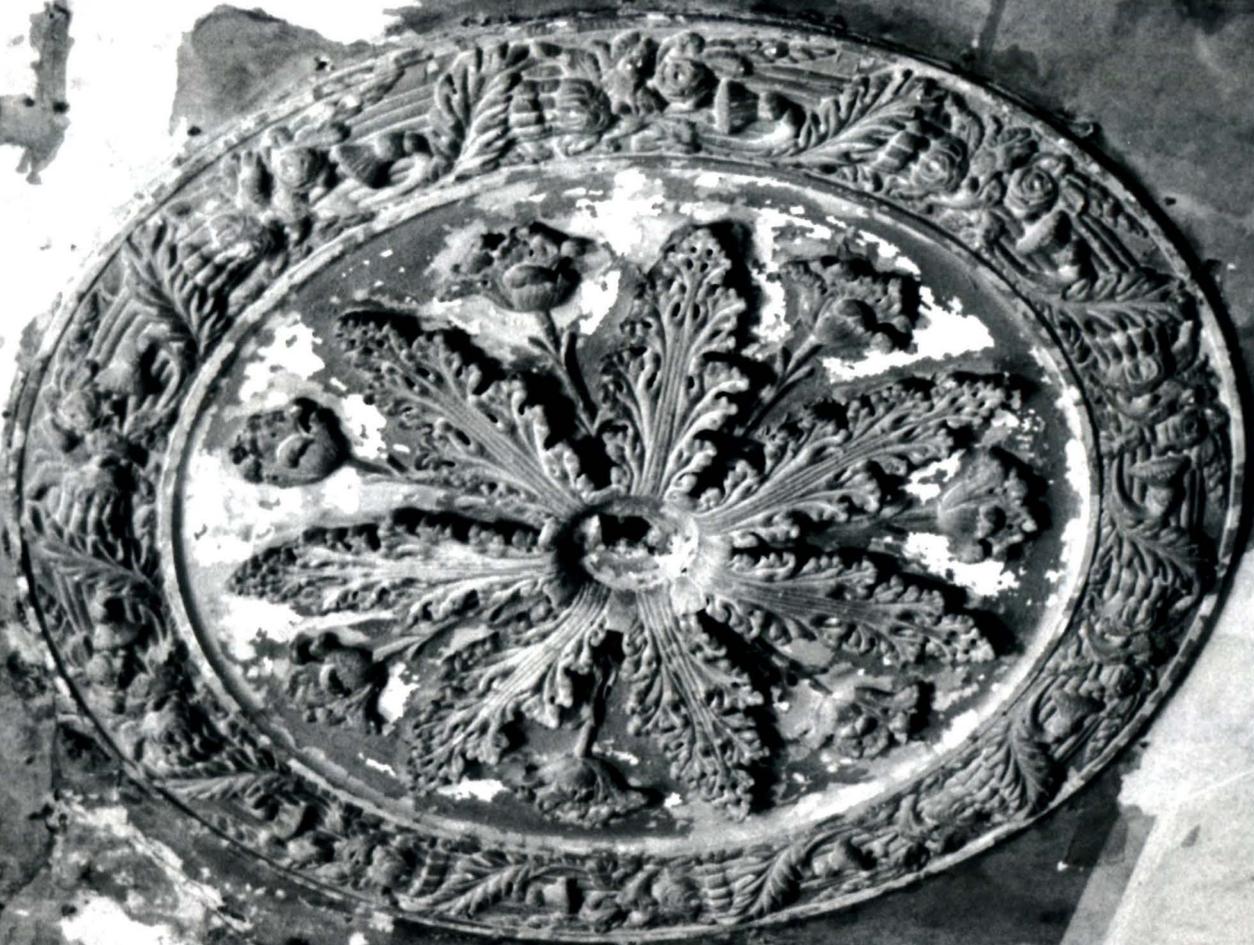
Photo 4 of 4

Looking skyward, the plaster ceiling center-piece of the easterly front room.
