National Register of Historic Places  
Registration Form

historic name Stonewall Mill Village Historic District  
other names/site number Stonewall

Clarke County, Mississippi  
Multiple Property Submission  
Stonewall Mill Village  
Historic District

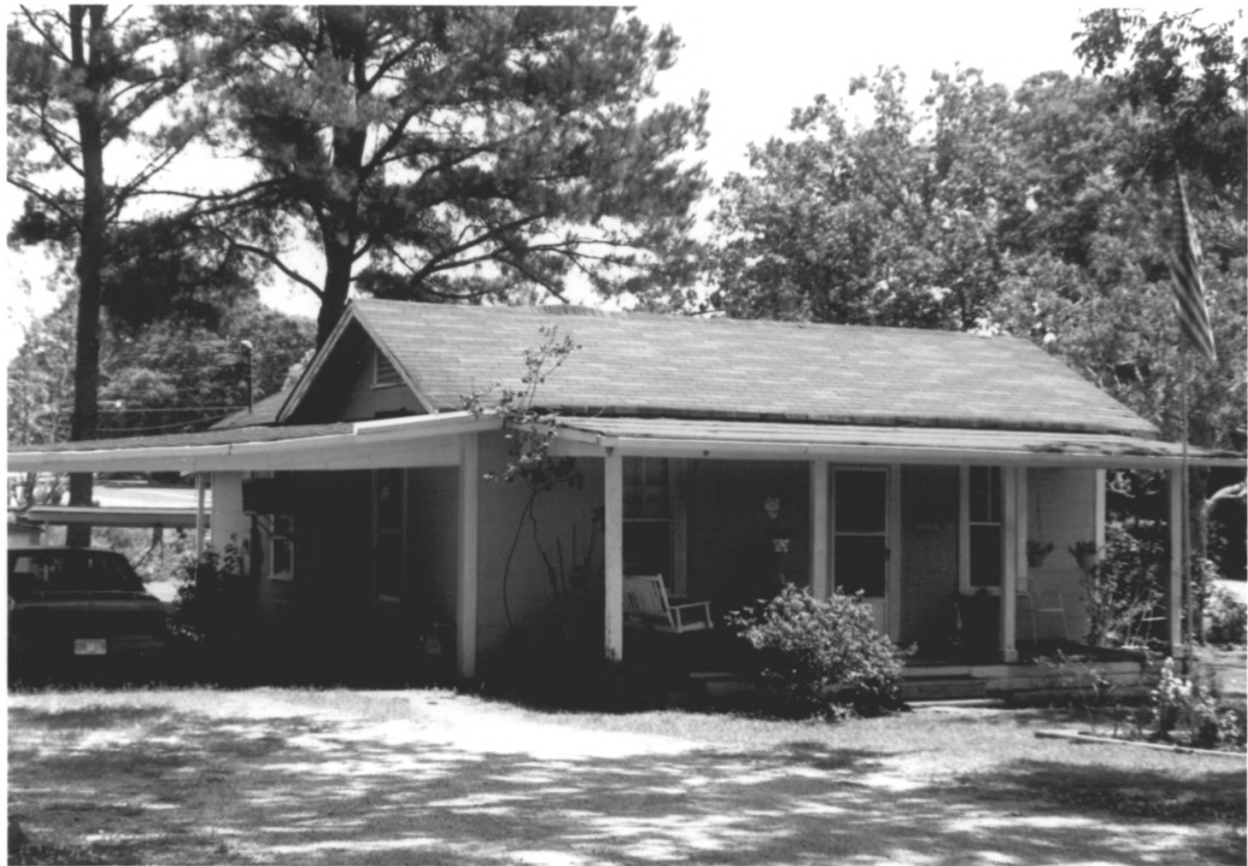
Photo 1 of 14

NEc of Allen & Erwin, Stonewall Mill  
Village Historic District  
Clarke Co. MS

1. C House (c. 1875)  
NE corner of Allen Ave. & Erwin Road  
Clad in asbestos shingles, this eave-oriented house retains its original 3 bay wide configuration and has a full-width front porch with simple posts supporting a shed roof. Located in the porch area is a single-leaf door flanked by 4/4 double hung sash windows. The majority of windows are 4/4 double hung sash. On the north (side) elevation is a carport. A wing and a porch were added to the rear elevation. The house appears to have a brick foundation. It is reputed to be the oldest house in Stonewall (Annie Purnell interview, 12 May 1993).

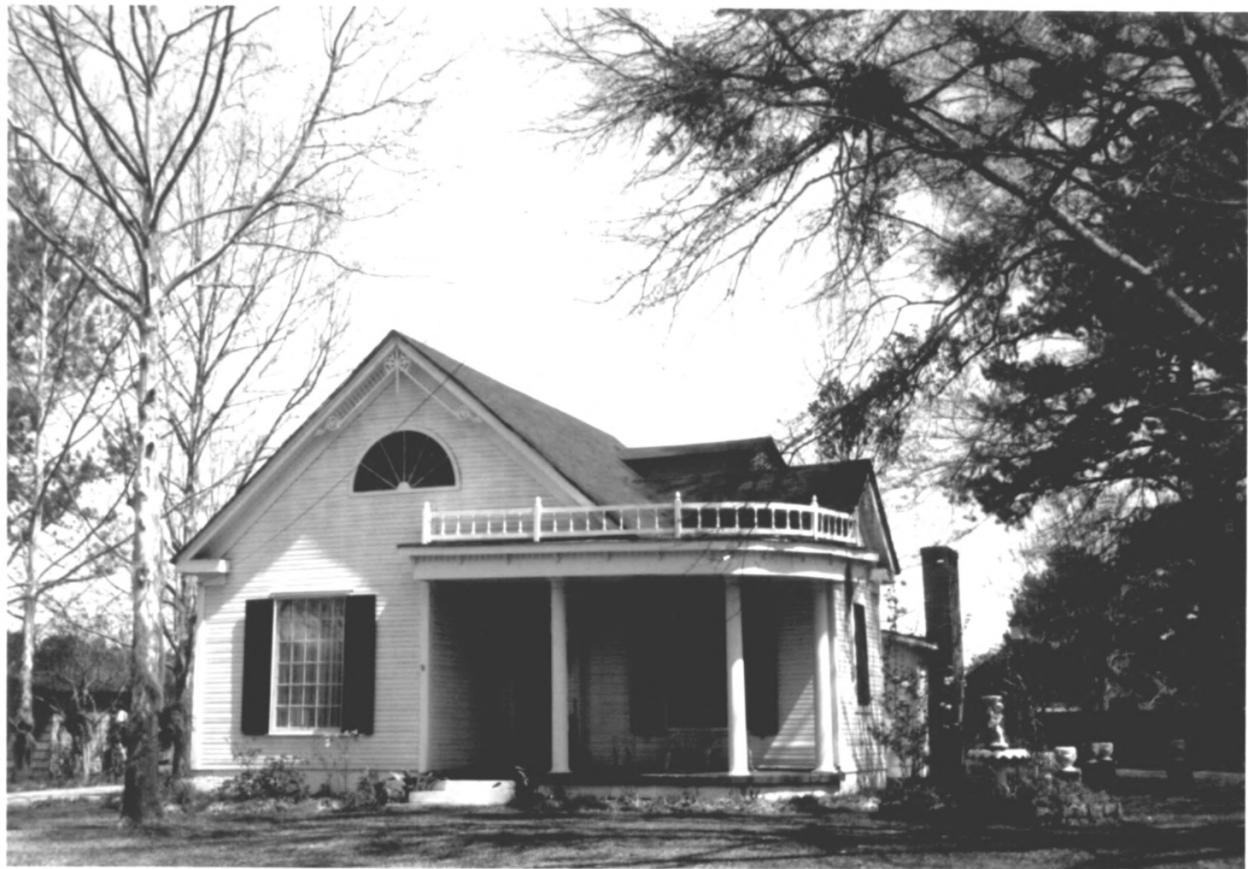
112 Erwin Rd.  
Stonewall Mill Village Historic District  
Clarke Co., MS  
Photo 2 of 14

25. NC House (c. 1905)  
112 Erwin Road  
This three by three bay, gable-oriented house with a side gabled wing has been "colonialized". Its porch now extends across the length of the side wing and features Tuscan columns. The porch roof is topped by a balustrade. The attic vent in the front gable has been replaced by a fanlight. The front windows have been replaced by large, multi-light windows.

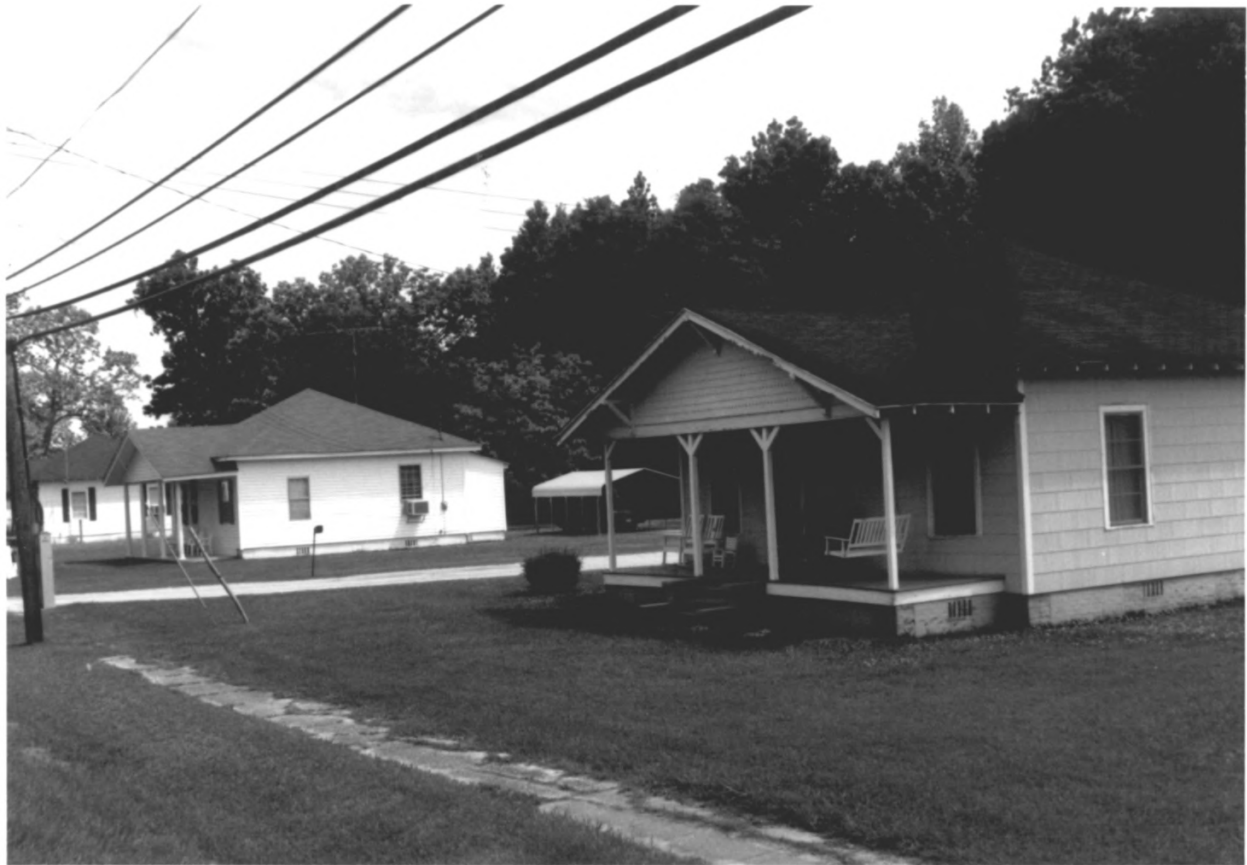
401 + 1 East of 401 Erwin Rd.  
Stonewall Mill Village Historic District  
Clarke Co., MS  
Photo 5 of 14

49. NC House (c. 1915/c. 1920)  
1 east of 401 Erwin Road  
This three by two bay cube is crowned by a pyramidal roof and clad in aluminum siding. The decking of its full-width front porch was removed and replaced by a concrete slab. The original posts have been replaced by Tuscan columns. In the porch area, brick steps lead up to the entrance. There are a variety of window styles.

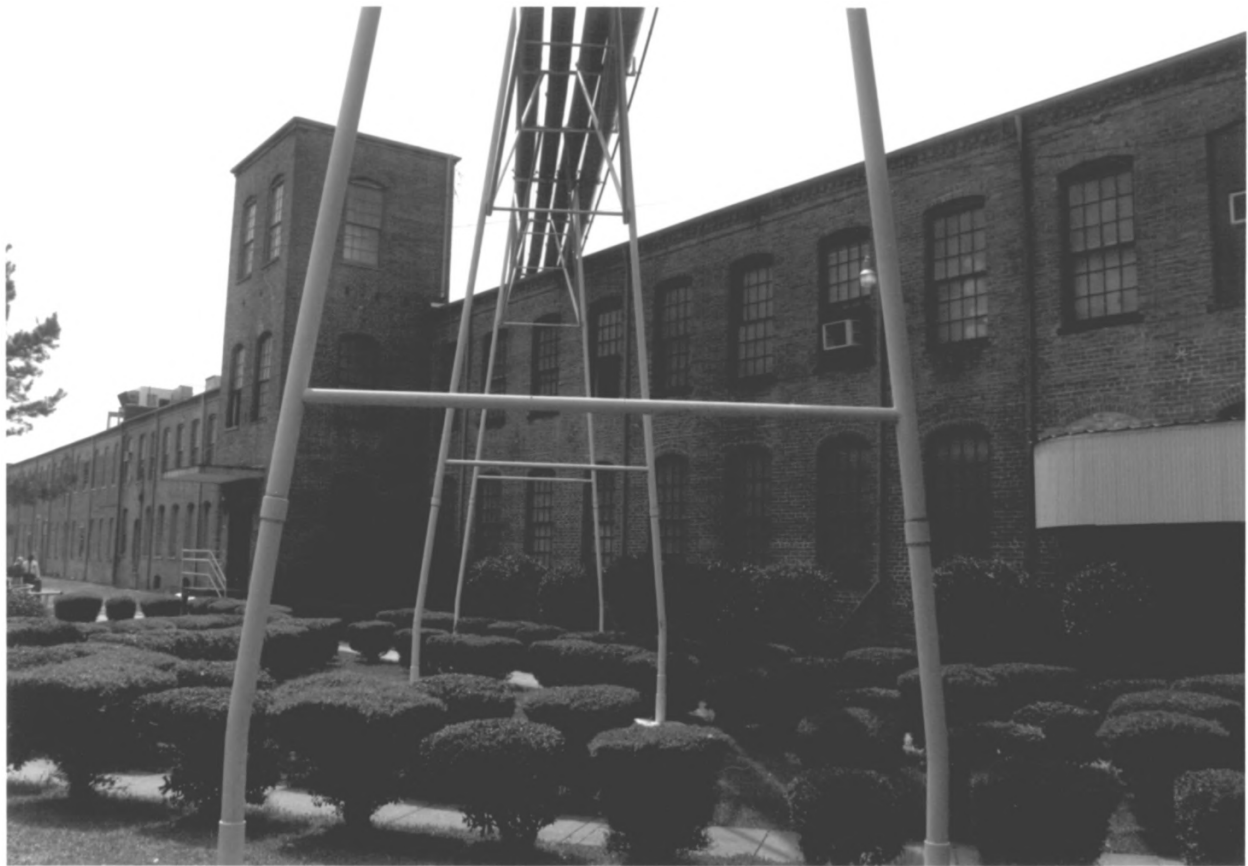
M. 1 - Stonewall Cotton Mills  
Stonewall Mill Village Historic District  
Clarke Co. MS  
Photo 6 of 14

Mill #1 of the Stonewall Cotton Mills still functions as a textile mill. It is a brick, two story industrial building marked by a three story, square tower on its east elevation. The 45 bay by 5 bay building rests on a high brick foundation. The mill consists of two distinct sections--the southernmost section of the building, which is eighteen bays long, and the northern section, which is twenty-seven bays long. Many of the windows are boarded up, but those left intact are 12/12 double hung sash with brick, segmental arches and either brick sills or wood sills. The northernmost section of the mill has the wood sills and the eighteen southernmost bays feature the brick sills. Simple brick corbelling serves as the cornice. Circa 1950, the narrow, north elevation of Mill #1 was attached to an addition of Mill #2.

The construction history of Mill #1 is somewhat convoluted. The Stonewall Manufacturing Company was founded in 1867 and incorporated under that name in 1870. Therefore, the first mill must have been constructed between 1867 and 1870. According to Roper, the first mill building was 65 feet by 60 feet, two

stories tall and had a wing containing engine and boiler rooms. Beginning in 1879, the mill was improved and the business expanded. The capacity of the mill was doubled in 1882 with the bricklaying begun on May 1 of that year (Roper 1947:n.p. & The Clarke County Times, July 1905:n.p.).

In 1885, the mill was almost 225 feet long and about 36 feet wide. The northernmost section of the building was approximately 125 feet long and one story tall with a basement. It had a square, two story tower located in about the middle of its east elevation. The weaving was done on the first floor and the shafting was done in the basement. Occasionally, manufactured goods were also stored here. The southernmost section of the mill was almost 200 feet long and two stories tall. The carding took place on the first floor and the spinning was done on the second floor. On this section's southwest corner was a rectangular, one story wing that housed the picker room and the loose cotton room. At the northwest end of the section was an L-shaped wing which housed a repair shop and perhaps the engine and boiler rooms (Sanborn Fire Insurance Map 1885).

A second story was added to part of Mill #1 in 1889 to house the yarn production. The 1890 Sanborn Map depicted a mill building that was the same dimensions as in 1885 but was completely two story. Its tower was three stories tall and contained a water tank. The wings were still extant and the one on the southwest corner had been enlarged. Now, the northern section of the mill housed the weaving, spinning, spooling and warping activities on its first and second floors (Roper 1947:n.p. & Sanborn Fire Insurance Map 1890).

Fire broke out in the old section of Mill #1 in 1902 and ruined that part of the building. It is believed that the oldest part of the mill comprised at least a portion of the southern section. The loss of that part of the mill and its machinery totalled \$58,000.00. This loss was covered by insurance and the Stonewall Cotton Mills added \$25,000.00 more to rebuild that portion of Mill #1. According to local historian Eugene Roper, the mill was also enlarged in 1902 but the Sanborn Maps do not bear this out. Mill #1 had essentially the same configuration from 1902 until at least 1926 with the only exception being an opener room that was added to the south elevation of the picker room which was on the southwest corner of the mill. Mill #1 was attached to Mill #2 at some point after the period of significance (Roper 1947:n.p. & Sanborn Fire Insurance Maps 1900, 1906).

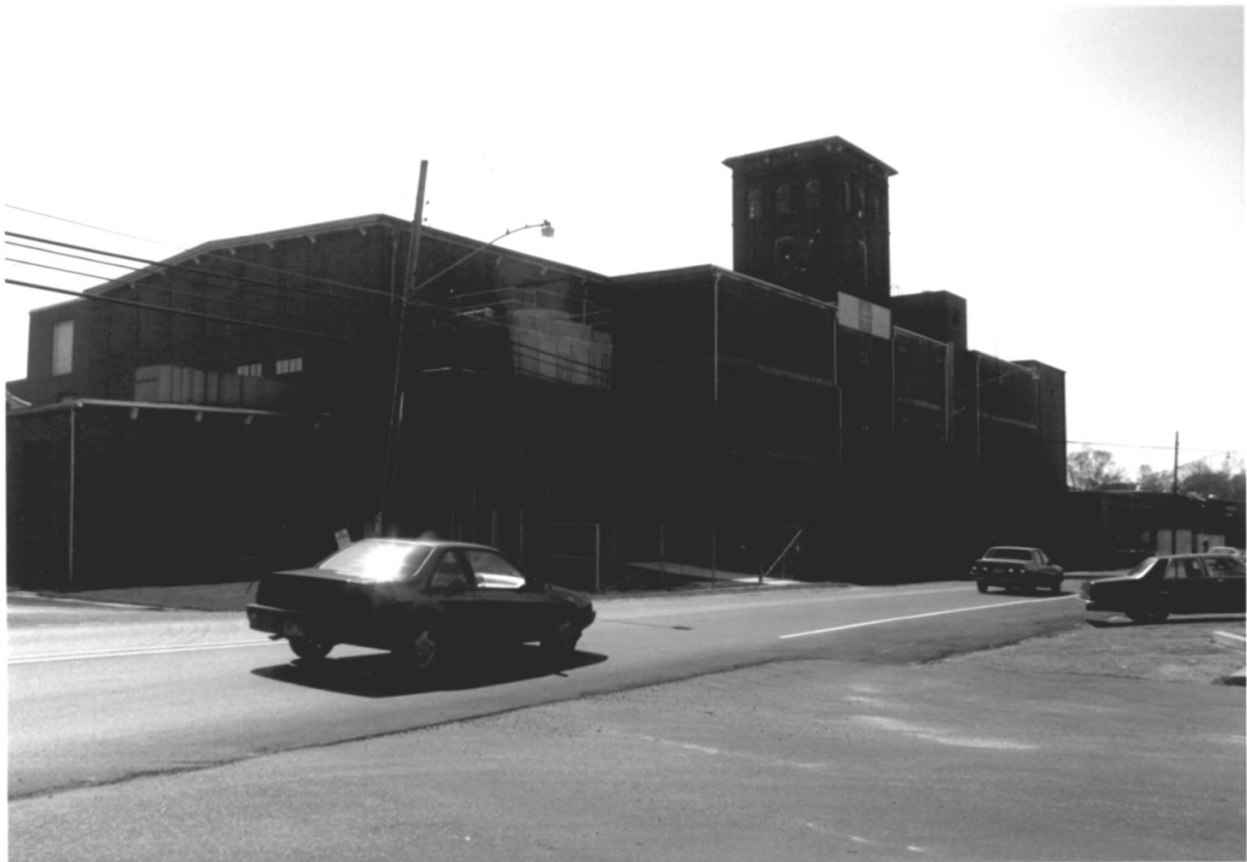
Photo 7 of 14

Mill #2 - Stonewall Cotton Mills  
Stonewall Mill Village Historic District

Mill #2 is a three story, seven bay deep, brick building with a broad gable roof accented by brackets. A five story, square water tower marks the mill's north elevation. On the tower's lower three stories the large window openings have been almost totally bricked in but display small four light windows. However, the water tower features decorative brick corbelling, round arched 6/6 double hung sash windows and segmental arched 9/9 double hung sash windows on its top two stories. The tower's roof is accented by brackets like the main roof. Three story additions dating from after the period of significance flank the water tower. There is also a one story addition on the northeast section of the north elevation. Most of Mill #2's windows have been totally or at least partially bricked up. Mill #1 now connects to Mill #2 on the latter building's south elevation.

Construction on Mill #2 began in October 1895. The mill cost \$250,000.00 to construct and contained ten thousand spindles and about three hundred looms to manufacture medium-weight sheeting. Two years later, \$50,000.00 was expended to enlarge Mill #2. The mill now housed fourteen thousand spindles of which four hundred were for hosiery and other yarns. Auxiliary machinery such as eleven carding machines and pickers were also purchased. Mill #2 was described by The Clarke County Times in 1905 as "a model and modern cotton mill, with all of the latest and most approved improvements known to cotton mill experts" (The Clarke County Times, July 1905:n.p. & Roper 1947:n.p.).

Mill #2 was somewhat U-shaped in 1900. On its southeast corner was a square, one story wing that housed the cloth room. A long, rectangular, one story wing on its southwest corner contained at least one engine. The weaving was done on the first floor of the mill, the carding on the second and the spinning on the third. The westernmost section of the mill housed the pickers and a dust room. The only major change to Mill #2 by 1906 was a platform which connected the cloth room to Mill #1. Between 1912 and 1926 a one story addition was constructed on the east (side) elevation of the mill. The depth of the addition equalled the combined depths of the main body of Mill #2 and its cloth room (Sanborn Fire Insurance Maps 1900, 1906, 1912, 1926).

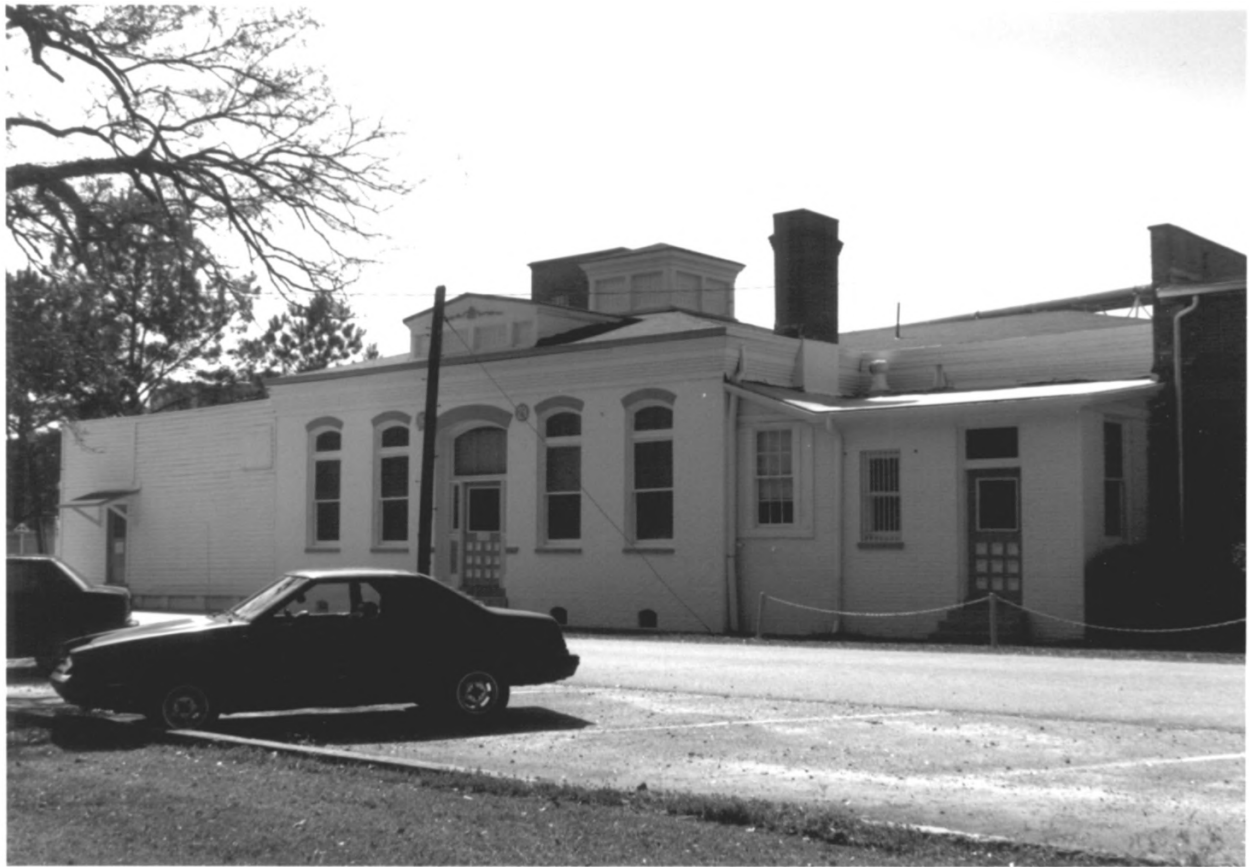
Stonewall Cotton Mills Office Building  
Stonewall Mill Village Historic District  
Clarke Co., MS  
Photo 8 of 11

The Stonewall Cotton Mills Office Building is still utilized as an office today. The one story brick building features a cornice of corbelled brick and a low hip roof

crowned by a square lantern. The front elevation of the roof displays a small gable. The multi-light windows of the gable and the lantern have been painted. The original five bay front facade of the building is comprised of a central, single-leaf door flanked by sidelights and capped by a large, segmental arched transom. This frontispiece is flanked by 1/1 double hung sash windows with brick slipsills and segmental arched transoms. On the south (side) elevation of the building is a one story, frame addition that was added after 1926 and is probably post-historic. The north (side) elevation has an exterior, corbelled brick chimney and several historic and post-historic brick additions. This elevation of the office building was connected to Mill #2 by 1950. The building's interior retains many of its original design elements such as wood wainscoting, seven panel and multi-panel doors and the door surrounds with their bull's eye corner blocks (Sanborn Fire Insurance Map 1926; Stonewall Scrapbook:n.p. & personal tour of building 26 March 1993).

This office building was constructed at about the same time as Mill #2. The latter building was erected on the site of three one-story office buildings described as the doctor's office, the general office and simply an office. The demolition of these three structures necessitated the construction of a new office building. As originally built, the structure was an almost square, one story, brick building with a small, one-story wing on its north elevation. In the ell created by this wing was a porch. A separate wraparound gallery extended across the front facade and the south (side) elevation. The office building retained this configuration until at least 1912. By 1926 a narrow addition had been added to the north side of the wing and its length equalled that of the wing and the porch combined. Today, the porch has either been enclosed or removed and there is a brick addition in the ell created by the wing. It was probably added prior to 1950 (Sanborn Fire Insurance Maps 1895, 1900, 1912, 1926 & Stonewall Scrapbook:n.p.).

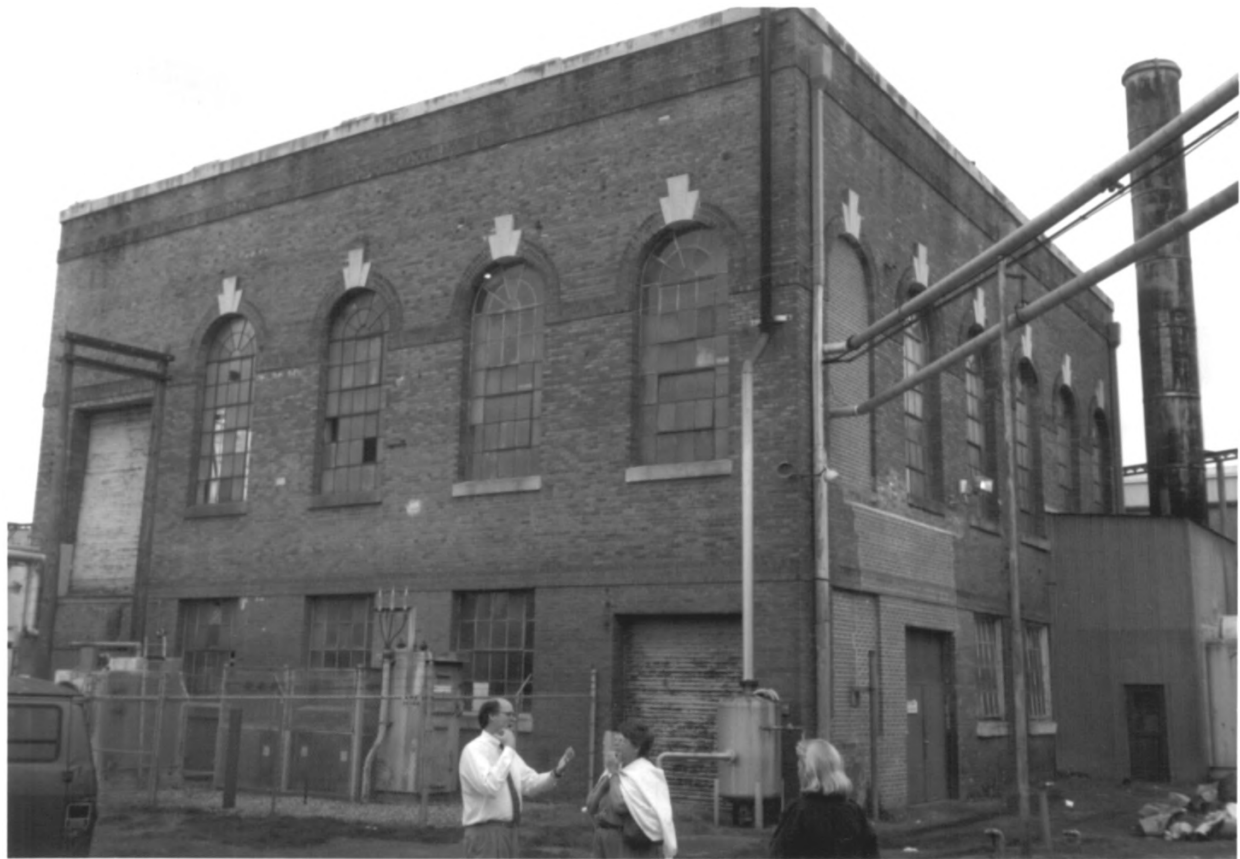
Photo 9 of 14

Powerhouse - Stonewall Cotton Mills  
Stonewall Mill Village Historic District  
Clarke Co., MS

This two-story, five-by-six bay, brick building is vaguely classical in design. Its first story features several entrances and multi-light windows with slipsills. The windows are positioned just below a brick beltcourse which encircles the building and serves as a continuous lintel. The round arched, multi-light windows of the second story feature slipsills and keystones. The arches of the windows are delineated in a decorative brick pattern and are "connected" to each other by a beltcourse. Another beltcourse near the top of the building outlines a simple frieze. On the east elevation one of the round arched windows has been bricked

up and new brickwork has been laid near the south corner of this elevation. The east elevation is also marked by a one story addition clad in corrugated tin.

Construction of this powerhouse was begun circa 1921 in order to provide the cotton mills with electricity. By 1926 it was housing four boilers and a dynamo (Doylene Davis Files; Roper 1947:n.p. & Sanborn Fire Insurance Map 1926).
