# National Register of Historic Places Registration Form

historic name North Elm Street Historic District  
other names/site number \_\_\_\_\_

city or town Hernando  vicinity

state Mississippi code MS county DeSoto code 033 zip code 38632

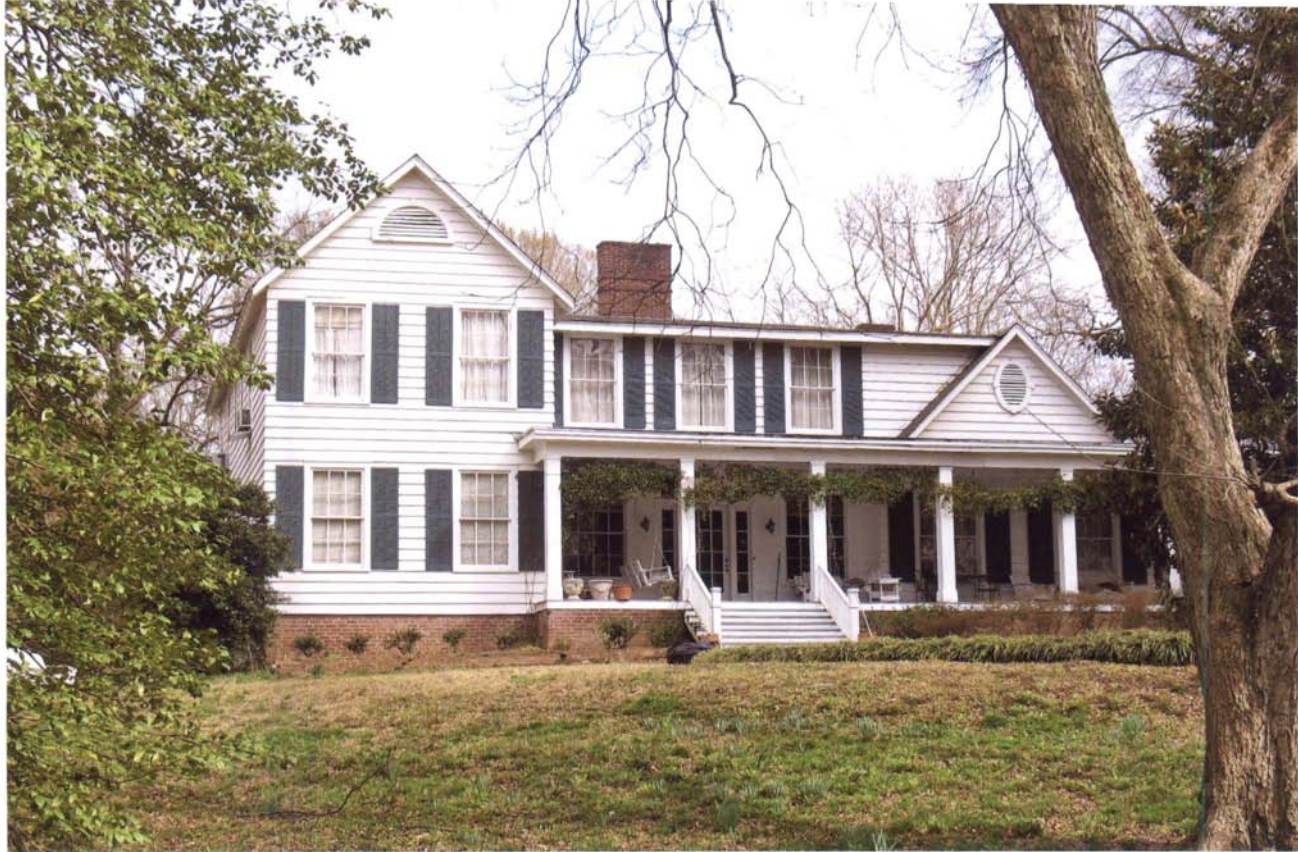
Photo 1 of 15

- 8. (C) 2310 Elm Street, North c. 1880**  
Two-story, residence with a cross-gable roof of asphalt shingles on a brick foundation. Partial width, projecting entry porch supported by wood box columns, with capitals and bases, on a wood porch deck with wood steps. The facade on the first floor is seven-bays (W, W, W, D, W, W, W) and five-bays (W, W, W, W, W) on the second floor. All windows are 6/6 wood double hung sash except the four under the porch which are all 8/8 wood double hung sash. All of the windows, except for the two flanking the entry door have applied louvered shutters. The entry door is wood with fifteen lights flanked by five light sidelights. In the gable to the left there is an arched louvered vent and in the other there is an oval louvered vent. There is a massive internal brick chimney visible. Eaves are boxed. There is a large side facing gable roof addition to the right side of the house which is open and supported by wood box columns. (Photo 1)

2310 N. Elm St.

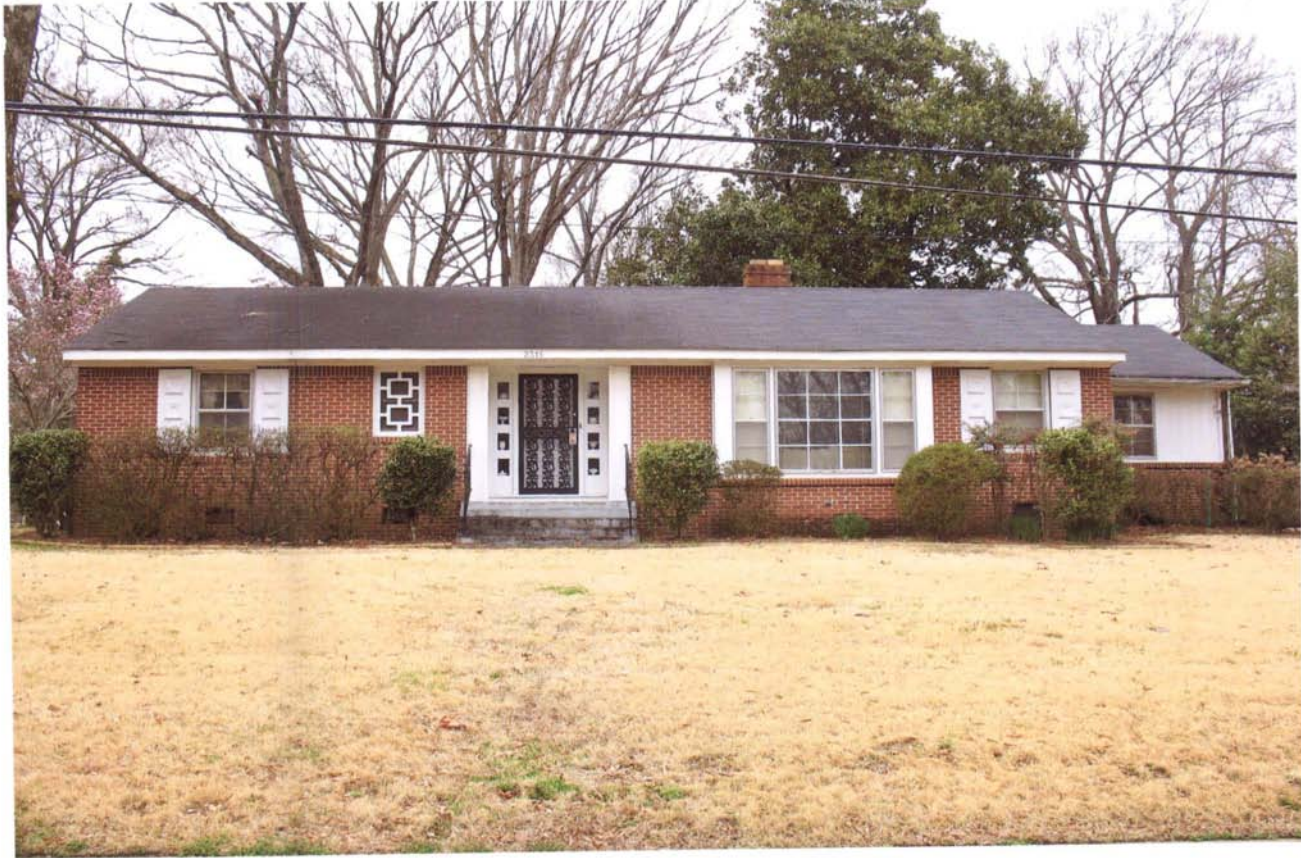
Photo 2 of 15

- 9. (C) 2315 Elm Street, North c. 1960 Ranch**  
One-story, brick veneer Ranch residence with a side facing gable roof of asphalt shingles on a brick foundation with metal vents. Undercut partial width entry porch framed by wood pilasters with a concrete stoop and concrete steps with metal rails. The facade is six-bays (W, W, D, W-Tripled, W, W). The single windows, except for the one to the left of the entry door, are 4/4 wood double hung sash with applied paneled shutters. The other single window is a decorative window with eight divisions. The tripled window is made up of a central picture window with twelve divisions flanked by 2/2 wood double hung sash windows horizontally divided. The entry door is wood with four projecting panels and decorative metal security door flanked by sidelights with four lights. Eaves are boxed. (Photo 2)

2315 N. Elm St.

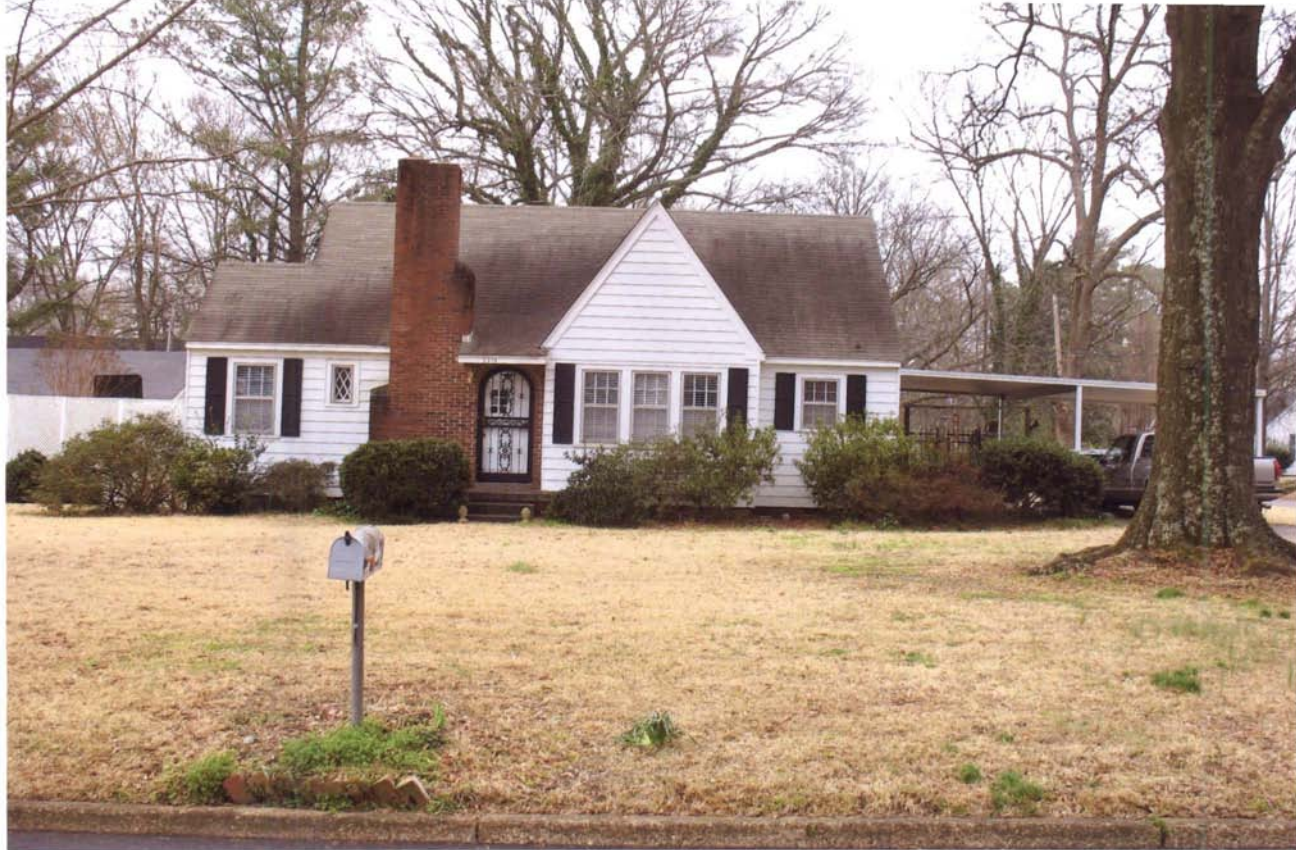
Photo 3 of 15

- 14a. (C) 2378 Elm Street, North c. 1940 Tudor Revival**  
One-story, Tudor Revival residence with a side facing gable roof of asphalt shingles on a brick foundation with metal vents. Concrete stoop with concrete steps. Façade is five-bays (W, W, D, W-Tripled, W) with wide horizontal wood lap siding with corner boards. The windows, except the one to the left of the door, are all 6/6 wood double hung sash with applied louvered shutters. The other window is a small diamond pane leaded glass window. There is a massive front exterior stepped brick chimney that encircles the entry door opening. The wood entry door is arched with vertical panels and six off center small lights and a decorative metal security door. Eaves are boxed. There is a shed roof carport addition to the right of the house supported by metal columns. (Photo 3)

2378 N. Elm St

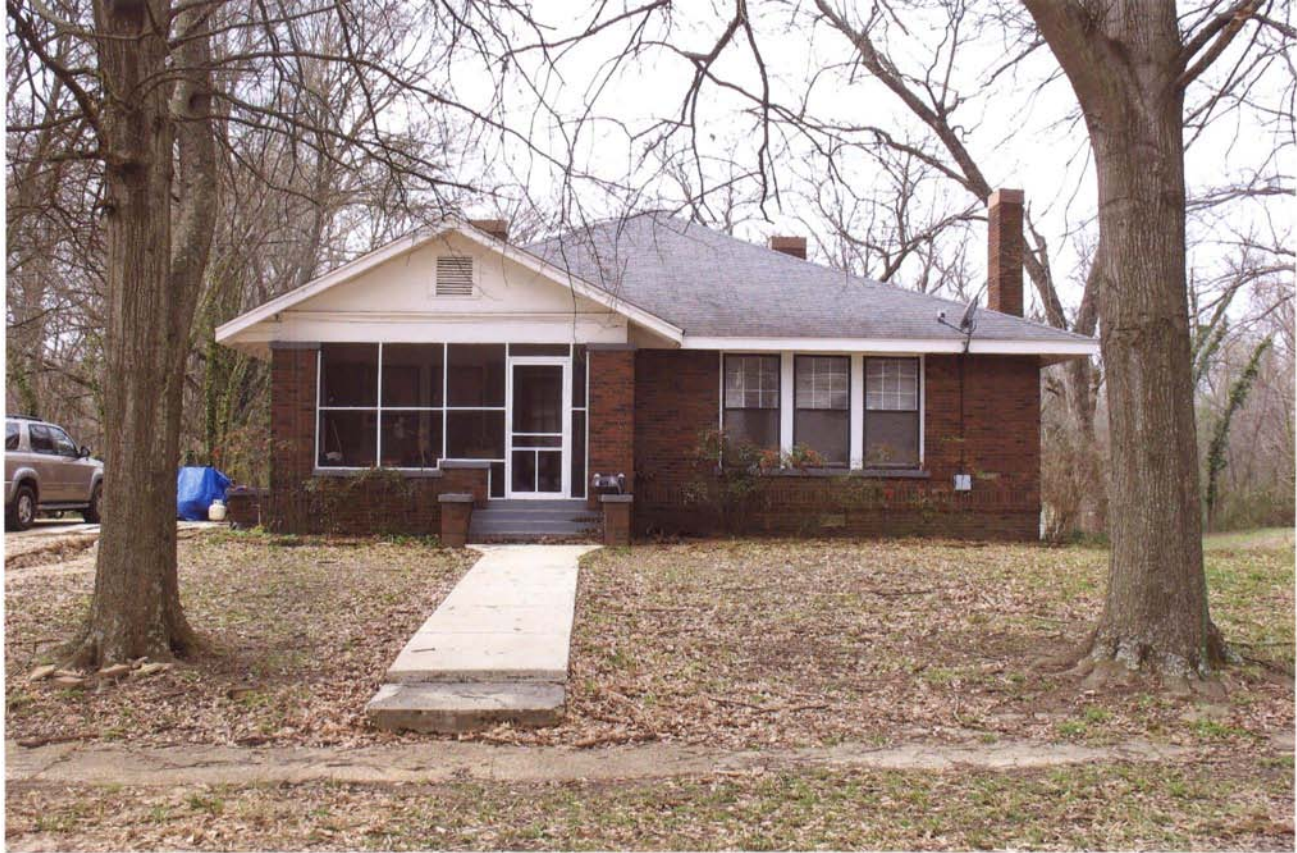
Photo 6 of 15

One-story, brick veneer Craftsman Bungalow residence with a hip roof of asphalt shingles on a brick foundation with metal vents. Partial width, front facing gable roof, projecting entry porch supported by brick columns with cast stone caps on a concrete deck with concrete steps and brick wing walls with cast stone caps. The porch has been screened in and the porch gable has a wood panel siding with a rectangular louvered vent. The facade is three-bays (W-Paired, D, W-Tripled). The windows are 9/1 wood double hung sash with cast stone sills. The entry door is wood with fifteen lights. There are two internal and one external brick chimneys visible, all with cast stone caps. Eaves are boxed. (Photo 6)

2295 Memphis St.

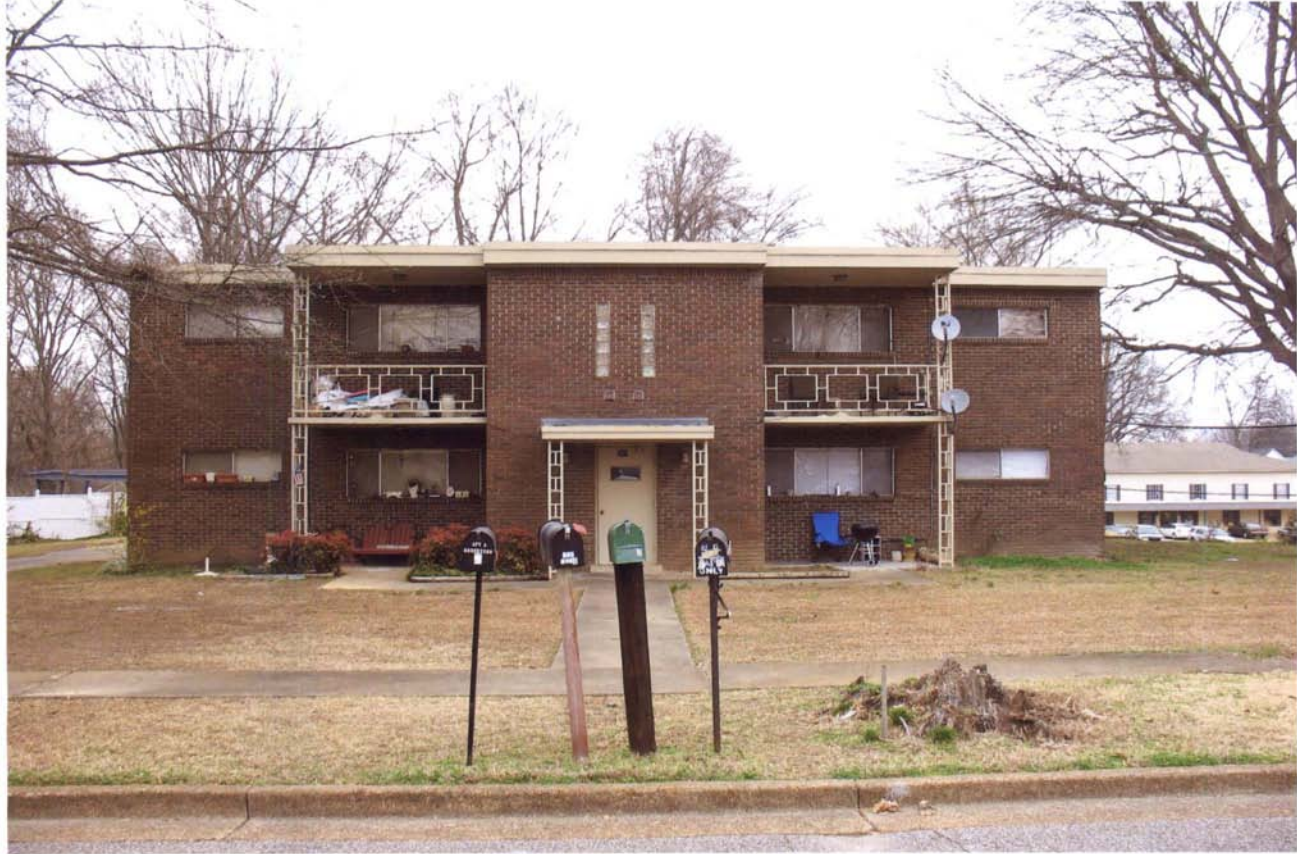
Photo 7 of 15

Two-story, brick veneer apartment building with four units and a flat roof on a concrete foundation. Projecting, flat roof, front entry porch supported by decorative metal posts on a concrete deck. Five-bay facade (W, W, D, W, W). Central bay has the main entrance and bays to either side consist of balconies supported by decorative metal posts with decorative metal railings. Windows are metal sliding units with two divisions and three divisions. The front door has one light over a louvered panel. There are glass concrete blocks over the front door on the second floor. There is a brick soldier course below the roof eave. (Photo 7)

362 North St.

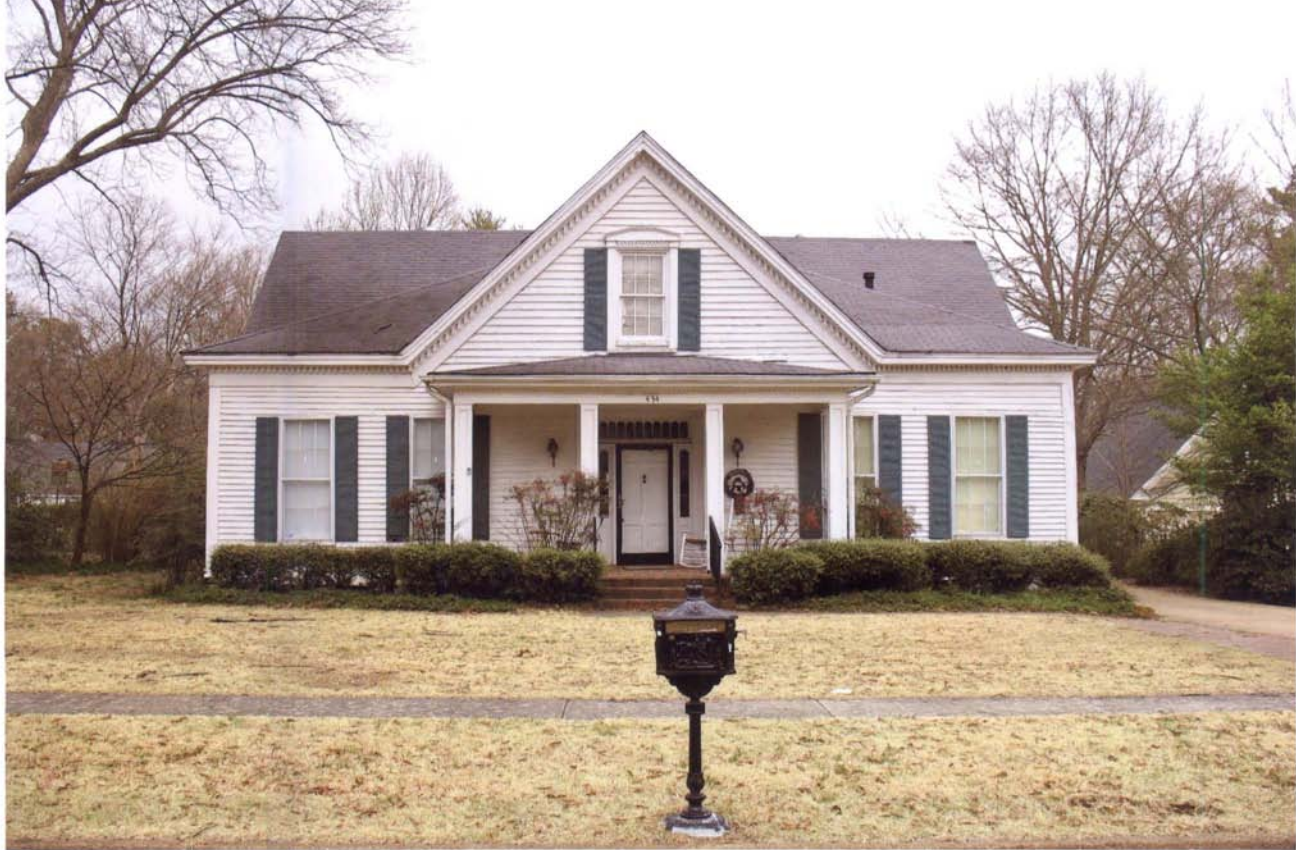
Photo 8 of 15

One-story, wood frame Italianate residence on a brick foundation with a side facing gable roof of asphalt shingles. Projecting porch, with a hip roof supported by box columns with recessed panels on a brick deck with brick steps. Facade is five-bays (W, W, D, W, W) with horizontal wood lap siding with corner boards. The windows are 6/6 wood double hung sash with applied louvered shutters. The front door is wood with six recessed panels with a transom of ten arched lights above and flanking sidelights with three lights, the top one arched, with a recessed panel below. Front facing gable roof over the entry porch has a 6/6 wood double hung sash window in the gable with applied louvered shutters with a pilaster surround and window hood featuring dentil trim. Eaves are boxed and have large eave boards with dentil molding. (Photo 8)

434 North St.

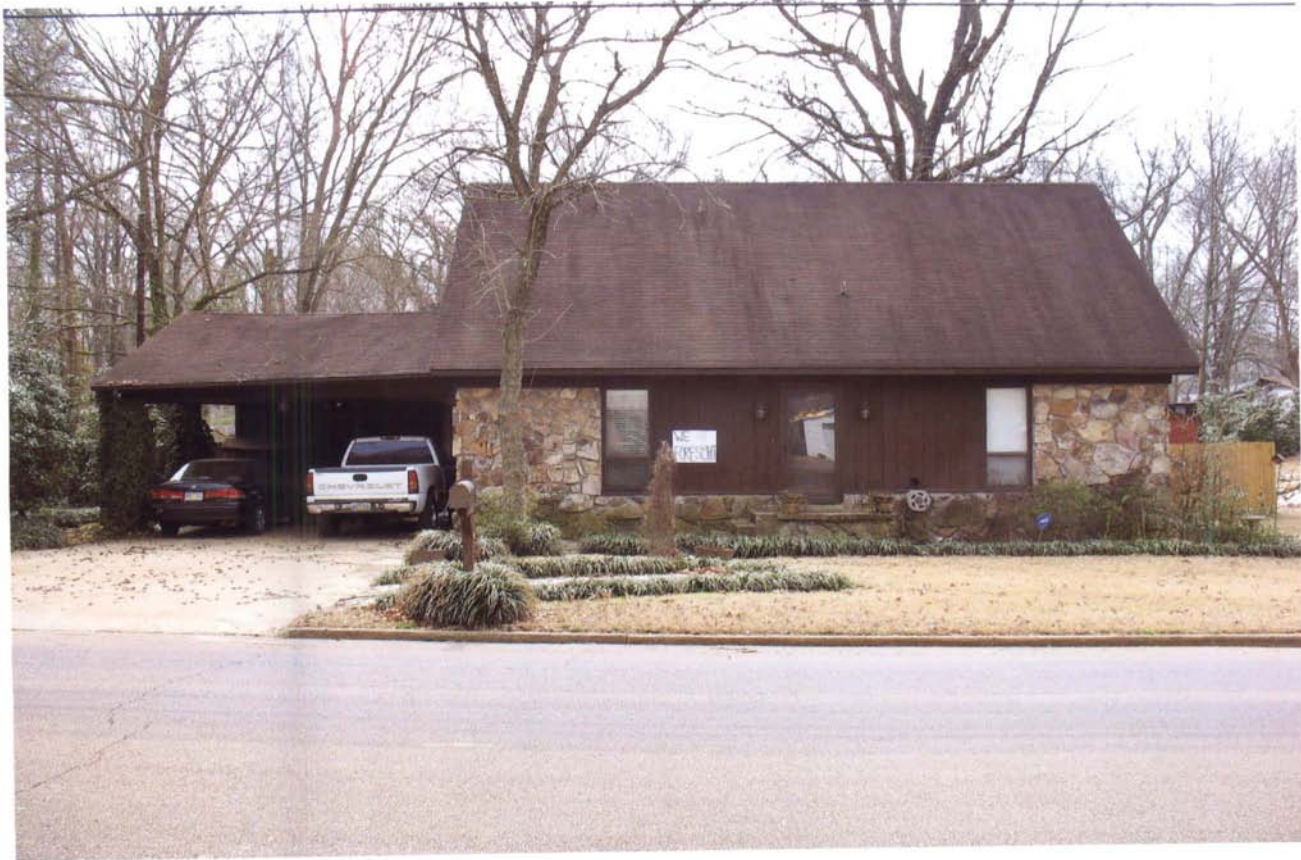
Photo 10 of 15

One-story, Contemporary residence with a side facing gable roof of asphalt shingles on a stone veneer foundation. Stone entry stoop and steps. Façade is three-bays (W, D, W) with a combination of stone veneer and vertical paneled siding. Windows are 1/1 metal with the upper portion fixed and the lower portion an awning window. The entry door is wood with eight projecting carved panels. There is a carport with a side facing gable roof attached to the left of the house and supported by wood posts. Eaves are boxed. (Photo 10)

445 W. Robinson St.

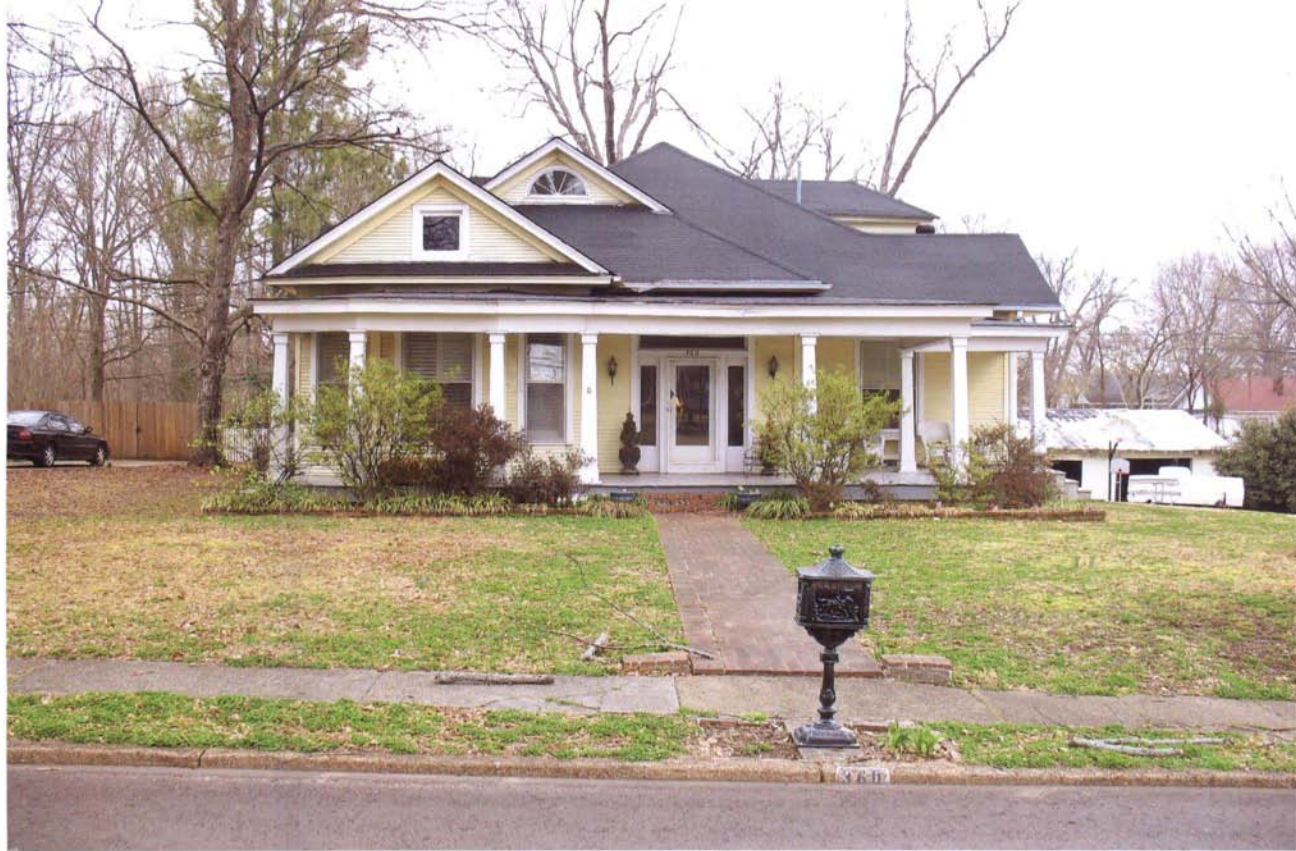
Photo 11 of 15

One-story, wood frame Queen Anne residence with a gable on multiple hip roofs of asphalt shingles on a brick foundation. Full width front porch supported by tapered wood box columns with capitals and bases on a wood porch deck with brick steps. The facade is five-bays (W, W, W, D, W) with horizontal thin strip wood lap siding with corner boards. The windows are 1/1 wood double hung sash with exterior storm windows. The front door is wood with a single light flanked by single light transom, and a single light transom above. There are two front facing gable roofs with the upper gable having a five light wood arched fan window and the lower gable have a single fixed light square window. Eaves are boxed. (Photo 11)

360 W. Valley St.

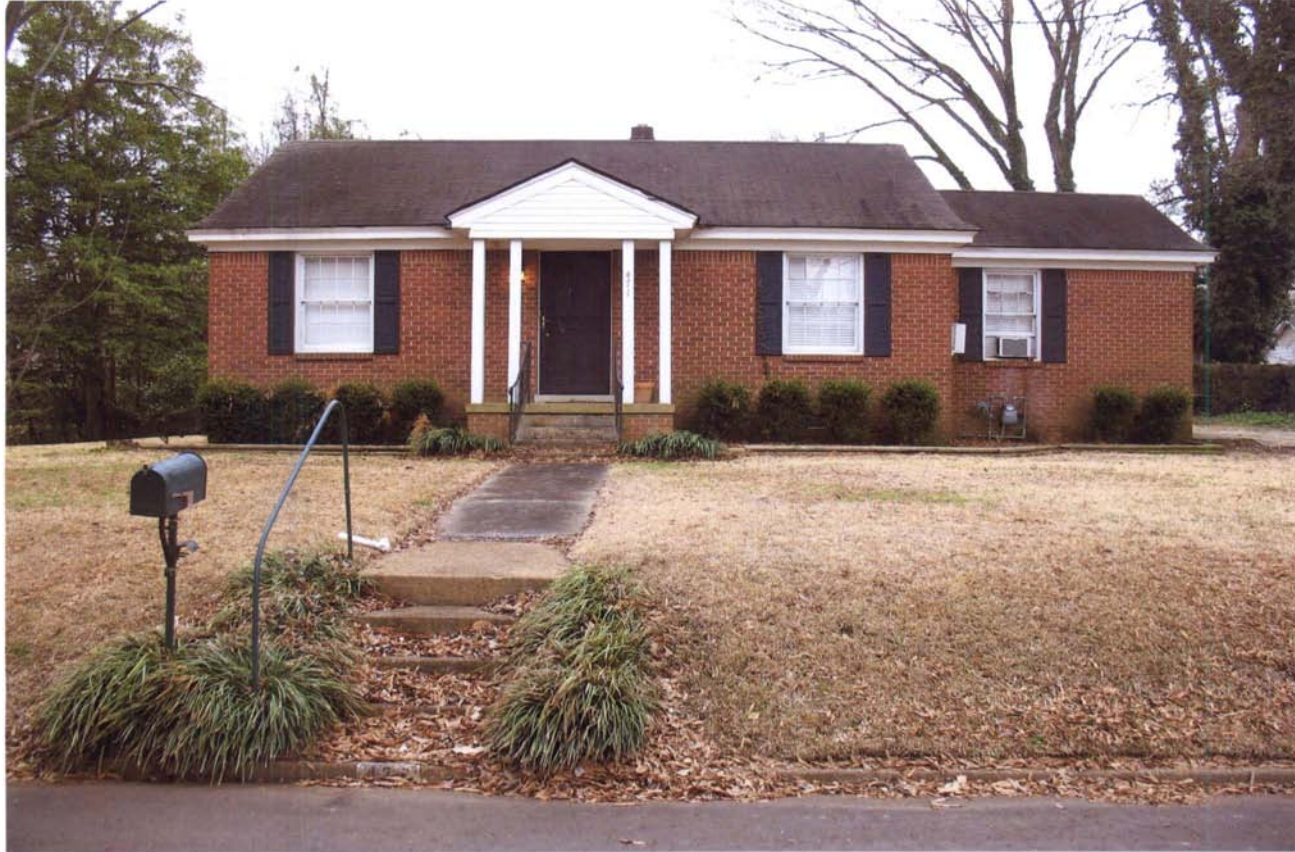
Photo 12 of 15

One-story, brick veneer Minimal Traditional residence with a side facing gable roof of asphalt shingles on a brick foundation with metal vents. Front facing gable roof partial width projecting entry porch supported by wood box columns on a concrete deck with concrete steps and metal rails. There is vinyl siding in the porch gable. The facade is four-bays (W, D, W, W). The two left windows are 8/8 wood double hung sash and the other window is a 6/6 wood double hung sash. Windows all have brick angled sills and applied louvered shutters. The entry door is wood with six recessed panels and a glass storm door. Eaves are boxed. (Photo 12)

471 W. Valley St.

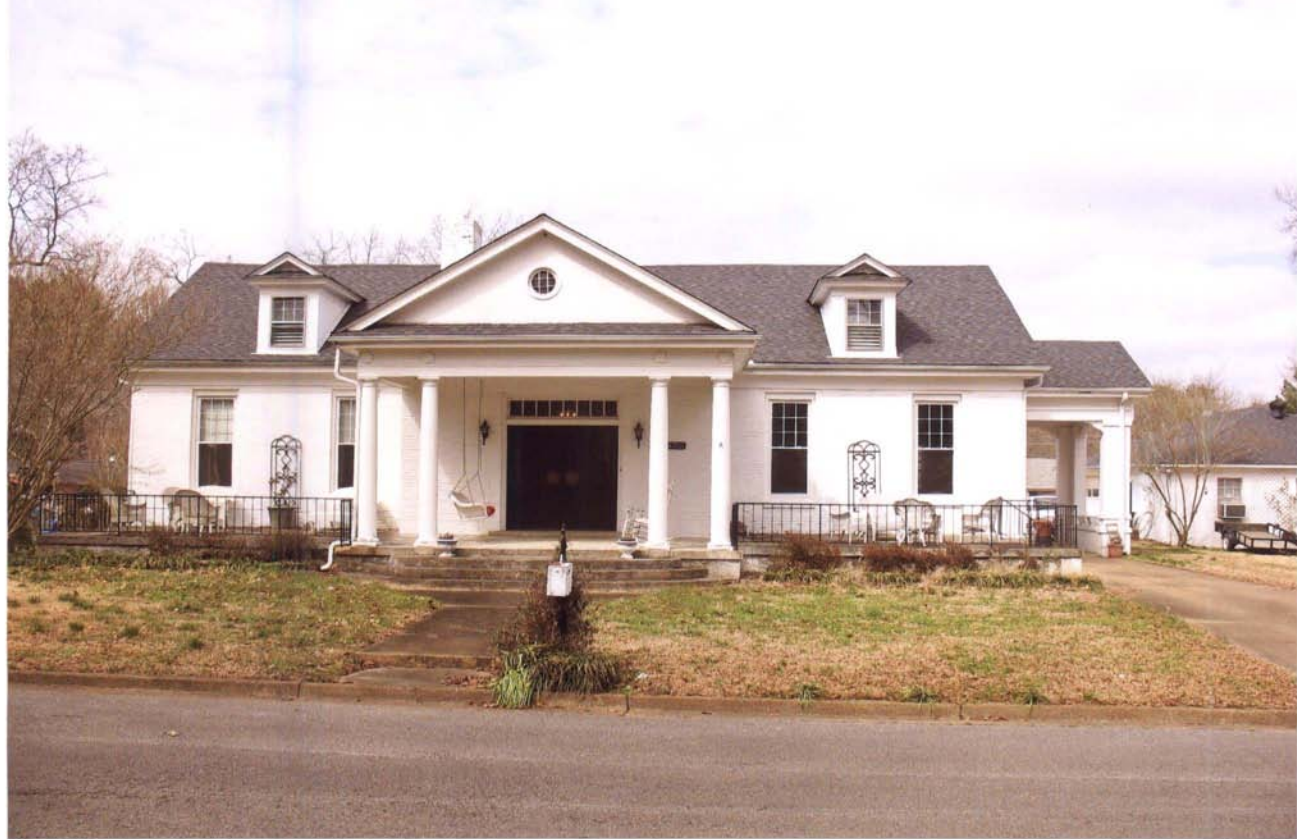
Photo 13 of 15

One-story, painted brick veneer Neoclassical residence with a side facing gable roof of composition shingles on a brick foundation. Partial width, front facing gable roof, projecting entry porch supported by wood Tuscan columns on a concrete deck. The deck extends the length of the house and has a decorative metal rail. Above each column is a rosette and in the gable is a circular light with nine divisions. The facade is five-bays (W, W, D, W, W). The windows are 9/1 single hung sash metal with angled brick sills. The entry door is a double door with each a wood slab a single thin light and decorative round appliqué surrounding door knobs. The door has an eight light transom above. There is front facing gable roof dormer to each side of the gabled porch with a 6/1 single hung sash metal windows. There is a porte-cochere attached to the right side of the house supported by brick columns with brackets on a low concrete wall. Eaves are boxed. (Photo 13)

530 Wadsworth Circle

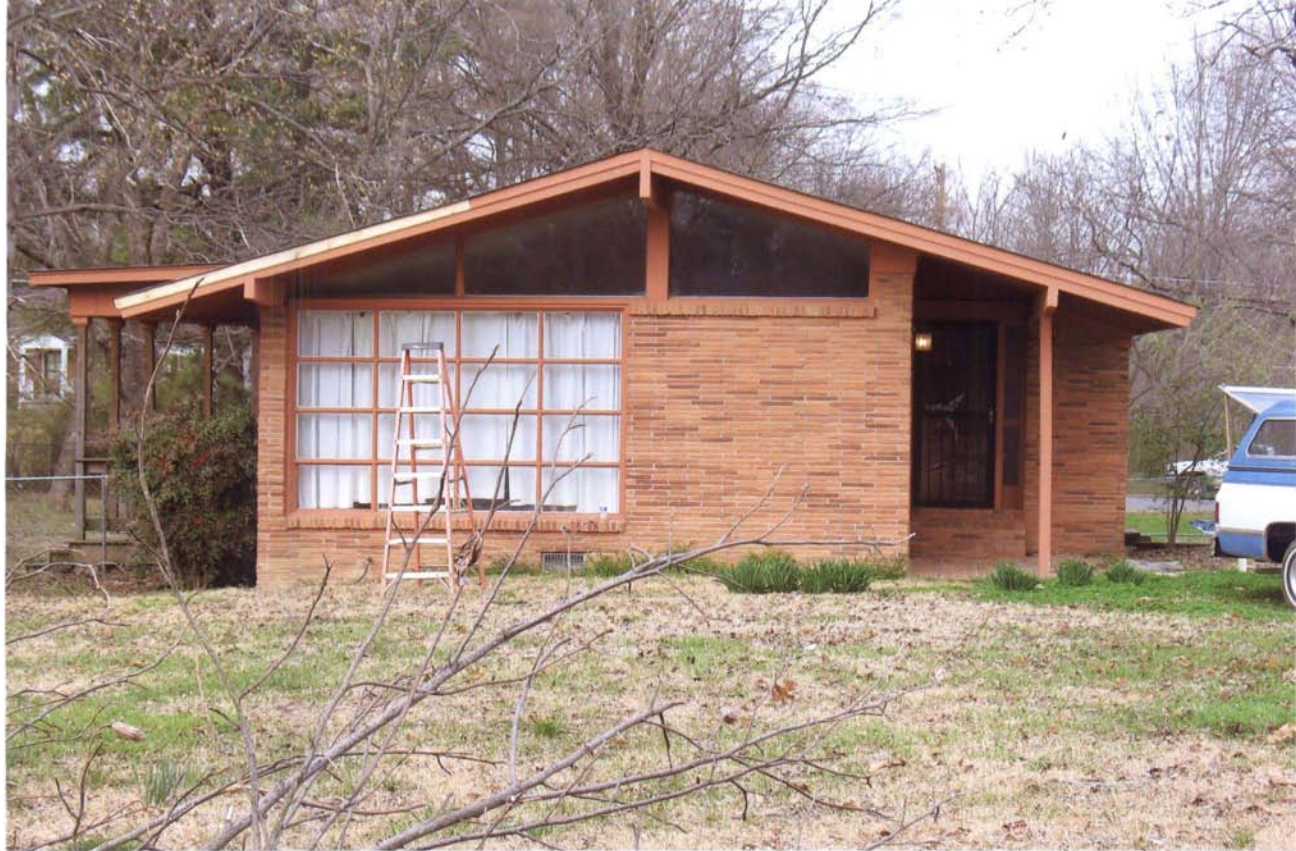
Photo 14 of 15

One-story, brick veneer Contemporary residence with a front facing gable roof on a brick foundation with metal vents. Partial width, undercut entry porch supported by wood posts and beam on a concrete deck. The facade is two-bays (W, D). The window is a picture window with sixteen lights. The entry door is a wood slab with a decorative metal security door and a two light sidelight. In the front gable there are three large fixed wood windows with single lights that match the angle of the gable. The front gable extends from the house supported by wood beams. To the left side of the house a flat roof porch is attached supported by wood posts. (Photo 14)

552 Wadsworth Circle
