**NATIONAL REGISTER OF HISTORIC PLACES
REGISTRATION FORM**

historic name: Kimbrough, John Hall House
other names/site number:

Kimbrough, John Hall House
Attala County, Mississippi

Narrative Description

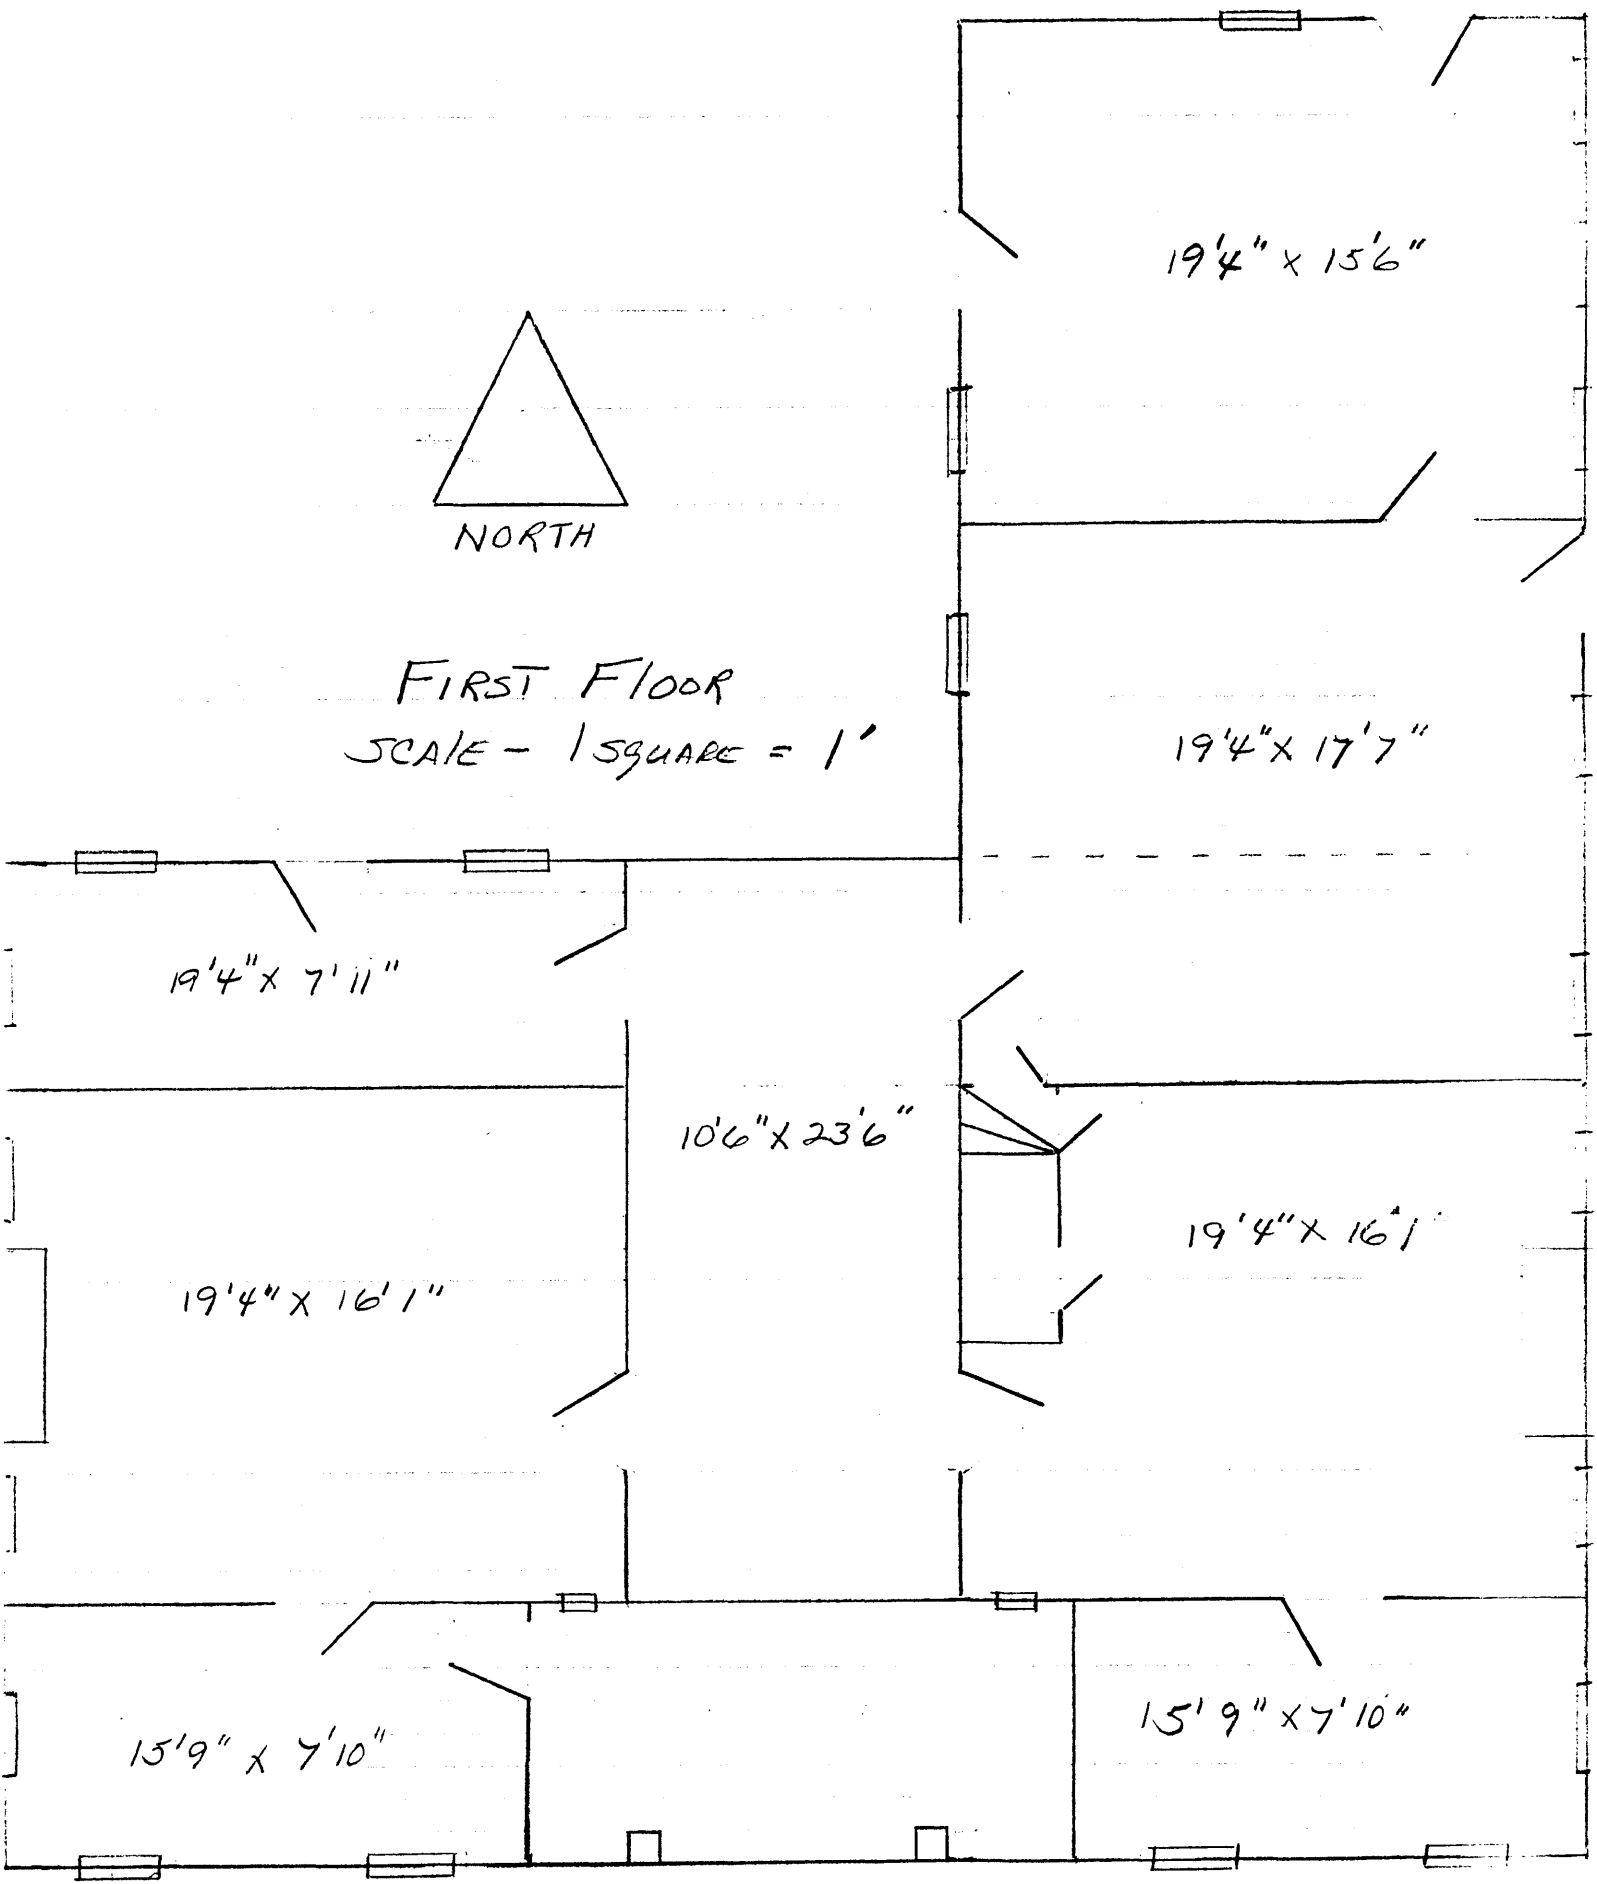
FIRST FLOOR
SCALE - 1 SQUARE = 1'

The John Hall Kimbrough House located approximately five miles north and slightly west of Ethel, Mississippi, and just off the Natchez Trace in the Liberty community in rural Attala County. The house is an excellent example of the traditional vernacular house form called a "dogtrot". Situated on a gentle rise off the Old Rockport Road, the John Hall Kimbrough House faces south onto a dirt road and is a one-and-one-half story, side-gabled, dogtrot house of wood frame construction with a rear ell. The house rests on stone piers with wood timbers and is constructed with sawn-cut bevel siding. The original wood shingles have been covered with corrugated metal. The house is believed to have been built in two phases circa 1860, and circa 1870. The original dogtrot was one room deep with rear and front galleries and a detached kitchen. However, about 1870 the galleries were enclosed to create four cabinet rooms and a rear ell was added incorporating the northeast cabinet room to the original kitchen. Also the ceiling was lowered in the east room to make a half-story room in the attic. Stone chimneys were attached to either end of the house; however, both deteriorated and only the east chimney has been replaced with brick in circa 1940.

The south facade is three-bays wide with the outer bays featuring paired, nine-over-six double-hung sash windows and the open dogtrot passage in the central bay. The doors and windows are trimmed with wooden surrounds. An undercut gallery supported by box columns originally spanned the facade but was enclosed to form two cabinet rooms circa 1870. Windows throughout the main house and ell are nine-over-six double-hung sash, while those in the kitchen are six-over-six double-hung sash.

The original 1860 rooms have retained their flushboard interior walls with wainscoting that were covered with lath and plaster. The cabinet rooms and rear ell feature beaded board walls indicating their later date. The ceilings throughout the house are board-and-batten along with a section of the wall of the east room near the staircase. Doors and windows throughout the house feature plain eared surrounds, and various forms of vernacular panel doors with their original hardware. The mantels are plain with mantel shelves and limited moldings. The upper half story is accessed by an interior staircase in the southeast room from both the southeast and dining room ell that connects the kitchen.

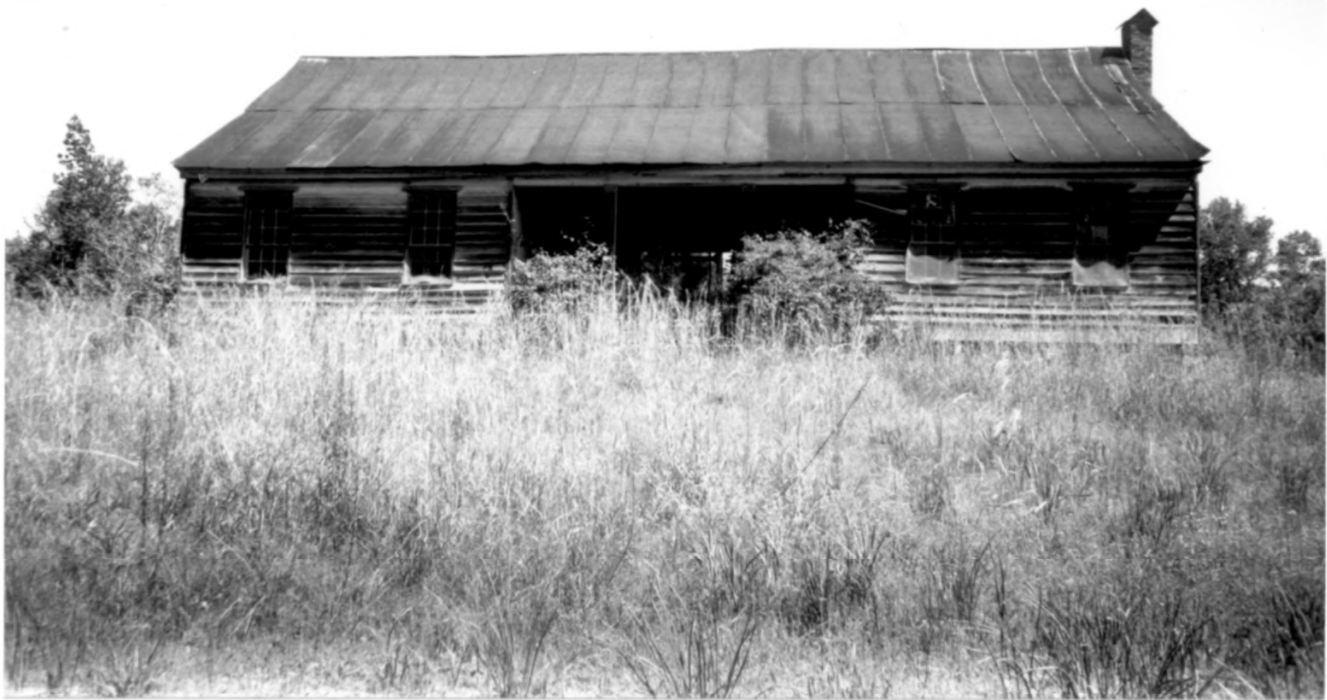
Photo 2 of 16

FACADE (South), View to North

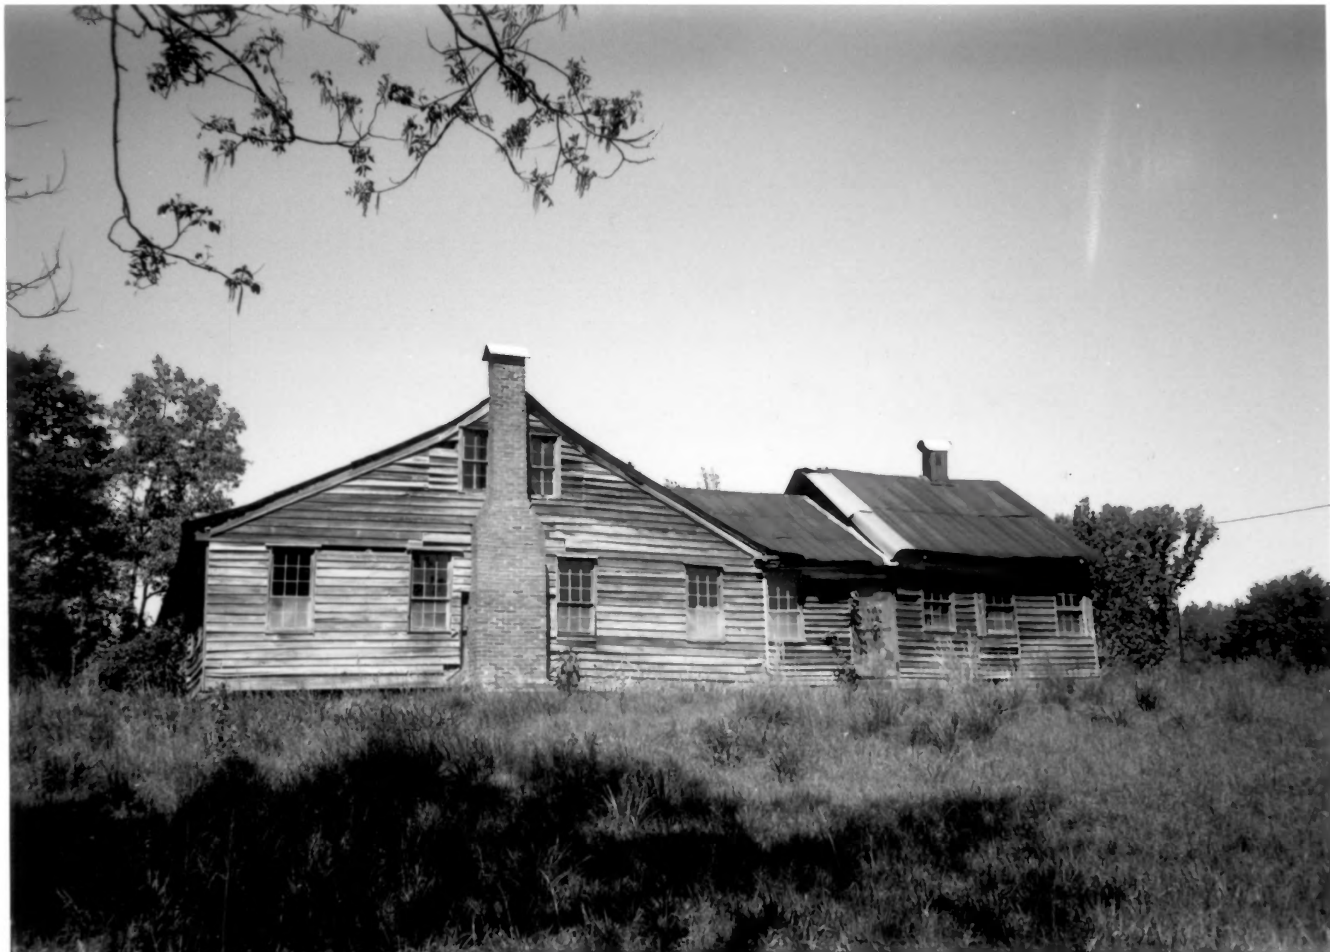
Photo 3 of 16

EAST ELEVATION, View to West

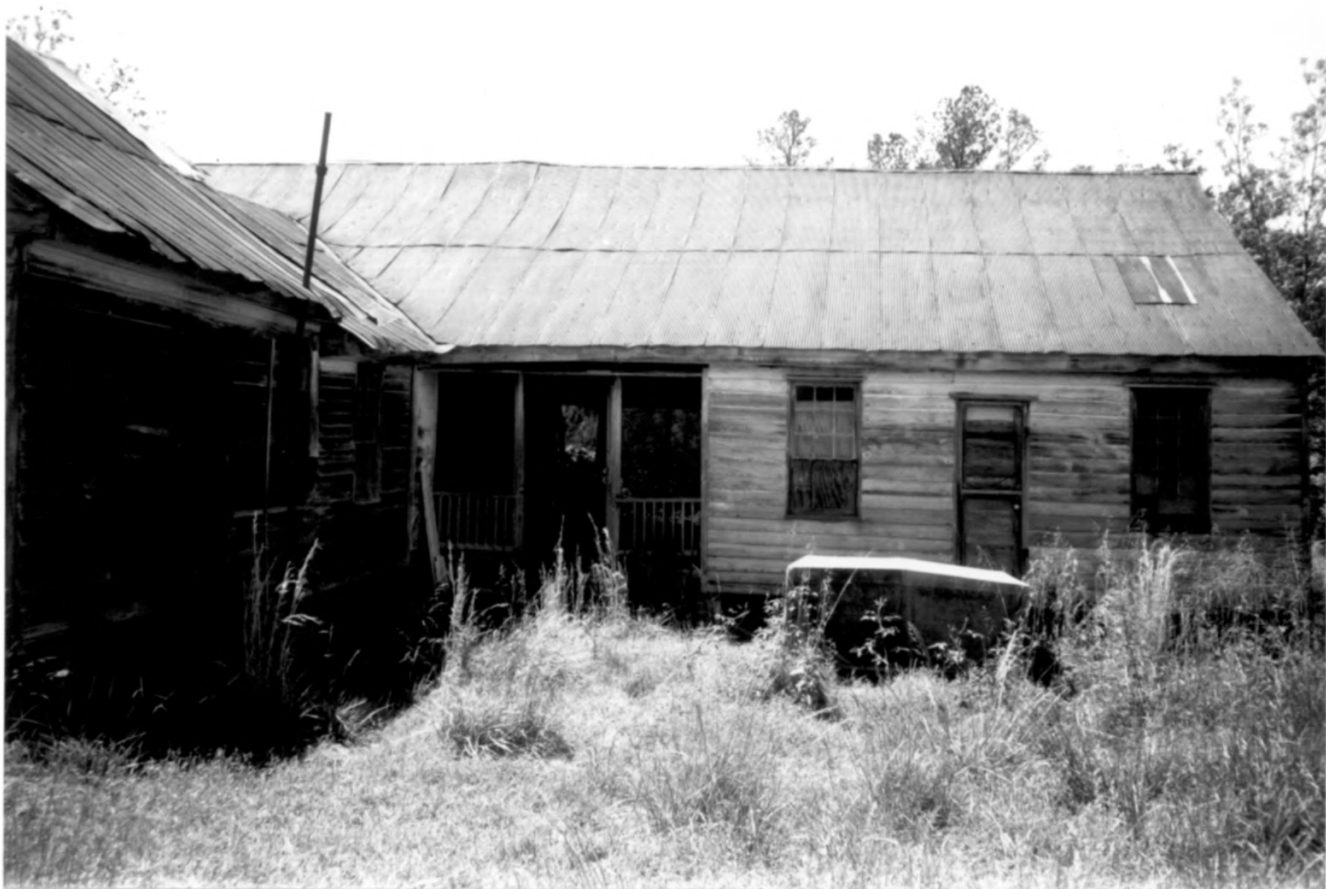
Photo 4 of 16

North Elevation and Ell West Elevation,
View to South

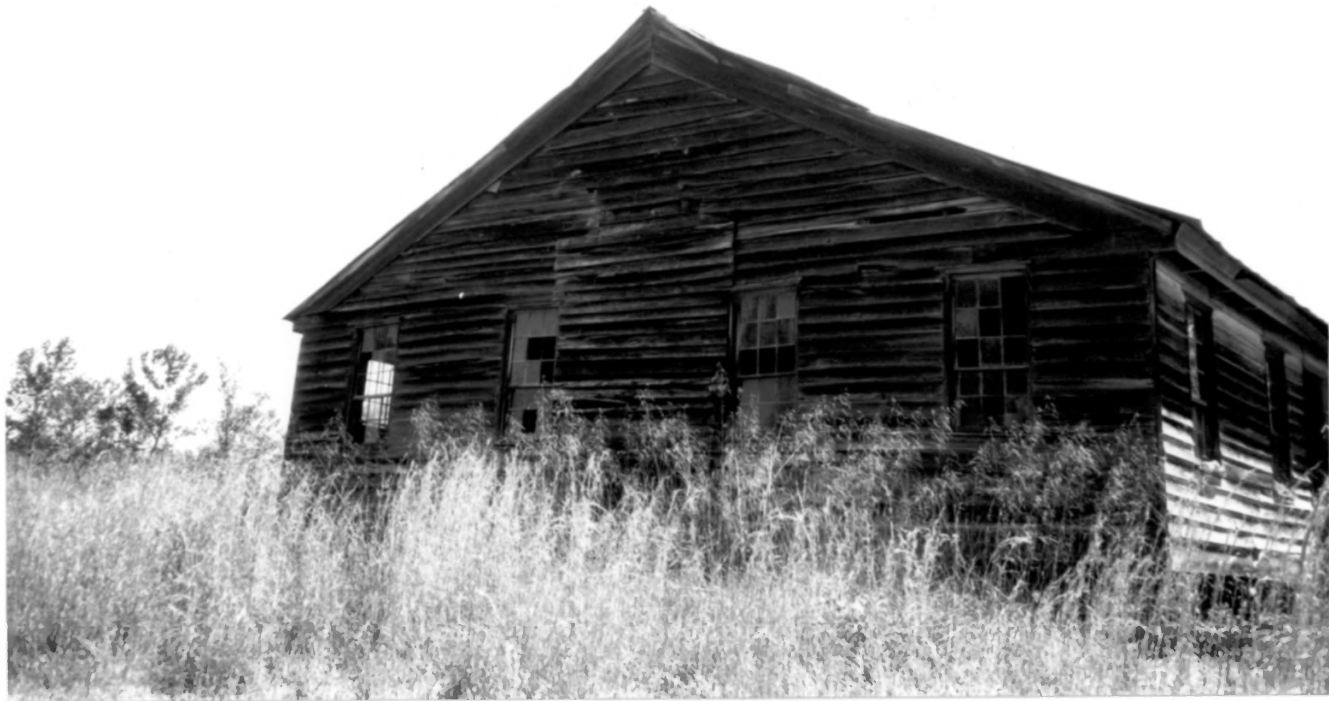
Photo 3 of 16

West Elevation, View to East

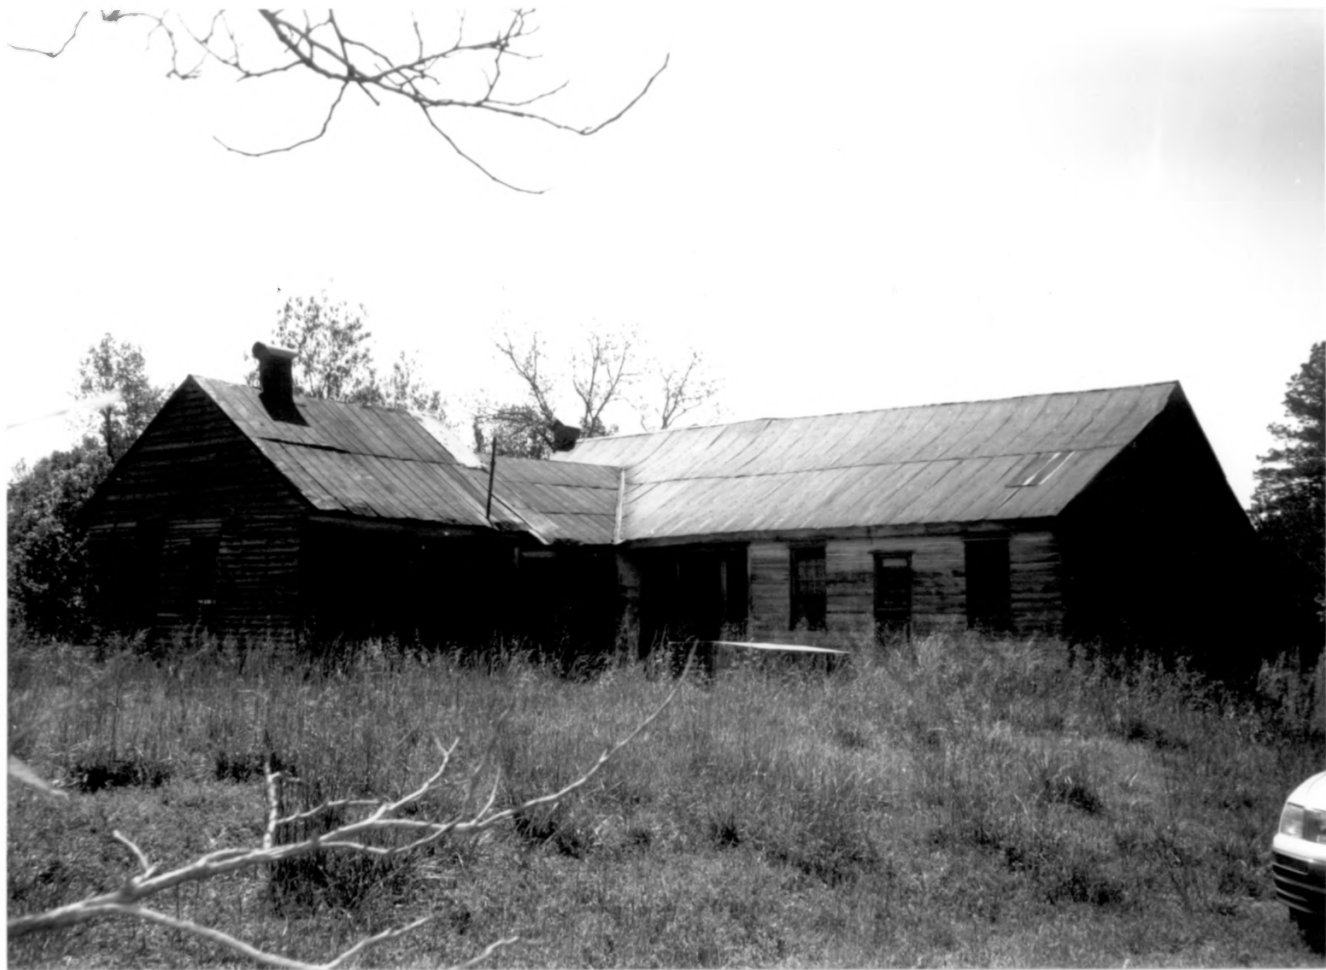
Photo 6 of 16

North and West ELEVATIONS,
View to Southeast

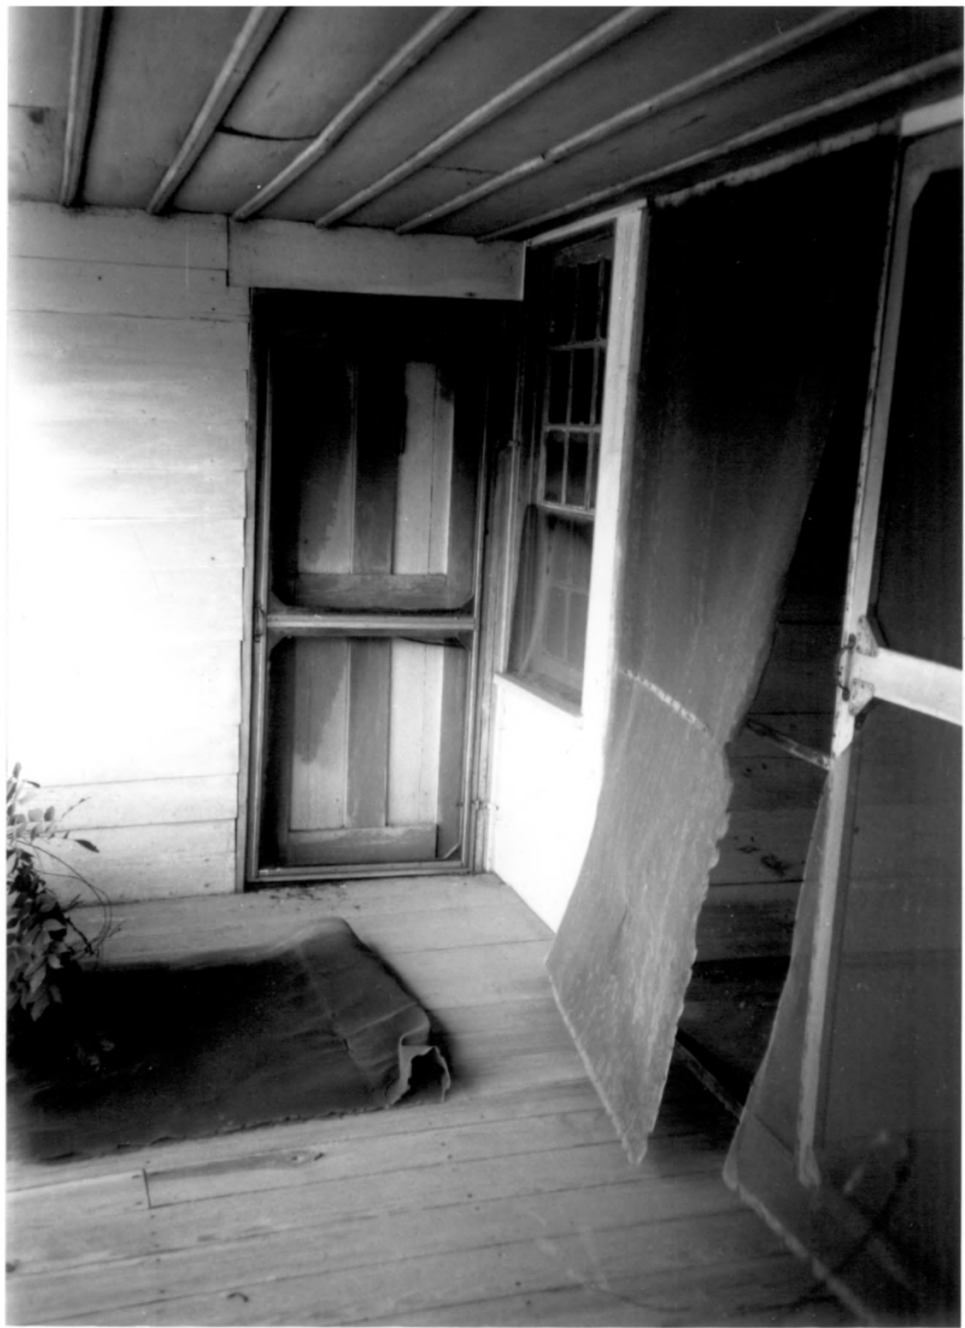
Photo 7 of 16

Door from Undercut Gallery to Southwest
Cabinet Room, View to West

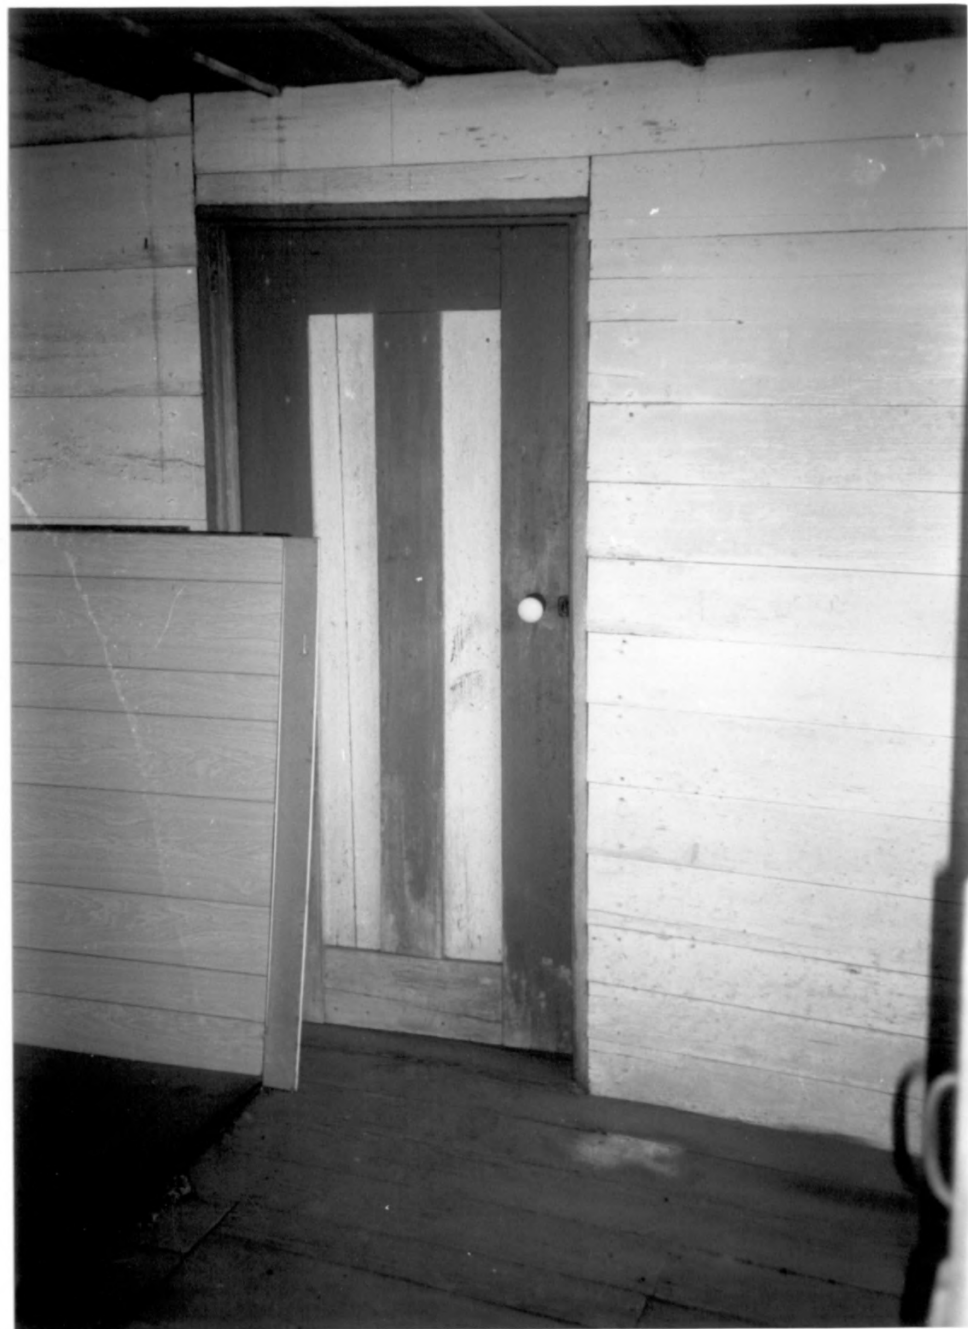
Photo 8 of 16

Door to Northwest Cabinet Room from
the open Dogtrot Passage,
View to West

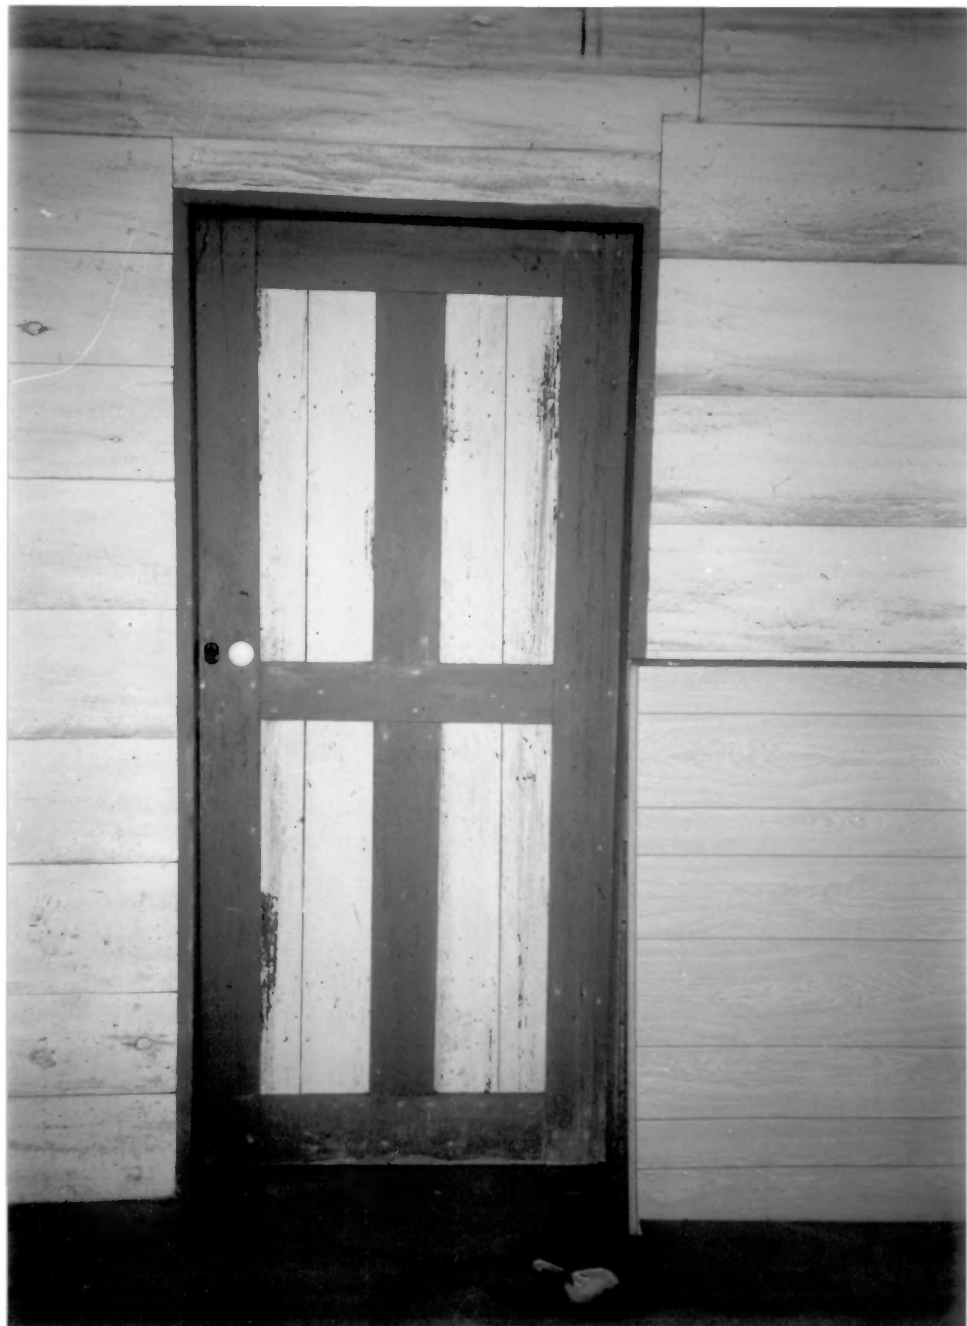
Photo 9 of 16

Door to West Room from open

Dogtrot Passage, View to West

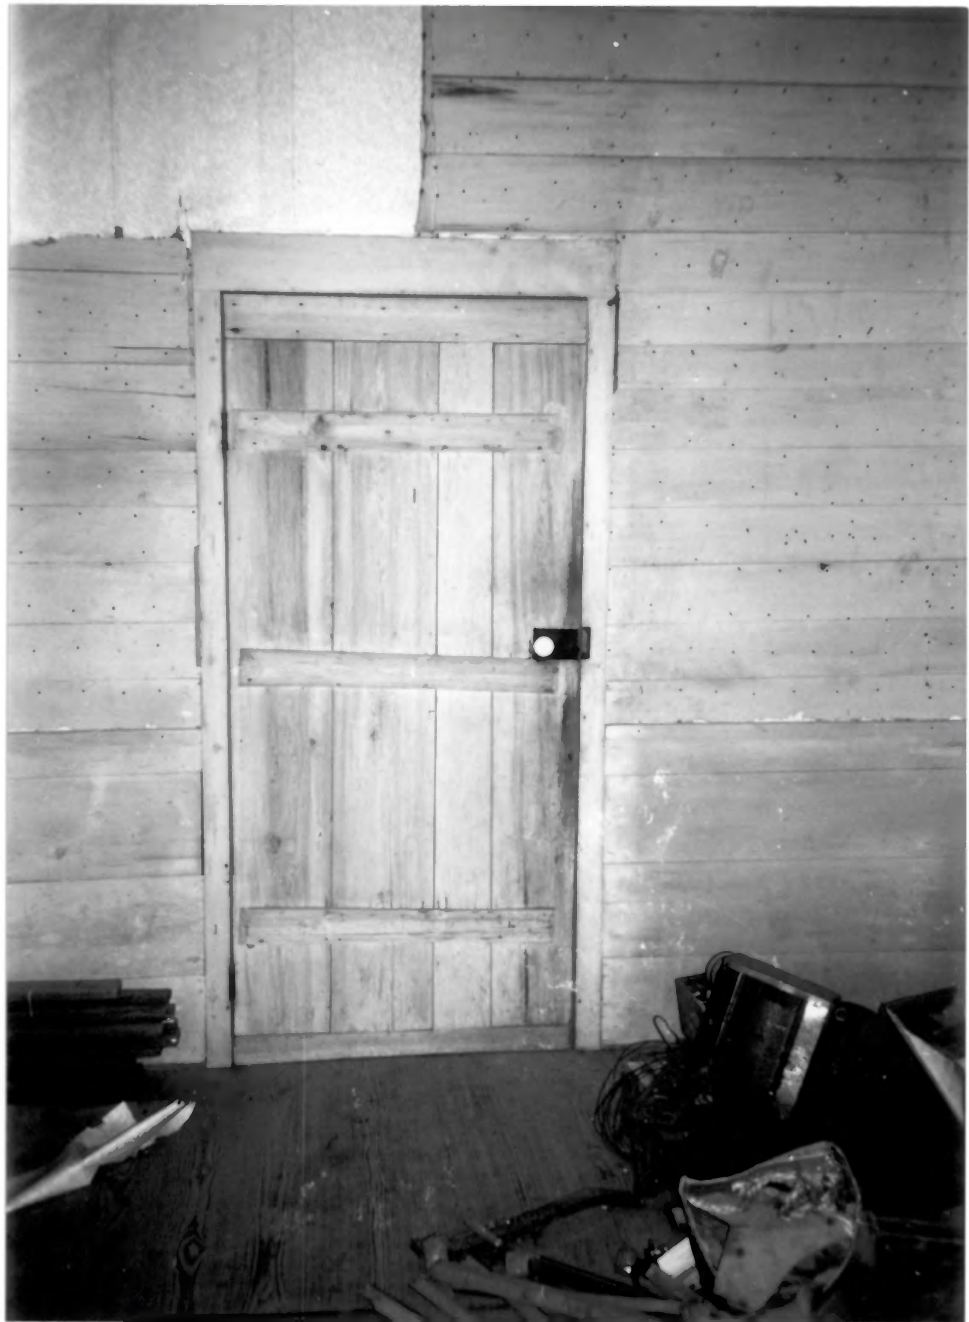
Photo 10 of 16

Door to West Room, inside, View
to East

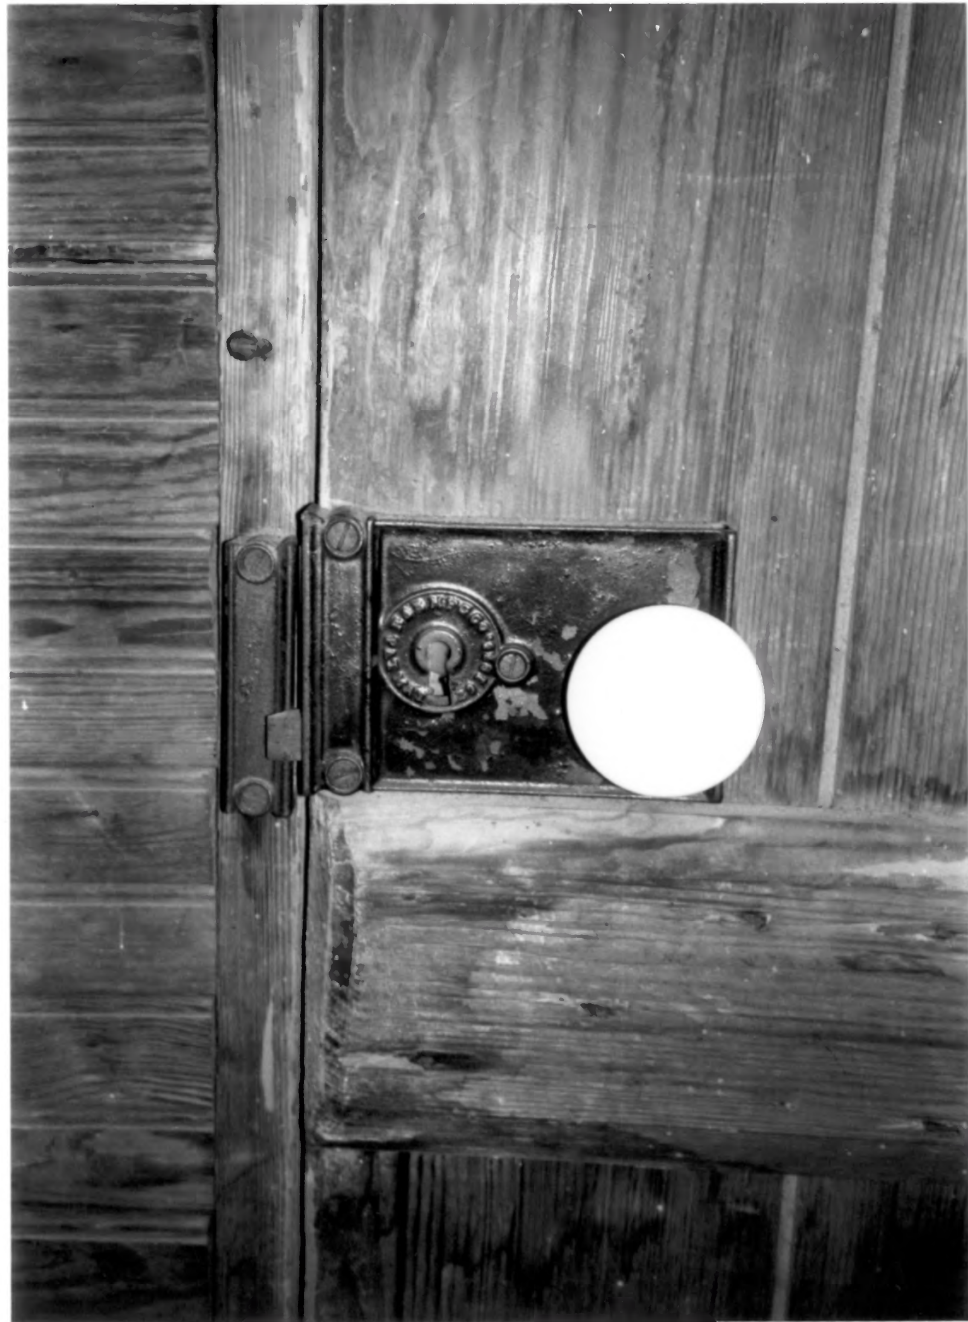
Photo 12 of 16

HARDWARE ON Northwest Cabinet Room
Door, View to East

The John Hall Kimbrough House retains an exceptional degree of integrity and demonstrates the craftsmanship of the vernacular dogtrot form as well as the aspirations of an early frontier family. This is demonstrated with the builder's conscious attempt to refine the home with wainscoting, plaster walls, decorative doors and hardware.

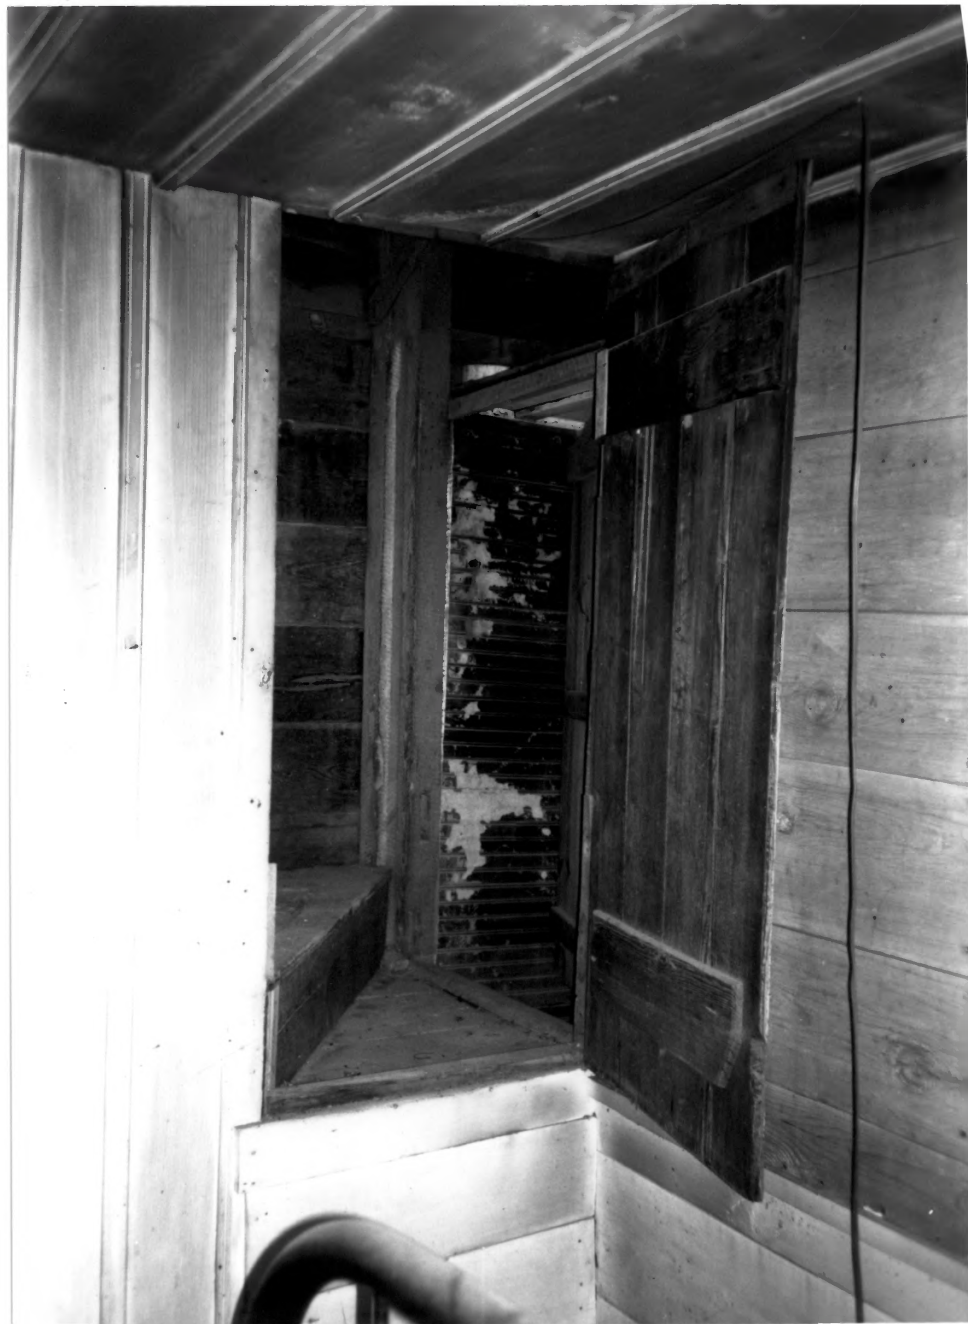
Photo 14 of 16

Door to Stairwell from East Room,
View to West
