OXFORD DESIGN GUIDELINES

OXFORD, MISSISSIPPI

JUNE 2011

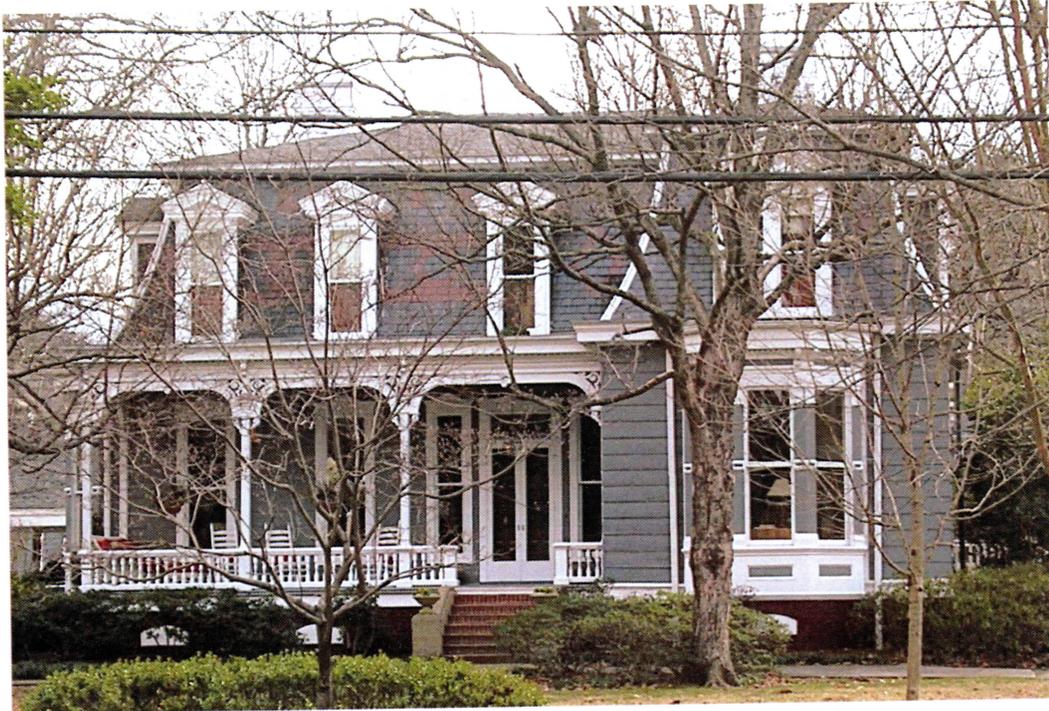
Figure 5: **ROBERTS-NEILSON HOUSE**

The Roberts-Neilson house at 911 South Lamar was constructed in about 1870 with a distinctive Mansard roof and is an outstanding example of the Second Empire style in Mississippi. An outstanding example of late Victorian architecture combining both the Gothic and Italianate styles is the Hamblett house at 619 Van Buren Avenue which was built about 1872. The house contains a completely curving stairway, the only one of its kind in this area.

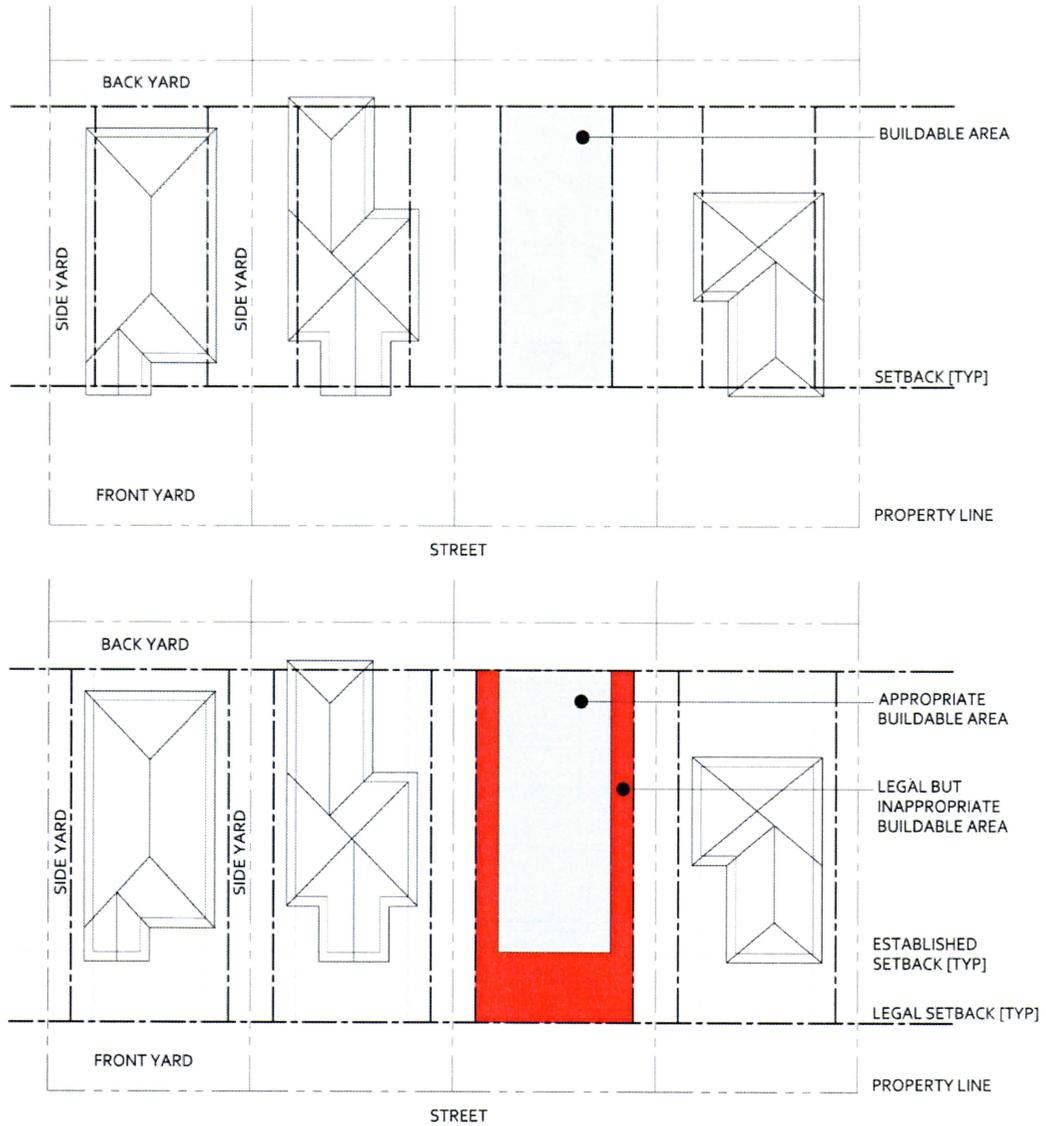
Figure 9: SETBACK and LOT COVERAGE EXAMPLES

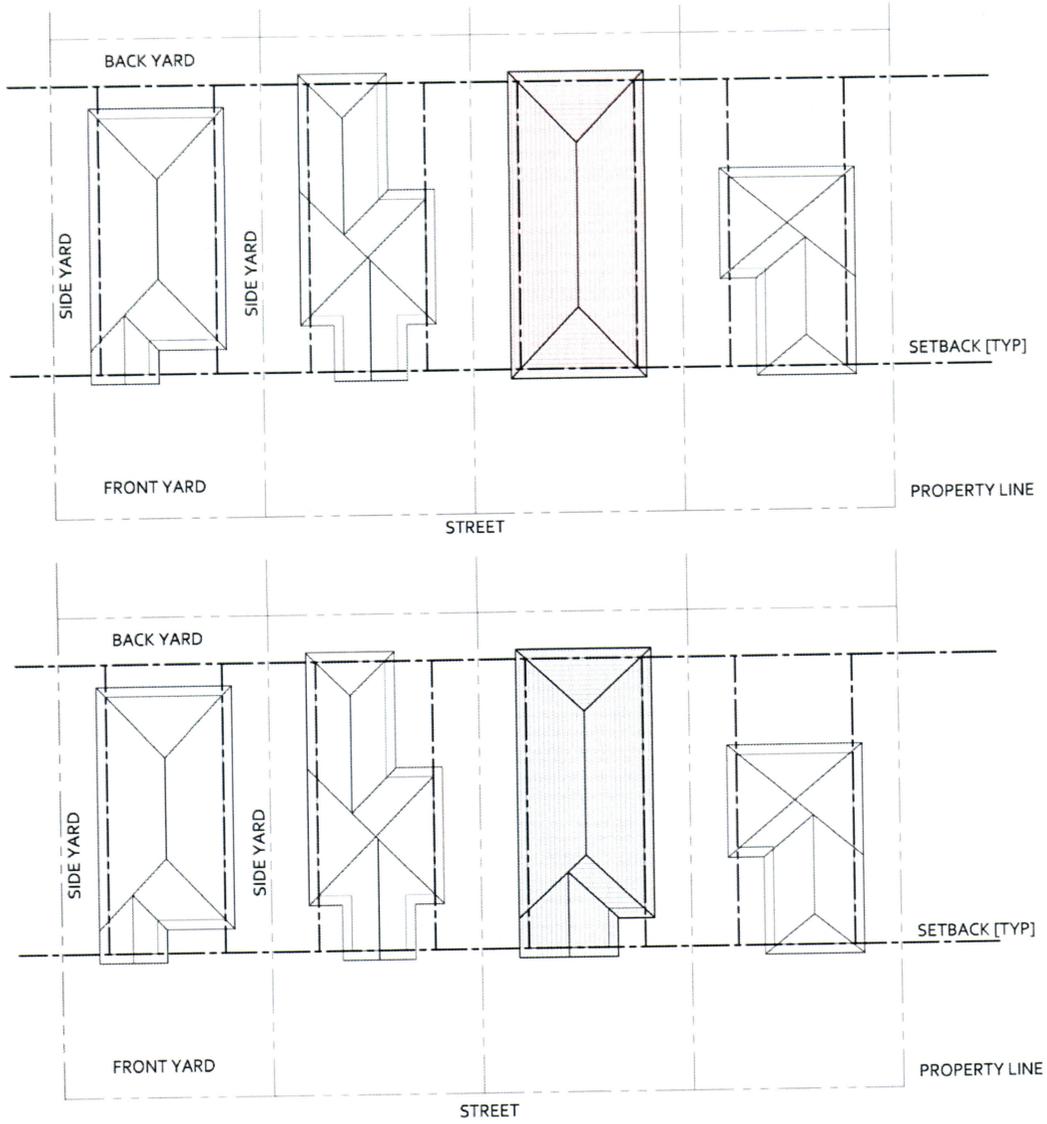
Figure 10: SETBACK and LOT COVERAGE EXAMPLES
INNAPPROPRIATE TOP
APPROPRIATE BOTTOM

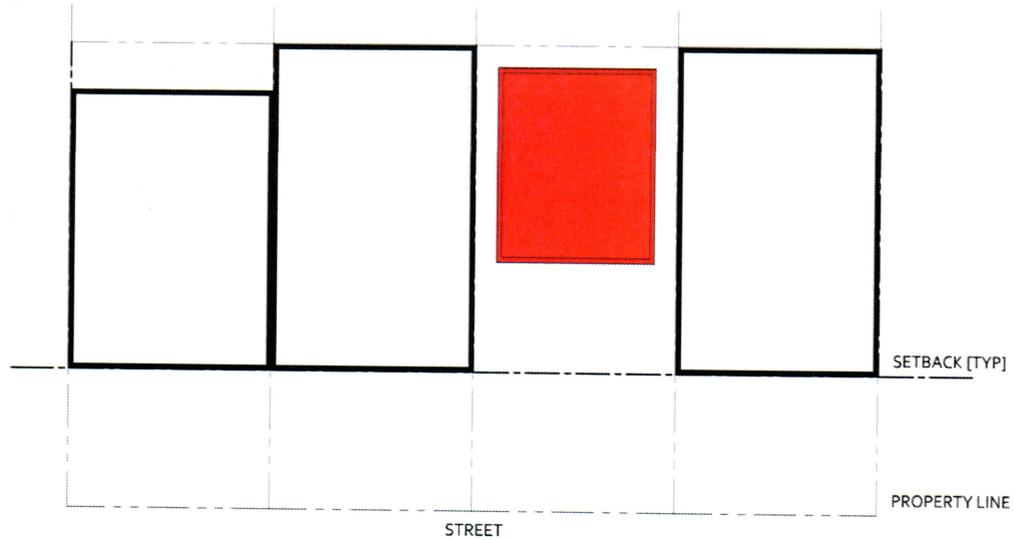
Figure 11: **INAPPROPRIATE SETBACK and LOT COVERAGE EXAMPLE**

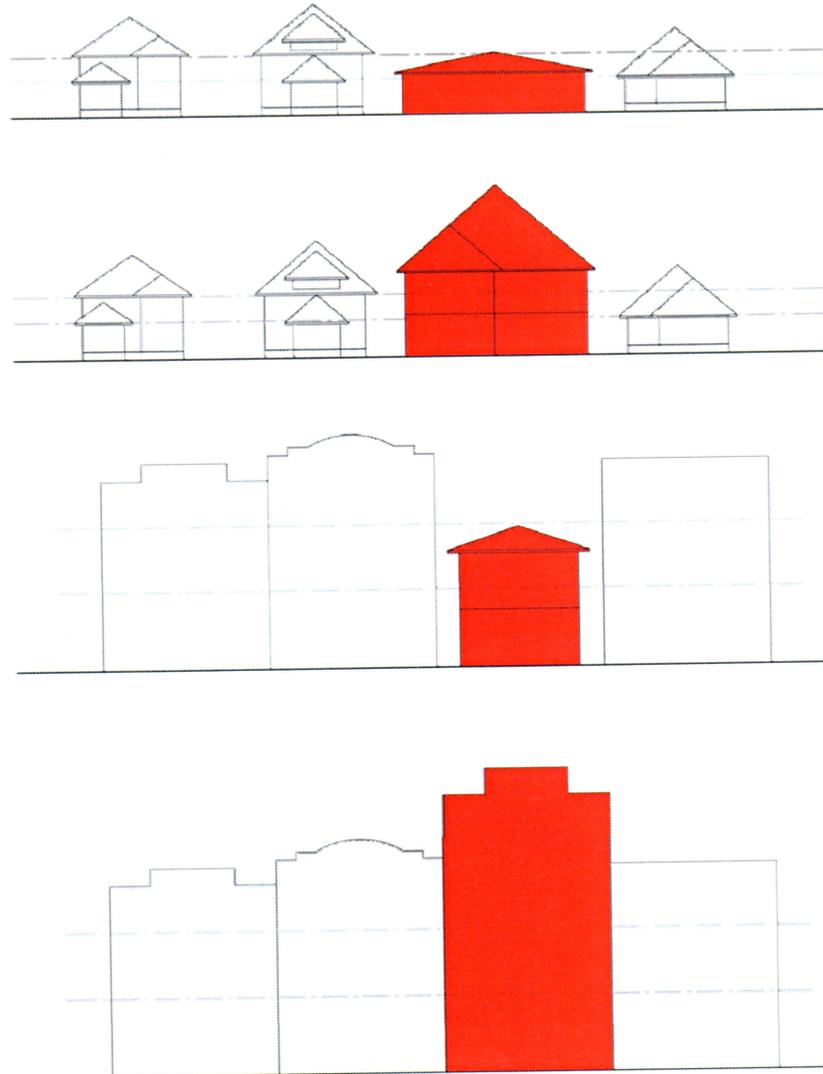
Figure 12: **INAPPROPRIATE NEW CONSTRUCTION EXAMPLES:**
NEW BUILDING WITH GREATER THAN TEN PERCENT DIFFERENCE in
EXISTING PATTERNS including:
SETBACK and LOTCOVERAGE
SCALE
PROPORTION
RHYTHM
MASSING

NEW BUILDING DRAWS ATTENTION TO ITSELF AND DETRACTS FROM THE REMAINDER OF THE HISTORIC DISTRICT

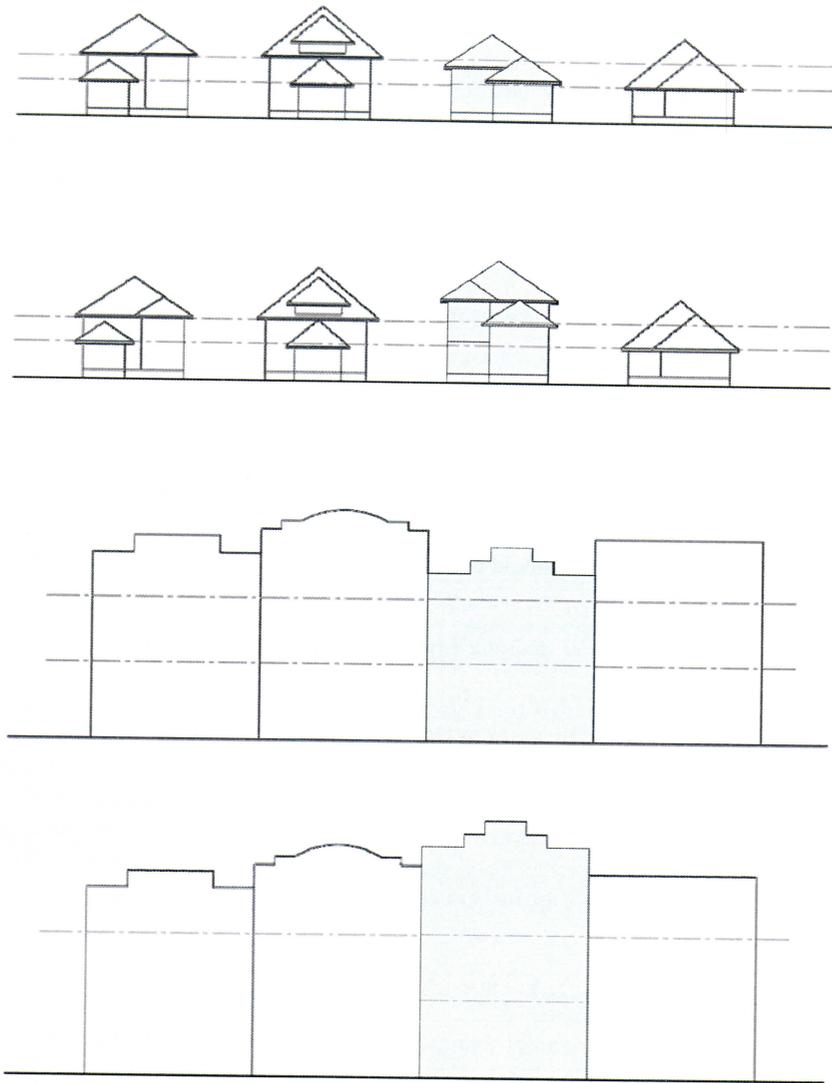
Figure 13: APPROPRIATE NEW CONSTRUCTION EXAMPLES
NEW BUILDING WITH LESS THAN TEN PERCENT DIFFERENCES in EXISTING PATTERNS
including:

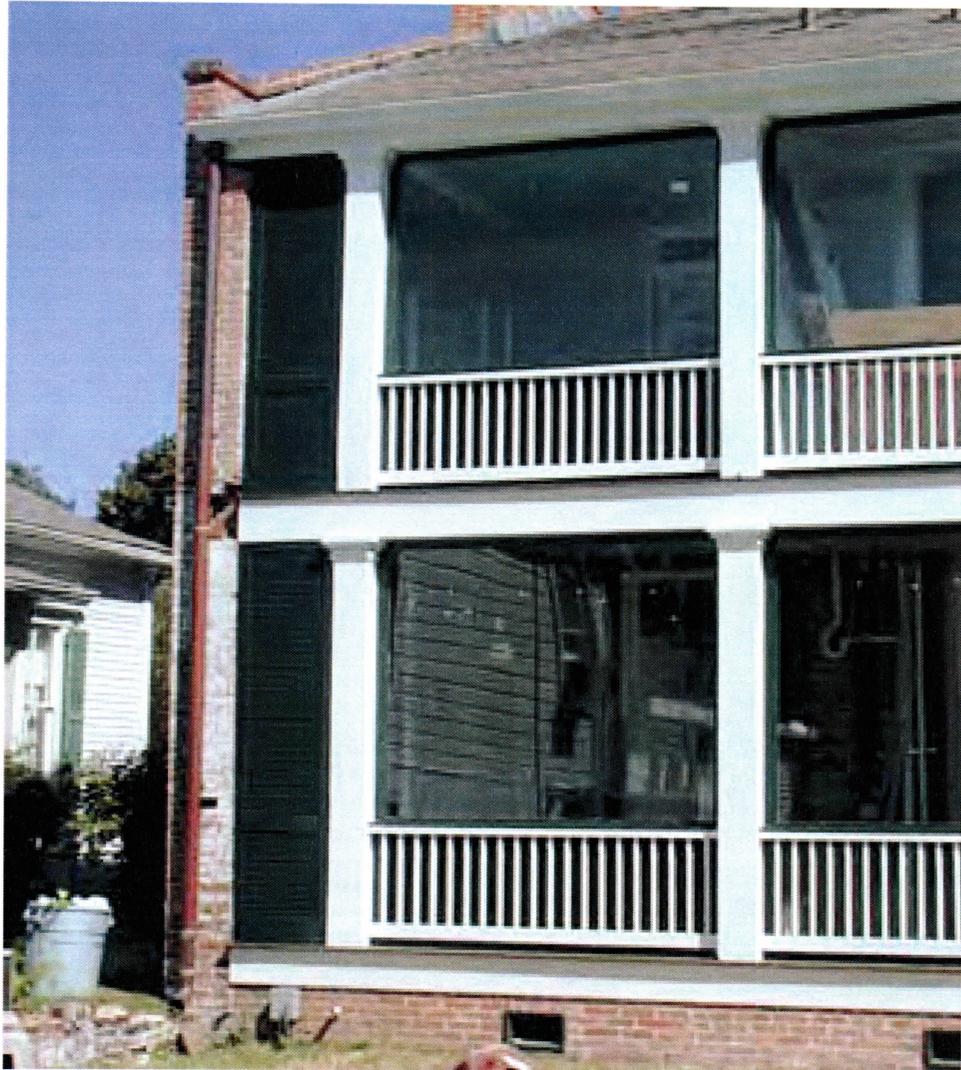
Figure 14: RESTORED HISTORIC HOUSE This historic house once had multiple rear additions that completely obscured the rear galleries. The deteriorated, insignificant rear additions were removed and the rear gallery was restored and enclosed with glass. The enclosed rear gallery contains the kitchen on the first story and a bathroom and sitting room on the second floor.

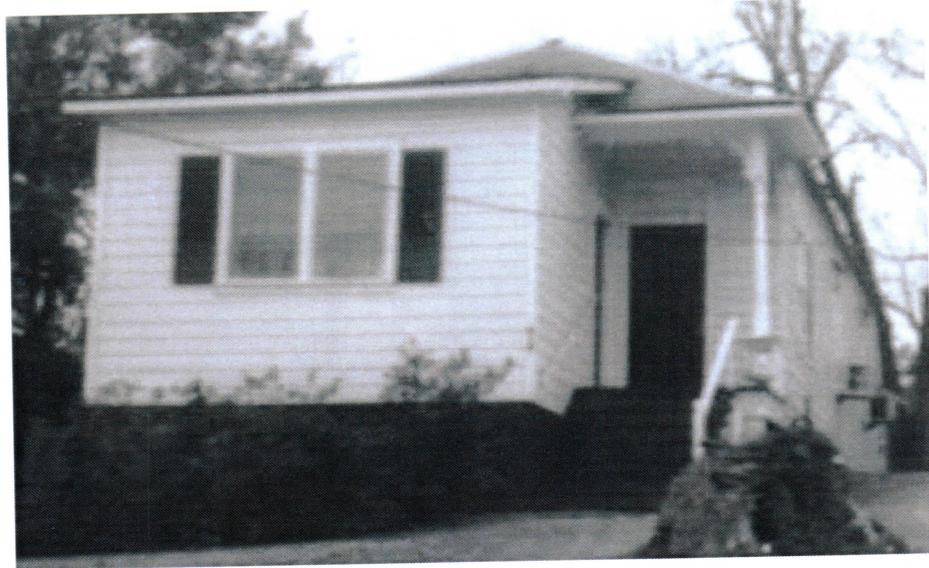
Figure 15: HOUSE WITH INAPPROPRIATE FRONT ADDITION front addition both encloses and enlarges a portion of an original full-width front porch. Note also the inappropriate shutters

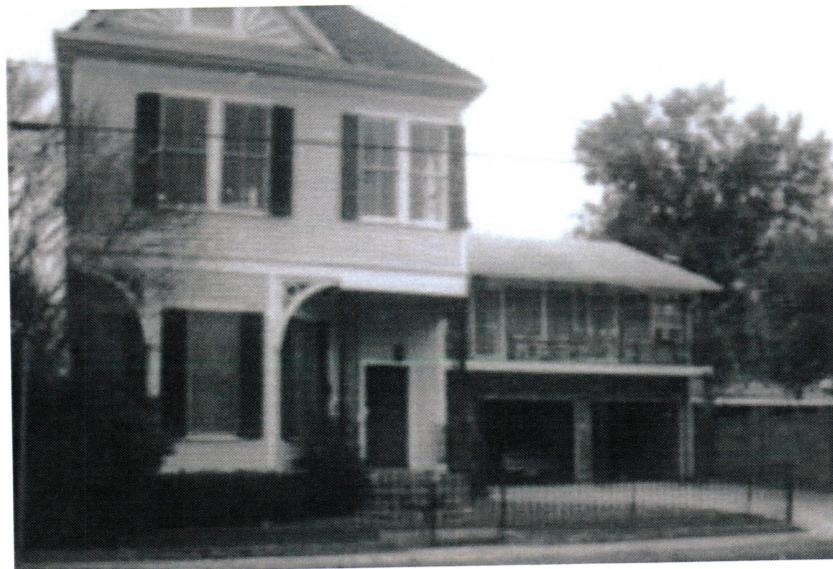
Figure 16: INAPPROPRIATE ADDITION This side addition is inappropriate in proportion and scale, height, materials, massing and roof shape. The upper and lower porches and the entry door of this historic house have also been remodeled.

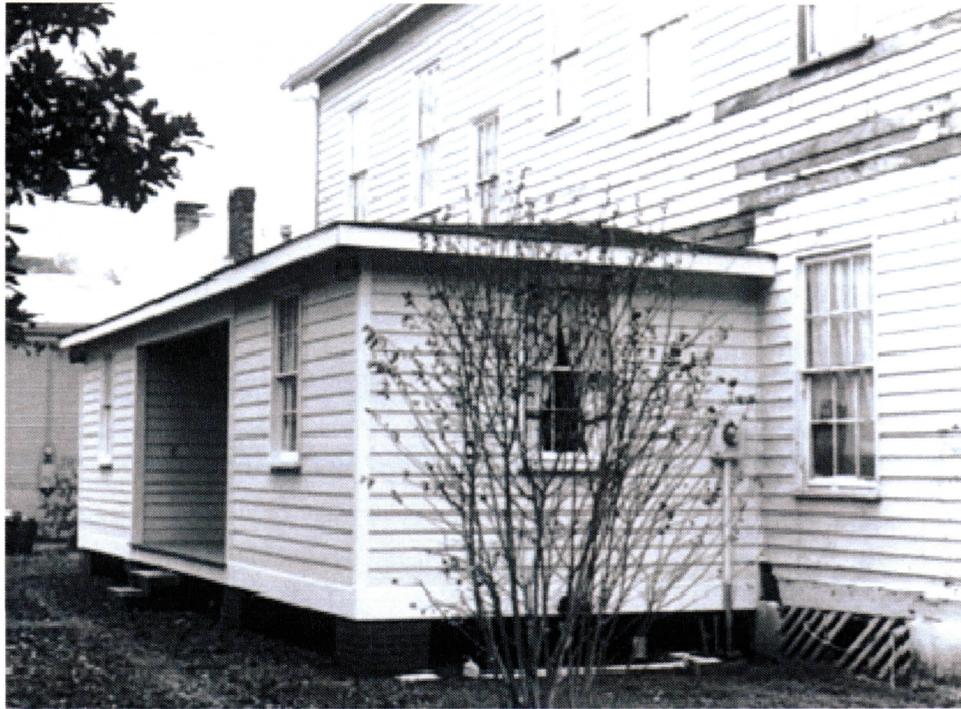
Figure 17: **APPROPRIATE ADDITION** This photograph illustrates an appropriately scaled and located rear addition.

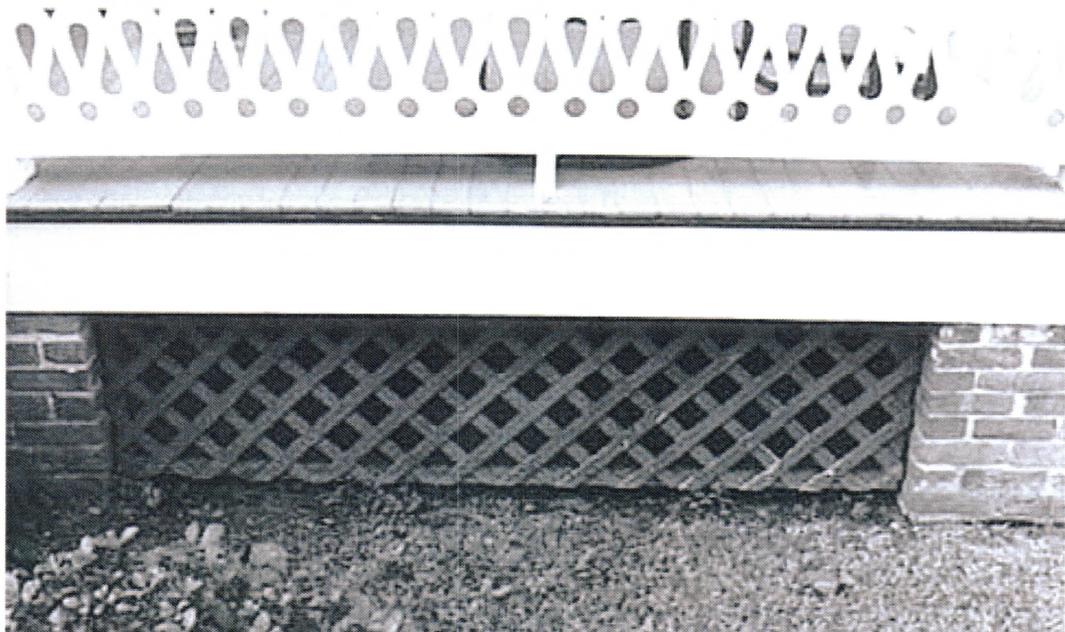
Figure 18: CRAWL SPACE appropriately enclosed by lattice panels, which are backed with roofing paper to block the wind and to prevent the growth of weeds behind the lattice panels

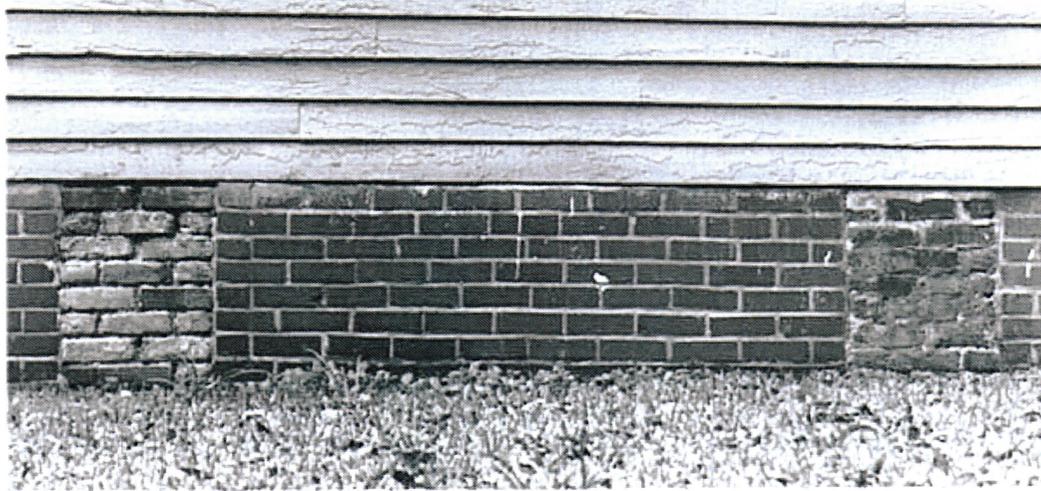
Figure 19: CRAWL SPACE ENCLOSURE visually inappropriate and has no vents to provide air circulation beneath the house.

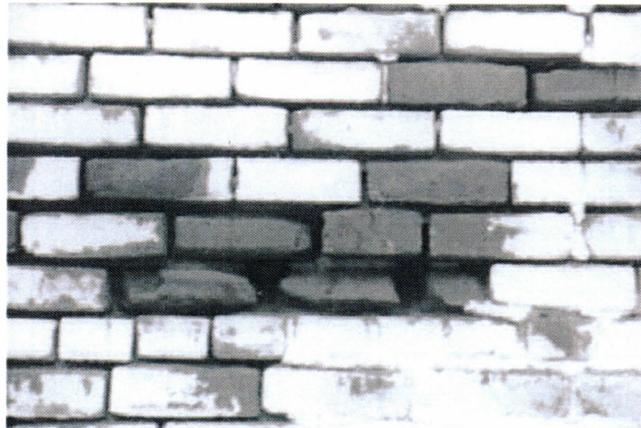
Figure 20: DETERIORATED BRICK This illustration shows a section of a painted brick wall with bricks showing evidence of spalling, or deterioration resulting from soft bricks and re-pointing with hard mortar

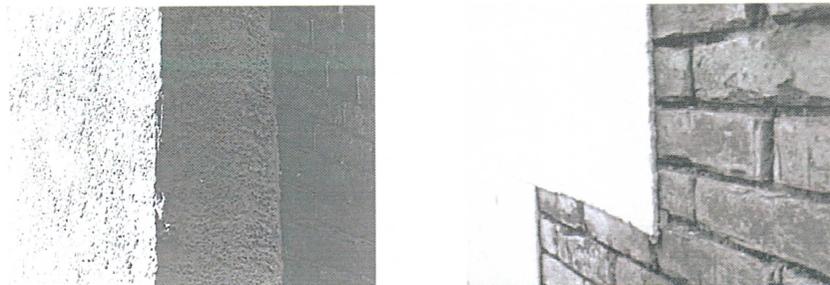
Figure 21: **STUCCO APPLICATIONS** Stucco is applied to brick to create both **ROUGH [LEFT]** and **SMOOTH [RIGHT]** surfaces.

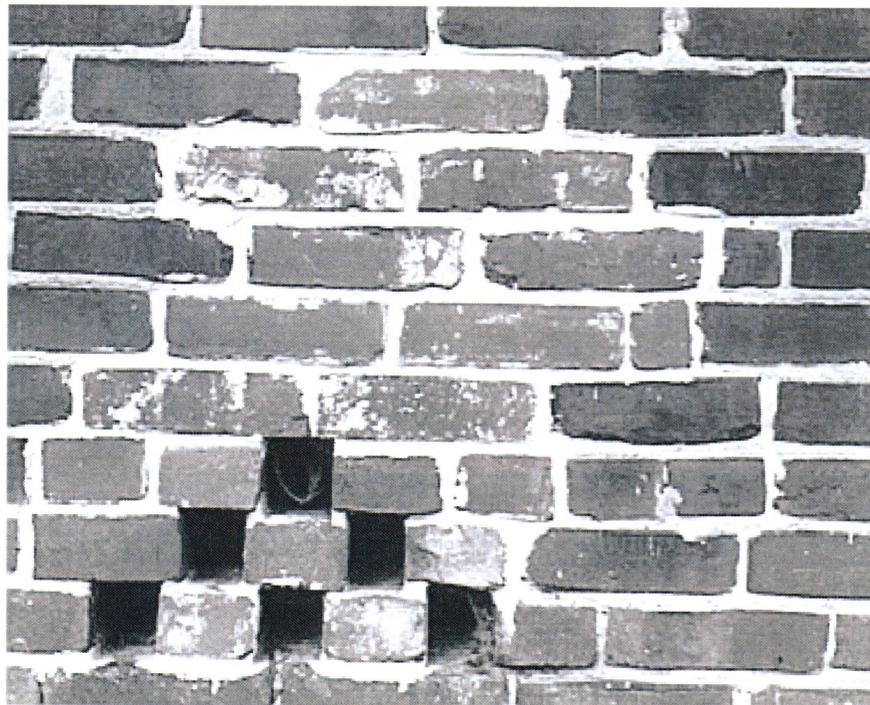
Figure 22: INNAPROPRIATE MORTAR REPAIR The mortar used in re-pointing this brick wall does not match the original in color (too white), texture (cement with little or no sand), or form (work is sloppy and mortar is smeared on the surface of the brick).

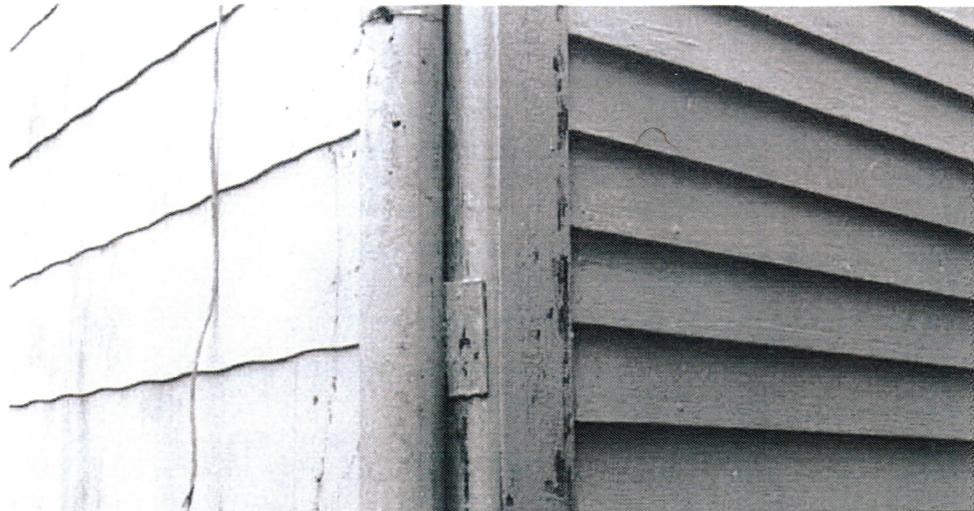
Figure 23: **INAPPROPRIATE ASBESTOS-SHINGLE SIDING [LEFT SIDE]** has been installed over the historic horizontal wood lap siding [RIGHT SIDE]. The inappropriate siding does not convey the same visual characteristics of the historic wood siding.

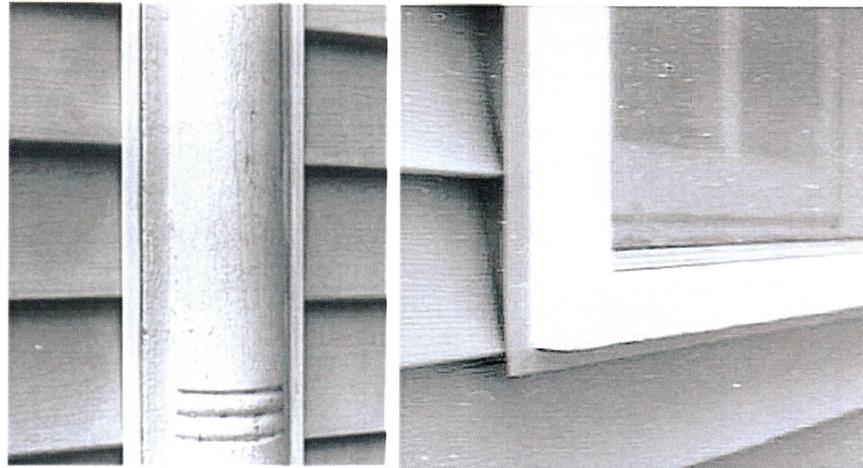
Figure 24: **VINYL SIDING WITH J CHANNELS** Examples of vinyl siding showing the installation of J-channels around every opening.

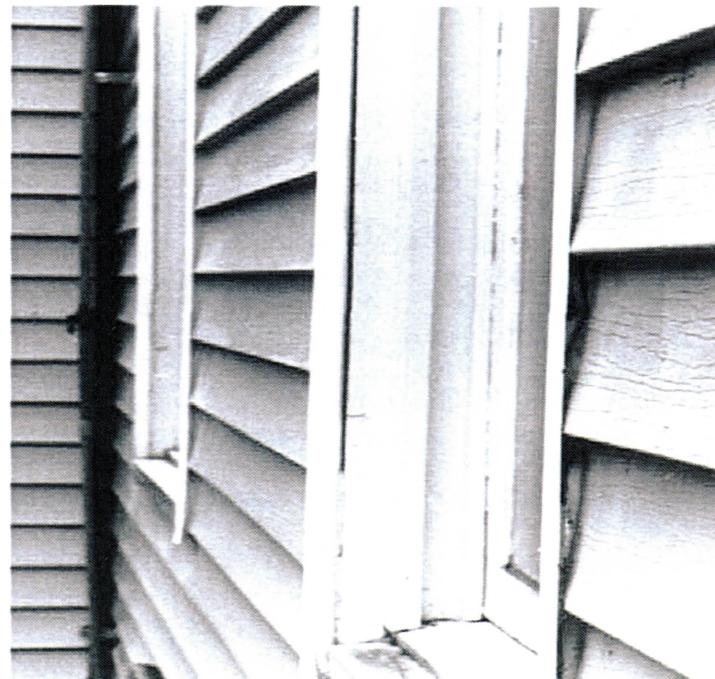
Figure 25: **VINYL SIDING OVER WOOD SIDING** Vinyl siding is applied over the original wood siding of this house. The vinyl siding is nearly flush with the trim around the windows, and J-channels have been installed around the windows that deflect water from seeping behind the siding.

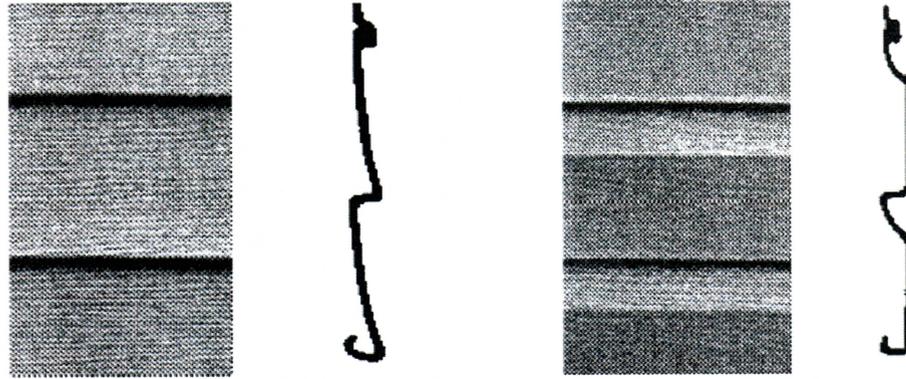
Figure 26: VINYL SIDING TYPES LEFT illustrates the straight drop design, which better replicates historic nineteenth century siding. RIGHT illustrates the coved or grooved siding, popular in the mid-twentieth century.

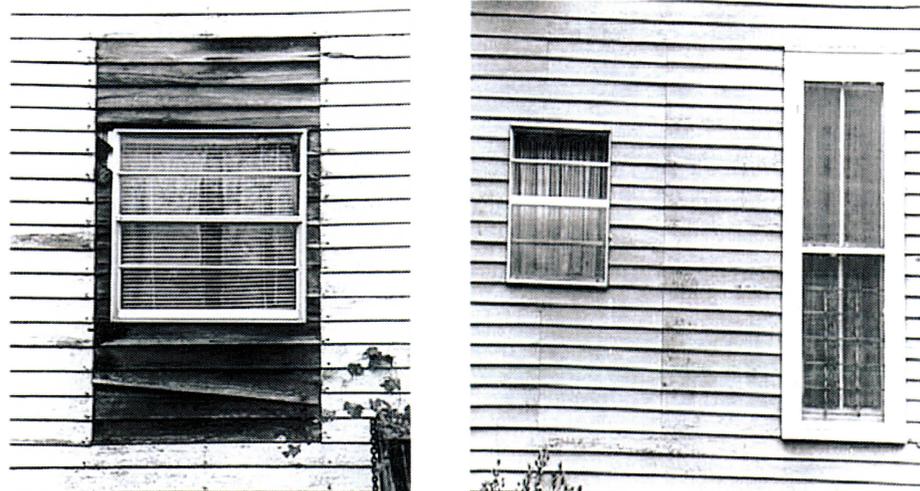
Figure 27: INNAPPROPRIATE WINDOW REPLACEMENTS LEFT: This metal window is not appropriate for a historic house. It is an obvious replacement for a much larger window. RIGHT: The small metal replacement window is inappropriate for a historic structure and does not convey the same visual appearance as the neighboring original window.

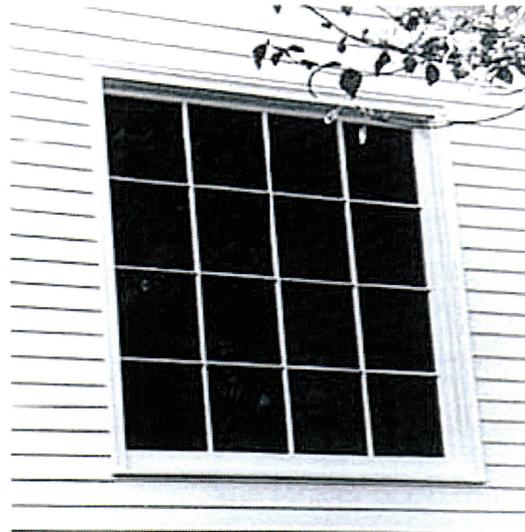
Figure 28: **INNAPPROPRIATE WINDOW TYPE** The proportions and glazing pattern of this picture window are not appropriate for a historic house

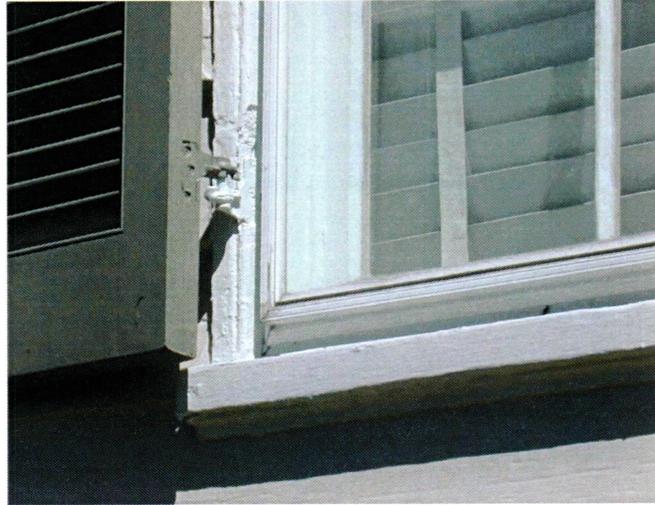
Figure 29: EXTERIOR STORM WINDOWS are inappropriate because they obscure the historic window detailing and sometimes protrude beyond the wall surface.

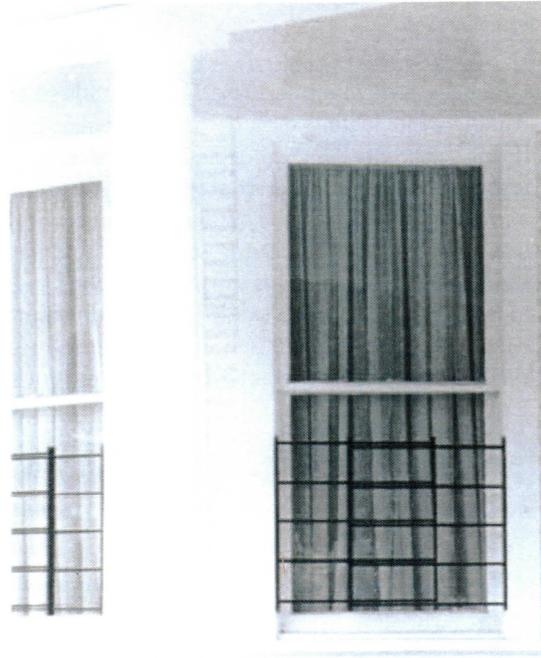
Figure 30: BURGLAR BARS are not appropriate for historic buildings because they change the character of windows and doors.

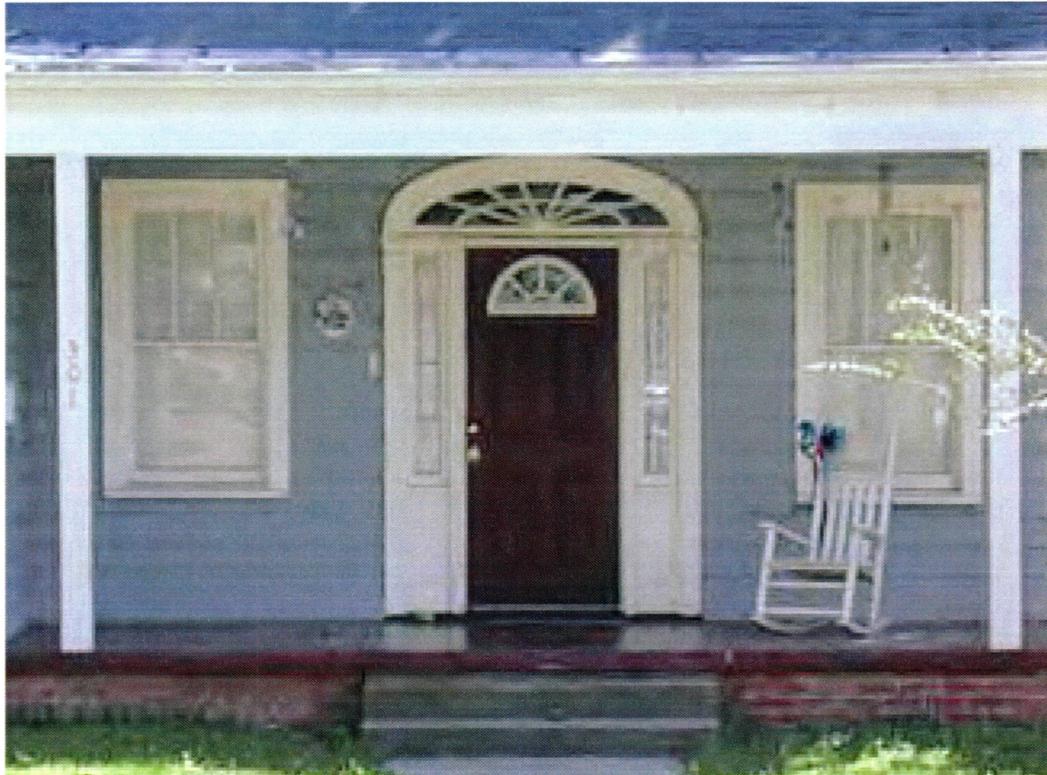
Figure 31: **INNAPPROPRIATE DOOR** Originally Queen Anne Style inappropriately remodeled with ca. 1960 "colonial" remodeling with a ca. 2000 fanlight later installed in the door itself.

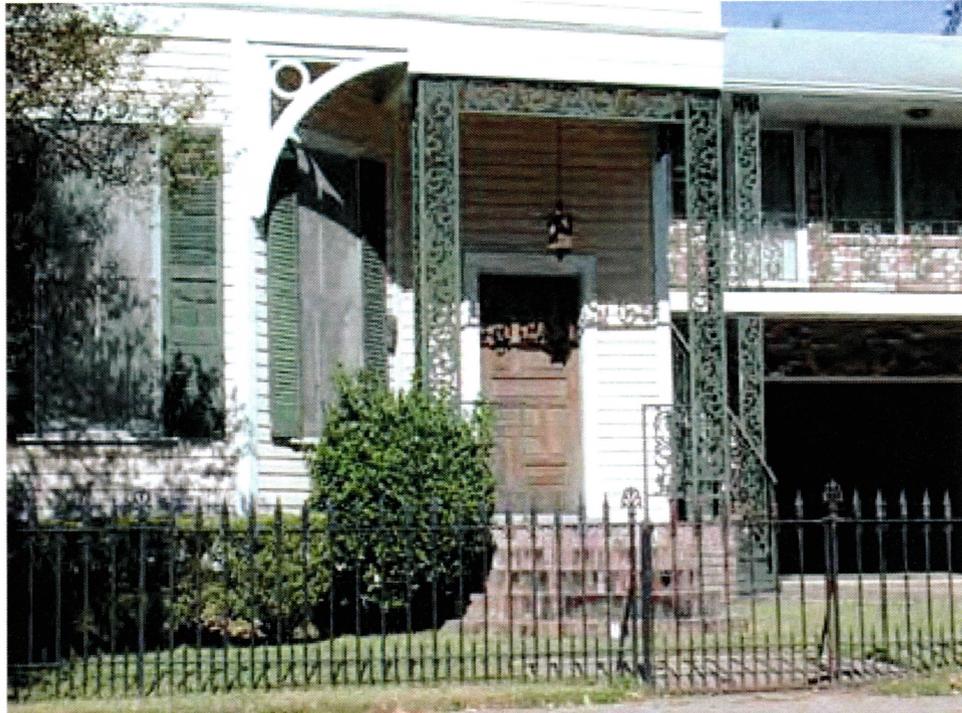
Figure 32: **INNAPPROPRIATE DOOR** Originally Queen Anne Style inappropriately remodeled with a ca. 1970 paneled door

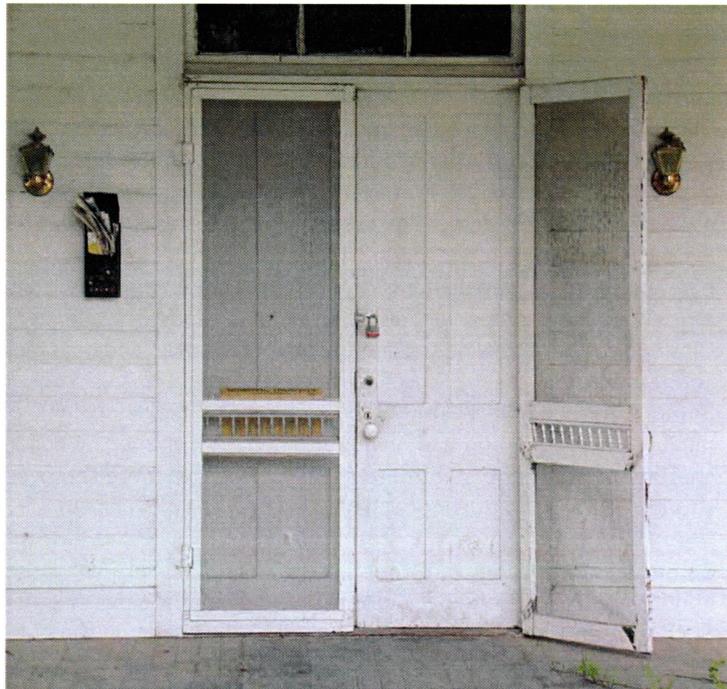
Figure 33: **APPROPRIATE SCREEN DOORS** These double-leaf screen doors are correctly sized and designed and are an appropriate addition to a Greek Revival house

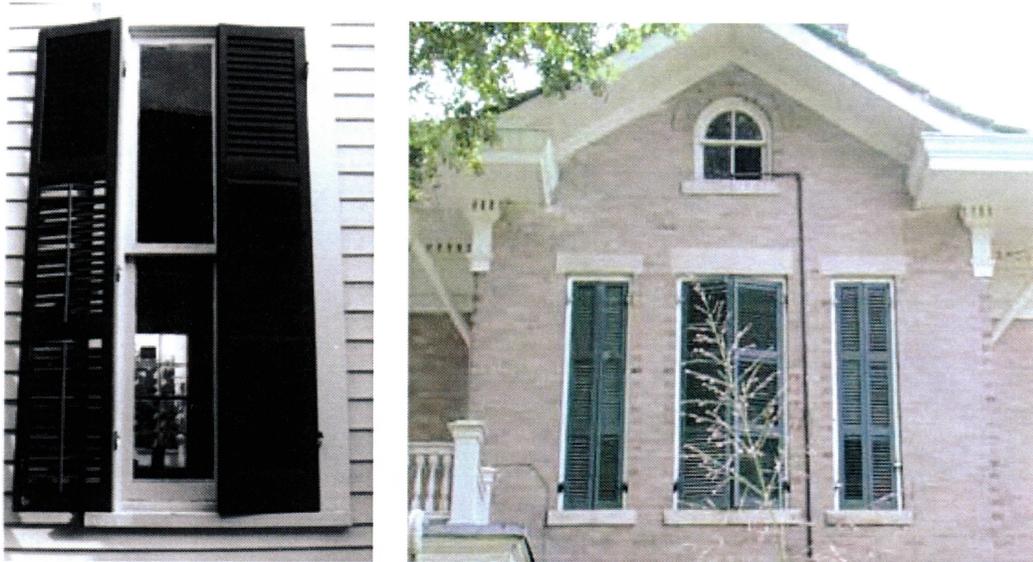
Figure 34: **APPROPRIATE SHUTTERS** The window blinds (popularly known as shutters) of these two houses are original and properly fit the windows.

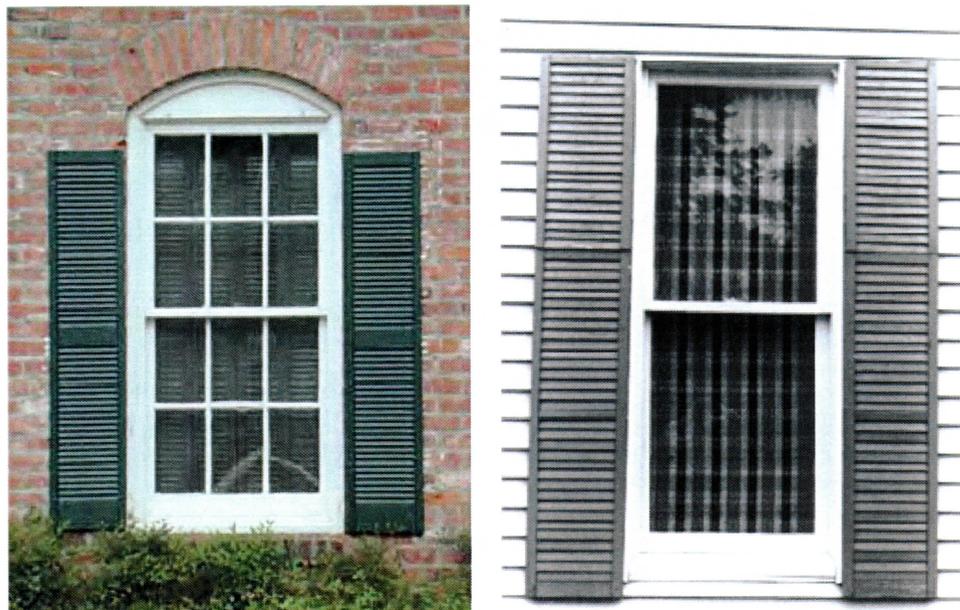
Figure 35: **INNAPPROPRIATE SHUTTERS** The vinyl-paneled shutters flanking the window [LEFT] are too narrow and incorrectly hung outside the window frame. Paneled shutters are also inappropriate for Victorian Houses [RIGHT] with one-over-one sash.

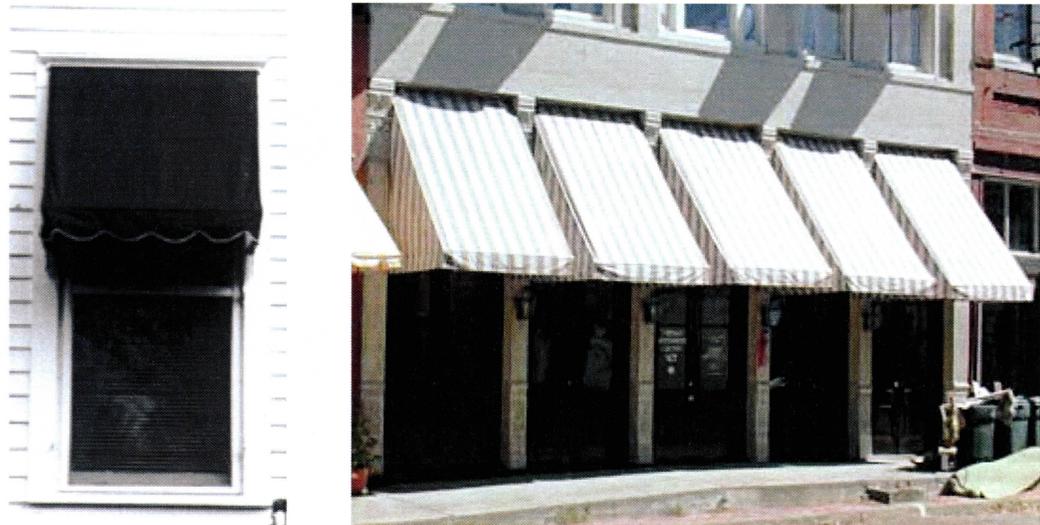
Figure 36: CANVAS AWNINGS are appropriate for houses and commercial buildings. The awnings illustrated ABOVE are correctly sized and properly hung.

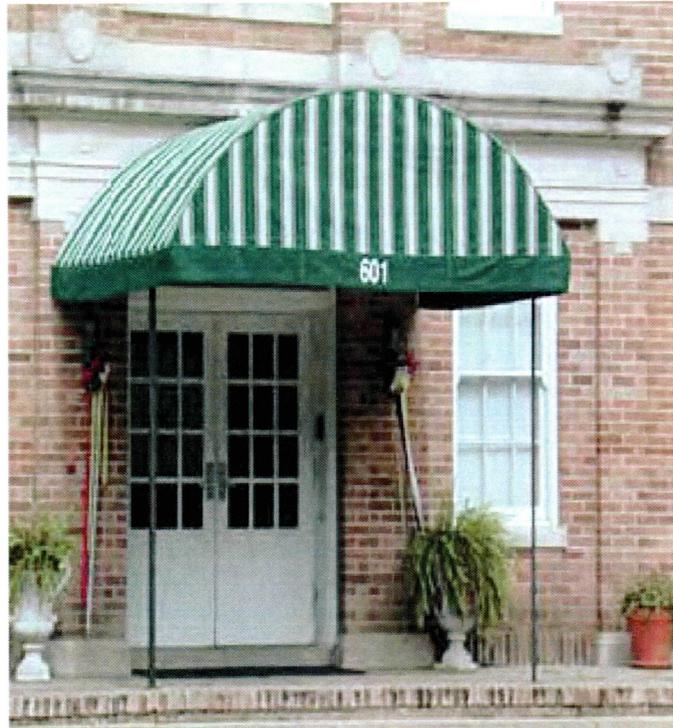
Figure 37: **POLE SUPPORTED AWNING** is appropriate for entrances of commercial buildings

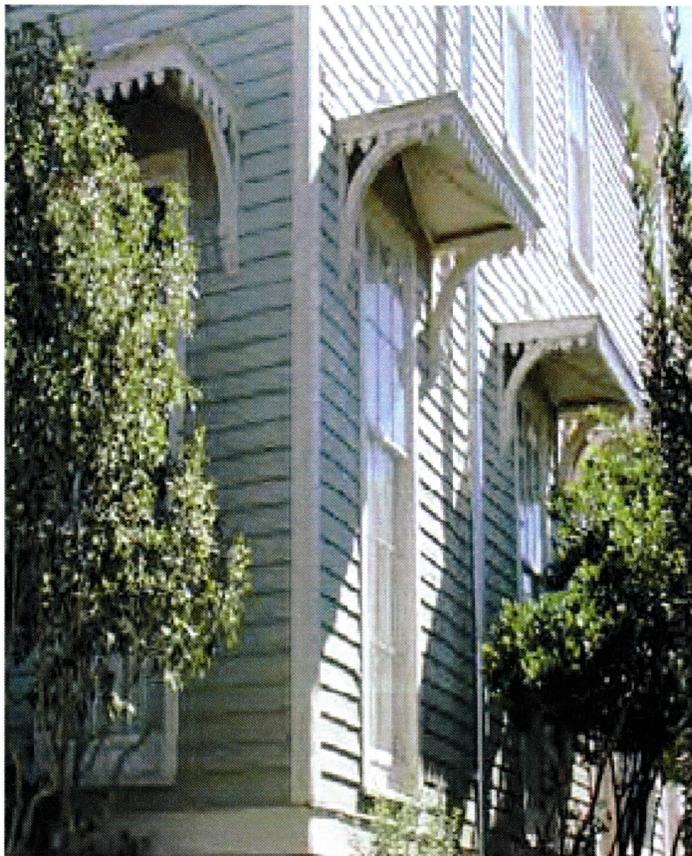
Figure 38: HISTORIC WOOD AWNINGS, supported by brackets, are original features of this Italianate style house dating to ca. 1870.

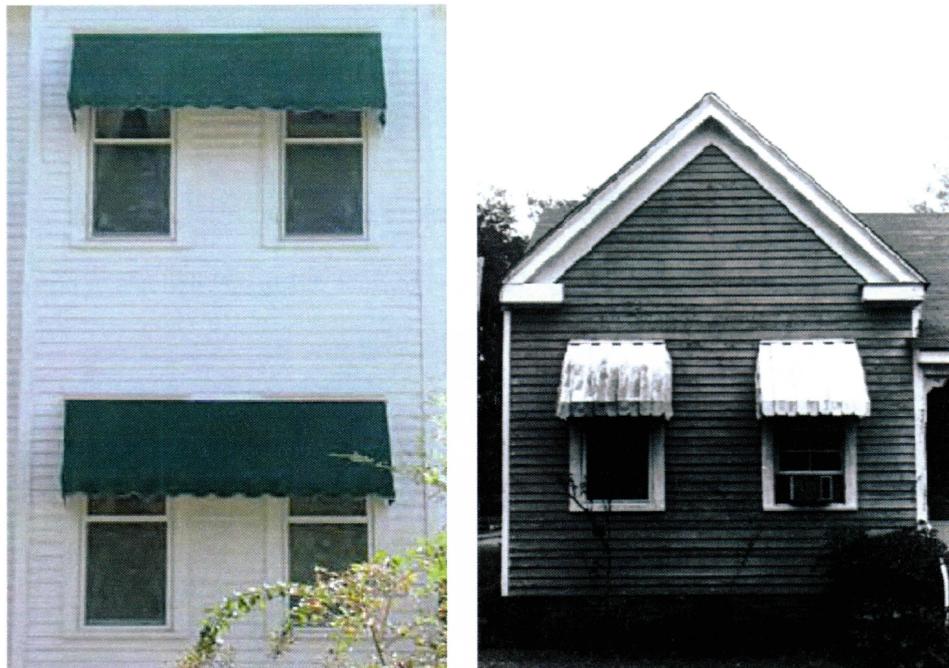
Figure 39: INAPPROPRIATE AWNINGS A single awning for two distinct windows is not appropriate. Each window should have its own canvas awning, sized to fit the opening, Metal window awnings are inappropriate for historic buildings.

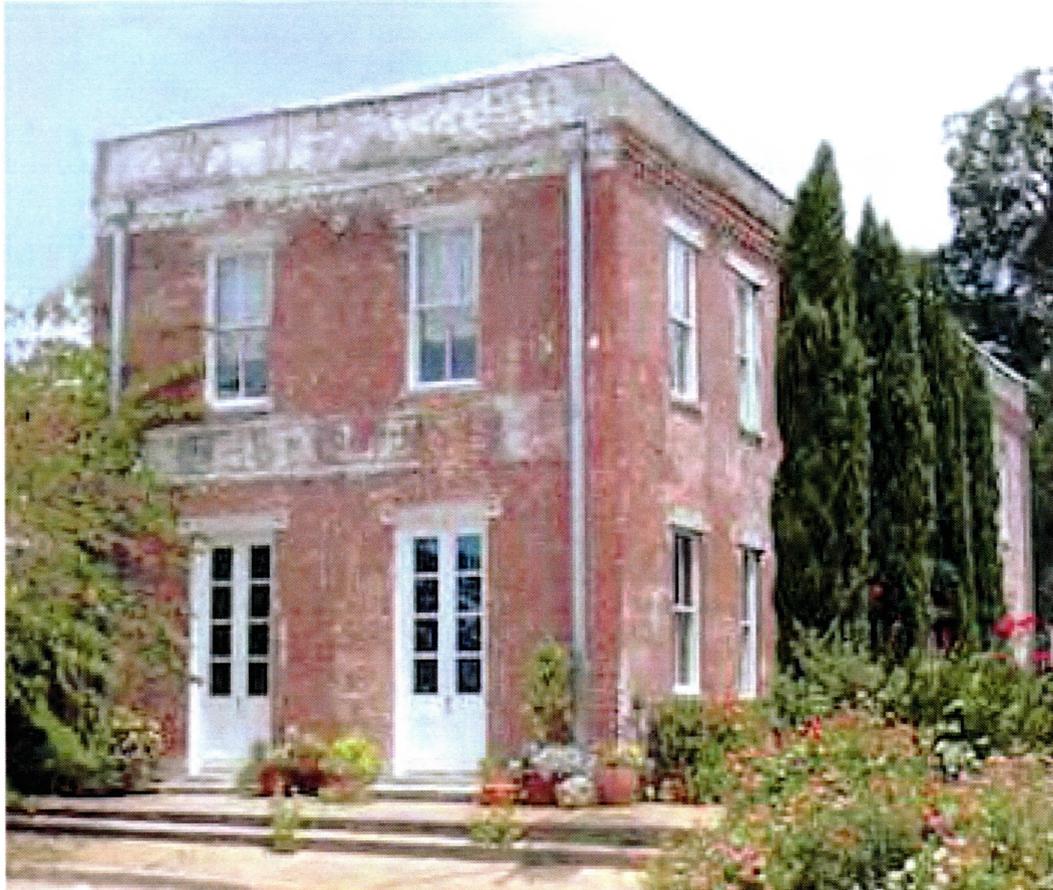
Figure 40: THE OLD PROBATE BUILDING IN RAYMOND (c. 1830) is one of the oldest servicing commercial buildings in Mississippi in the Greek Revival style.

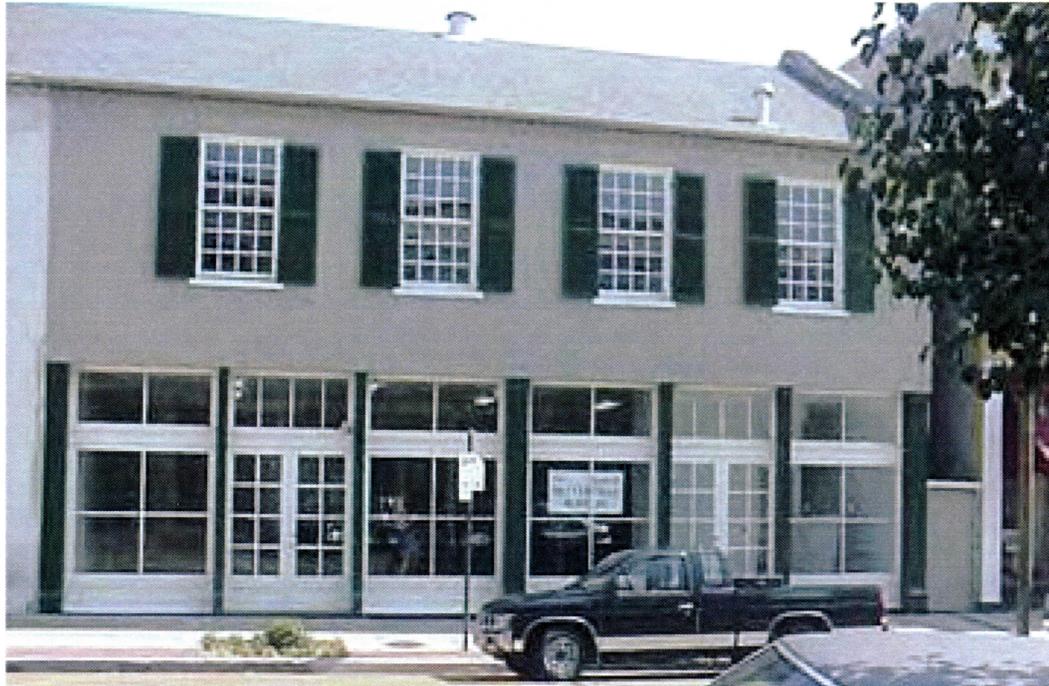
Figure 41: CAST IRON STOREFRONT This commercial building is a good example of an 1840's building with a late 19th century cast iron storefront replacing the original storefront
