OXFORD DESIGN GUIDELINES

OXFORD, MISSISSIPPI

JUNE 2011

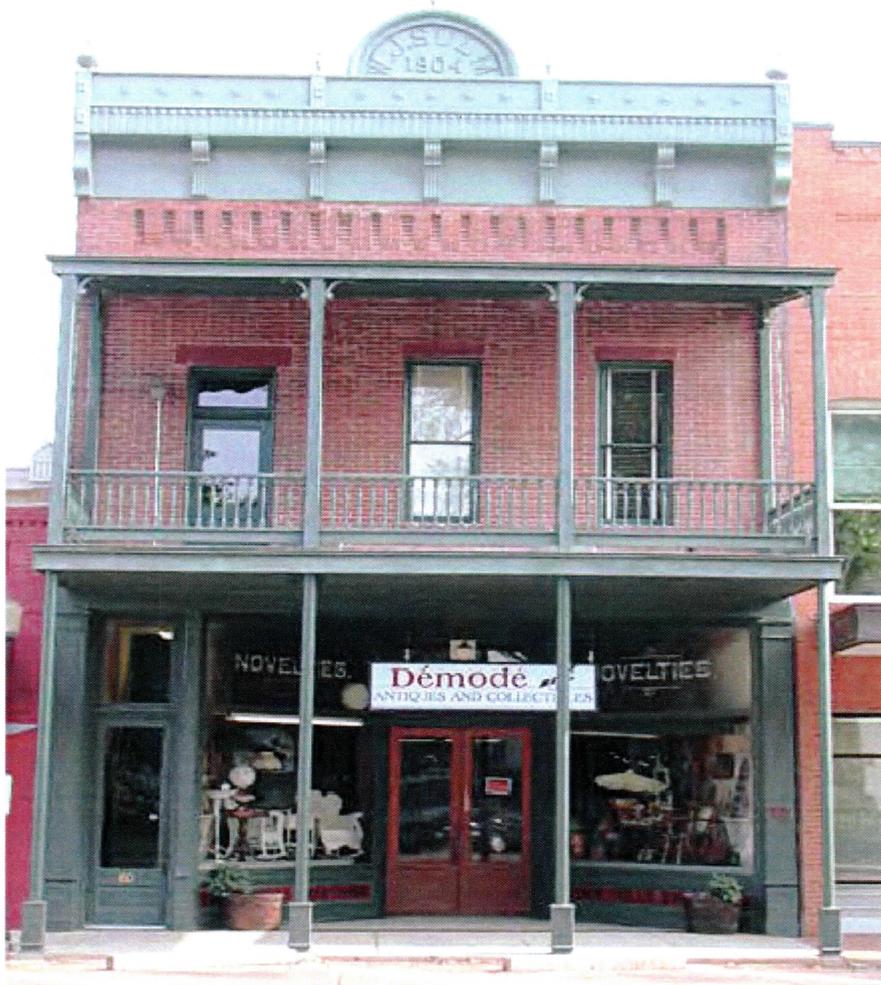
Figure 42: POST CIVIL WAR STOREFRONT featured at this commercial building with pressed metal parapet and two-story porch. The main entrance contains double-leaf doors flanked by display windows over panels, and a secondary entrance with single-leaf door providing access to the second story. All first story openings feature transoms.

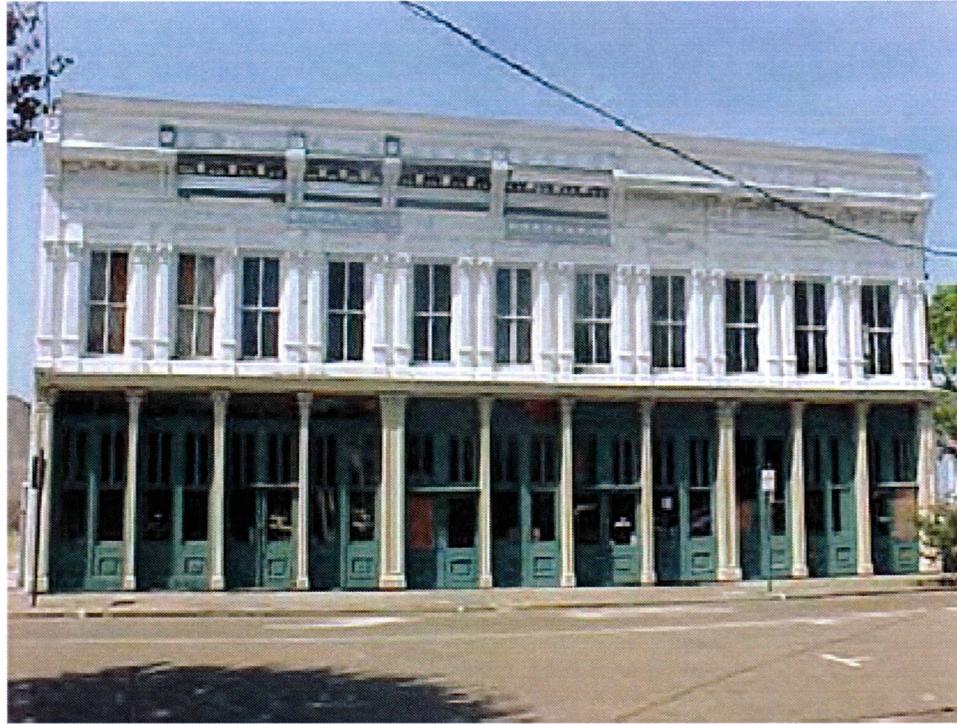
Figure 43: STOREFRONT WITH REPEATING DOORWAYS This commercial building is a good example of a storefront with a number of repeating doorways

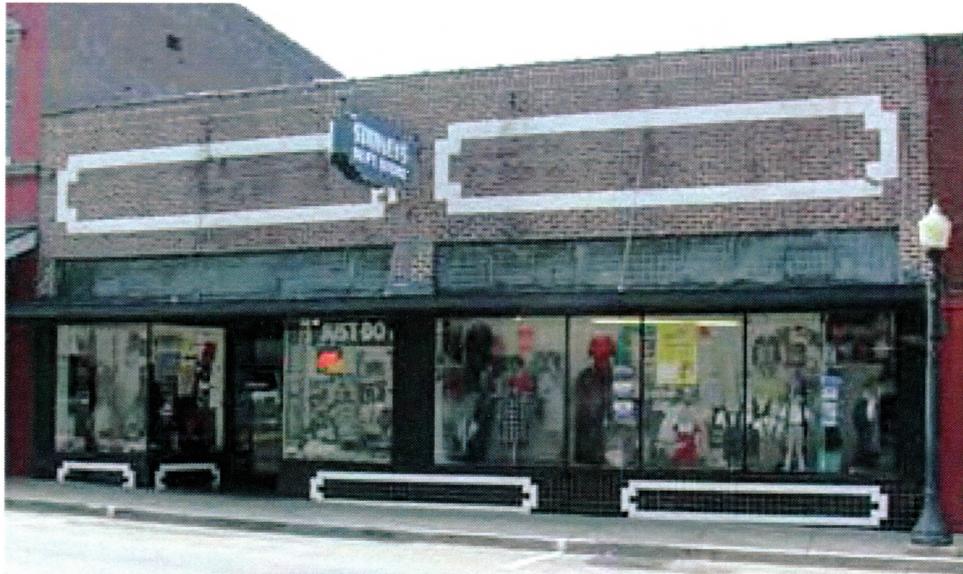
Figure 44: **STOREFRONT EXAMPLE** This is an example of a well preserved storefront dating to the first half of the twentieth century. The building features plate glass windows with a fixed metal canopy and opaque transom above and ceramic tiles below

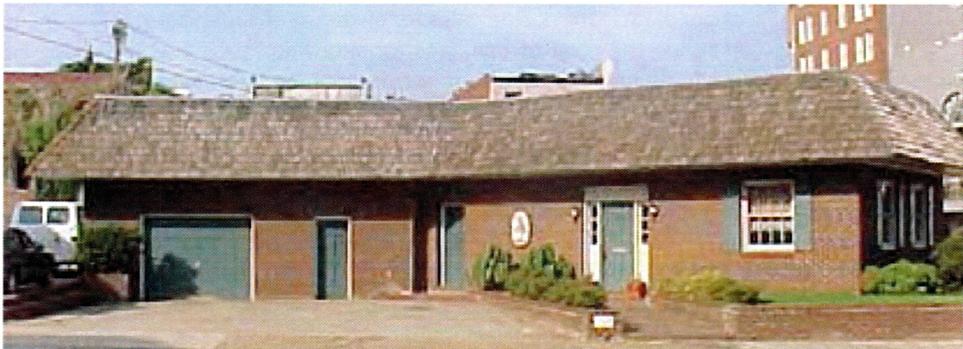
Figure 45: **1960s INAPPROPRIATE REMODELING** on the right illustrates the popularity of mansard roof additions and "Colonial" motifs, including "old brick", a doorway with sidelights, and shutters.

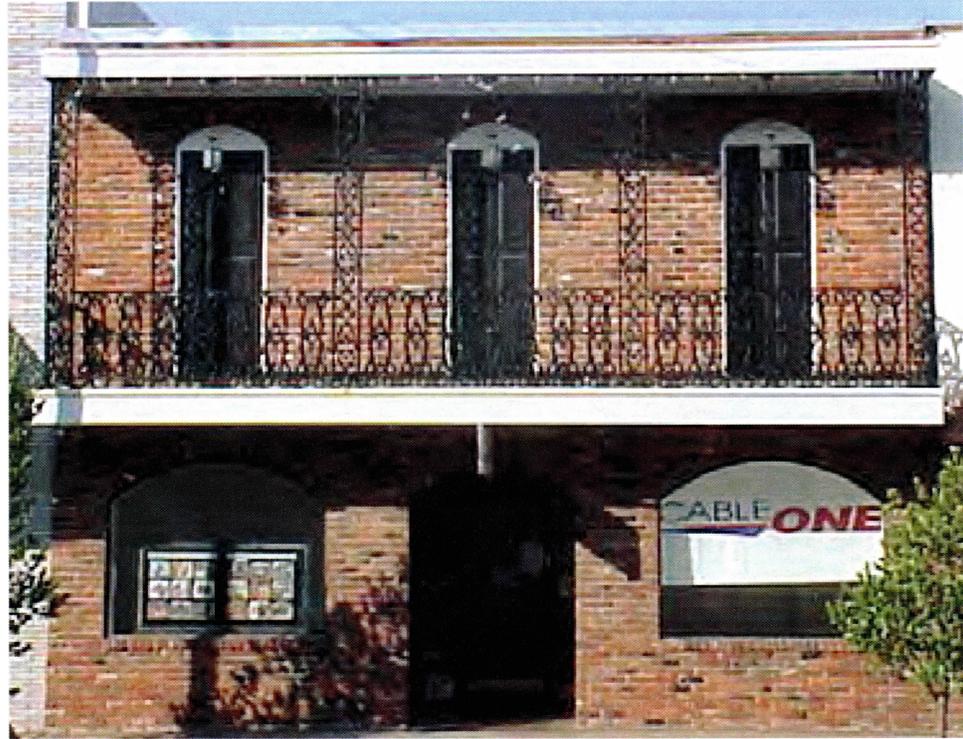
Figure 46: INNAPPROPRIATE REMODEL This one-story building received an inappropriate pseudo-New Orleans style remodeling that created a fake two-story appearance with “old brick” siding, shuttered French doors on the upper level, and a balcony.

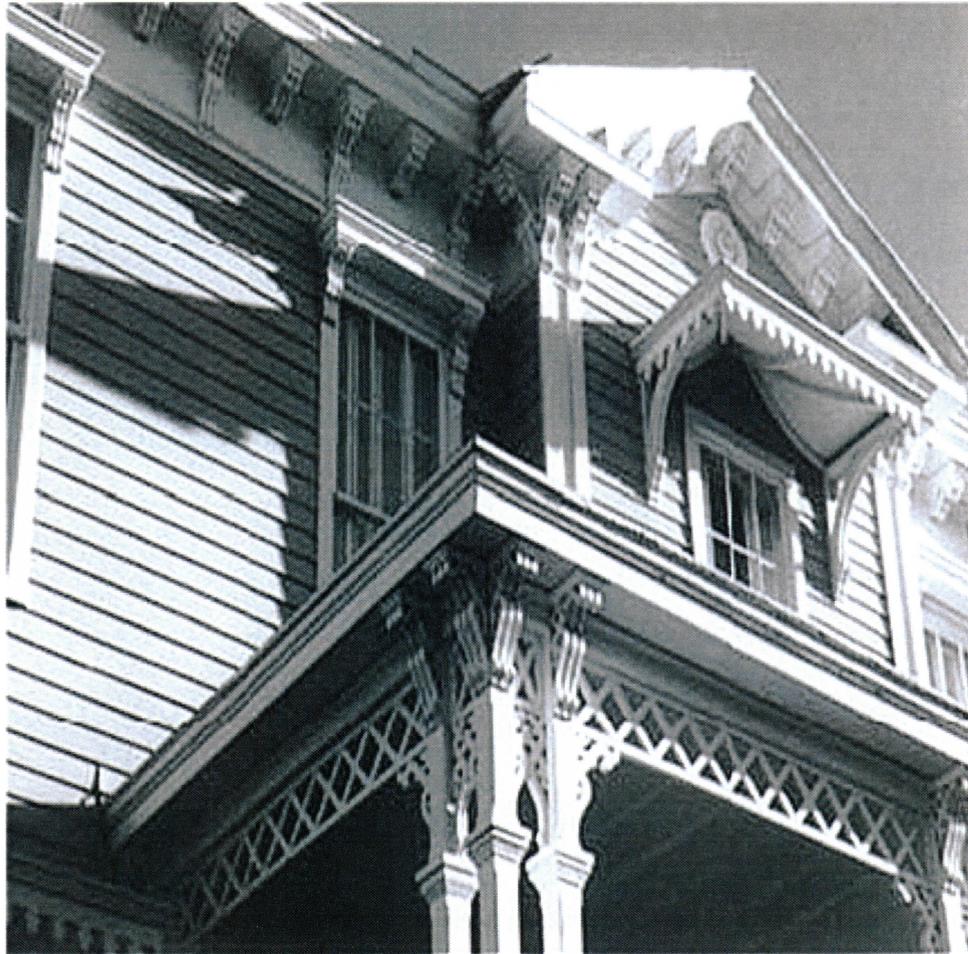
Figure 47: AN ITALIANATE STYLE HOUSE WITH ORNAMENTAL BRACKETS supporting the roof eaves.

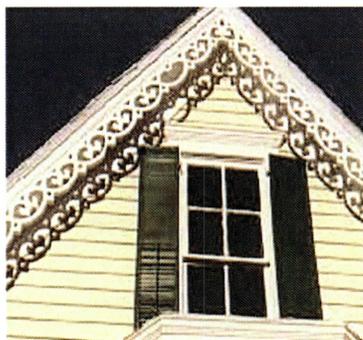
Figure 48: EXAMPLE OF A GOTHIC STYLE HOUSE WITH DECORATIVE VERGEBOARDS (also called bargeboards).

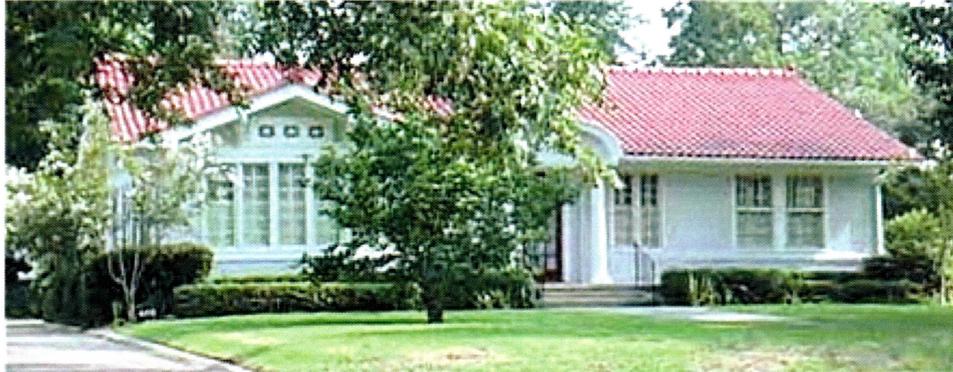
Figure 49: CLAY TILE ROOF Example of an Italian Renaissance Revival house with its original clay tile roof. If this roof were replaced with a new roof of another material, much of the house's historic character would be lost.

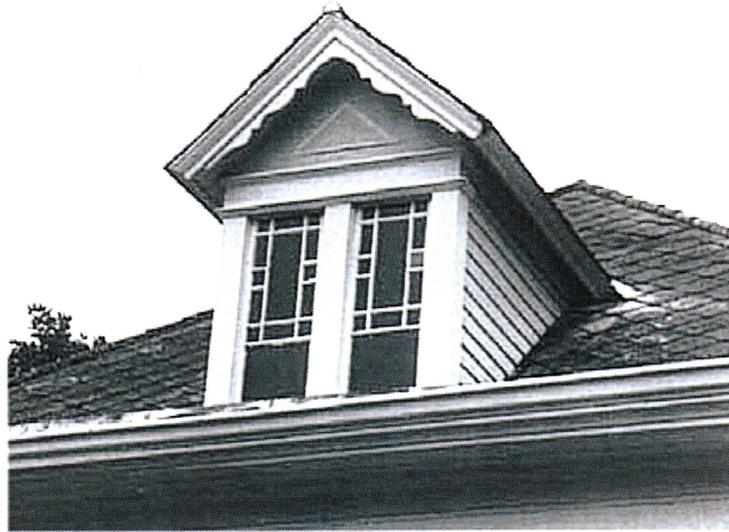
Figure 50: DORMER WINDOW ON A QUEEN ANNE STYLE HOUSE.

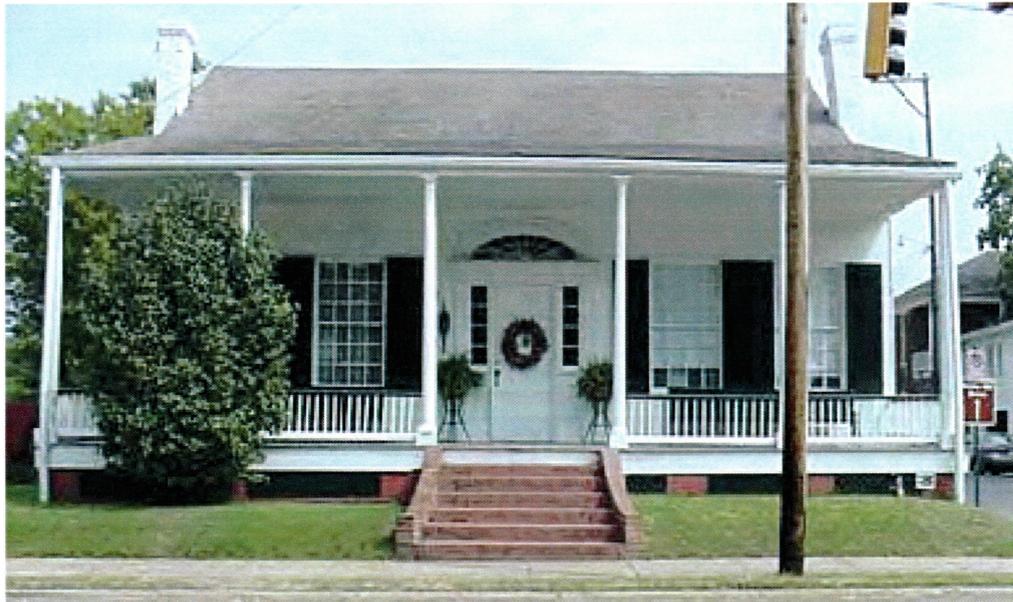
Figure 51: INNAPPROPRIATE ENTRY STEP REPLACEMENT at this Federal style cottage
Original wood entry steps replaced by brick steps divert attention from the original historic detailing of the house.

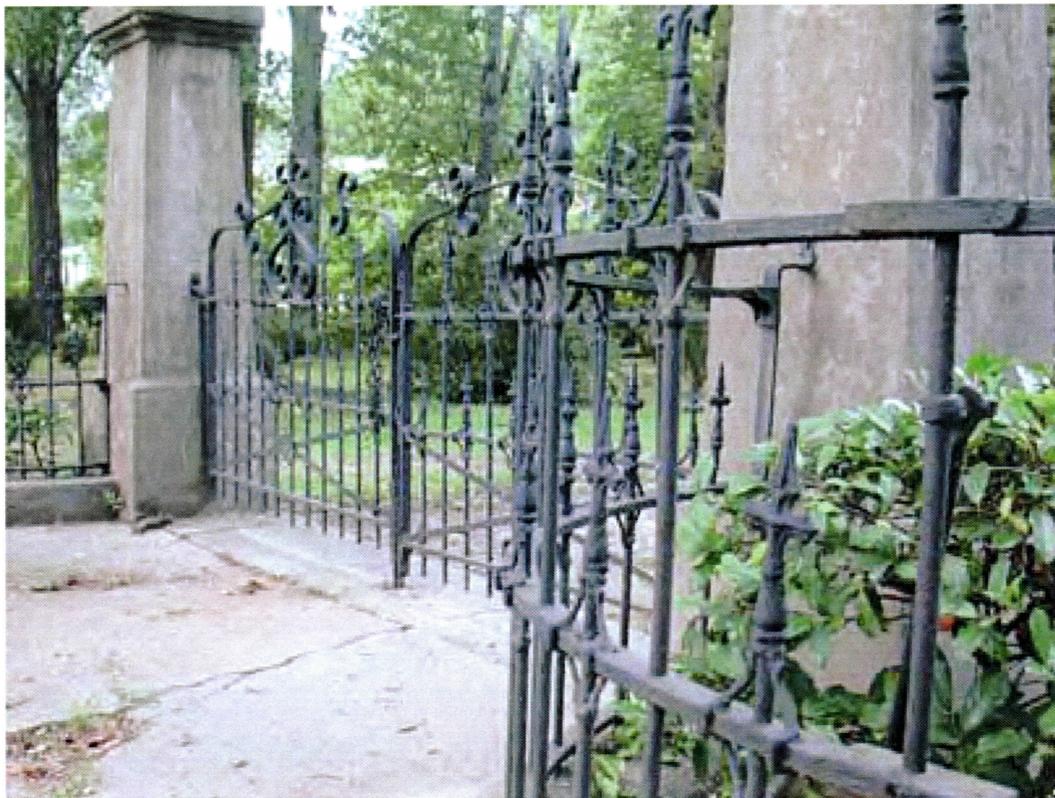
Figure 52: DECORATIVE IRON FENCING

Urban areas featured both wood and iron fences, but picket fences were more common. Picket fencing typically extended along sidewalks, only in front of houses, unless the house had a corner location. Picket fencing in the nineteenth century often featured a skirt or base board, which could be easily replaced, when deteriorated, without disturbing the pickets above. The pickets that held the gate latch were often painted dark to obscure finger prints, which also helped pedestrians identify the point of entry.

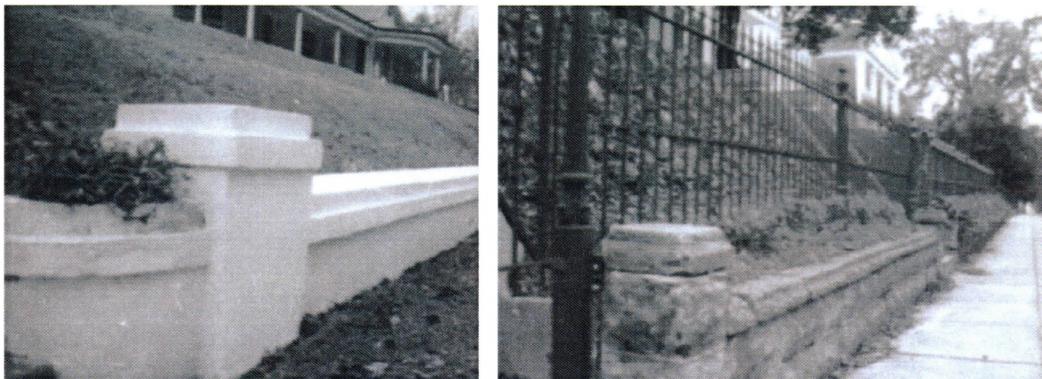
Figure 53: **RETAINING WALLS.** Many historic houses featured retaining walls.

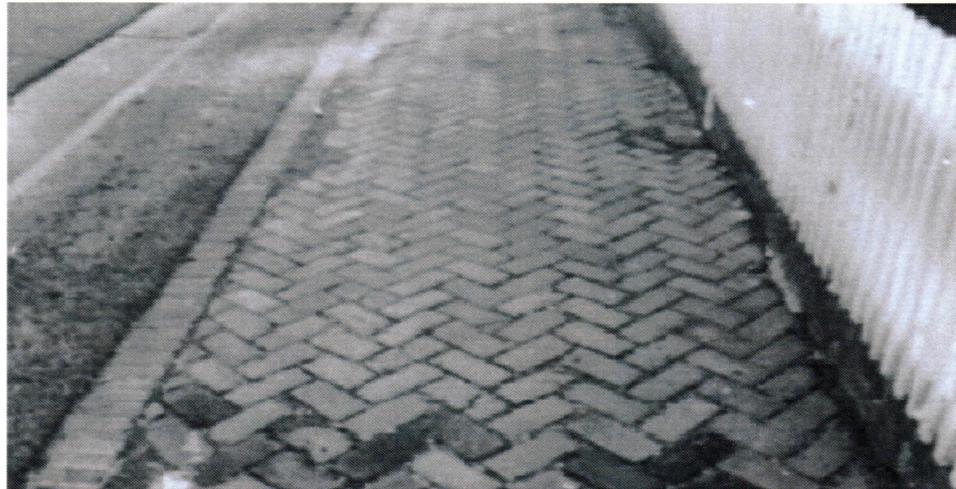
Figure 54: BRICK SIDEWALK LAID IN A TYPICAL HERRINGBONE PATTERN

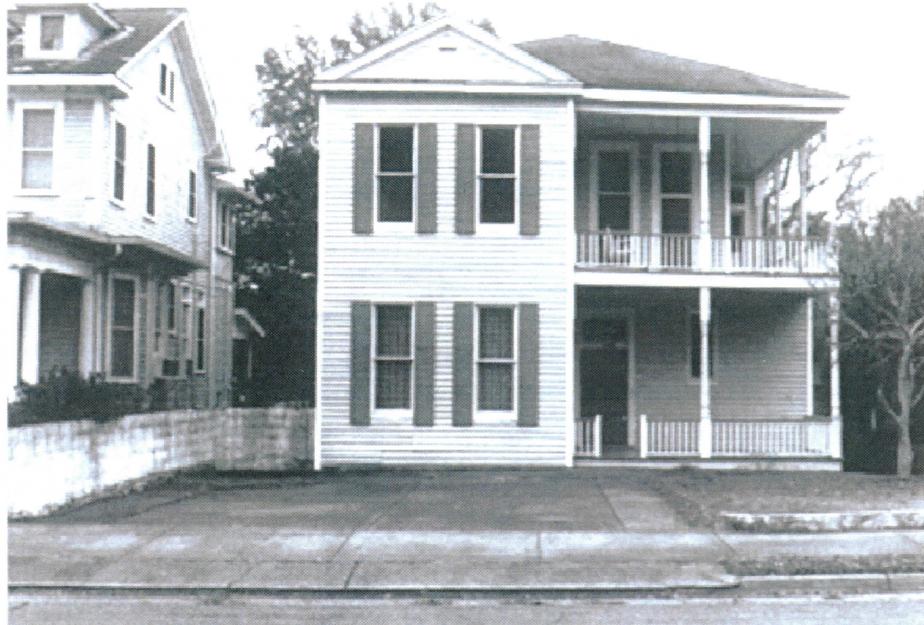
Figure 55: **INAPPROPRIATE PAVING AT FRONT YARD** of this historic house for parking. Parked cars and the lack of landscaping disrupt the character of the historic neighborhood.
