# **RAYMOND DESIGN GUIDELINES**

Prepared by: David Preziosi, AICP - Mississippi Heritage Trust  
2008

**RAYMOND, MISSISSIPPI**

**ADOPTED NOVEMBER 4, 2008**

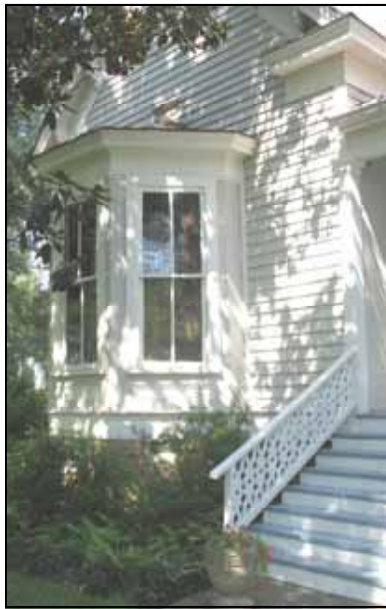
*The Raymond Design Guidelines will encourage the preservation of architectural detailing like the original bay with wood double hung wood windows, wood lap siding, wood stairs, and cut balustrade of the 237 North Oak Street, a significant expression of the Queen Anne style of architecture.*

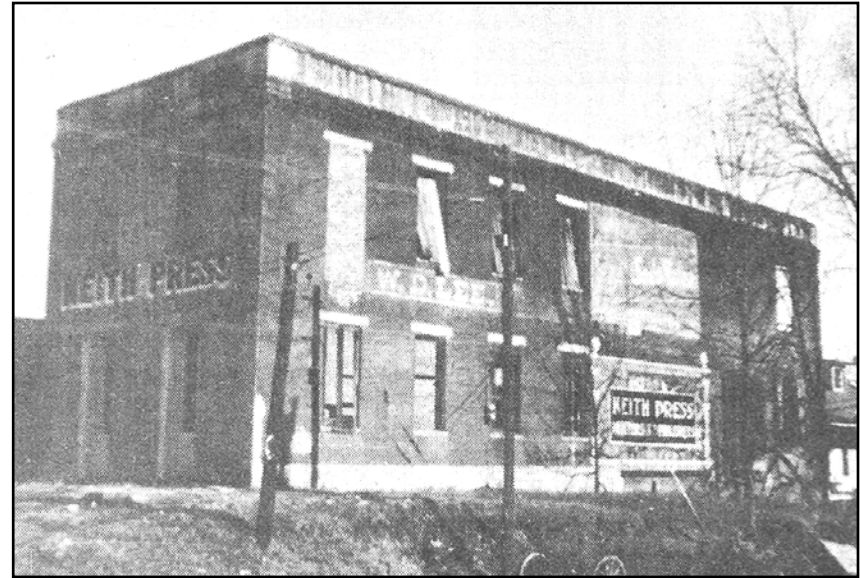
*This photo shows the Chancery Building when it was used as the Keith Press building and before they made alterations to the front façade. Those alterations were removed when the current owner remodeled the building.*

Other surviving antebellum buildings continue the boldness and simplicity of the courthouse on a smaller scale. Believed to be the oldest building in town is the circa 1830 Probate Building (also known as the Keith Press building), a long, two-story structure with its short, two-bay end facing the Town Square. Built of brick laid in Flemish bond, it features handsome stone lintels accentuated by roundel blocks.

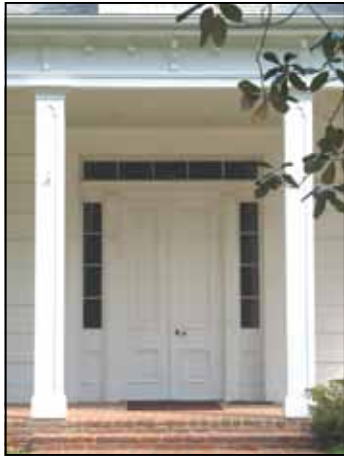
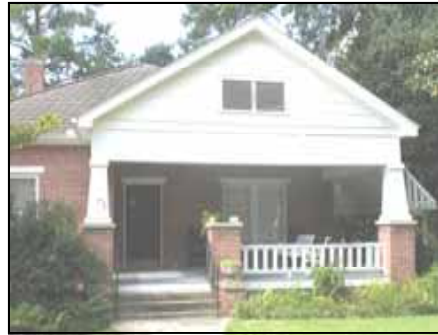
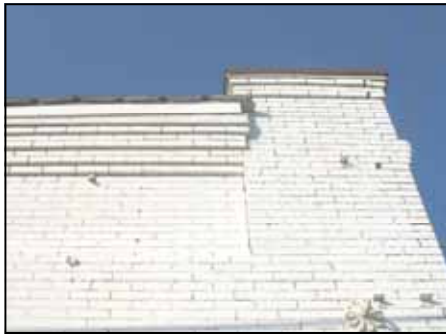
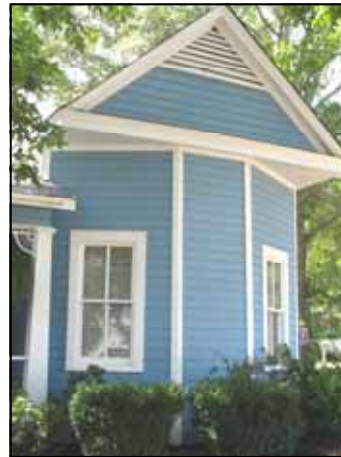
*Above are some of the architectural features found in Raymond. Typical double entrance doors with sidelights of the Greek Revival style in the upper left, a front porch with tapered wood columns on brick bases characteristic of the Craftsman style in the upper right, a chamfered bay under a gable roof which is a feature of the Queen Anne style in the lower right, and the decorative brick work and corbelling of a commercial building on Main Street in the lower left.*

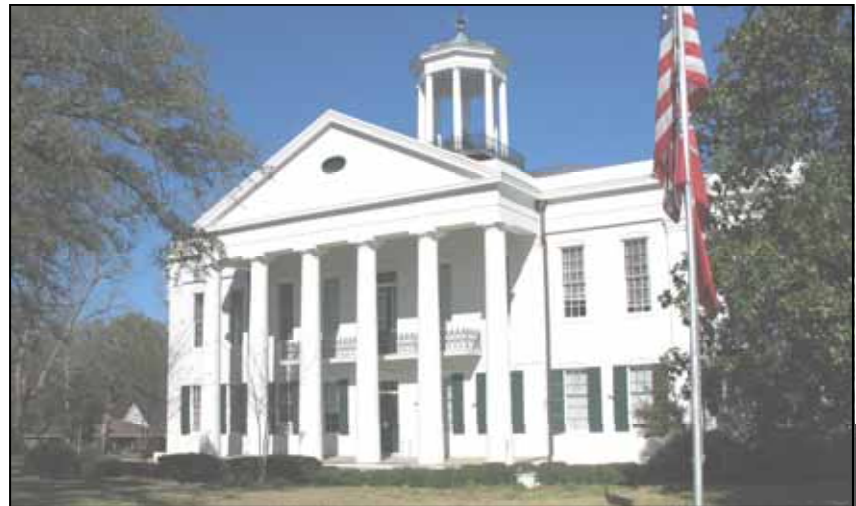
*The Courthouse has typical Greek Revival characteristics such as rectangular massing, low pitched roof, Grecian Doric columns without bases, and stucco scored to look like stone.*

The town's chief edifice is the Hinds County Courthouse (1857-1859), celebrated as one of the state's finest Greek Revival public buildings. The rectangular two-story building has stuccoed and scored masonry walls, tall windows at both stories, and towering porticoes of Tuscan order on all four sides. It is capped by an open, columned cupola. The bold and simple Greek Revival style embodies the work of the brothers George and Tom Weldon, a famed architectural and contracting firm from the Natchez area who also designed the 1858 Old Warren County Courthouse in Vicksburg. The Weldon brothers also had a hand in designing and constructing the Gibbs and Harper buildings in the photo to the left.

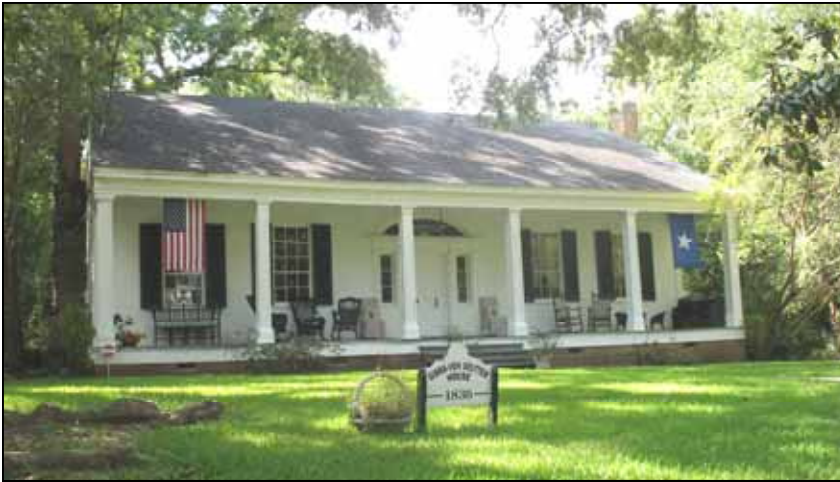
*104 Dupree Street has a full width inset gallery supported on square vernacular wood columns, and a low-pitched roof typical of the Greek Revival features.*

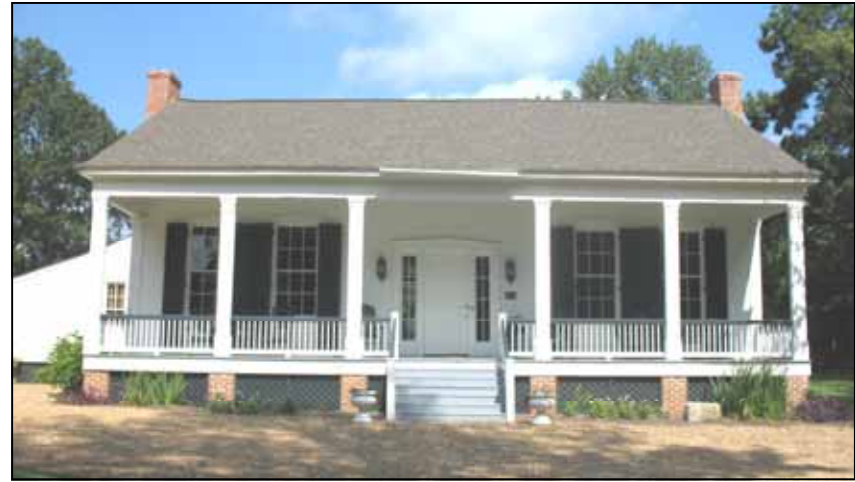
*The Greek Revival style house at 233 North Oak Street was moved into Raymond and restored back to its original appearance.*

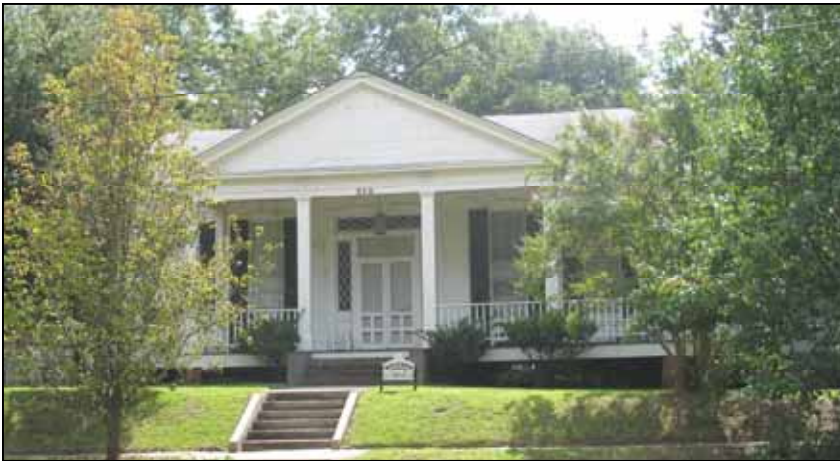
*The house at 214 Port Gibson Street is Greek Revival in style with its gabled projecting porch supported on square vernacular columns and typical multi-paned windows.*

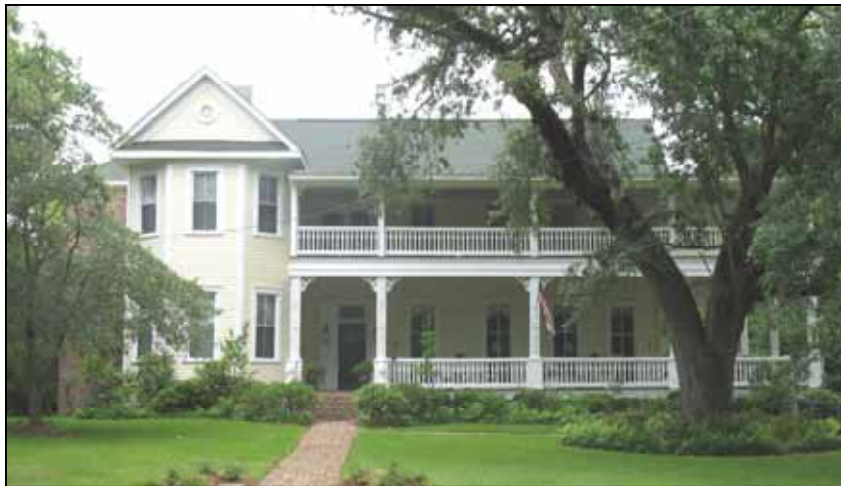
*235 West Main Street is an excellent example of the Queen Anne style with its chamfered bay under the gable roof projection, original wood double hung windows, typical of the style.*

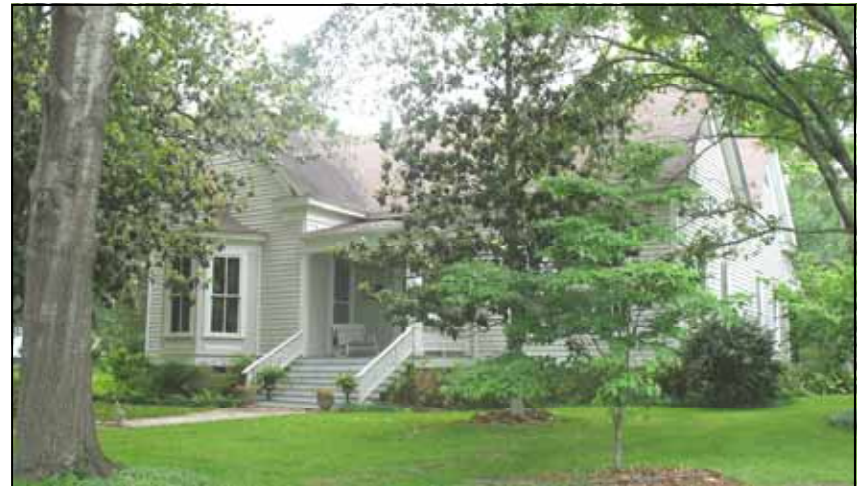
*237 North Oak Street has multiple gable roofs, projecting chamfered bay, original wood double hung windows all typical of the Queen Anne style.*

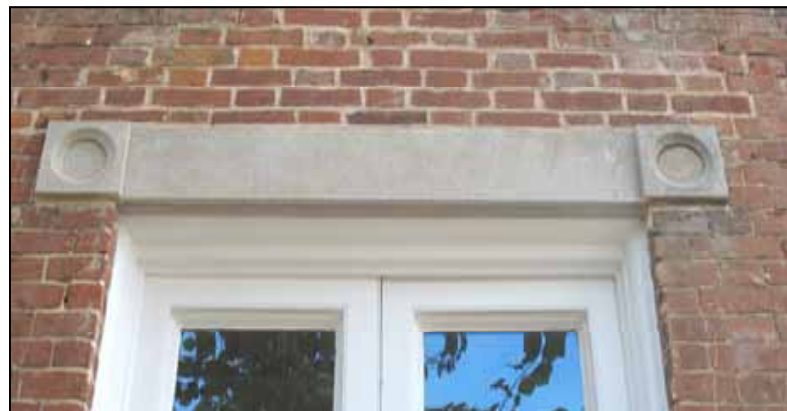
*The circa 1830 commercial building at 234 Town Square has carved stone lintels over the doors and windows.*

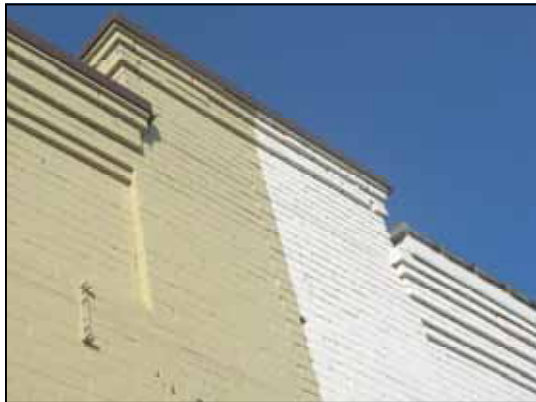
*The brickwork of the parapets on several commercial buildings in Raymond feature decorative brick patterning and projecting bricks to give interest to the façade.*

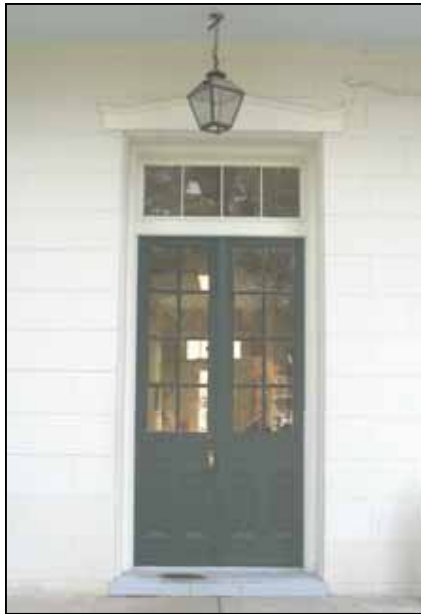
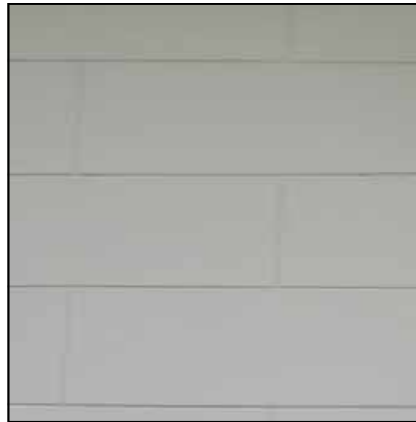
*The Courthouse has a stucco finish which is scored to look like stone blocks, a characteristic of the Greek Revival style.*

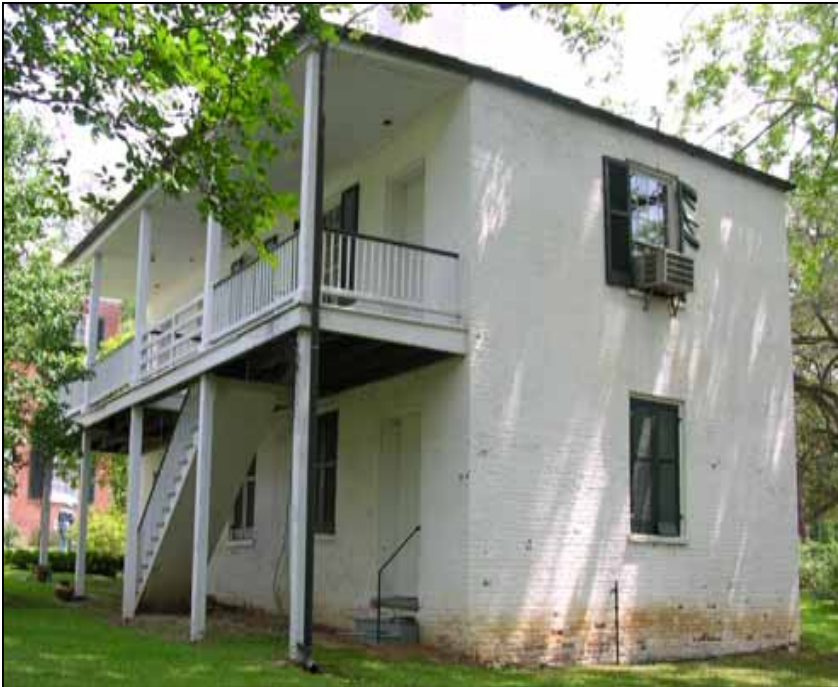
*This kitchen building behind a historic mansion in Natchez shows the effects of rising damp along the base of the building. Water running along the façade and pooling at the base of the side elevation is the source of the problem. Controlling water run-off and preventing the pooling of water will correct the problem.*

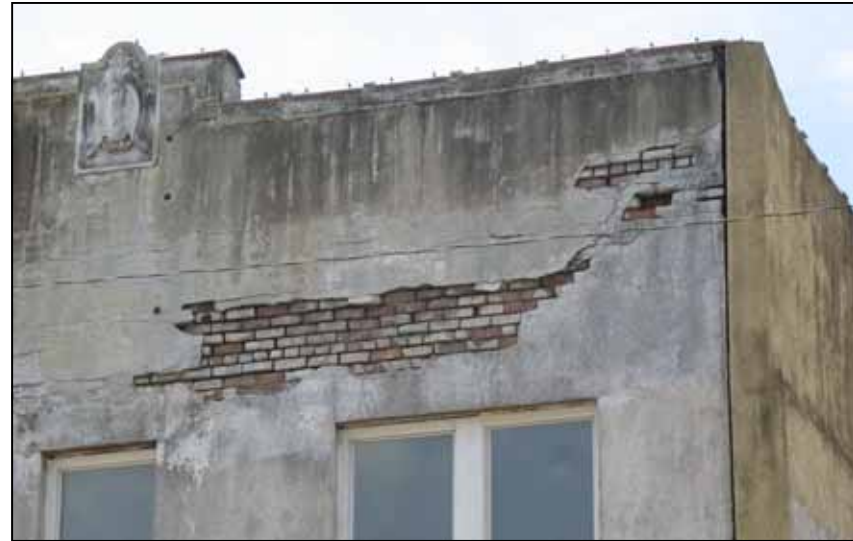
*This building is suffering from falling damp most likely from water that is infiltrating at the top of the parapet and causing the noticeable stucco discoloration at the top of the wall and the problems with the stucco losing its bond with the brick below and falling off of the building.*

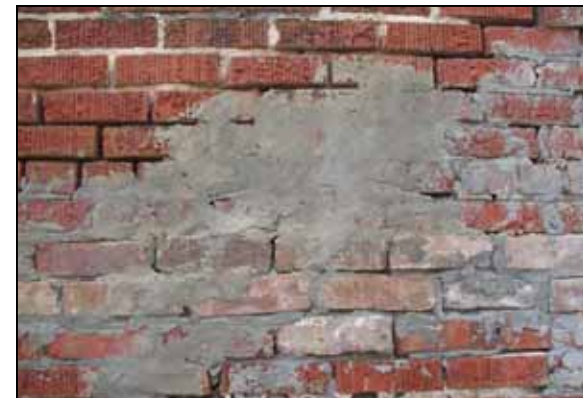
*The owner of this brick building tried to stop the mortar erosion and water infiltration by smearing concrete over the deteriorated areas. This makes it very difficult to properly repair the problems in the future and has caused more damage to the brick surface*

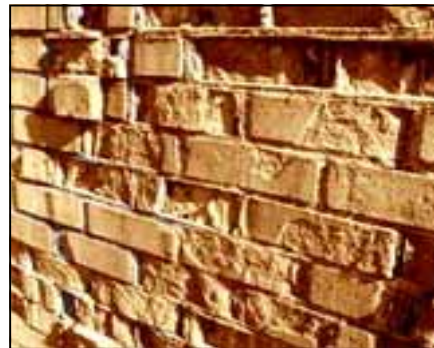
*This photograph supplied by Chagrin Falls Preservation in Ohio illustrates the spalling that can occur only five years after using portland cement mortar in repointing.*

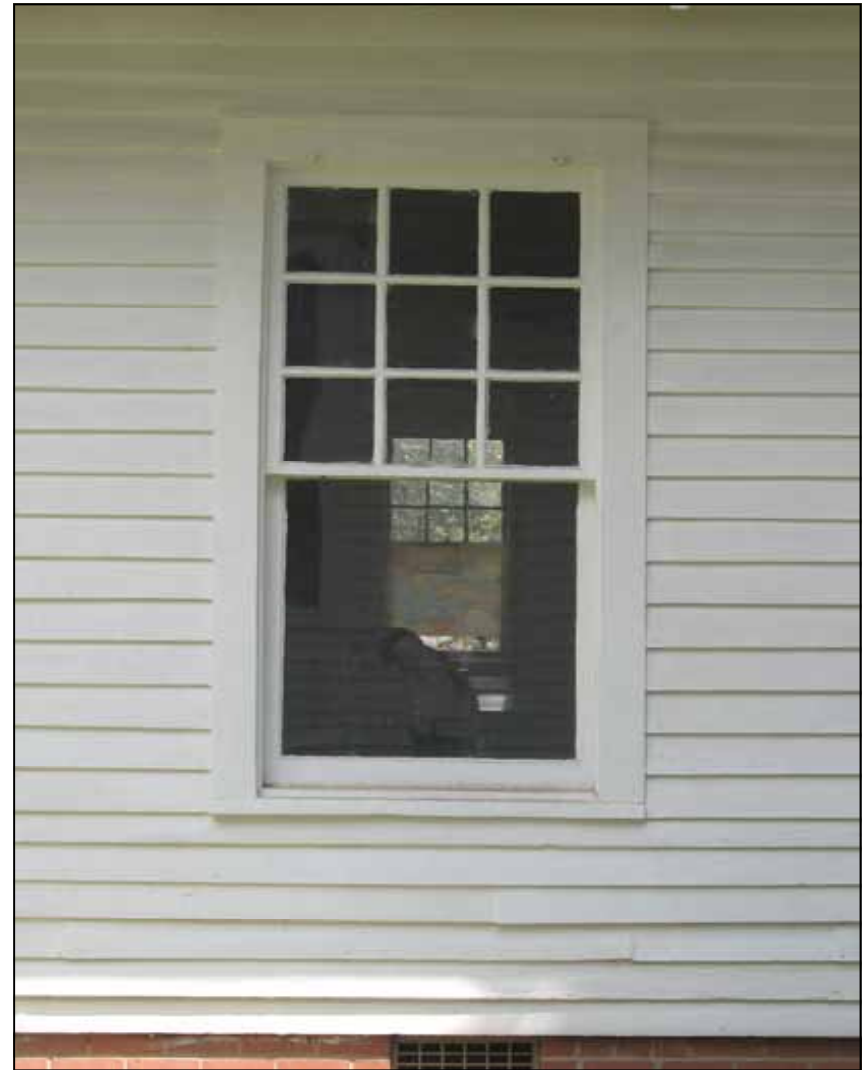
*125 Port Gibson Street uses beveled wood siding which is typical of the Craftsman style of architecture.*

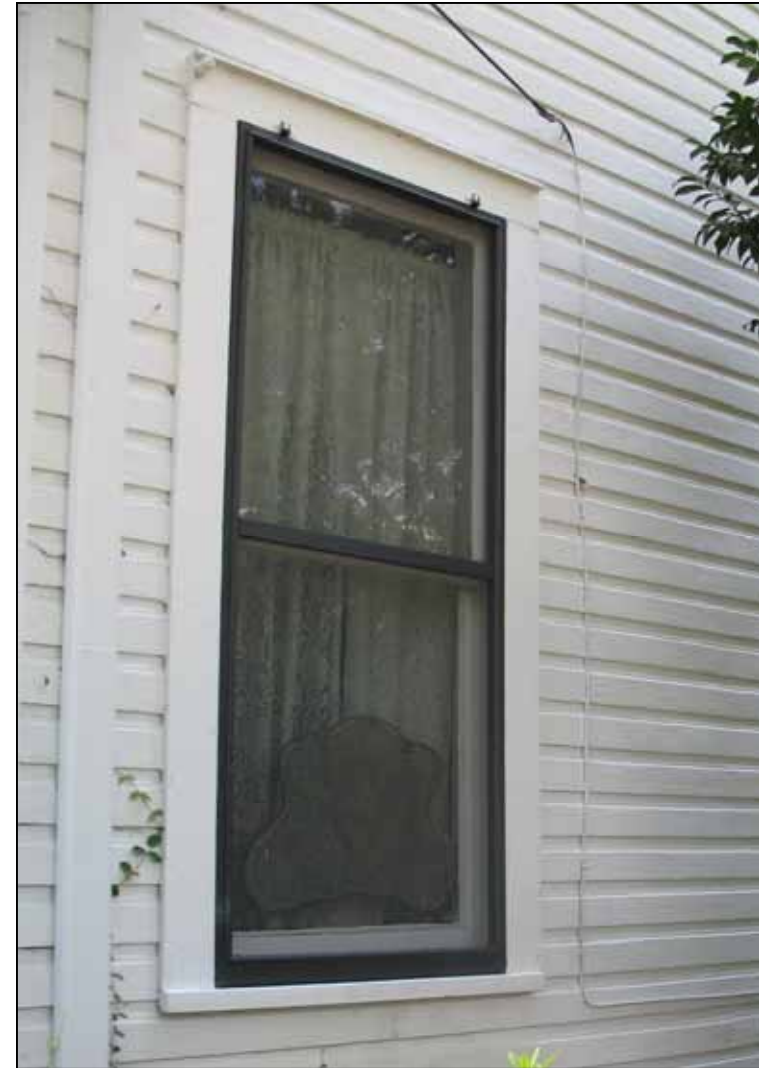
*The house at 101 Dupree Street uses Shiplap siding on the side of the house.*

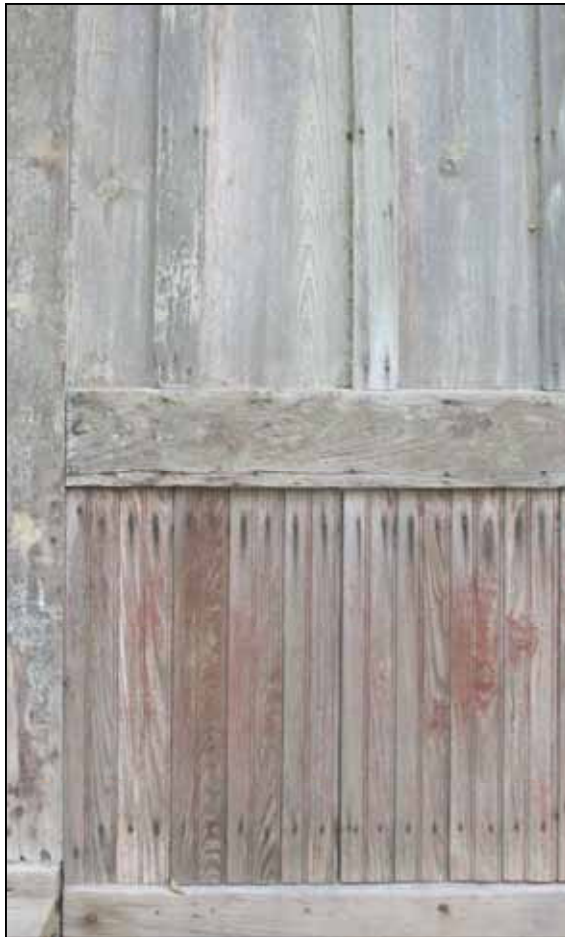
*The Raymond railroad depot uses a combination of board-and-batten siding over tongue-and-groove beadboard siding.*

**Board-and-batten siding** consists of vertical boards that are laid flat against structural members and are spaced at least 1/2 inch apart to allow for expansion. Wood strips, called battens, are applied atop the boards to cover the spacing. Board-and-batten siding is often associated with vernacular buildings.

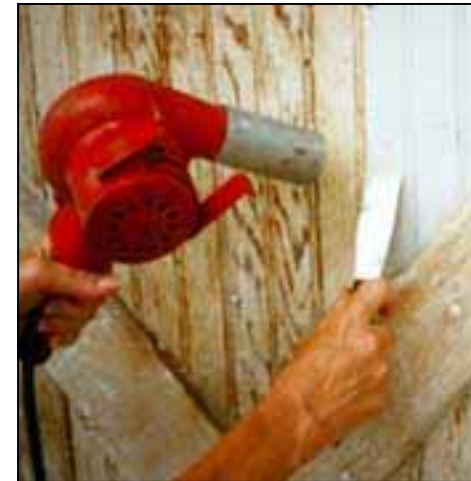
*These National Park Service photographs above illustrate a painted finish with severe peeling (left) and the use of a electric heat gun (right) to remove a deteriorated paint finish.*

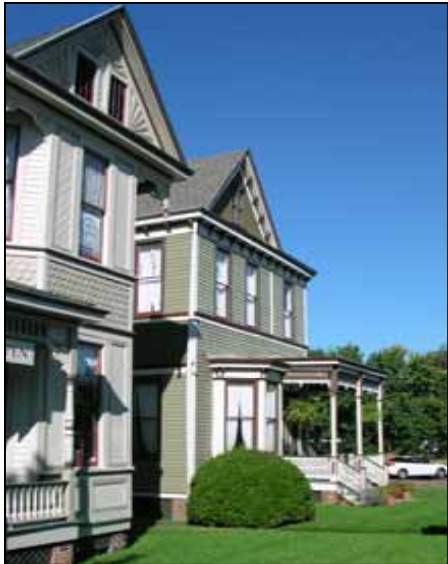
*These two Victorian houses in Natchez were restored in the mid-1980s and feature typical late nineteenth-century paint schemes. Both houses were thoroughly scraped, sanded, washed, primed (oil primer), and painted (two finish coats of latex). Both houses have insulated attics but no wall insulation. Their mid-1980s paint jobs still looked good over a decade later.*

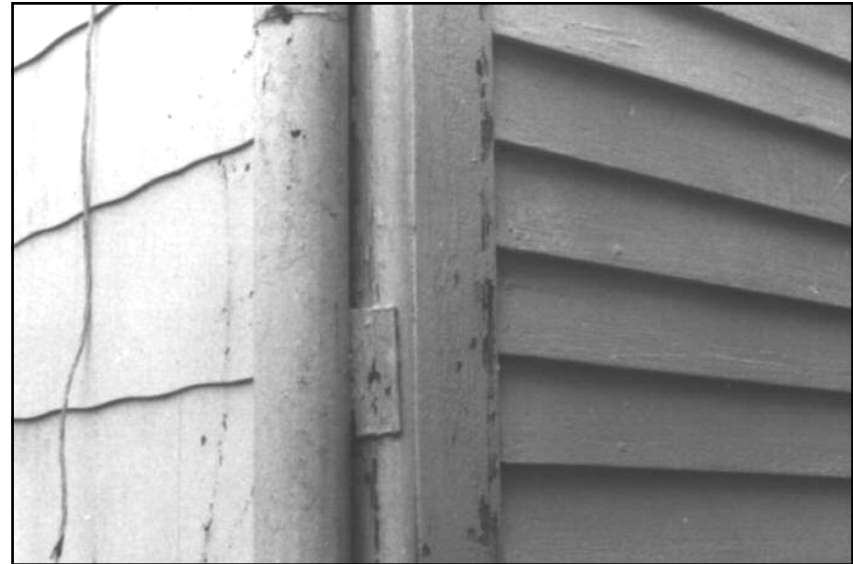
*Inappropriate asbestos-shingle siding has been installed over the historic horizontal wood lap siding. The inappropriate siding does not convey the same visual characteristics of the historic wood siding and can obscure moisture and termite damage.*

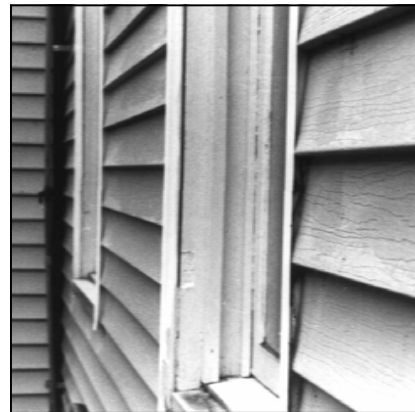
*These photographs illustrate how vinyl siding negatively alters the exterior appearance of a historic building. The vinyl siding is nearly flush with the trim around the windows, and J-channels have been installed around the windows to prevent water infiltration behind the siding.*

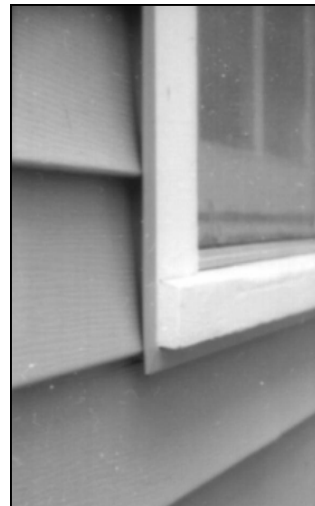
*Examples of vinyl siding showing the installation of J-channels around every opening and the historic trim, if it survived the installation process.*

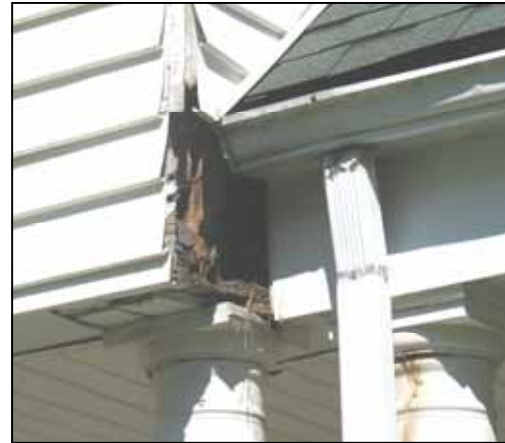
*Rotten wood was found under the vinyl siding on this house in Ripley. Water got trapped behind the vinyl siding causing the wood underneath to deteriorate without being noticed until the siding fell off.*

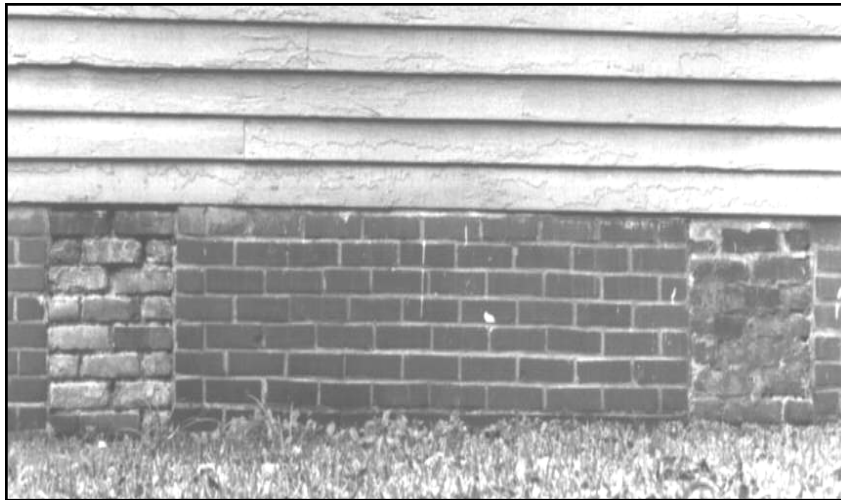
*This crawl space enclosure between the original brick piers has altered the historic character of this house and is visually inappropriate. The enclosure also has no vents to provide air circulation beneath the house to prevent the build up of moisture under the house..*

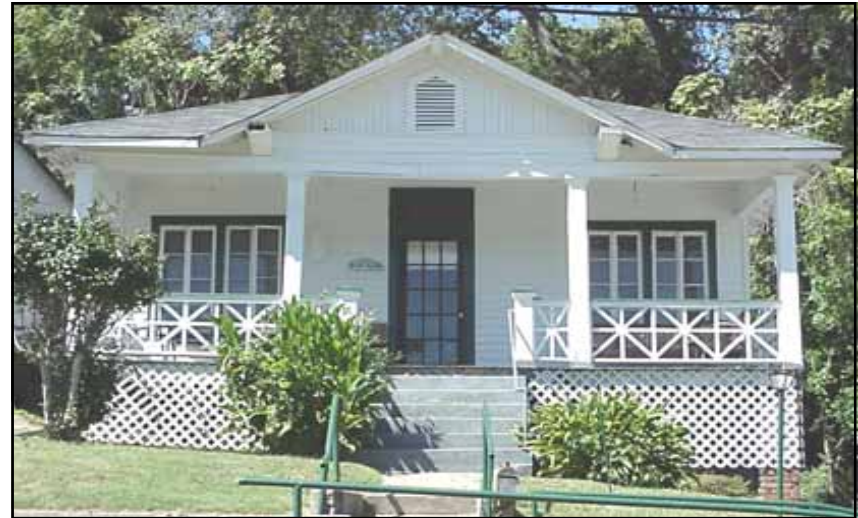
*The lattice used to enclose the crawl space beneath this historic house in Natchez is inappropriately installed, because it overlaps and obscures the brick supporting piers.*

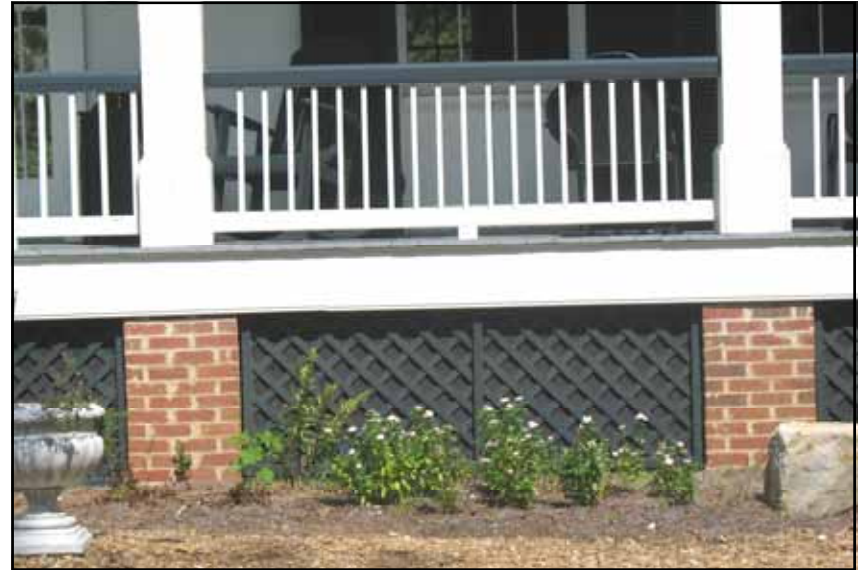
*The lattice panels between the brick piers appropriately enclose this crawl space.*

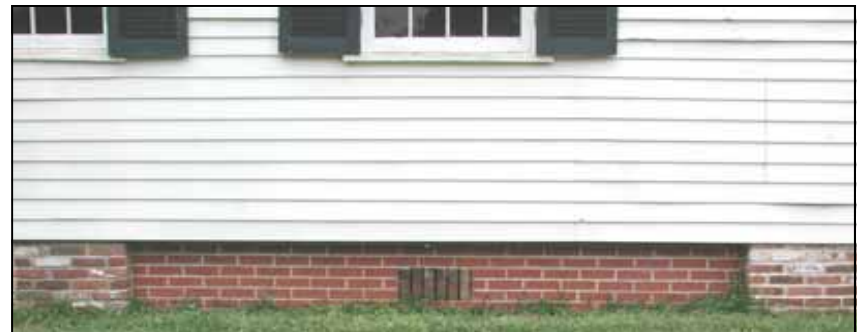
*At least this homeowner recessed the new brick crawl space enclosure. This treatment would look more appropriate if the new brick were painted black and faced with lattice.*

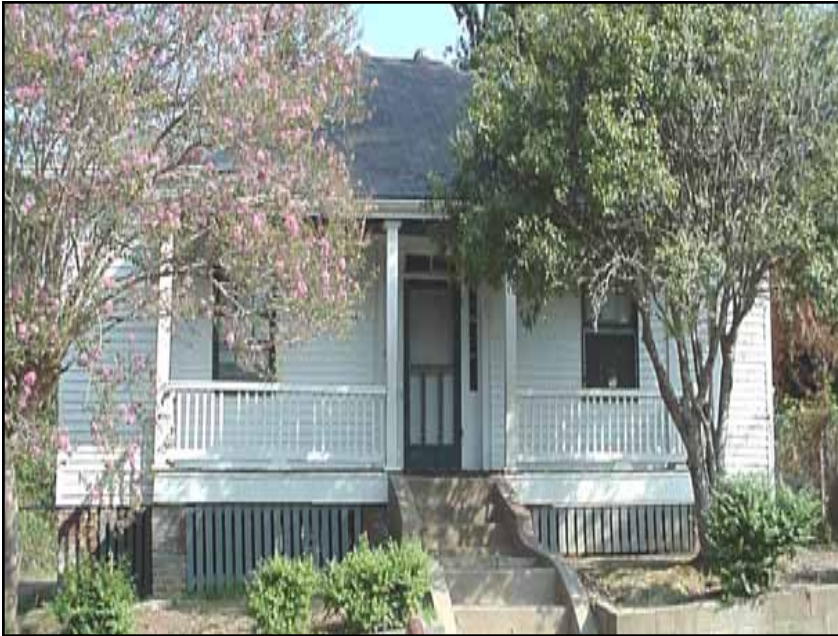
*This vernacular house in Natchez features a crawl space appropriately enclosed with vertical boards nailed to a frame between the brick piers.*

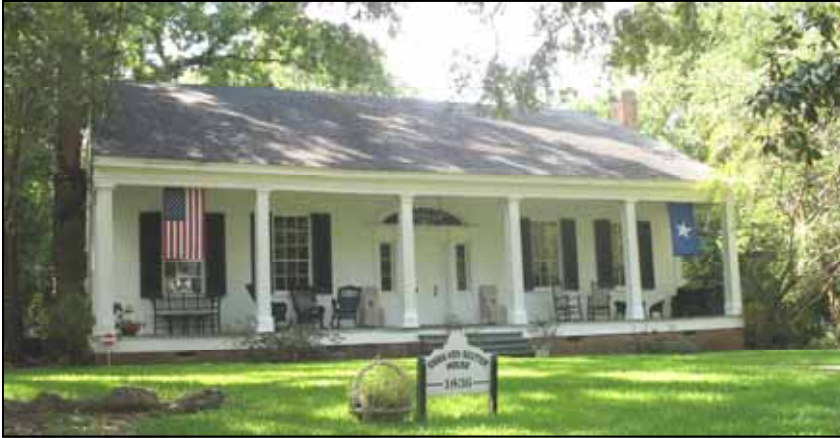
*104 Dupree Street has a low-pitched side gable roof which is typical of the Greek Revival style.*

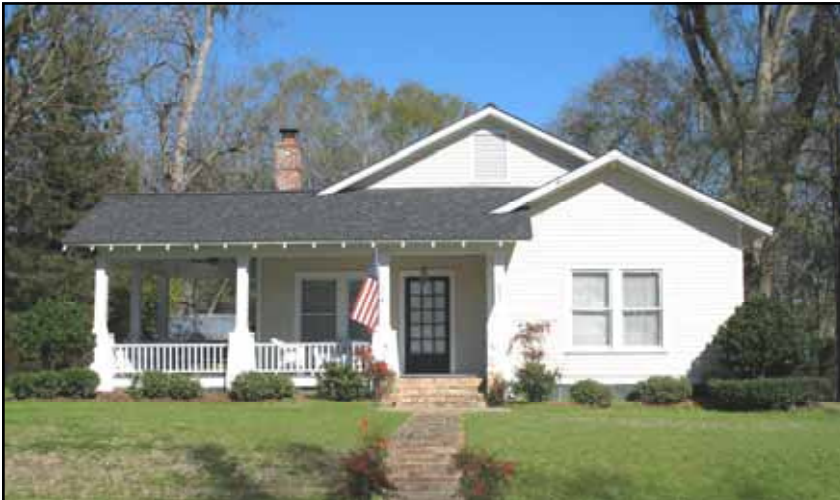
*The Craftsman style house at 217 West Main Street features multiple low-pitched gable roof with exposed rafter tips.*

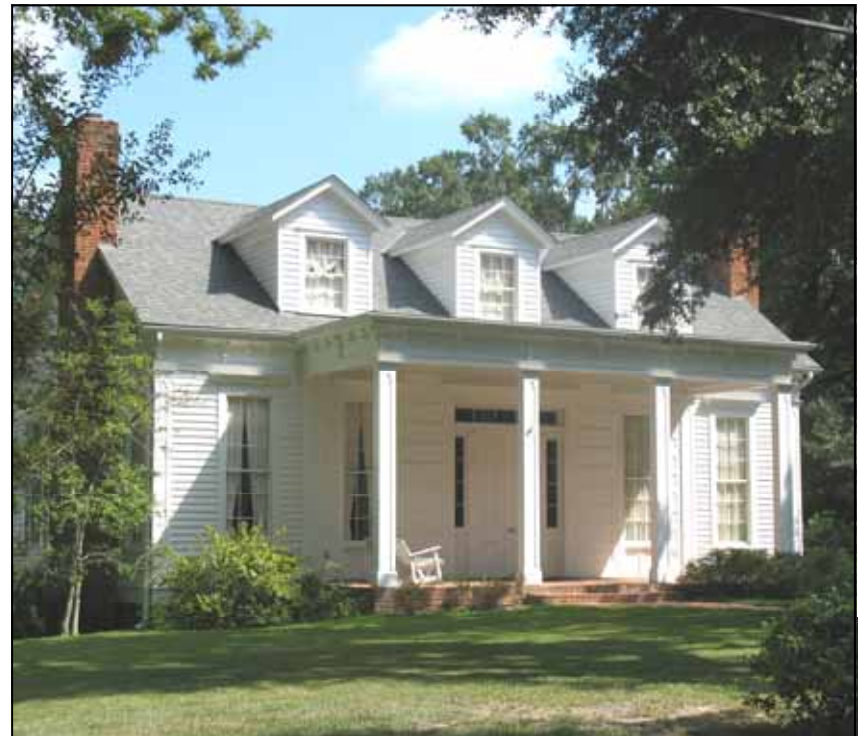
*101 Dupree Street has three gabled dormers that were a later addition to the Greek Revival style house.*

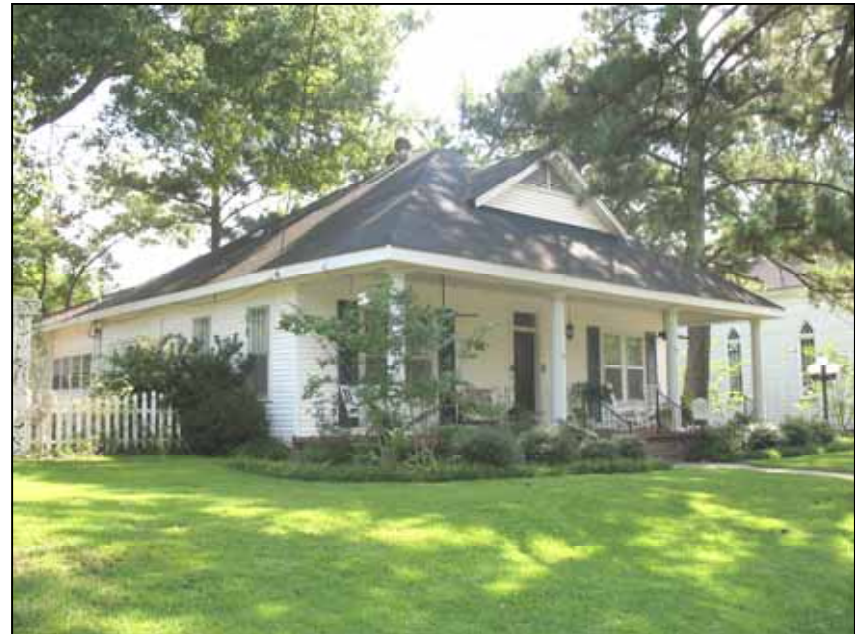
*The house at 213 Main Street features a pyramidal roof.*

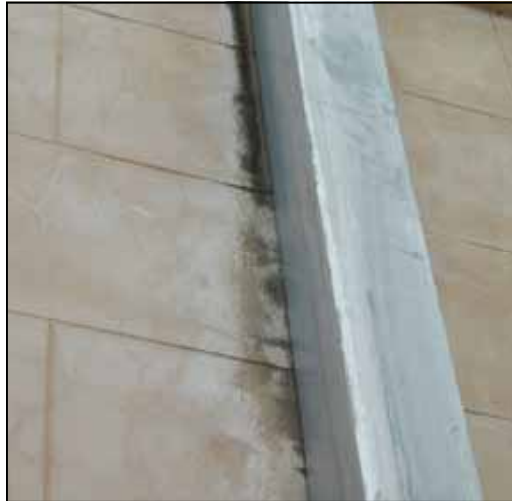
*This photograph illustrates moisture problems on the stucco of this commercial building. Rectangular downspouts that lie flat against the building are more likely to cause moisture deterioration than round downspouts.*

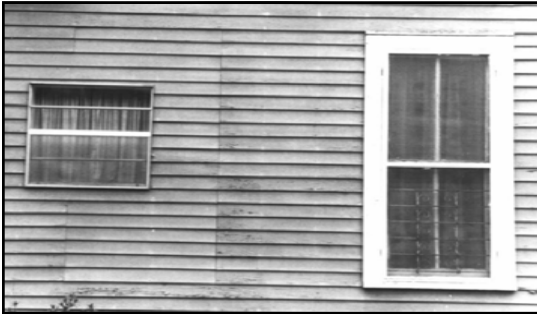
*The metal window on the left is inappropriate for a historic structure and does not convey the same visual appearance as the neighboring original window.*

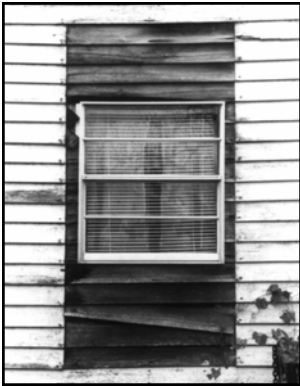
*This metal window is not appropriate for a historic house. It is an obvious replacement for a much larger window that has been removed. The original window hole has been filled by unpainted boards. Modern metal windows with horizontal divisions, like this ones above and below on the left, are not suitable for historic buildings.*

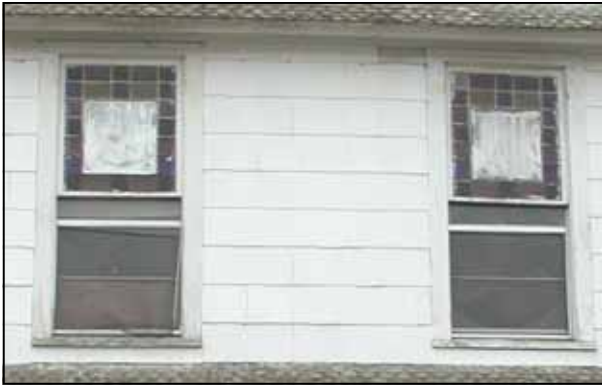
*These poorly sized aluminum window screens alter the appearance of these historic windows.*

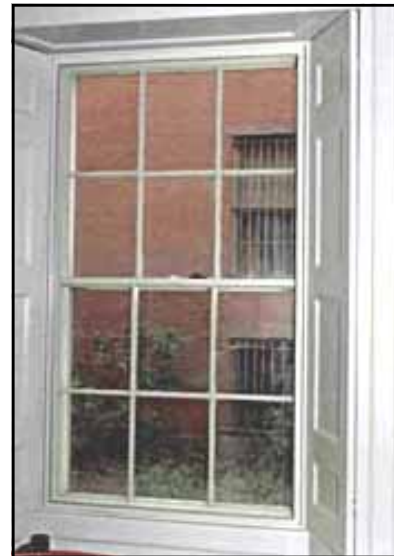
*These photographs of windows in two historic houses illustrate the use of “invisible” interior storm windows. Interior storm windows are easier to remove for cleaning, are not visible on the exterior of the house, and are barely visible on the interior. Manufacturers of “invisible” interior storm windows offer storm windows that are attached either by clip or by magnetic seal, like the examples pictured above.*

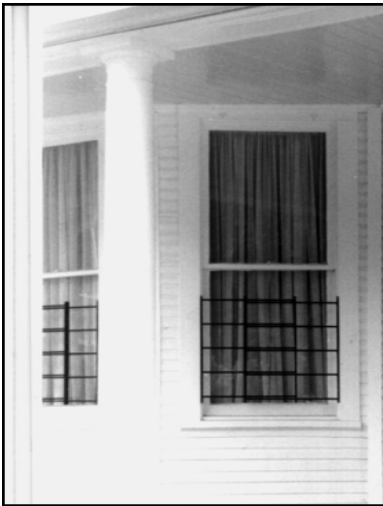
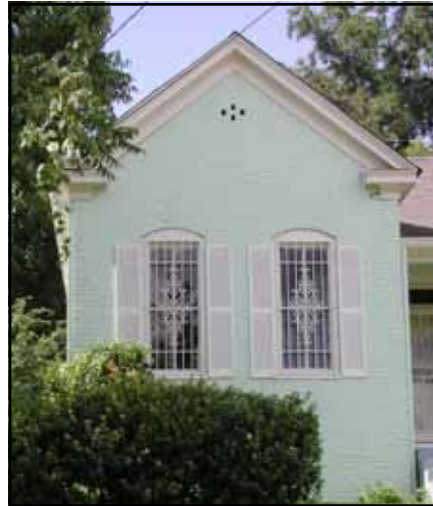
*Security or burglar bars are not appropriate for historic windows, because they change the historic character of the windows.*

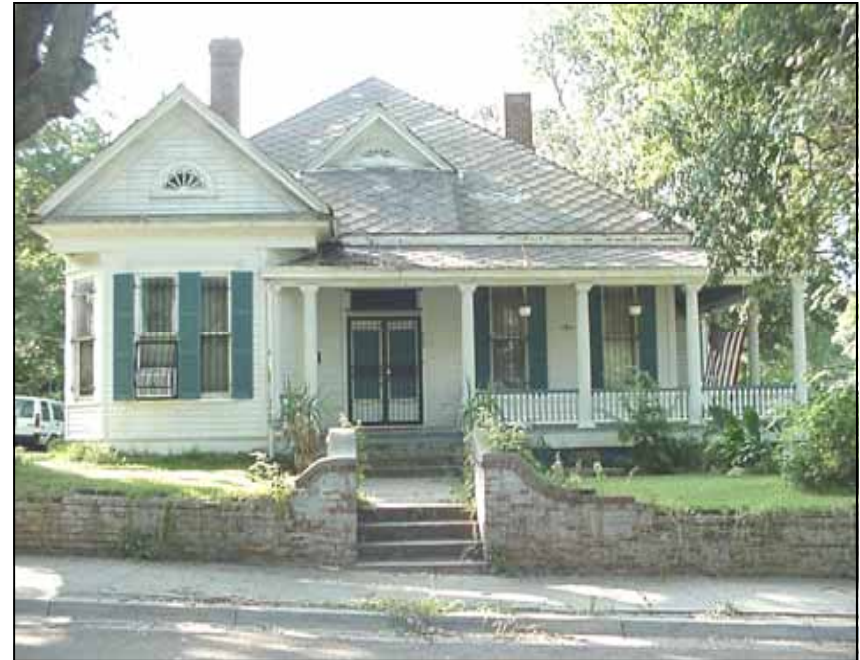
*Security or burglar bars mask the historic details of this Queen Anne cottage, illustrated in detail on the right.*

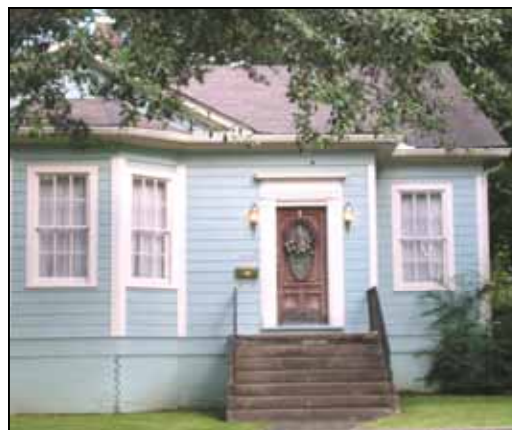
*This mass-produced, leaded-glass door is not appropriate for this mid-twentieth-century Colonial Revival cottage, which would have featured a “colonial” paneled door.*

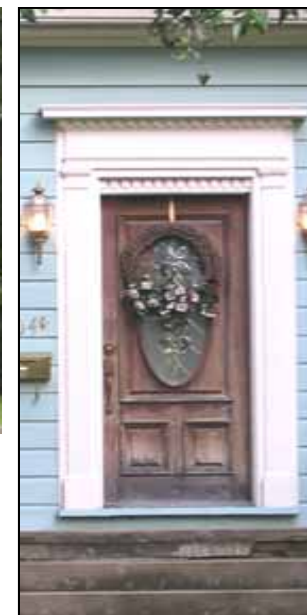
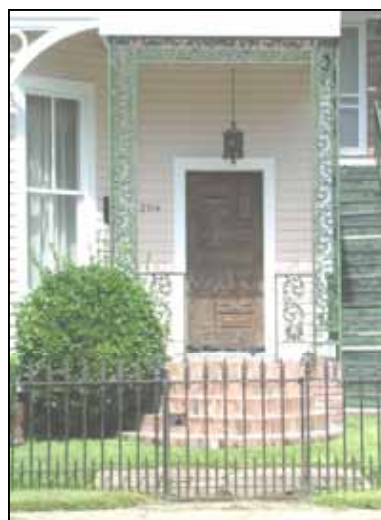
*This Queen Anne style house has lost its original corner porch and entrance doorway. The original doorway would have featured a transom and single-leaf door with glazed upper panel. The original porch was enclosed and a new, inappropriate 1970s door with raised panels was installed. Unfortunately, the house also lost its original porch detailing and entrance steps.*

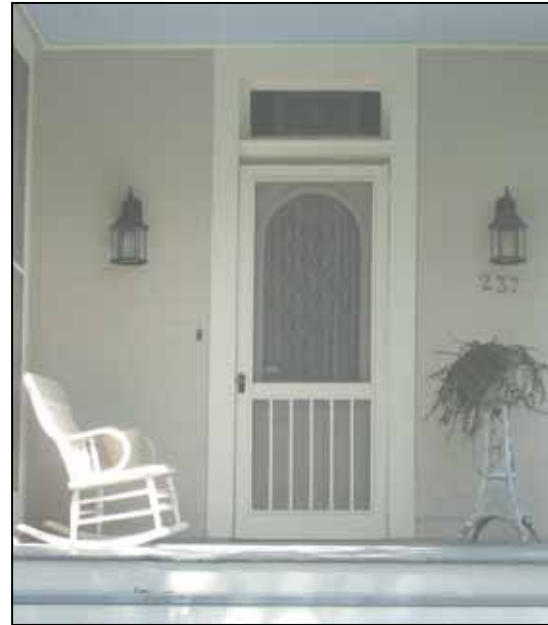
*The screen door of this Queen Anne style house at 237 North Oak Street is most likely a later addition, however it is simple in design and properly fits the door opening.*

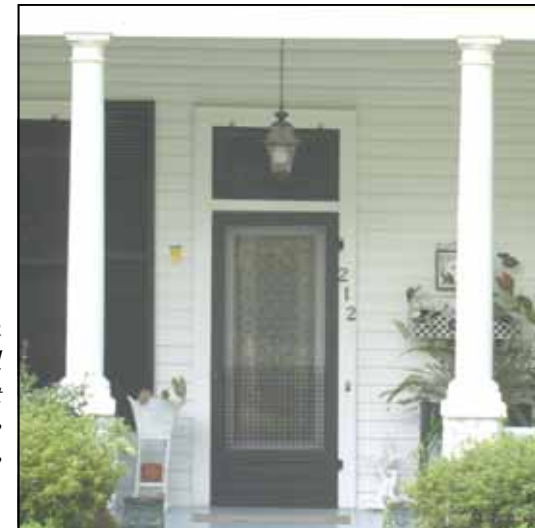
*This screen door on this Colonial Revival style house at 212 West Main Street is a simple design that fits the character of the house.*

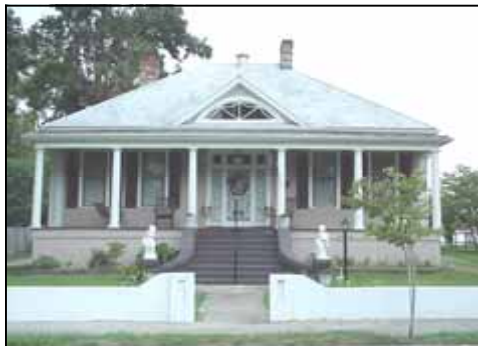
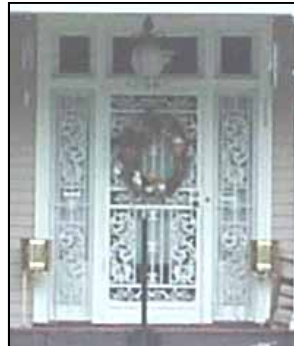
*A security or burglar door and sidelight grilles (right) obscure the historic doorway of this Colonial Revival house. Burglar doors and barred windows also increase the risk of death from fire, by making it difficult for rescue personnel to enter the building.*

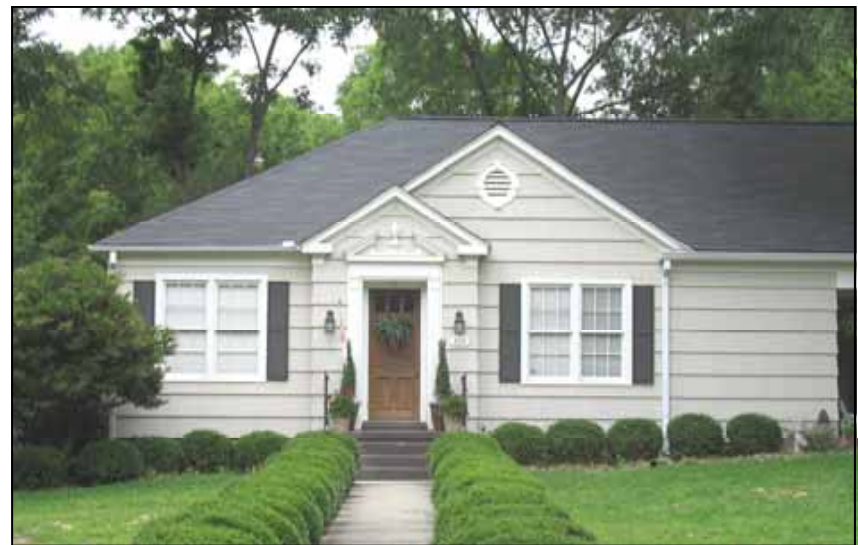
*Although these applied shutters are not operable they are appropriate for the architectural style of this house at 229 Port Gibson Street as they are characteristic of the Minimal Traditional style used in the 1940s and 1950s.*

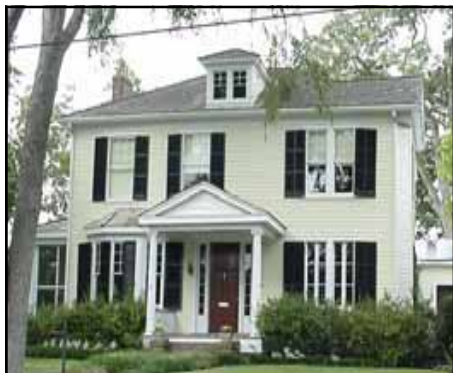
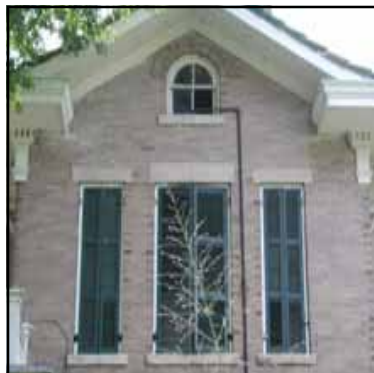
*The window shutters of these two houses are original and properly fit the windows. The house on the left illustrates original shutters that are properly sized and hung for paired windows and a bay window.*

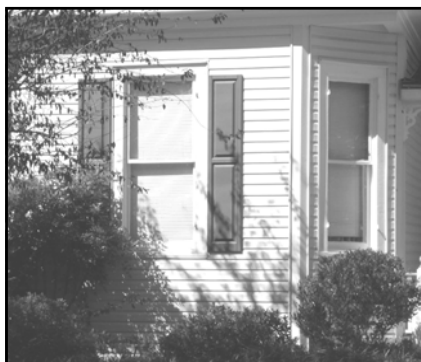
*The vinyl shutters flanking this window are too narrow and incorrectly hung outside the window frame. Paneled shutters are also inappropriate for Victorian houses.*

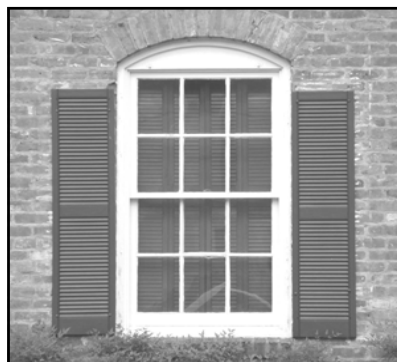
*Shutters on this arched window are too short, too narrow, and wrongly hung outside the window frame. Shutters for this window should also form an arch when closed.*

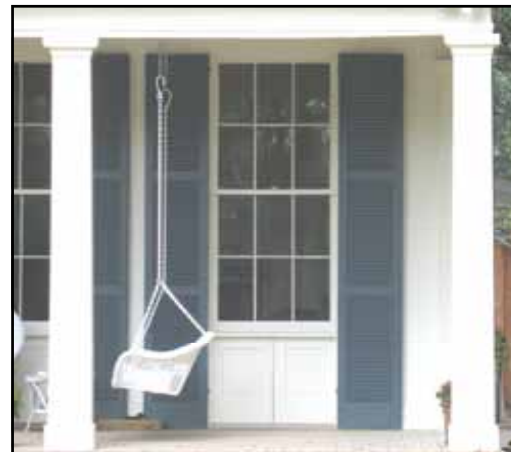
*The window at 45 Copper's Well Street has properly sized and hinged louvered shutters. Underneath the window is Jib door with two panels that open up to allow people to pass through the window to the porch. The shutter properly covers this area as well.*

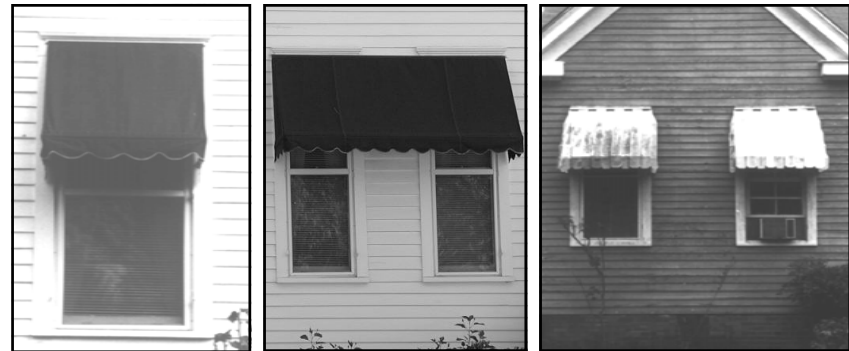
*Canvas awnings are appropriate for residential buildings. The awning above left is correctly hung. The center one is incorrectly hung with one awning for two windows. The metal awnings above right are not correct for historic buildings.*

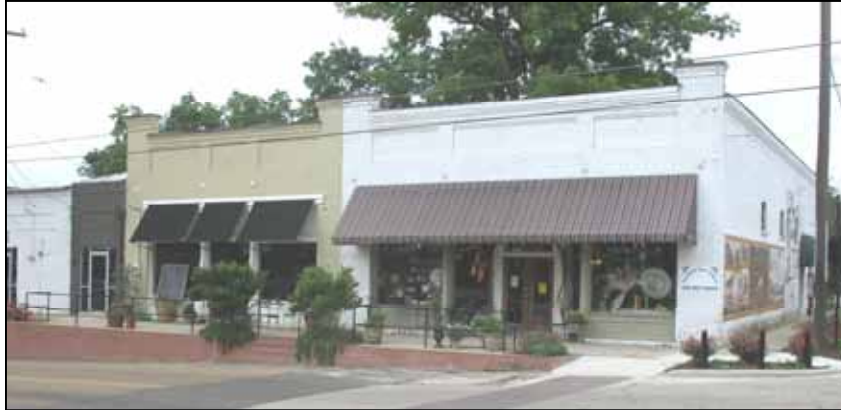
*The canvas awnings on these two commercial buildings on Main Street show two appropriate ways to install awnings using a single awning over all of the doors and windows or the alternative of using single awnings over each opening. Originally these buildings had suspended metal canopies.*
