# **RAYMOND DESIGN GUIDELINES**

Prepared by: David Preziosi, AICP - Mississippi Heritage Trust  
2008

**RAYMOND, MISSISSIPPI**

**ADOPTED NOVEMBER 4, 2008**

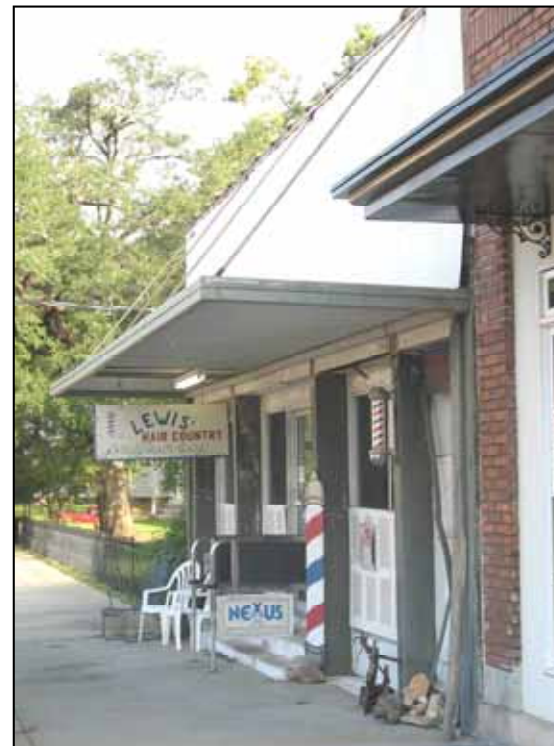
*117 West Main Street uses a suspended metal canopy supported by metal rods which was very common for commercial buildings built in the 1910s to 1940s. Several buildings on East main Street still have visible hooks on the front walls where the canopy supports were attached.*

Canopies should be at least eight feet above the sidewalk and connect to the building above storefront windows.

Metal rods or chains should be used to suspend the canopy and securely anchored to the building wall. Look for original anchors before installing new ones.

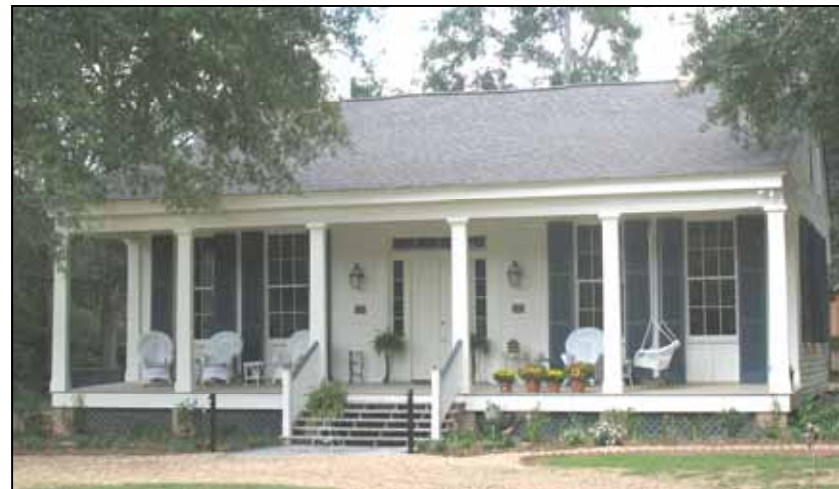
*The house at 45 Cooper's Well Street features an integral porch with a bold square columns typical of the Greek Revival style.*

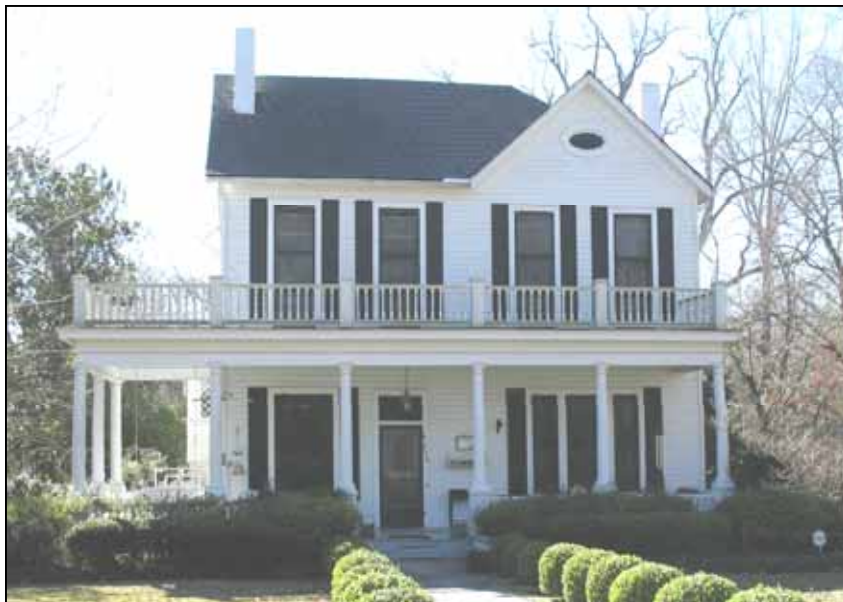
*This Colonial Revival House at 214 West Main Street features a full width and wrap around porch with Tuscan style columns on bases typical of that architectural style.*

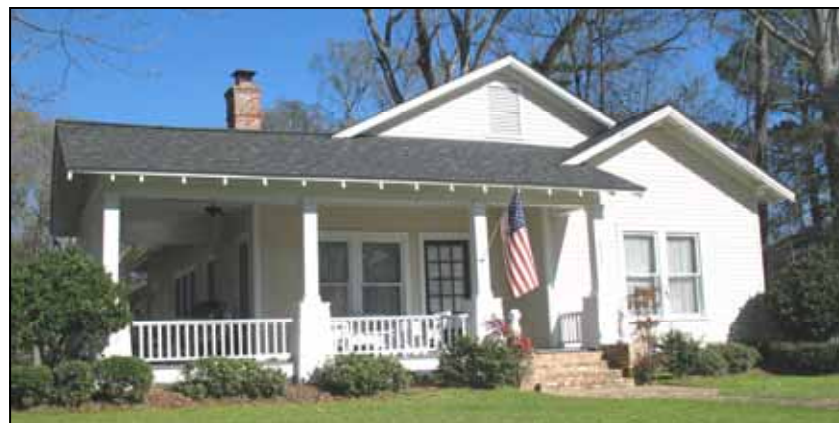
*This Craftsman style house at 217 West Main Street has a projecting porch with tapered columns on brick piers typical of that style.*

A porch that features tapered box columns resting on brick piers is one of the most identifiable and common characteristics of the Craftsman/Bungalow style. The pedestals are sometimes linked by a brick porch wall that substitutes for a balustrade. In Raymond there are also Craftsman/Bungalow style houses with a more unusual combination of paired or multiple columns on a pedestal or base. There are also several houses in Raymond that are of an earlier style than the Craftsman/Bungalow style but received updated porch components during the period when Craftsman/Bungalow style houses were popular. The concrete

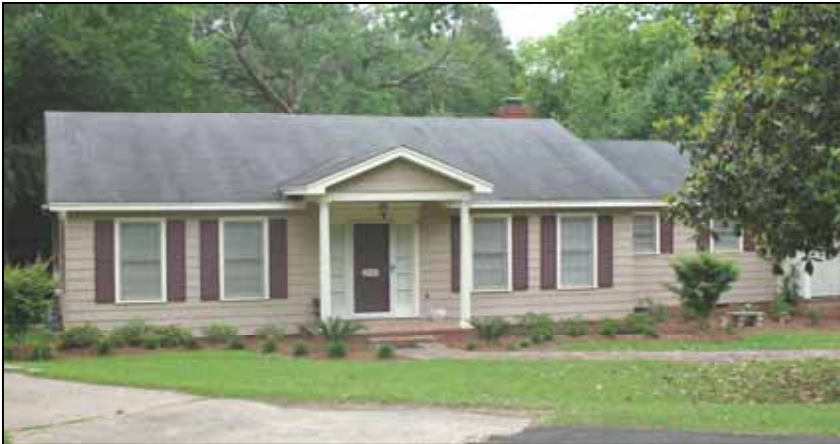
*This Minimal Traditional style house at 240 North Oak Street has a small projecting porch supported by simple Tuscan style columns.*

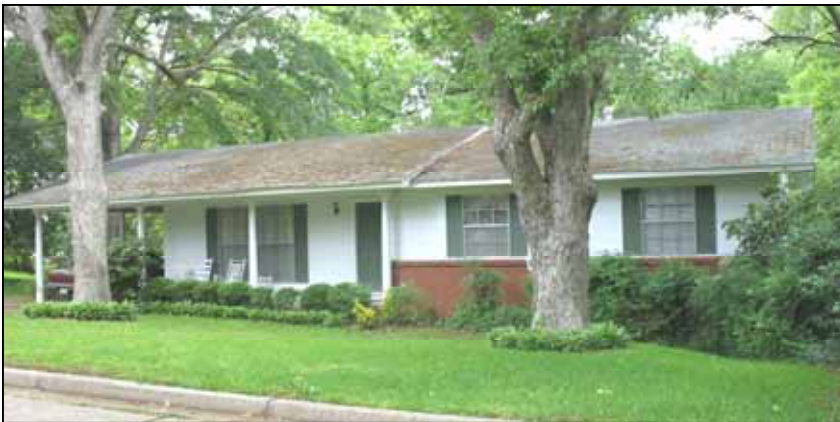
*This Ranch style house at 113 Elm Street has an integral porch that extends to the carport supported by Tuscan style columns.*

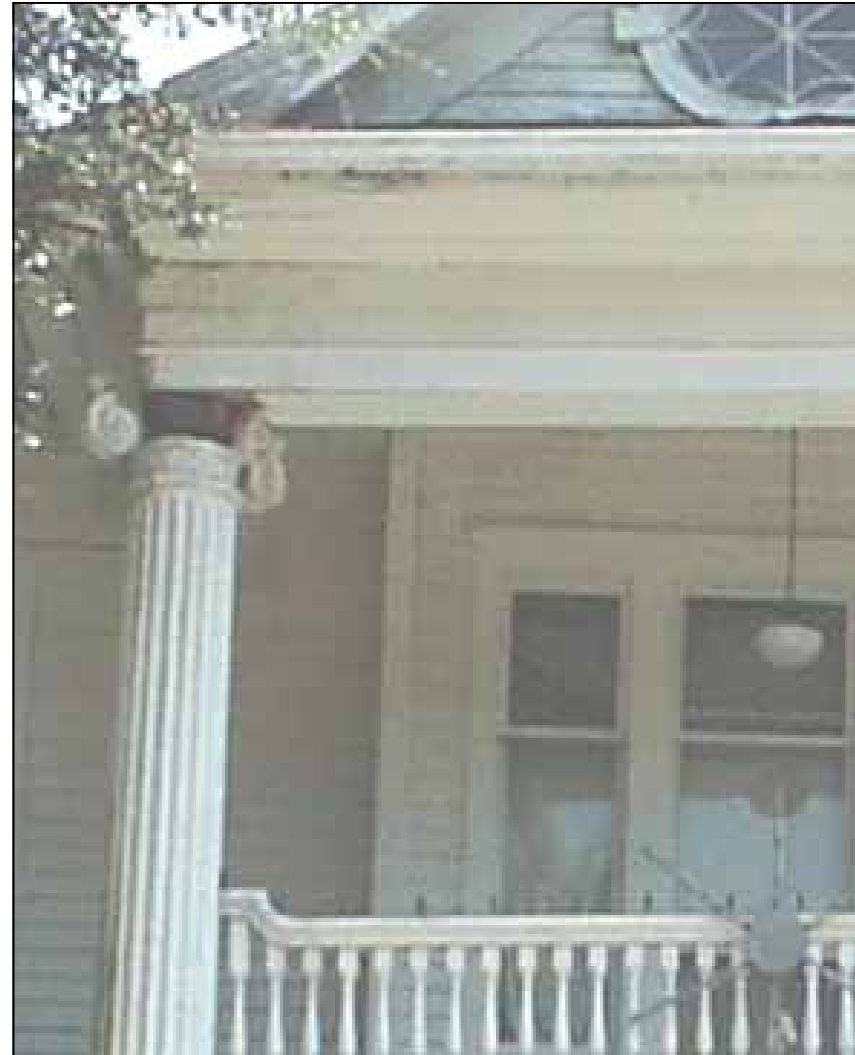
*Failure to clean and maintain gutters is the primary cause of porch deterioration such as the damage caused to the column capital.*

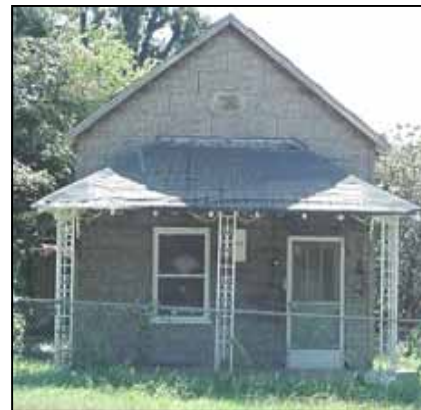
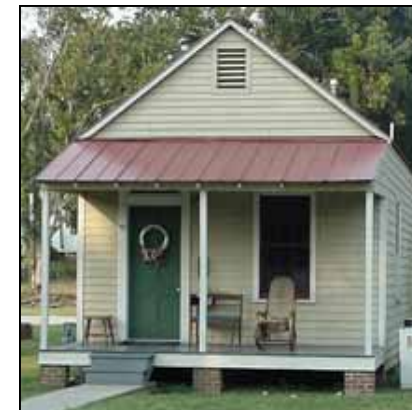
*These two Natchez shotgun houses illustrate how changing the porch components alters the historic appearance and integrity of the house. The original columns on the house on the left were replaced with metal trellis columns while the house on the right has wood columns, which are also replacements but are more in keeping with original style of the building.*

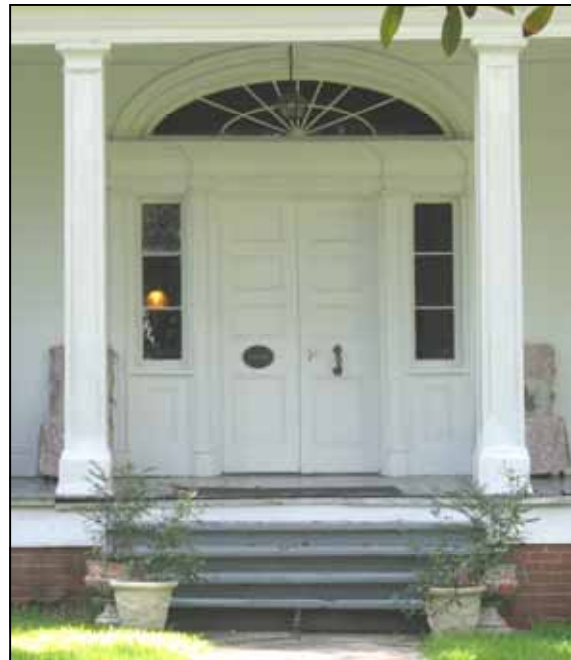
*The steps of this Greek Revival style house at 104 Dupree Street are appropriately constructed of wood painted the same color as the porch floor.*

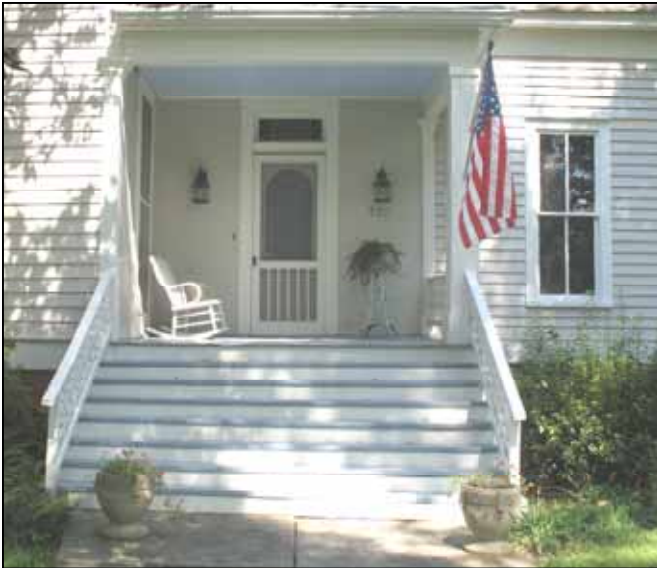
*The steps of this Queen Anne style house at 237 North Oak Street are appropriately constructed of wood.*

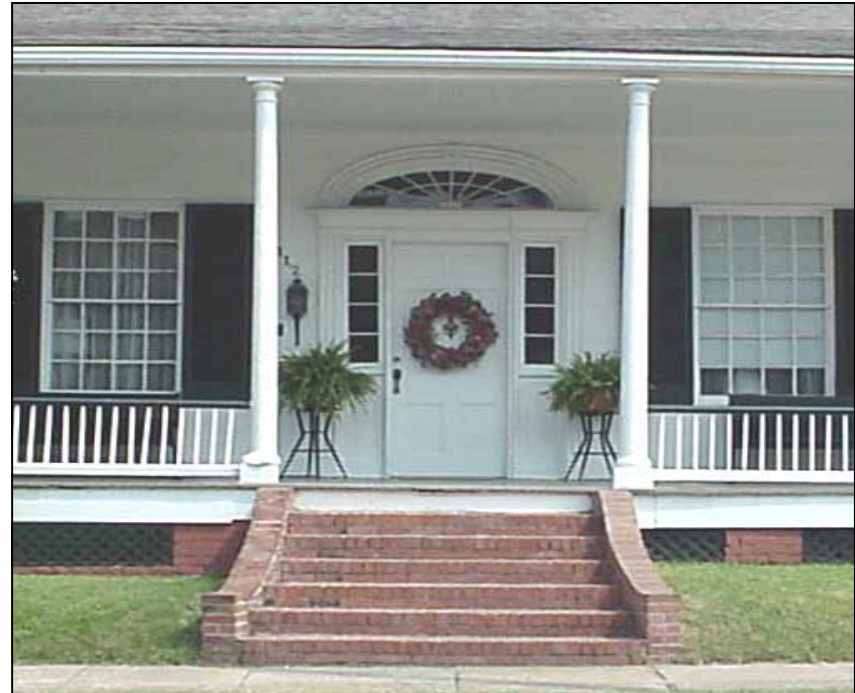
*The brick steps overpower this house and draw attention from the historic character of the building.*

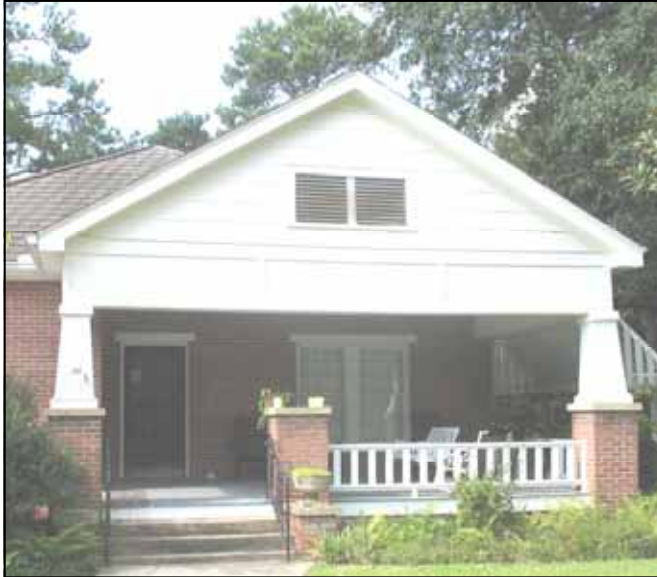
*This Craftsman style house at 140 West Main Street uses concrete steps which are appropriate for the style of house.*

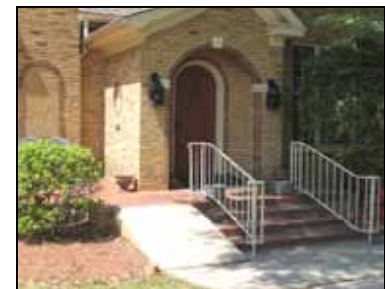
*This former house in Amory, now a dentist office, uses an inconspicuous ramp to the side of the stairs to provide accessibility to the building.*

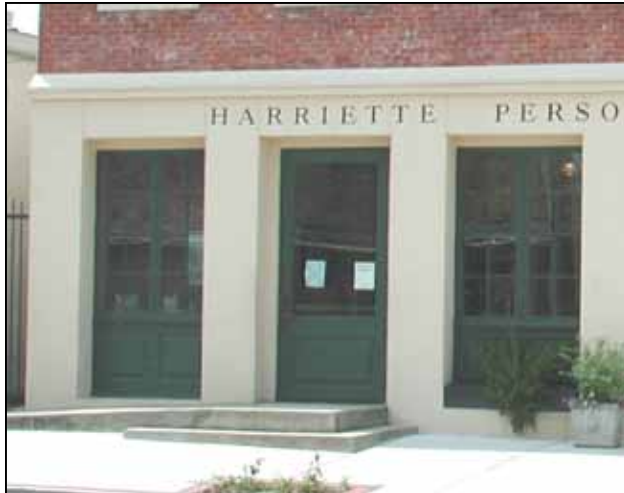
*The example of the ramp on a commercial building in Port Gibson provides accessibility to the building in a sensitive manner.*

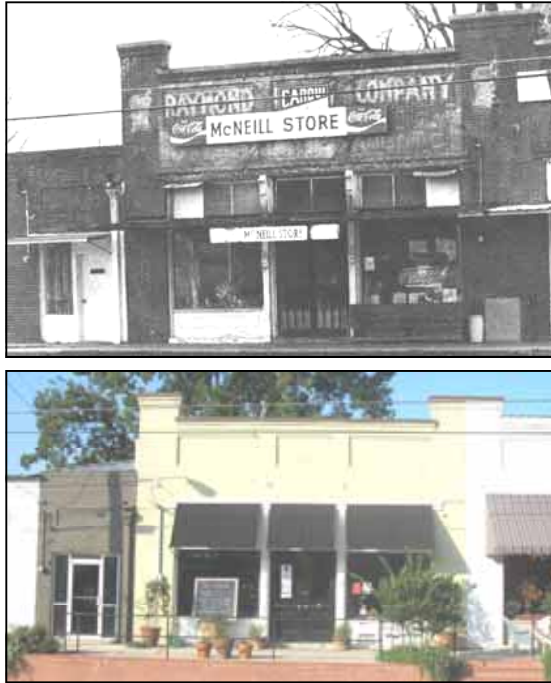
*The top photo (courtesy of Pattie Adams Snowball) shows 104 East Main Street in the 1940s and the bottom photo is the same building today. The building is a store-front type with a central entrance flanked by display glass and separated by cast iron columns. Note the original transoms in the top photo which are now covered by the awning. Originally the building had a suspended metal canopy rather than the awnings it has today.*

The **Store-front** type is the simplest type of commercial architecture named for the traditional use of the its first floor as a store. Typically store-fronts are made up of a large opening in the façade supported by cast iron columns or other vertical divisions separating a central entrance flanked by display windows on either side. Most store-fronts have symmetrical divisions. In earlier store-front buildings transoms were located over doors and display windows to allow additional light into

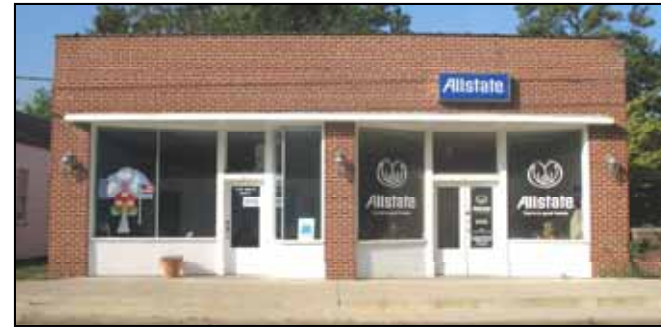
*The building at 126-128 West Main Street is a good example of a double-front commercial building with its clearly divided store-front areas, yet they have similar detailing to the doors and display windows.*

The **Double-front** commercial building was built for two enterprises with a common façade and detailing. Buildings may be one or two stories high. The double-front differs from the business block, which also may have two storefronts, in that it does not have an emphasized central entrance or a high degree of ornamentation. The store-fronts for each portion of the building may be symmetrical or asymmetrical with the division of the opening between the entry door or doors and the display glass.

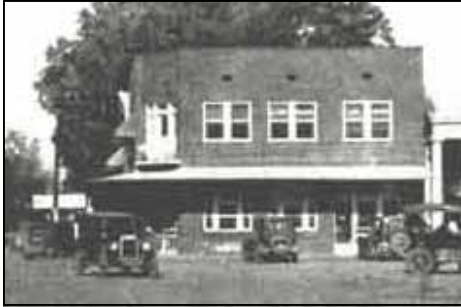
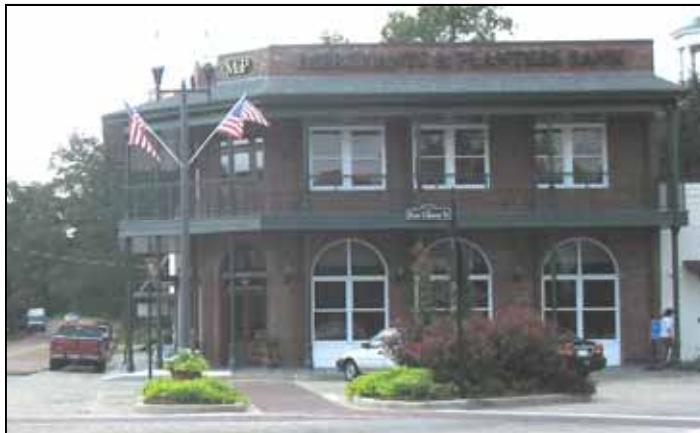
*The top photo (courtesy of Pattie Adams Snowball) shows the Merchants and Planters Bank in 1929 and the bottom photo is the same building today after its recent renovation which added the wrap-around gallery. The building is a good example of the business block with a prominent entrance, in this case a corner entrance instead of a central entrance.*

of buildings in Raymond; however, there is only one remaining with the Merchants and Planters bank constructed in 1923. With the recent renovation of the bank the wrap-around gallery was added which was not original to the building.

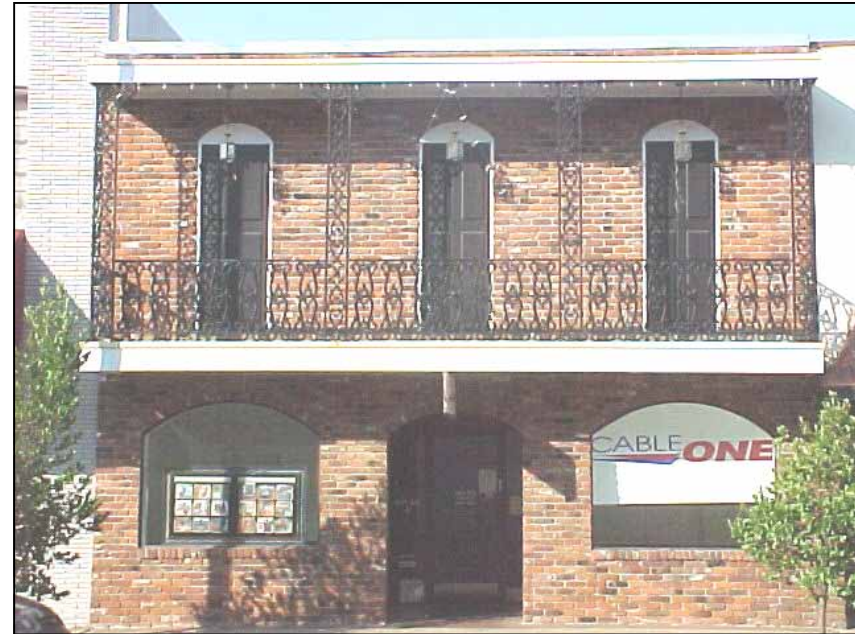
*Avoid creating a false historic appearance like this one-story building in Natchez where a faux New Orleans style balcony and doors were added to make it look like a two-story building.*

With alterations to commercial storefront buildings avoid creating a historic appearance that never existed. Many business owners created “colonial” storefronts during the mid-twentieth century in a misguided attempt to create a historic appearance. Common elements of the typical “colonial” storefront were multi-paned windows, doorway pediments, poorly fitting shutters, and lap siding. The installation of an entire aluminum storefront and an aluminum canopy became a popular treatment for commercial buildings in the 1950s and 1960s. By the 1970s, almost every city in America featured one or more commercial buildings whose facades were totally obscured by windowless aluminum. In the 1960s and 1970s, the addition of shingled mansard roofs became popular as quick storefront fix-ups. Also popular were the fake New Orleans storefronts, which featured “old brick,” modern French doors, shutters, and iron balconies.

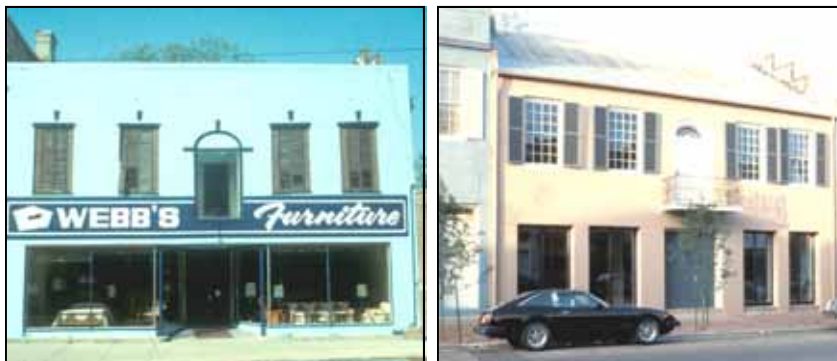
*No photographs existed to guide the restoration of the first-story of the Natchez commercial buildings above and below. Following National Park Service guidelines, the owner installed a contemporary first-story storefront that is compatible with the building and the streetscape in the top photo. Below original storefront doors found in the building and historical precedents and patterning found on other Natchez buildings were used for the new storefront design.*

If the storefront has been altered over time and it is desired to go back with a more appropriate storefront, it is acceptable to install a contemporary treatment that respects the character of the historic building and is compatible with the streetscape. For example, the new storefront openings might echo the conjectural size and placement of original openings but feature simple glass infill.

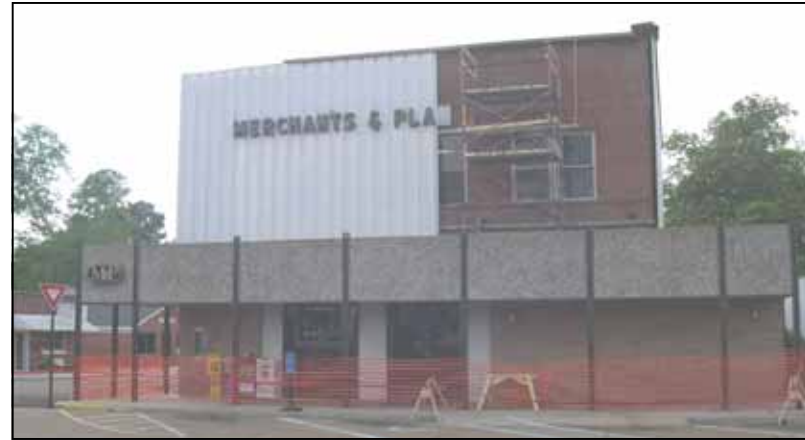
*In an attempt to modernize the Merchants and Planters Bank in the 1970s the building was covered by metal panels which hid the brick work and original windows of the façade. The storefront level also had extensive renovations with the removal of original windows and the addition of a modern brick veneer and new canopy covering the sidewalk.*

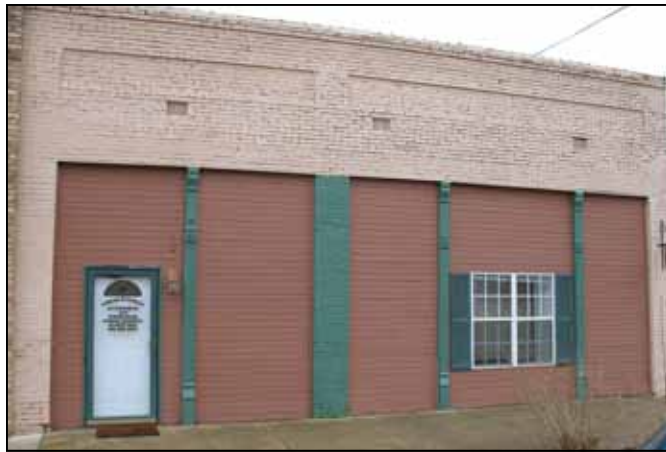
*This historic commercial building in Como, Mississippi has been drastically altered with the removal of the original display glass and doors and replacement with inappropriate wood siding and a modern residential style door and windows. The original cast iron columns are still visible showing the original divisions of the storefront.*

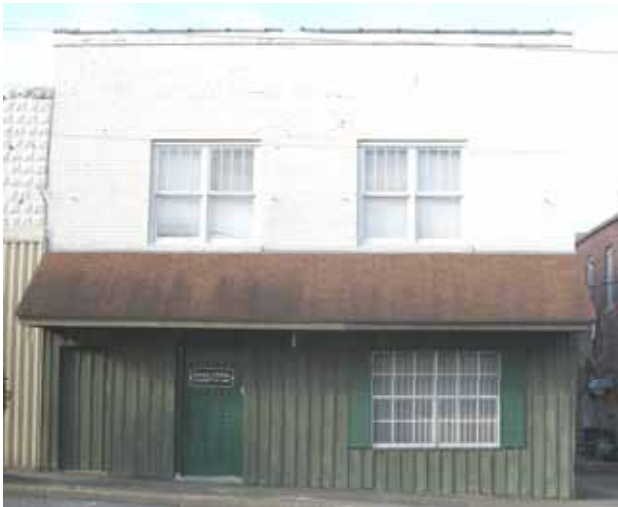
*This historic commercial building in Newton, Mississippi had an inappropriate shingled awning added to the building and the original storefront was removed and inappropriately replaced with board-and-batten siding with a residential door and windows.*

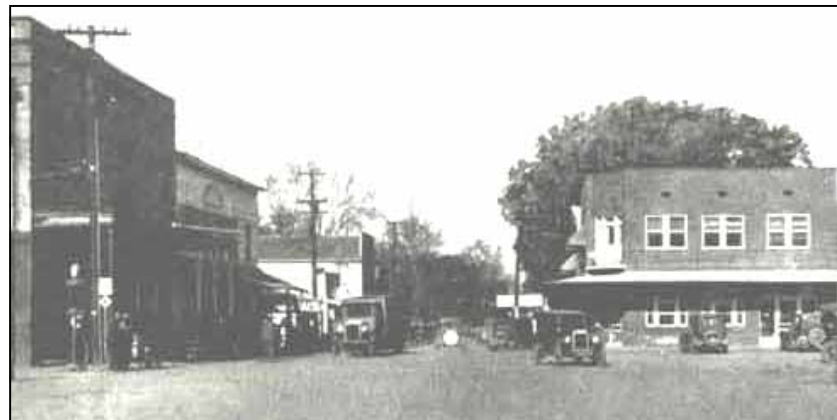
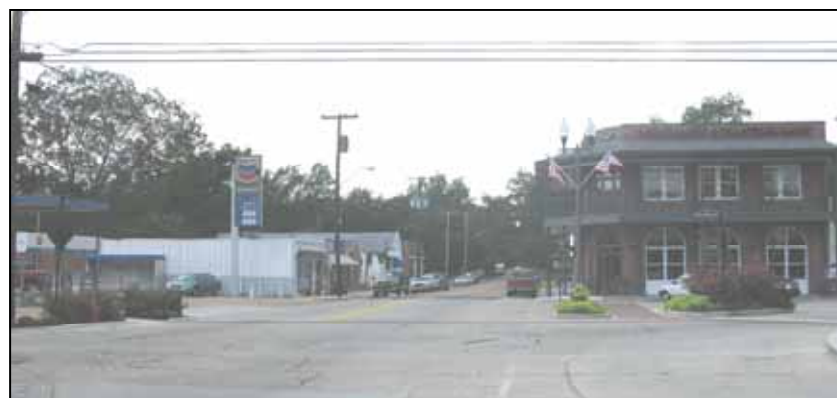
*The photos above show Main Street in 1929 and today. Notice the changes that have taken place on the northeast side of the street where the historic two-story commercial buildings were removed for the construction of the service station. The bank has also been altered from the original design. Historic photo courtesy of Pattie Adams Snowball.*

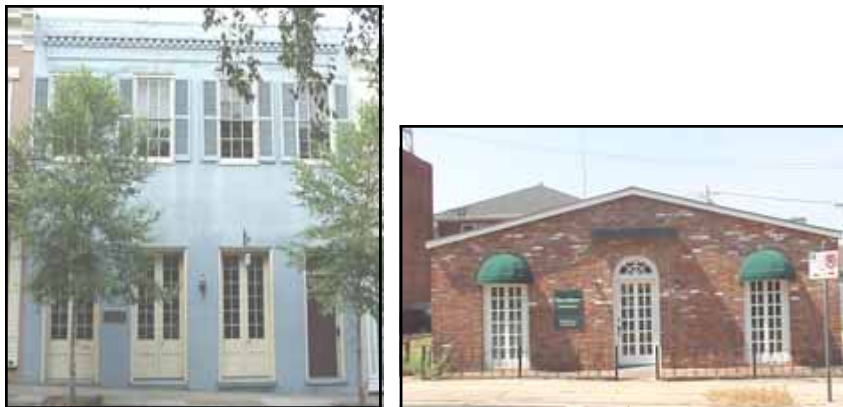
*The circa 1965 building in Natchez on the right stands on the same block as the ca. 1870 historic building on the left. This is an example of incompatible new commercial construction with inappropriate height, scale, proportion, massing, and roof design for the streetscape.*

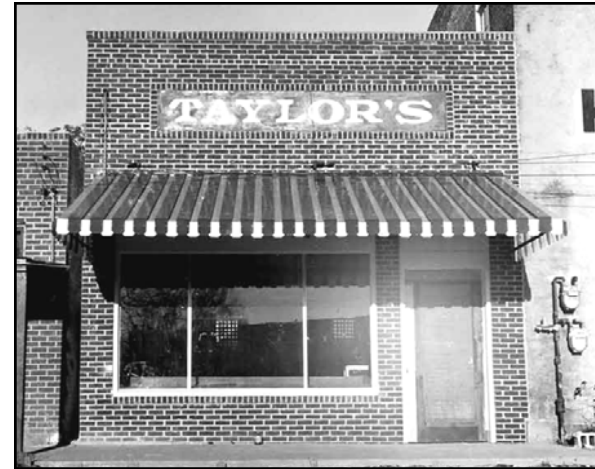
*This old photograph of 244 Town Square illustrates the historic use of signage with the sign placed above the storefront and in the specially designed sign board area delineated by the decorative brick pattern. Photo courtesy of Pattie Adams Snowball.*

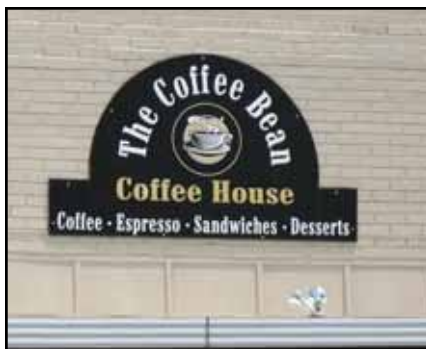
*This professionally designed wall sign from Philadelphia is an example of an appropriately designed sign for a historic commercial building without an original sign board location that uses an interesting design shape.*

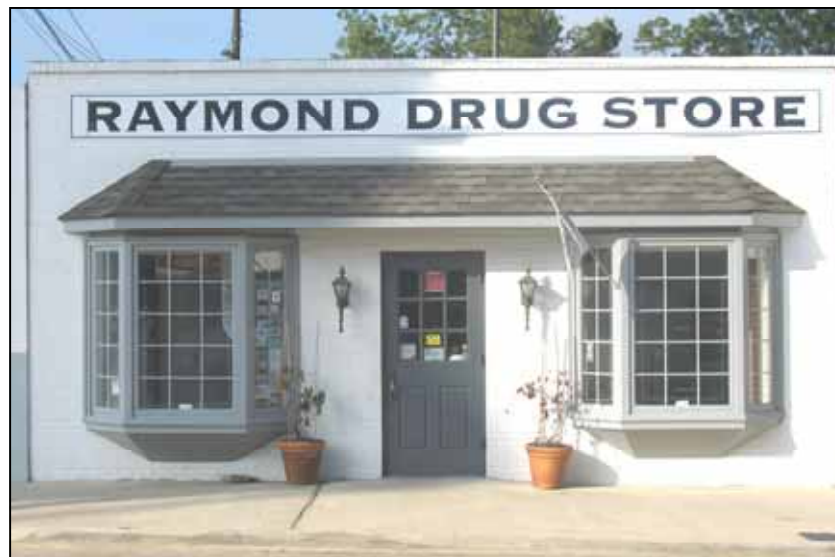
*The signage on this downtown Raymond building is in an appropriate area for this building. The lettering is of an appropriate size and fits neatly in the sign board.*

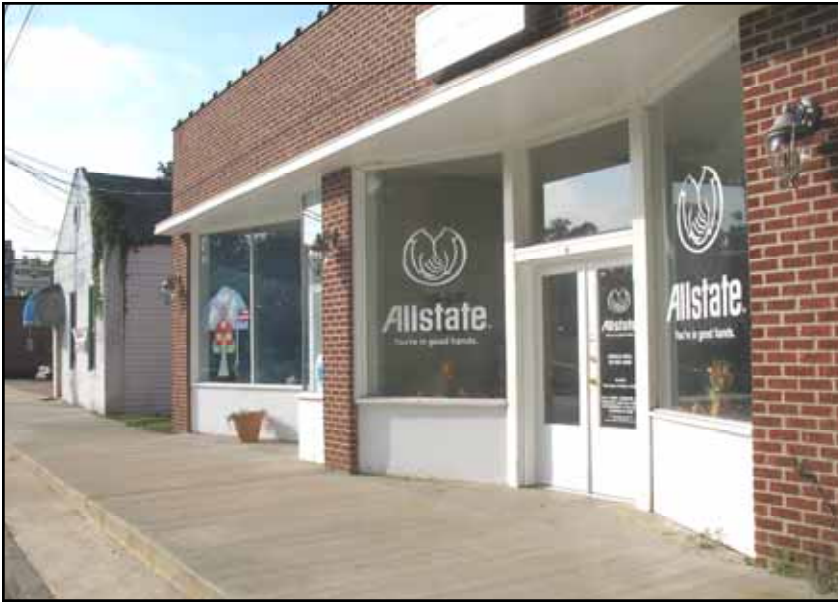
*The window sign on this building in Raymond is very effective displaying the name of the business and hours. The signage can easily be altered with the change of business or in the case of a retail store for the addition of new items or removal of existing items.*

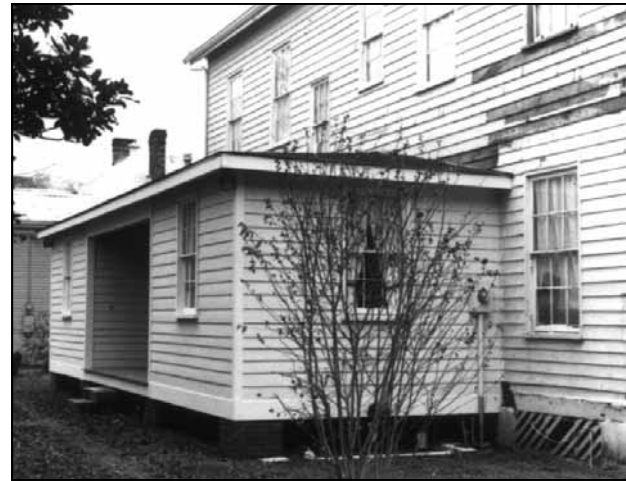
*This rear addition is secondary to the original house and reads as an addition yet uses materials similar to the original house.*

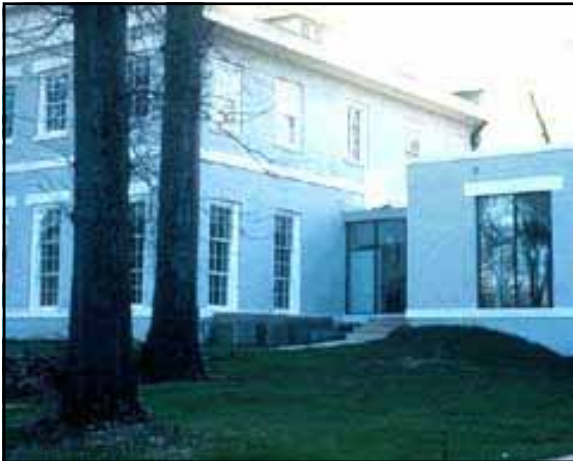
*This National Park Service photograph illustrates an appropriate design for a modern addition and a proper method of connecting it to the historic building.*

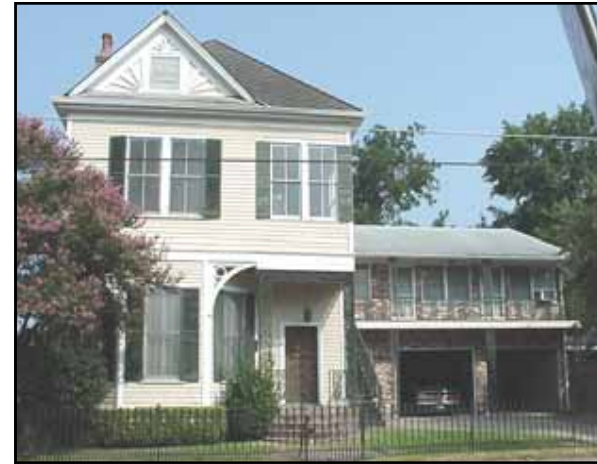
*This side addition is inappropriate in proportion and scale, height, materials, massing, and roof shape. The upper and lower porches, the entrance door, and the second-story windows of this historic house have also been remodeled.*

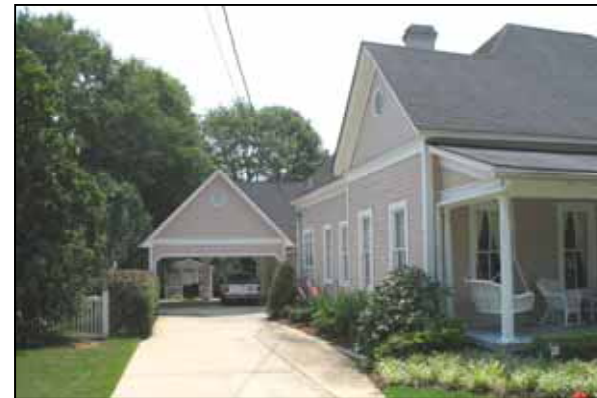
*This example of a carport addition is very successful as it does not compete with the historic house and uses similar materials and roof pitch to maximize the compatibility.*

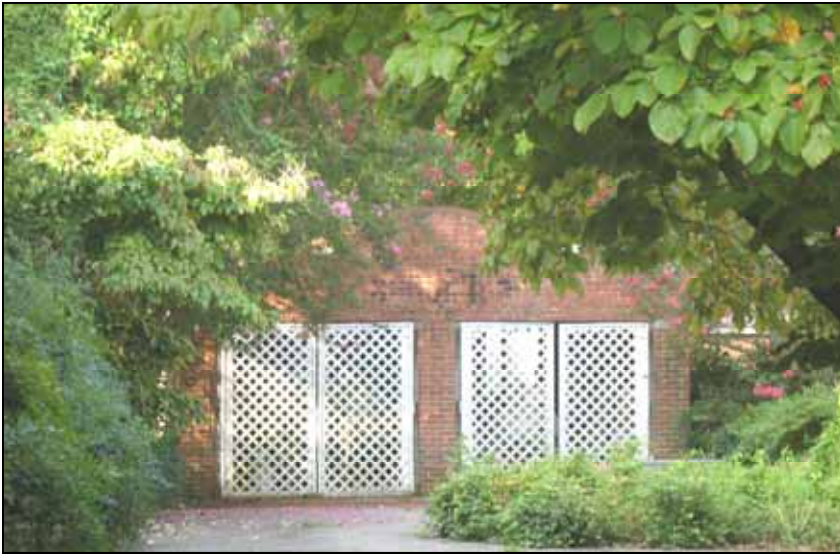
*The house at 140 West Main Street has both an early example of a detached garage before it became popular to attach the garage to the main house. This type of garage should be preserved as an example of early garage construction and is especially important since few survive today.*

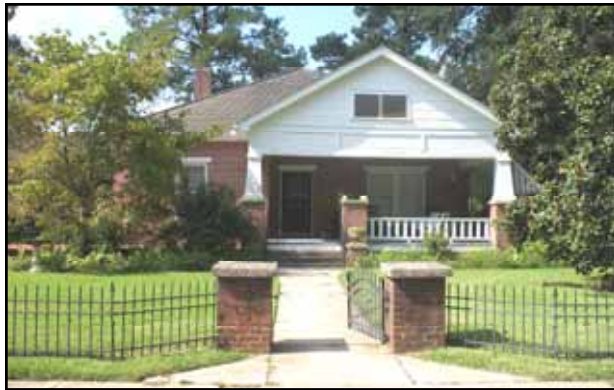
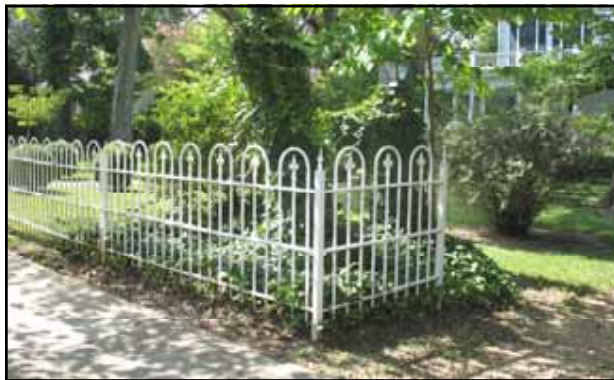
*The houses at 140 and 214 West Main Street, along with the Courthouse, all use traditional iron fencing to enclose the front yards.*

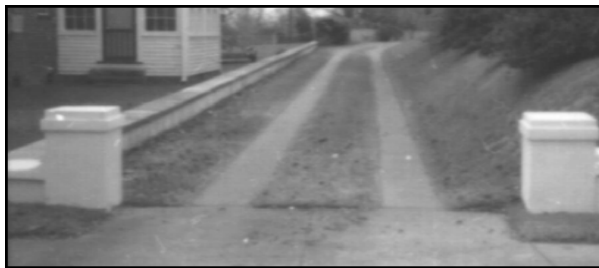
*Concrete strips are appropriate for driveways in historic districts. They minimize the impact of driveways on the character of the historic property and its neighborhood.*

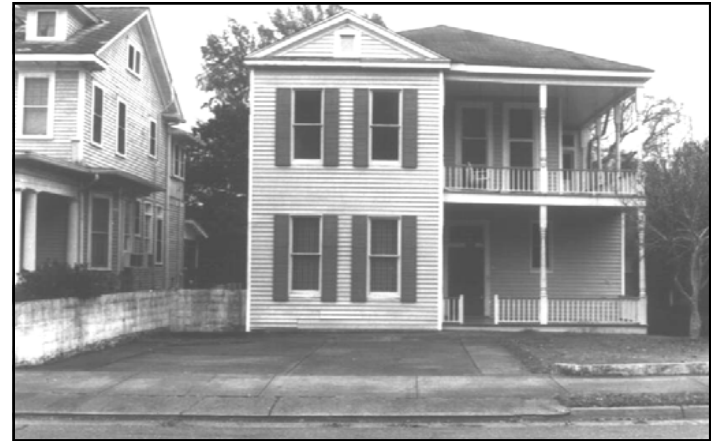
*The front yard of this historic house has been inappropriately paved for parking. Parked cars and the lack of landscaping disrupt the character of the historic neighborhood.*

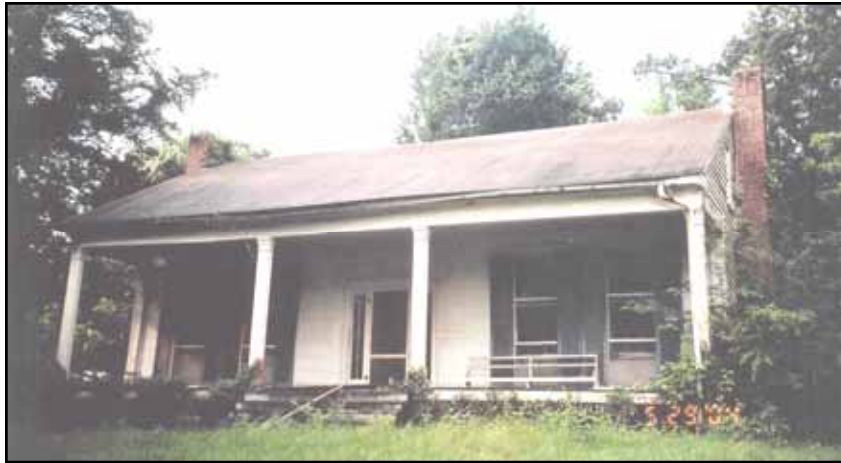
*The house at 233 North Oak Street was moved to Raymond from outside the city as the owner wanted it demolished. In order to save the house the only option was to move it. The house was relocated to a vacant lot on North Oak Street where it was restored for use as a Bed & Breakfast.*
