# NATIONAL REGISTER OF HISTORIC PLACES REGISTRATION FORM

other names/site number: Aberdeen Downtown Historic District

Section: 7 Page: 1 Aberdeen Downtown Historic District  
Monroe Co., Mississippi

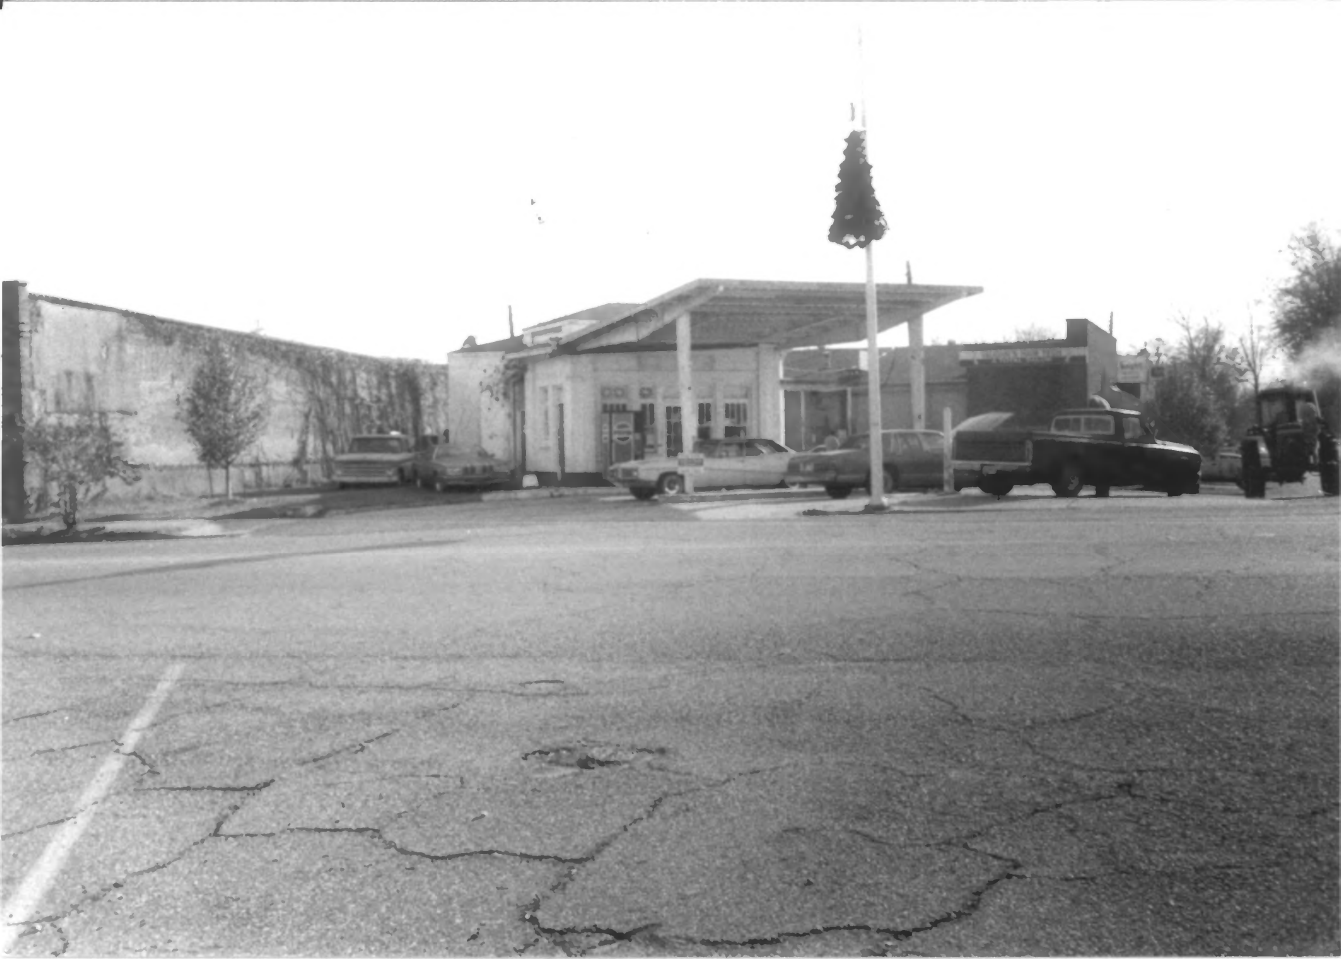
Photo #1 of 32

This is a brick, one-story, five-bay gas station. Its centered entrance features a multi-light, single-leaved door flanked by two-over-one windows with four-over-one outer windows. The fenestration is a capped transom. A modern canopy extends from the building to cover the gas pumps and a two-bay aluminum and cement block service area with shed roof is attached to the rear of the building. (PHOTO #1)

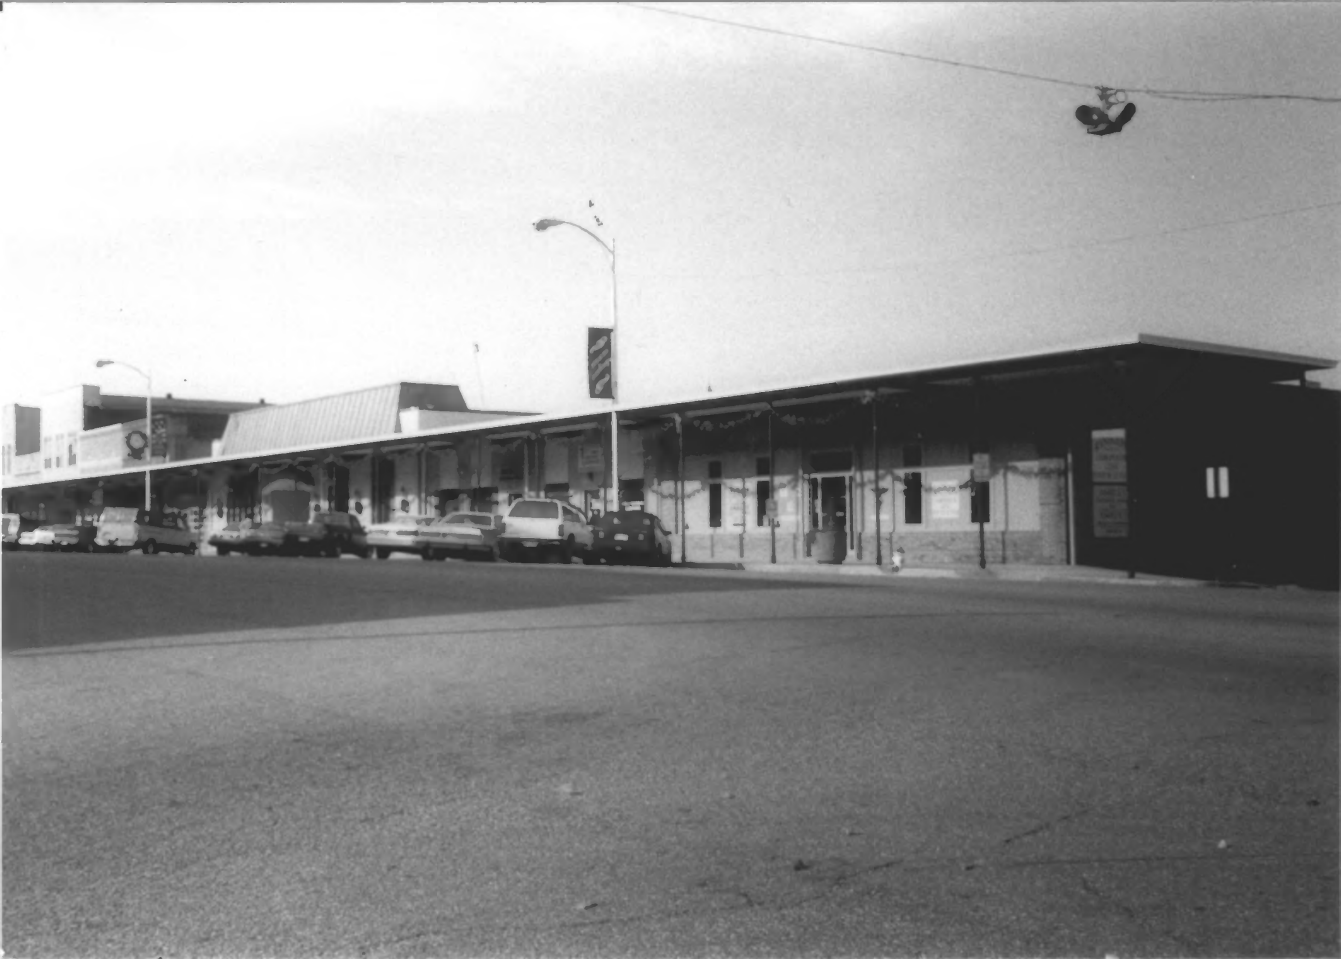
Photo #2 of 32

This is a horizontal grouping of brick, one-story, commercial buildings that are divided into three storefronts. The building reads window, window, door, window, door, window, window, window, door, window, window. All windows and doors are plate glass with an emphasis on the vertical. The western section of the building has been covered with colored aggregate panels while the eastern section remains brick. (PHOTO #2)

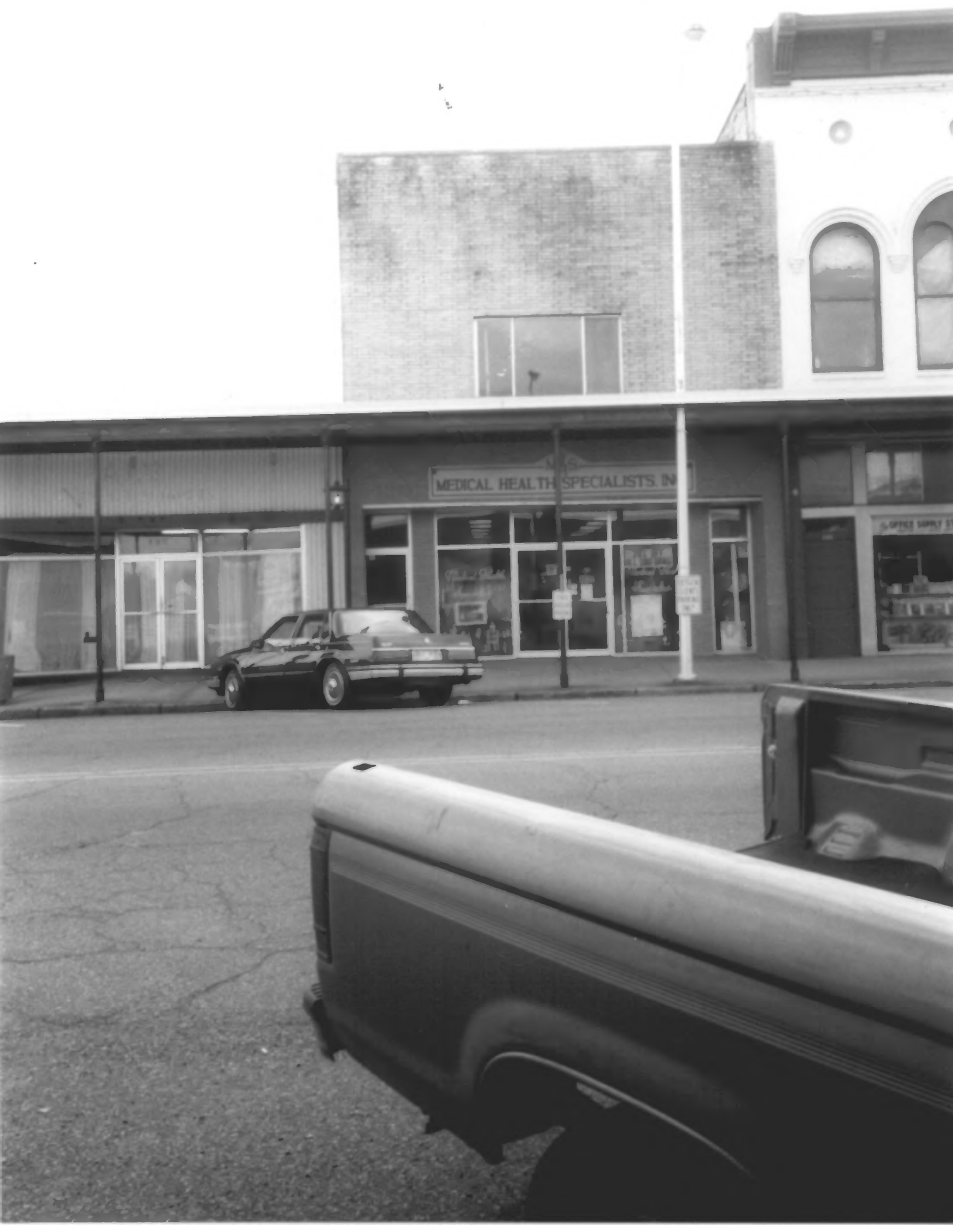
Photo #3 of 32

This is a brick, two-story, single bay commercial building. Its storefront has been modernized with a centrally placed double, all-glass door, flanked by plate-glass windows with transoms. On the western half of the building is an all-glass door with transom that leads to the upper story. On the eastern half of the building a narrow, plate-glass window with transom has been placed. The second story has been re-bricked and all historic features have been enclosed. A single, three-light, fixed glass replacement window is centrally placed on the building. (PHOTO #3)

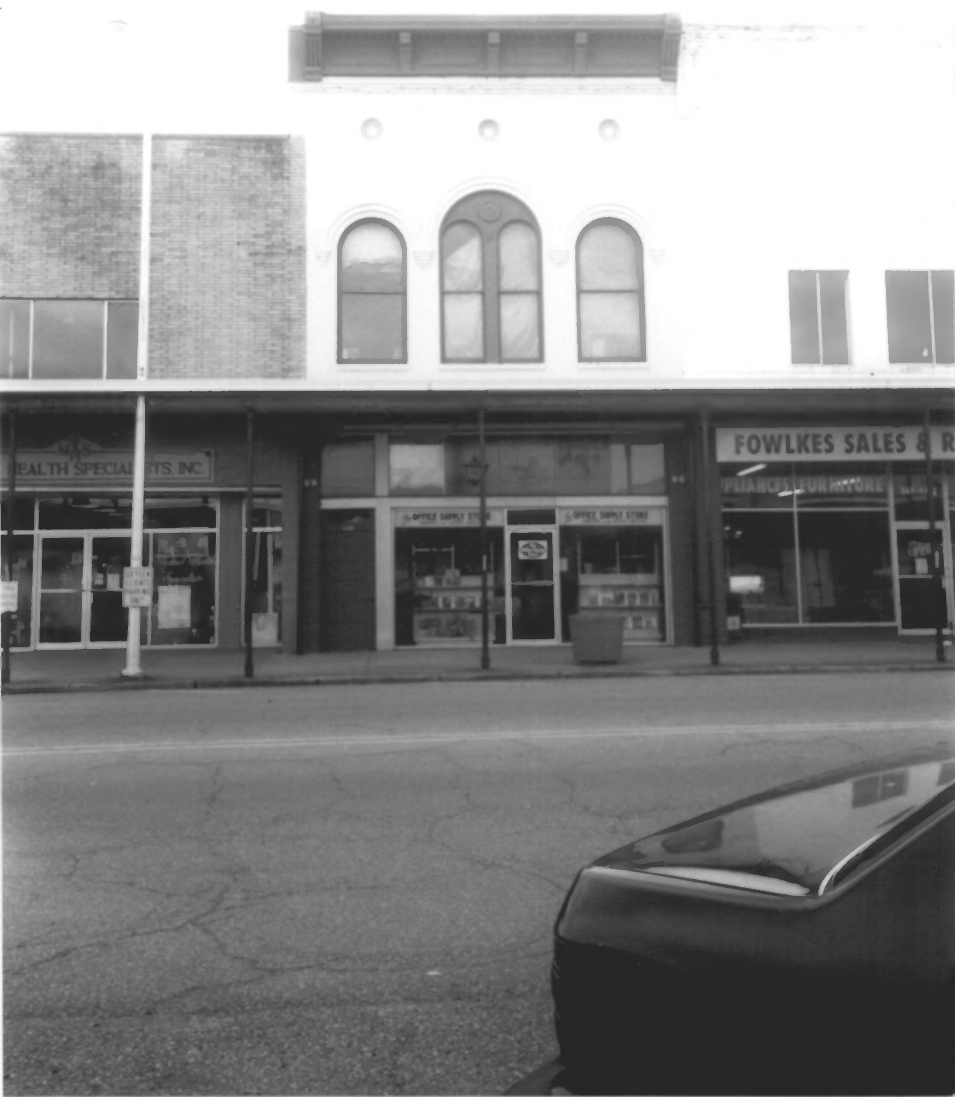
Photo #4 of 32

This is a brick, two-story, three-bay, commercial building. The storefront is characterized by its centrally placed all-glass door that is flanked by plate-glass showcase windows. The building seems to retain its historic transom but it has been covered with enameled panels. On the western half of the building, is a five-paneled wooden door with a colored, glass block transom. The second story features a centrally placed, paired, round-headed arched window set into a decorative tin frame and flanked by single, one-over-one round-headed arched windows. All the windows have brick hood molding and a corbel course. Above each of these windows are circular ventilators with cast-iron grills. The building is crowned with a tin cornice that features panels, brackets, and dentils. (PHOTO #4)

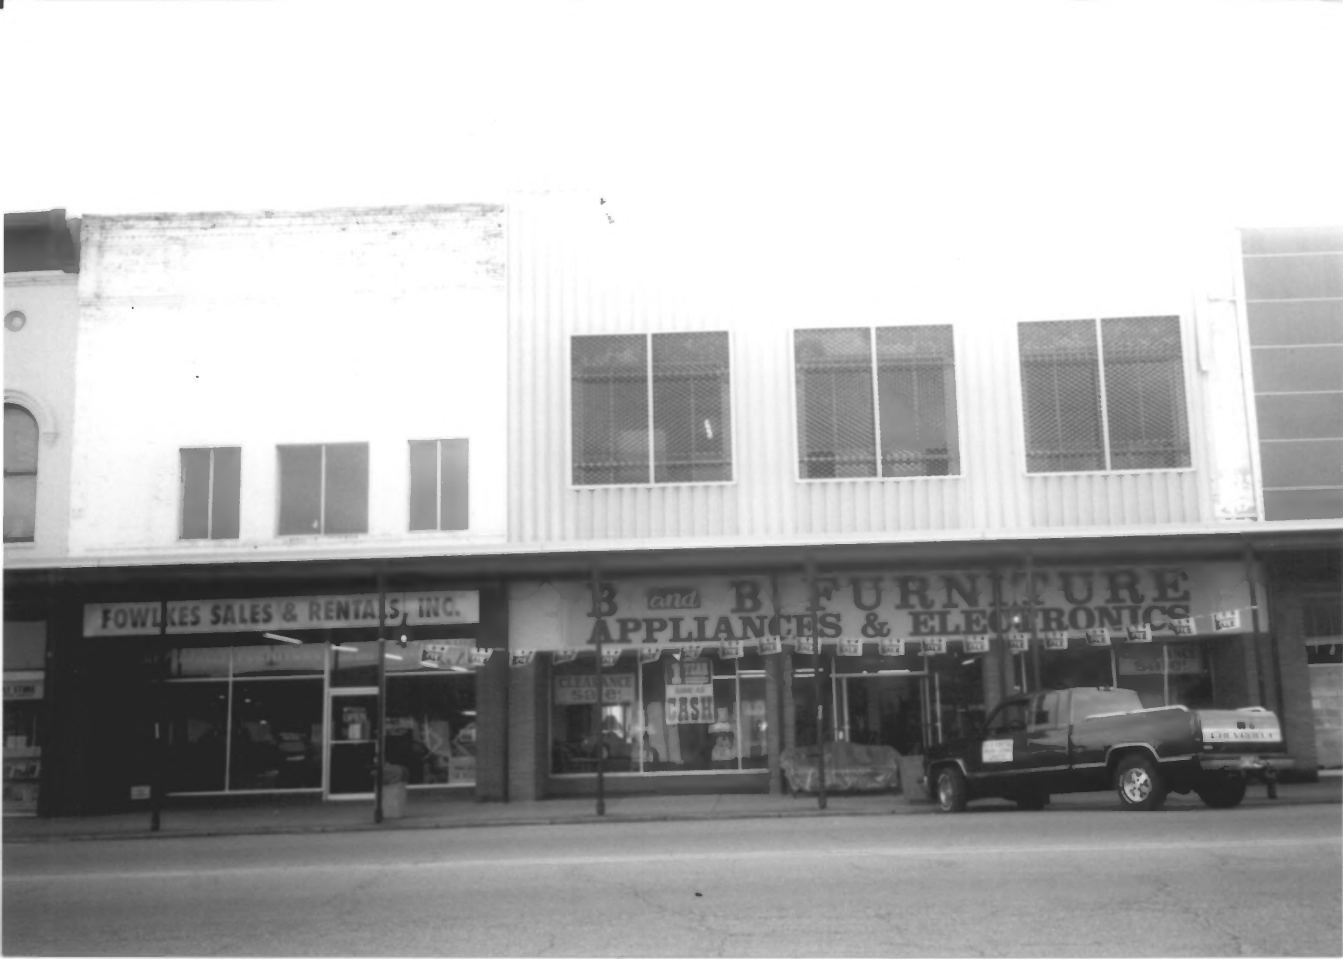
Photo #5 of 32

This is a brick, two-story, three-bay commercial building. The storefront and second story have been modernized retaining only its historic brick cornice. The storefront has an asymmetrically placed all-glass door flanked by plate-glass windows with transoms. Above the transom is a horizontal band of metal panels for the signboard. The second story has three bays of irregularly placed, two-light casement windows. The building is capped with a decorative brick cornice highlighted by brick brackets. (PHOTO #5)

This is a brick, two-story, three-bay, double-lot commercial building. The storefront and second story have been modernized and do not retain any historical features. The storefront has centrally placed all-glass double doors with plate-glass sidelights and transoms. Flanking the entrance is plate-glass windows set in aluminum frames divided by modern brick piers. The transom has been enclosed with metal panels for a signboard. The upper story has three bays that are exposed through openings in the aluminum siding that covers the entire second story. (PHOTO #5)

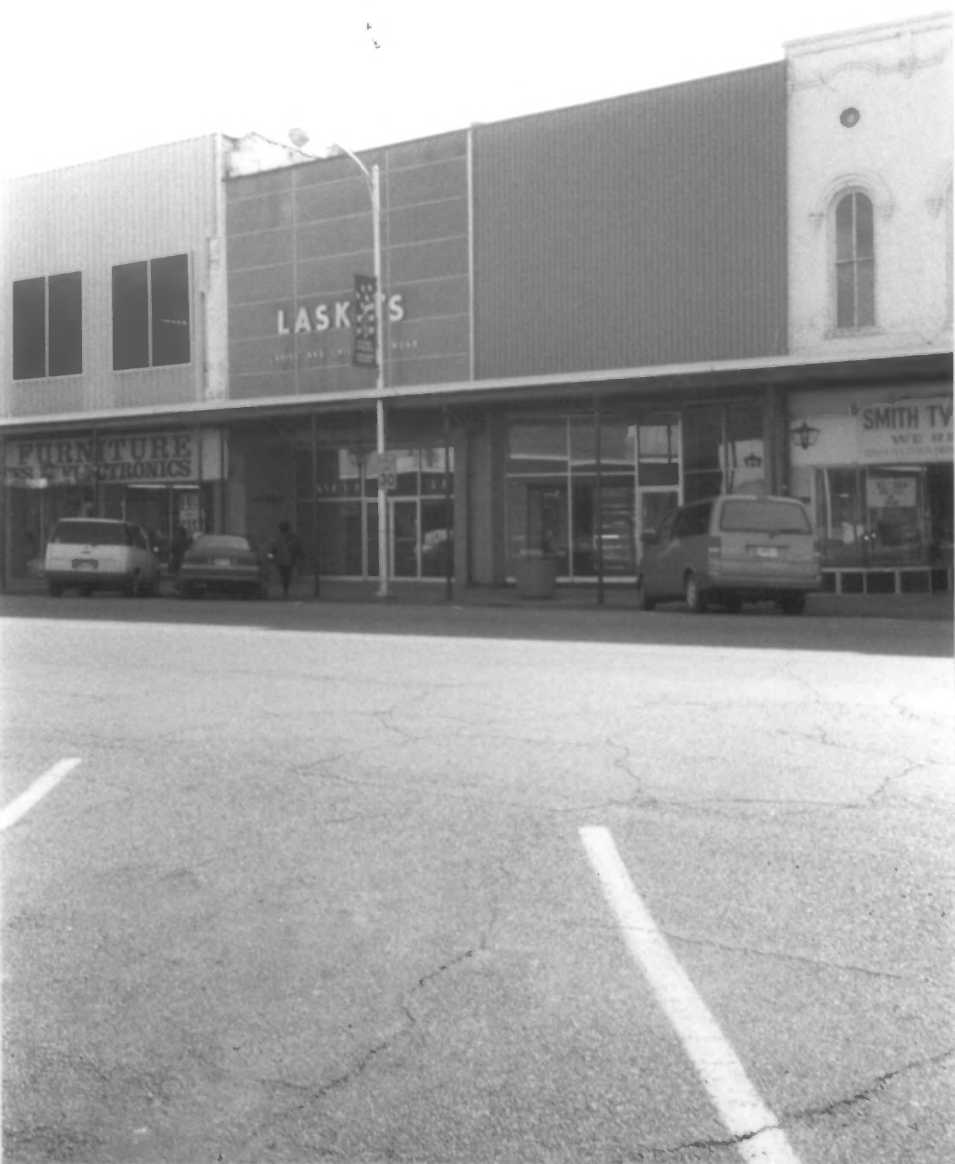
Photo # 6 of 32

This is a brick, two-story, commercial building. The buildings has been modernized with a storefront that is characterized by a centrally placed all-glass door flanked by plate-glass windows with transoms. The second story has been covered with aluminum siding that if removed might make this a contributing element to the district. (PHOTO #6)

This is a brick, two-story commercial building. The entrance is a centrally placed all-glass door flanked by plate-glass windows with transoms. The second story has been covered with aluminum siding that if removed might make this a contributing element to the district. (PHOTO #6)

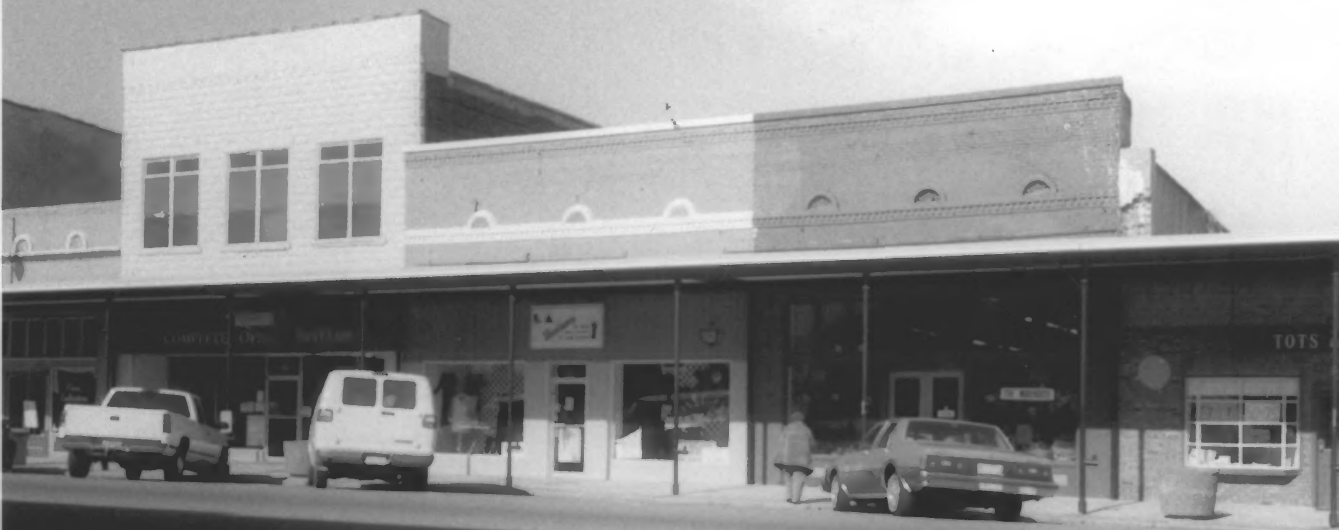
# 7 of 32

This is a brick, one-story commercial building. The entire facade retains many of its original features. The storefront consists of a wooden double-leaf door flanked by plate-glass show windows. Paneled wood aprons are beneath the windows. The whole storefront is wood-framed, with an eight-light transom. The upper level has two rows of brick dentils with a painted name plate and three semicircular ventilators cast-iron grills. (PHOTO #7)

This is a brick, one-story, three-bay commercial building. The storefront is modern with a centrally placed all-glass door with transom flanked by plate-glass windows. The transom has been covered with aluminum siding and is currently used for the name plate. The upper level has brick dentils with three semicircular ventilators with cast-iron grills. (PHOTO #7)

This is a rough-faced concrete-block, two-story, three-bay, commercial building. The storefront is modern with a centrally placed all-glass door flanked by plate-glass windows and covered transoms. The second story windows have wooden frames and are currently enclosed. Across the top of the building is a painted name plate. (PHOTO #7)

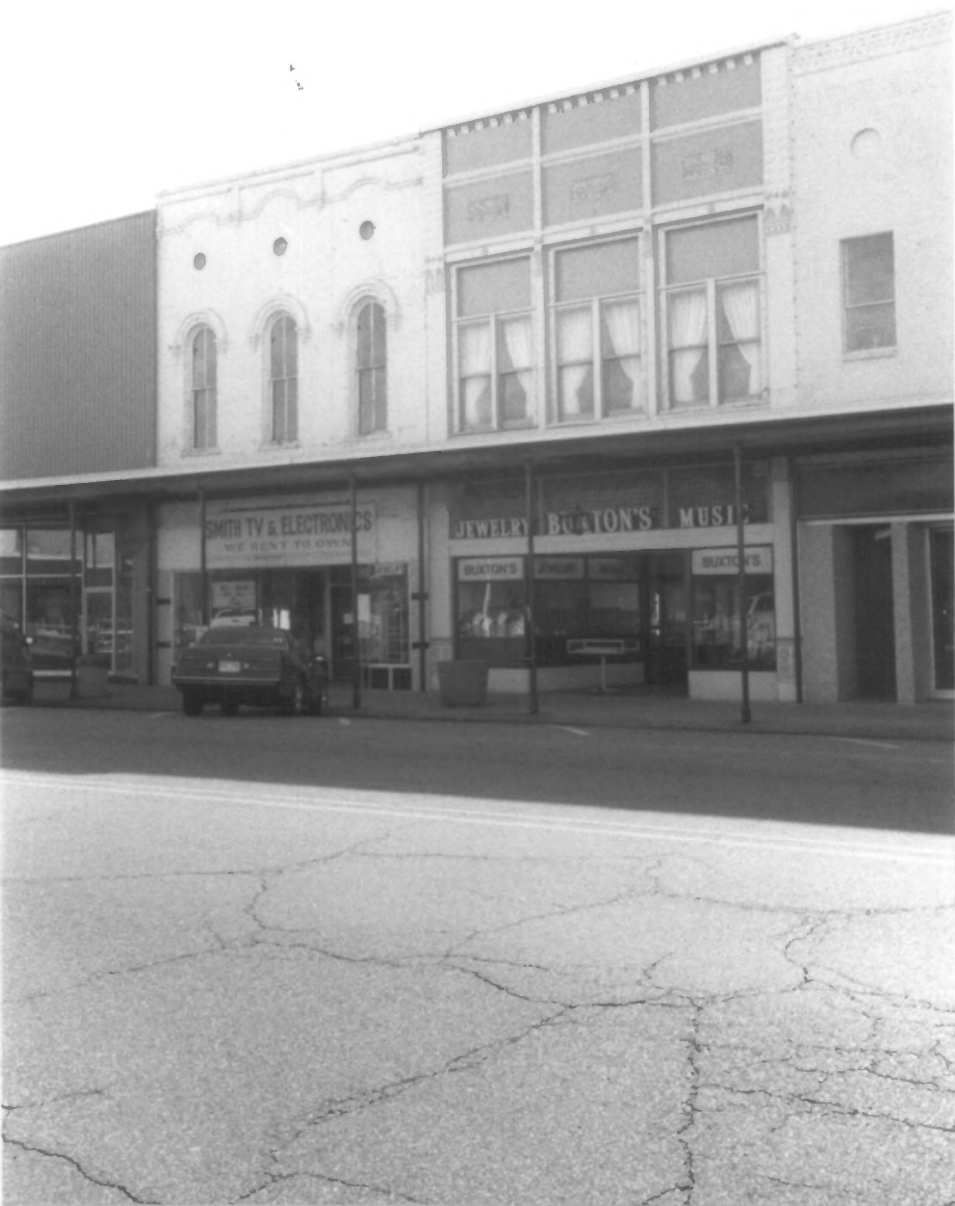
Photo # 8 of 32

This is a brick, two-story, three-bay commercial building. The storefront has been modernized with a centrally placed recessed, all-glass door flanked by plate-glass show windows. The transoms have been covered with a wood signboard. The second story has three, two-over-two double-hung sash, round-headed arch windows with plain sills and capped with projecting hood molding. Single wooden shutters are attached to the facade around and between the windows. Three circular ventilators with cast-iron grills are placed above the windows. The cornice is composed of projecting brick dentils with round arches and a corbel course. (PHOTO #8)

This is a brick, two-story, three-bay commercial building. The storefront has been restored and retains its original recessed show windows with enameled transom signboards. Above the show windows are transoms designed in colored glass blocks with ceramic letters. The second story has three bays of paired one-over-one double-hung sash windows set into wooden frames with enclosed transoms. The windows are separated by pilasters that feature decorative capitals that do not adhere to classical motifs. Geometrical designs of six rectangular boxes are highlighted on the upper story by contrasting paint and projecting brickwork. Also, three rectangular ventilators with cast-iron grills are placed centrally over the windows and a row of dentils crown the building. (PHOTO #8)

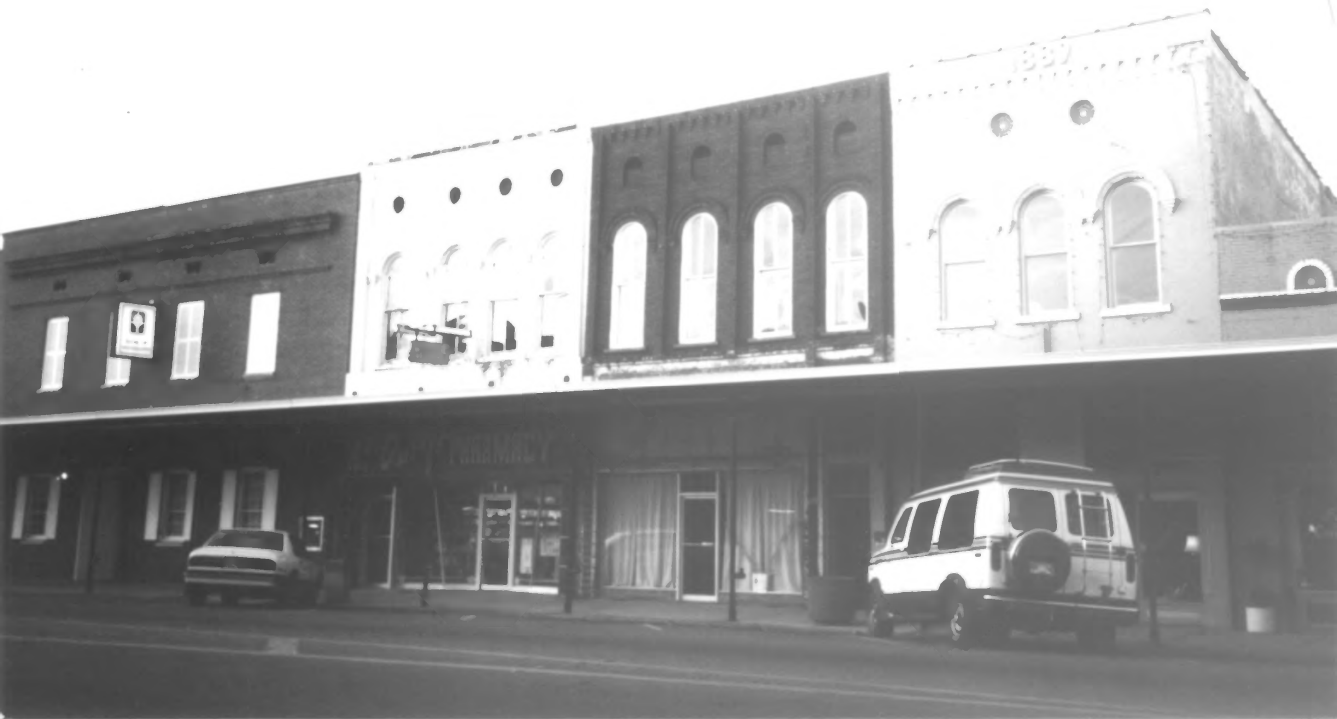
Photo 49 of 32

This is a brick, two-story, three-bay commercial building. The storefront is recessed with centrally placed paired double-glass-and-panel doors and flanked with plate-glass windows with fixed glass block transoms. The second story has three round-headed arch, one-over-one double-hung sash windows capped with stepped arches. Two circular ventilators with cast-iron grills are placed over the windows and topped with a corbel course. The date panel reads 1889 but Sanborn maps indicate re-modeling must have occurred around 1910 to constitute the building's current appearance. (PHOTO #9)

This is a brick, two-story, four-bay commercial building. The first story has a flush modern storefront with a centrally placed all-glass door with transom and flanked by plate-glass windows. The second story has four enclosed round-headed arch windows with capped, stepped arches and are separated with decorative brick pilasters. Above each window is a recessed, partially bricked rounded decorative motifs and capping the building is brick dentils. (PHOTO #9)

This is a brick, two-story, four-bay commercial building. The first story has a flush, modern storefront that reads door, window, door, window. The storefront is all-glass set into aluminum frames. A transom may survive behind the now wooden signboard. The second story has a four round-headed arch two-over-two double-hung sash windows capped with stepped arches. The building may originally have a pressed metal cornice that was removed or replaced with decorative brickwork and four circular ventilators with cast-iron grills. (PHOTO #9)

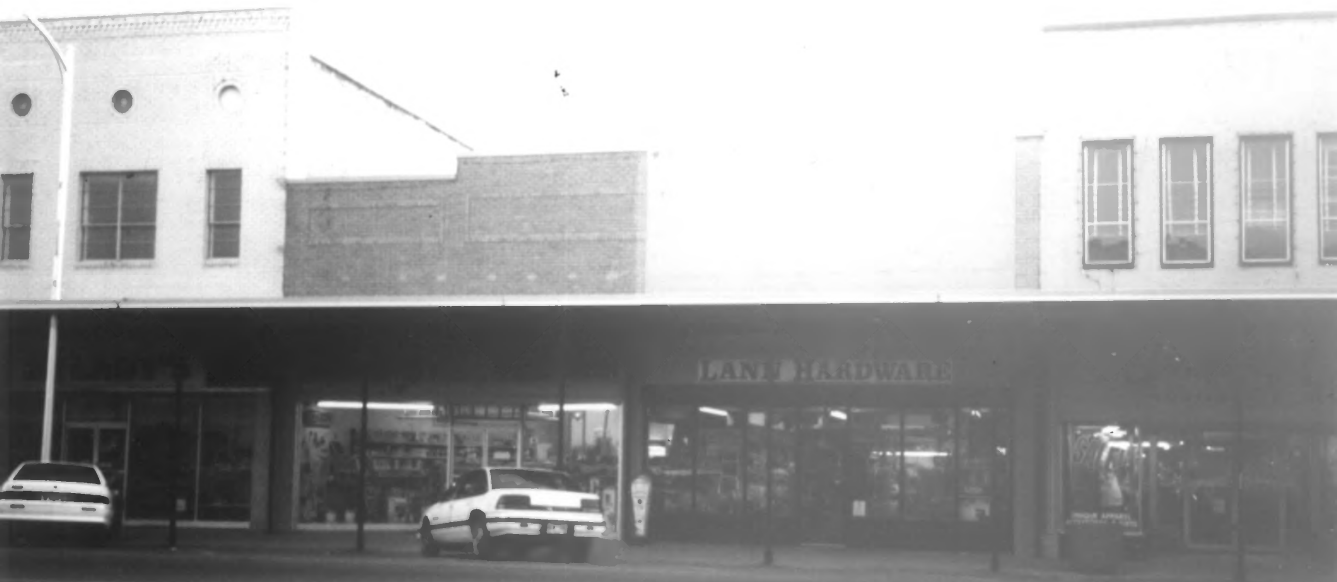
Photo #10 of 32

This is a brick, one-story, commercial building with a three-bay storefront distinguished by central double-leafed doors in a shallow recess between aluminum framed windows. A vertical, ribbed, stepped metal facade obscures many original details. (PHOTO #10)

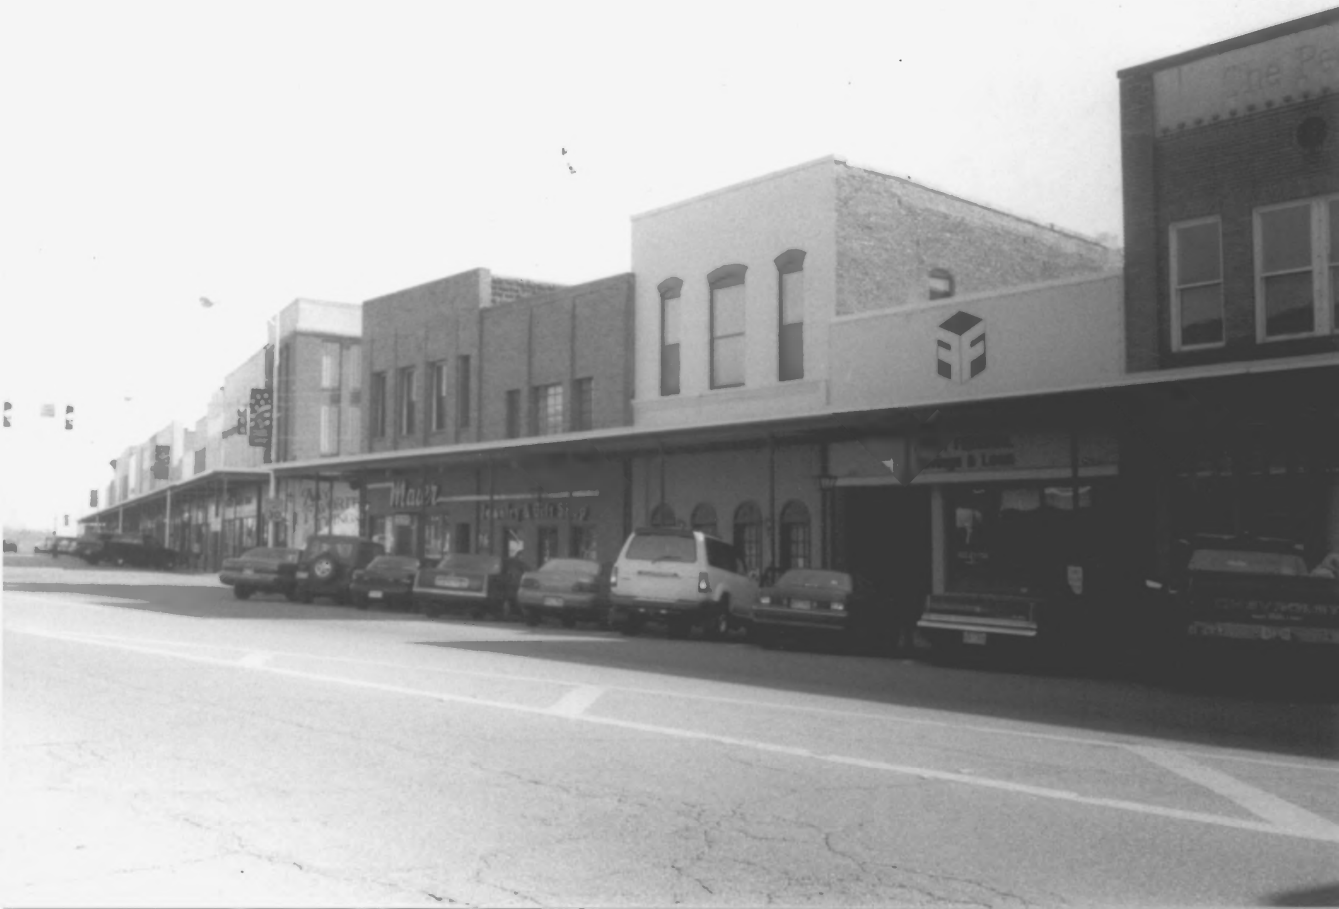
Photo 13 of 32

This is a brick, two-story, three-bay, commercial building. The storefront is composed of three bays of fixed light windows set into brick frames. The second story is also characterized by three bays of fixed light windows set into brick frames with decorative buttresses dividing them. As noted in 101 West Commerce, this building is the older Maier Jewelry store that has been re-bricked to create the appearance of a double-lot commercial building. (PHOTO #13)

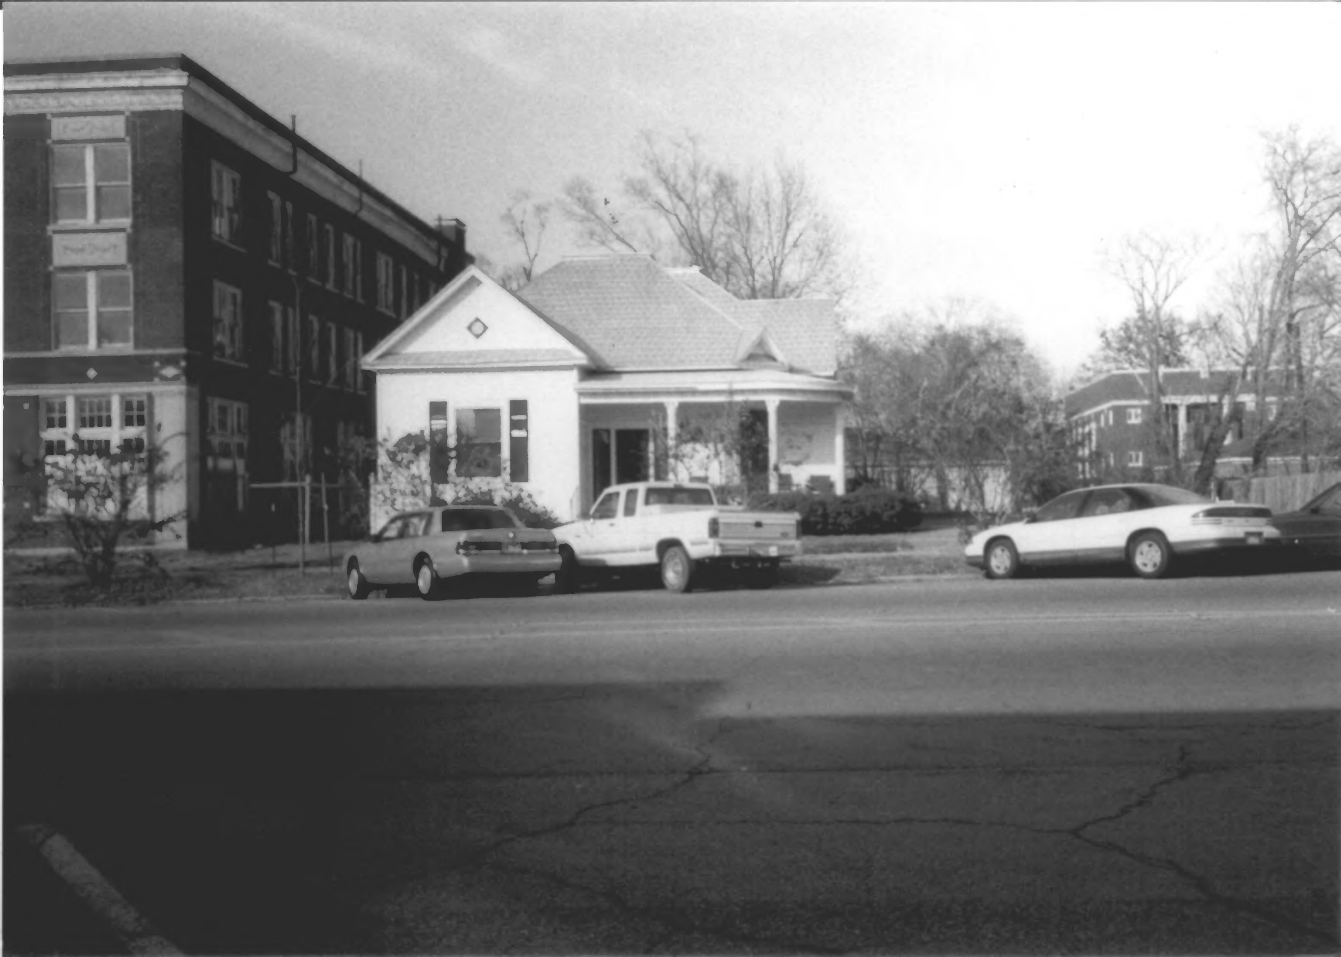
Photo #120 of 32

This is a frame, one-and-a-half story, multi-gabled, truncated-hip roofed residential building of Queen Anne design that rests on a brick foundation. The building is no longer a residence but has been converted into an office and updated by enclosing sections of the porch and covering the facade with aluminum siding. The irregularly massed building has a projecting gable end at the west end of the south facade. The entrance is a single-paneled door flanked by leaded glass sidelights in a plain wood frame. The entrance and a clipped corner window at the east end of the facade are under a wraparound porch supported by fluted Ionic columns, irregularly spaced. The wraparound porch has been partially enclosed on the east end. All windows are one-over-one double-hung sash with plain surrounds. (PHOTO #20)

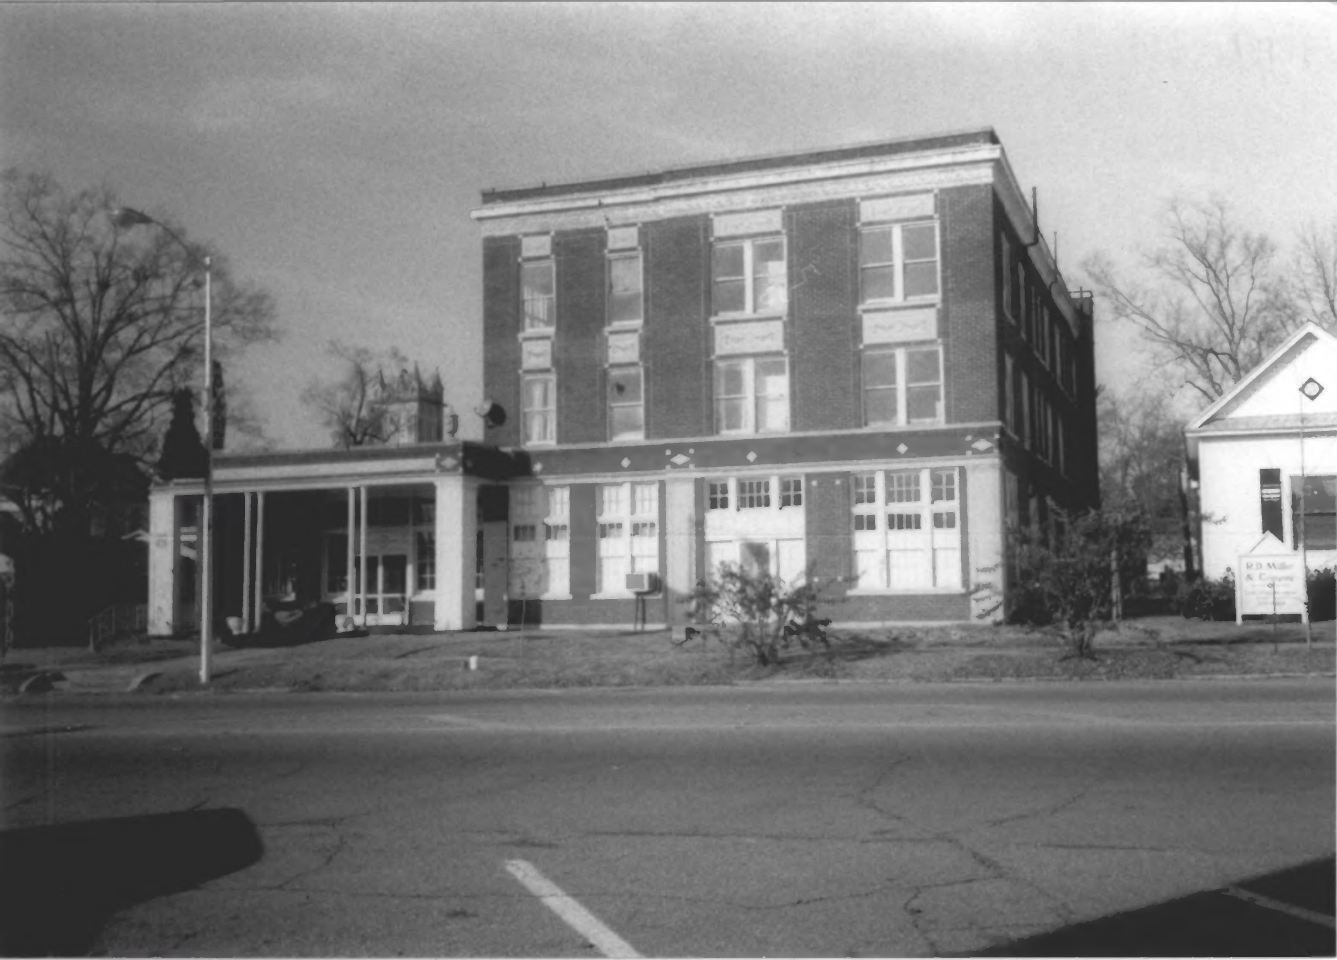
Photo ~~21~~ 21 of 32

The Tombigbee Inn is a brick, three-story, flat roof building of Neo-Classical Revival style that rests on a limestone foundation. The irregularly massed structure is composed of a three-story, four-bay facade with an attached one-story entrance. The entrance is marked with two Doric piers with panels as well as two colonnades. Paired two-panel doors with fixed eight-light sidelights and transoms are flanked by paired four-over-four framed windows with transoms. The main body of the building is three-stories with four bays. The first story bays consist of two paired six-over-six framed double-hung sash windows with fixed six-light transoms followed by a decorative cast-stone, engaged Doric pier followed by an single paneled door framed with four-over-four double-hung sash windows with fixed four-light and eight-light transoms. The western most bay contains three framed windows with the central window being an eight-over-eight double-hung sash flanked by four-over-four double-hung sash windows with fixed four-light and eight-light transoms and followed by another decorative cast-stone, engaged Doric pier. All first story windows have cast-stone sills and lintels. The second and third stories are separated by a decorative band of bricks with inlaid stone diamonds. The second and third stories have one-over-one double-hung sash windows in single and paired placements with cast-stone festoons and swags. Finally, a decorative stone cornice surmounted by a brick parapet tops the building. (PHOTO #21)

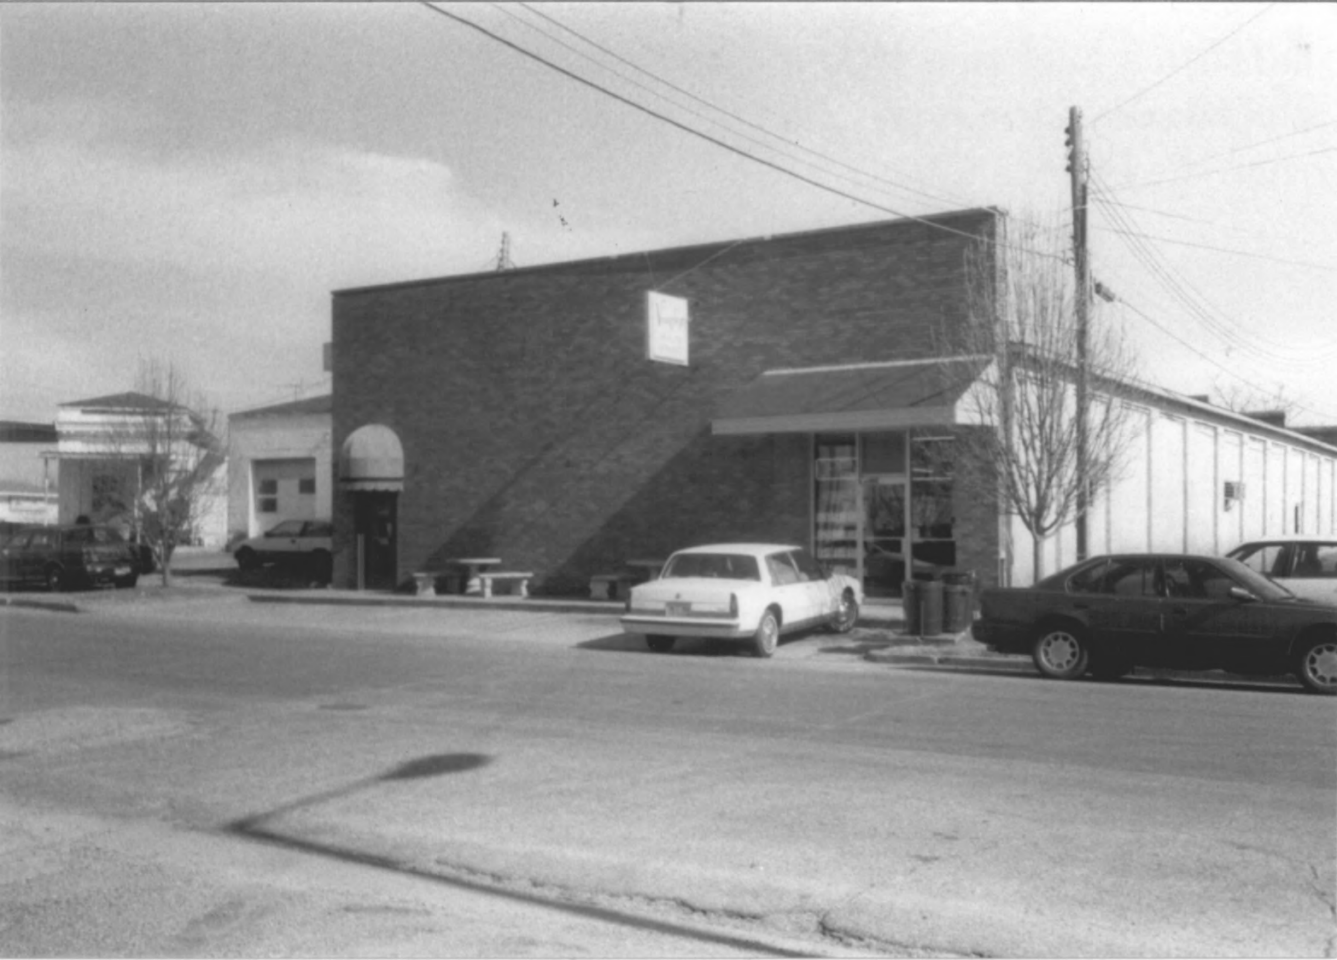
Photo #25 of 32

This is a brick one-story, six-bay commercial building. The building reads single-light plate-glass window, door, single-light, plate-glass window, door, two-light, plate-glass window, four-light, plate-glass window. The windows are all fixed and set into brick and aluminum frames with covered transoms. The doors are slightly recessed single-light with wooden frames and also have covered transoms. The building has a false front that reads as a stepped parapet. (PHOTO #25)

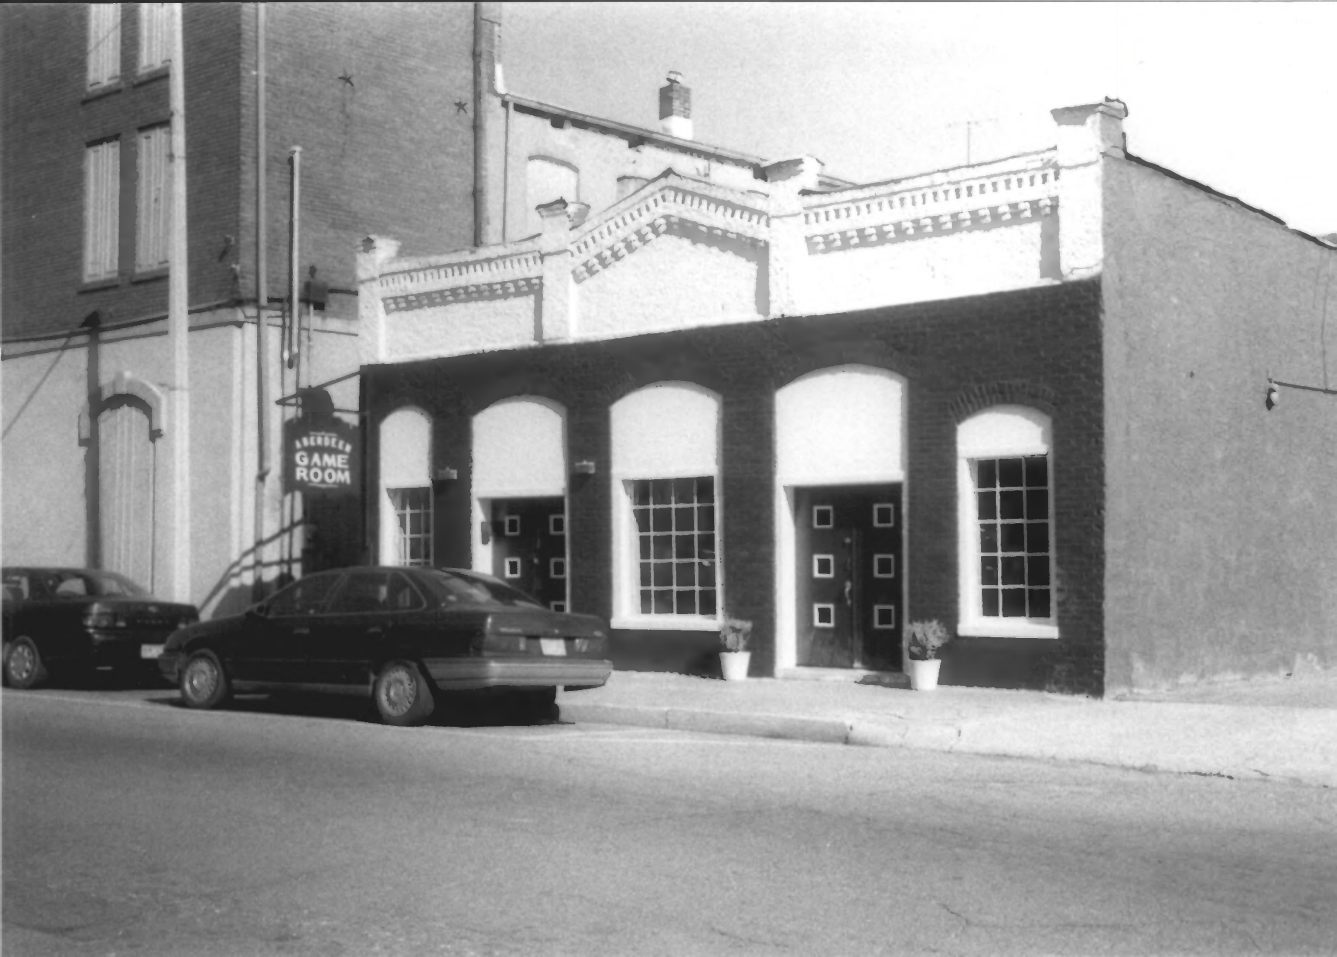
Photo #27 of 32

This is a brick, one-story, five-bay, false front commercial building. The storefront reads window, door, window, door, window. All have been replaced; however, the original brick frames have been retained and in-filled with modern bricks to accommodate the smaller replacement windows and doors. The outer windows are fifteen-light fixed glass windows that are slightly recessed into the original frames and have two brick surrounds, the modern and historic. The center window is a twenty-light fixed glass window that is slightly recessed into its original frame and also has two brick surrounds. The two sets of doors are slightly recessed, modern double-slab doors with three vertical lights in each. The doors are also placed in two brick surrounds. In order to accent the surrounds, the owner has painted the modern and historic in contrasting colors. The building is topped with an elaborate triangular pediment with parapets on the ends of the building as well as on the ends of the pediment. Brick corbel courses and dentils tops the building. (PHOTO #27)

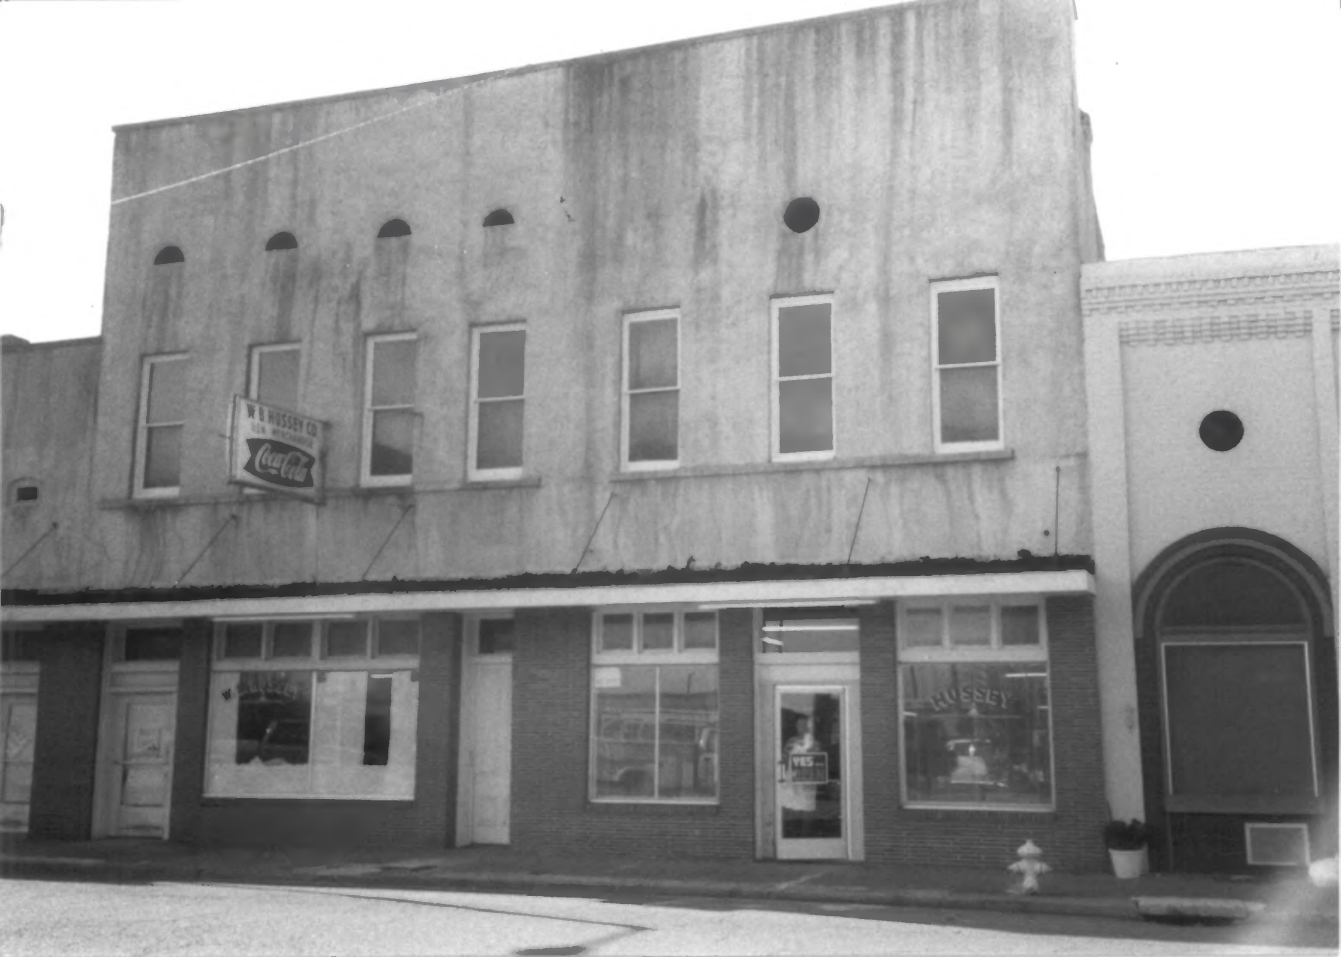
Photo # 30 of 32

This a brick, two-story, seven-bay, double-lot commercial building. The building was constructed as two separate structures but the facade has been re-faced with stucco and now reads as a single building. The storefront has been re-bricked and modernized however retaining its original doors and windows. The building reads door, window, door, window, door, window. The doors are replacement all-glass doors with its historic transoms. The central door however is a historic panel door that leads to the upper story. The windows have been altered with plate-glass with their original transoms sent into wooden frames. The second story is comprised of seven double-hung sash windows set into wooden frames. Above the windows are five circular ventilators with cast-iron grills. (PHOTO #30)
