# NATIONAL REGISTER OF HISTORIC PLACES REGISTRATION FORM

other names/site number: Aberdeen Downtown Historic District

Section: 7 Page: 1 Aberdeen Downtown Historic District  
Monroe Co., Mississippi

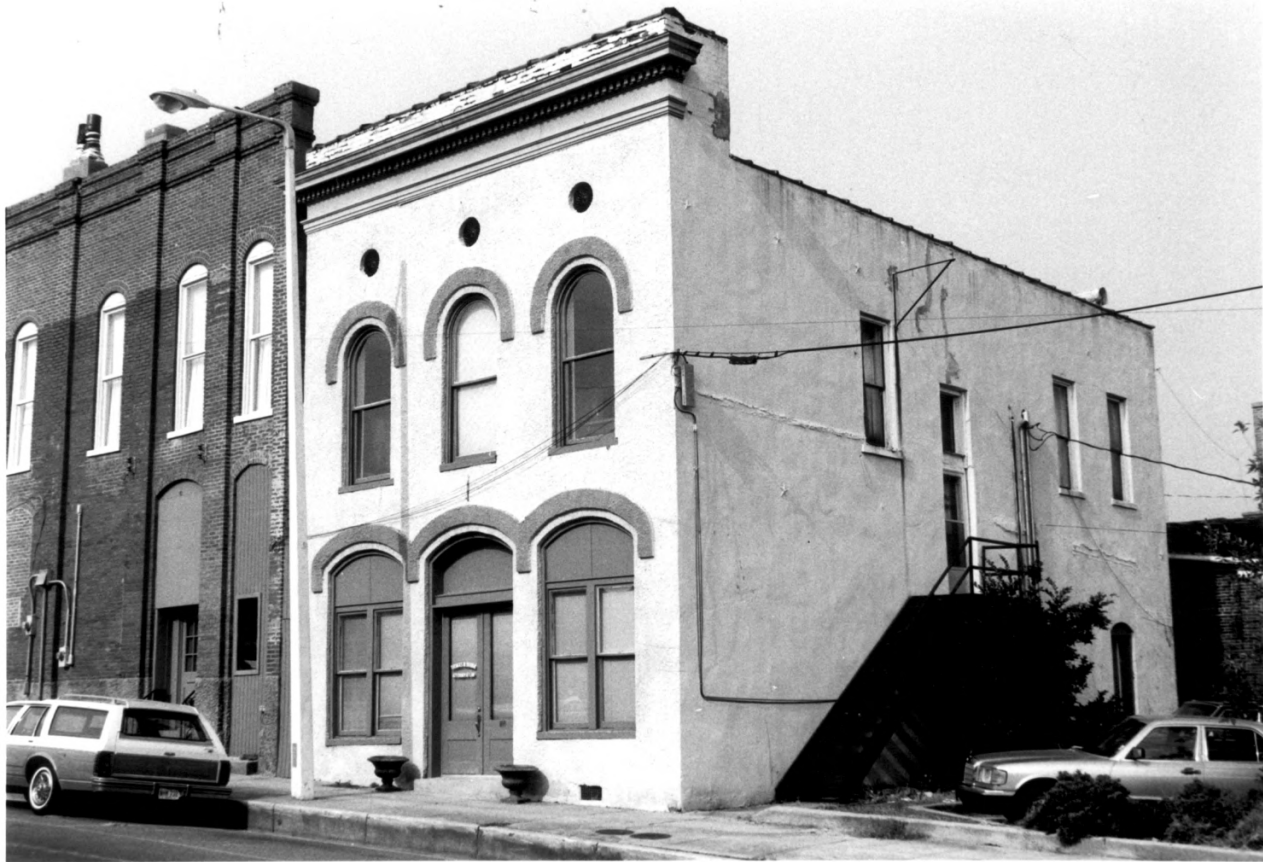
Photo 11 of 11

The building at 107 N. Meridian is another which retains its character to a high degree from the period of significance. Its age is difficult to determine. A building of its size and shape appears on the Sanborn maps continuously from 1885, but the appearance of its facade suggests that it was either rebuilt or remodeled shortly after the turn of the century. Its facade has not been modernized since that time and is in good condition. This building has the second of two extant pressed metal cornices in downtown Aberdeen.
