NATIONAL REGISTER OF HISTORIC PLACES REGISTRATION FORM

other names/site number: Hazlehurst Historic District

street & number: extending along S. Extension, Georgetown, Gallatin, Monticello and interior streets
city or town: Hazlehurst vicinity _____
state: Mississippi code MS county Copiah code 029 zip code 39083

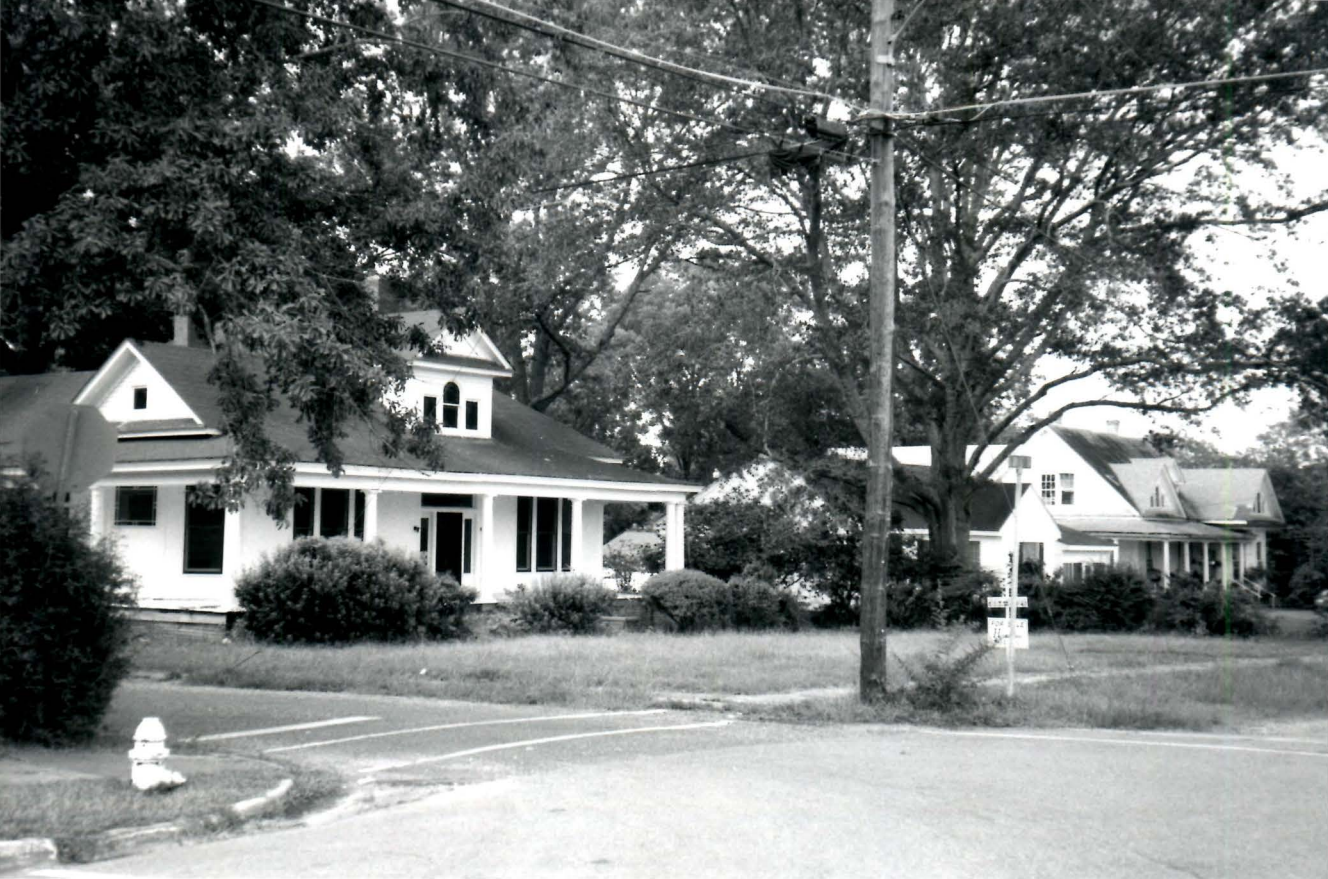
Photo 3 of 45

- 24A. (C) Office c.1915
One-story, clapboard office building with gable-on-hip roof of raised-seam metal and a raised brick foundation/partial basement. Windows are 1/1 double-hung, wood-framed, both paired and single, with 1-light transoms. A three-sided bay with hipped roof and simple brackets has been added on the northern elevation and features multi-light, steel casements. Doors are 6-panel and 1-light, 3-panel. Former, undercut porch on the eastern elevation has been enclosed with raised-seam metal. Wide eaves are boxed with tongue-and-groove siding. [PHOTO #3]

- B. (C) Water Tower c.1905
Steel, circular, water tower supported on four steel girders and topped with conical, metal roof. [PHOTO #3]
- C. (C) Linter Storage Shed c.1935
One-story, corrugated-metal warehouse building with gable roof of raised-seam metal and a poured-concrete foundation. Rafters are exposed at the eaves, and a shed-roofed porch on the southern elevation has been enclosed with corrugated metal.

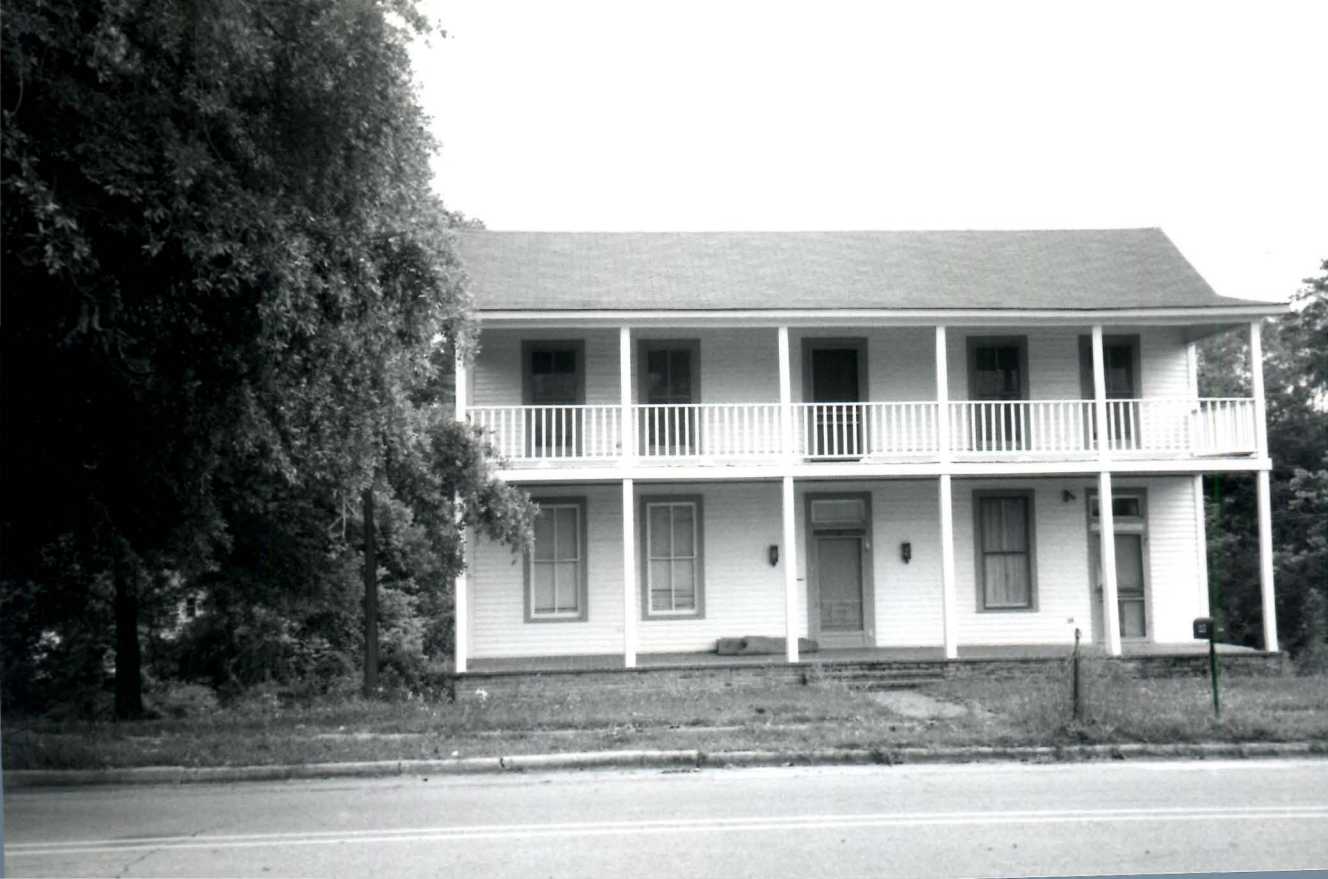
113 E. Gallatin St. [#104]
Hazlehurst, Copiah Co, MS
Hazlehurst Historic District
Photo 15 of 45

The vernacular building tradition continued unabated in Hazlehurst throughout the early 1900s, but by the 1920s, vernacular forms were being built more rarely, and today, only a few vernacular house forms remain from later than 1920. Many examples of vernacular houses from the period 1900-1920 remain in the district, including several L-front cottages along Ainsworth Street [#2, 4, 5], a composite cottage at 206 E. Frost Street [#96], pyramidal cottages at 210 E. Frost Street [#97] and 107 E. Gallatin Street [#101], a galleried cottage at 506 Georgetown Street [#181], gable-front cottages at 517 Georgetown Street [#187] and 215 N. Haley Street [#230], and a gable-front-and-wing at 111 E. Gallatin Street [#103]. The sole I-house, built c.1905, in the district stands at 113 E. Gallatin Street [#104].

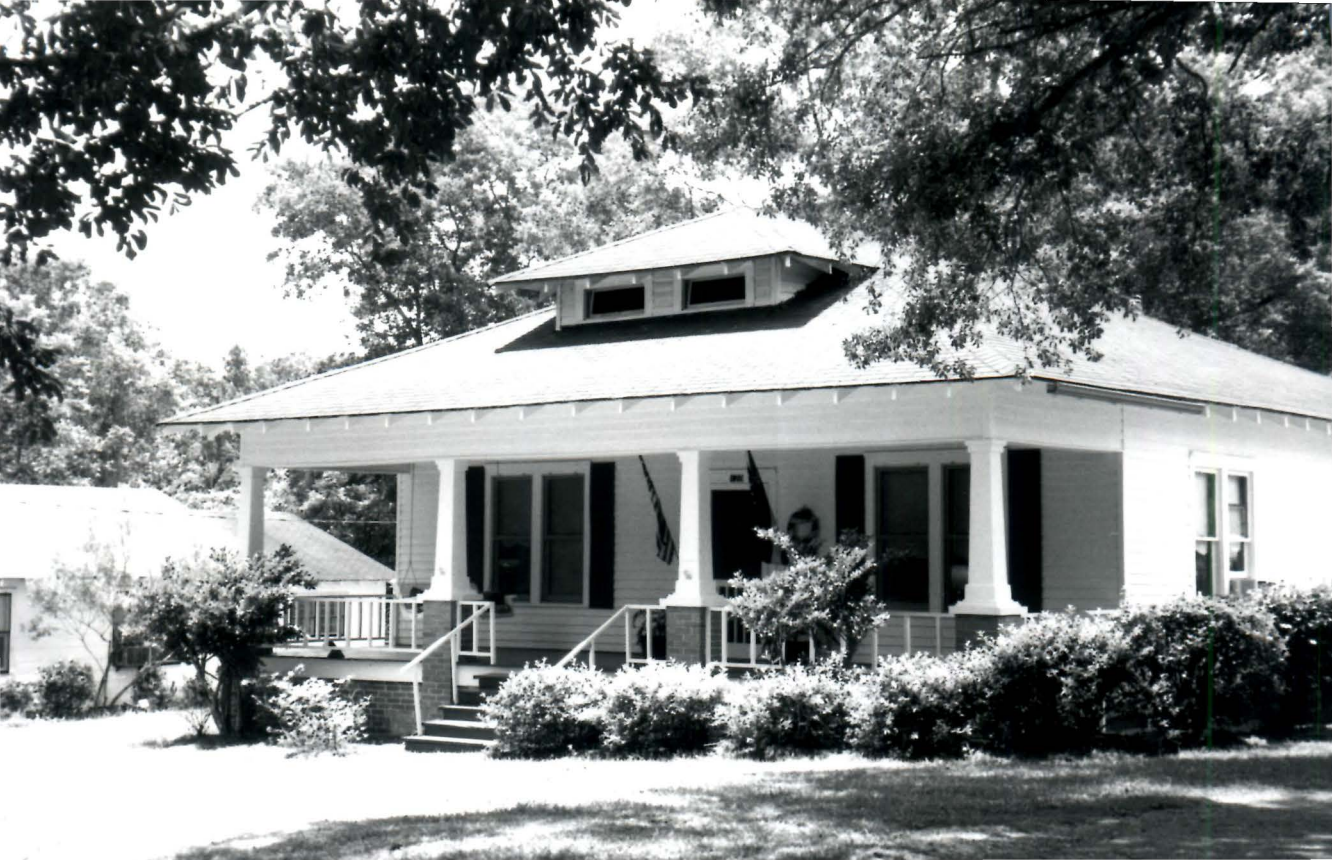
... U. King Street L 2100
Hazlehurst, Copiah Co, MS
Hazlehurst Historic District
Photo 39 of 45

- 246A. (C) 120 S. King Street c.1920 Craftsman bungalow
One-and-a-half-story, clapboard Craftsman bungalow with hipped roof of asphalt shingles and a brick-pier foundation. A hipped dormer pierces the roof at the center of the front slope and features two 1-light hopper windows. Full-width porch is undercut and rests on four battered columns atop brick piers. Facade (E) has three bays, symmetrically spaced, with a central multi-light door flanked by two paired 1/1 double-hung-sash, wood-framed windows with molded lintels. Rafters are exposed at the eaves. [PHOTO #39]

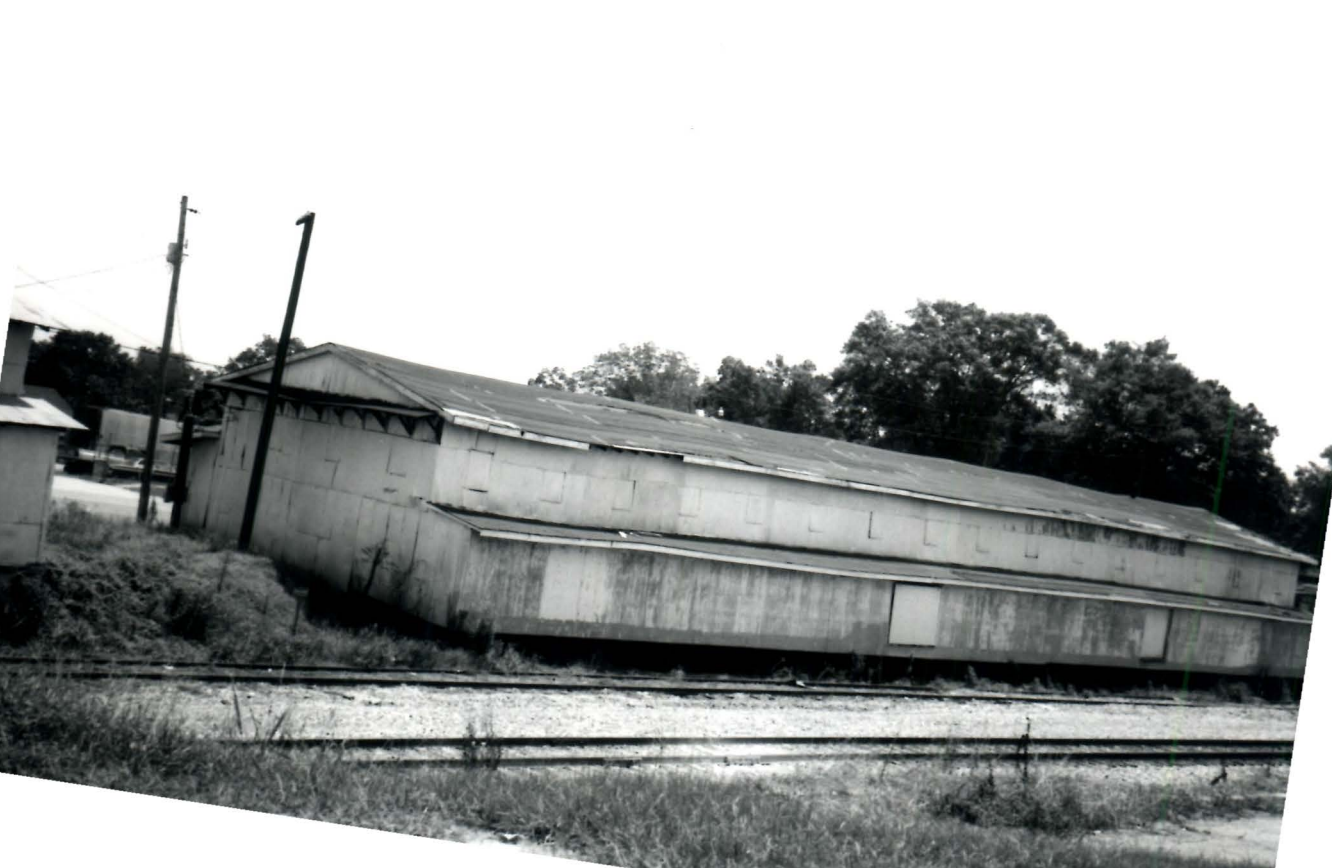
(former) tomato packing shed L-2031

263. (C) 100 block, Monticello Street, even side c.1925-30
(originally) tomato packing shed
Two-story, corrugated-metal tomato packing shed located at the northwest corner of Frost and Monticello Streets, just off the railroad tracks. A long, rectangular building with tar-papered gable roof, the lower floor has been enclosed with corrugated metal (it would originally been open). Two, shed-roofed loading porches run lengthwise along the building, parallel to both the railroad and Monticello Street. The loading porch on the east elevation (Monticello Street) remain open, while that next to the railroad has been enclosed. Rafters are exposed, and a small pent roof supported with triangular knee braces is in each gable end. [PHOTO #40]

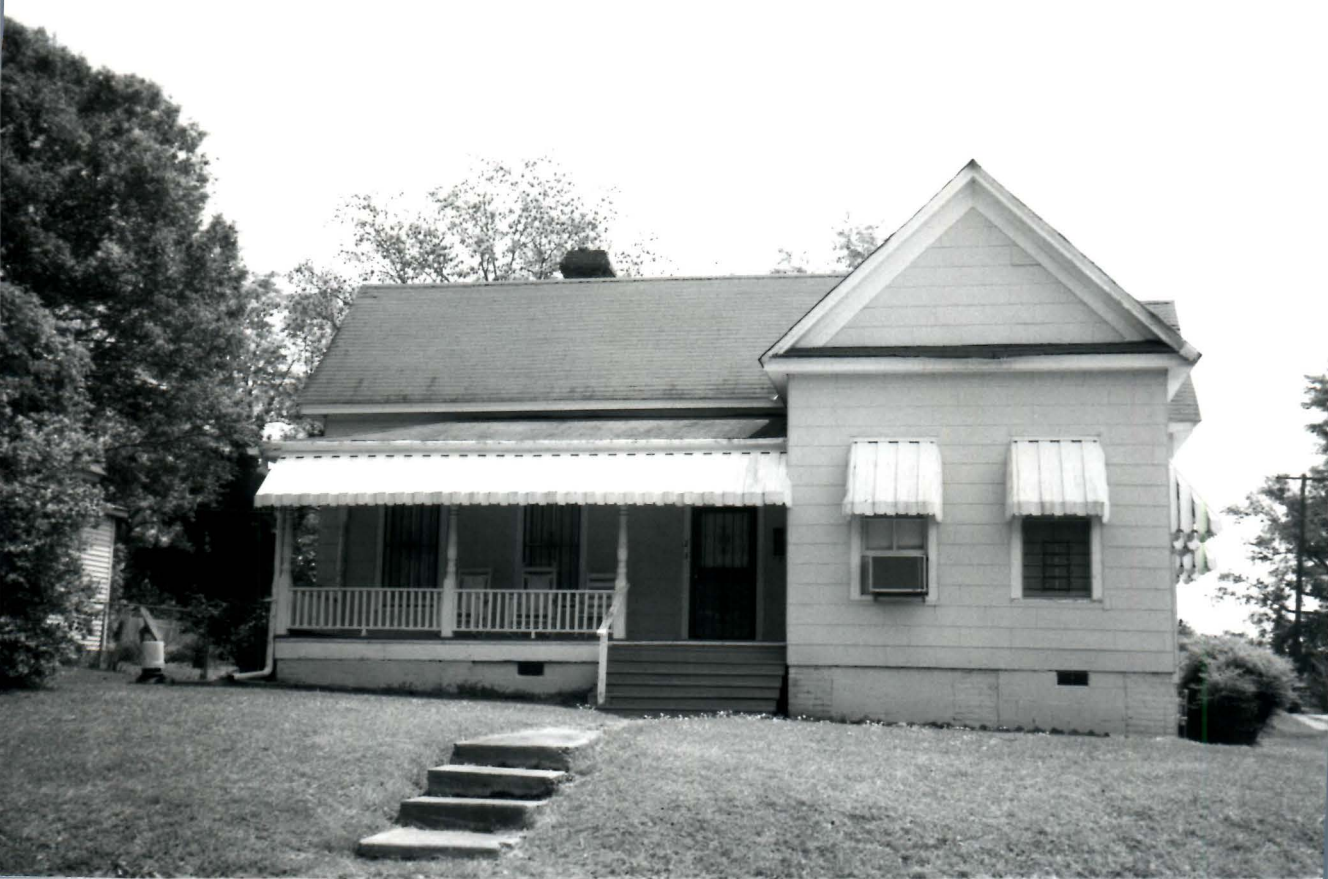
213 Monticello St. [269]

269. (C) 213 Monticello Street c.1895 L-Front cottage
One-story, asbestos-shingled, L-front cottage with cross-gabled roof of asphalt shingles and brick-pier foundation infilled with concrete block. This house is almost identical to 211 Monticello, but retains more of its original details. Facade (W) has five bays, symmetrically spaced, with two windows and a door sheltered under a hipped-roof porch and two windows in the gabled L-front. Windows are 2/2 double-hung sash in wood frames, and the door is 1-light, 3-panels. The porch is supported on three turned posts with wood balustrade. A metal awning shelters the porch and all windows. The front-facing gable is pedimented with a pent roof. A brick chimney with corbelled top is behind the gable ridge, and another is on the ridge of the L-front gable. [PHOTO #41]

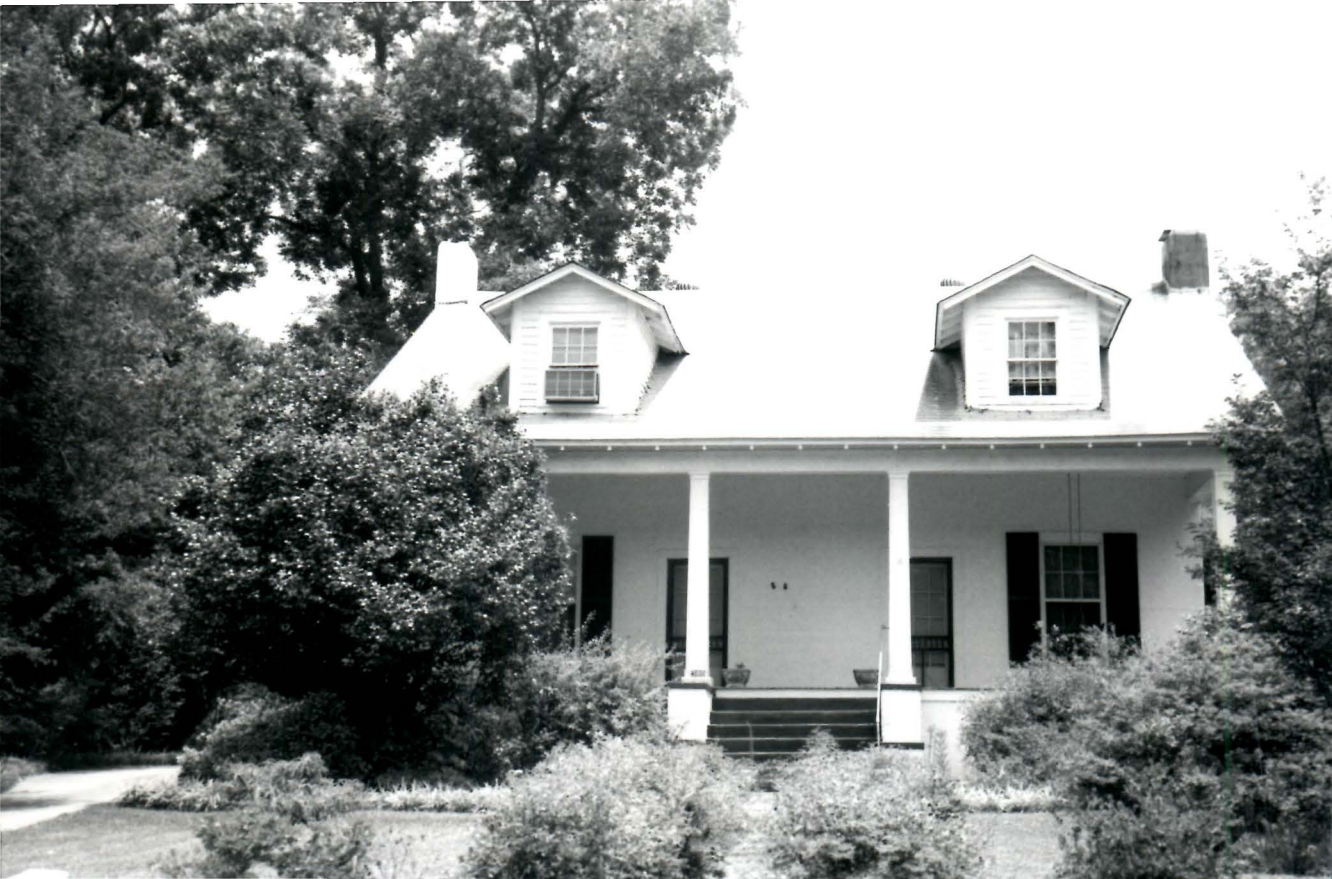
318 North Street [#278]

278. (C) 318 North Street c.1855 Galleried cottage
Green House
One-and-a-half-story, clapboard, galleried cottage with side-gabled roof of asphalt shingles and a stuccoed foundation. Two, gabled dormers (later additions) with exposed rafters and 6/6 wood-framed windows pierce the roof on the front slope. Full-width porch is undercut, with exposed rafters and simple frieze resting on four boxed, paneled, tapered columns. Facade (W) has flush siding and four symmetrical bays--two, central, 12-light doors are flanked by two 6/6 wood-framed windows with applied shutters. Two, exterior, stuccoed chimneys are at the gable ends. [PHOTO #42]

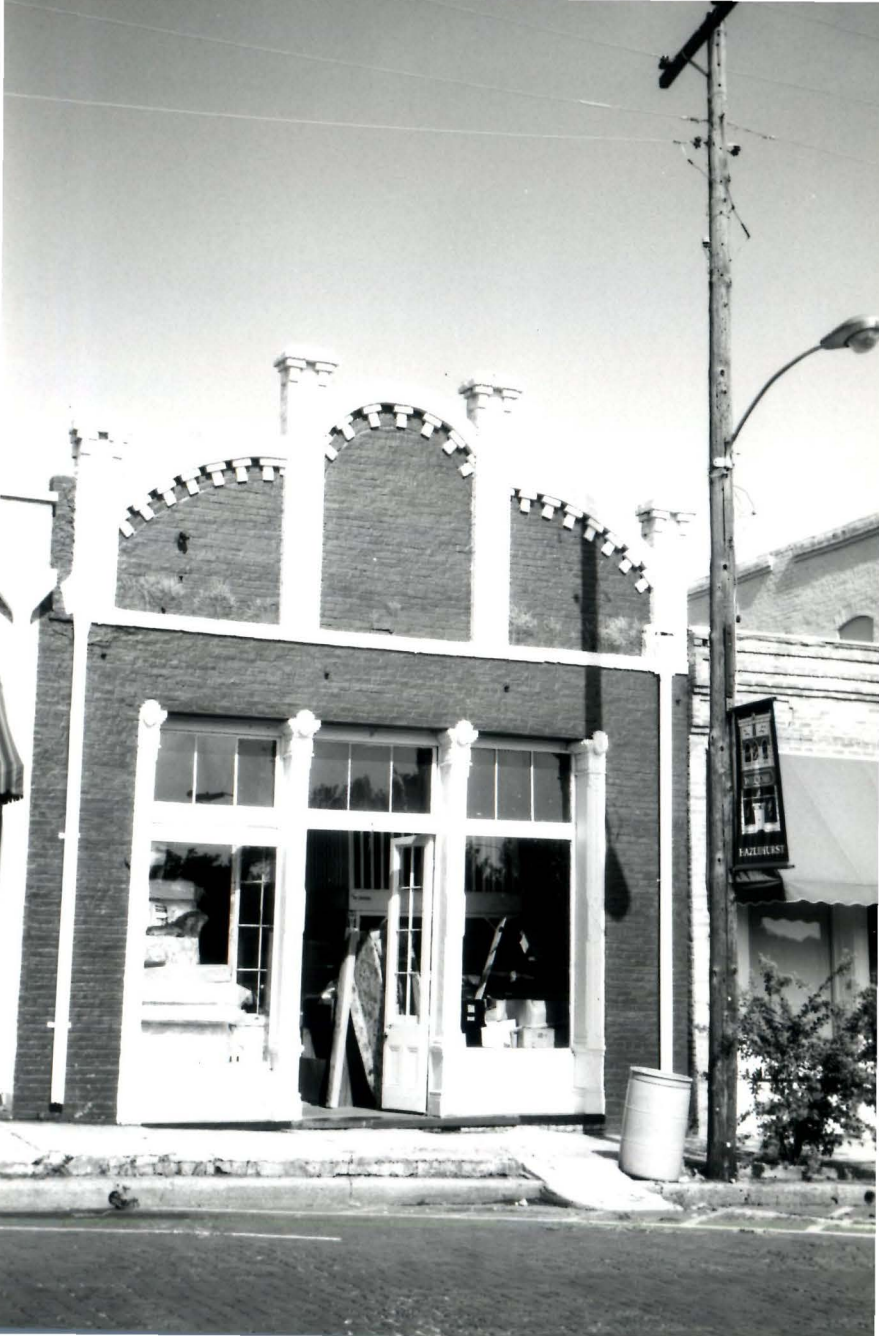
14/5? N. Ragsdale Avenue [#287]
Hist Hazlehurst Historic District
Hazlehurst, Copiah Co, MS
Photo 43 of 45

287. (C) 145? N. Ragsdale Avenue 1886
One-story, painted-brick commercial building with gabled roof behind a highly decorated false-front parapet. Parapet consists of three segmental arches divided by four brick pilasters with corbelled caps, which extend above the parapet. Oversized dentils and a two-course stringcourse complete the parapet decorations. Four ornate cast-iron pilasters with dentils at the top divide the storefront into three bays--two wood-framed storefront windows with beadboard bulkheads and 3-lights transoms flank a double-leaf, 8-light, 2-panel door with 3-light transom.
[PHOTO #43]

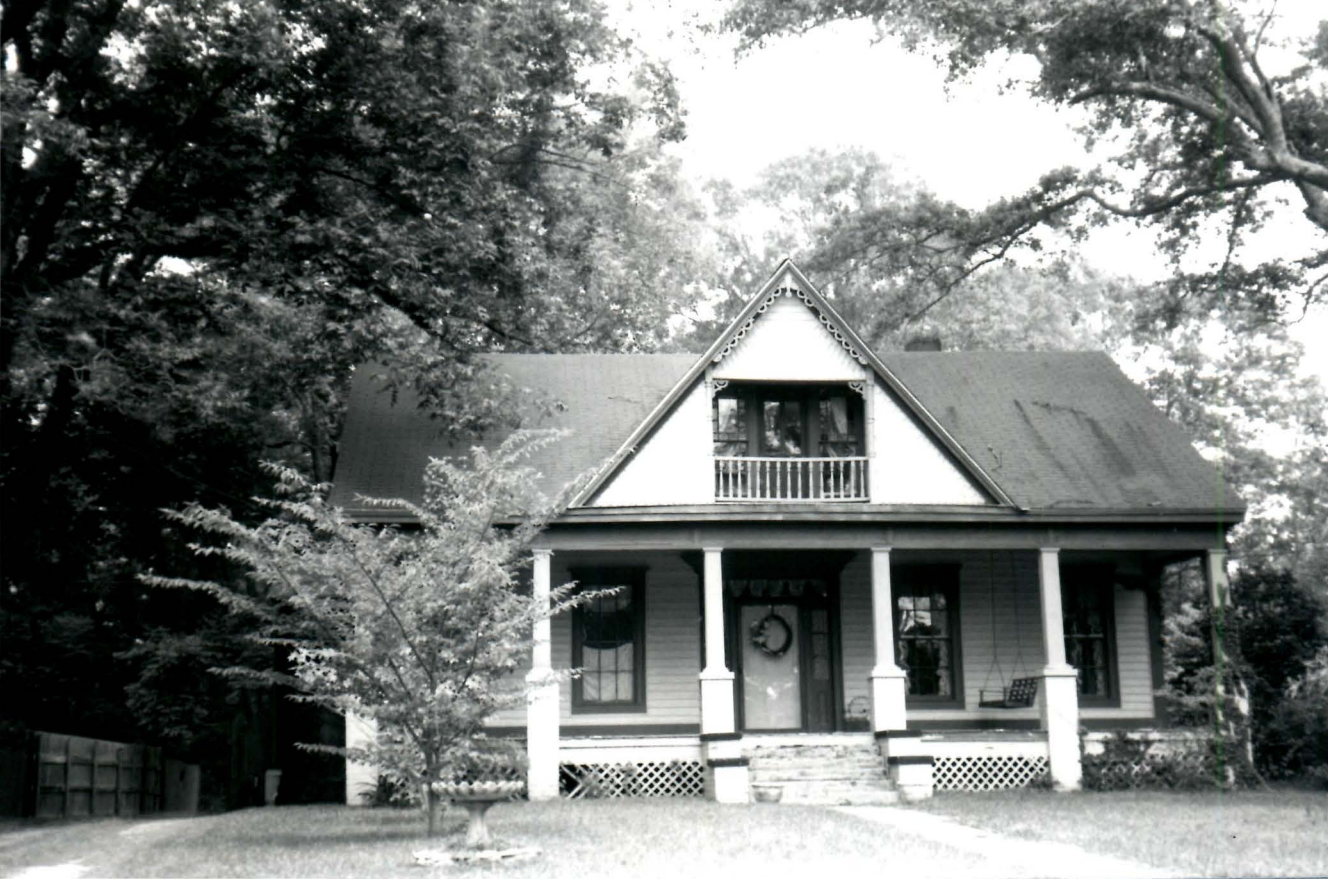
104 W. Watson Drive L# 306

306. (C) 104 Watson Drive c.1895 Galleried cottage w/Queen Anne details
One-and-a-half-story, clapboard galleried cottage with side-gabled roof of asphalt shingles and a brick-pier foundation. Queen Anne details include decorative shinglework, flat jigsaw brackets and vergeboard and turned posts and balustrade, all concentrated in the upper balcony recessed into a central, intersecting gable which dominates the facade (S). An undercut porch is full-width on the facade and was altered c.1930 from the Queen Anne style to the current Craftsman-style porch supports--the porch now rests on boxed columns atop brick piers with concrete tops. Facade has five bays, symmetrically spaced, with a central entrance flanked by four 6/6 double-hung, wood-framed windows with molded cornices. Entrance consists of a replacement 6-panel (Cross-and-Bible) door with 3-light, 1-panel sidelights and a 6-light transom and topped by a full entablature. Upper balcony consists of a 2-light, 2-panel door flanked by 1/1 wood-framed windows with art glass in the upper sashes. A stuccoed chimney is located behind the main gable ridge. [PHOTO #44]
