United States Department of the Interior  
National Park ServiceNational Register of Historic Places  
Registration Form

historic name Mill Village; South Tupelo; Mill Town  
other names/site number Mill Village Historic District

street & number roughly bounded by railroads, Chestnut & Green not for publication N/A  
city, town Tupelo N/A vicinity  
state Mississippi code MS county Lee code 081 zip code 38801

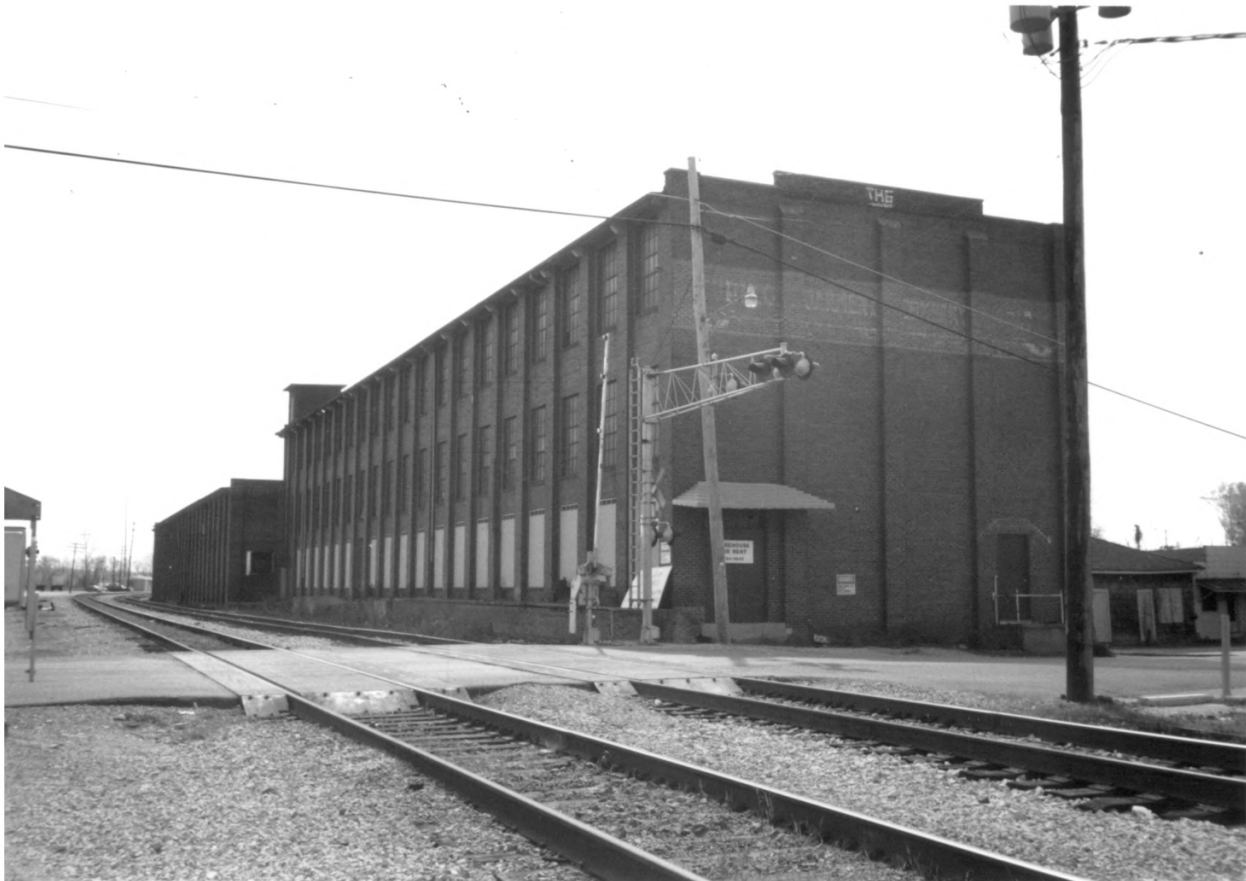
The Tupelo Garment Company  
Mill Village Historic District  
Tupelo, <sup>MS</sup> Mississippi

This factory appears to be mostly vacant, but at least part of it is used for storage. This building that formerly housed a shirt factory is comprised of a long, rectangular, two story section and a somewhat shorter, three story section. Of brick construction, this 42 by 2 bay building is capped by a flat roof hidden by stepped parapets. In the northeast corner of the three story section, the roof is pierced by a small tower. The building's elevations display brick piers interspaced with openings, generally multi-light windows or boarded up windows.

The building is situated on a sliver of land located between the Burlington-Northern Railroad and Bluebell Alley. It overshadows the small houses just south of it.

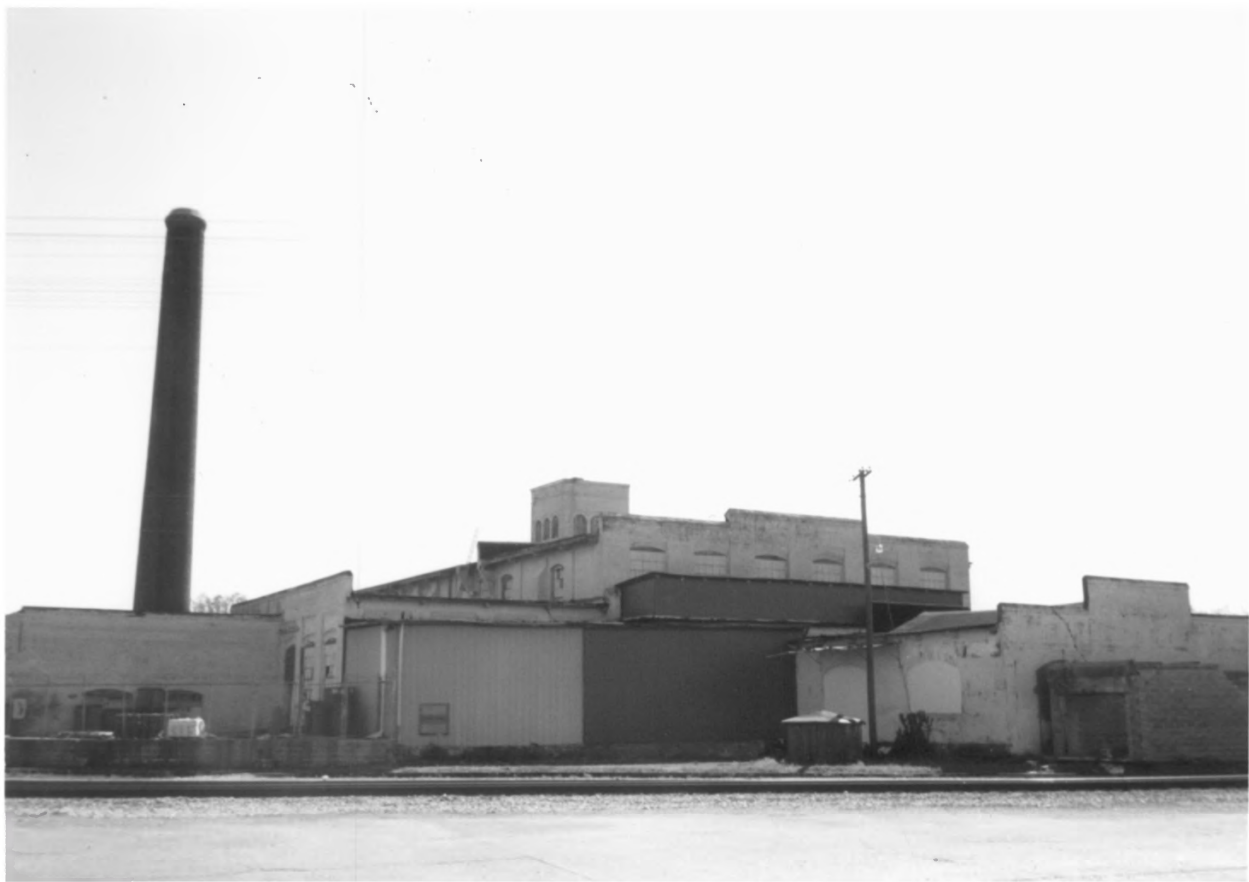
Tupelo Cotton Mill #1  
Mill Village Historic District  
Tupelo, <sup>MS</sup> Mississippi  
Susan Enzweiler  
March 30, 1991  
MS Dept of Archives + History  
View to South  
# 2 of 43

This former cotton mill now serves as an office and a warehouse for a wholesale company. It is a two story, 22 by 6 bay, rectangular, brick building with a 12 by 3 bay, brick addition that was built onto its south elevation in 1919. There are several historic and post-historic additions on its north elevation, but the original configuration of the mill is still readily apparent.

The original section of the mill has segmental arched, multi-light windows and, on the west elevation, a square, four story water tower displaying brick corbelling, beltcourses and triads of round-arched windows. On the north side of the water tower is a two story, block addition with a metal frame door and modern, metal sash windows which punctuate the bricked up areas where the large, original windows once were. On the east elevation of the mill, near its north end, is an original, one story wing with large, multi-light windows capped by segmental arches of corbelled brick. These windows are set in slightly recessed areas and interspaced with piers.

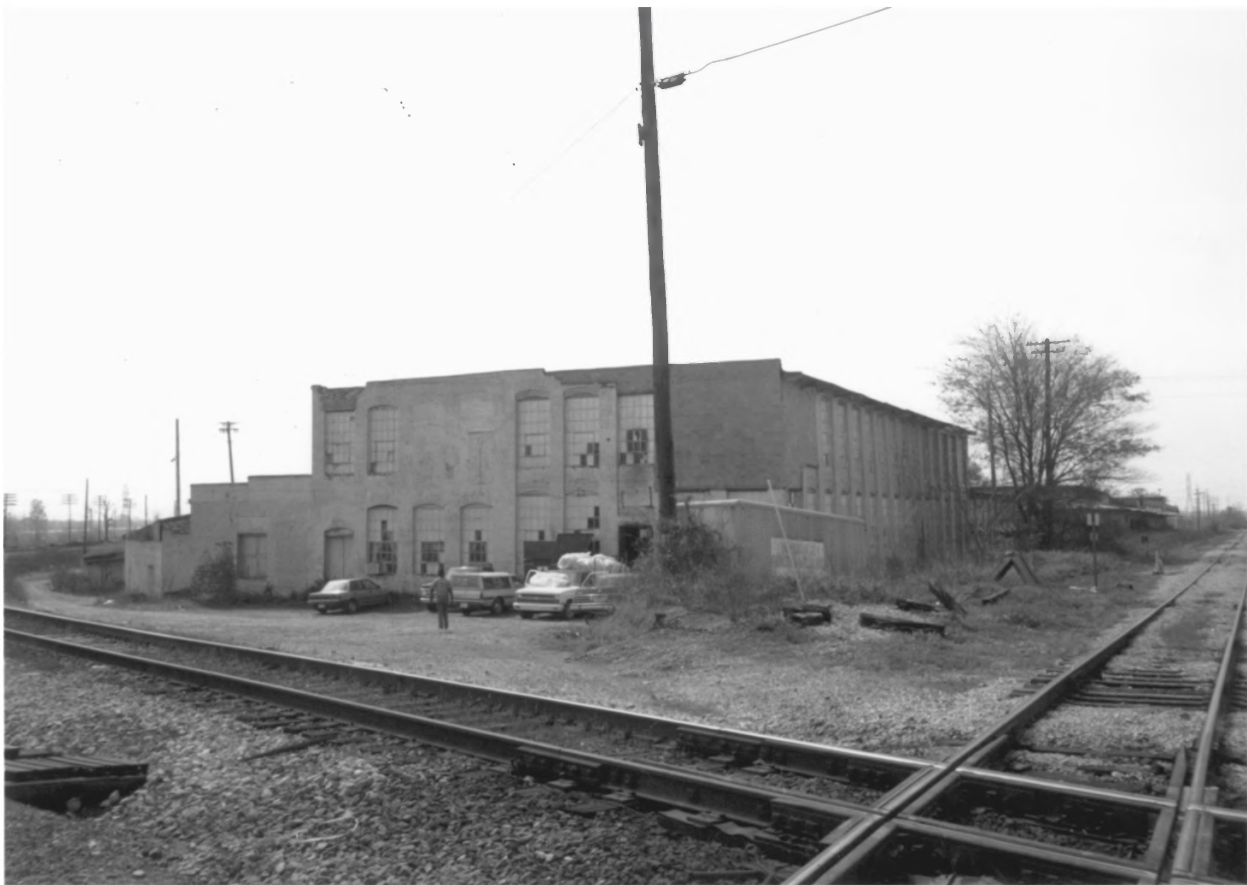
Tupelo Cotton mill #2  
Mill Village Historic District  
Tupelo, <sup>MS</sup> Mississippi  
Susan Enzweiler  
April 15, 1991  
MS Dept of Archives + History  
View to Southeast  
#4 of 43

This two story, 11 by 23 bay, brick building is somewhat C-shaped due to its many historic additions. The northern section of the original building has large, multi-light windows with corbelled segmental arches. On its northwest corner, the building has been "patched up" with concrete block. The southern section of the original building has large, multi-light windows. The east (side) elevation has several additions and a square, two story tower. The northernmost of these additions are badly deteriorated; their rear walls are missing. Some windows have been boarded up. The mill has a flat roof.

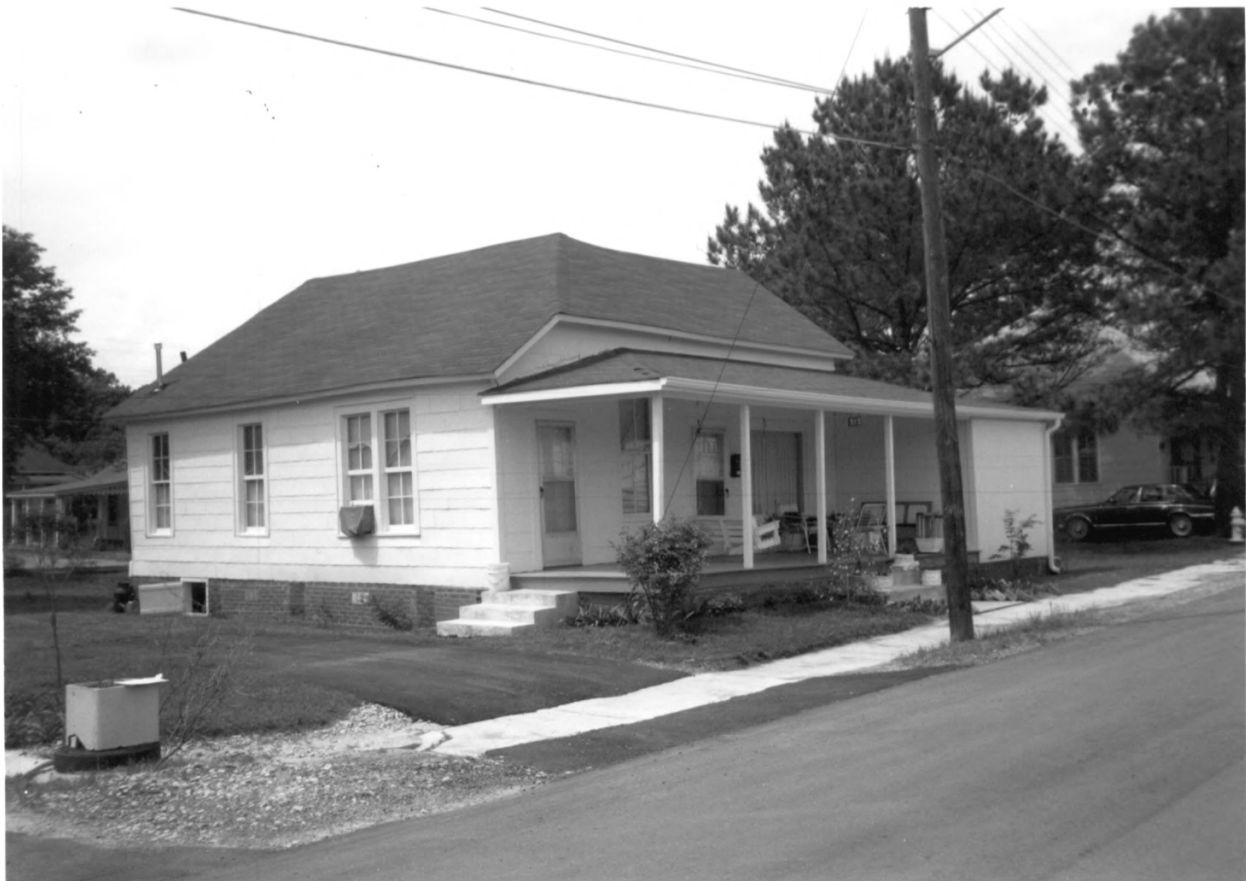
Eliza Robins Club Room  
Mill Village Historic District  
Tupelo, <sup>MS</sup> Mississippi

5. NC 512 Broadway Eliza Robins Club Room  
Now serving as a residence, this one story, frame building is clad in composite board. Part of its front porch is enclosed and it also has some new windows. The building originally had a wraparound front porch and served as a clubhouse until at least 1924. By 1929, it was a dwelling and retained its wraparound porch. Since then, the building has been extensively altered. Built between 1914 and 1919.

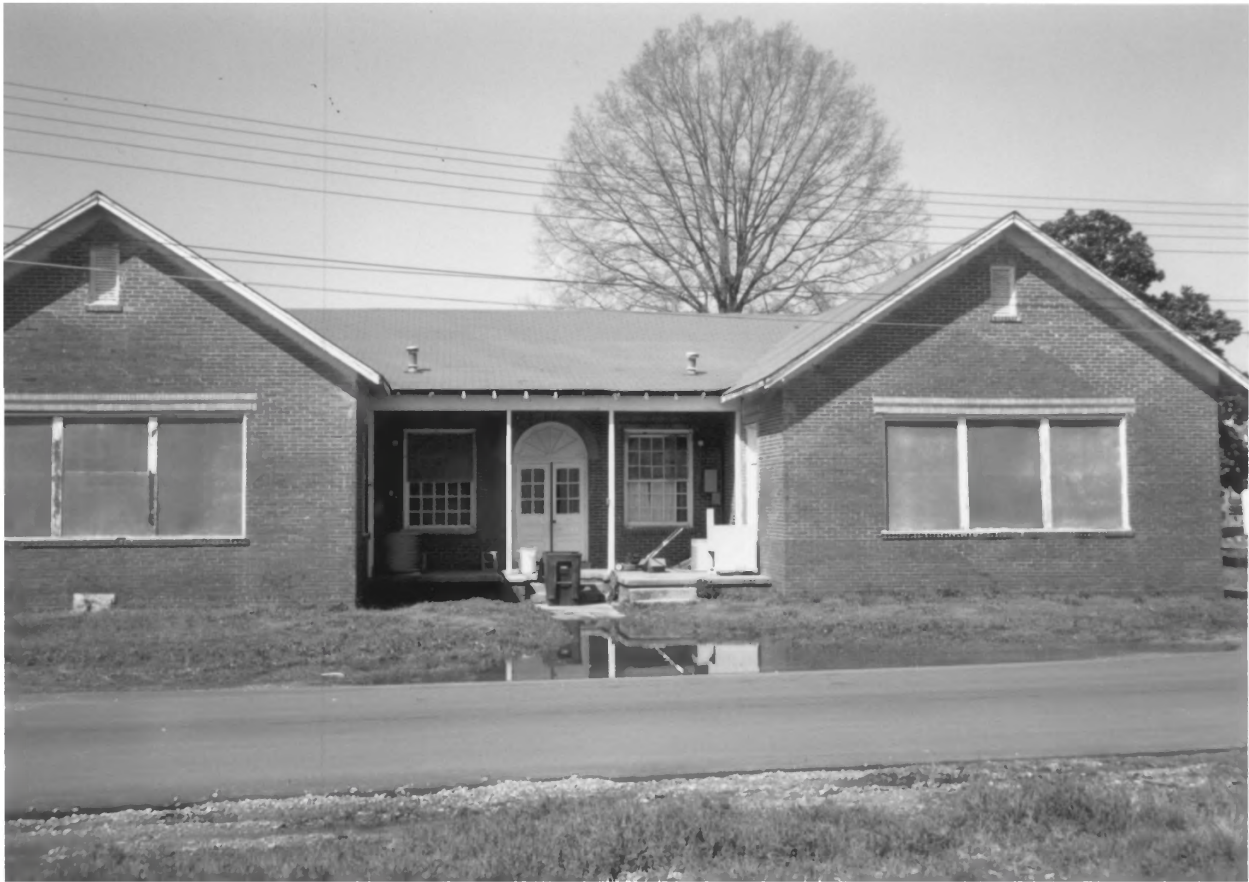
South Tupelo Public School / Ledyard School  
Mill Village Historic District  
Tupelo, <sup>MRA</sup> Mississippi

6. C 1st building south of 512 Broadway South Tupelo Public School/Ledyard School  
Crowned by a hip roof, this one story, brick school has a front facade with a recessed porch flanked by brick wings. In the porch area is a double-leaf entrance flanked by multi-light windows. The other windows are boarded up. Now used for storage, this school was constructed between 1919 and 1924 and served as an educational facility for the first four grades until at least 1940. A breezeway connecting the rear elevation of this building to the rear elevation of the church on Maple Street was constructed after the period of significance.

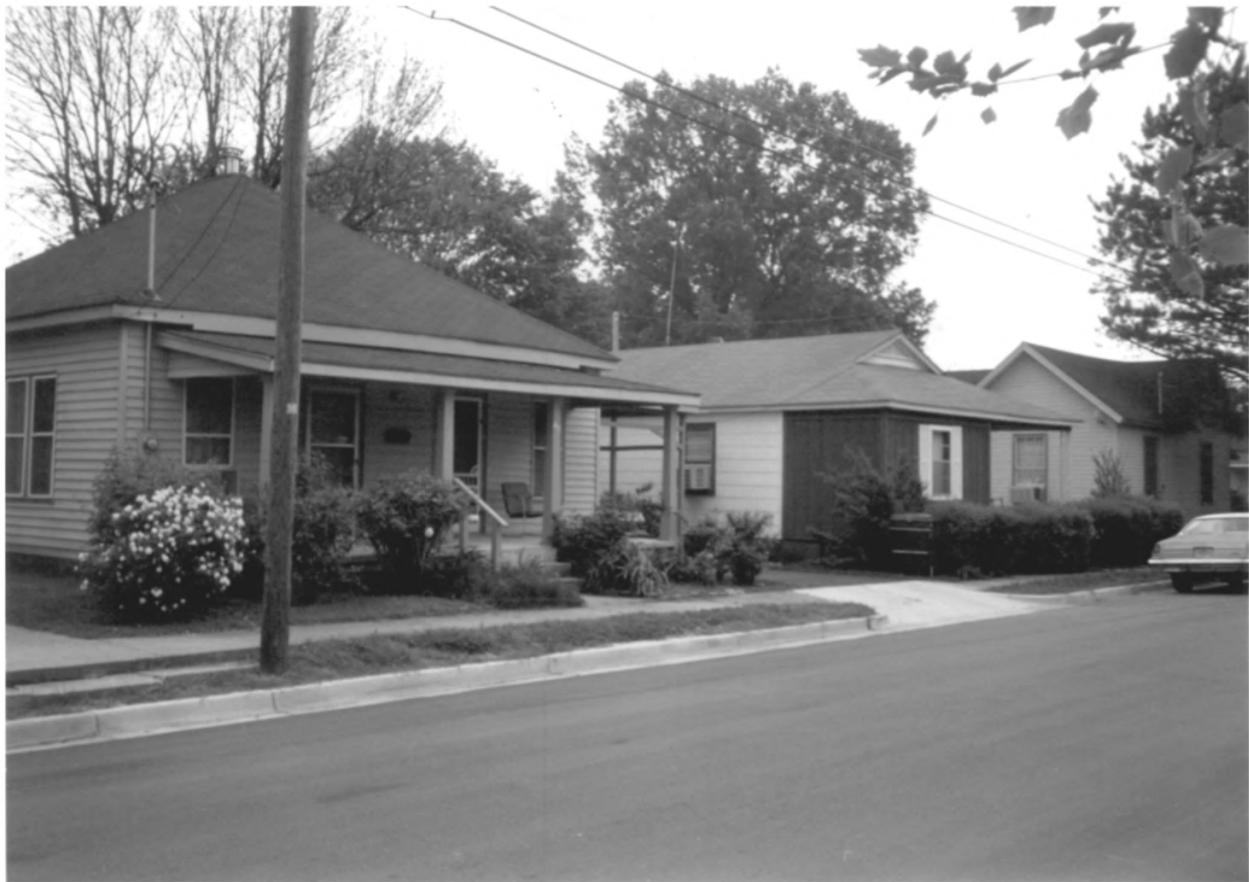
418, 414 Chestnut St.  
Mill Village Historic District  
Tupelo, <sup>MS</sup> Mississippi,  
Susan Enzweiler

13. NC 414 Chestnut  
This small, frame cottage with its gable-on-hip roof has been extensively altered. It is covered in vertical planking and composite board and also displays new sash windows. Half of its integral front porch is enclosed in siding and the open section has a wrought iron post. There is also a rear addition. Built c. 1935.

14. C 418 Chestnut  
Covered in aluminum siding, this one story, square cube is crowned by a steeply pitched hip roof. The front porch has wooden pillars supporting a shed roof. In the porch area are two entrances flanked by 4/4 double hung sash windows. Most of the windows are single or paired 4/4. On the east elevation is a new carport. There is also a rear addition. Built between 1919 and 1924.
