**National Register of Historic Places
Inventory—Nomination Form**

historic Richland

RICHLAND

Church Hill, Jefferson County, Mississippi

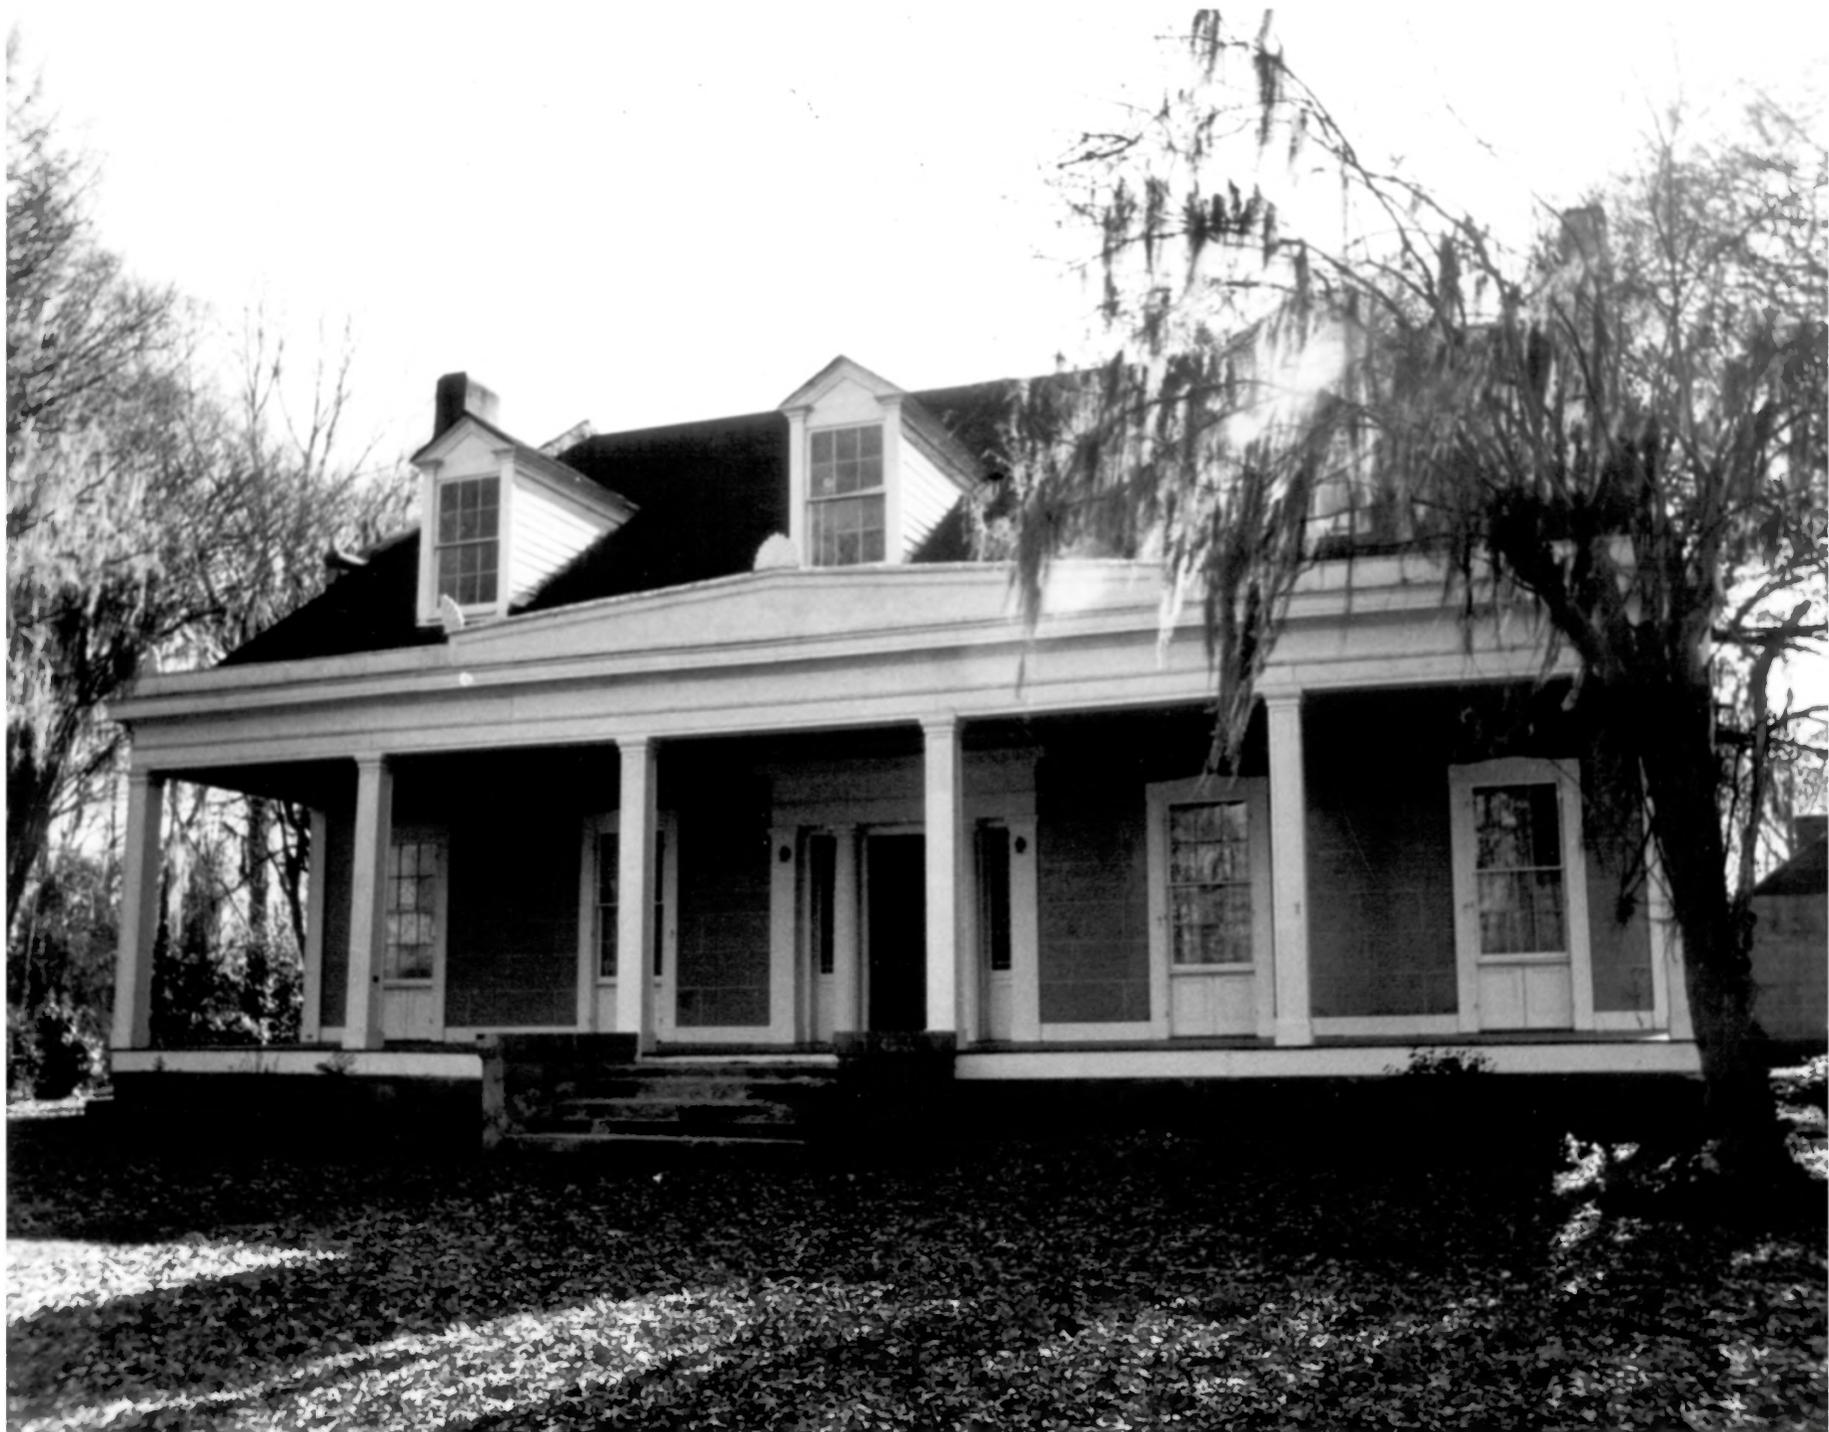
Photo 1 of 5

Looking southeasterly, the northerly
facade of Richland.

Entered by a gravel driveway off the southerly side of State Highway 553, about one mile northwest of its intersection with the Natchez Trace Parkway, Richland is a story-and-a-half, brick, Greek Revival plantation residence. Three gabled and pilastered dormers pierce the front and rear slopes of the gabled roof, which features parapet gable ends, each with three, inside-end chimneys. The northerly facade is fronted by a gallery supported by paneled and molded box columns that support a full, molded entablature embellished with a molded cresting with acroteria. The columns were originally linked by a wooden railing, now missing, but possibly featuring a regionally popular sheaf-of-wheat design, which is employed at Roseland, a Condordia Parish, Louisiana, plantation house that is a near twin to Richland. The five-bay facade is stuccoed and scored in imitation of stone and is finished with an unmolded base. Access to the interior is provided through a center-bay doorway and flanking jib windows filled with six-over-six, double-hung sash atop molded-panel jib doors. The windows are trimmed with peaked, molded surrounds with corner blocks and are closed by original shutter blinds (removed for repairs when exterior photographs were taken). The entrance frontispiece consists of a full molded entablature supported by fluted Doric columns and paneled pilasters enclosing a single-leaf, molded two-panel door and sidelights with rectilinear molding set over molded panels.

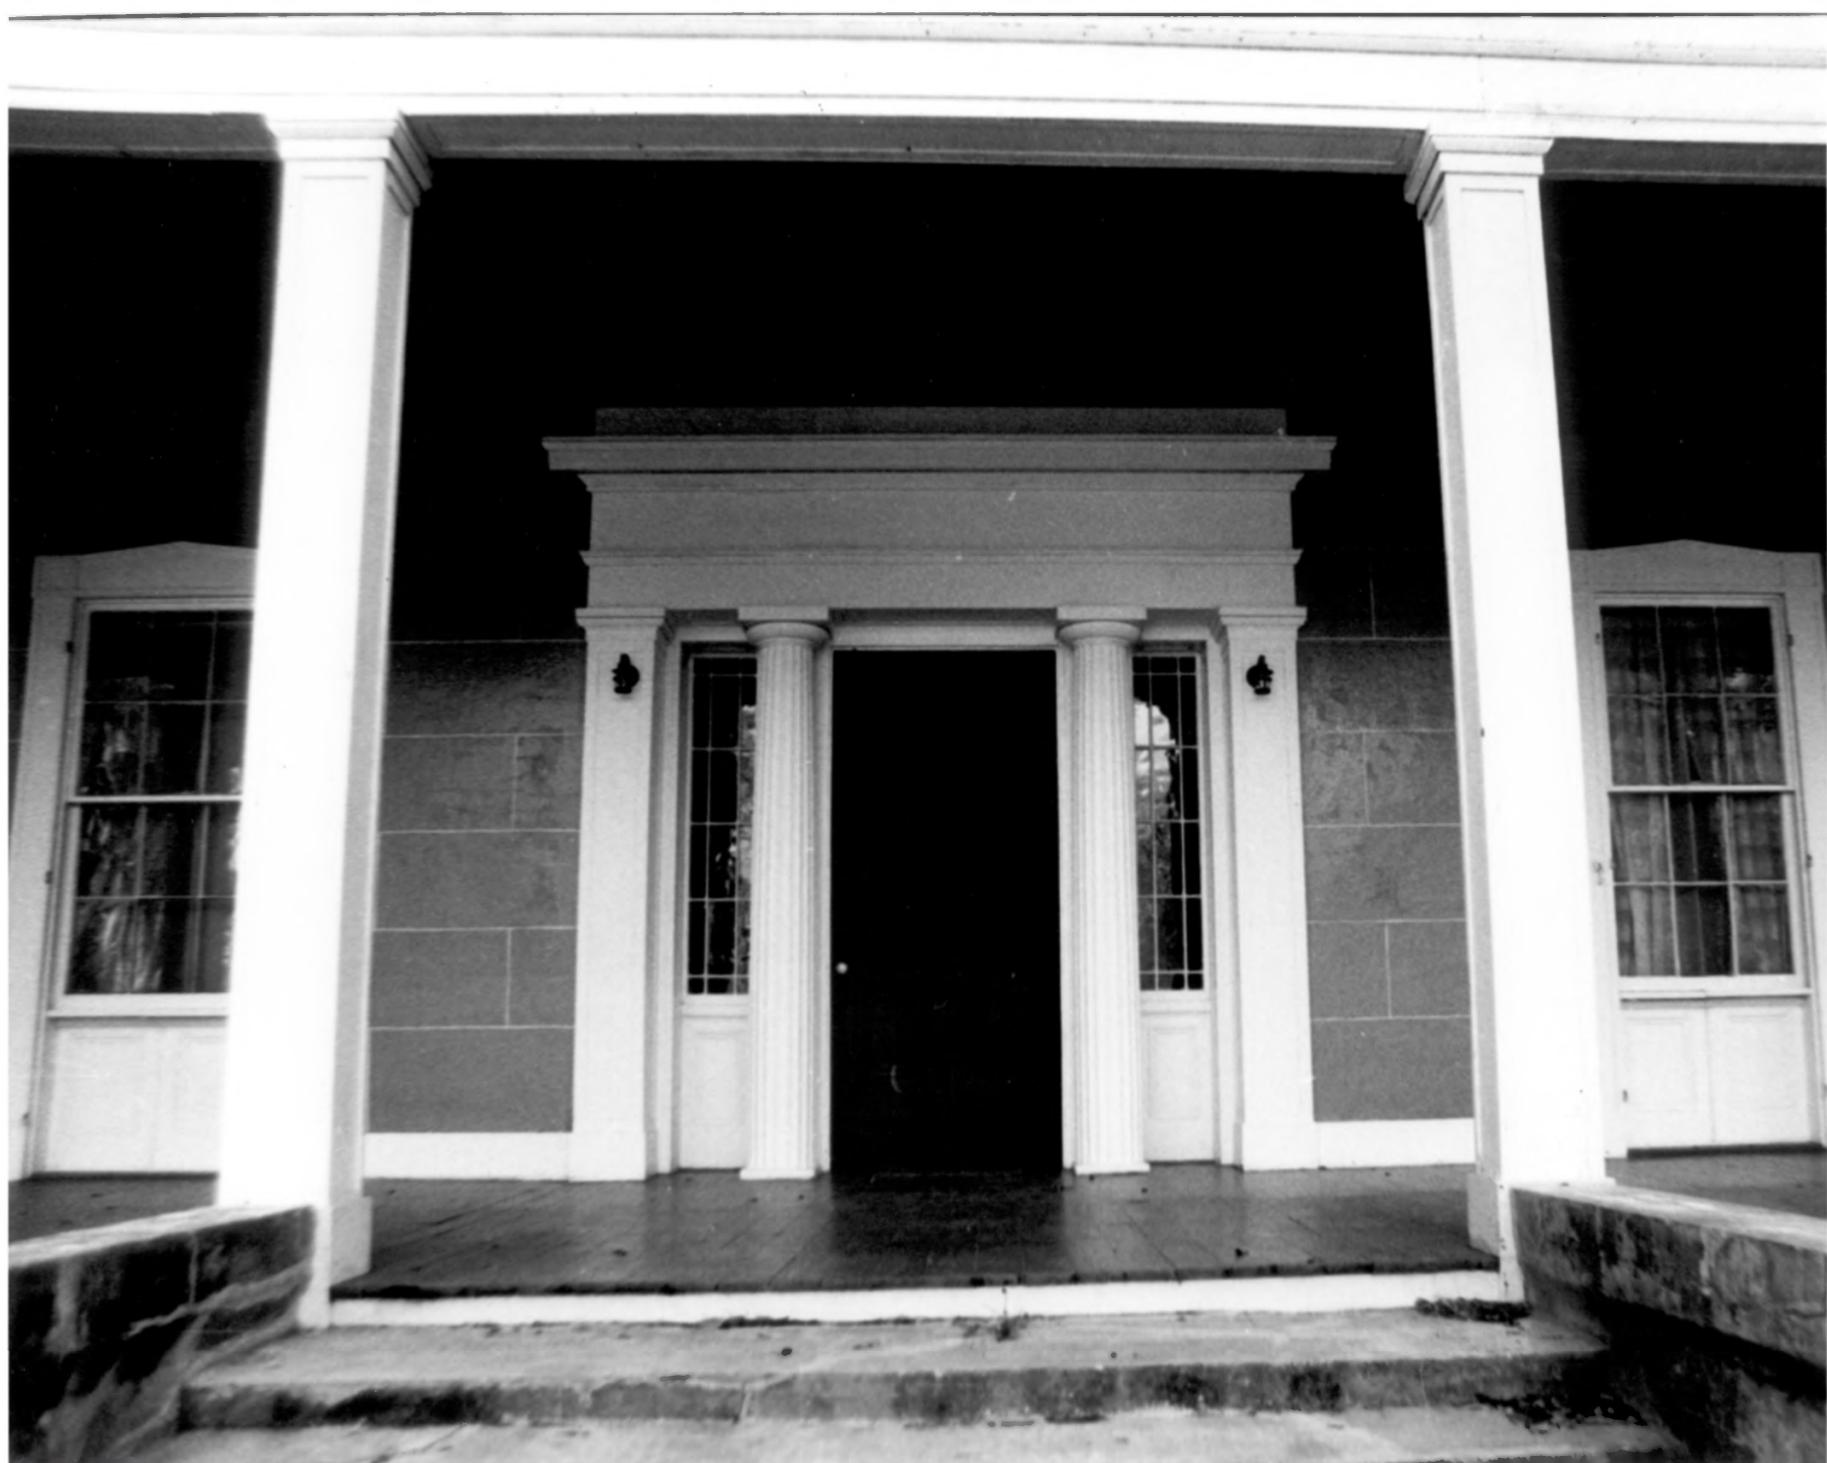
Photo 2 of 5

Looking southerly, the entrance frontis-
piece of Richland.

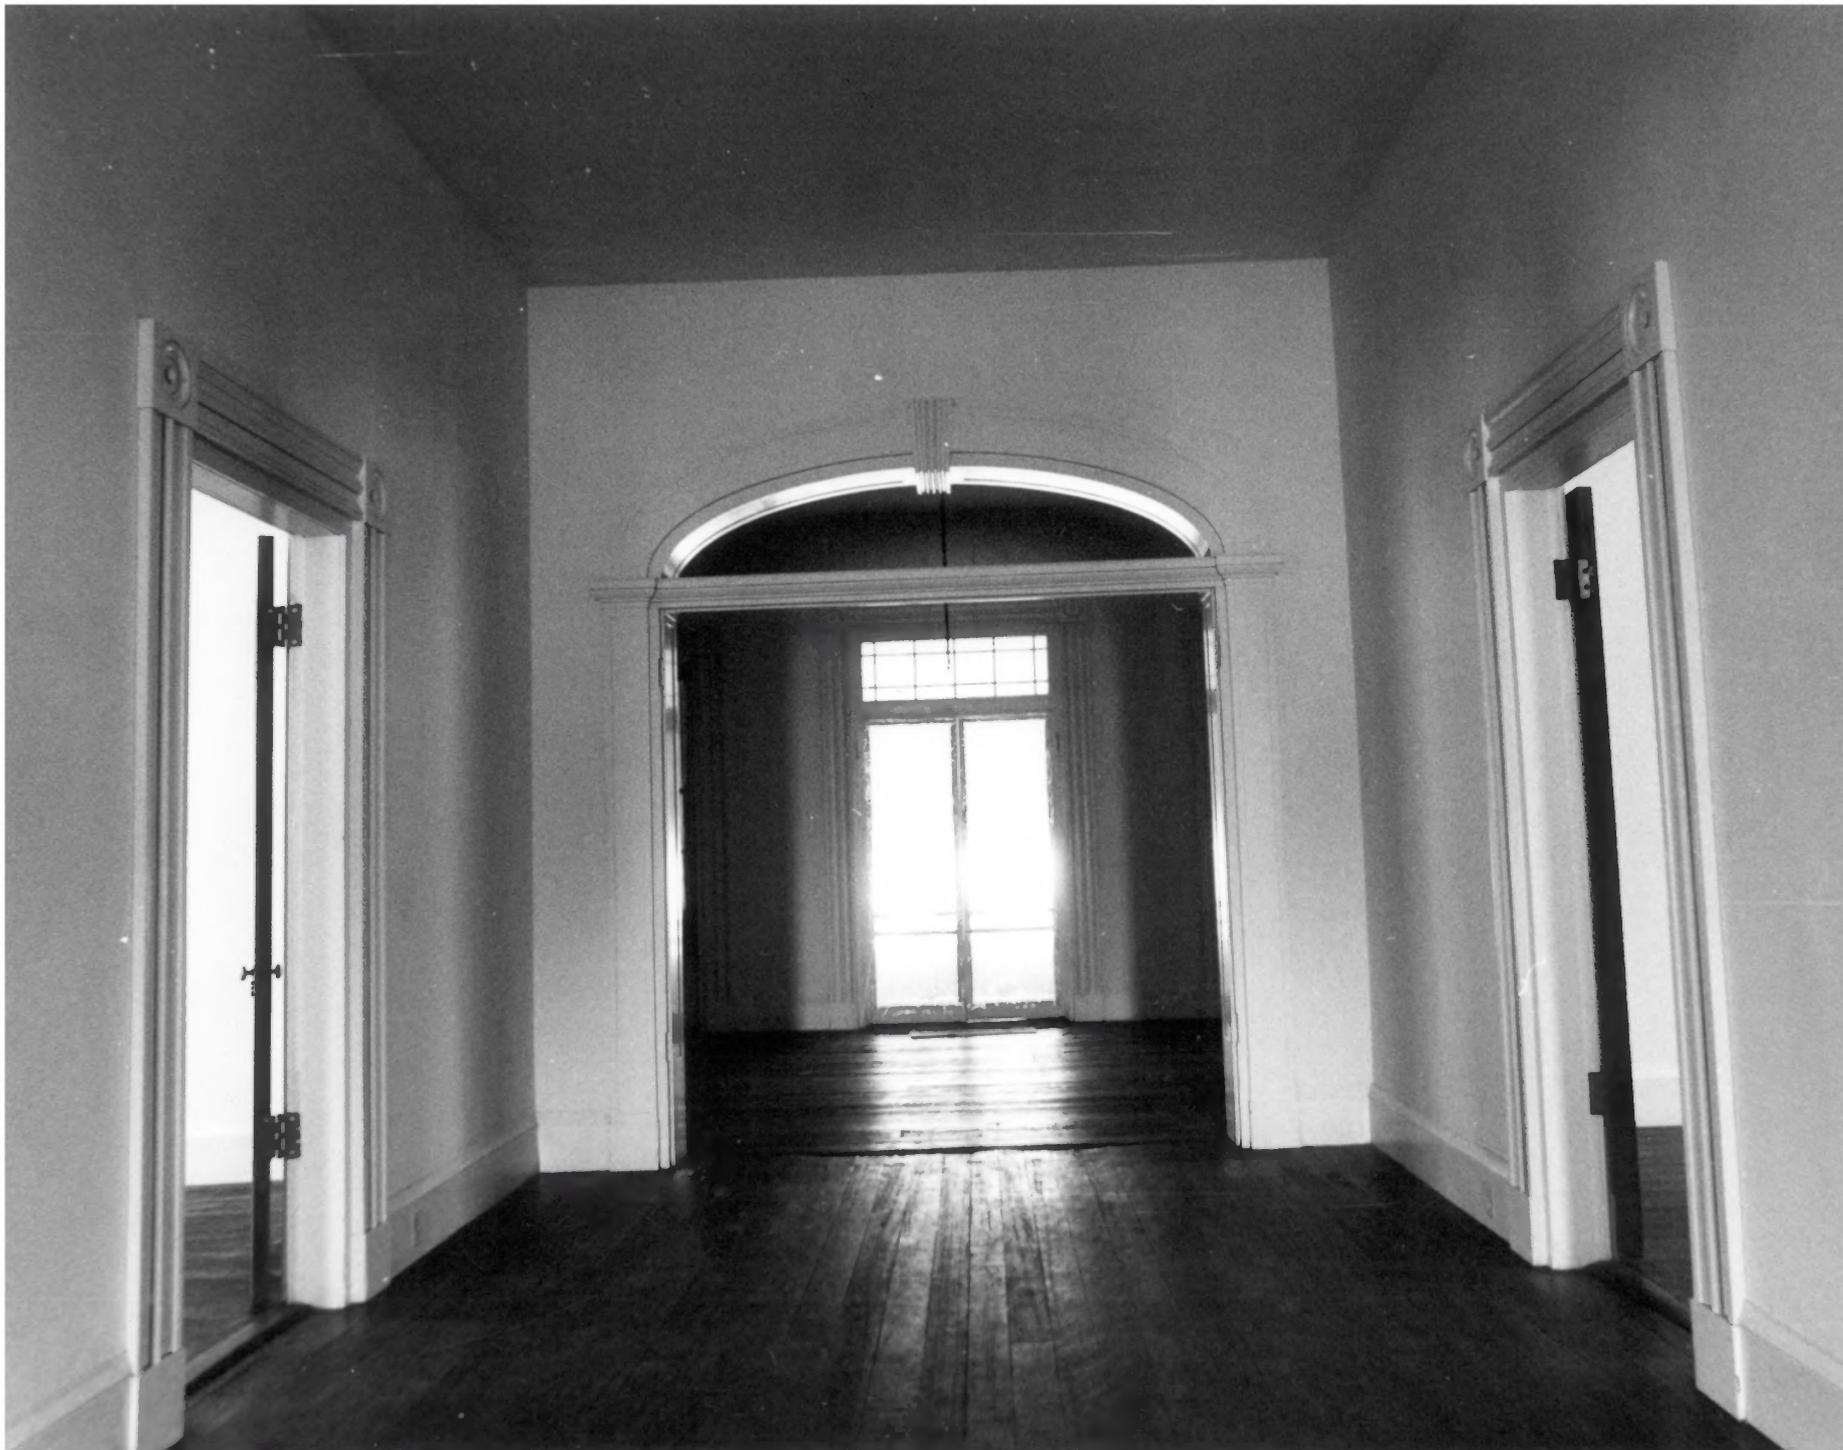
Photo 3 of 5

Looking southerly, the main hallway of
Richland.

The interior floor plan is a double-pile plan with central passage with two additional ranges of rooms to the rear. The first range of rooms features a large central room that contains the stairway to the second story and is flanked by smaller rooms, or "cabinets." The second range, added ca. 1860, echoes the first range with a porch, enclosed in the mid-twentieth century, flanked by "cabinet" rooms. The interior door and window trim of the first story has symmetrical molding with corner blocks, windows with flared jambs set over molded panels, doors with two molded panels, and molded bases with a single fascia. Sliding doors divide the double parlors on the westerly side of the main passage and a keystone arched doorway with hinged doors (removed for repairs when photographs were taken) separate the main passage from the stairway room to the rear. Ornamental plaster work is limited to a hallway centerpiece with unusual ears of corn.

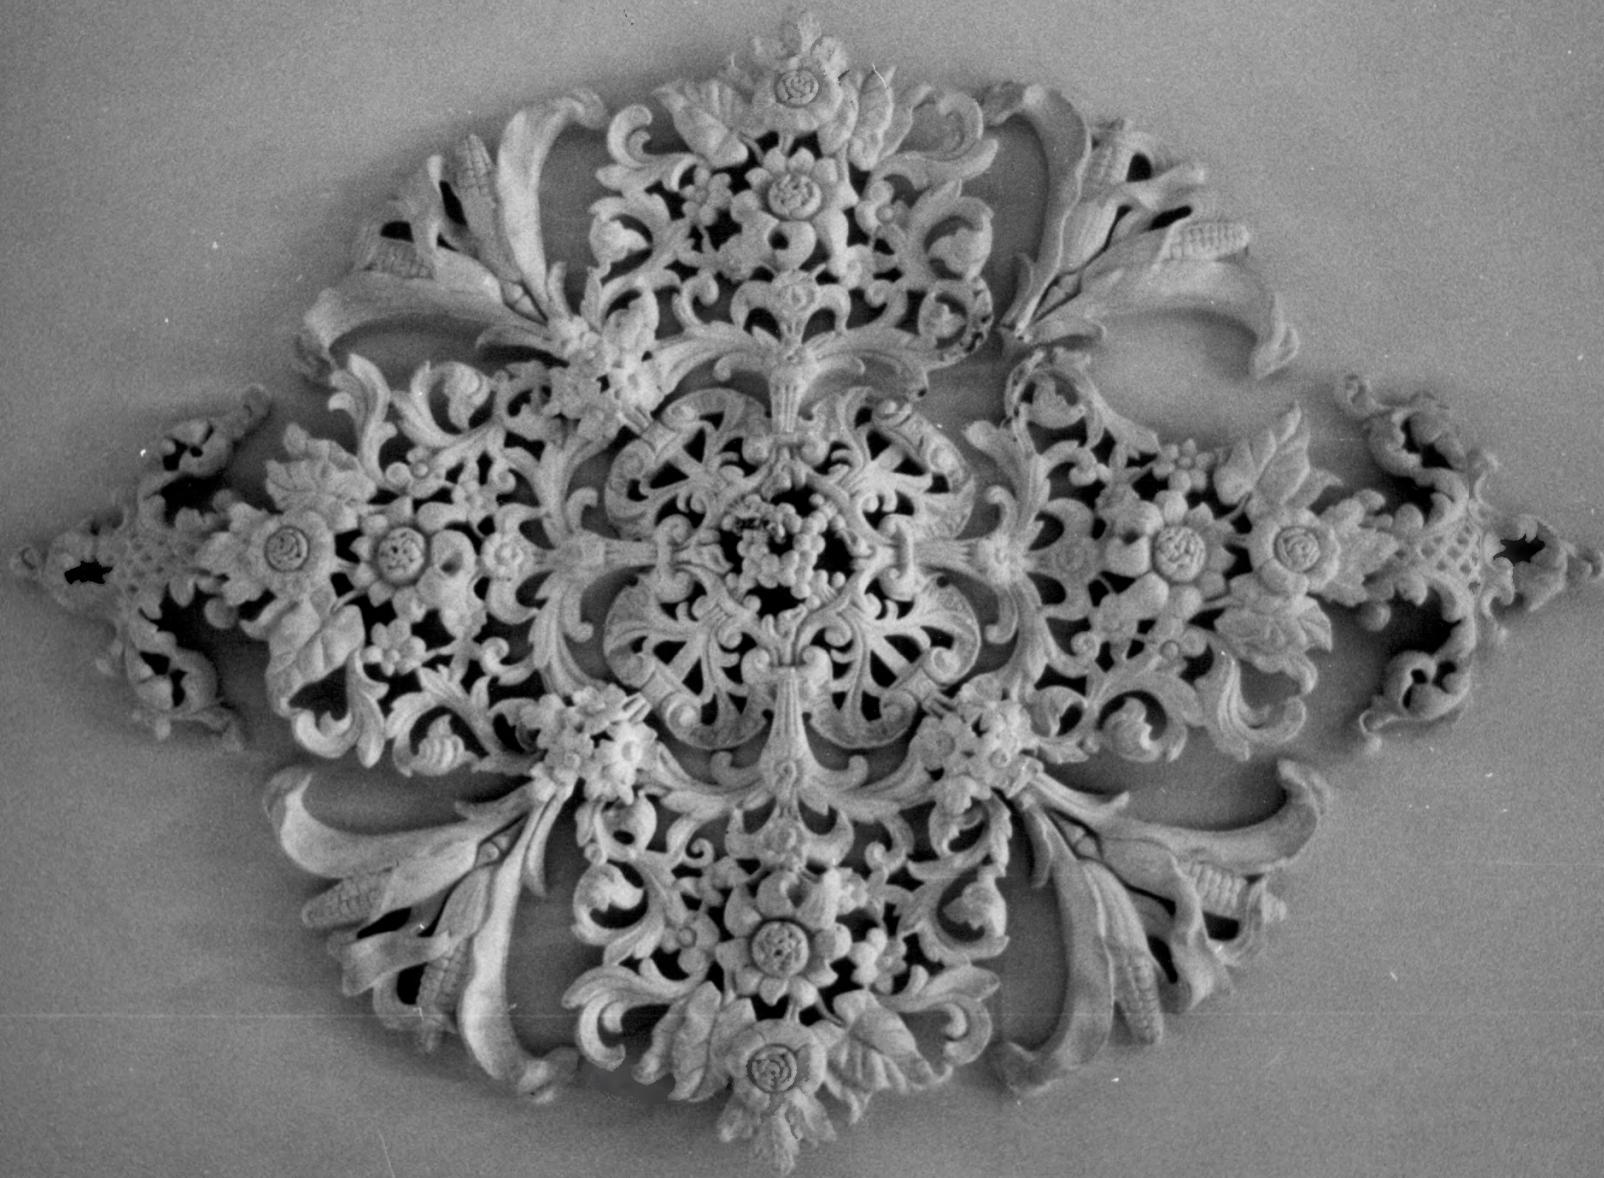
Photo 4 of 5

Looking skyward, the plaster centerpiece
of the main hallway of Richland.

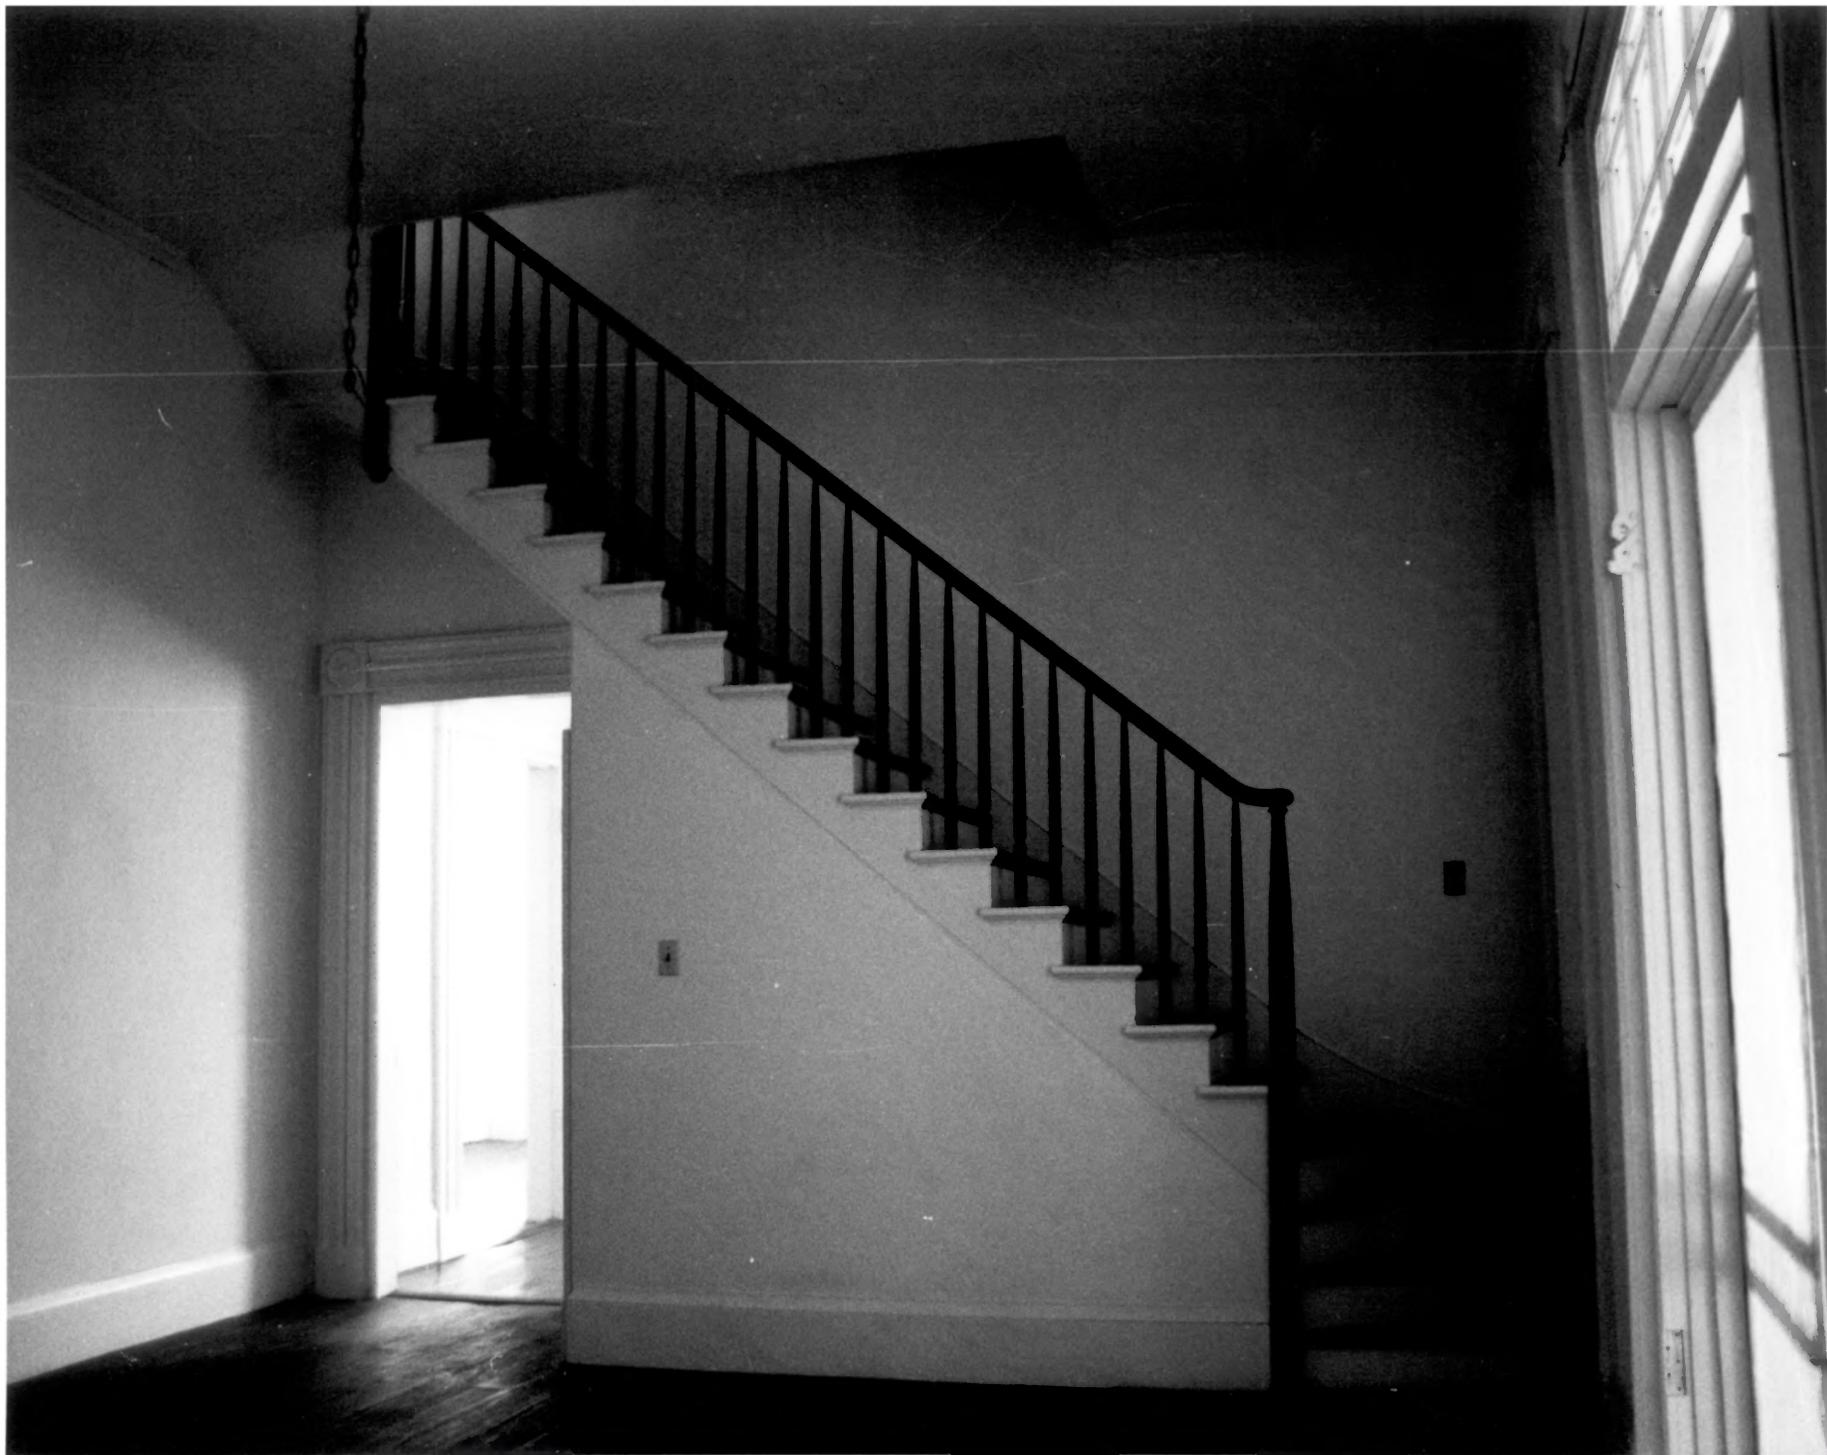
Photo 5 of 5

Looking easterly, the stairway in the
back hallway room of Richland.

The stairway to the second story, which has turned newels and balusters, runs along the eastern wall of the stairway room in a northerly direction and begins and ends with winders making quarter turns. The second-story rooms and hallway are more plainly trimmed with architrave door and window surrounds, molded doors, beaded bases, and wooden pilastered mantel pieces. The house also features a basement accessed by an interior stairway that runs beneath the stairway to the second story and also by exterior steps on the easterly side elevation of the house. An unusual feature of the basement is an original cistern. The architectural integrity of Richland is outstanding and includes the survival of original oak-grained millwork.
