**NATIONAL REGISTER OF HISTORIC PLACES
INVENTORY -- NOMINATION FORM**

Harris-Banks House

White Arches

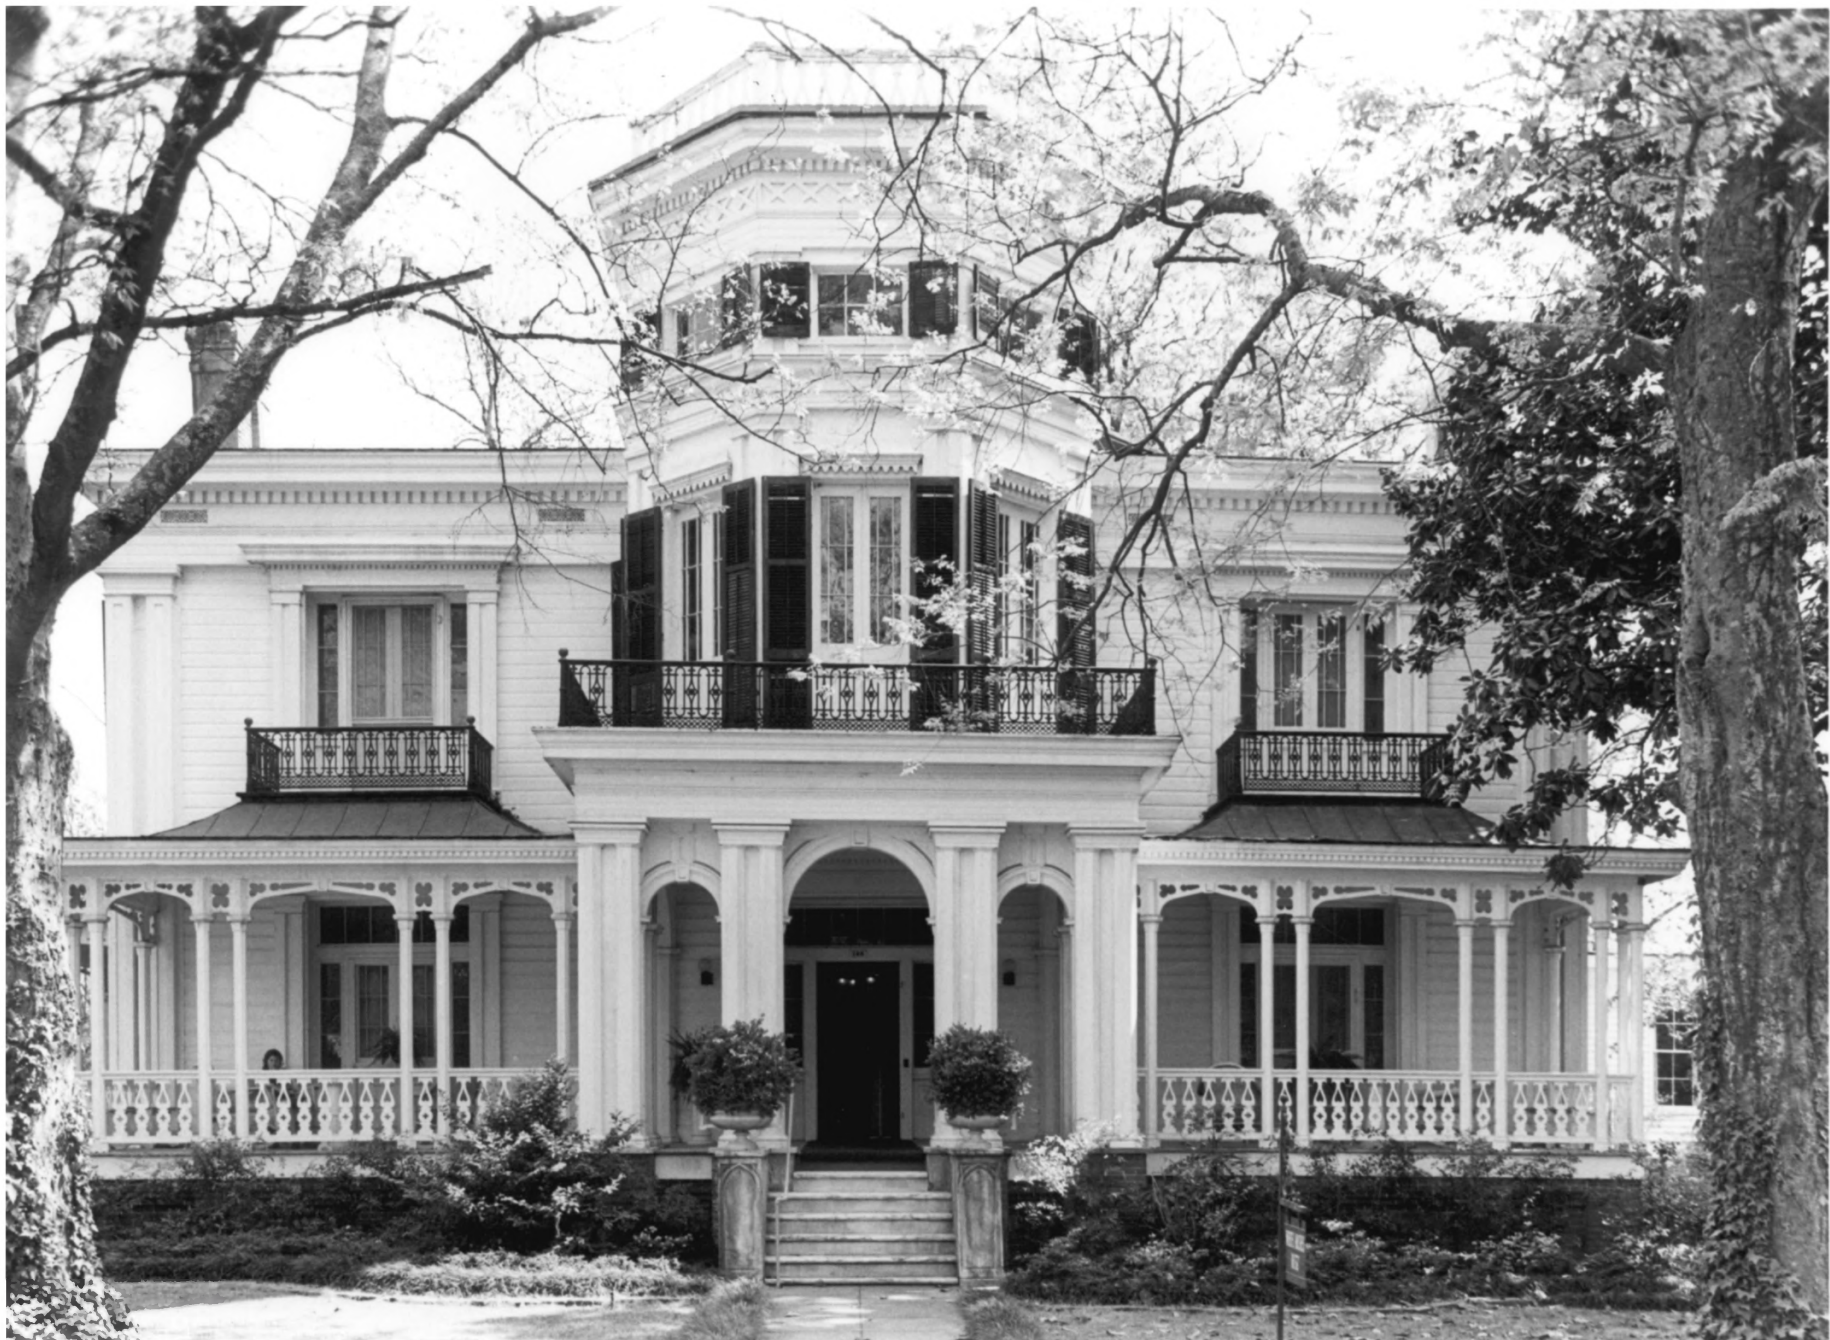
Photo No. 1 - Harris-Banks House
Columbus, Lowndes County, Mississippi
Mary McCahon Shoemaker
April, 1978
Mississippi Department of Archives and History
North elevation (facade), from the north.

The Harris-Banks House stands on a large, half-block lot on the southwest corner of Seventh Street South and Second Avenue South in Columbus, Mississippi. The two-story, three-bay-by-five-bay frame dwelling rests on a brick foundation and is sheltered by a nearly flat roof. The structure is a highly individualistic and elaborately detailed regional expression of the Italianate style combined with picturesque eclecticism. Deeply paneled pilasters set at each corner of the house carry a simplified classical entablature with a frieze pierced to accommodate vents covered with cast-iron grates. The facade, or north elevation, is dominated by a one-and-one-half-story engaged octagonal tower that is elevated on the single-bay, flat-roofed portico that shelters the central entrance. A graceful, classically inspired arcade is set between wooden, octagonal columns clustered around the square supporting piers that carry the tower. On each side of the portico are canopy-roofed galleries with coupled, attenuated, octagonal colonnettes linked by a lacey, millworked frieze composed of Tudor arches and pierced spandrels. Flat, sawn balustrades enclose the galleries.

The engaged tower is lavishly detailed in the eclectic mode with paneled pilasters that carry a full entablature and frame the double-leafed, glazed doors set in four of the five exposed faces on the principal level. Shallow, scalloped hoods, identical to those used throughout, cap each opening. The upper half-story echoes the arrangement of the principal level, with truncated pilasters flanking the small two-by-six-light windows that carry a much richer entablature with a diamond-fret frieze and an overhanging cornice crowned by a sawn balustrade.

In contrast to the tower, all other bays on the facade are set in frontispieces that repeat the detailing of the pilasters at the corners of the house and the accompanying entablature. Transoms are set over the recessed, glazed upper panel, double-leaf doors and side lights on the first level, but are omitted on the second. Etched-glass glazing is used throughout in the side lights and transom.

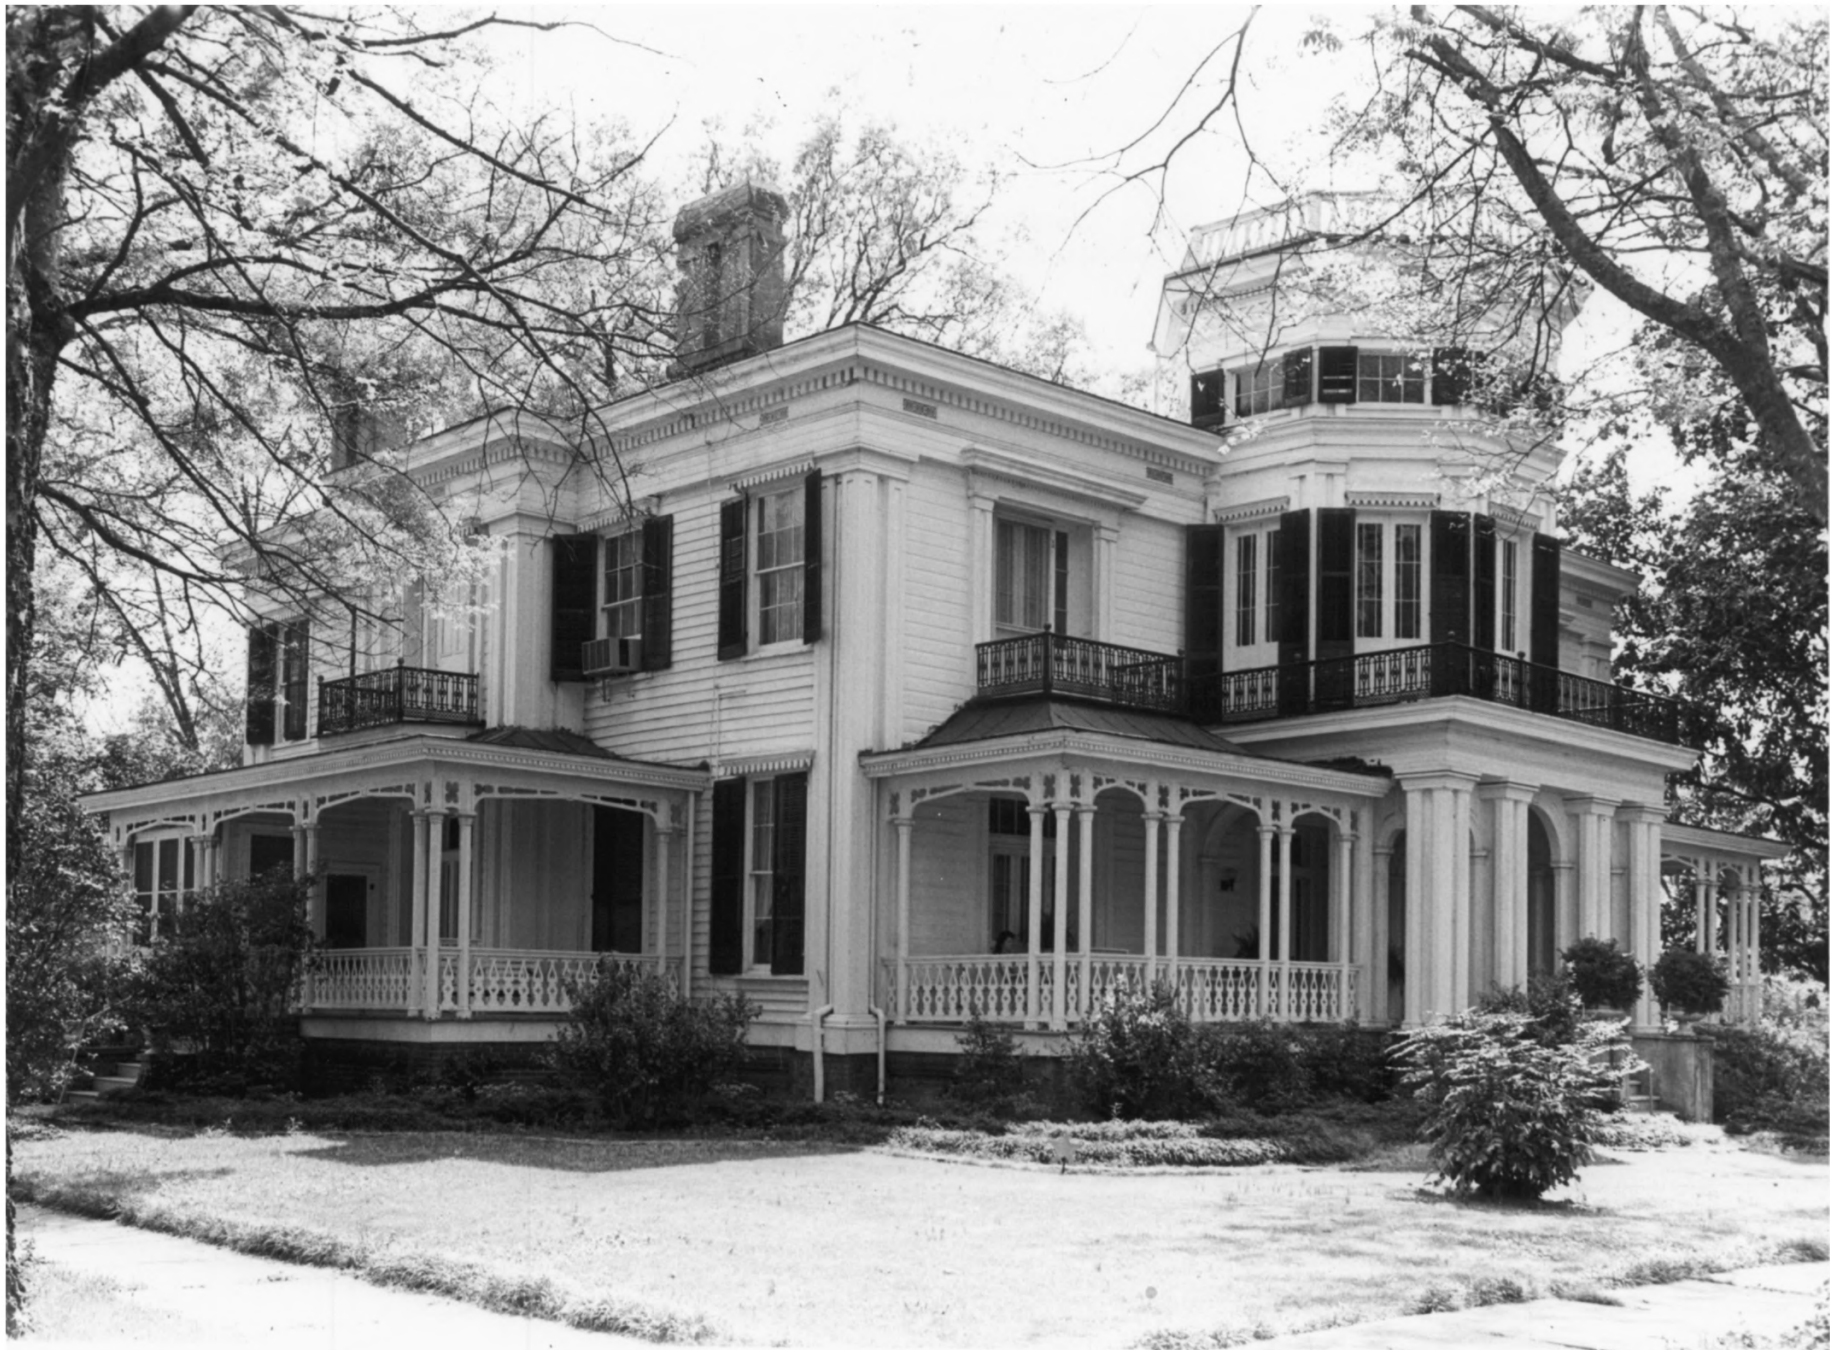
Photo No. 2 - Harris-Banks House
Columbus, Lowndes County, Mississippi
Mary McCahon Shoemaker
April, 1978
Mississippi Department of Archives and History
North (facade) and east elevations, from the
northeast.

A three-bay gallery shelters the first level of the five-bay secondary facade, or eastern elevation, and is detailed with millwork similar to that on the galleries of the main facade. The southernmost bay has been enclosed to accommodate a solarium. A shallow pavilion emphasizes the simply detailed central entrance bay. Set above is a small balcony enclosed by a cast-iron balustrade and serviced by a single-leaf door, flanked by side lights and set in a simple frontispiece. The rear, or southern elevation, features a small, double-tiered gallery with giant-order, octagonal columns.

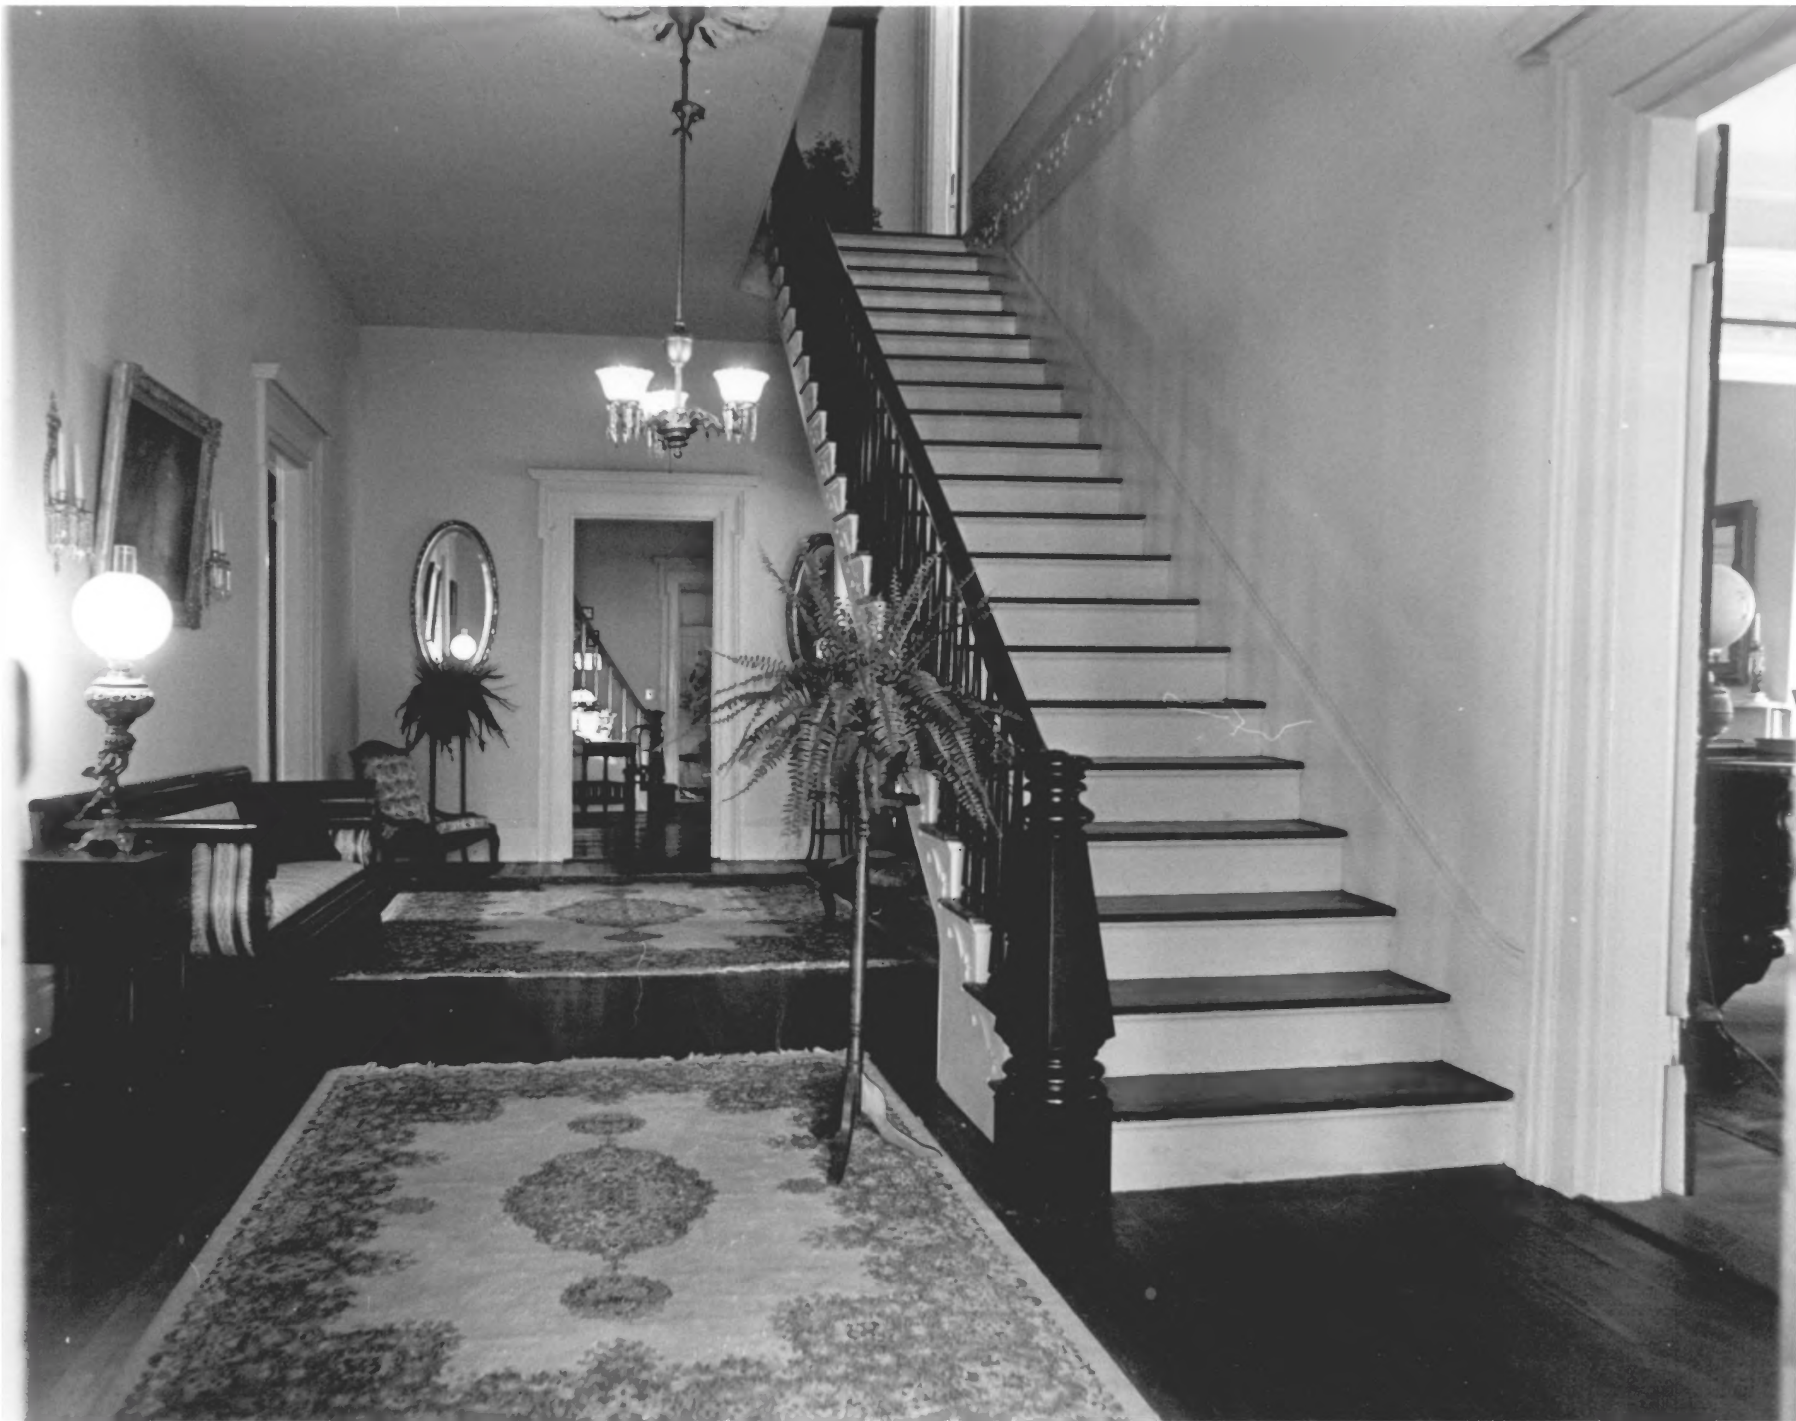
Photo No. 3 - Harris-Banks House
Columbus, Lowndes County, Mississippi
Mary McCahon Shoemaker
April, 1978
Mississippi Department of Archives and History
Interior: first level central stair hall,
looking south.

The L-shaped, double-pile plan of the interior is appointed in a more restrained, more classically inspired manner than the exterior. The wide central hall is dominated by a large, cantilevered dogleg staircase. To the rear of the central hall is a separate, secondary stair hall with a fully finished spiral staircase that provides access to the rear gallery. The western file of rooms contains double parlors, with an attached butler's pantry, which are joined by four-panel, double-leaf sliding doors, while the eastern file contains a library, a large cross hall, and a bedchamber with a separate dressing room off the rear.

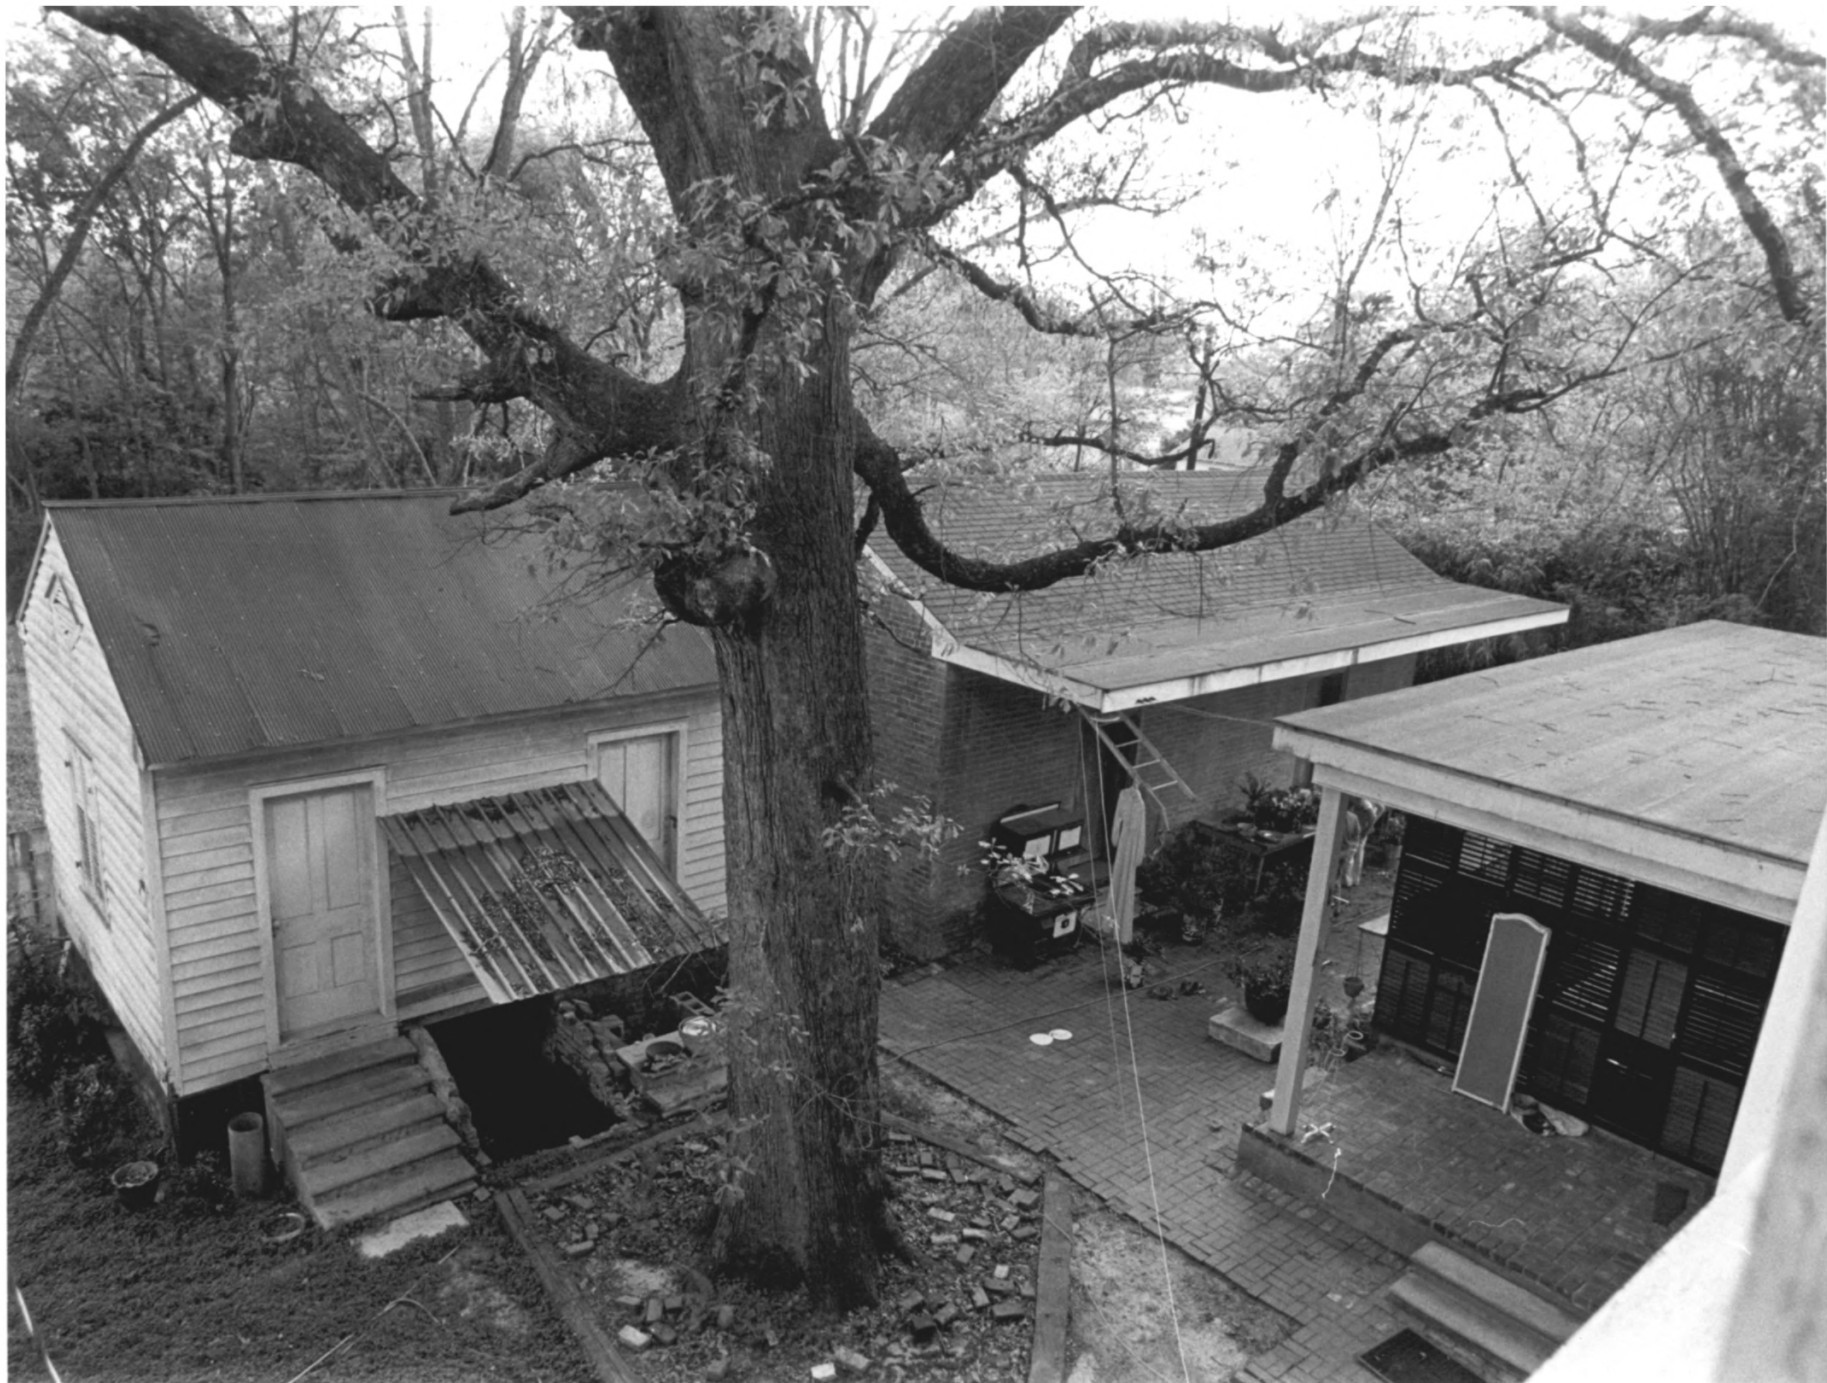
Photo No. 6 - Harris-Banks House
Columbus, Lowndes County, Mississippi
Mary McCahon Shoemaker
April, 1978
Mississippi Department of Archives and History
Outbuildings and service yard to the south-
west of the house. Looking southwest
from the second level of the rear gallery.

Located immediately behind the southwest corner of the house are a late nineteenth-century, two-bay kitchen built of pressed brick and an interesting frame outbuilding. The latter is set on a high brick foundation over a cellar which is reached by a central bulkhead opening.
