National Register of Historic Places Inventory—Nomination Form

China Grove Methodist Church Continuation sheet Walthall Co., Miss.

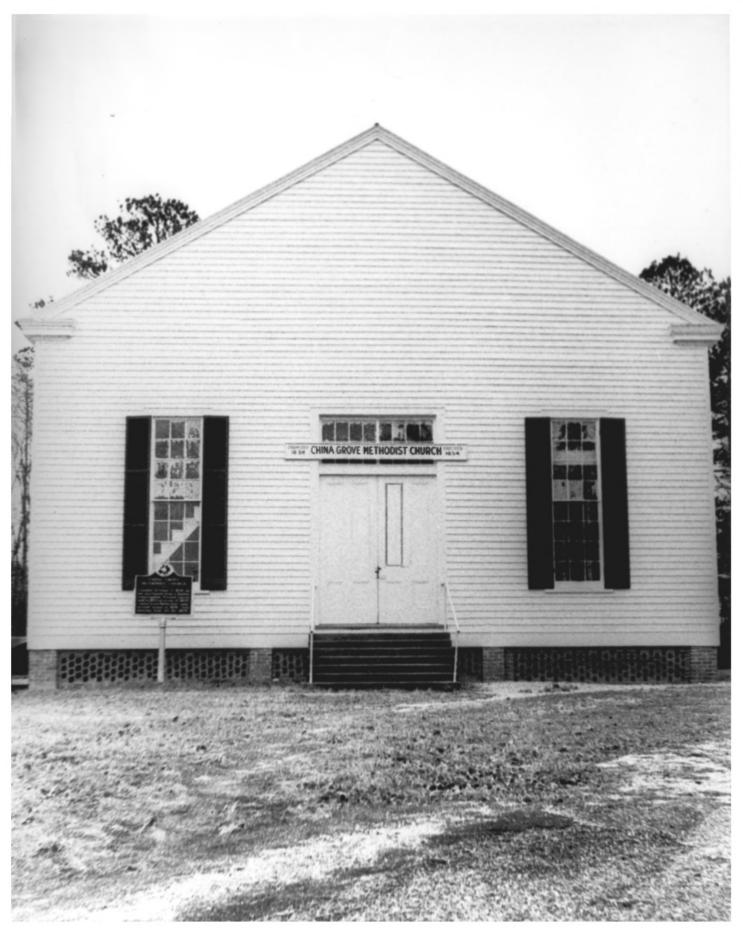
CHINA GROVE METHODIST CHURCH near Tylertown, Walthall County, Mississippi Brian Knippers February 1984 The Tylertown Times View to the east of major facade Photo 1 of 7

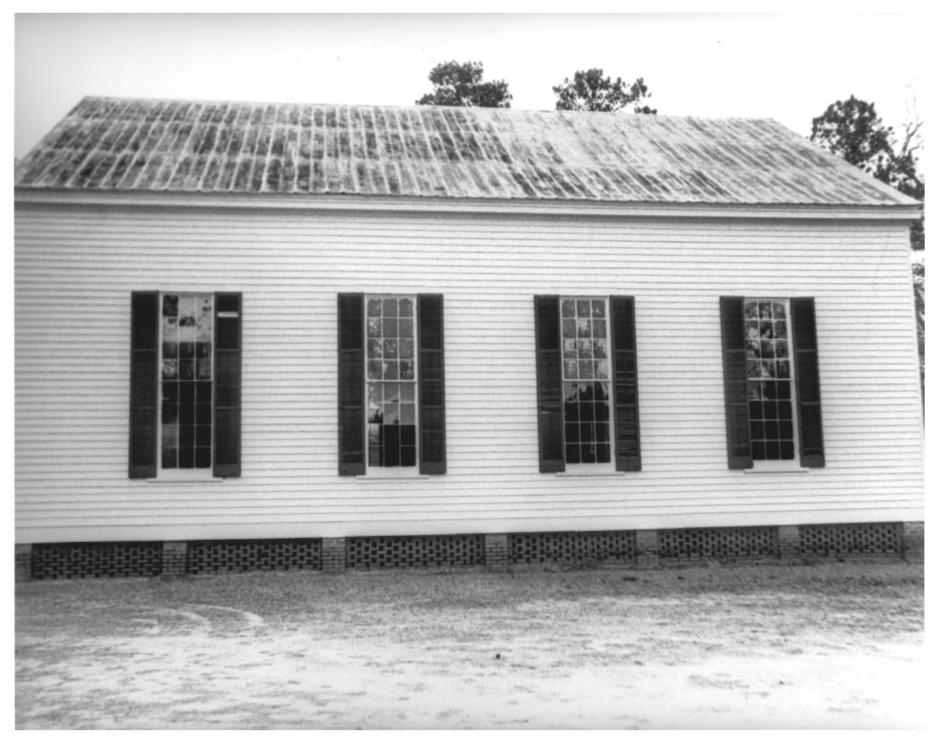
CHINA GROVE METHODIST CHURCH near Tylertown, Walthall County, Mississippi Brian Knippers February 1984 The Tylertown Times View to the south Photo 2 of 7

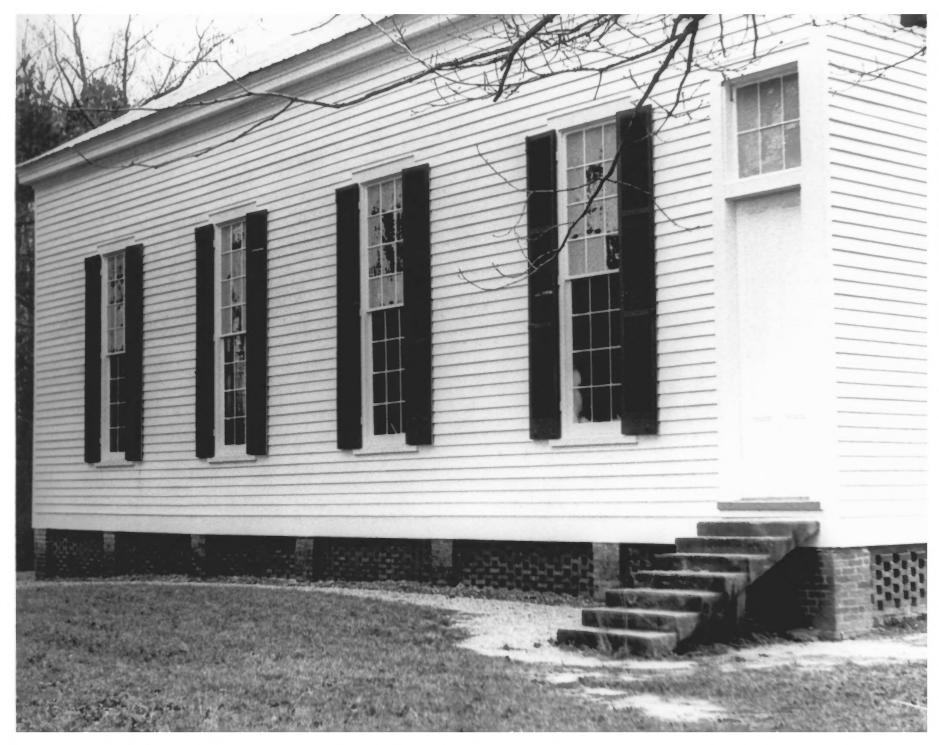
CHINA GROVE METHODIST CHURCH near Tylertown, Walthall County, Mississippi Brian Knippers February 1984 The Tylertown Times View to the southeast Photo 3 of 7

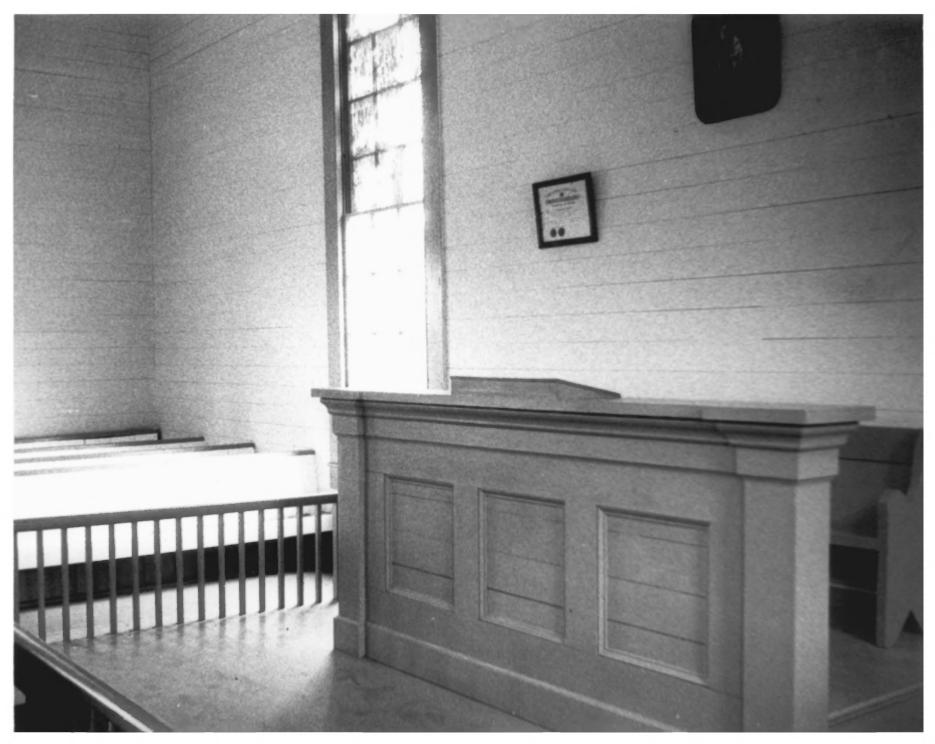
The interior space of the church is undivided with a slave gallery at the western end and a raised chancel area with pulpit at the eastern end. The interior walls and ceiling are finished in horizontal matched boards with a wide, unmolded baseboard, and all interior door and window facings are unmolded. An unusual, apparently original, panel of horizontal matched boards stands behind the center back pew to screen the entrance area from the seating area. The sides and backs of the pews, which are original, are constructed of vertical matched boards, and the pews have shallow seating. The slave gallery, which is supported by molded box columns, is accessed by an open, singleflight stairway that runs in a southerly direction and is entered from an exterior doorway on the northern side elevation. The circular handrail of the stairway, which features rectangular-sectioned balusters, is mortised into the door surround rather than a newel to provide a sense of separation from the seated congregation. The box columns supporting the slave gallery are echoed on the gallery level by additional box columns which extend to the ceiling, and the slave gallery is railed like the stairway. The raised chancel differs from the gallery and stairway by having a turned baluster railing. The well detailed, molded pulpit, which is wide and low, is adorned with pilasters and three rectangular panels of horizontal matched boards.

CHINA GROVE METHODIST CHURCH near Tylertown, Walthall County, Mississippi Brian Knippers February 1984 The Tylertown Times Interior view of pulpit area Photo 4 of 7

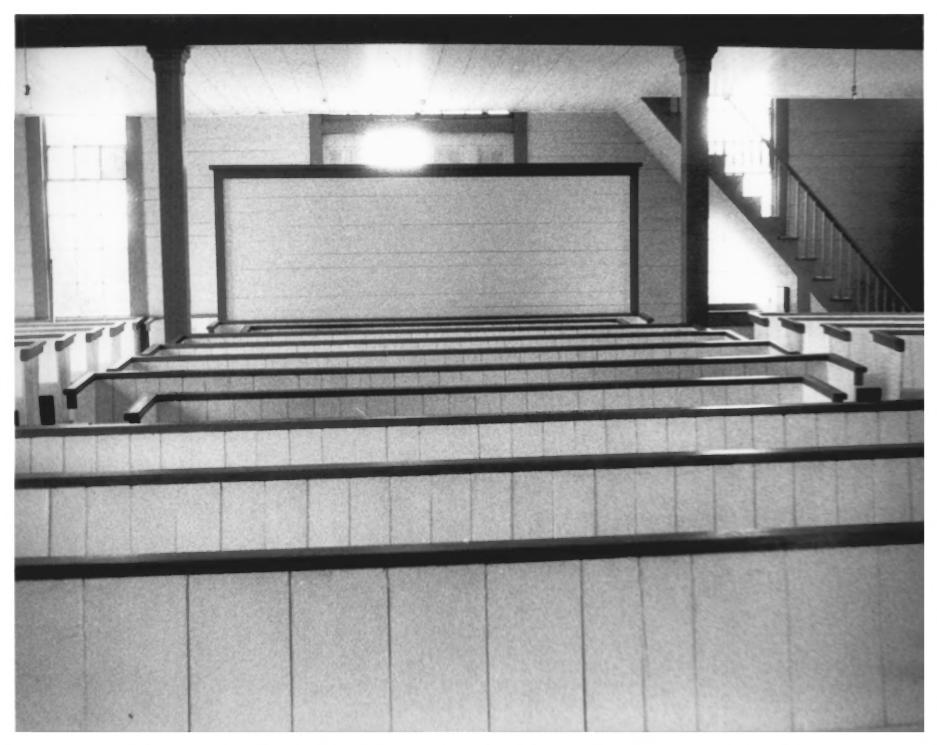
CHINA GROVE METHODIST CHURCH near Tylertown, Walthall County, Mississippi Brian Knippers February 1984 Interior view toward rear of church Photo 5 of 7

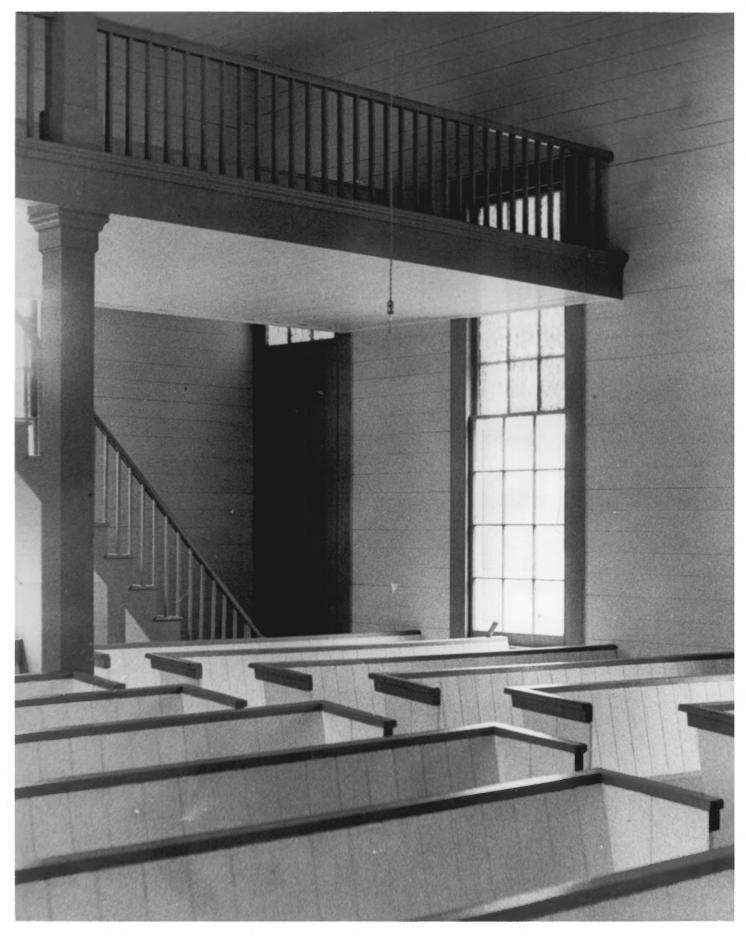
CHINA GROVE METHODIST CHURCH near Tylertown, Walthall County, Mississippi Brian Knippers February 1984 Interior view of slave gallery, stair Photo 6 of 7

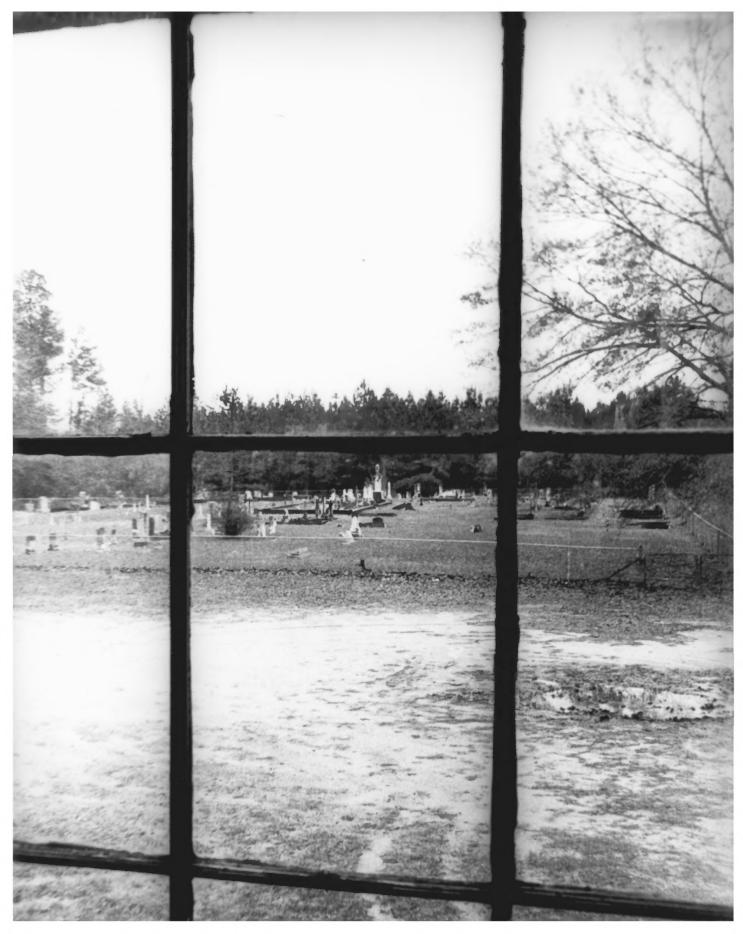
Adjacent to the church building, on its southern side, is the church cemetery.

CHINA GROVE METHODIST CHURCH near, Tylertown, Walthall County, Mississippi Brian Knippers February 1984 The Tylertown Times View south of church cemetery Photo 7 of 7
