**National Register of Historic Places  
Inventory—Nomination Form**

historic Canemount

CANEMOUNT  
Lorman, Claiborne Co., Miss.

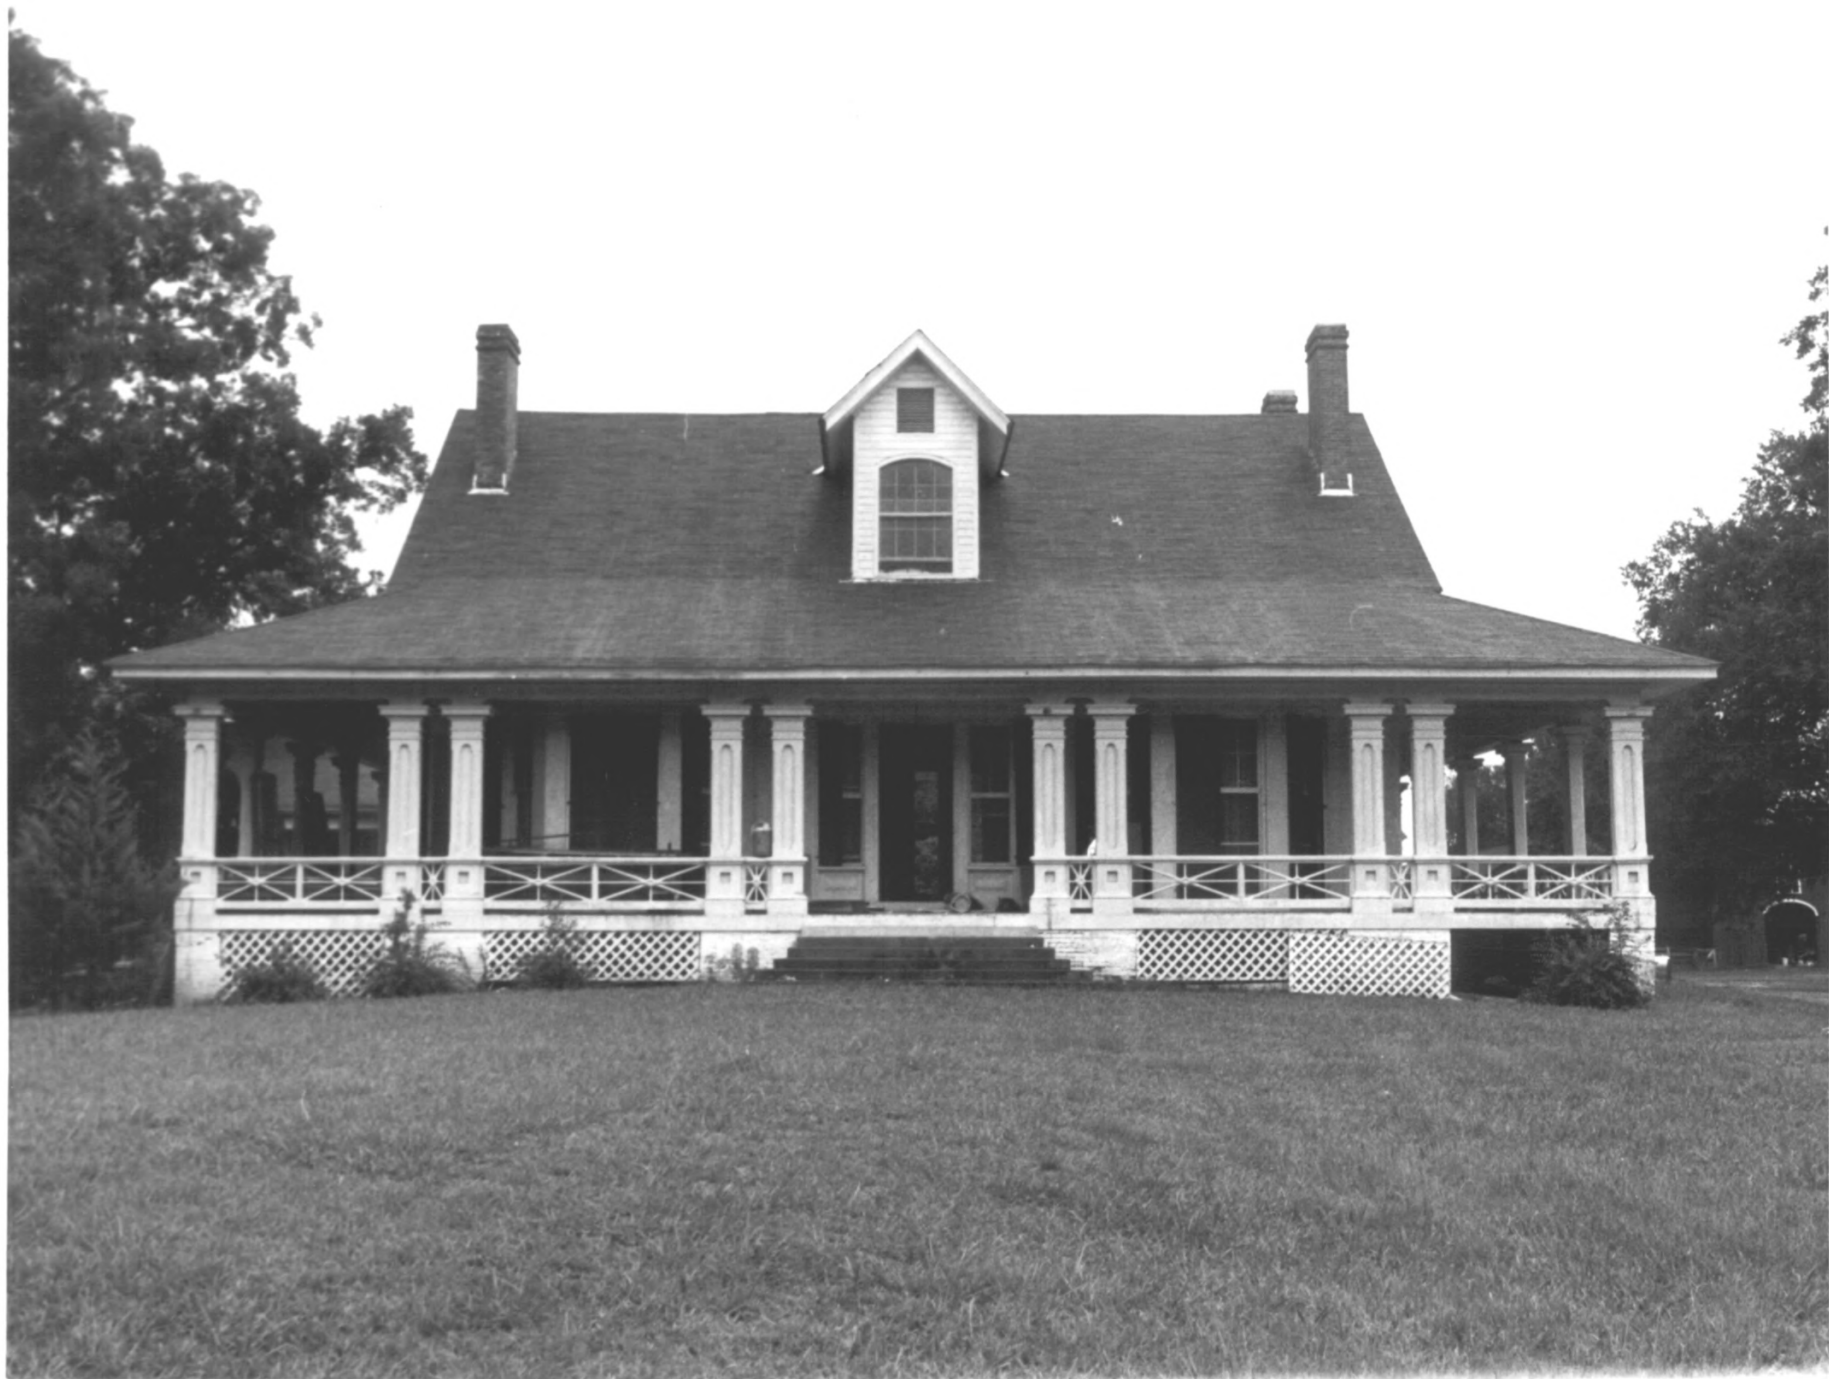
Photo 1 of 7

Looking easterly, the westerly facade of  
Canemount.

Situated on an approximate 1100-acre plantation on the eastern side of State Highway 552 about a mile and a half north of Alcorn State University, Canemount is a story-and-a-half, painted brick, Italianate residence that is situated on a picturesque rise visible from the highway and entered by a graveled plantation drive. The house features a gable on hip roof with wide overhanging eaves sheltering the gallery that wraps around all elevations of the house. Two, inside-end brick chimneys are located at the southern end of the gable roof, and one, inside-end brick chimney is located at the northern end of the roof. Piercing the front and rear slopes of the roof is one, gabled-roof dormer with wide roof overhang. The arched window frames of the dormers are filled with eight-over-eight, double-hung sash. The encircling gallery features a molded cornice supported on the facade by paired wooden columns with molded capitals, neckbands, and arched panels that rest upon paneled pedestals. Matching columns on pedestals, not arranged in pairs, support the side and rear gallery sections. The pedestals are linked by an unusual railing composed of panels of spindles radiating from molded diamonds. All windows of the first story are topped by wooden lintels, are floor length, are filled with varying combinations of either four-over-six, six-over-nine, or eight-over-twelve, double-hung sash, and are closed by original shutter blinds. The westerly facade is divided into three symmetrical bays with a center-bay entrance flanked by polygonal bays. The entrance doorway consists of a single-leaf, molded, four-panel door that is untransomed and set within paneled posts and jambs that are flanked by wide sidelights over molded panels. The sidelights feature four-over-four, double-hung sash. The rear doorway echoes the main entrance except that the sidelights are not set over molded panels.

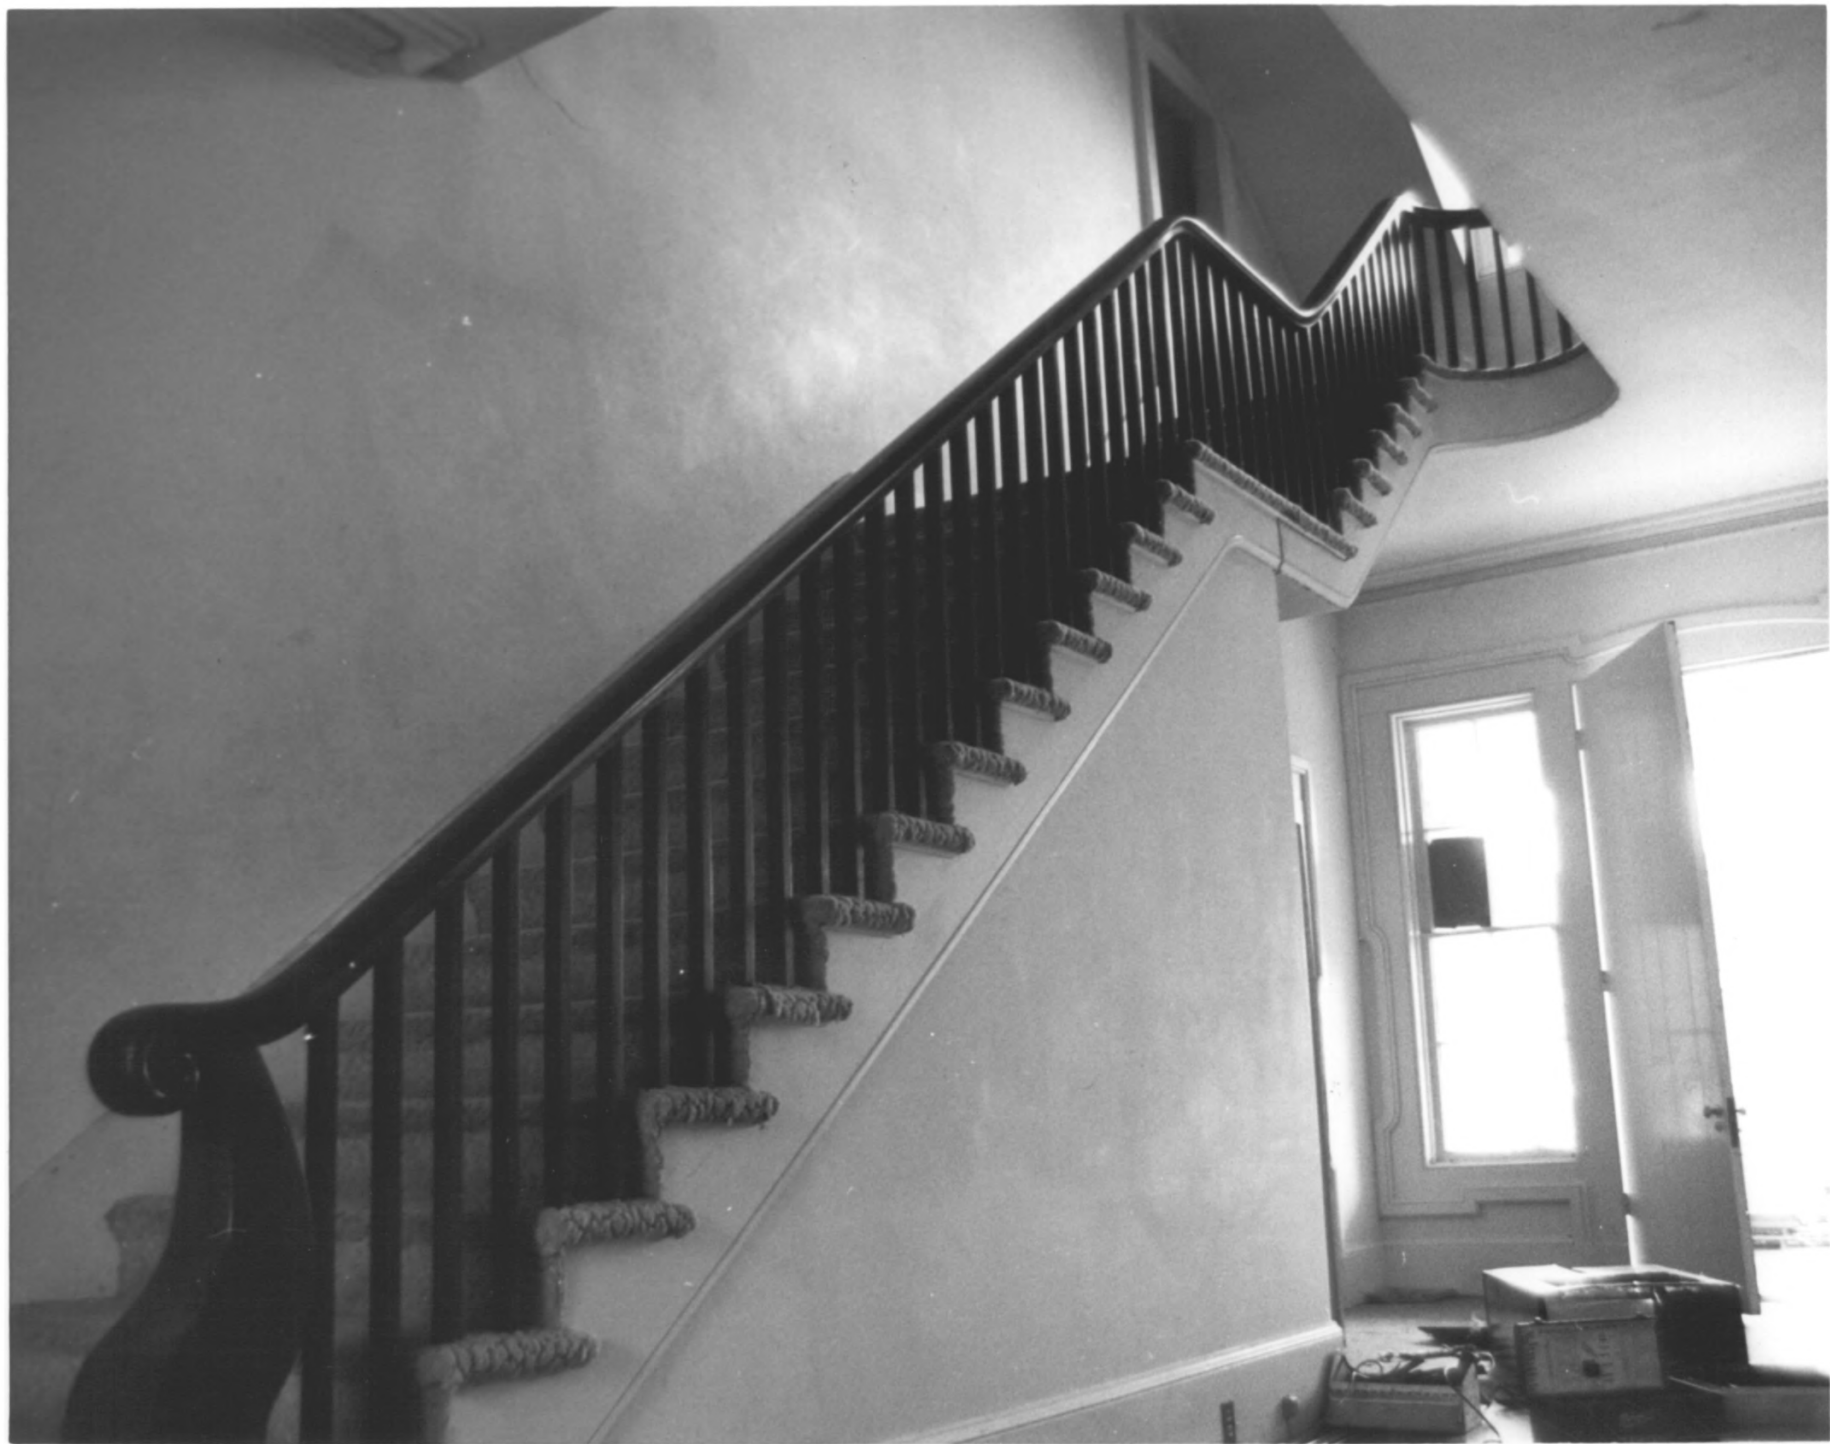
Photo 2 of 7

Looking northeasterly, the stairway of  
the central passage.

The interior plan is basically a double-pile plan with central passage. On the southern side of the hallway are double parlors separated by sliding doors, and, on the northern side, is a large dining room with smaller pantry room to the rear. The interior doors are four-paneled and molded, the door and window surrounds are molded with a single fascia, and the bases are molded. An unusual, possibly unique, feature of the interior millwork at Canemount is found in the door and window surrounds of the first-story hallway and double parlors. These highly distinctive surrounds have a recessed central tablet and an elliptical indentation slightly below midway in the vertical side pieces. Ornamental plaster work at Canemount consists of molded cornices and three foliated ceiling centerpieces. The mantel pieces of the three major downstairs chambers are executed in marble. Access to the second story is provided by an unusual stairway which runs along the northerly hall wall. This stairway, which features an S-curved newel and rectangular-sectioned balusters, is a single-flight stair with intermediate landing that runs in an easterly direction. The second-story is more plainly trimmed with unmolded bases, unmolded architrave surrounds, and plain, diminutive marble mantel pieces. Unusual features of the second story are the doorways with original operable transoms and the floor plan, which features two larger bedrooms with smaller rooms to the eastern rear and double closets to the western front that are accessed from the bedrooms and the hallway.

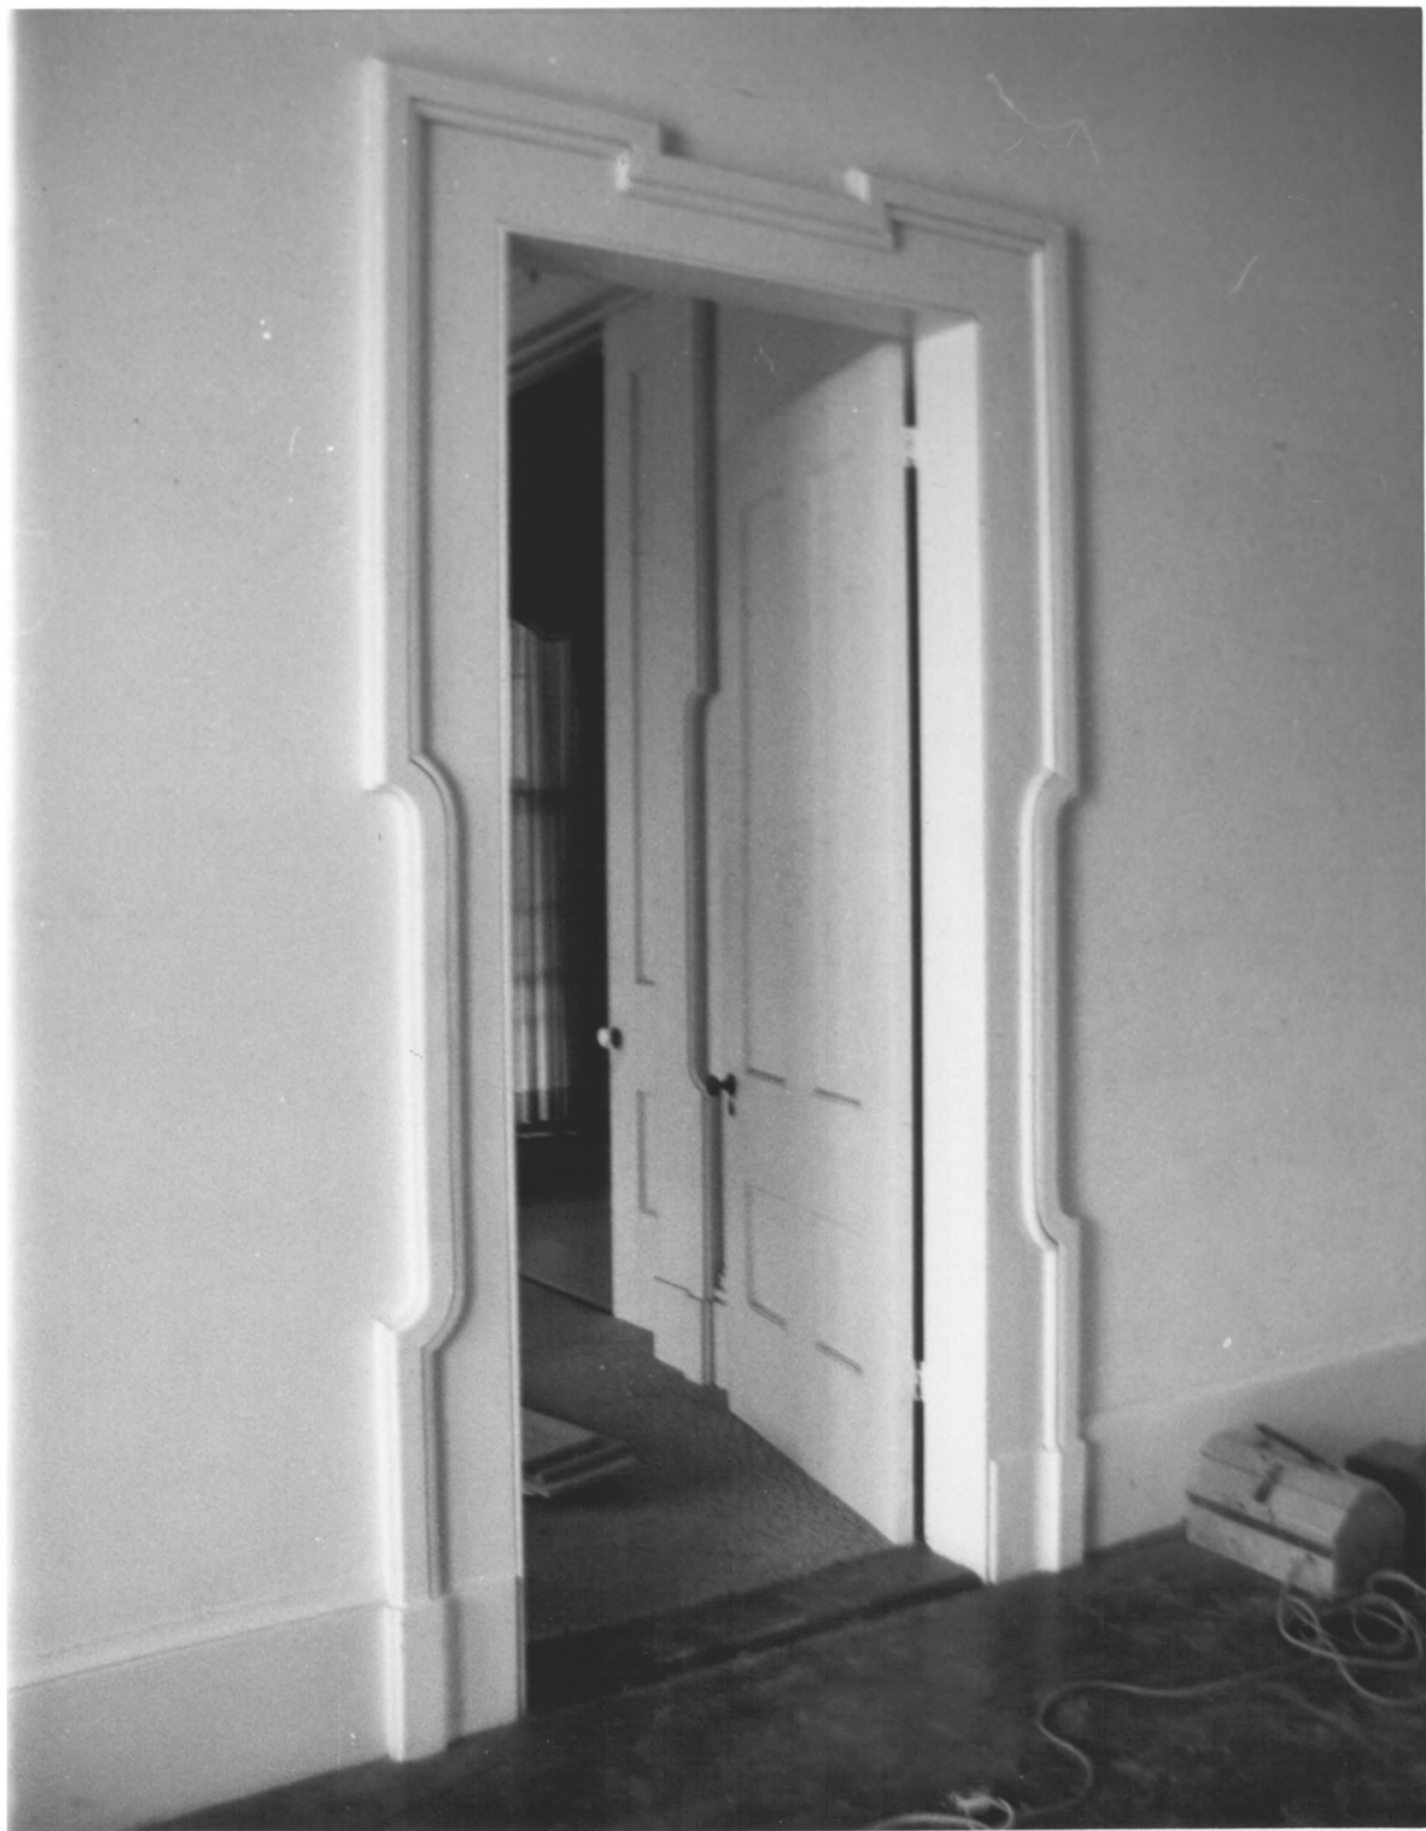
Photo 3 of 7

Looking southerly, the unusual doorway  
surround of Canemount.

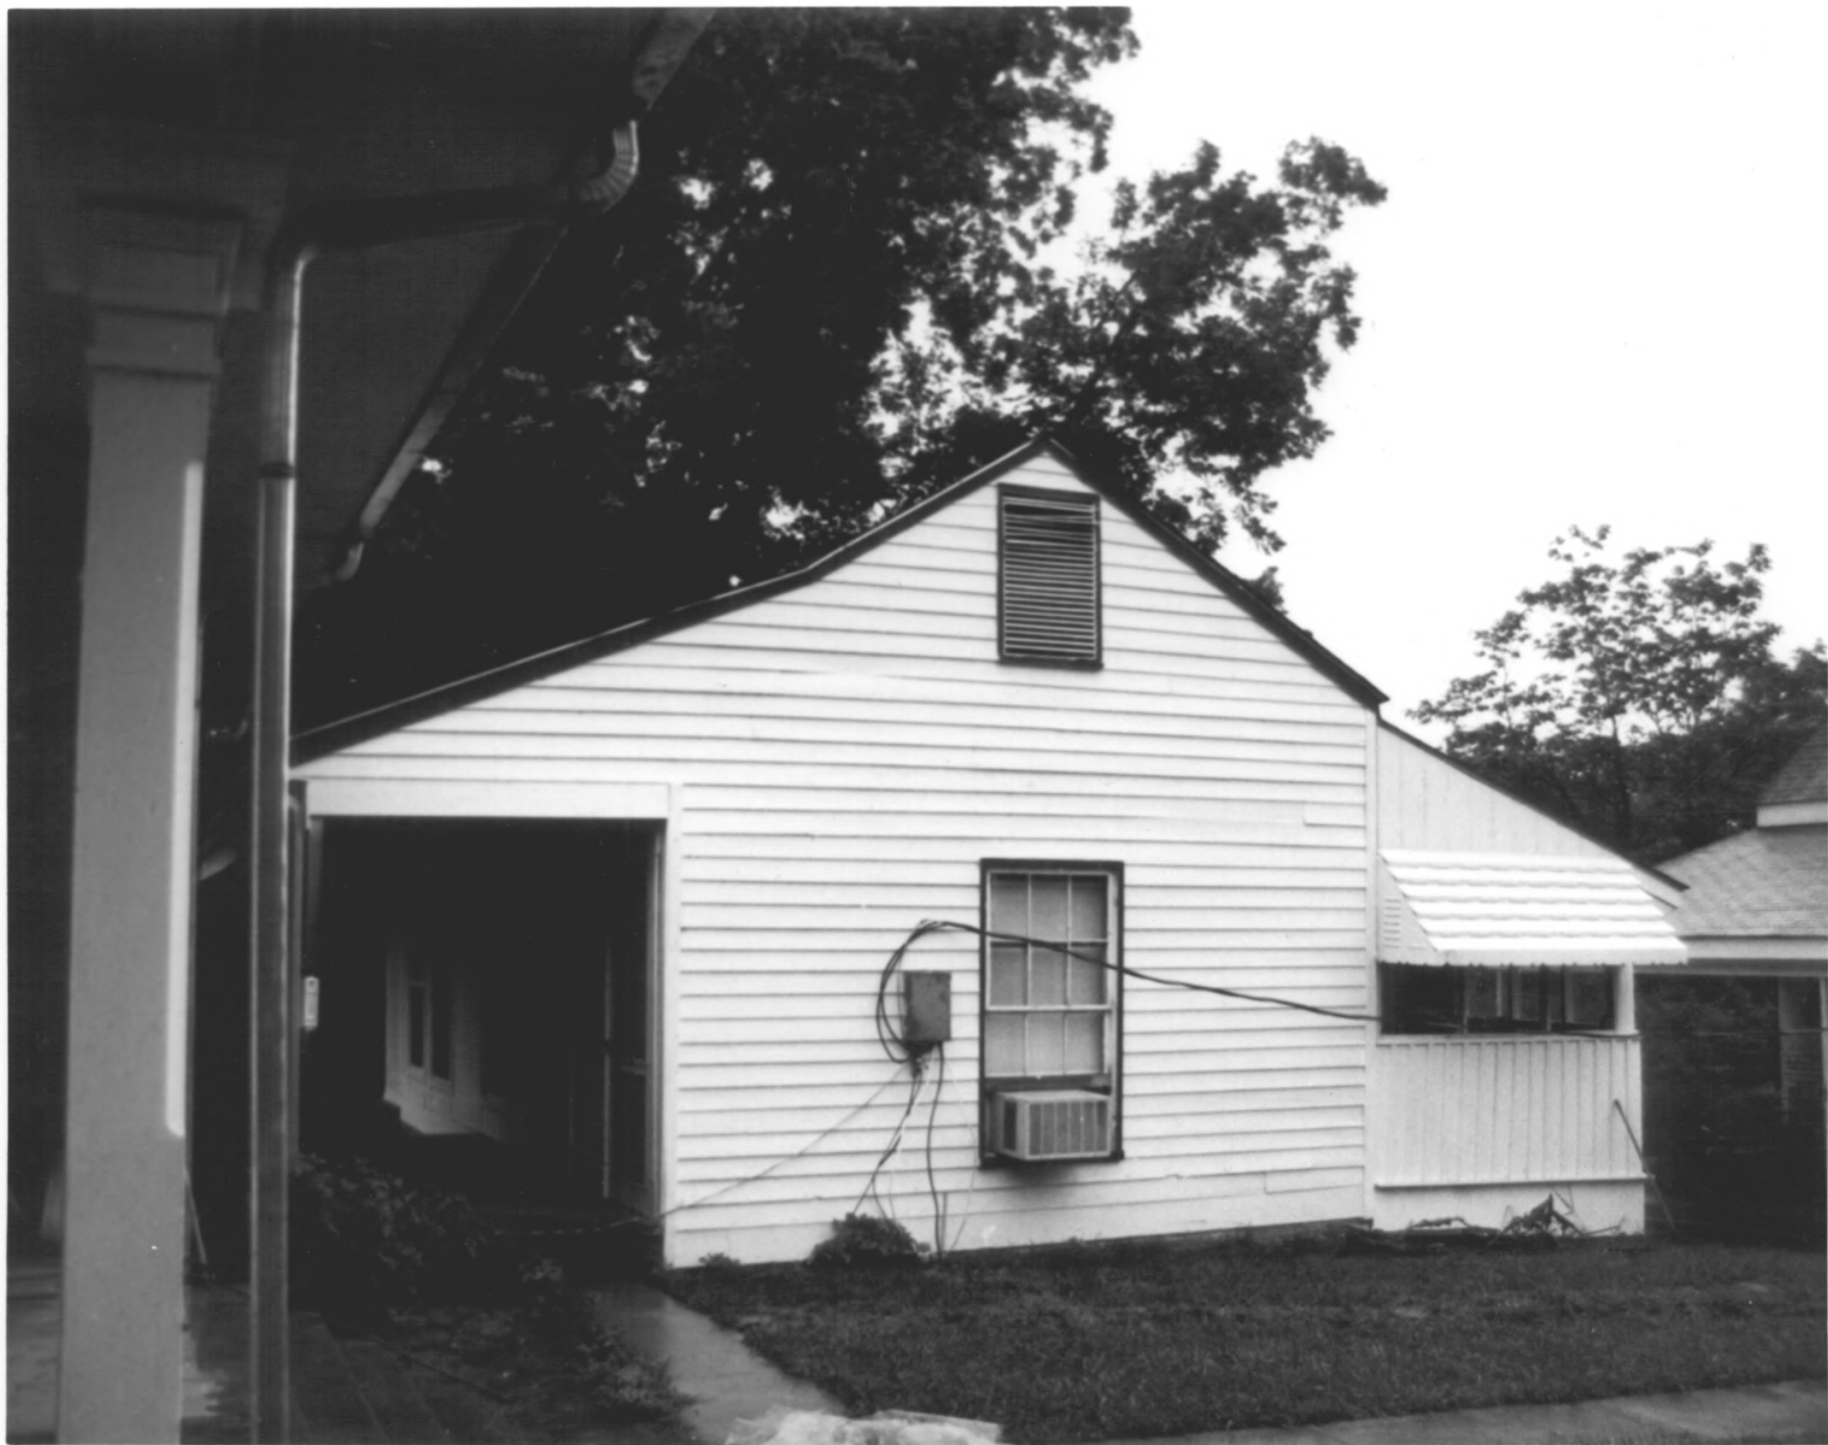
Photo 5 of 7

Looking northerly, the southerly gable end of the frame tenant building located at the northeast corner of the house.

An array of original outbuildings have survived. At the northeast corner of the house is located a one-story six-bay frame building with broken-slope gable roof and front gallery. This well-detailed building features unmolded door and window surrounds with corner blocks and plinths and a beaded-board facade finished with a base. To the rear of this building are a one-story, gabled-roof brick outbuilding with a dairy trough and a one-story board-and-batten tenant house with undercut front gallery. Also surviving are an additional board-and-batten tenant house with gabled roof and undercut gallery and the original carriage house.

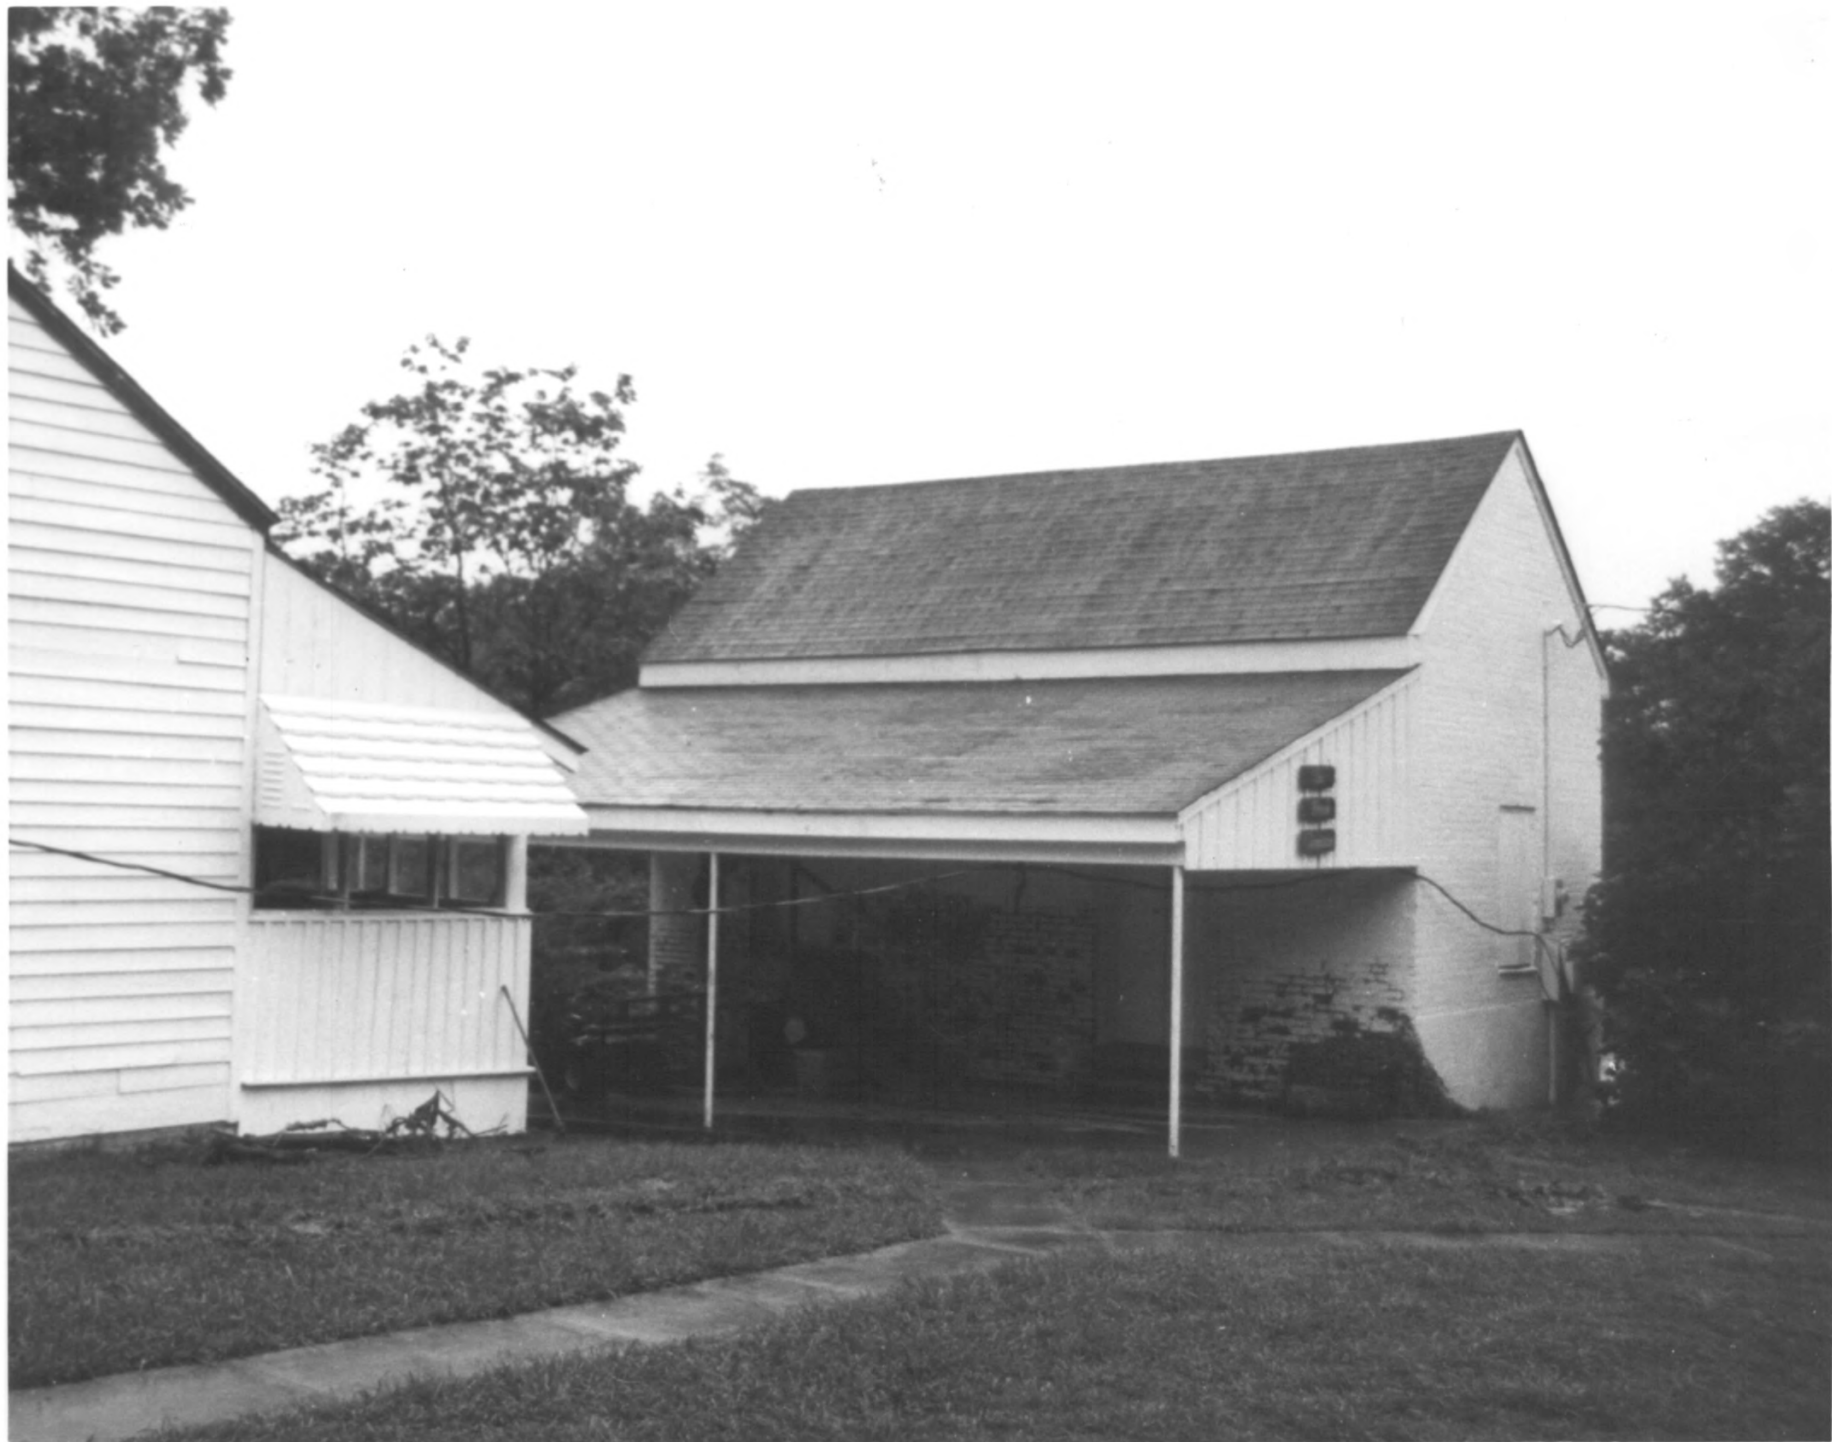
Photo 6 of 7

Looking northeasterly, the westerly facade and the southerly side elevation of the brick outbuilding with dairy and a portion of the southern elevation of the frame outbuilding at the rear of the house.

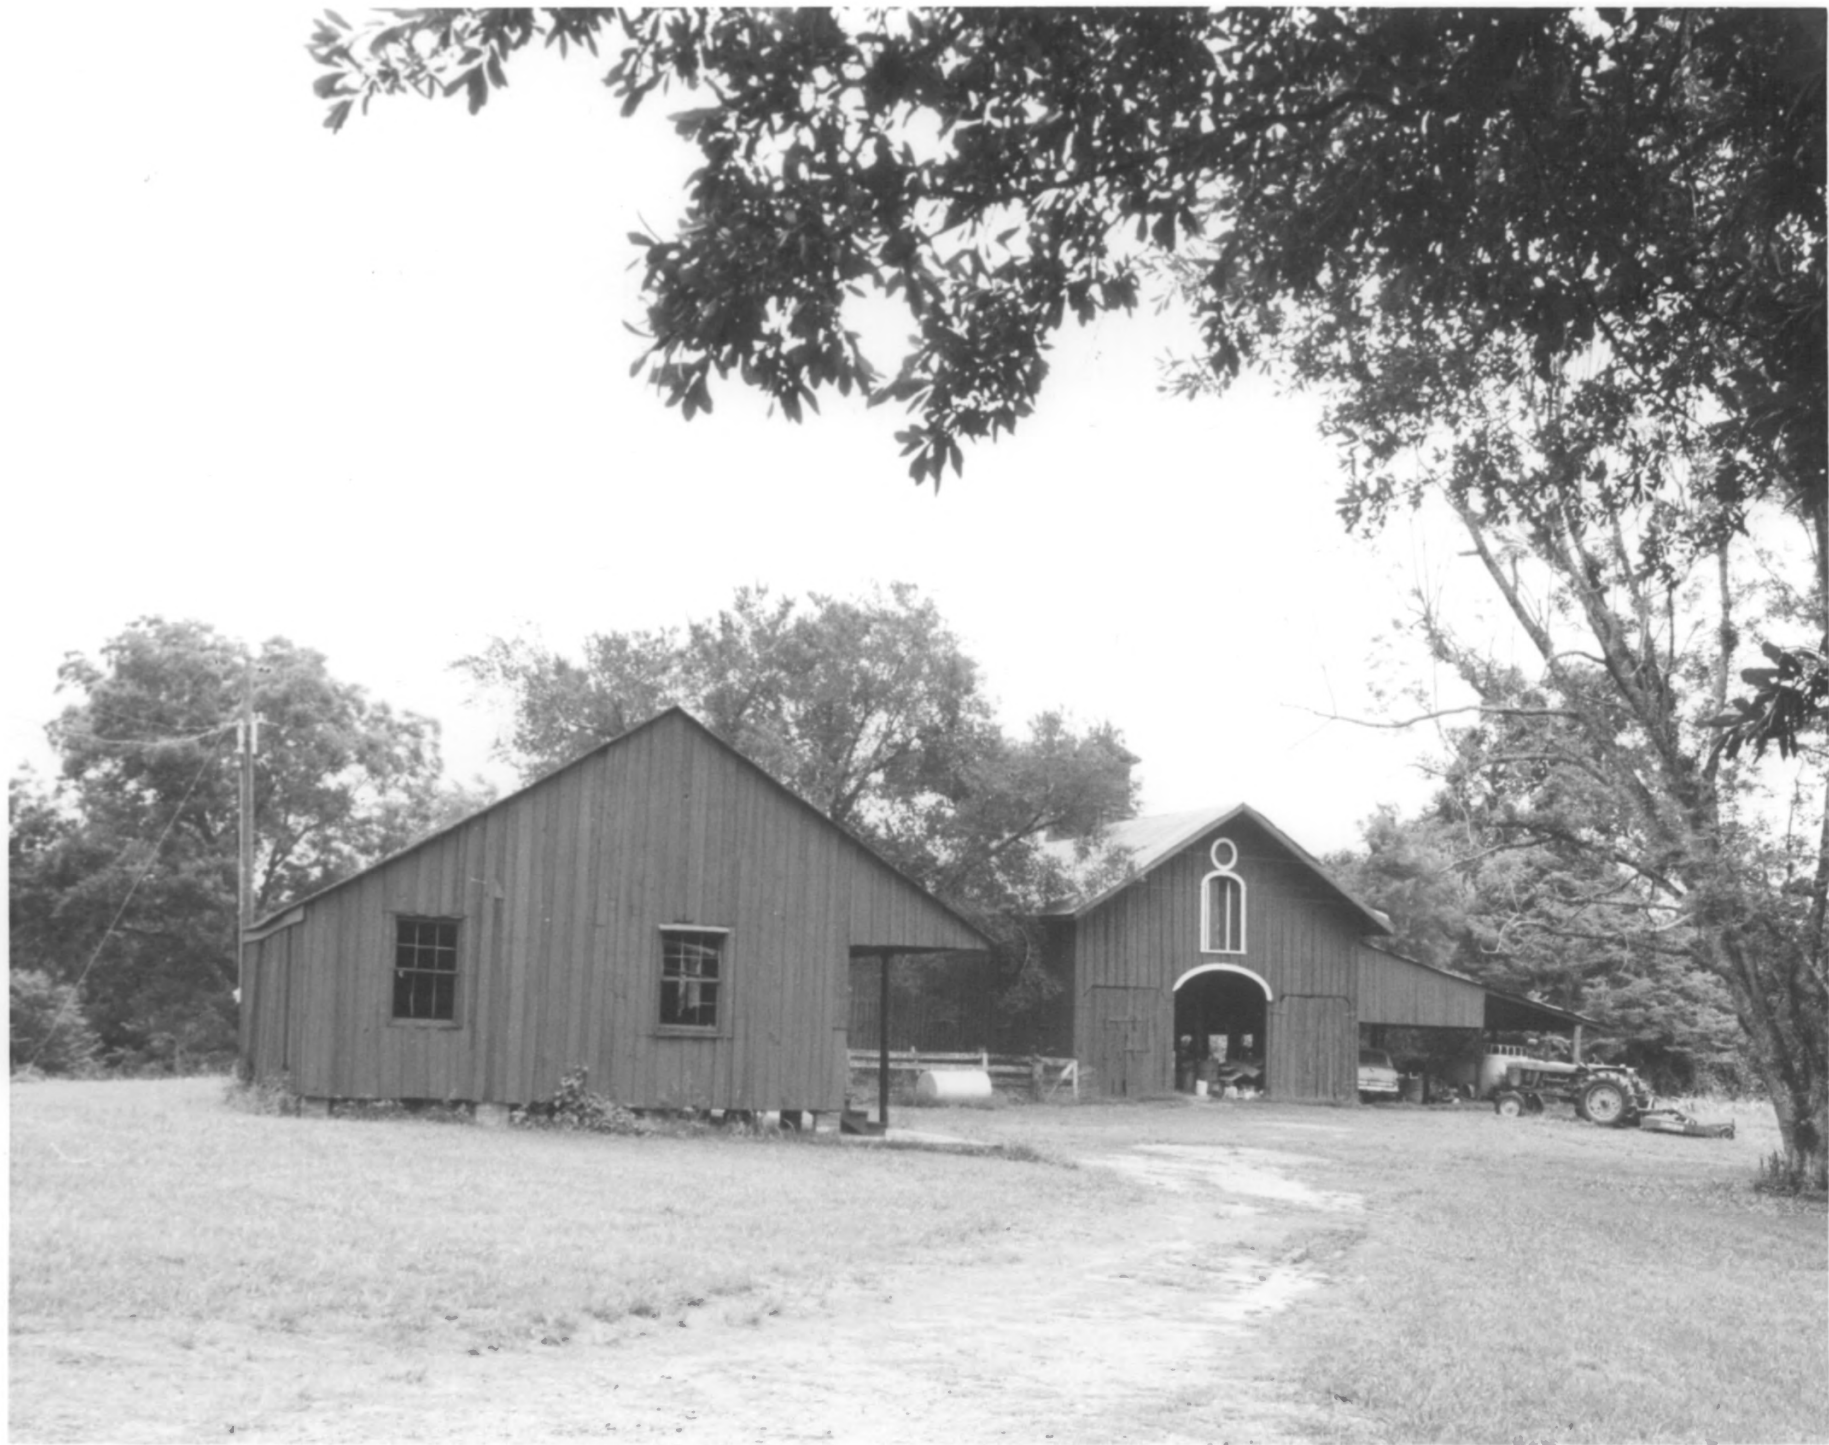
Photo 7 of 7

Looking easterly, the westerly facade of the carriage house and the westerly side elevation of a tenant house.
