**NATIONAL REGISTER OF HISTORIC PLACES  
REGISTRATION FORM**

historic name: Robertson - Yates House  
other names/site number:

street & number: 5000 Robertson Gin Road  
city or town: Hernando vicinity X  
state: Mississippi code: MS county: DeSoto code: 033 zip code: 38632

Robertson-Yates House  
DeSoto County, Mississippi

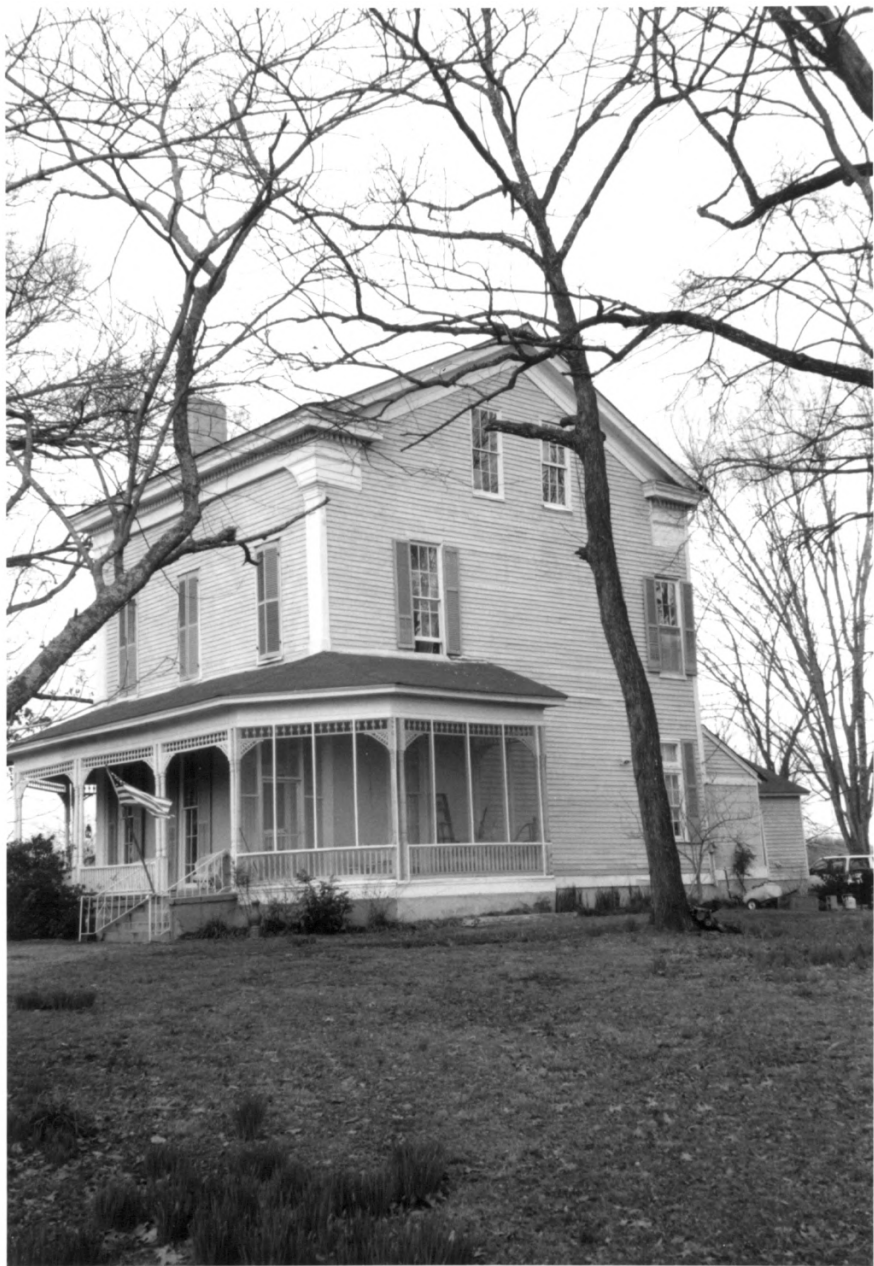
Photo 1 of 6

Oblique exterior frontal view  
from south west

The front façade of the house has three bays. Each bay of the upper story contains a six-over-six double-hung window covered by louvered shutters. On the lower story, each of the two northern bays contains a floor-length, six-over-nine double-hung window with louvered shutters. The southern bay contains the entrance, consisting of a single-leaf door framed by triple-light sidelights and surmounted by a single-pane transom. The corners of the façade are ornamented with paneled pilasters which support an entablature of unusual form: it has a complete cornice and denticulated frieze, but the architrave has been omitted except for two curving sections atop each pilaster. The entire entablature, including the partial architrave, wraps around the corners to extend a short distance on the north and south walls.

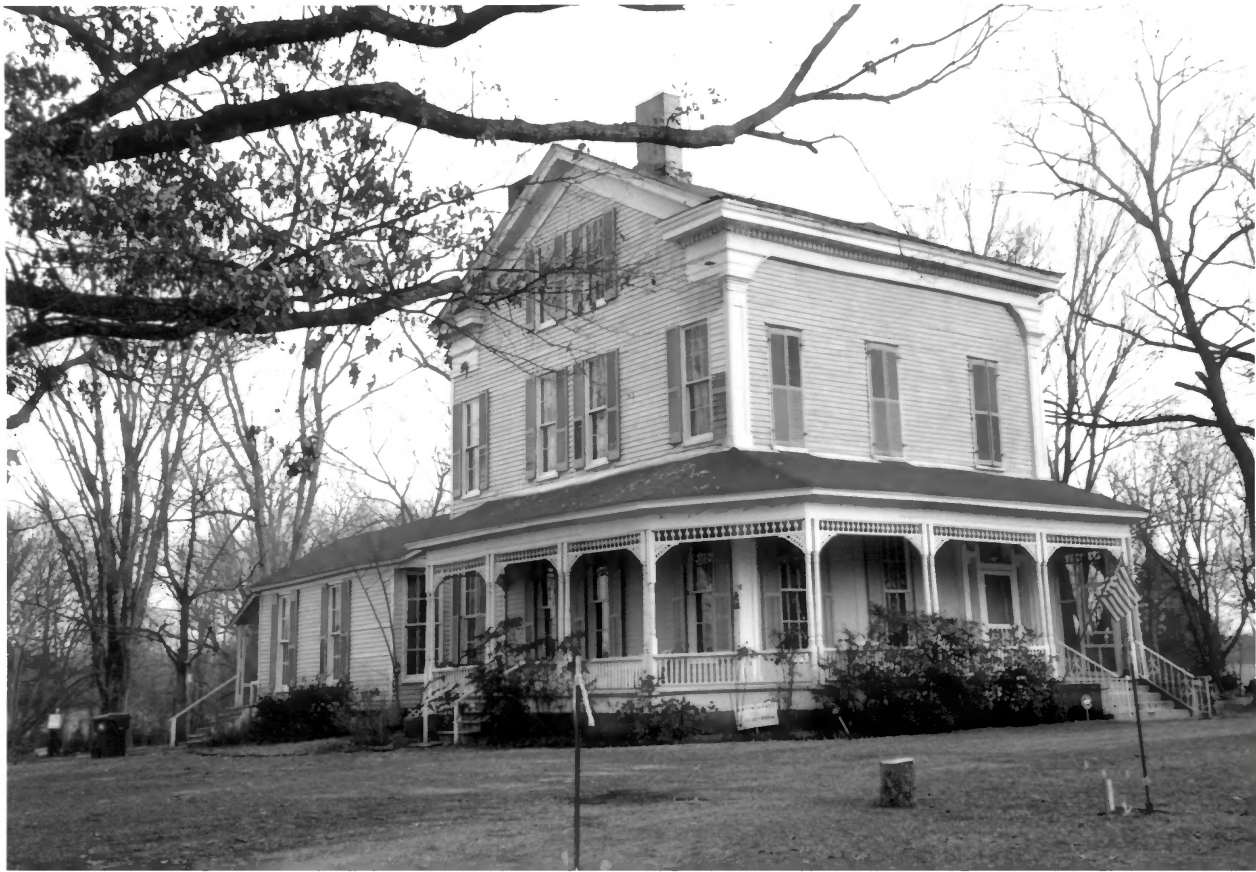
photo 2 of 6

Oblique exterior frontal view  
from northwest

The north wall of the house has four windows on each story. On the lower story are three six-over-nine windows, with louvered shutters, within the area enclosed by the porch, and a six-over-six window to the east beyond the porch, with three six-over-six windows on the one-story rear wing. On the upper story of the north wall are four six-over-six double hung windows with shutters. In the gable are two smaller six-over-six windows with shutters. The gable is trimmed with a raking cornice with a wide, simple frieze. At either side are the partial entablature sections that have wrapped the corners from the front and rear walls.

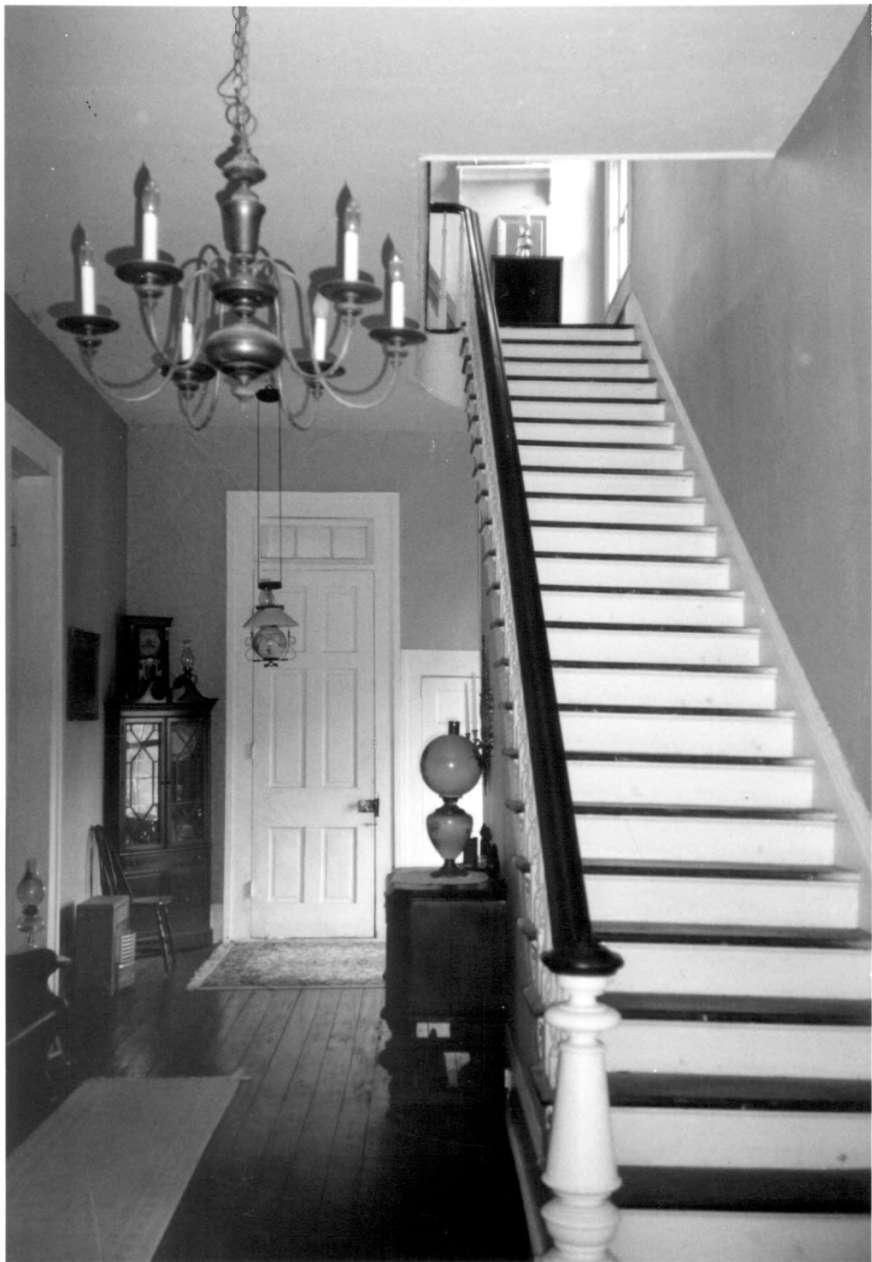
photo 3 of 6

Stair hall

The front door opens into a stair hall that extends the full depth of the south side of the house. Within this hall is a straight-run staircase with newel-post and balusters of mid-nineteenth century design. On the north side of the hall are doors opening into the two main first-story rooms. The ceiling height is 12 feet. The floor is made of six-inch wide yellow poplar boards.

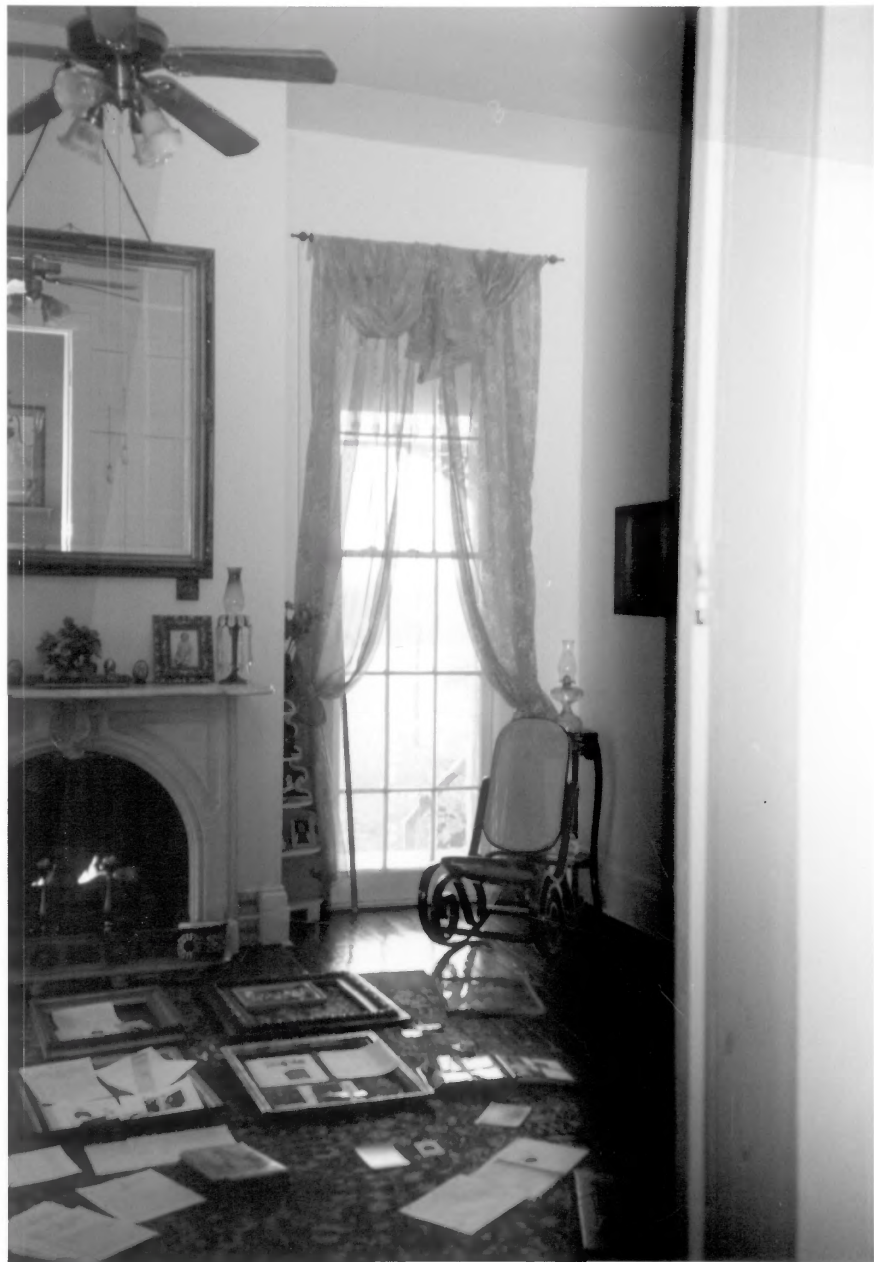
Photo 4 of 6

Front parlor, view to ~~west~~ north

Immediately to the left of the stair hall, upon entry, is the front parlor. It features a round-arched Italianate marble mantel on its north wall. On the east side of the front parlor is a wide set of sliding doors that open to the second parlor, which contains a simple pilastered Greek Revival mantel, above which is an ornate Late Victorian mirrored overmantel.

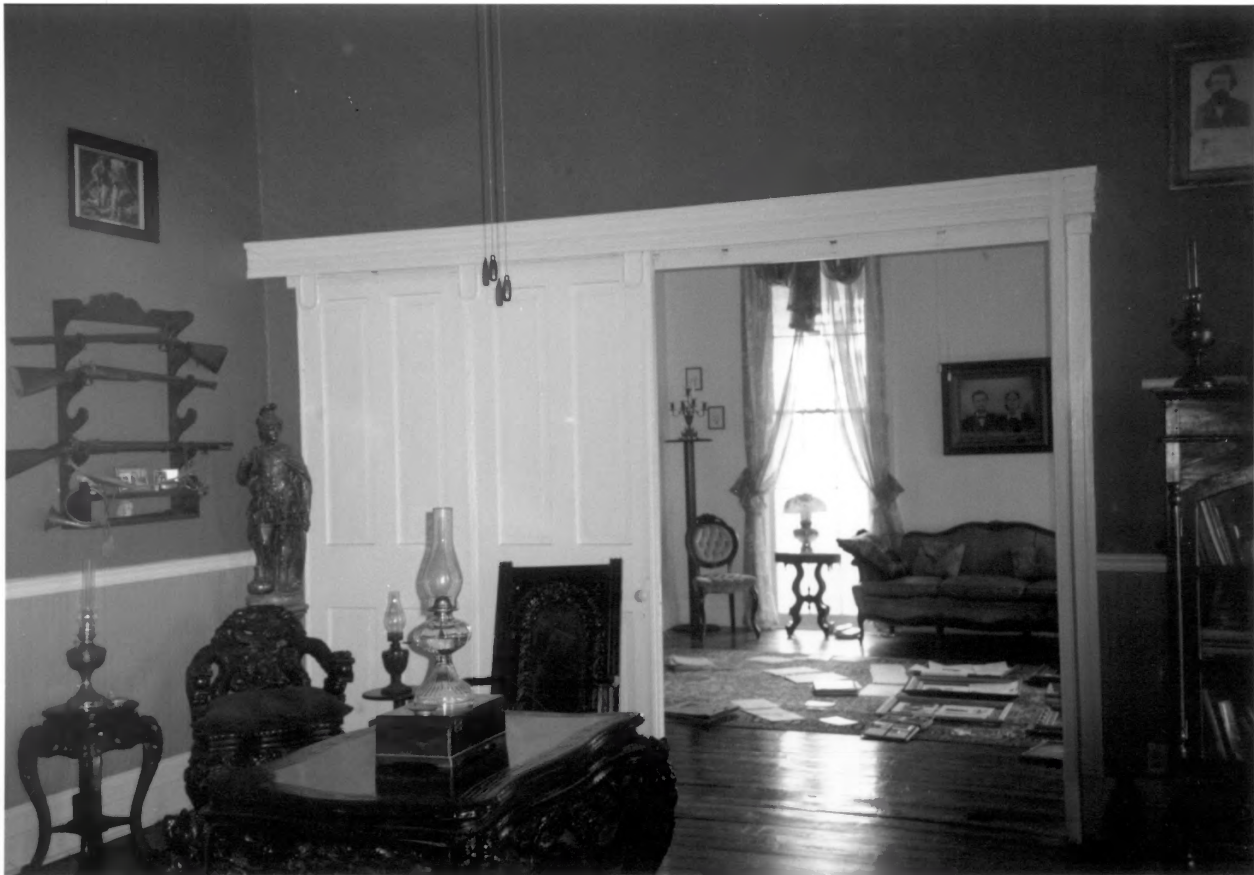
photo 5 of 6

opening between the front parlor  
and back parlor, view to west

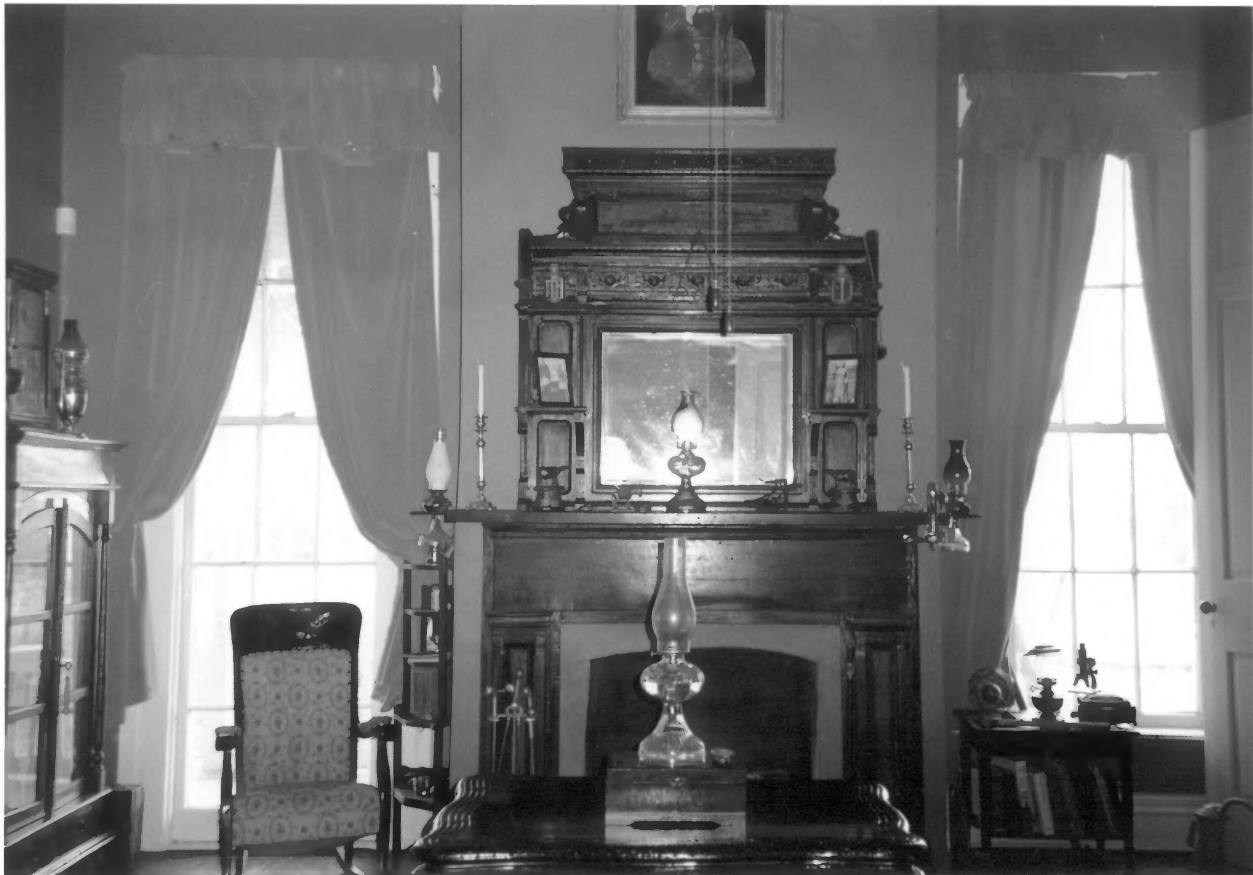
photo 6 of 6

back parlor, view to north
